**REPORT NUMBER: SINCAP-CAL-22-003**

**NEW CAR ASSESSMENT PROGRAM (NCAP)  
MOVING DEFORMABLE BARRIER SIDE IMPACT TEST**

**Hyundai Motor Company  
2022 Hyundai Ioniq 5  
Five Door SUV**

**NHTSA No: M20224202**

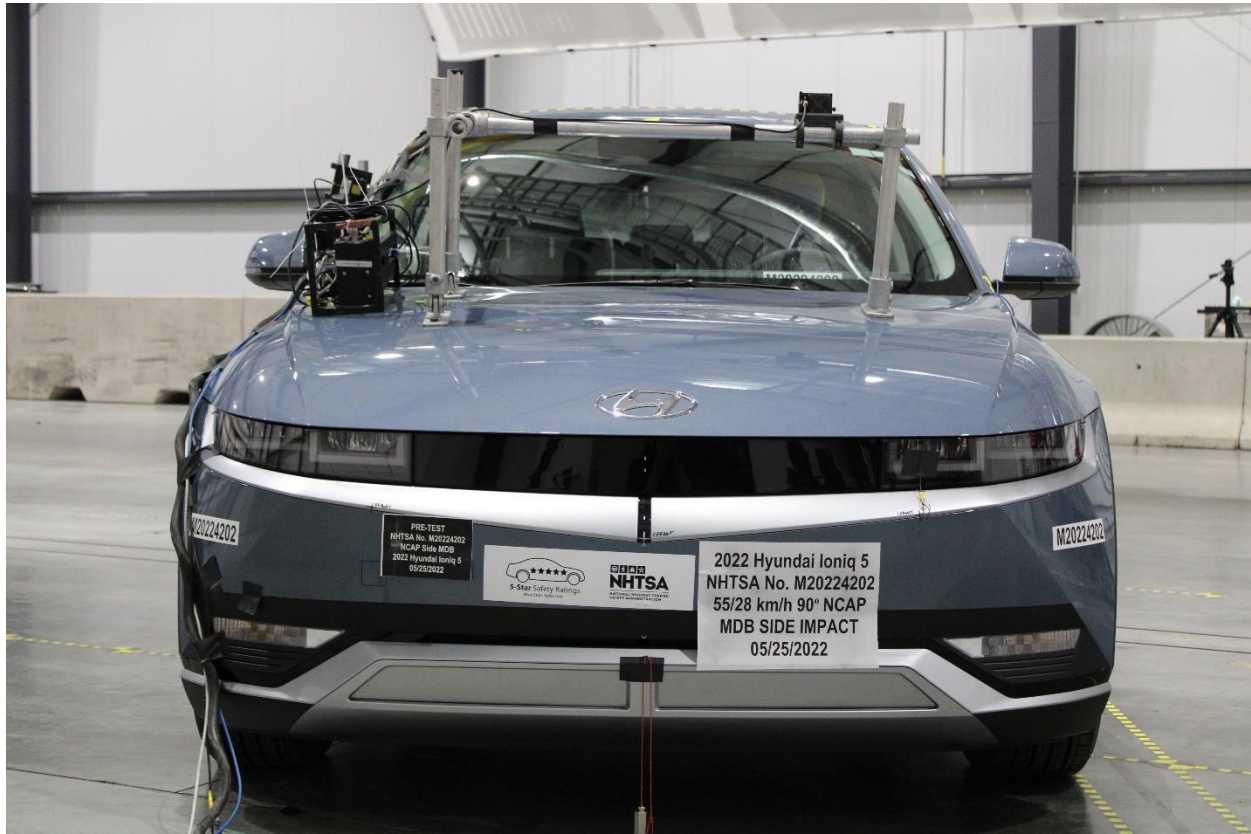
**Figure A-3: Pre-Test Frontal View of Test Vehicle**

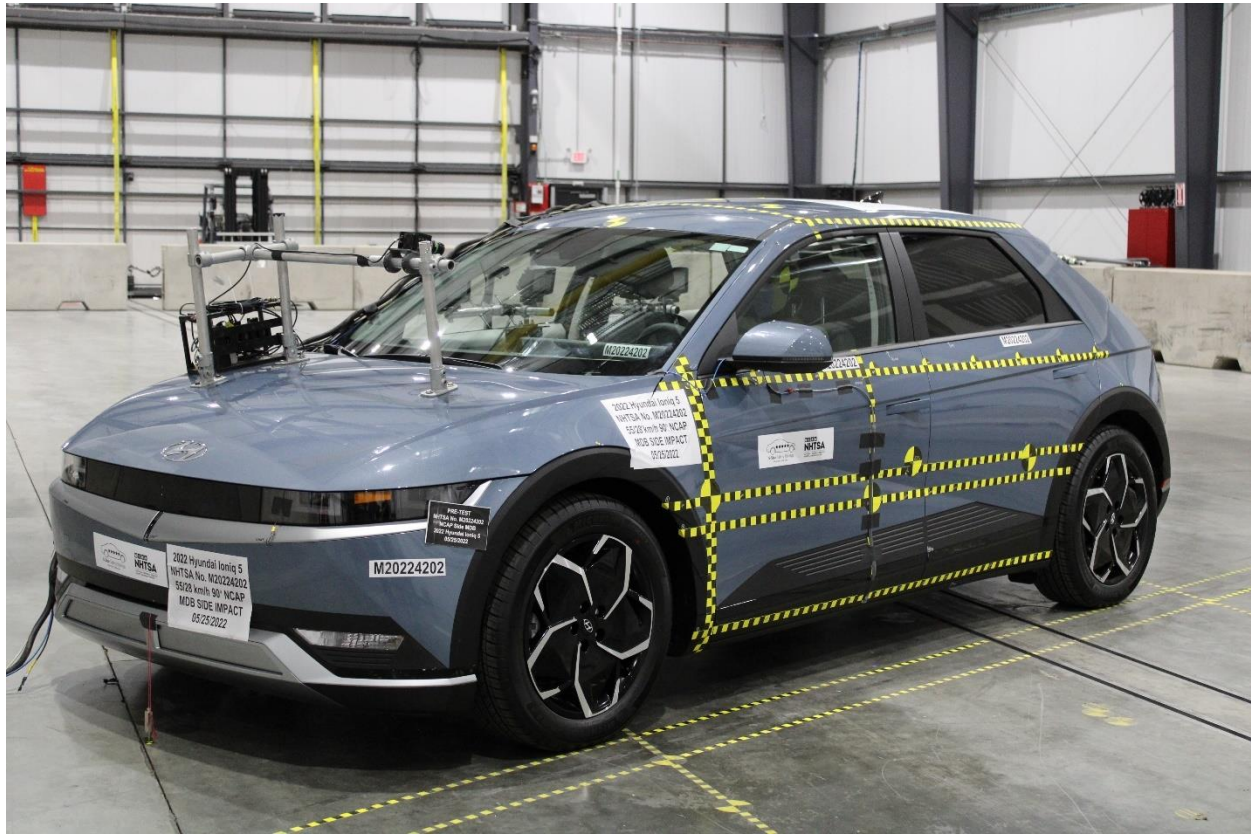
**Figure A-5: Pre-Test Left Front  $\frac{3}{4}$  View of Test Vehicle**

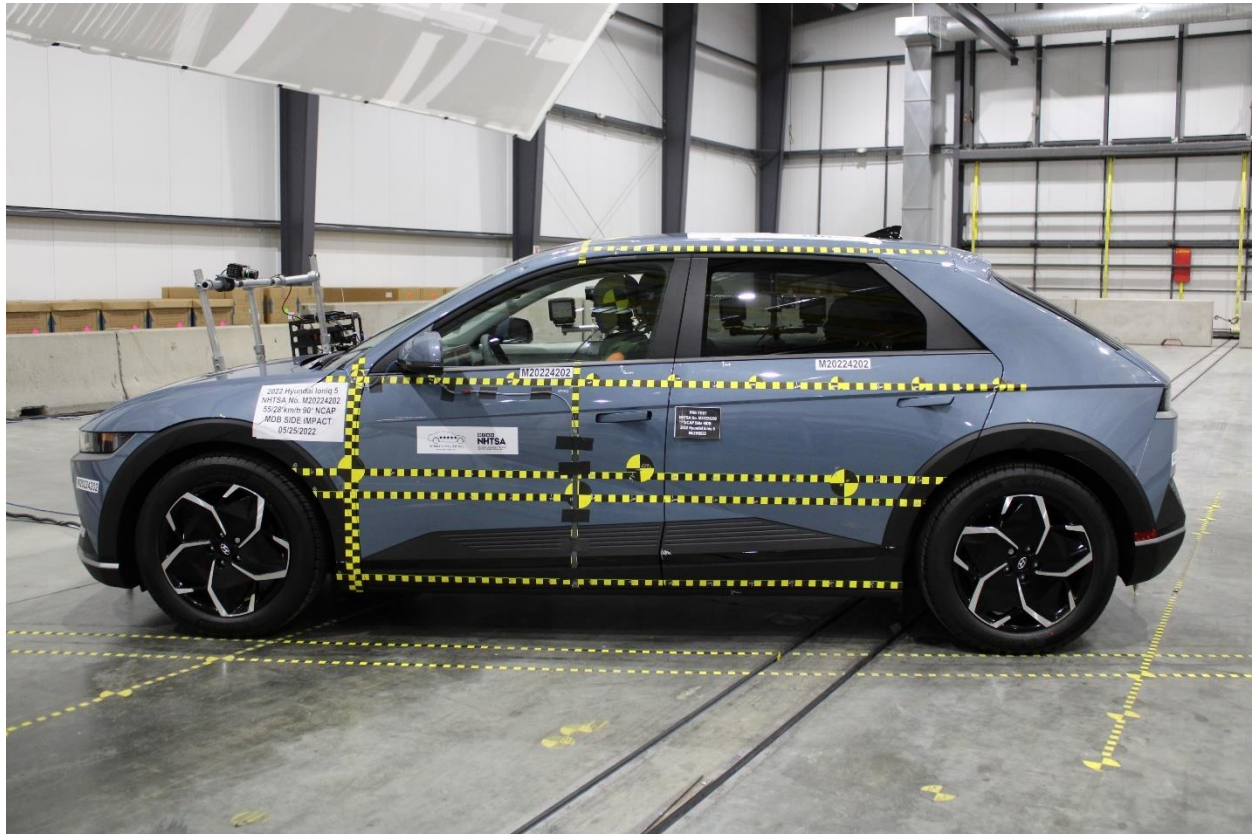
**Figure A-7: Pre-Test Left Side View of Test Vehicle**

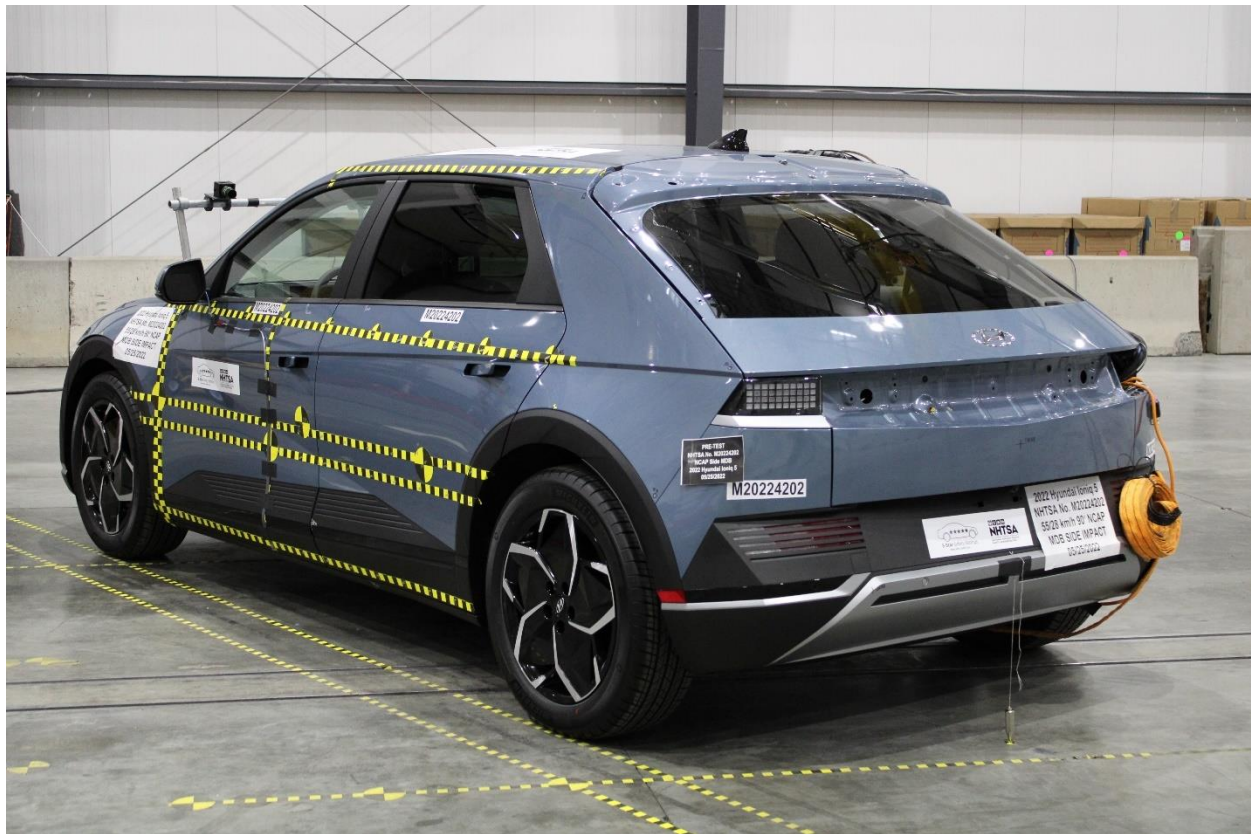
**Figure A-9: Pre-Test Left Rear  $\frac{3}{4}$  View of Test Vehicle**

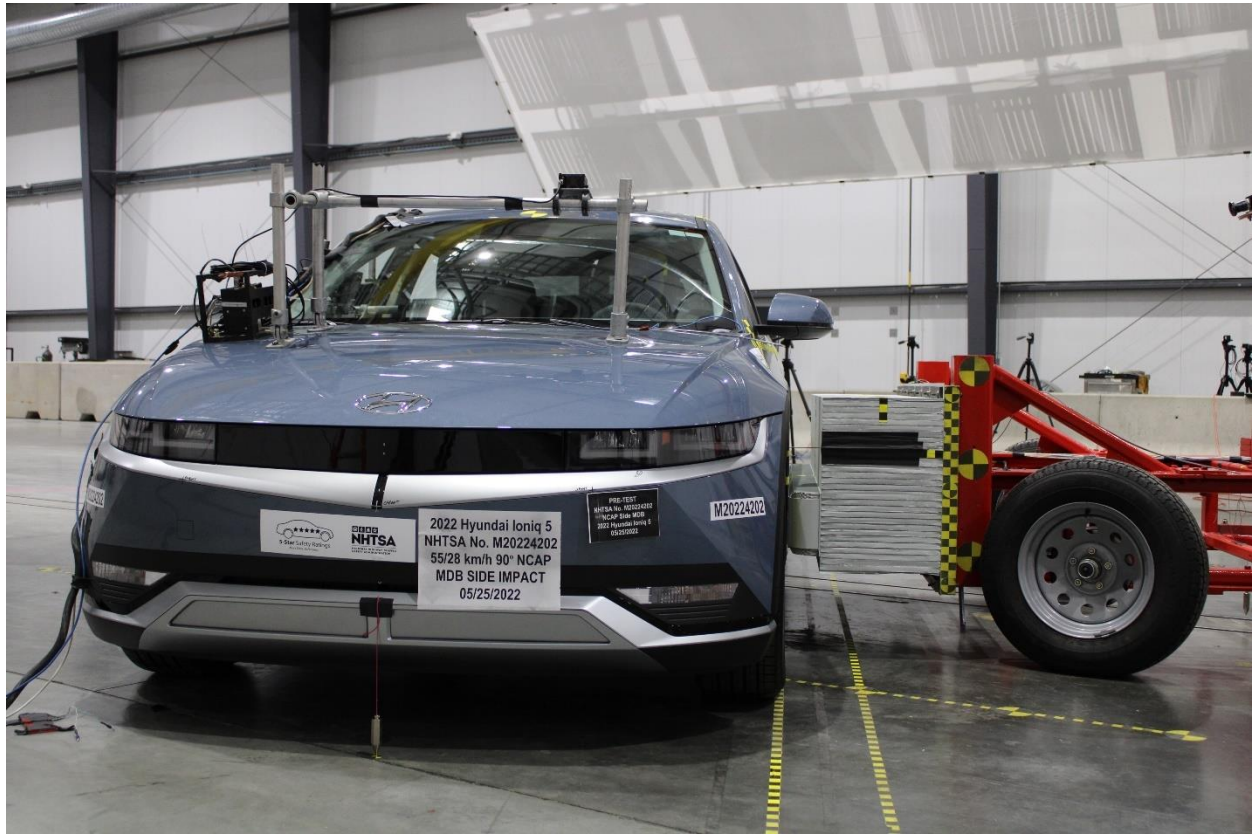
**Figure A-17: Pre-Test Left Side View of MDB Positioned Against Side of Test Vehicle**

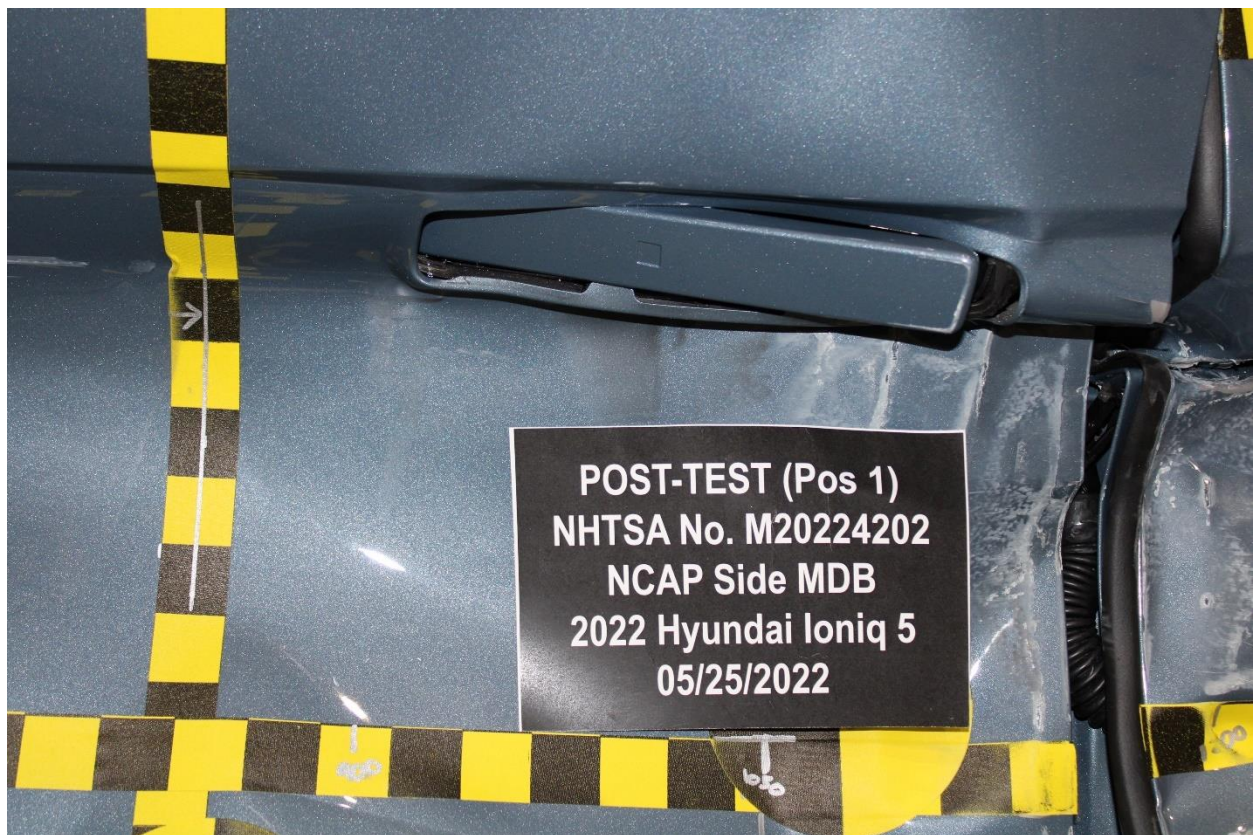
**Figure A-22: Post-Test Left Front Door Latch Close-Up**

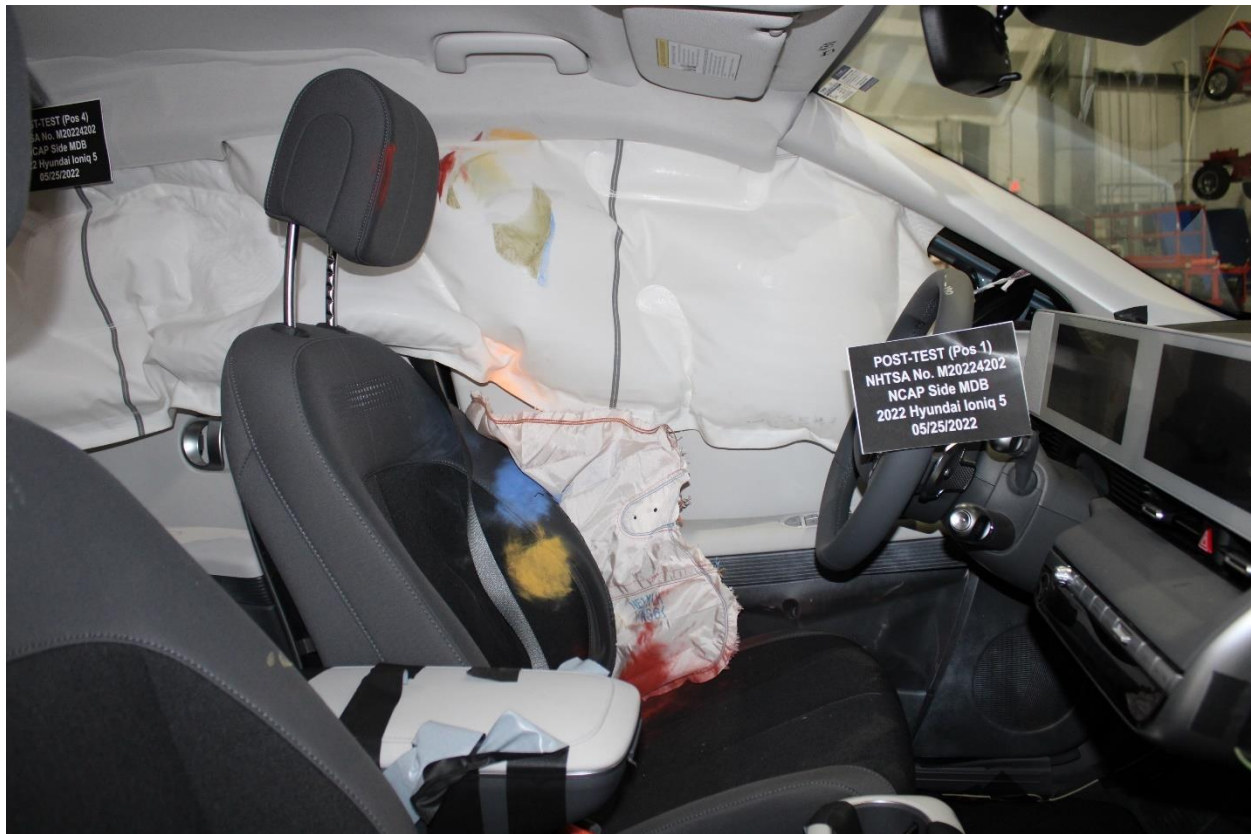
**Figure A-47: Post-Test Driver Inner Door Panel View Showing Driver Dummy Contact Locations**

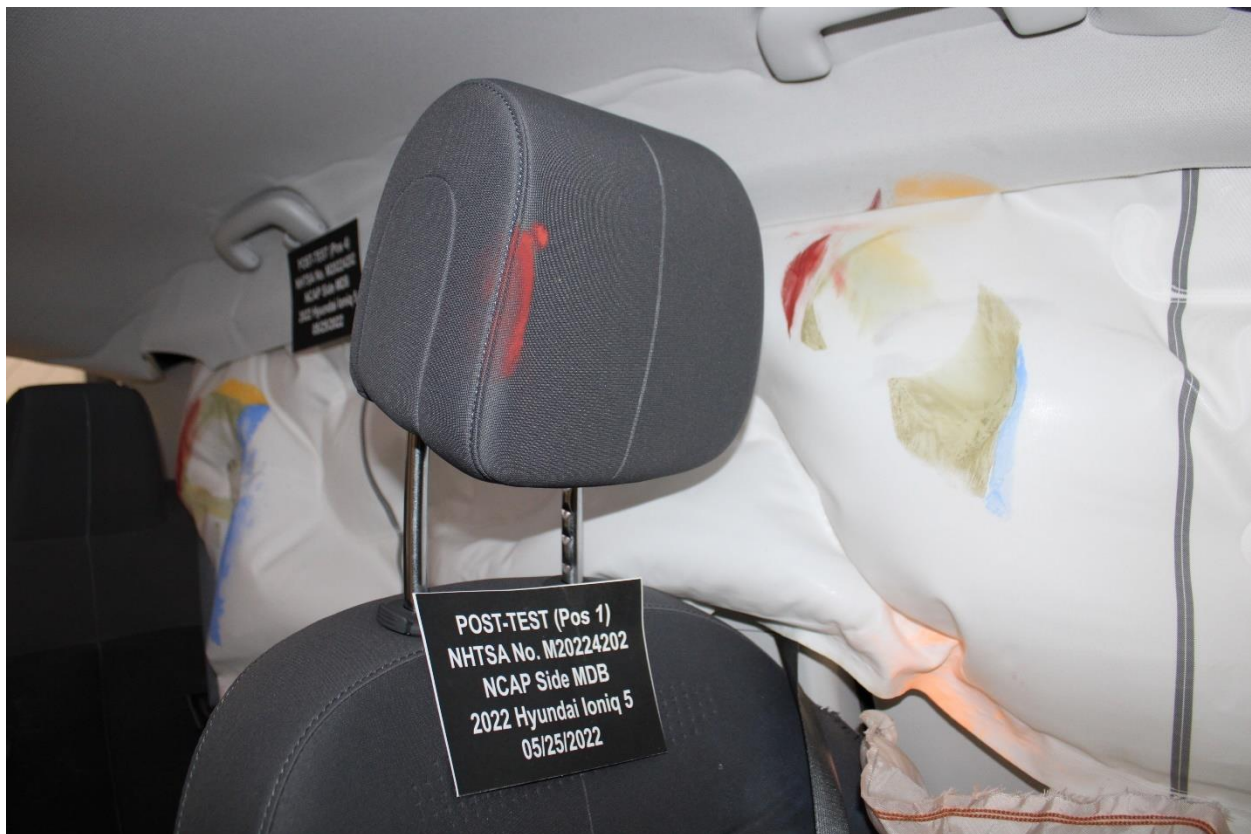
**Figure A-48: Post-Test Driver Dummy Close-Up Head Contact with Vehicle View**

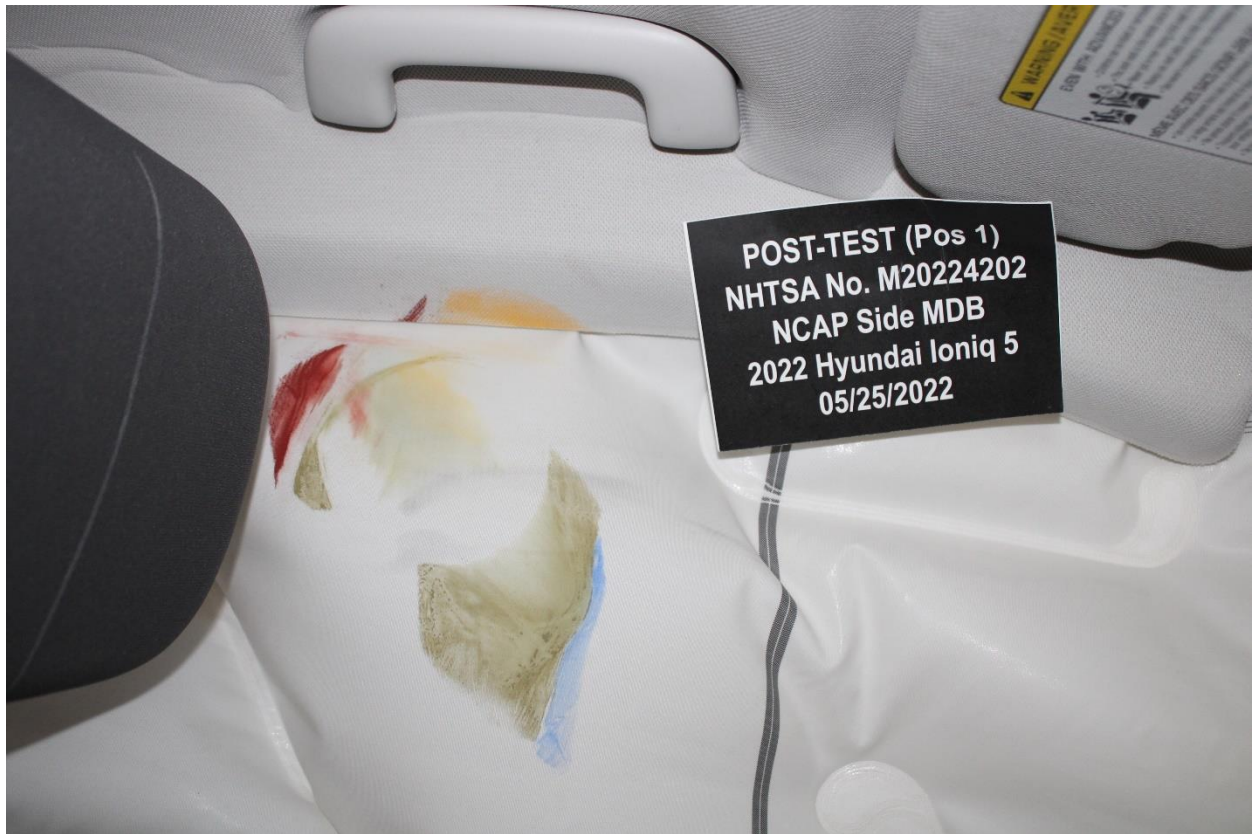
**Figure A-49: Post-Test Driver Dummy Close-Up Head Contact with Side Air bag View**

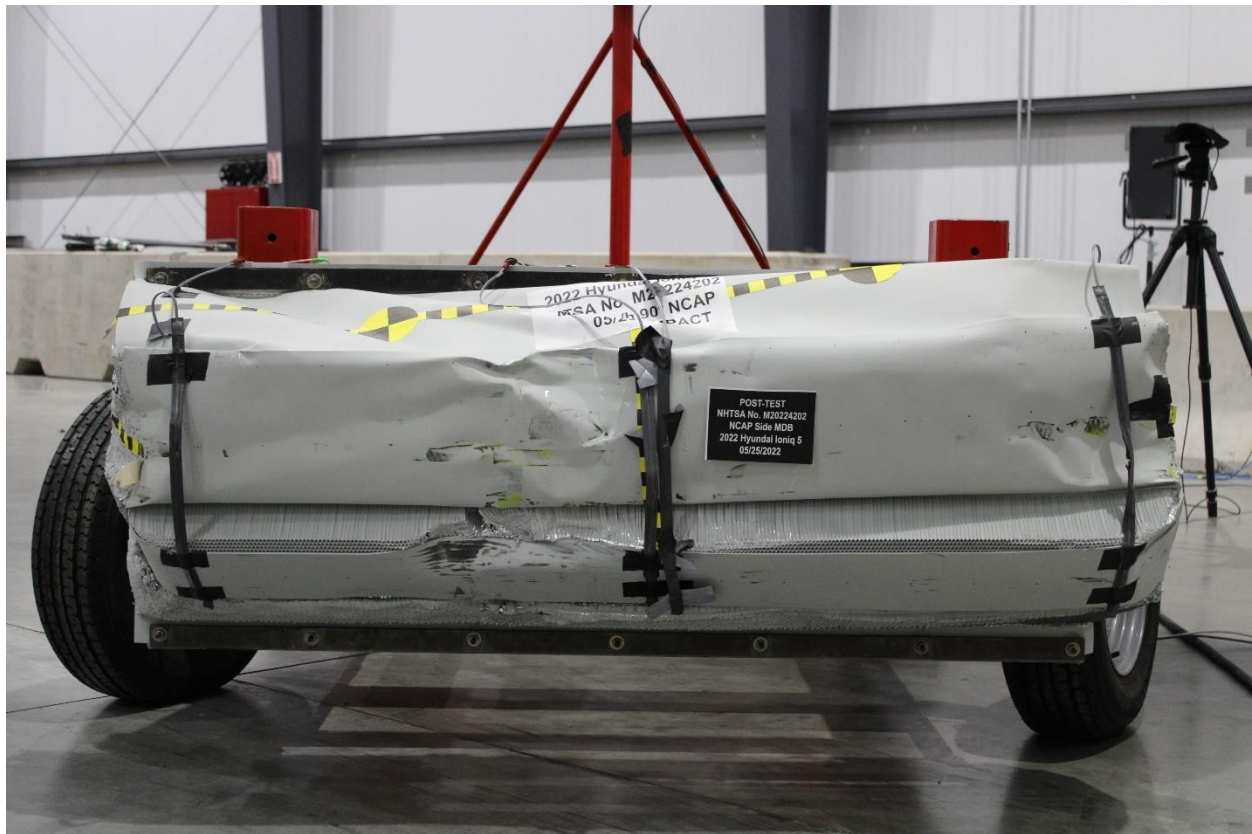
**Figure A-85: Post-Test Front View of MDB Impactor Face**

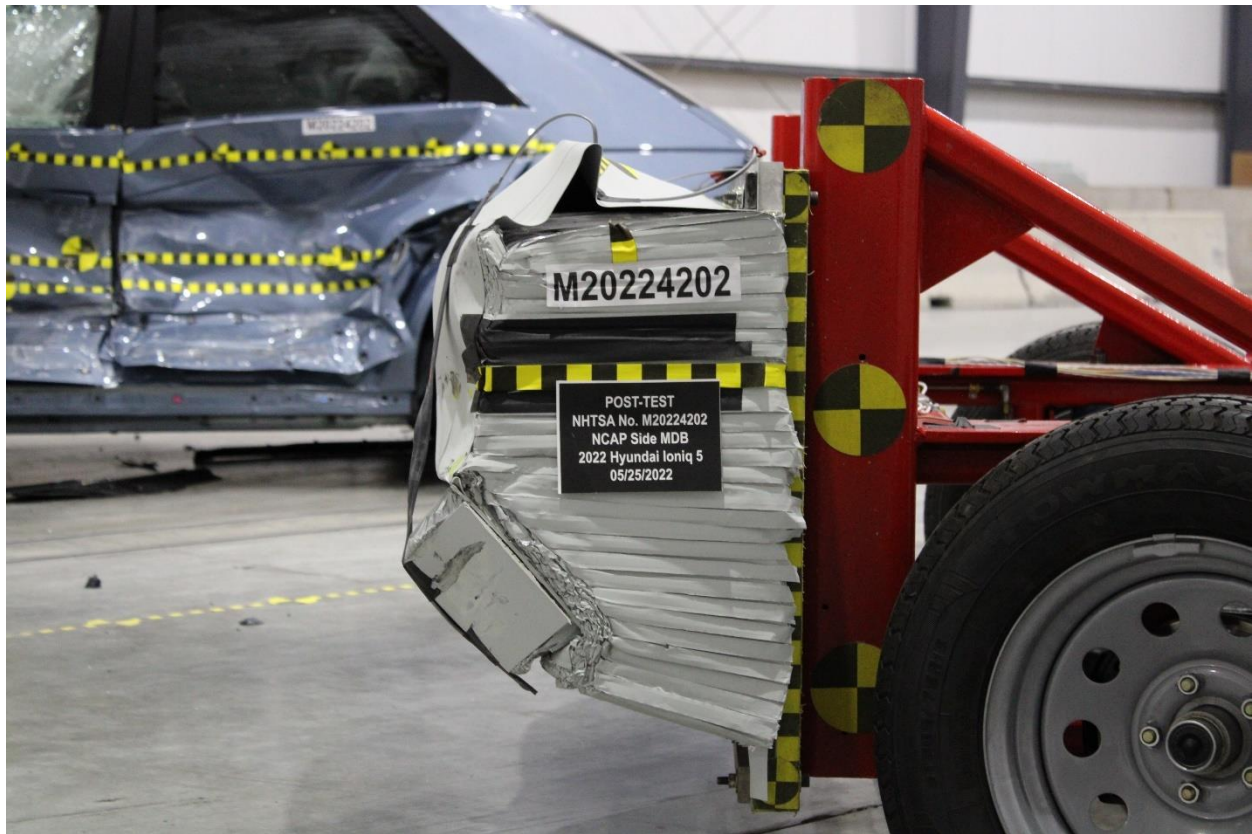
**Figure A-89: Post-Test Left Side View of MDB Impactor Face**

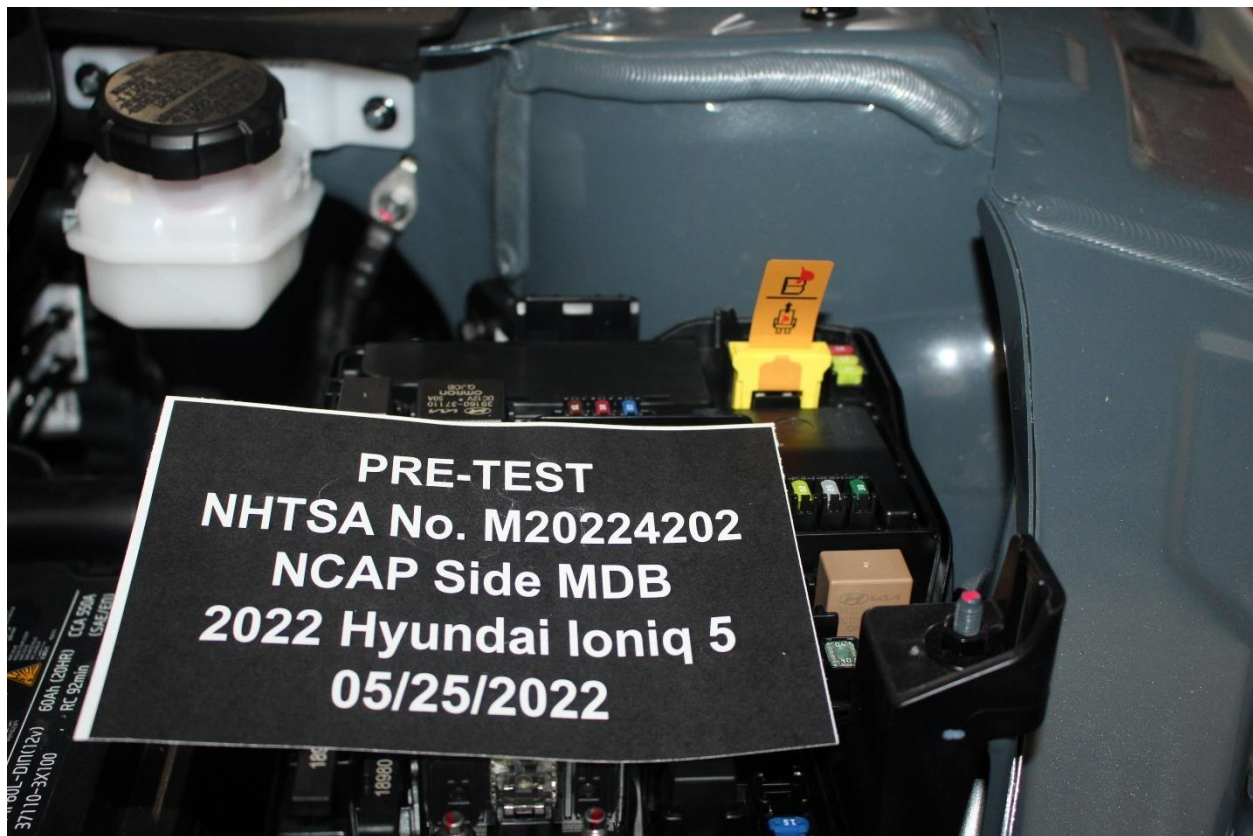
**Figure 305-7: Manual High Voltage Service Disconnect Removed (Show Plug)**

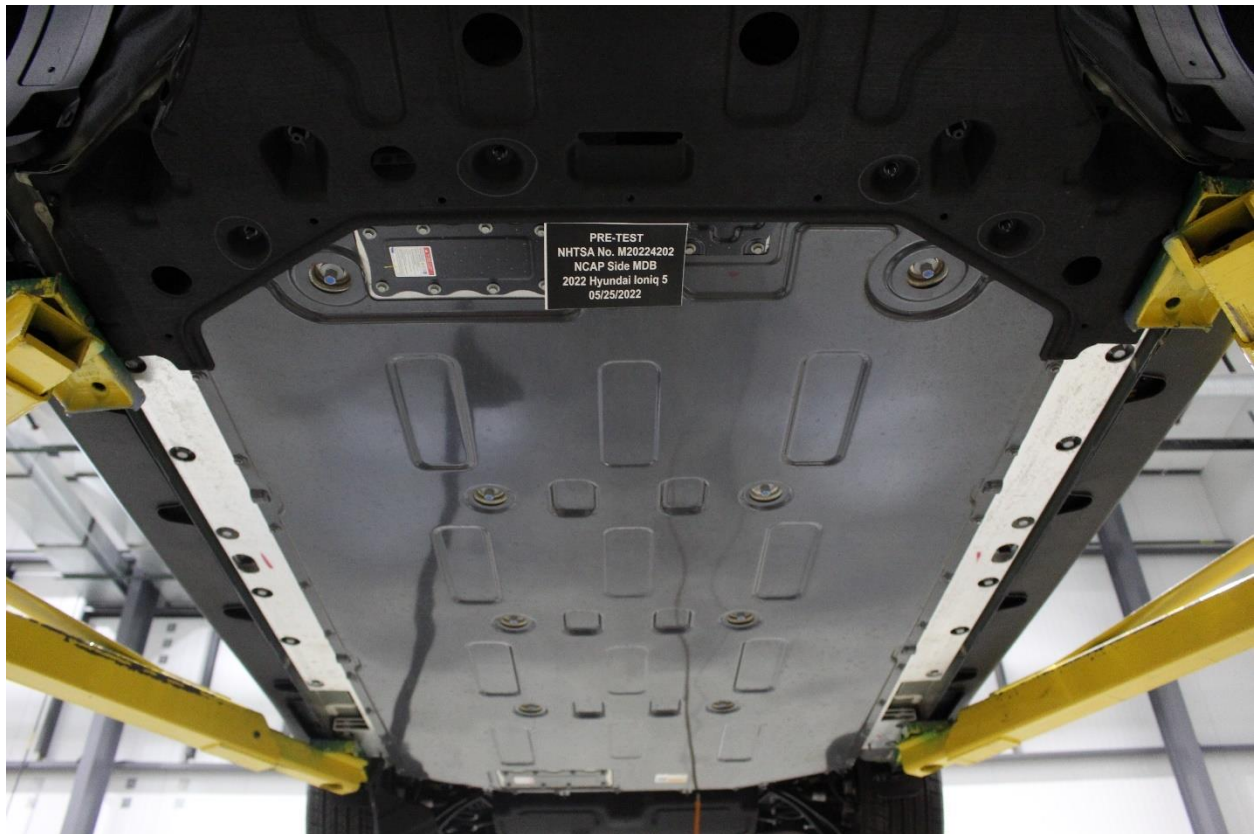
**Figure 305-9: Pre-Impact View of Propulsion Battery**

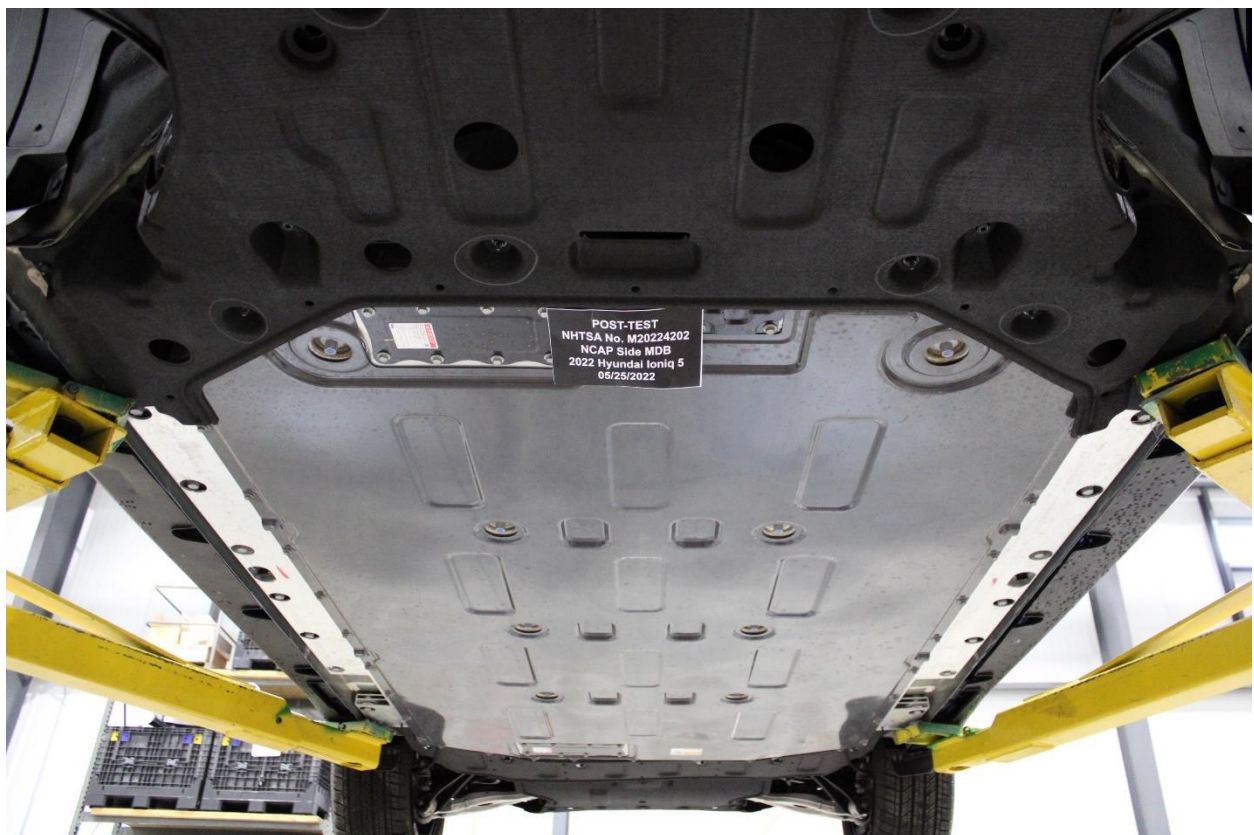
**Figure 305-10: Post-Impact Front View of Propulsion Battery**

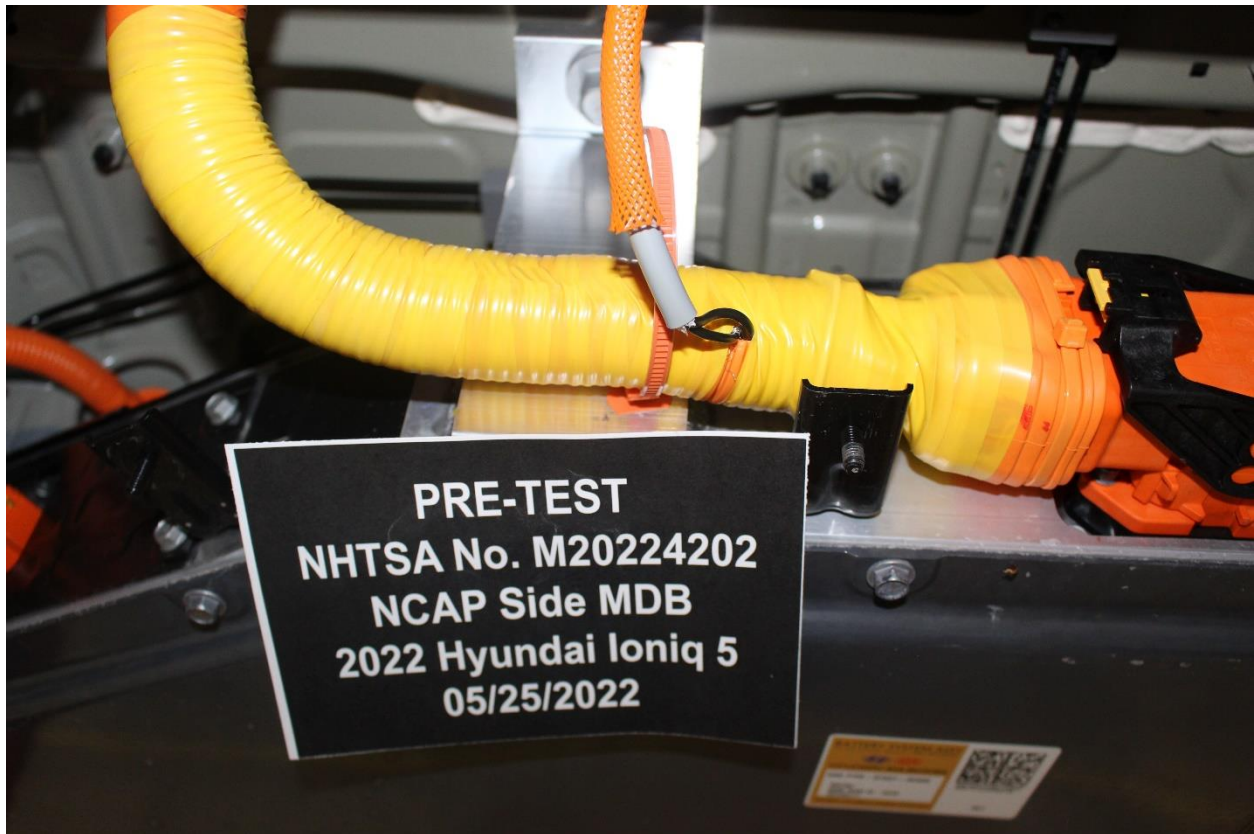
Figure 305-23: Pre-Impact Close Up View of High Voltage Leads Attached
