**REPORT NUMBER: SPNCAP-CAL-22-003**

**NEW CAR ASSESSMENT PROGRAM (NCAP)  
SIDE IMPACT POLE TEST**

**Hyundai Motor Company  
2022 Hyundai Ioniq 5  
Five Door SUV**

**FINAL REPORT**

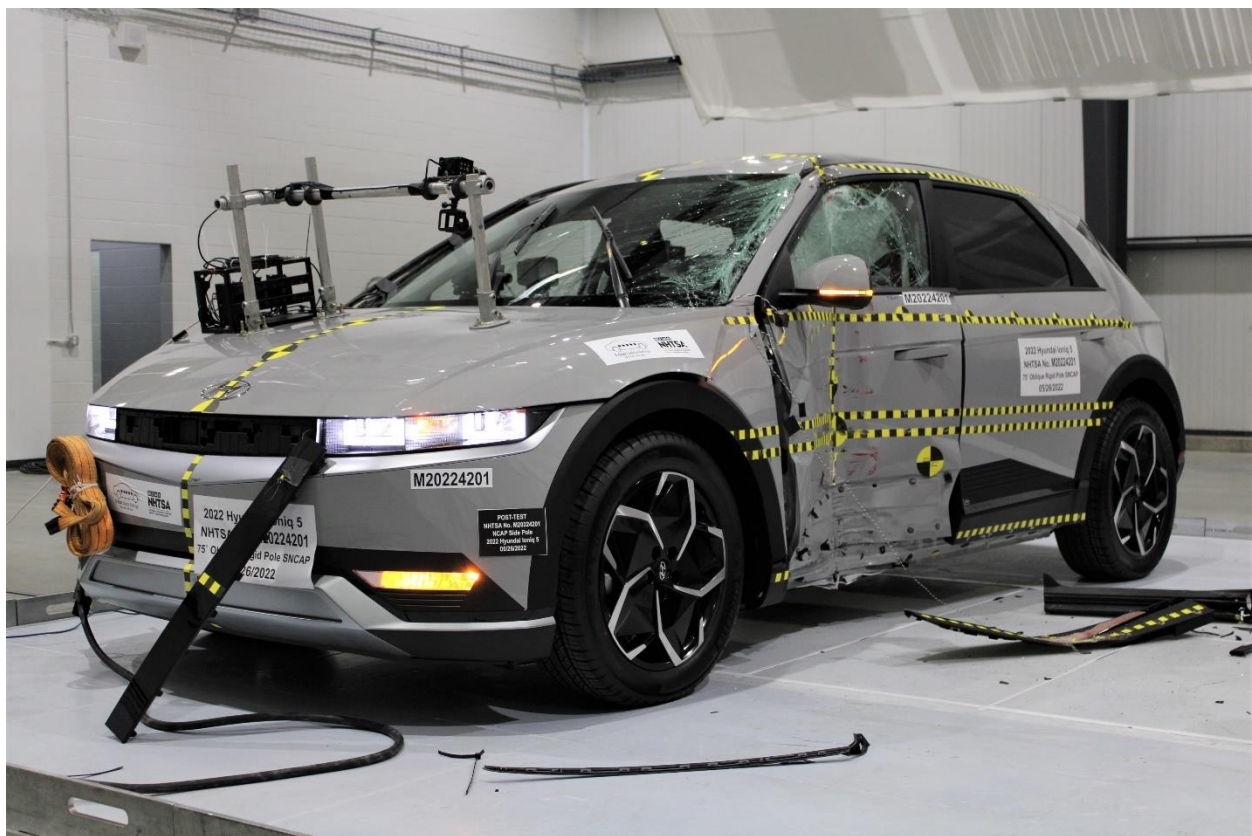
**Figure A-6: Post-Test Left Front  $\frac{3}{4}$  View of Test Vehicle**

| Critical Areas of Performance | Observations and Conclusions |
|---|---|
| Windshield Damage | Cracks along driver side & some separation along A-Pillar |
| Side Window Damage | Driver Window cracked throughout |

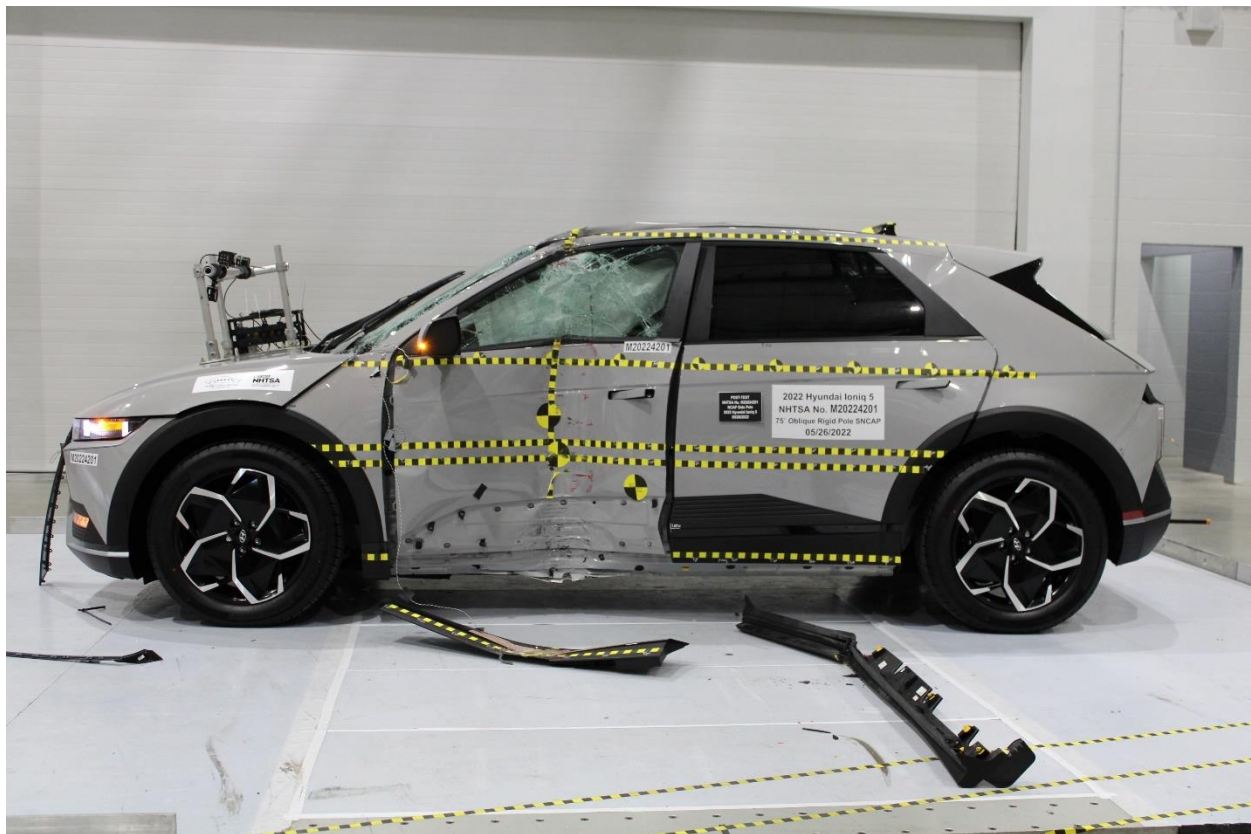
**Figure A-8: Post-Test Left Side View of Test Vehicle**

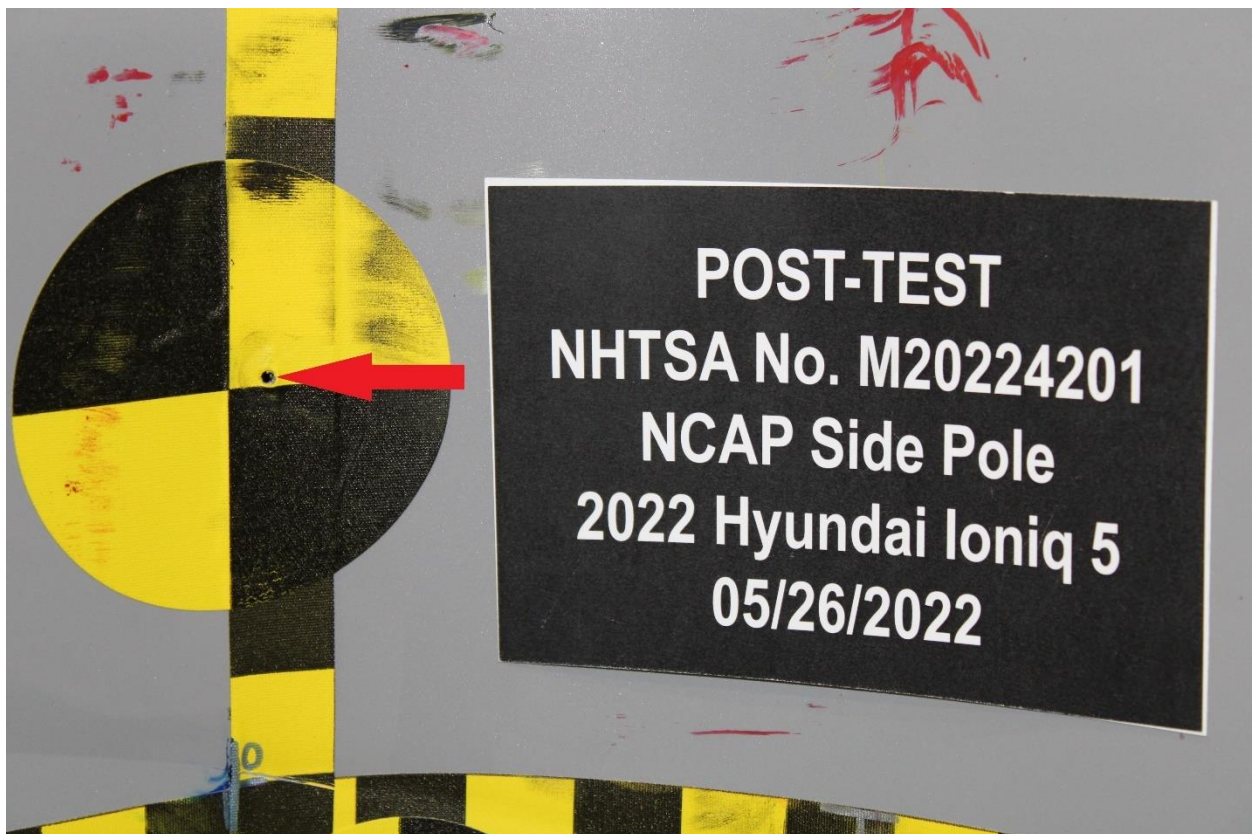
**Figure A-20: Post-Test Close-Up View of Impact Point Target Showing Impact Location**

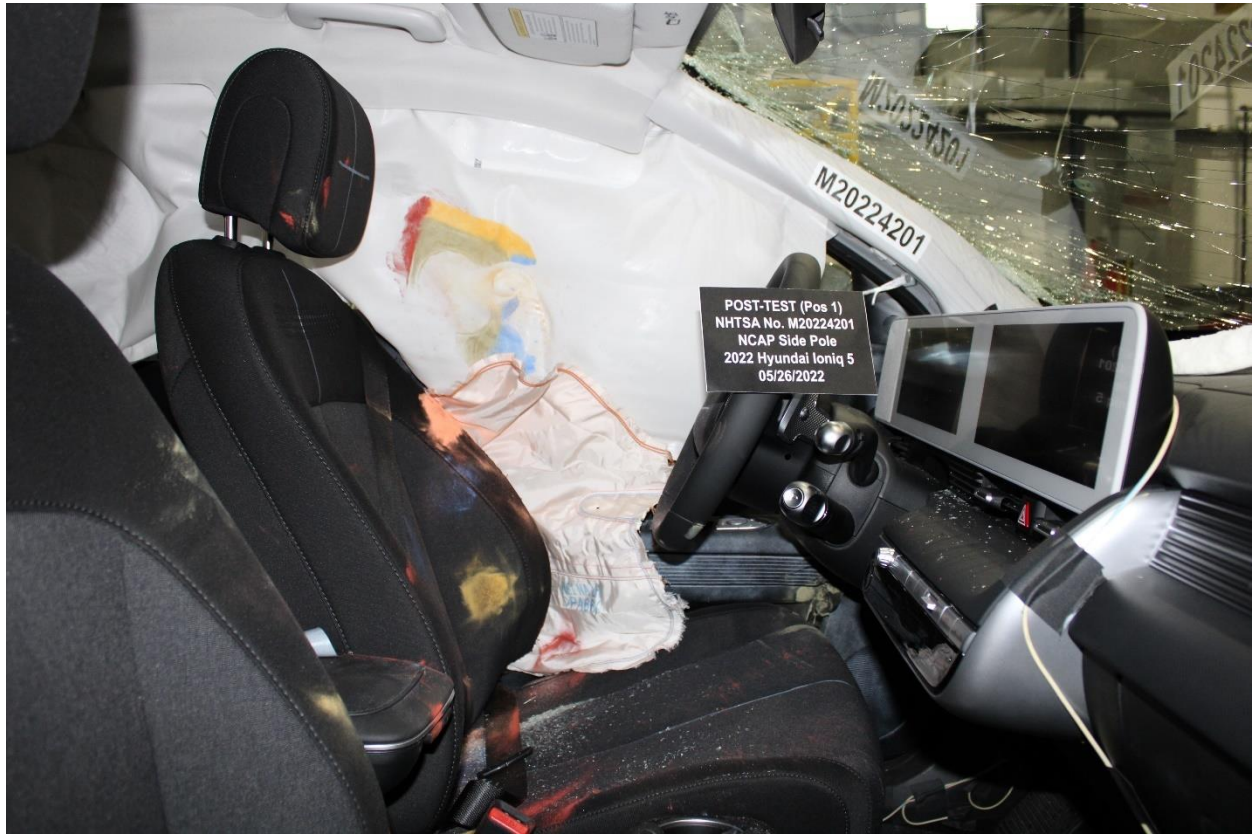
**Figure A-45: Post-Test Inner Door Panel View Showing Dummy Contact Location**

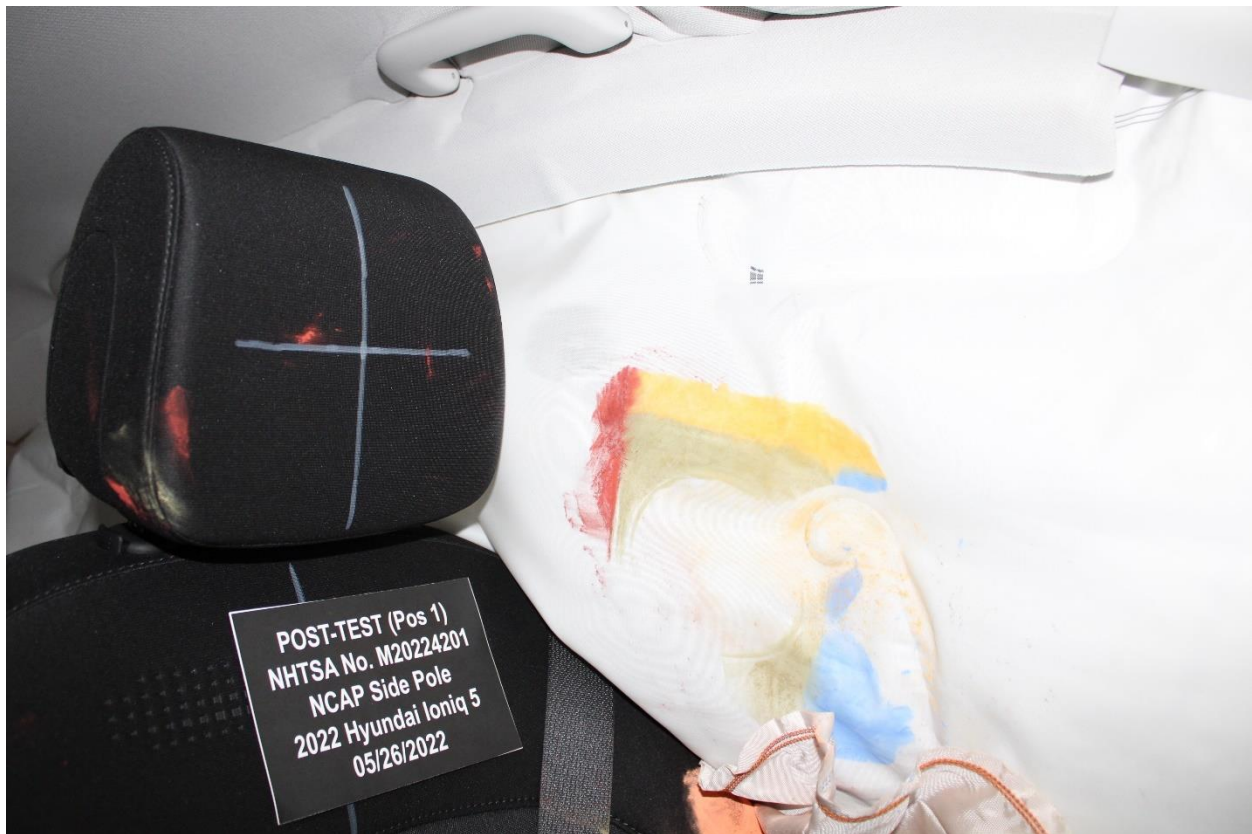
**Figure A-46: Post-Test Dummy Close-Up Head Contact with Vehicle Interior View**

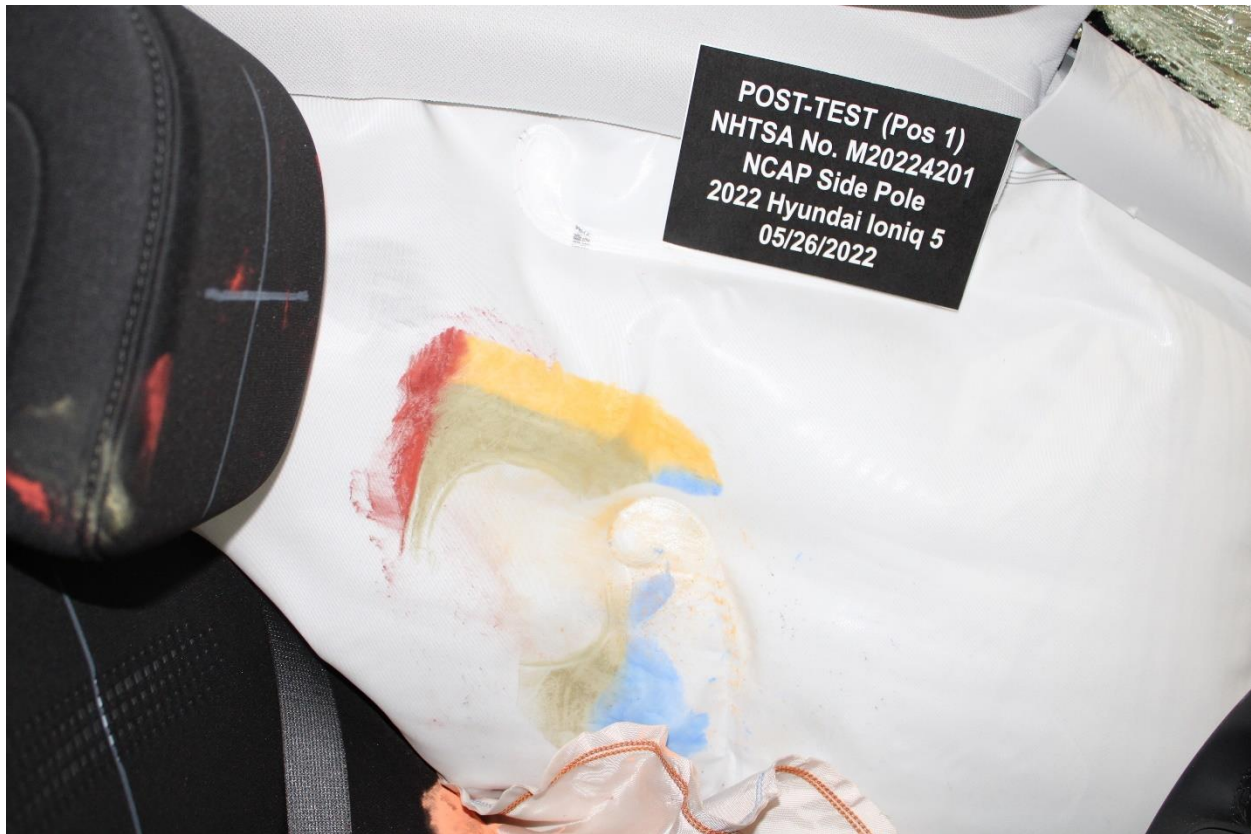
**Figure A-47: Post-Test Dummy Close-Up Head Contact with Side Airbag View**

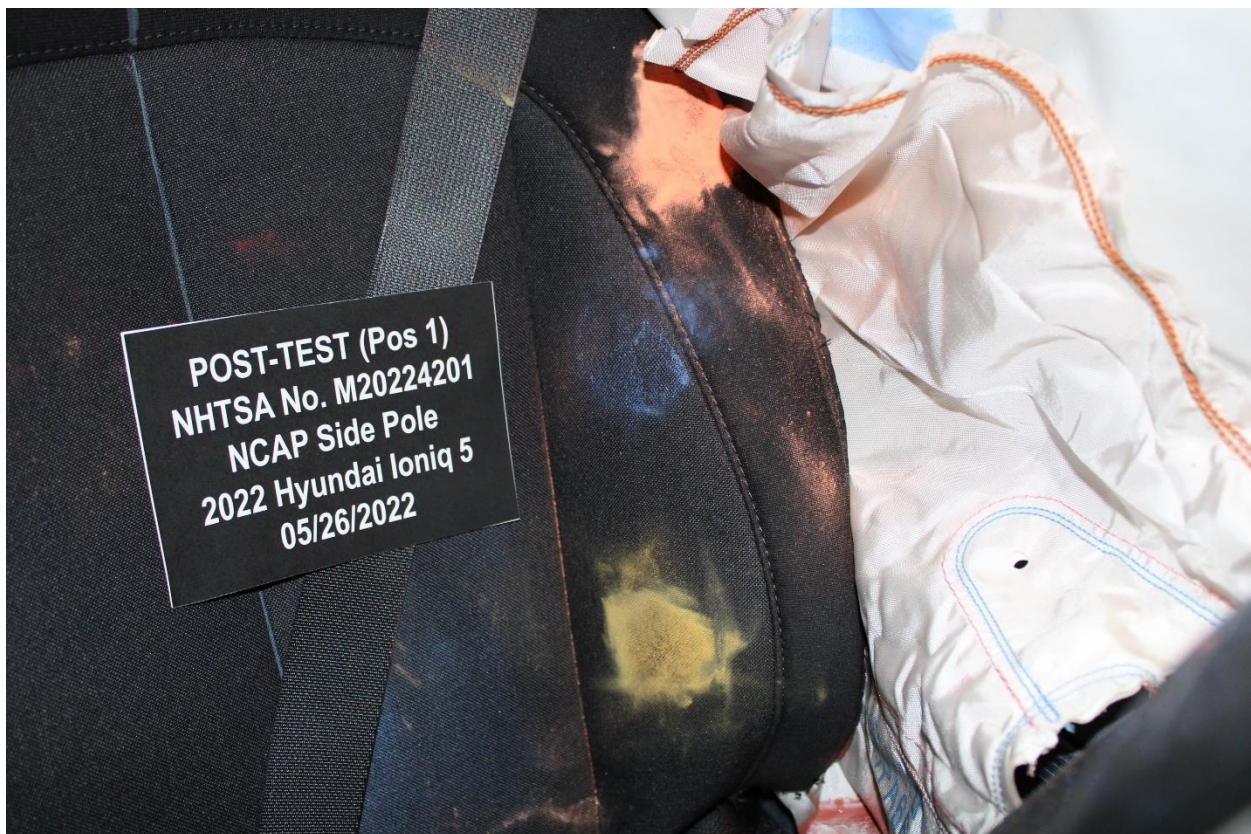
**Figure A-48: Post-Test Dummy Close-Up Torso Contact with Vehicle Interior View**

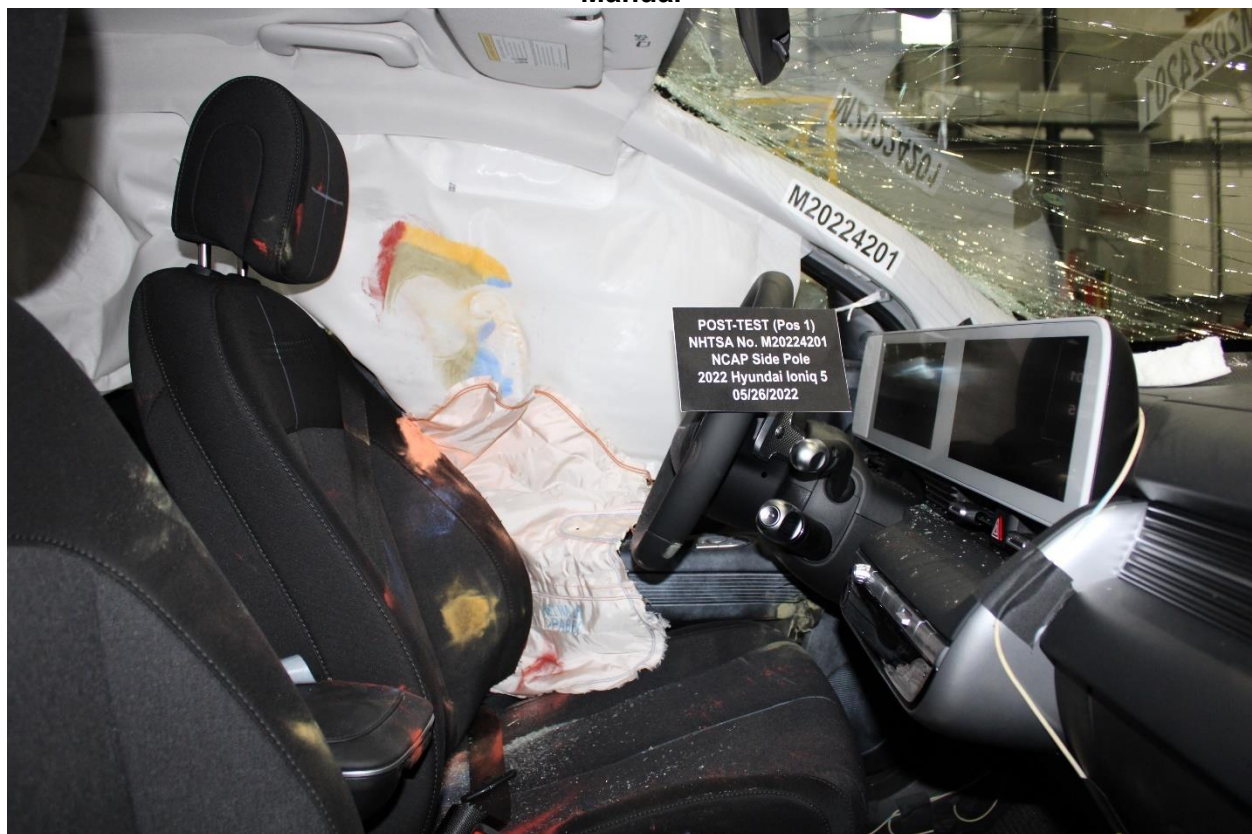
**Figure A-73: Post-Test View of Shattered Vehicle Inner Door Panel**

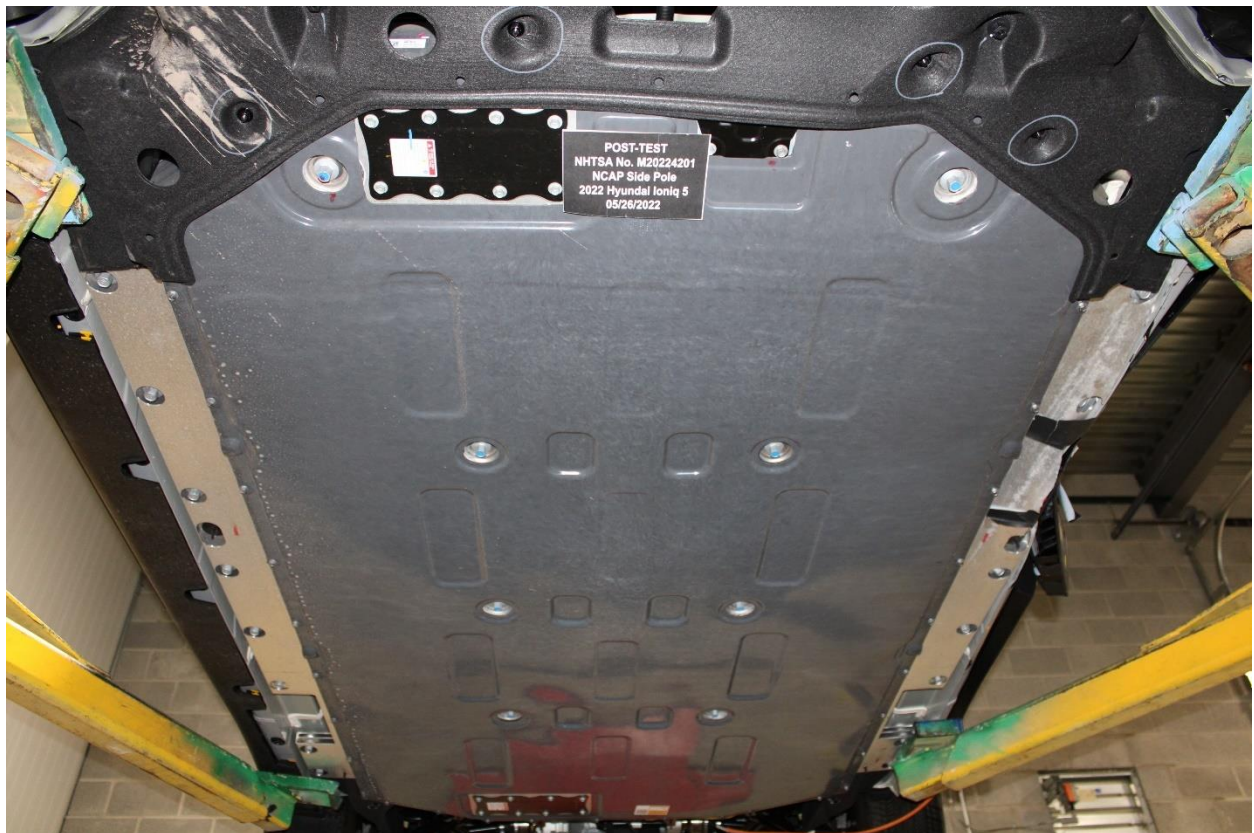
**Figure 305-10: Post-Impact Front View of Propulsion Battery**

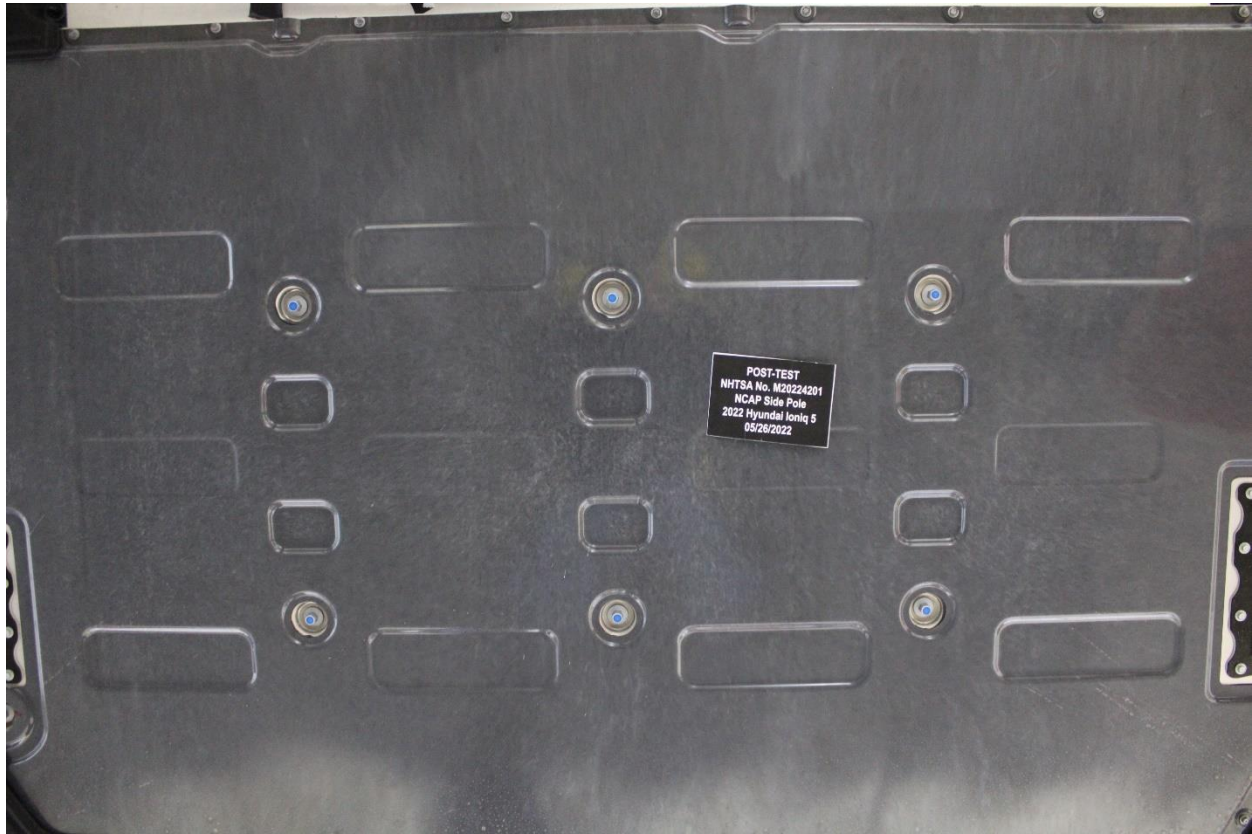
**Figure 305-13: Post-Impact View of Battery Box(s) or Container(s) Which Holds Individual Battery Modules**
