**REPORT NUMBER: SideNCAPMDB-KAR-22-005**

**NEW CAR ASSESSMENT PROGRAM (NCAP)  
MOVING DEFORMABLE BARRIER SIDE IMPACT TEST**

**General Motors, LLC.  
2022 Chevrolet Bolt EUV SUV**

**NHTSA No: M20220102**

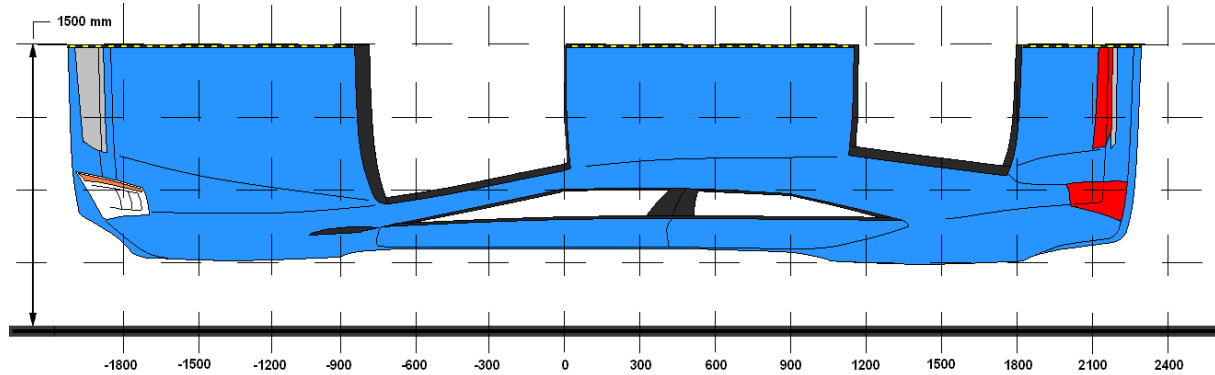
**VEHICLE AND MDB DAMAGE PROFILE DISTANCES**

**VEHICLE DAMAGE PROFILE DISTANCES**

DPD	Distance From Impact Point (mm)	Level	Pre-Test (mm)	Post-Test (mm)	Crush (mm)
1	2250	4	645	616	-29
2	1800	2	630	880	250
3	1200	2	641	839	198
4	600	2	631	853	222
5	150	2	625	738	113
6	-300	3	616	617	1

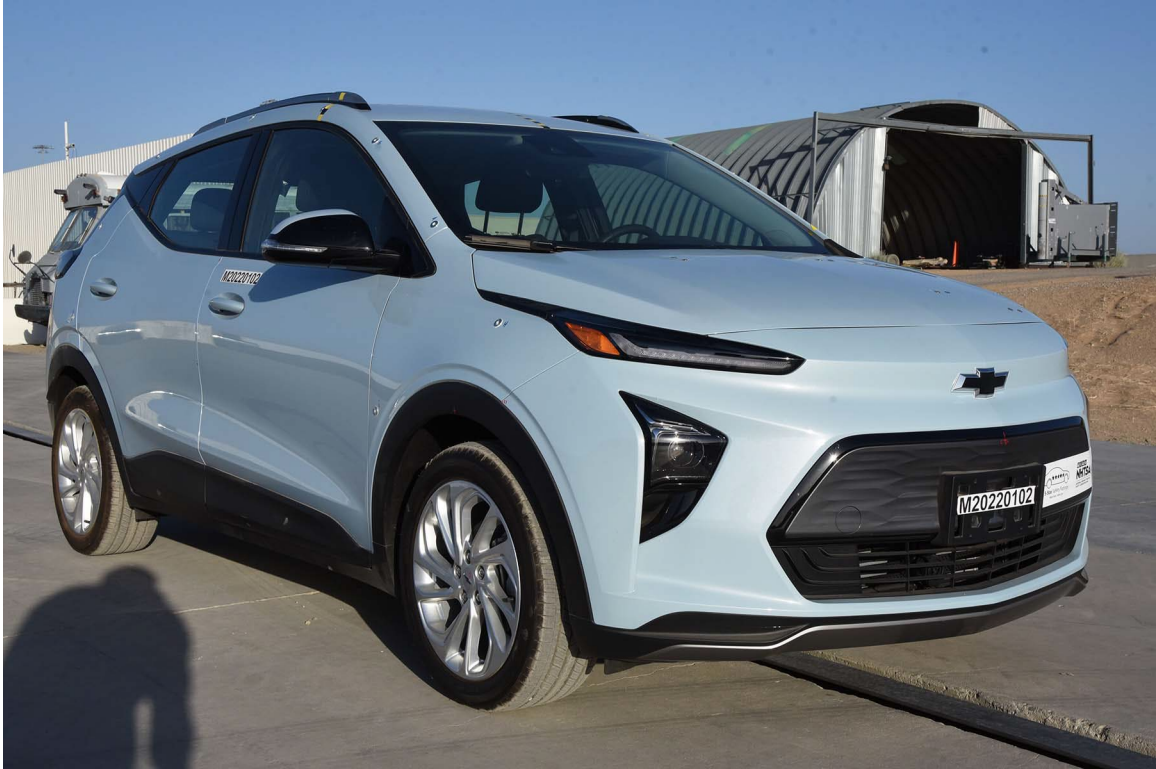
FIGURE 1. As-Delivered Right Front  $\frac{3}{4}$  View of Test Vehicle
