REPORT NUMBER: SPNCAP-CAL-22-004

**NEW CAR ASSESSMENT PROGRAM (NCAP)
SIDE IMPACT POLE TEST**

**Ford Motor CO.
2022 Ford Maverick XL
Four Door Truck**

NHTSA No: M20220210

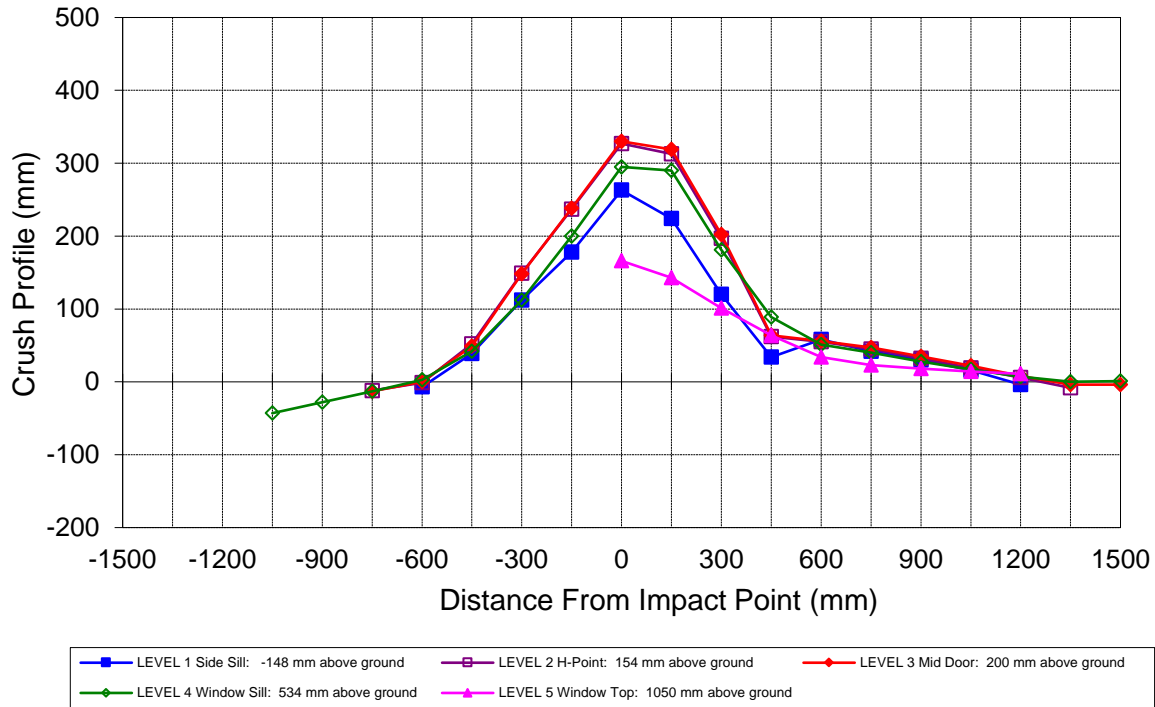
Vehicle Exterior Crush Measurements - Visual Representation

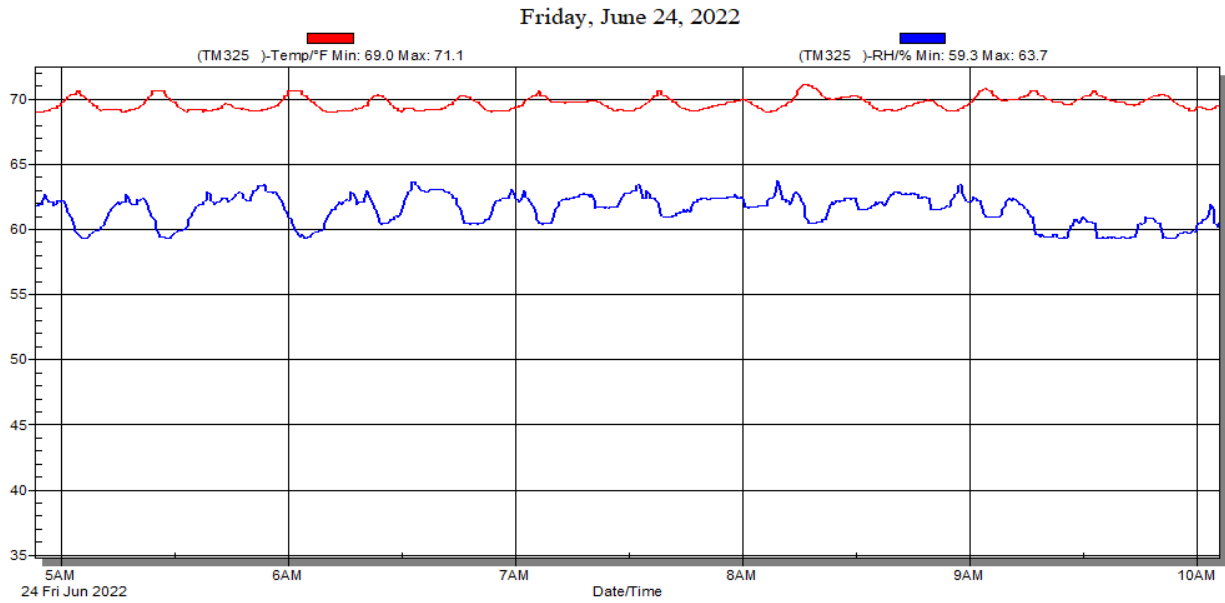
Temperature and Humidity Stabilization Chart / Data for Dummies and Test Vehicle

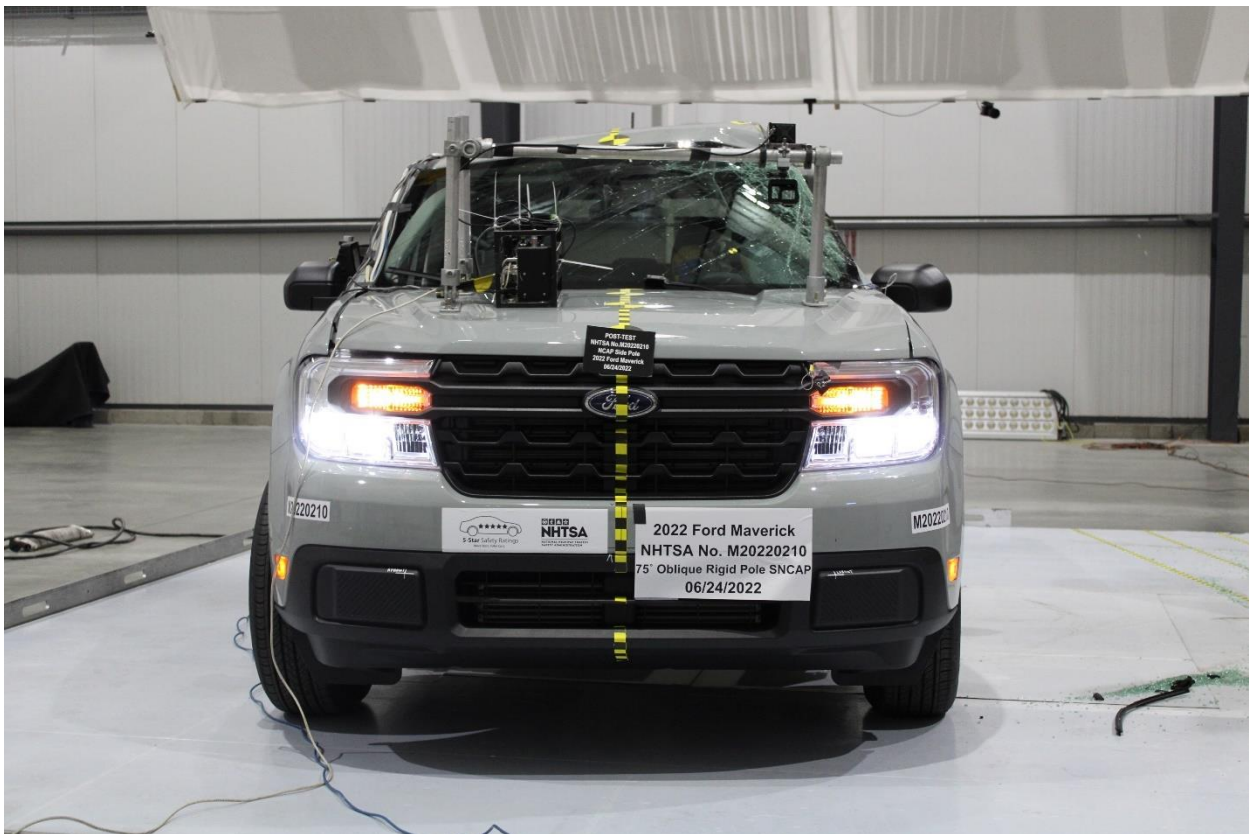
Figure A-4: Post-Test Frontal View of Test Vehicle

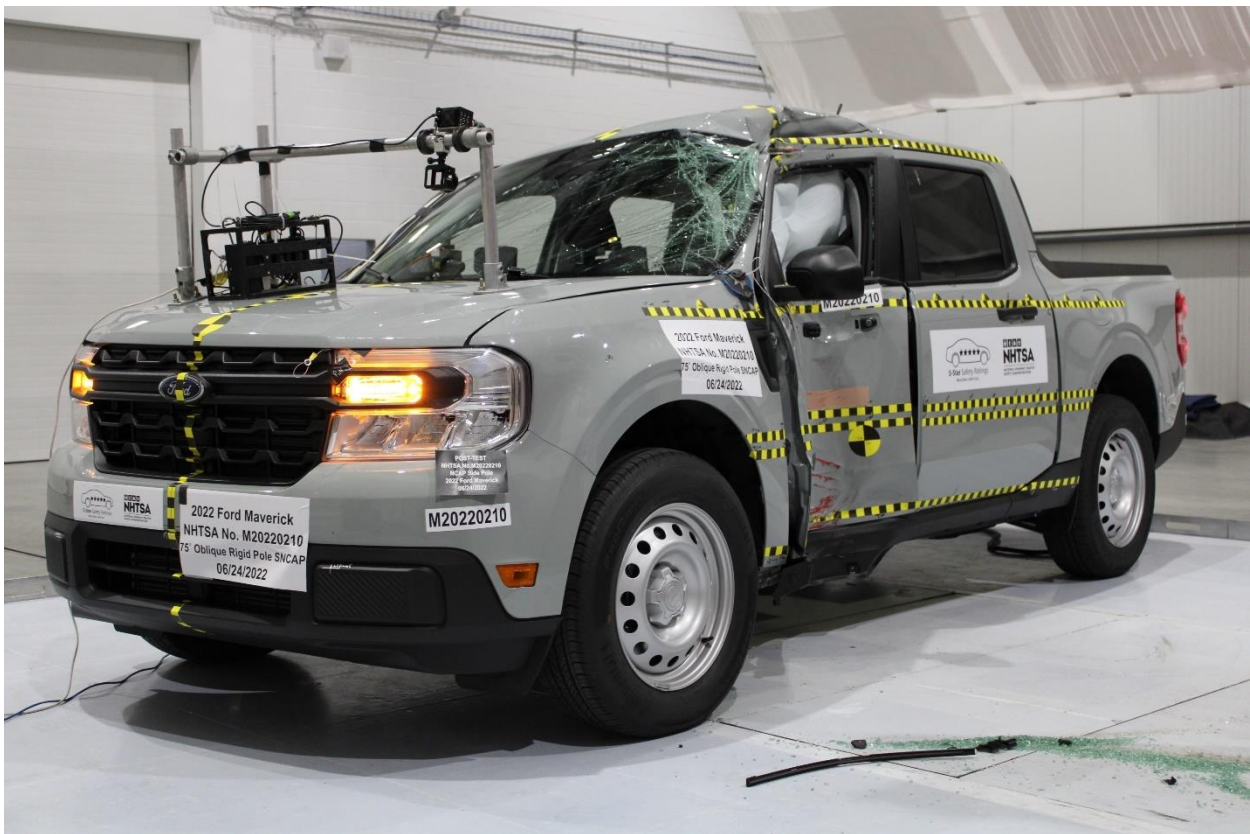
Figure A-6: Post-Test Left Front $\frac{3}{4}$ View of Test Vehicle

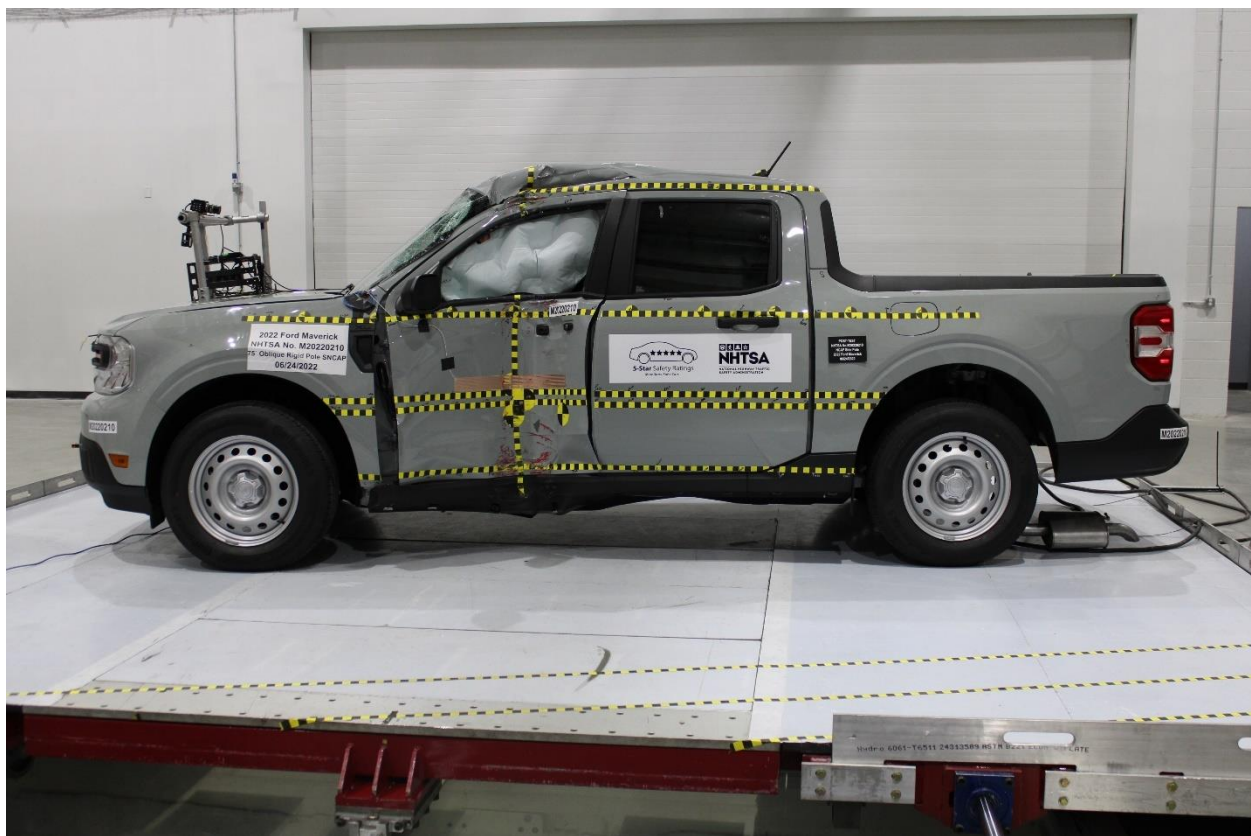
Figure A-8: Post-Test Left Side View of Test Vehicle

Critical Areas of Performance	Observations and Conclusions
Pillar Performance	A-Pillar and B-Pillar Buckled
Sill Separation	Minor separation at Impact Location
Windshield Damage	Cracks Throughout, Propagating from Struck Side A-Pillar
Side Window Damage	Driver Window Shattered Completely
Other Notable Effects	None

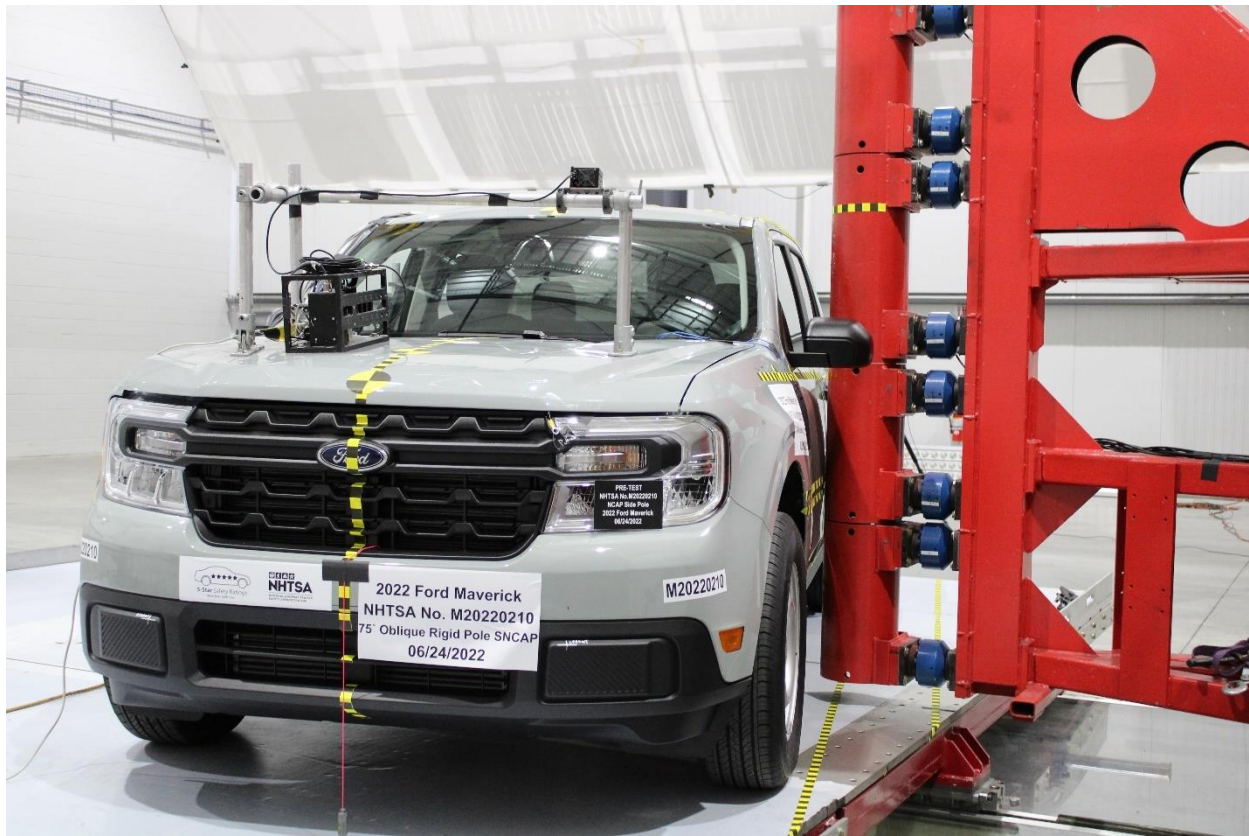
Figure A-17: Pre-Test Left Side View of Pole Positioned Against Side of Vehicle

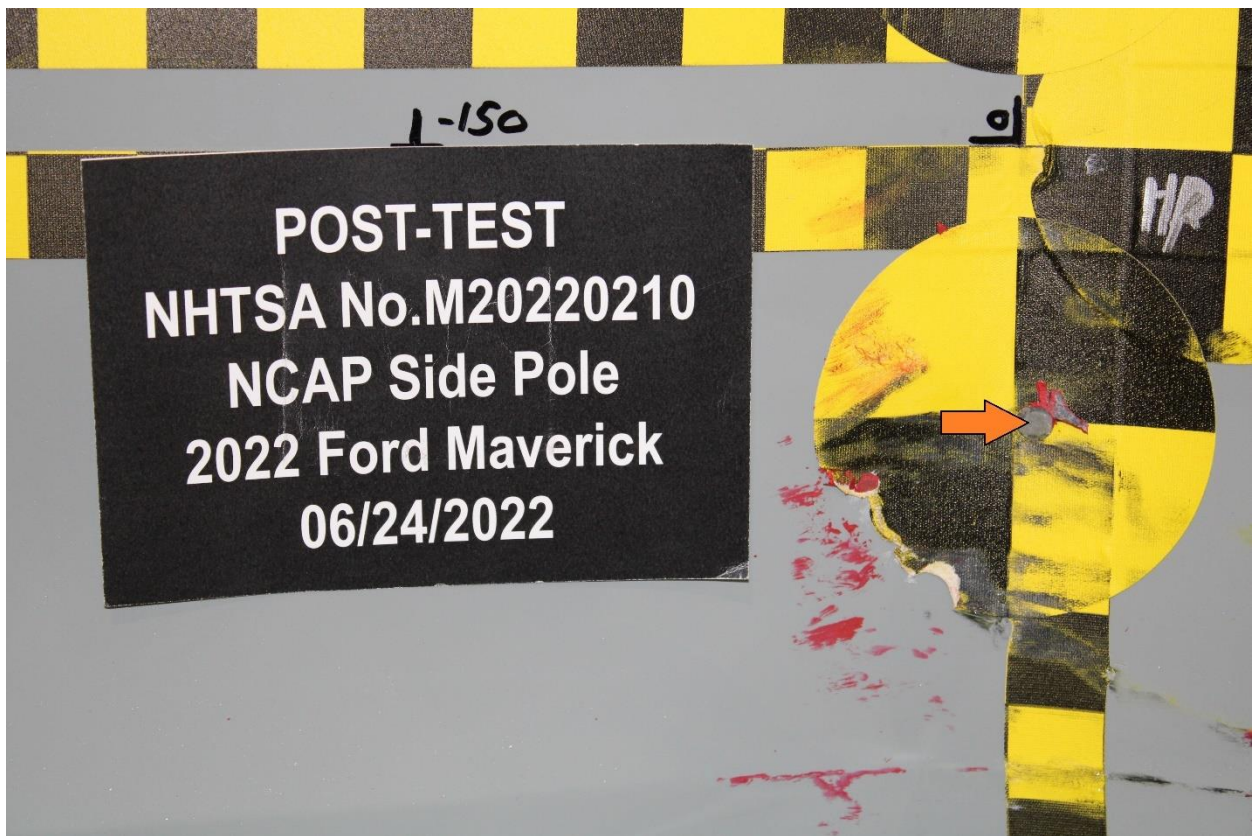
Figure A-20: Post-Test Close-Up View of Impact Point Target Showing Impact Location

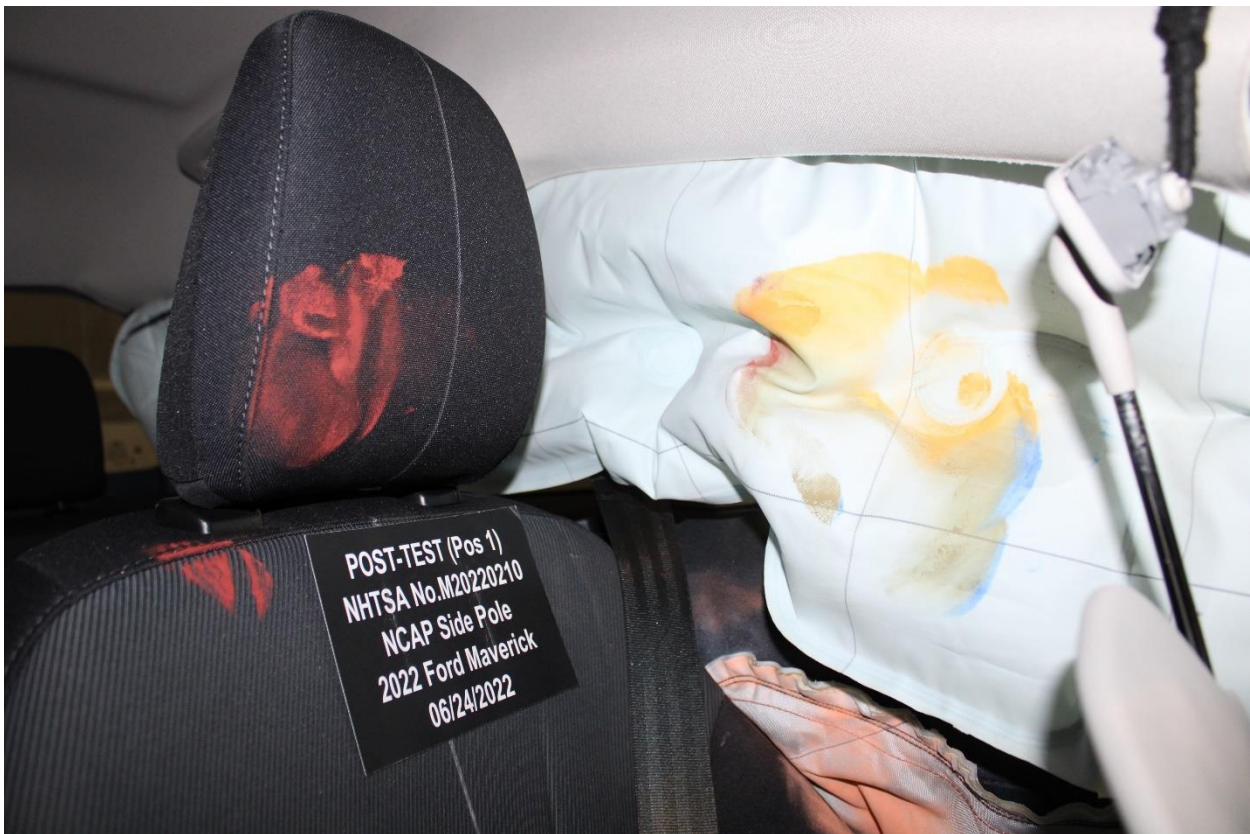
Figure A-46: Post-Test Dummy Close-Up Head Contact with Vehicle Interior View

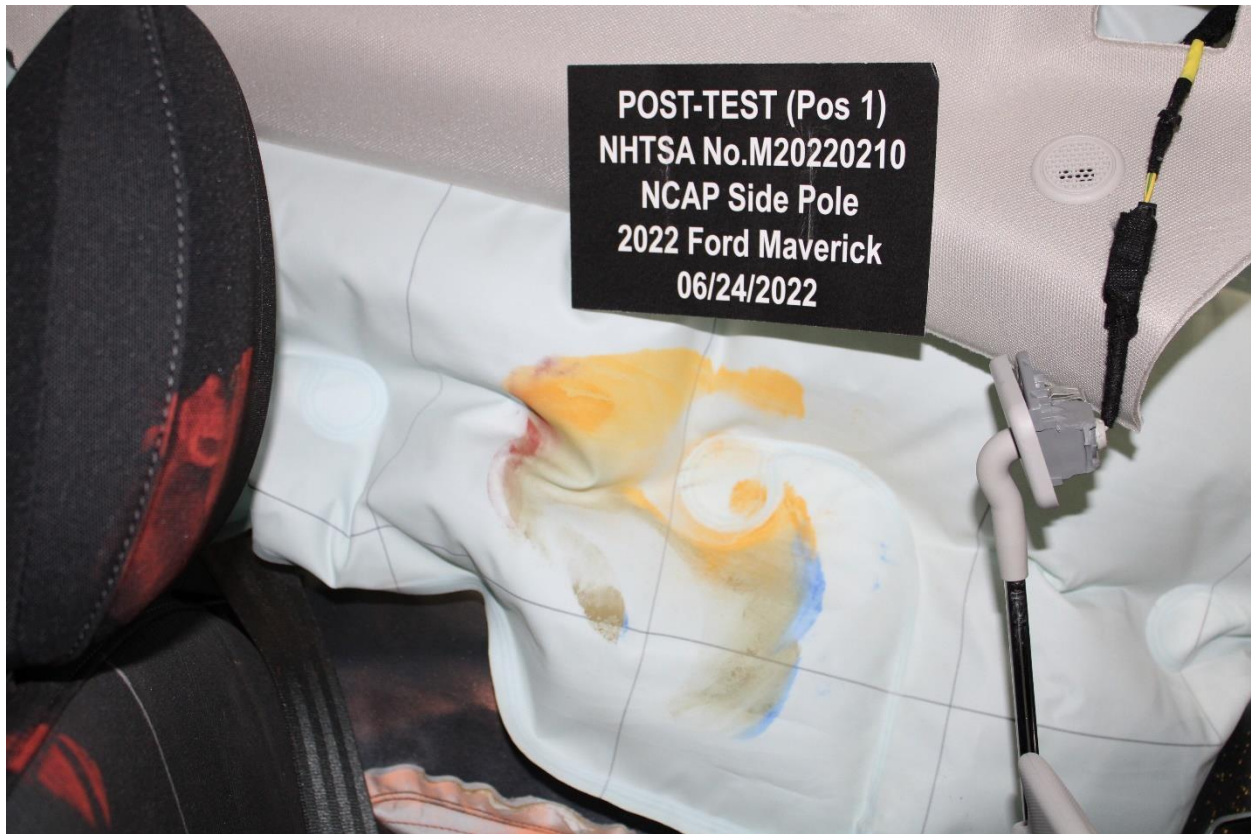
Figure A-47: Post-Test Dummy Close-Up Head Contact with Side Airbag View

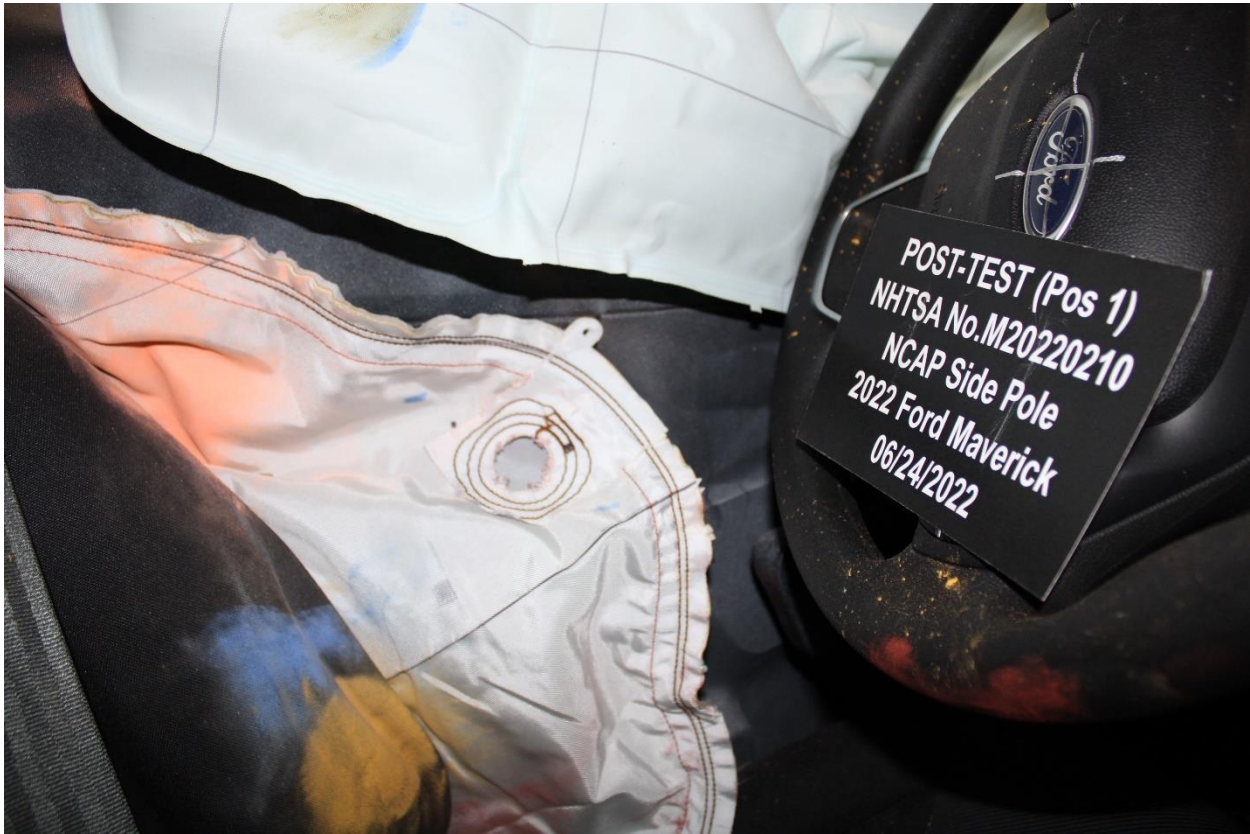
Figure A-49: Post-Test Dummy Close-Up Torso Contact with Side Airbag View

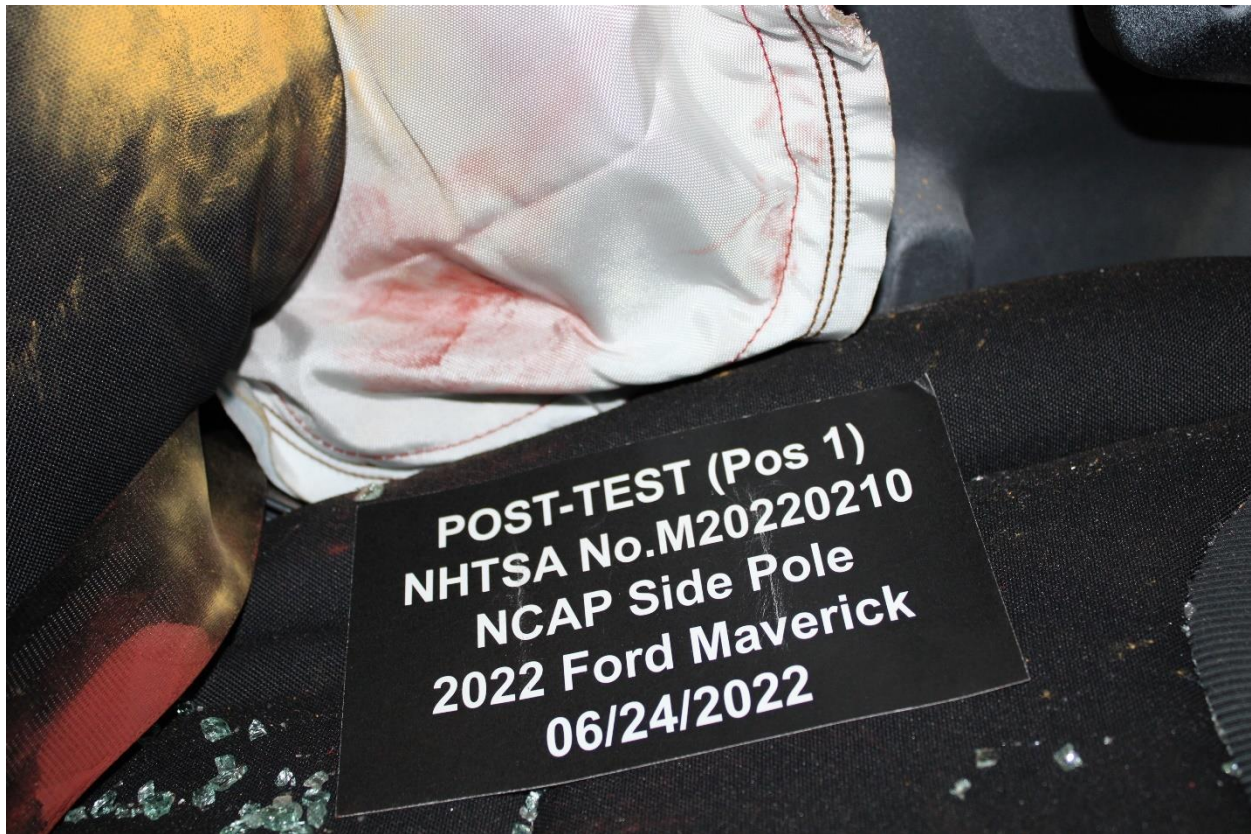
Figure A-51: Post-Test Dummy Close-Up Pelvis Contact with Side Airbag View

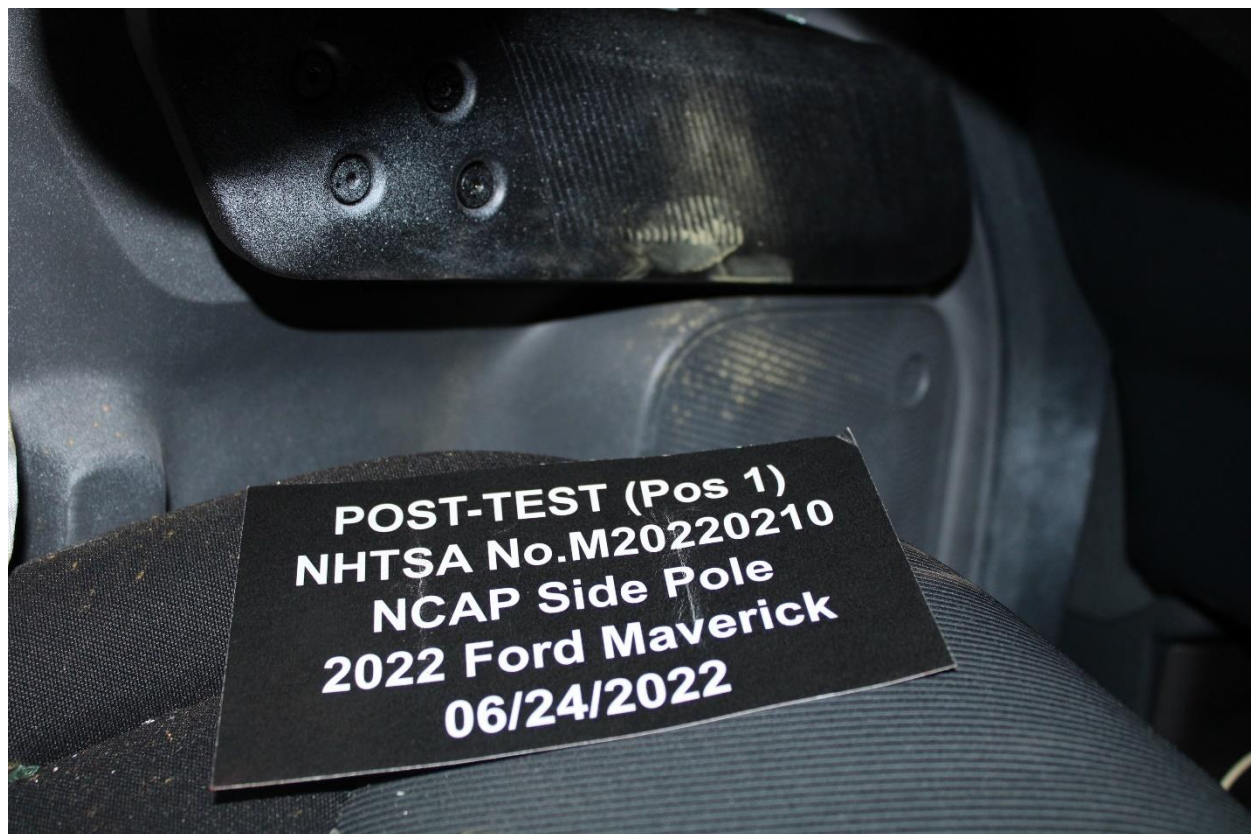
Figure A-52: Post-Test Dummy Close-Up Knee Contact with Vehicle Interior View

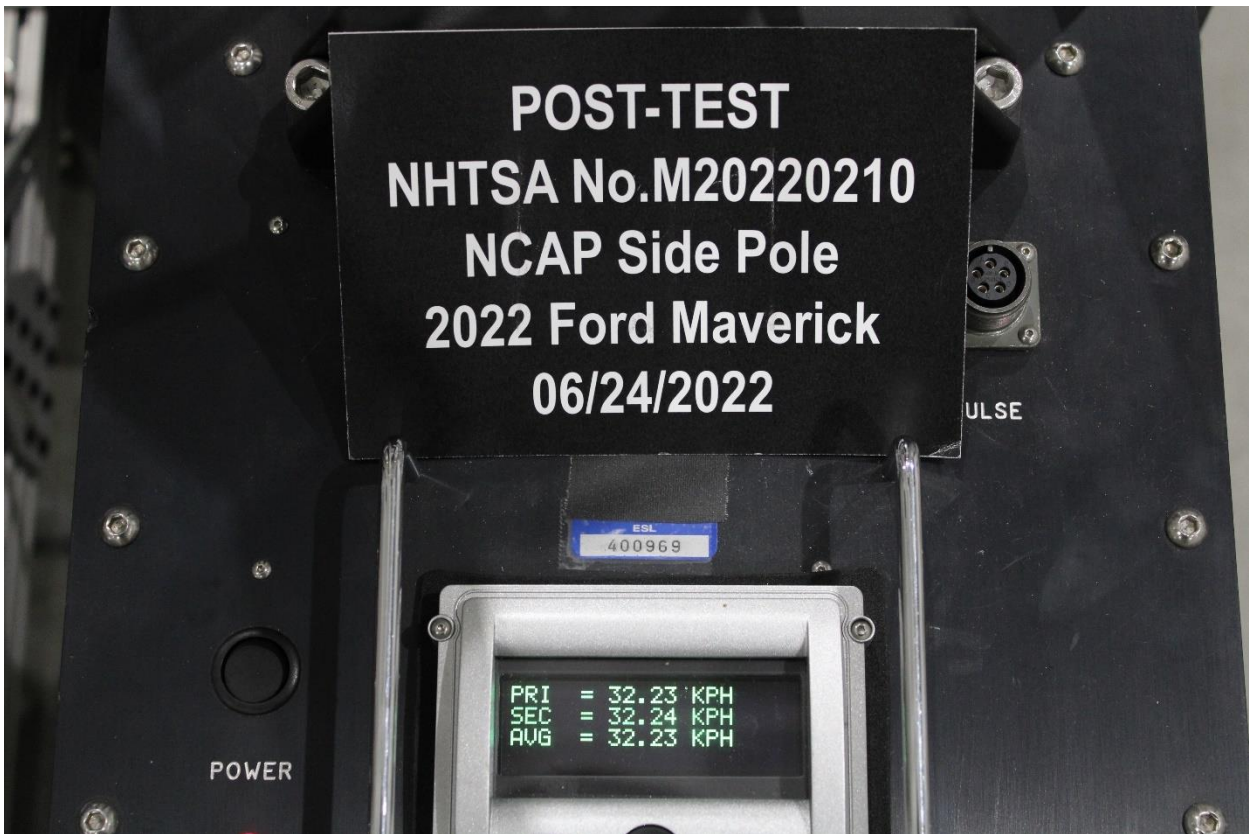
Figure A-64: Post-Test Primary and Redundant Speed Trap Read-Out

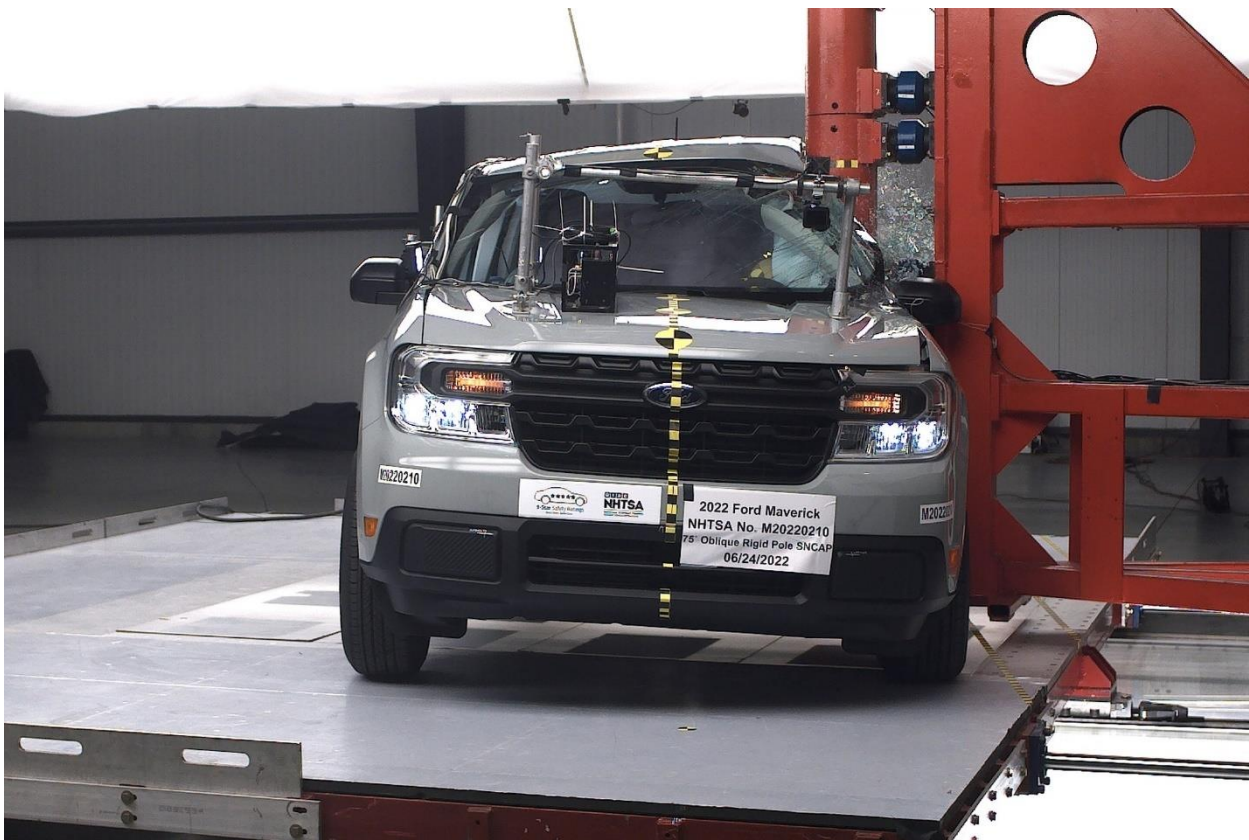
Figure A-70: Impact Event

A rigid pole side impact test was conducted on a 2022 Ford Maverick XL Truck. The subject vehicle was towed into the rigid pole at an angle of 75° and a velocity of 32.23 km/h. The test was conducted by Calspan Corporation's Transportation Test Operations facility in Buffalo, New York on June 24, 2022. Pre-test and post-test photographs of the test vehicle and side impact dummy (SID-IIs) are included in Appendix A of this report.
