**REPORT NUMBER: NCAP-MGA-22-026**

**NEW CAR ASSESSMENT PROGRAM (NCAP)  
Frontal Barrier Impact Test**

**POLESTAR PERFORMANCE AB  
2022 Polestar 2 5-Door Hatchback  
NHTSA No.: M20225900**

**FINAL REPORT**

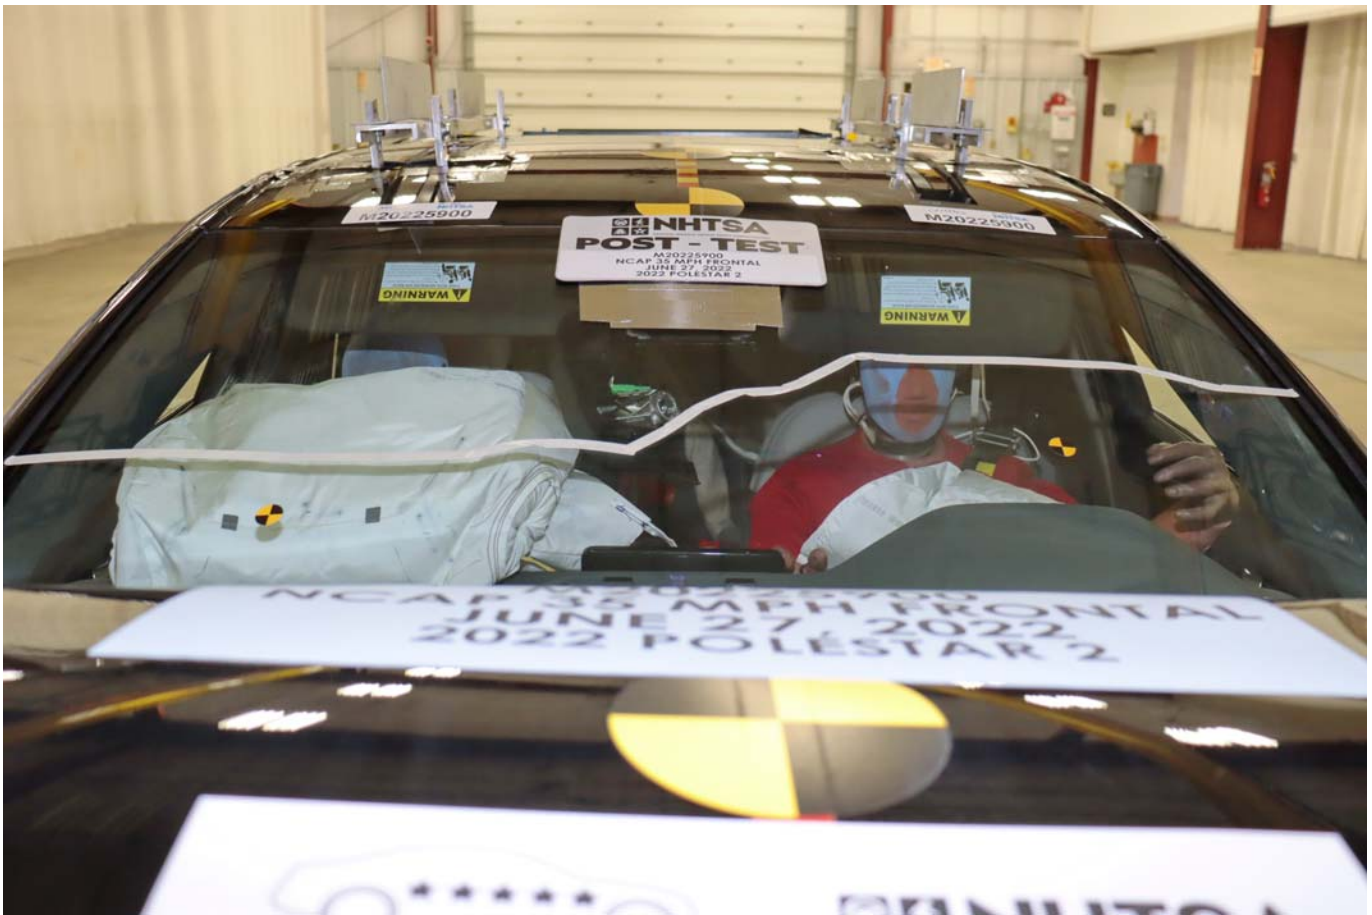
Photo No. 019 - Post-Test Windshield View

There was 100 percent windshield retention and no intrusion into the protected zone of the windshield during the event. There was no Stoddard Solvent or battery electrolyte leakage and no loss of high-voltage battery isolation after the event or during any phase of the static rollover.

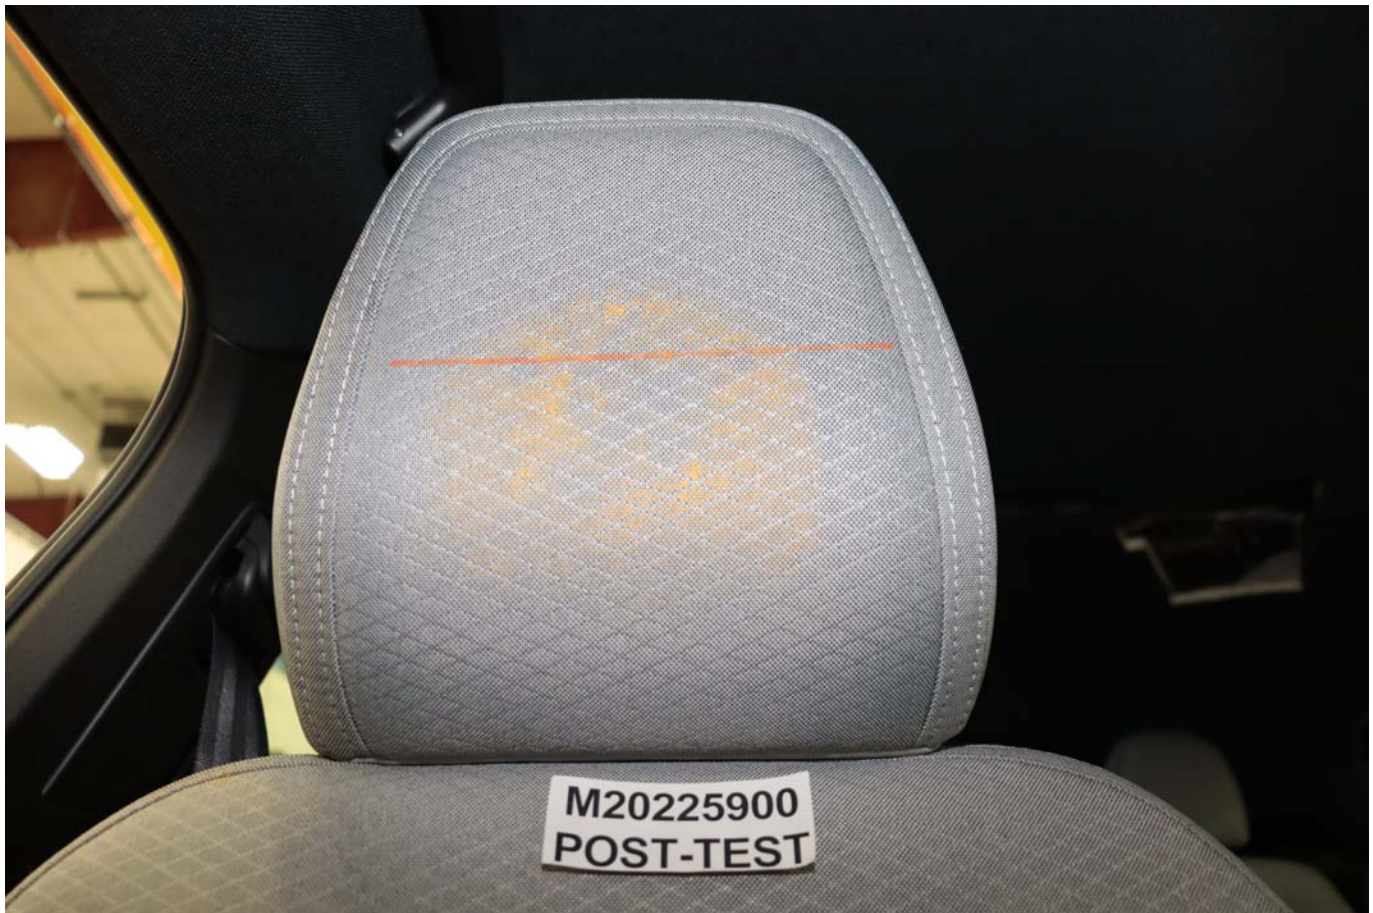
Photo No. 073 - Post-Test Passenger Dummy Contact with Headrest

The passenger's visible contact points were as follows: The passenger's head contacted the airbag. The passenger's head also contacted the headrest. The passenger's knees contacted the glove box.
