**REPORT NUMBER: SPNCAP-CAL-20-005**

**NEW CAR ASSESSMENT PROGRAM (NCAP)  
SIDE IMPACT POLE TEST**

**Polestar Performance AB  
2022 Polestar Polestar 2  
5-Door Hatchback**

**FINAL REPORT**

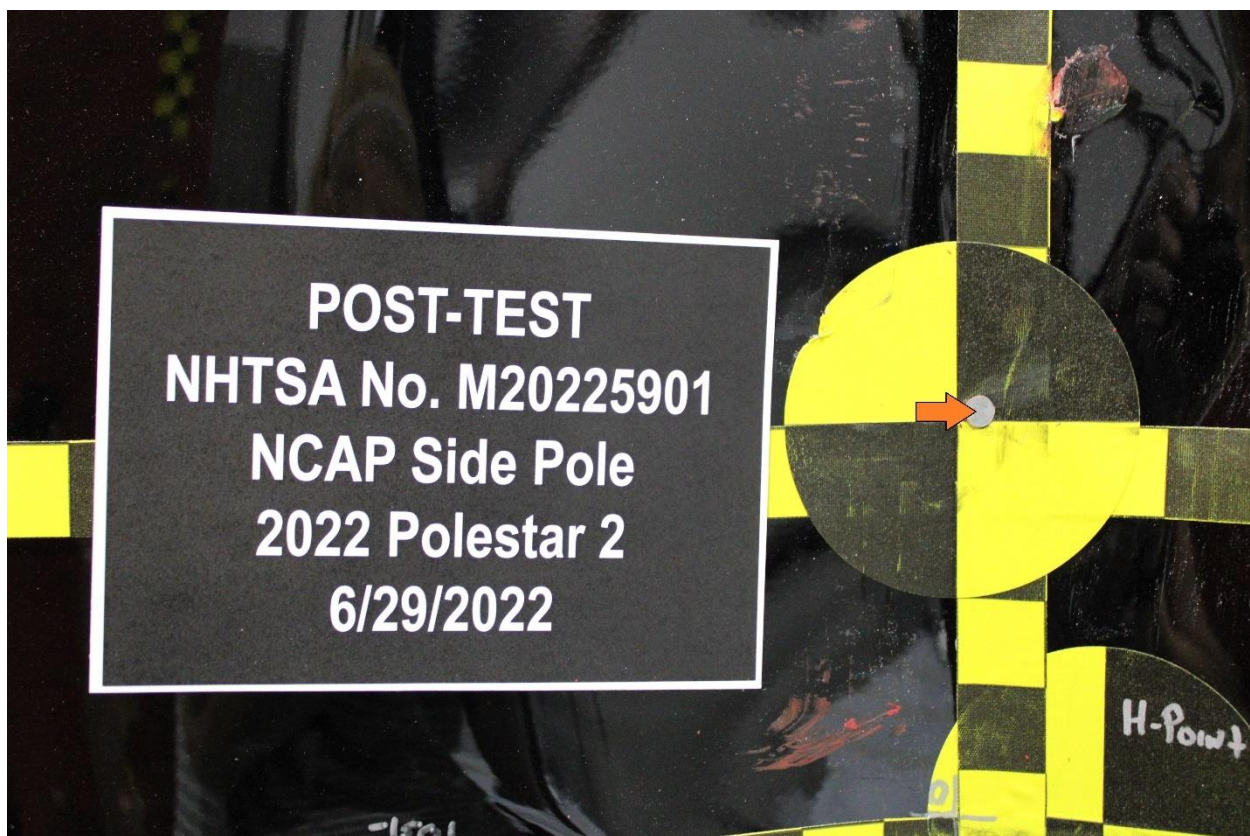
Figure A-20: Post-Test Close-Up View of Impact Point Target Showing Impact Location

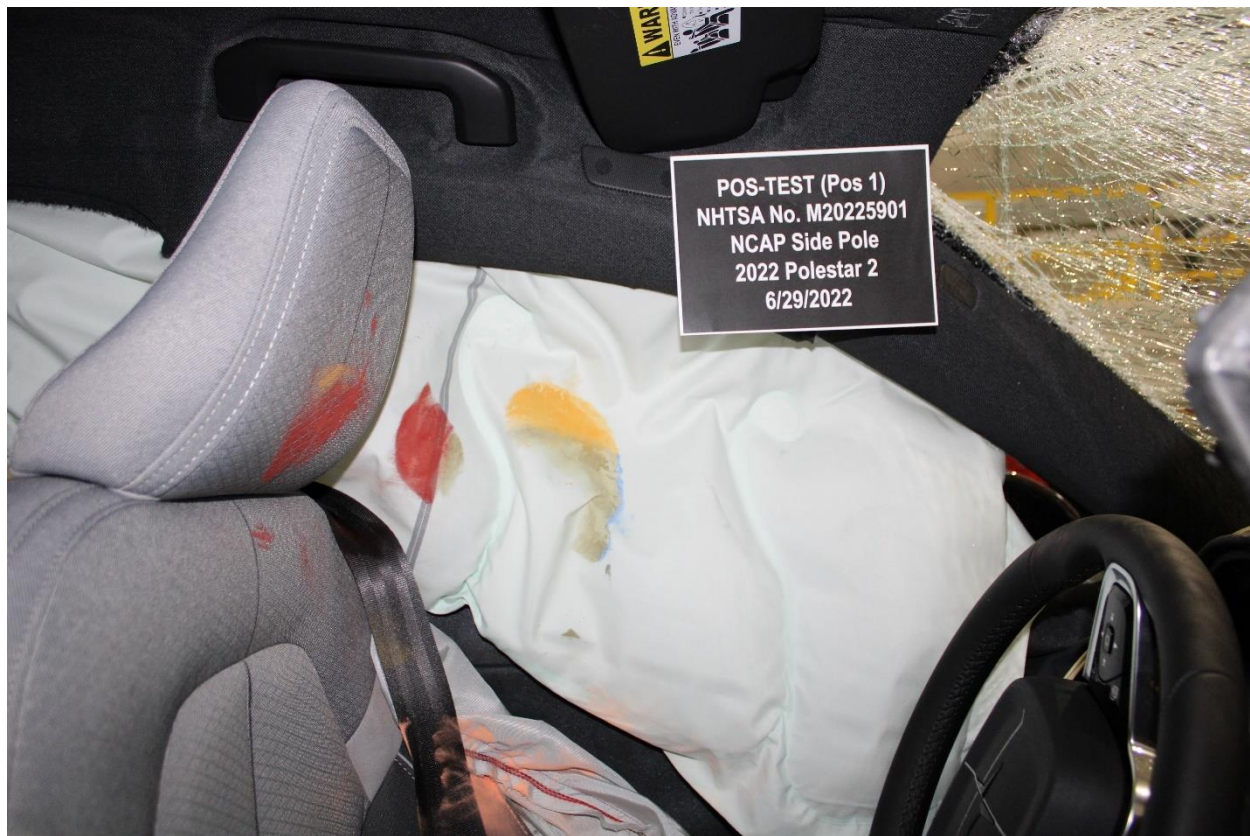
**Figure A-46: Post-Test Dummy Close-Up Head Contact with Vehicle Interior View**
