**REPORT NUMBER: SINCAP-CAL-22-005**

**NEW CAR ASSESSMENT PROGRAM (NCAP)  
MOVING DEFORMABLE BARRIER SIDE IMPACT TEST**

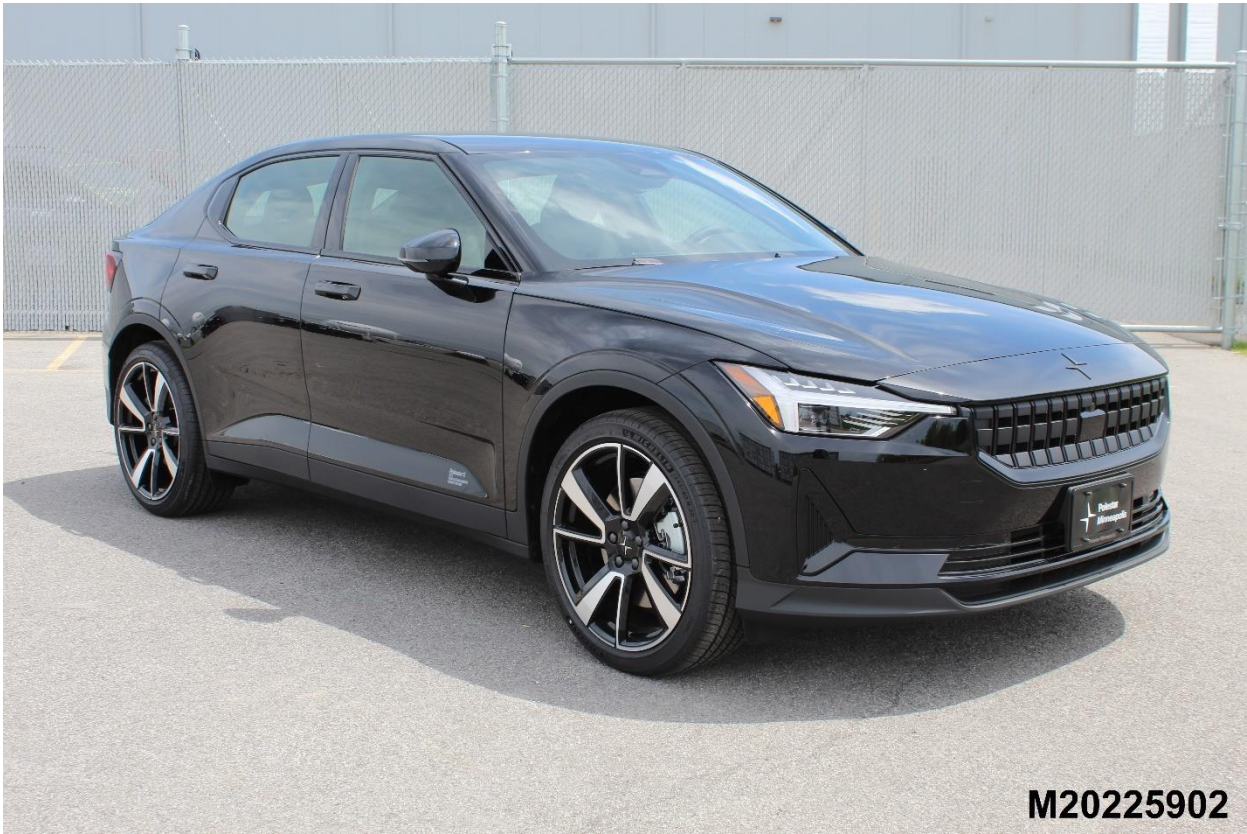
305-31	FMVSS No. 305 Static Rollover 360 Degrees	A-73
305-32	Pre-Impact View of the Vehicle Passenger Compartment Adjacent to Propulsion Battery	A-73
305-33	Post-Impact View of the Vehicle Passenger Compartment Adjacent to Propulsion Battery	A-74
305-34	Post-Impact Propulsion Battery System Mounting and/or Intrusion Failure(s)	A-74
305-35	Post-Impact View of Battery Component Intrusion	A-75
305-36	Post-Impact View of Battery Module Movement or Retention Loss	A-75
305-37	Post –Impact View of Propulsion Battery Electrolyte Spillage Location (Prior to static roll)	A-76
305-38	Post –Impact View of Propulsion Battery Electrolyte Spillage Location (After to static roll)	A-76
