**REPORT NUMBER: SideNCAPPole-MGA-22-028**

**NEW CAR ASSESSMENT PROGRAM (NCAP)  
Side Impact Pole Test**

**NISSAN MOTOR CO., LTD.  
2022 Nissan Rogue Sport SV 5-Door SUV  
NHTSA No.: M20225208**

**MGA RESEARCH CORPORATION  
5000 Warren Road  
Burlington, WI 53105**

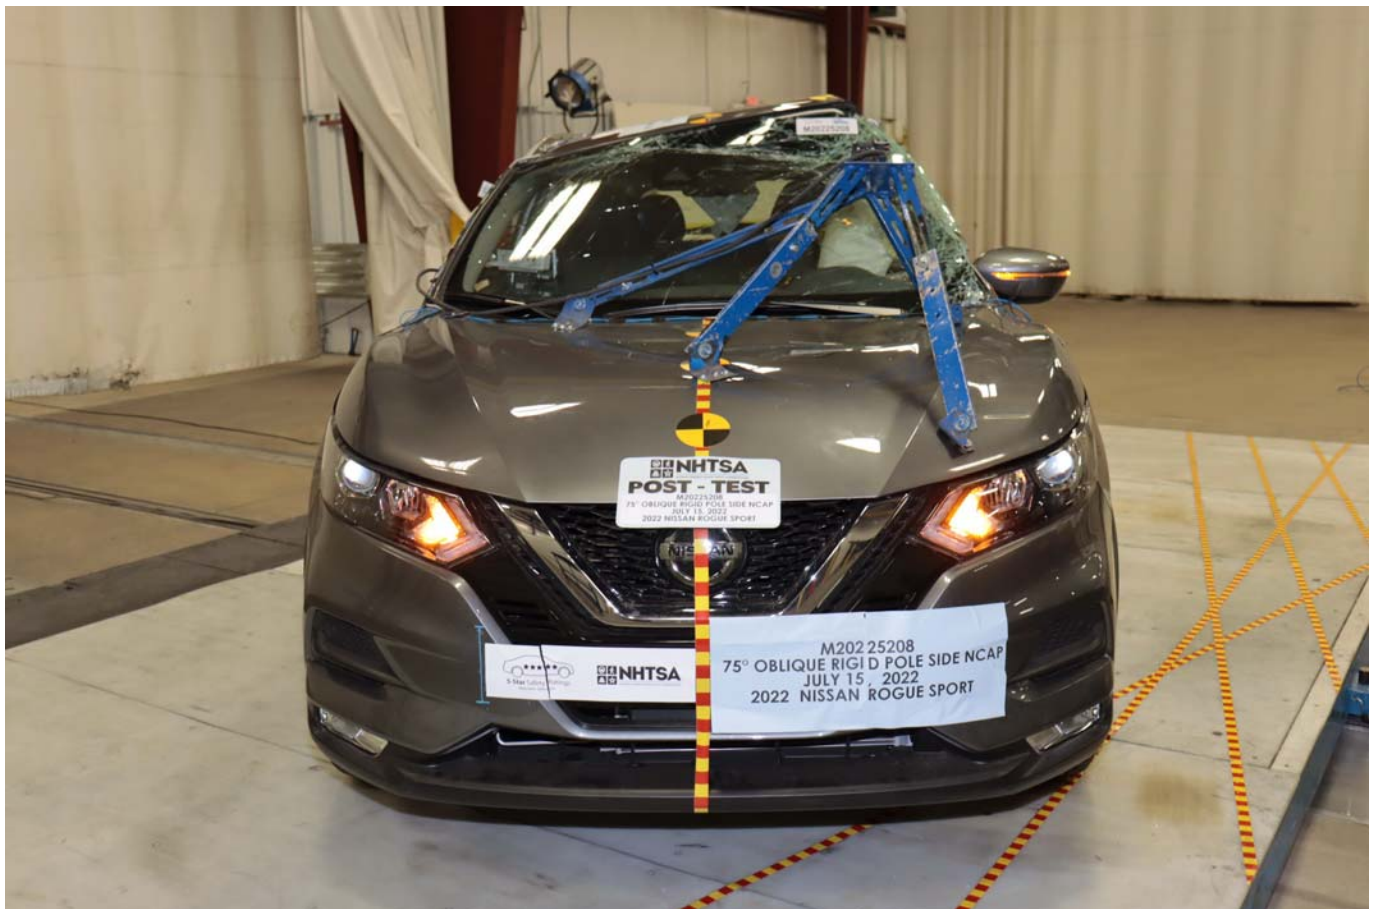
Photo No. 004 - Post-Test Frontal View of Test Vehicle

| Critical Areas of Performance | Observations and Conclusions |
|---|---|
| Windshield Damage | Broken |

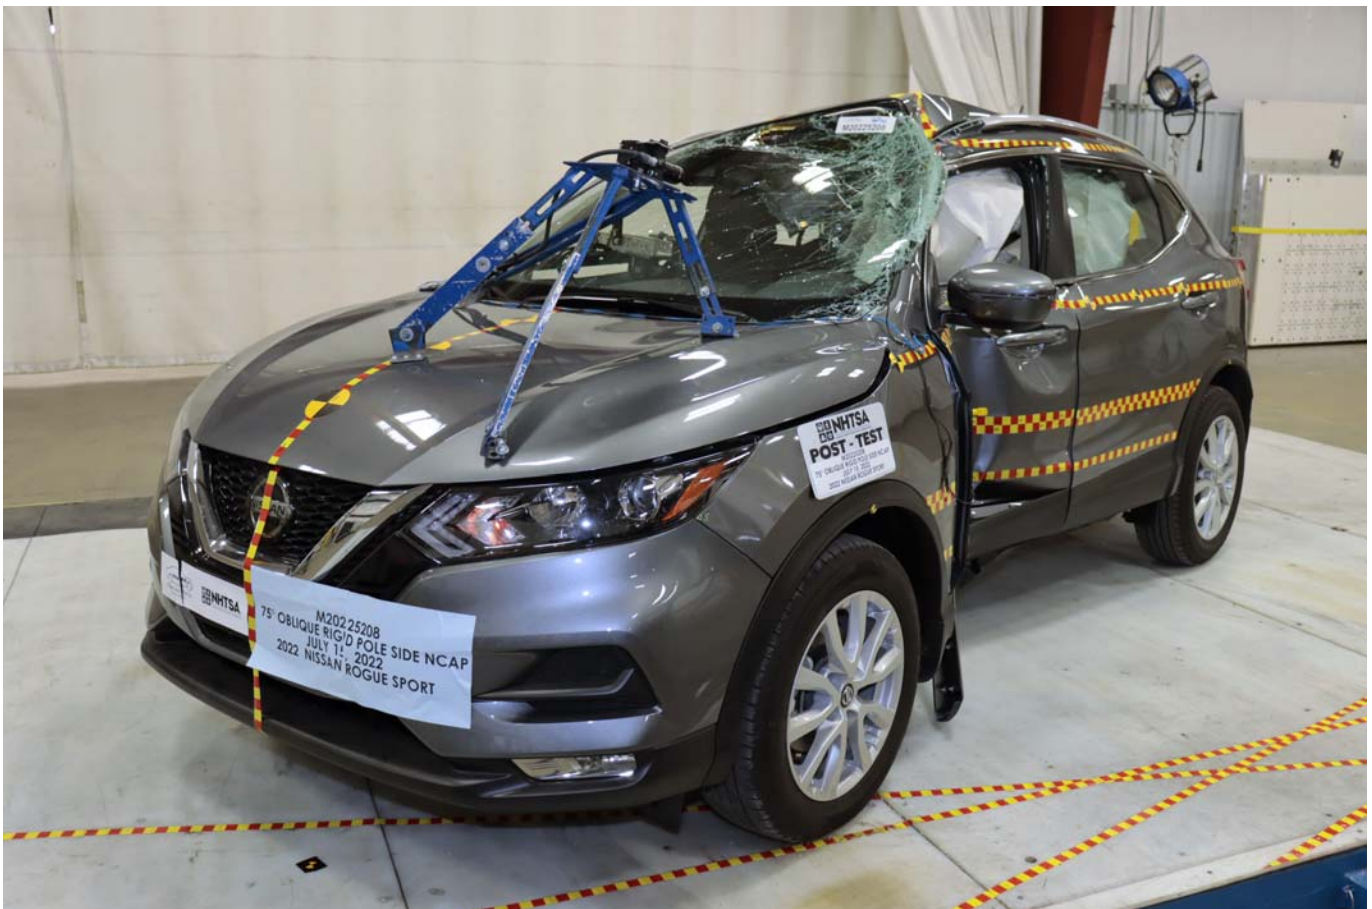
Photo No. 006 - Post-Test Left Front Three-Quarter View of Test Vehicle

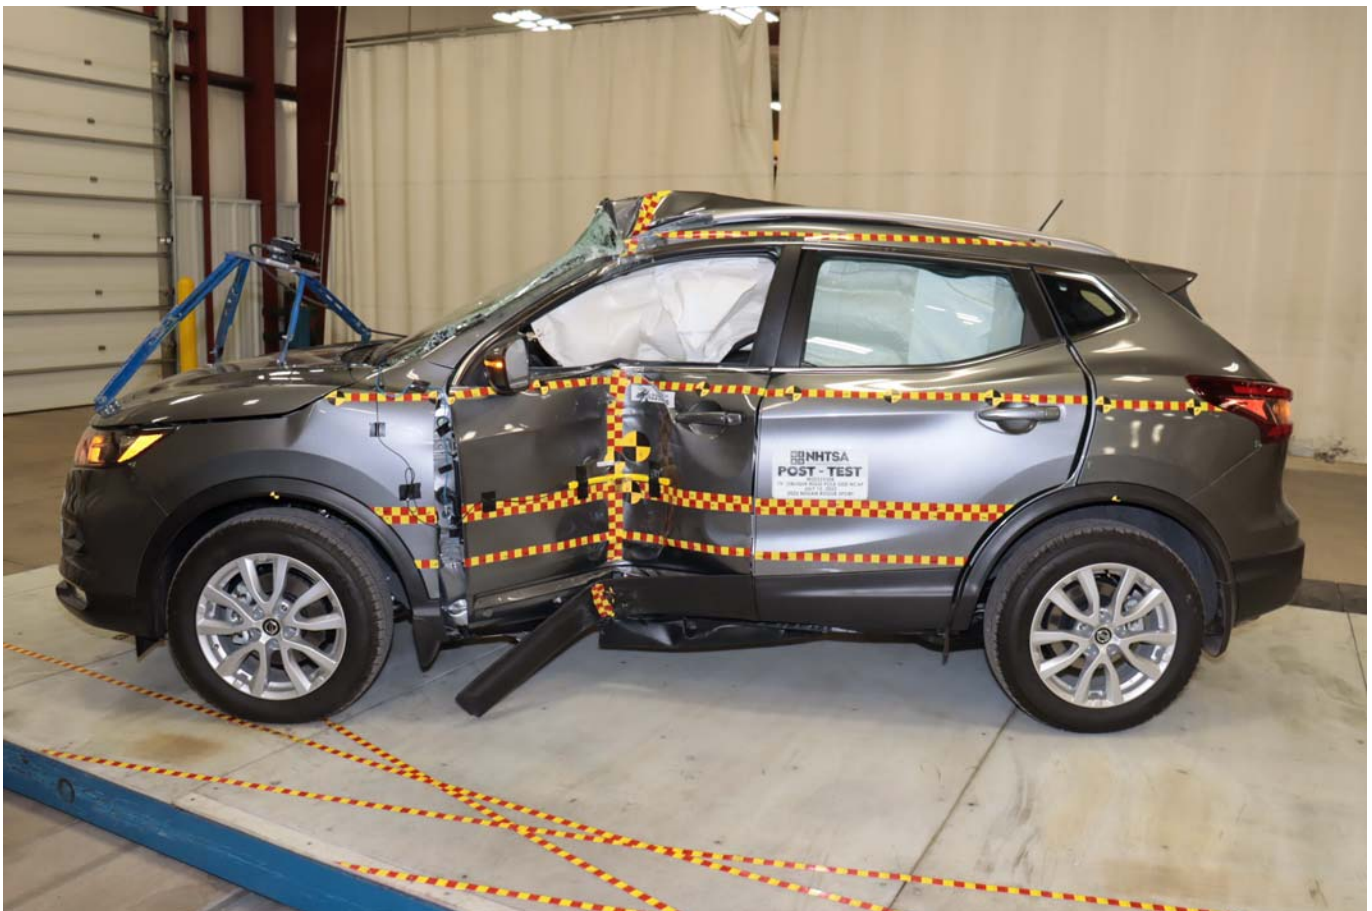
Photo No. 008 - Post-Test Left Side View of Test Vehicle

| Critical Areas of Performance | Observations and Conclusions |
|---|---|
| Side Window Damage | LF Window Broken |

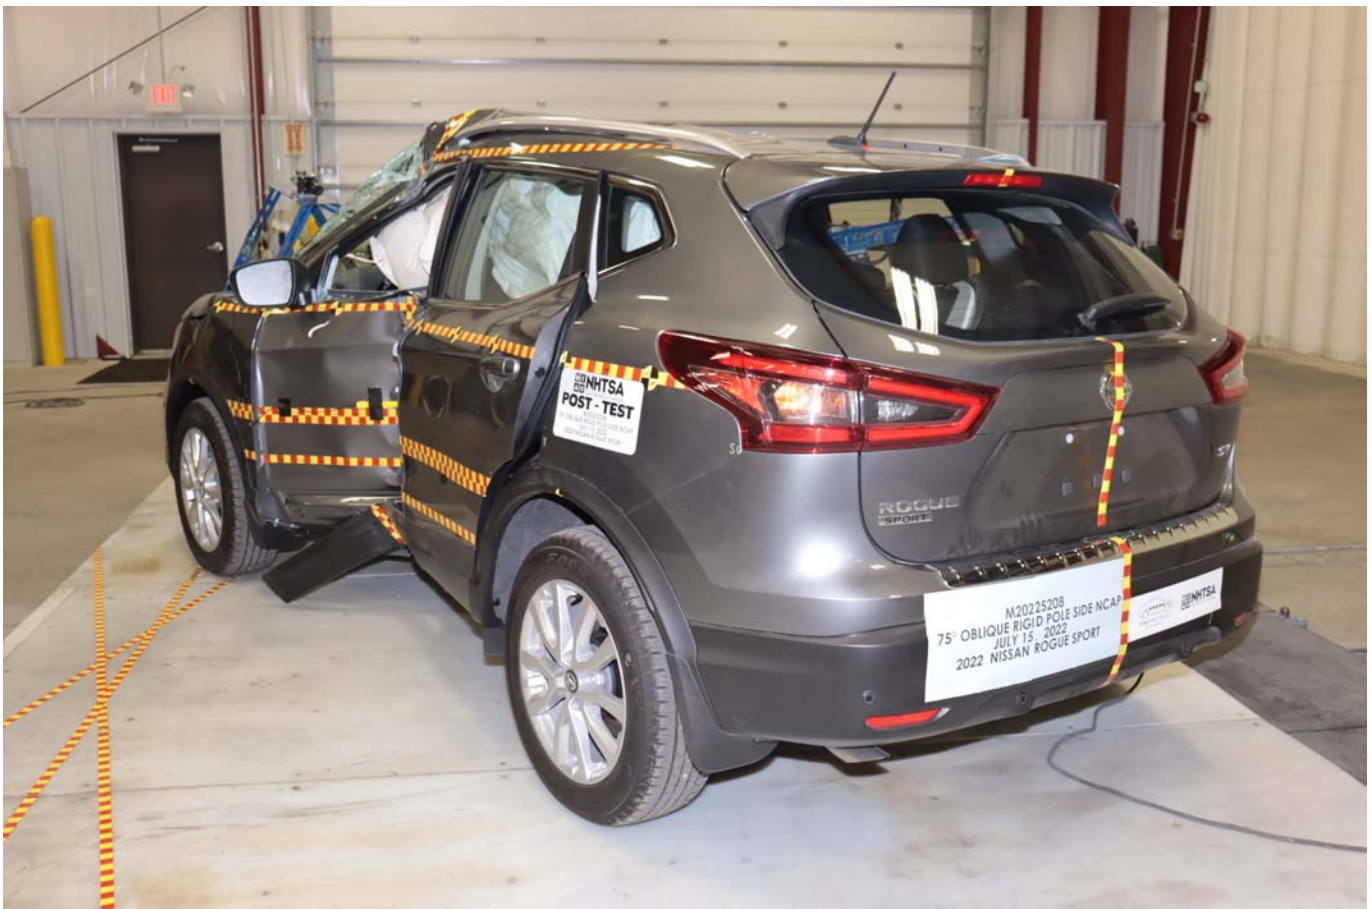
Photo No. 010 - Post-Test Left Rear Three-Quarter View of Test Vehicle

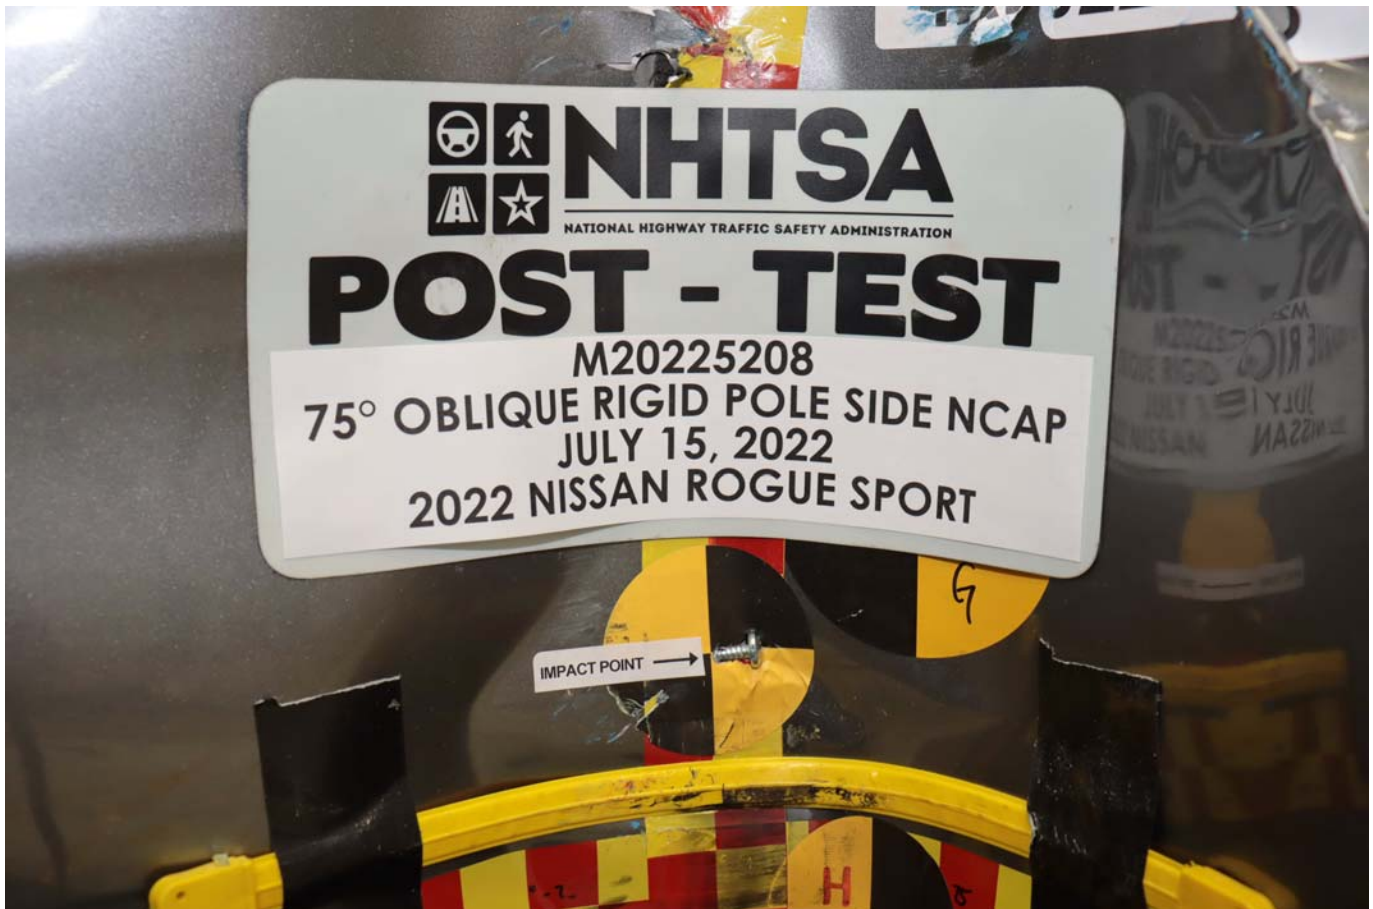
Photo No. 020 - Post-Test Close-Up View of Impact Point Target Showing Impact Location

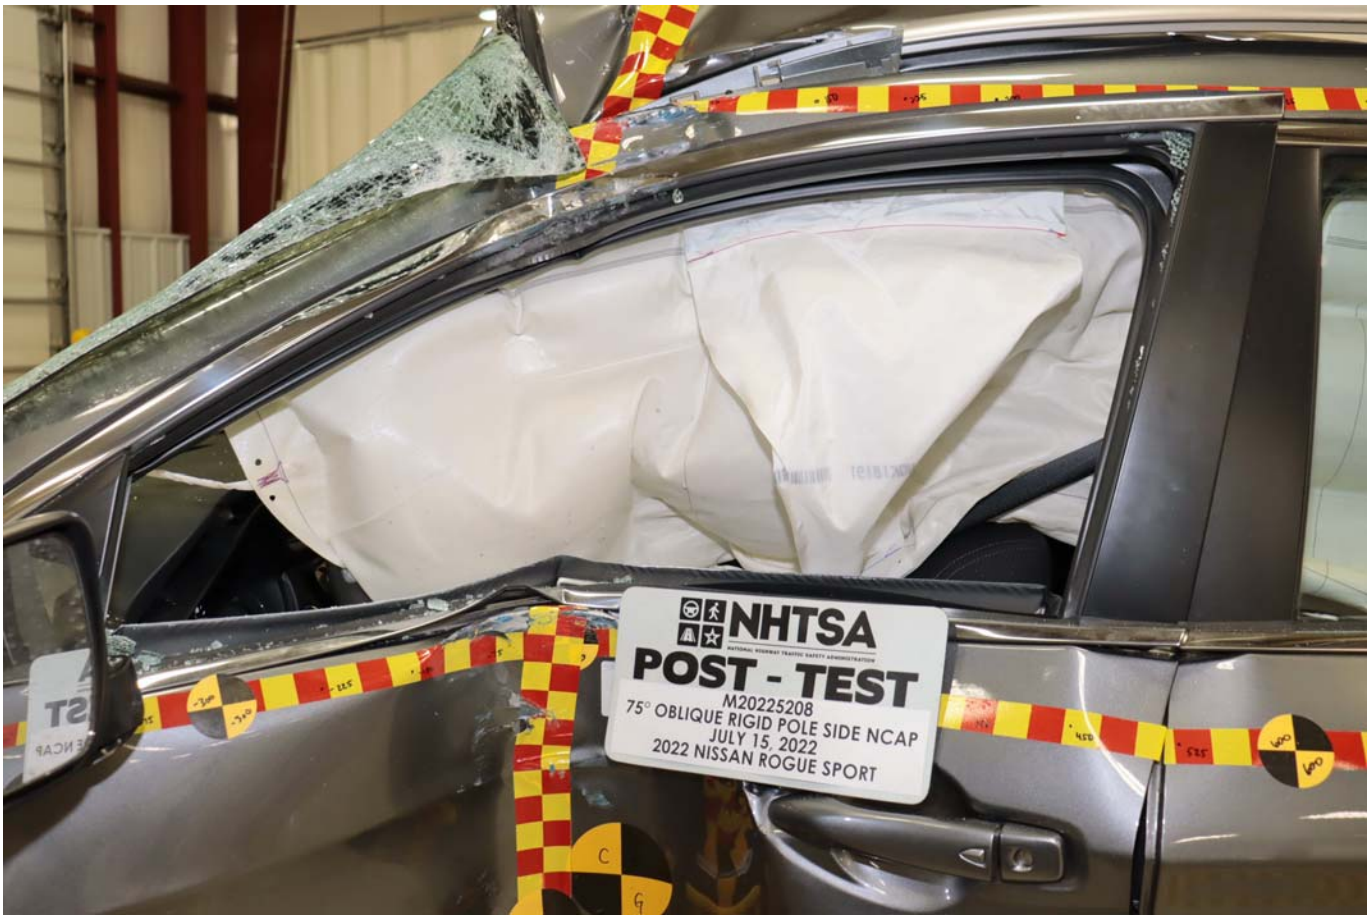
Photo No. 025 - Post-Test Left Side View of Dummy Shoulder and Door Top View

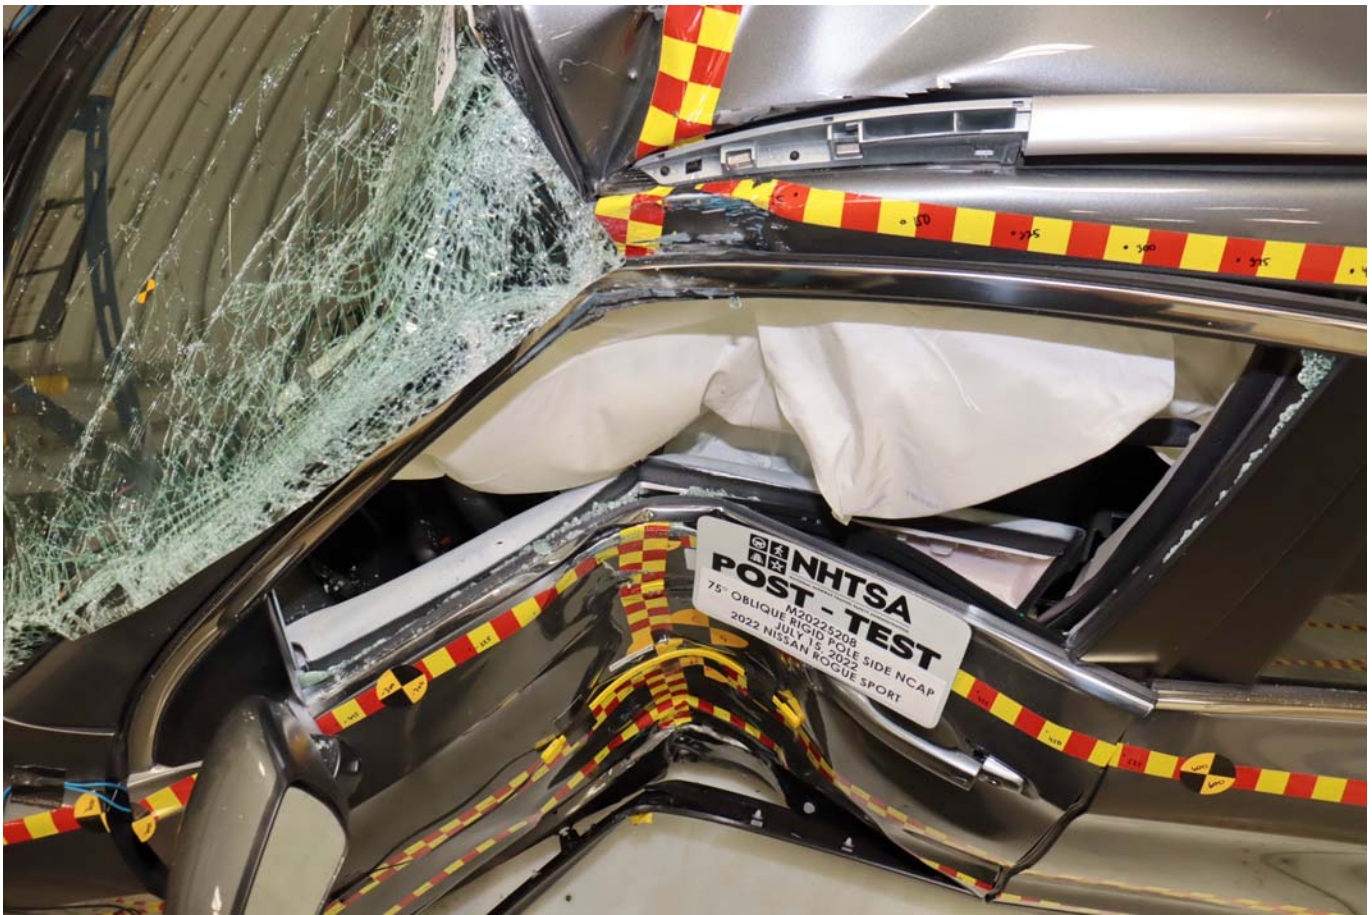
Photo No. 041 - Post-Test Dummy and Door Clearance View

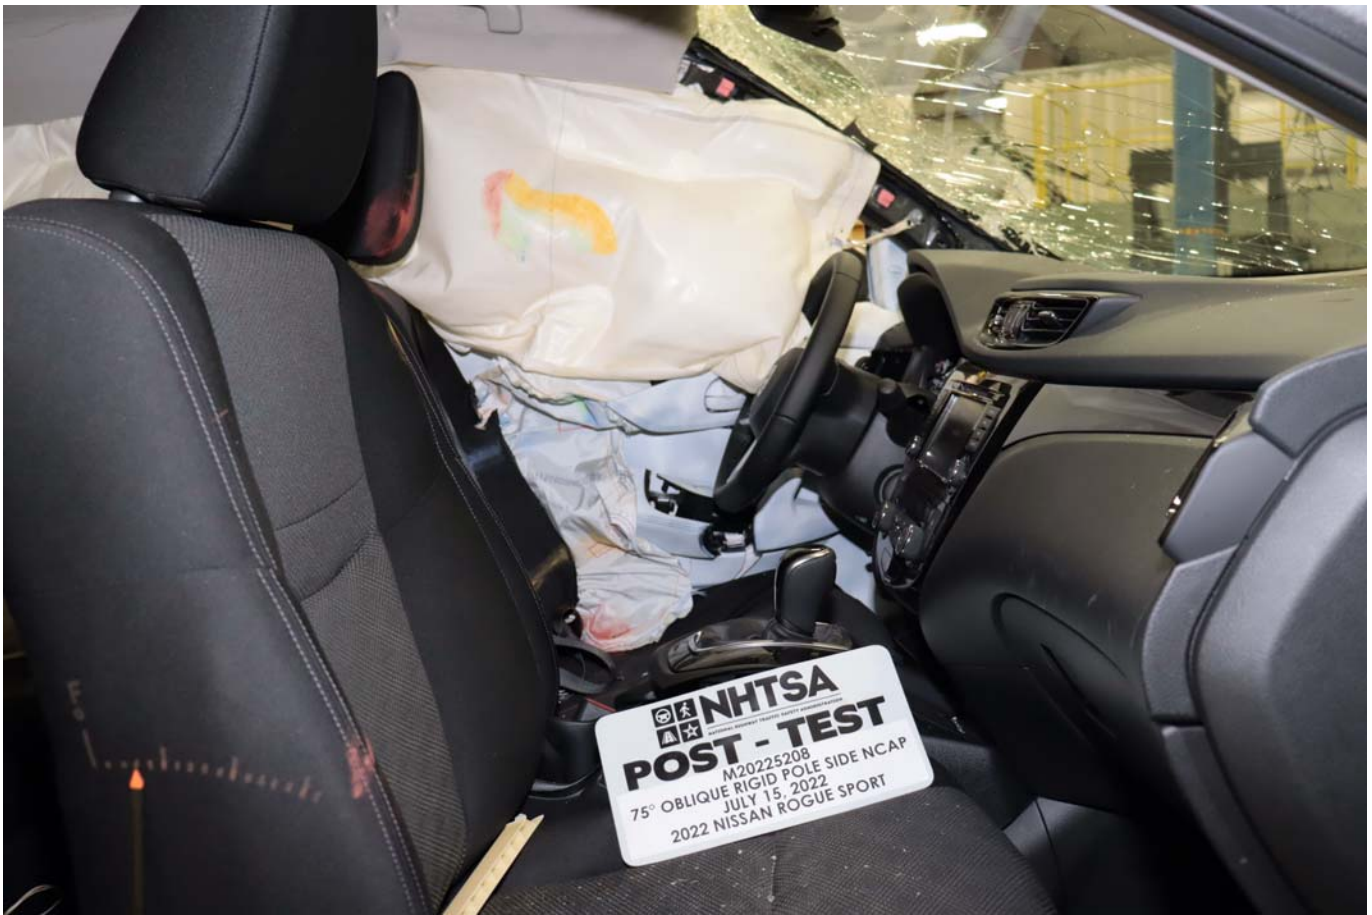
Photo No. 045 - Post-Test Inner Door Panel View Showing Dummy Contact Location

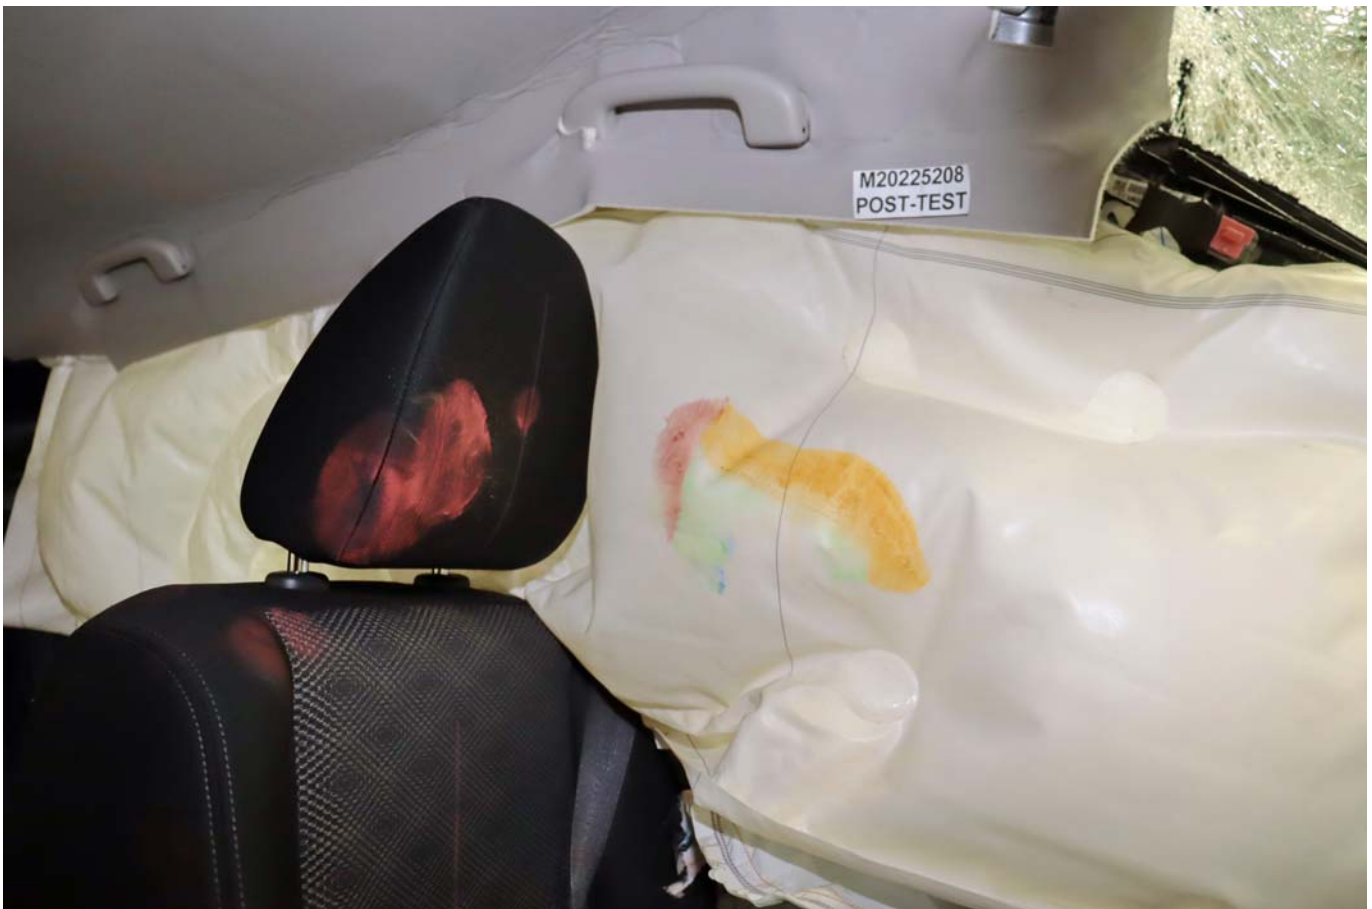
Photo No. 046 - Post-Test Dummy Close-Up Head Contact with Vehicle Interior View

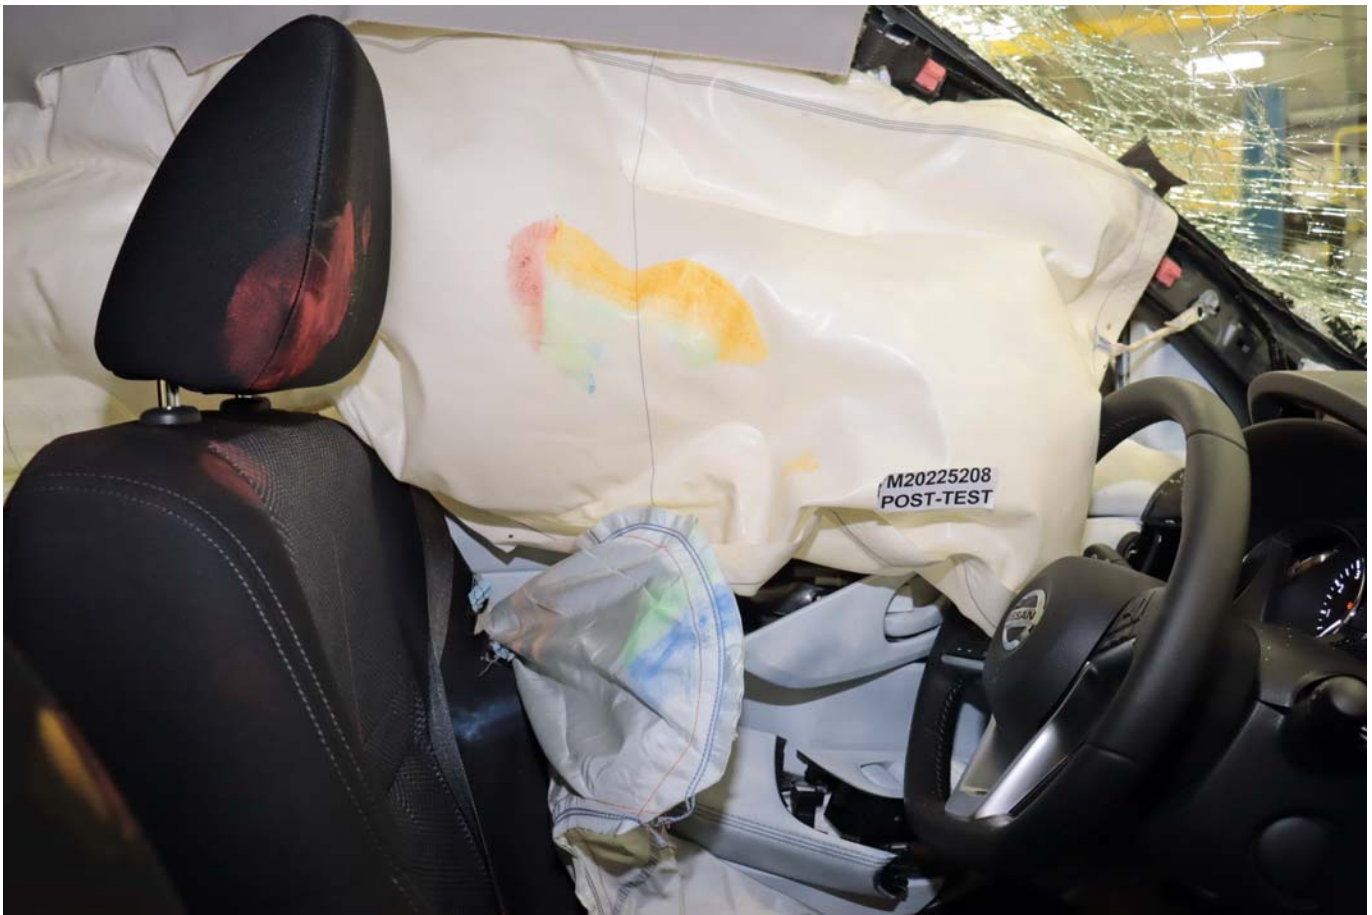
Photo No. 047 - Post-Test Dummy Close-Up Head Contact with Side Air Bag View

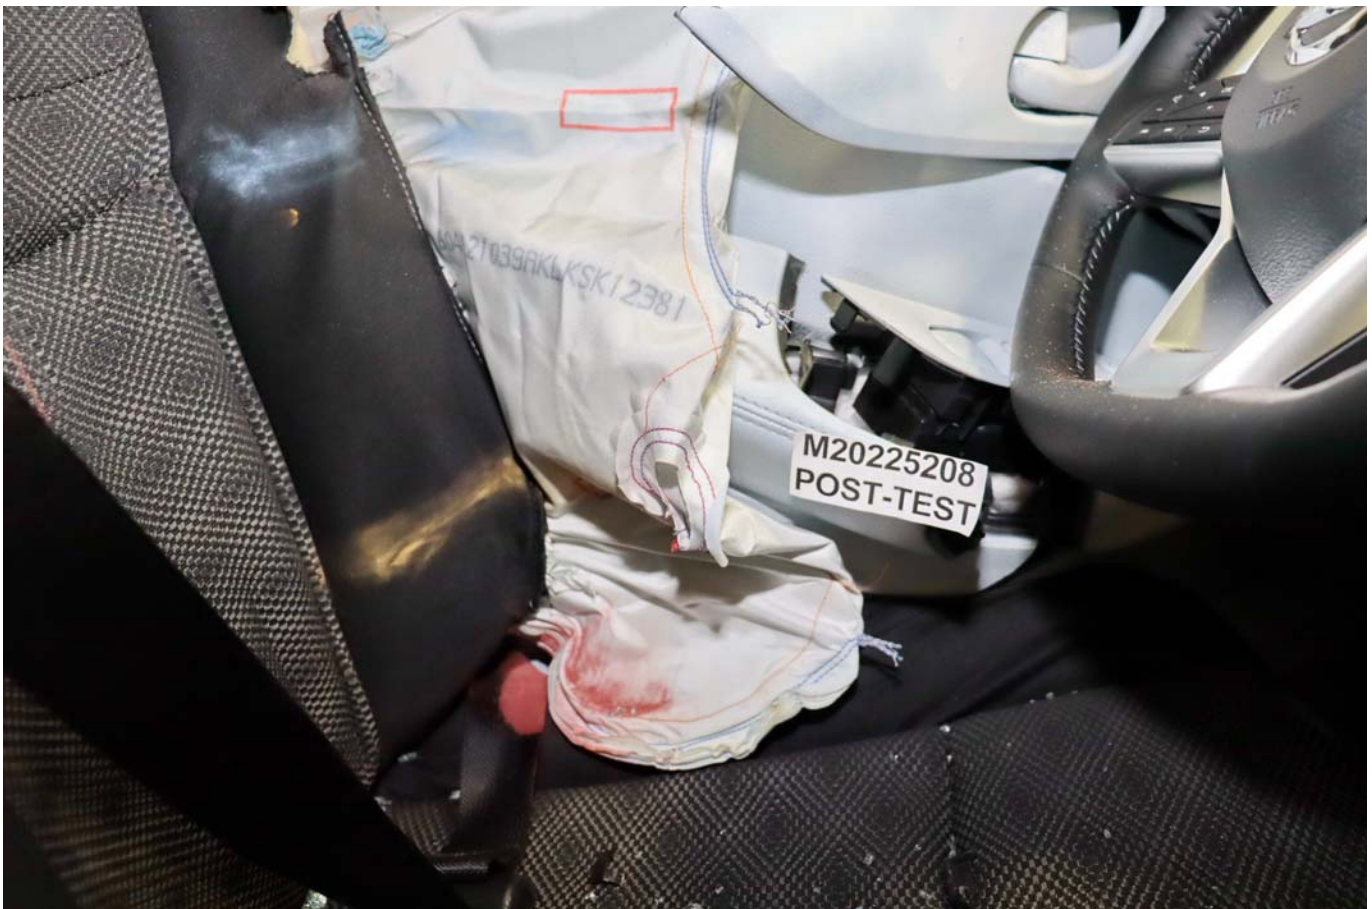
Photo No. 048 - Post-Test Dummy Close-Up Torso Contact with Vehicle Interior View

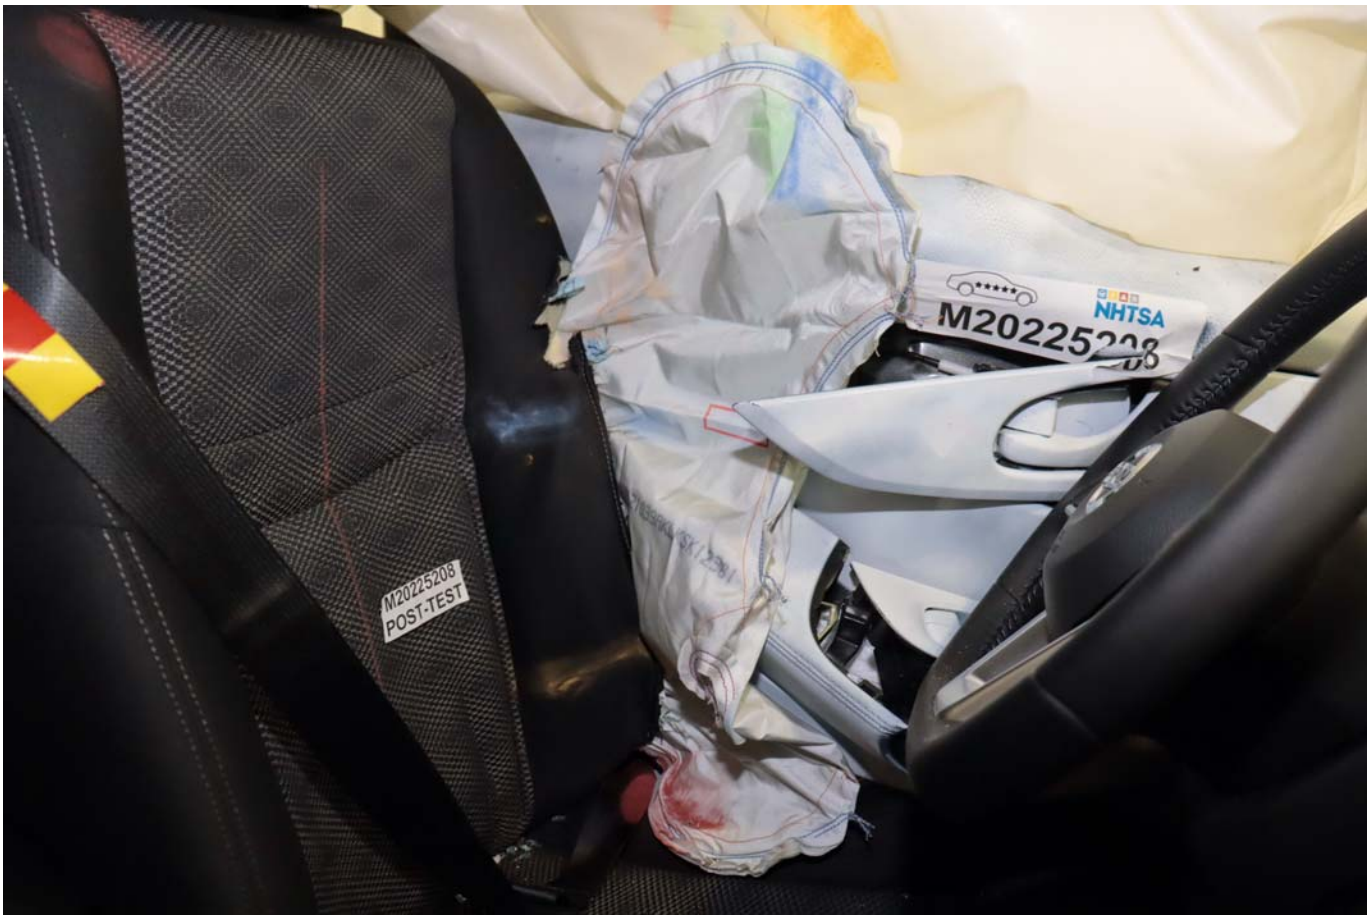
Photo No. 049 - Post-Test Dummy Close-Up Torso Contact with Side Air Bag View

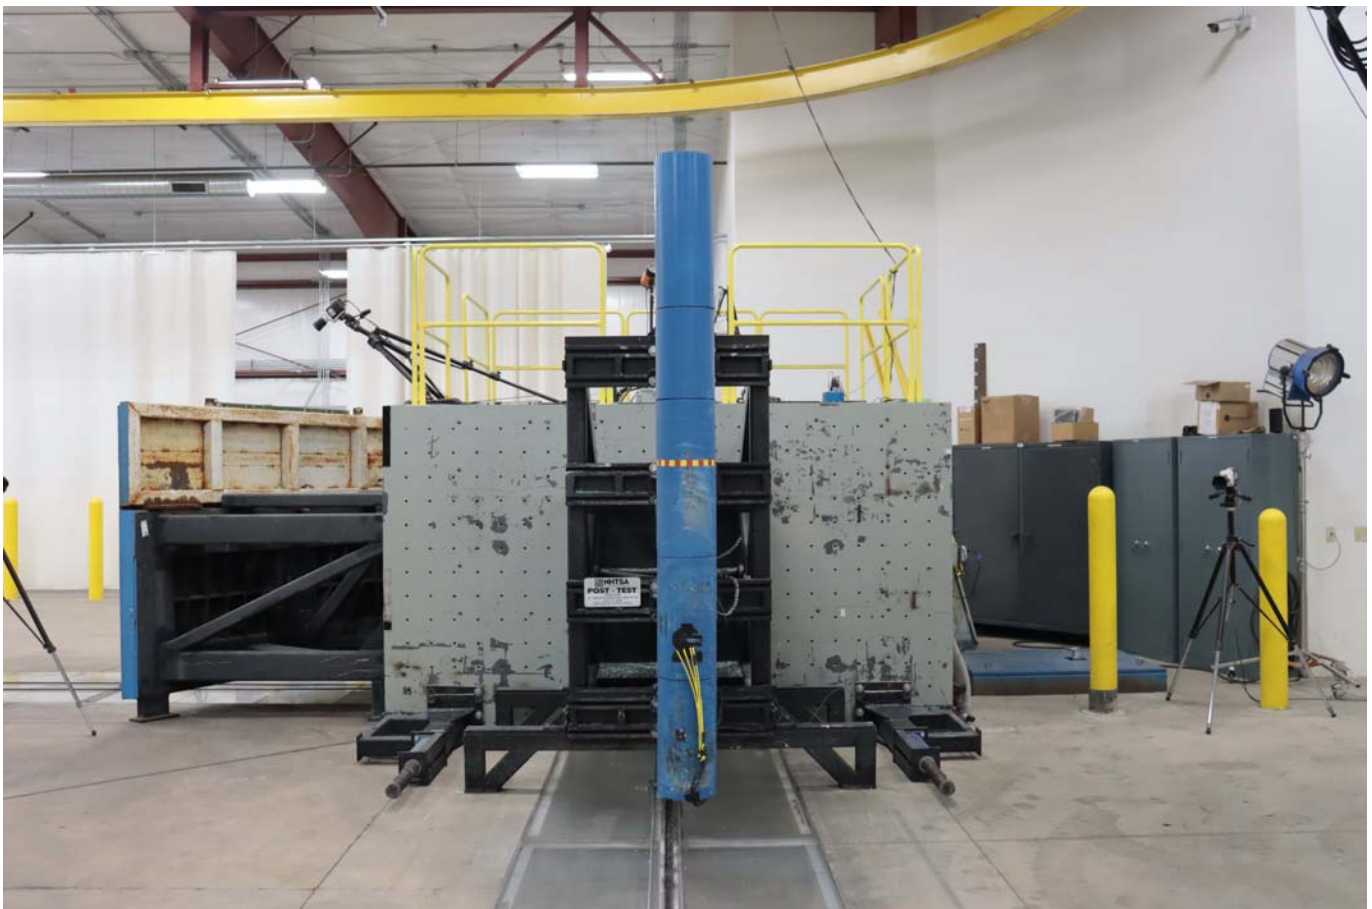
Photo No. 060 - Post-Test Pole Barrier Front View

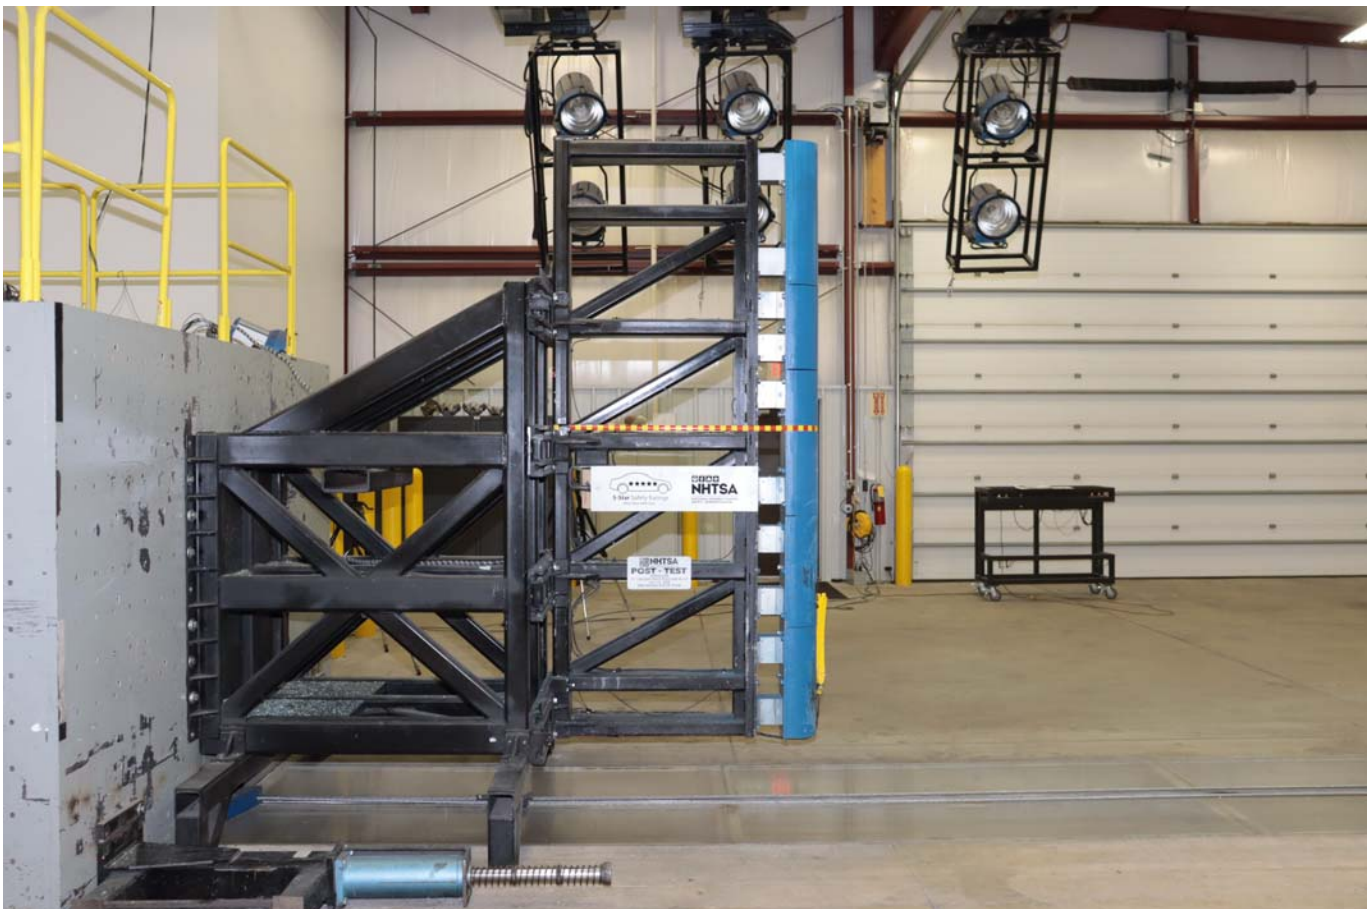
Photo No. 062 - Post-Test Pole Barrier Side View

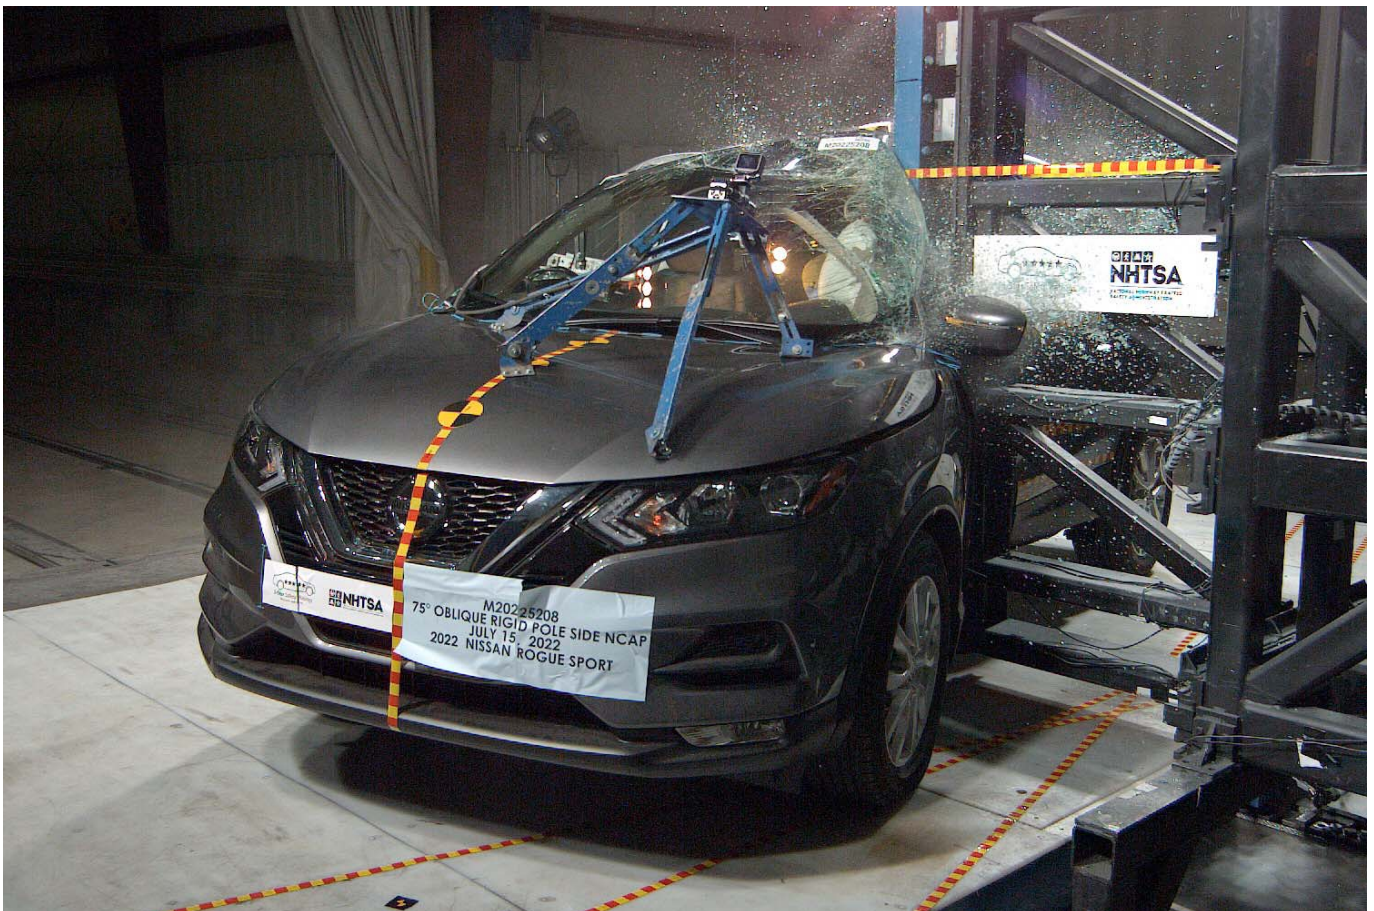
Photo No. 070 - Impact Event
