**REPORT NUMBER: SideNCAPPole-MGA-22-030**

**NEW CAR ASSESSMENT PROGRAM (NCAP)  
Side Impact Pole Test**

**FORD MOTOR CO.  
2022 Ford F-150 SuperCrew HEV  
NHTSA No.: M20220217**

**FINAL REPORT**

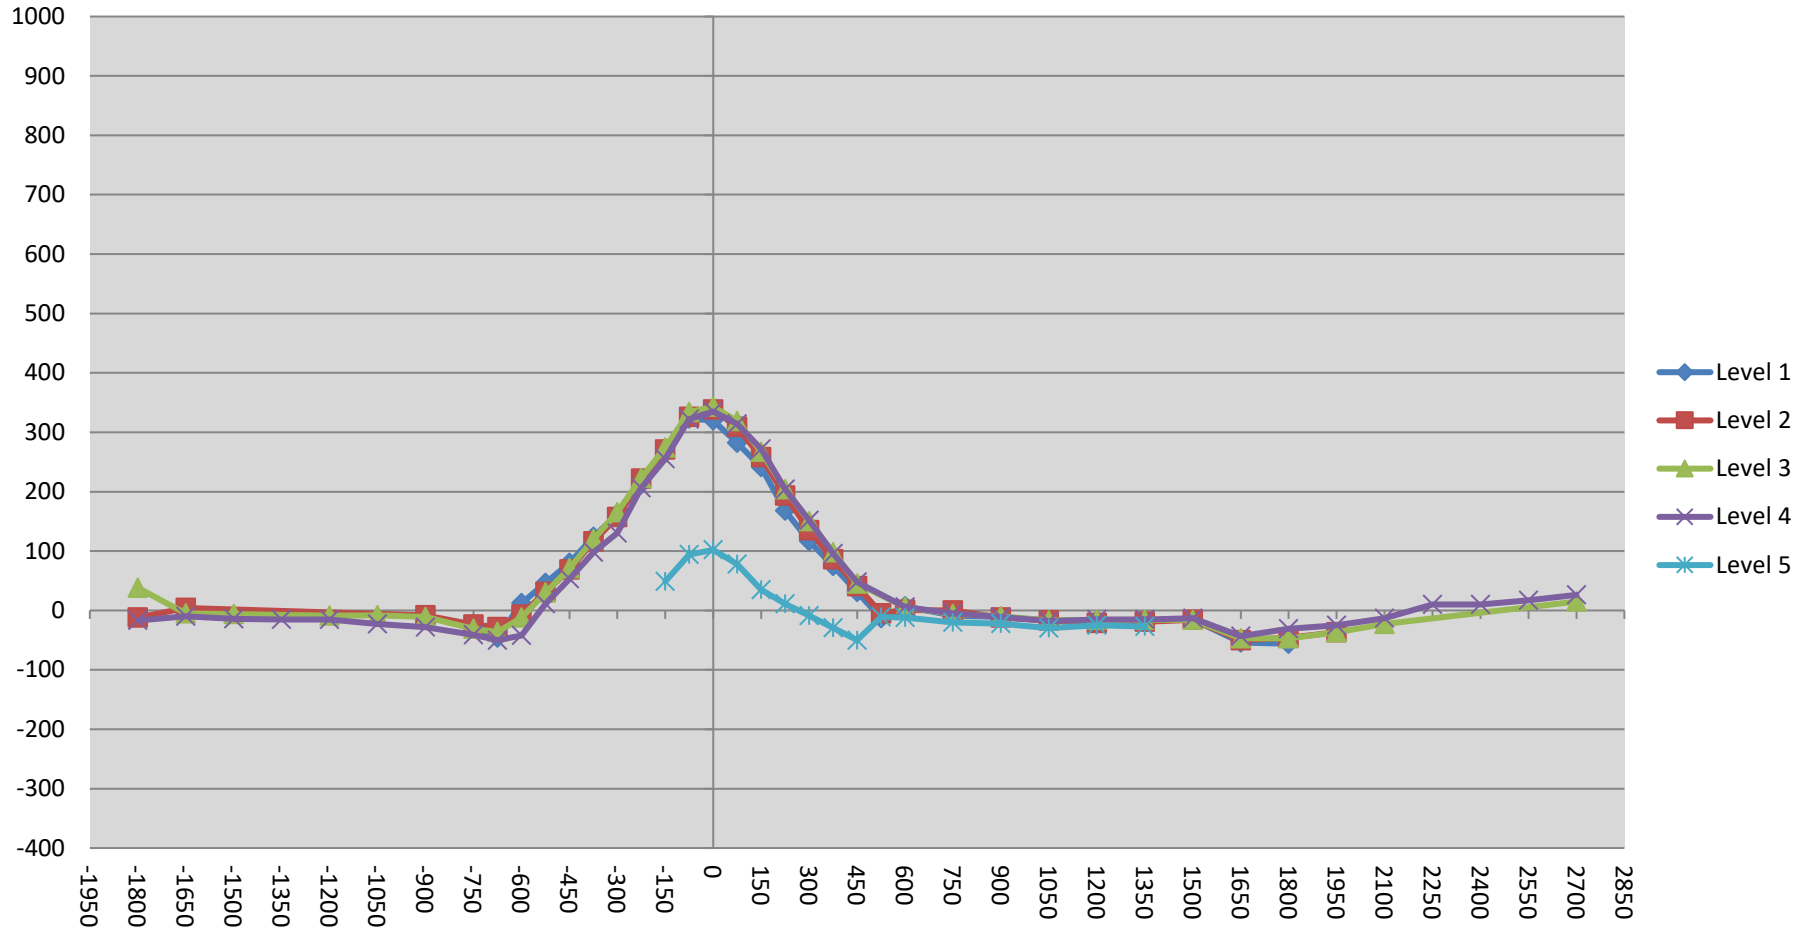
Pre-test measurements are taken when the vehicle is in the "As Tested" weight condition. Vehicle measurements forward of the vertical impact reference line are negative. The crush profile grid is established prior to the test based on an estimated impact point.

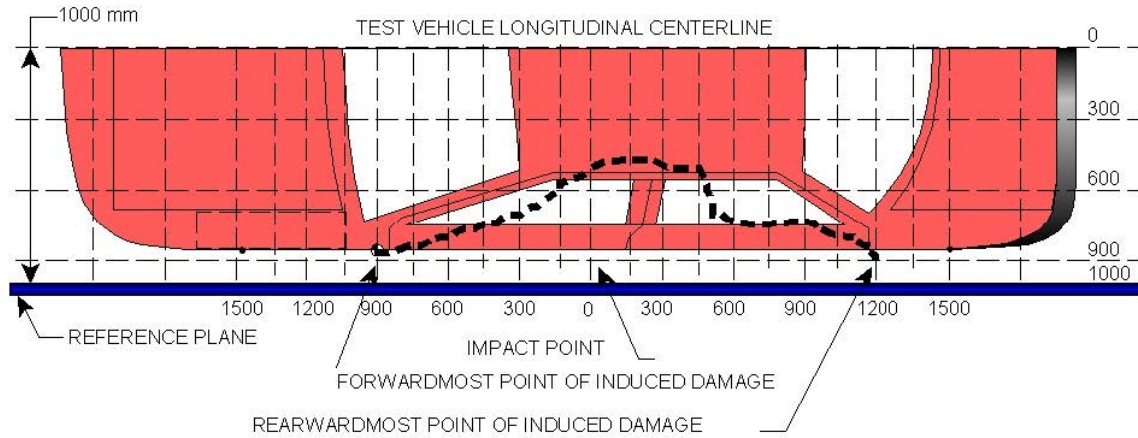
**VEHICLE DAMAGE PROFILE DISTANCES**

DPD	Distance from Impact Point (mm)	Level	Pre-Test (mm)	Post-Test (mm)	Max. Static Crush (mm)
1	500	3	88	94	6
2	260	3	91	260	169
3	20	3	93	435	342
4	-220	3	95	335	240
5	-460	3	99	152	53
6	-700	3	102	63	-39
