**REPORT NUMBER: NCAP-KAR-22-007**

**NEW CAR ASSESSMENT PROGRAM (NCAP)  
FRONTAL BARRIER IMPACT TEST**

**TOYOTA MOTOR MANUFACTURING, TEXAS, INC.  
2022 TOYOTA TUNDRA CREWMAX 4X4 4-DOOR TRUCK**

**FINAL REPORT**

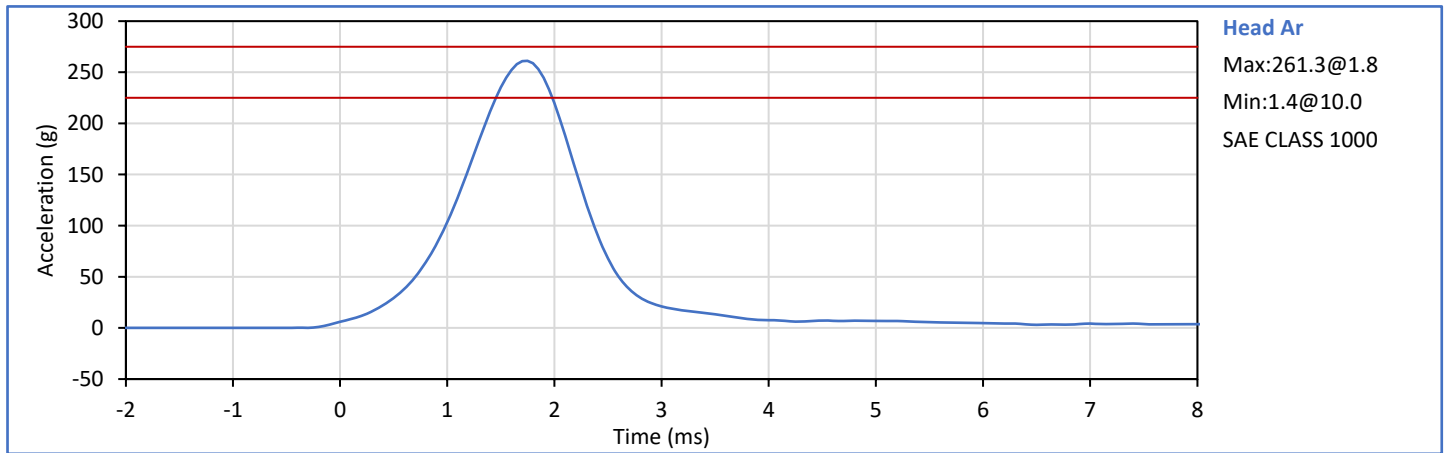
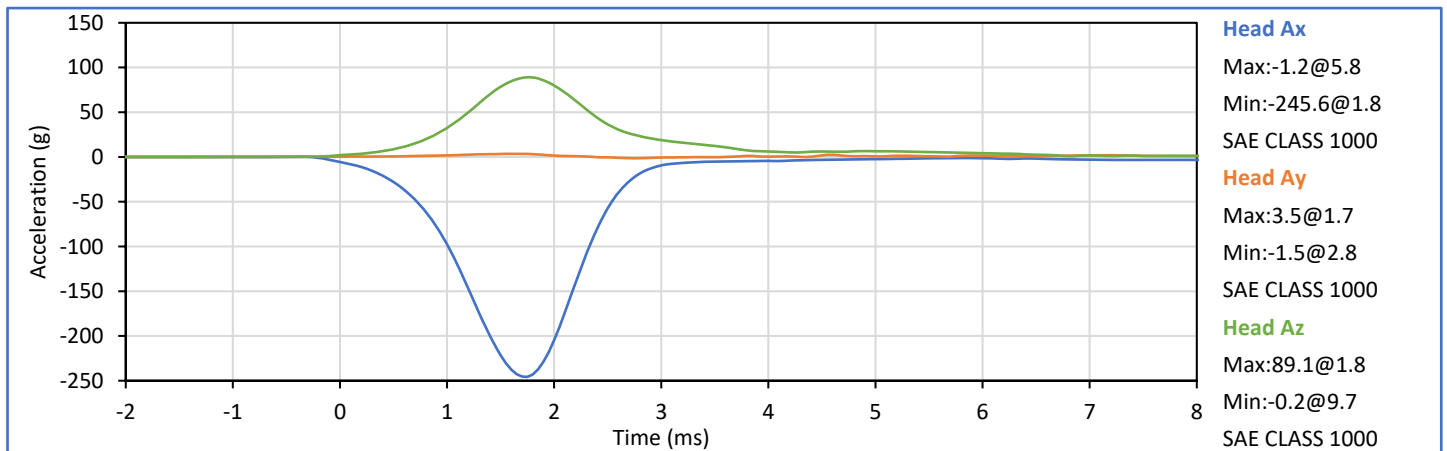
Tested Parameter	Units	Spec. Low	Spec. High	Result	Pass/Fail
Laboratory Temperature	°C	18.9	25.6	21.2	Pass
Laboratory Relative Humidity	%	10	70	50	Pass
Peak Resultant Acceleration	g	225.0	275.0	261.3	Pass
Peak Lateral Acceleration	g	-15.0	15.0	3.5	Pass
Oscillations After Main Pulse	%	0.0	10.0	0.0	Pass
Is Acceleration Unimodal?	Yes/No	Yes		Yes	Pass
<b>Overall Test Results</b>					<b>Pass</b>

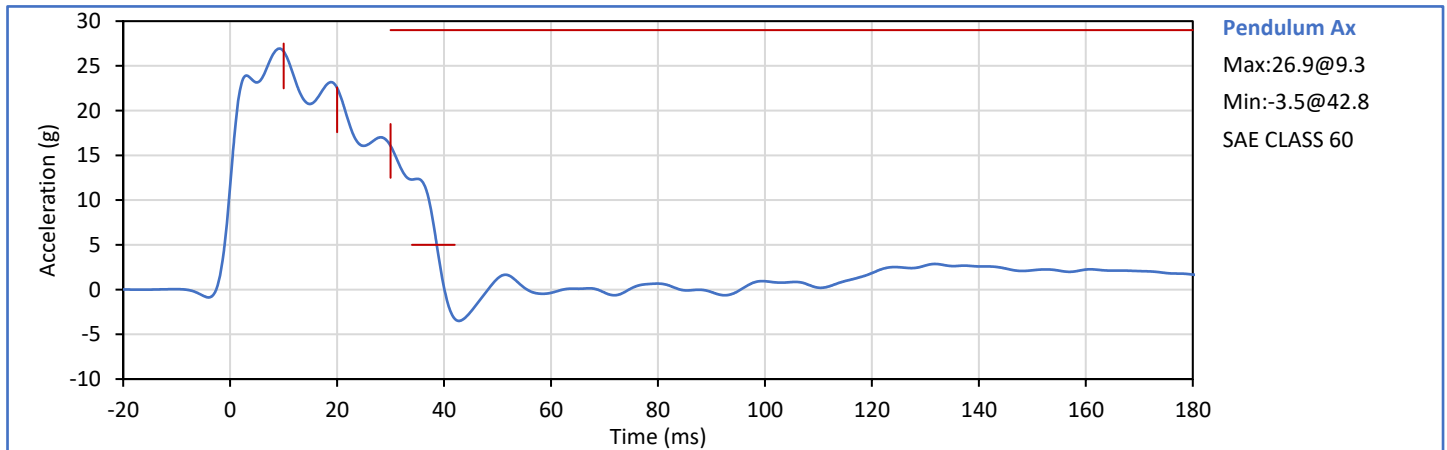
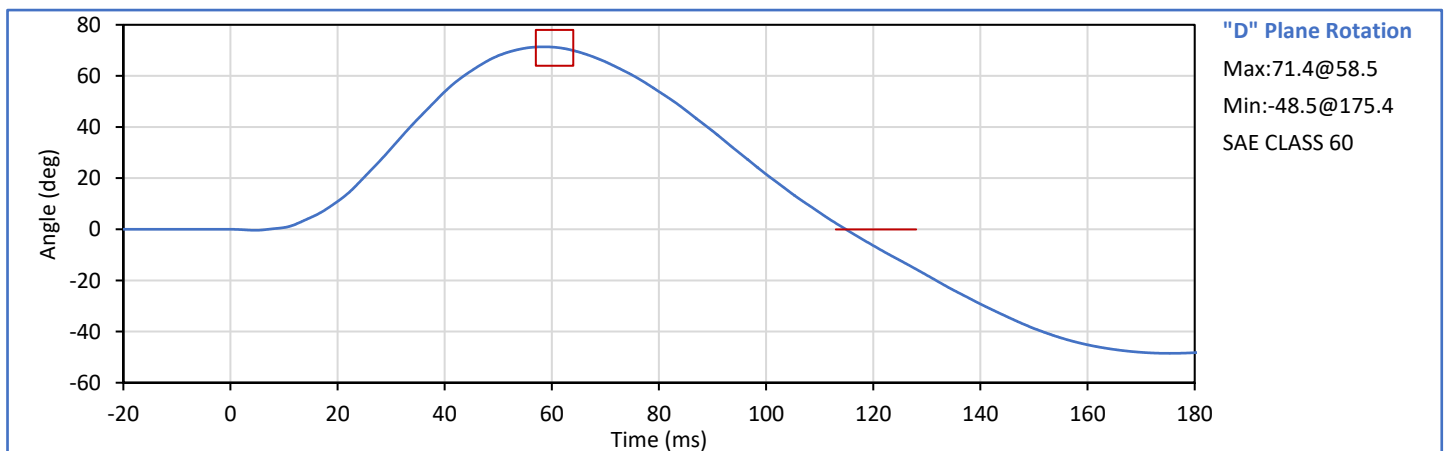
Tested Parameter	Units	Spec. Low	Spec. High	Result	Pass/Fail
Laboratory Temperature	°C	20.6	22.2	21.7	Pass
Laboratory Relative Humidity	%	10	70	48	Pass
Pendulum Velocity	m/s	6.89	7.13	6.96	Pass
Pendulum Deceleration at 10 ms	g	22.5	27.5	26.6	Pass
Pendulum Deceleration at 20 ms	g	17.6	22.6	22.5	Pass
Pendulum Deceleration at 30 ms	g	12.5	18.5	16.1	Pass
Peak Pendulum Decel After 30 ms	g	0.0	29.0	16.1	Pass
Deceleration Decay to Cross 5g	ms	34.0	42.0	38.6	Pass
"D" Plane Rotation peak	deg	64.0	78.0	71.4	Pass
	ms	57.0	64.0	58.5	Pass
"D" Plane Rotation Decay to Zero	ms	113.0	128.0	114.9	Pass
Moment About Occipital Condyle	Nm	88.1	108.5	100.0	Pass
	ms	47.0	58.0	51.3	Pass
Moment Decay, Peak to Zero	ms	97.0	107.0	98.0	Pass
Overall Test Results					Pass

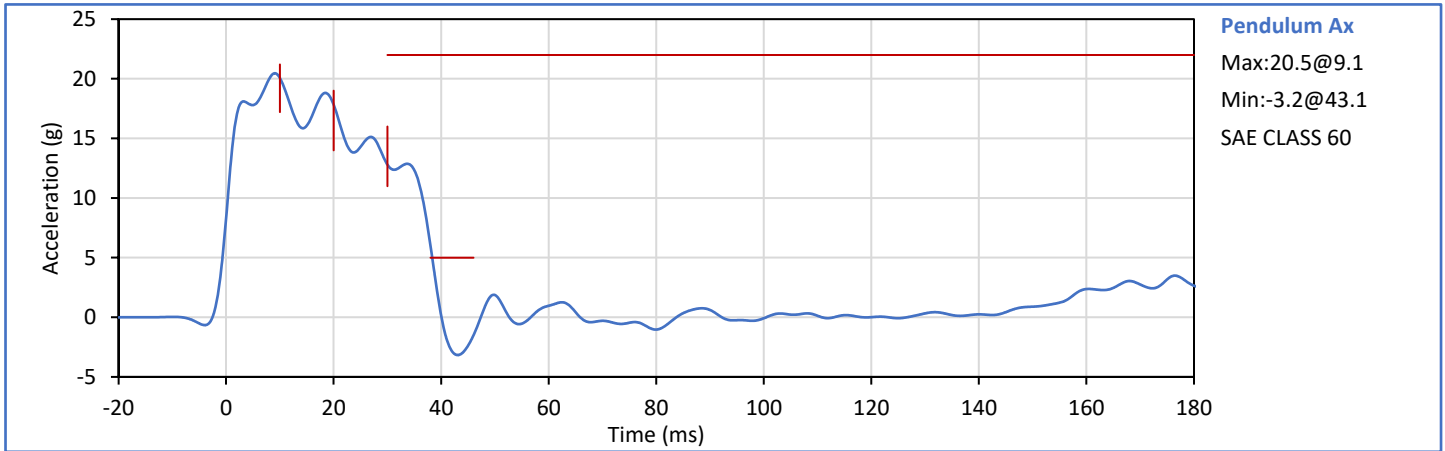
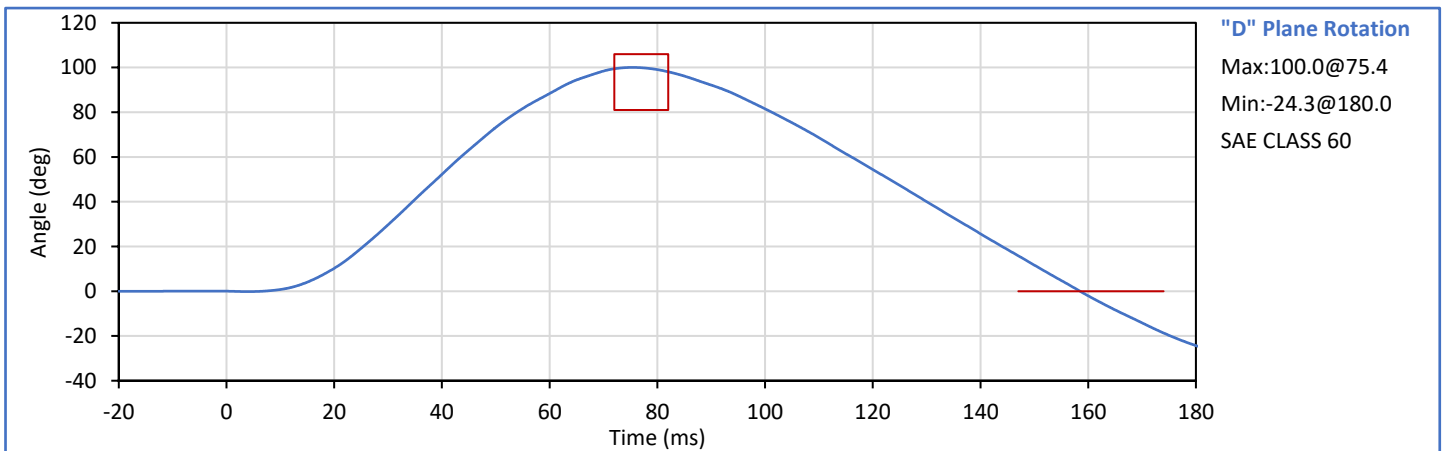
Tested Parameter	Units	Spec. Low	Spec. High	Result	Pass/Fail
Laboratory Temperature	°C	20.6	22.2	21.7	Pass
Laboratory Relative Humidity	%	10	70	30	Pass
Pendulum Velocity	m/s	5.94	6.19	6.11	Pass
Pendulum Deceleration at 10 ms	g	17.2	21.2	20.1	Pass
Pendulum Deceleration at 20 ms	g	14.0	19.0	17.8	Pass
Pendulum Deceleration at 30 ms	g	11.0	16.0	12.8	Pass
Peak Pendulum Decel After 30 ms	g	0.0	22.0	12.9	Pass
Deceleration Decay to Cross 5g	ms	38.0	46.0	38.3	Pass
"D" Plane Rotation peak	deg	81.0	106.0	100.0	Pass
	ms	72.0	82.0	75.4	Pass
"D" Plane Rotation Decay to Zero	ms	147.0	174.0	158.5	Pass
Moment About Occipital Condyle	Nm	-79.9	-52.9	-73.1	Pass
	ms	65.0	79.0	70.9	Pass
Moment Decay, Peak to Zero	ms	120.0	148.0	140.2	Pass
Overall Test Results					Pass

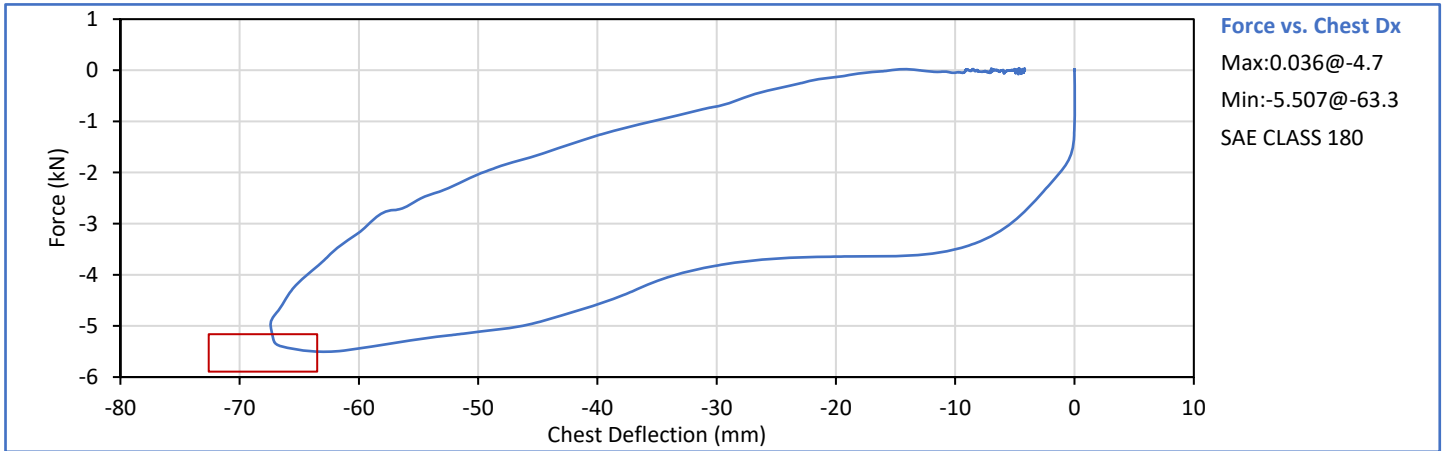
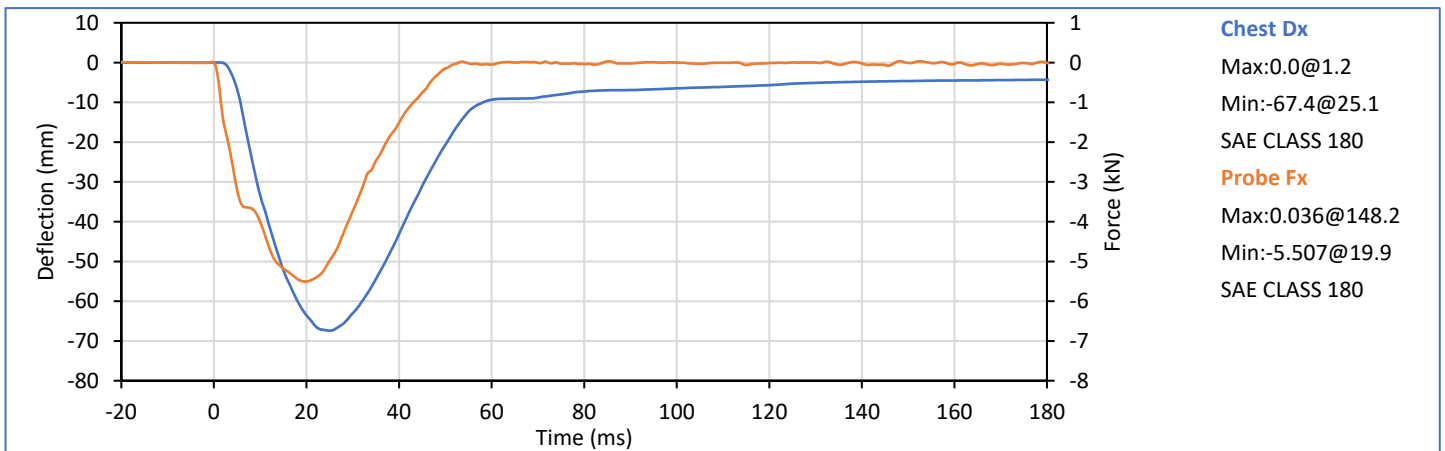
Tested Parameter	Units	Spec. Low	Spec. High	Result	Pass/Fail
Laboratory Temperature	°C	20.6	22.2	21.9	Pass
Laboratory Relative Humidity	%	10	70	43	Pass
Probe Velocity	m/s	6.58	6.82	6.72	Pass
Peak Chest Deflection	mm	-72.6	-63.5	-67.4	Pass
Peak Probe Force	kN	-5.893	-5.159	-5.507	Pass
Internal Hysterisis	%	69.0	85.0	70.1	Pass
<b>Overall Test Results</b>					<b>Pass</b>

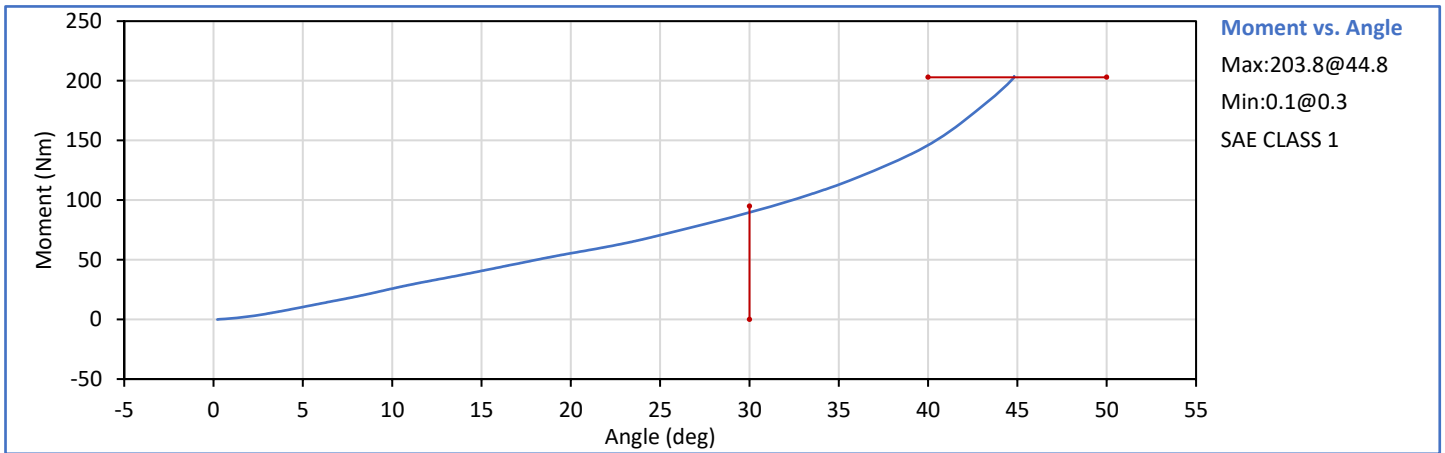
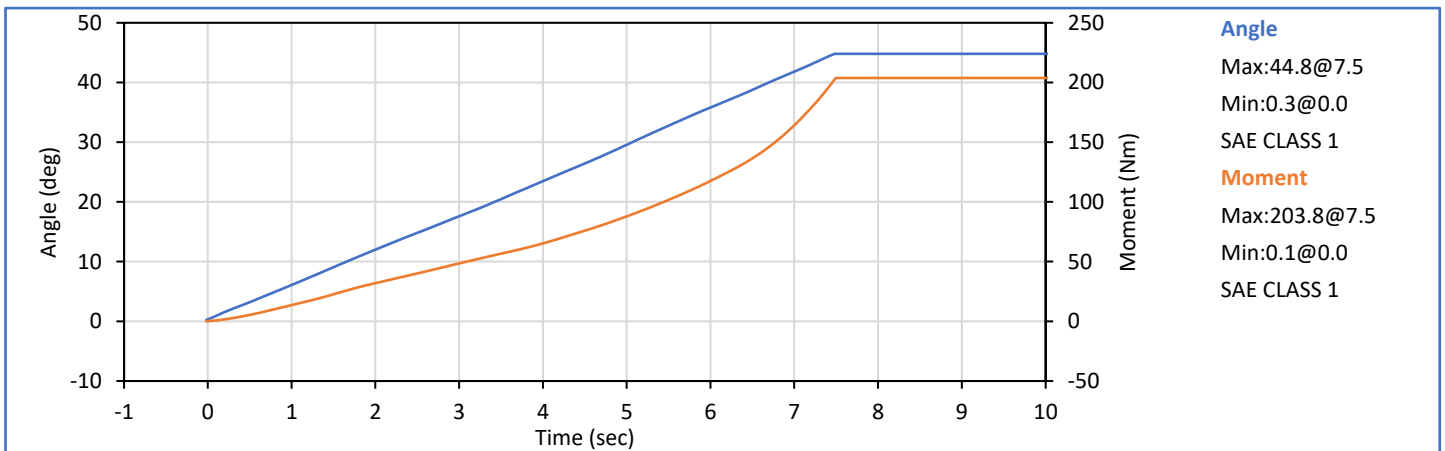
Tested Parameter	Units	Spec. Low	Spec. High	Result	Pass/Fail
Laboratory Temperature	°C	18.9	25.6	21.1	Pass
Laboratory Relative Humidity	%	10	70	46	Pass
Left Hip Rotation Rate	deg/s	5.0	10.0	5.9	Pass
Left Femur Torque at 30°	Nm	0.0	95.0	89.5	Pass
Left Hip Rotation at 203 Nm	deg	40.0	50.0	44.8	Pass
<b>Overall Test Results</b>					<b>Pass</b>

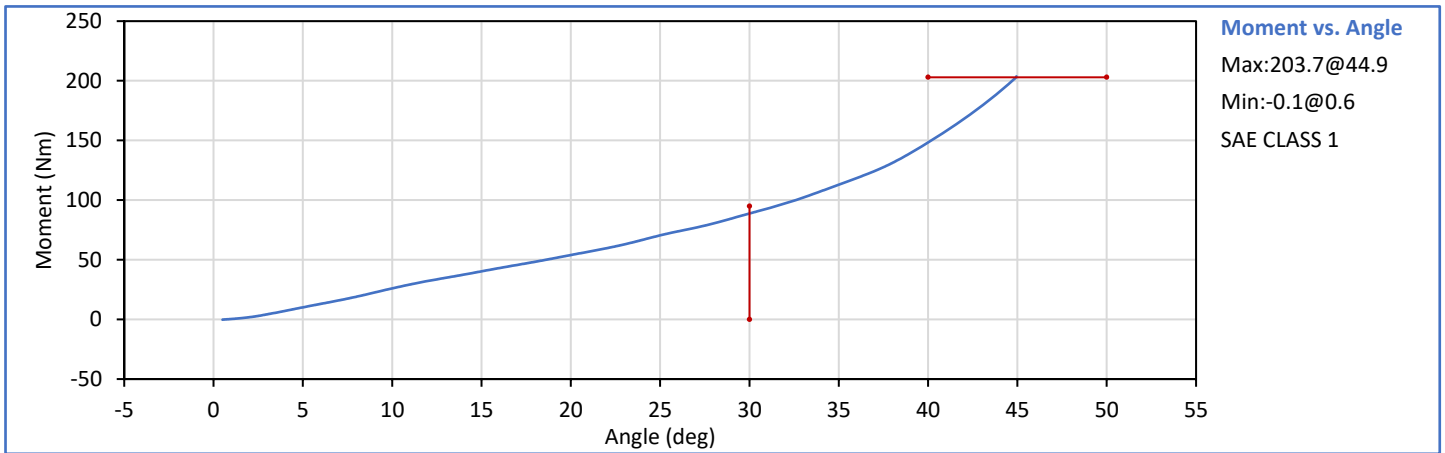
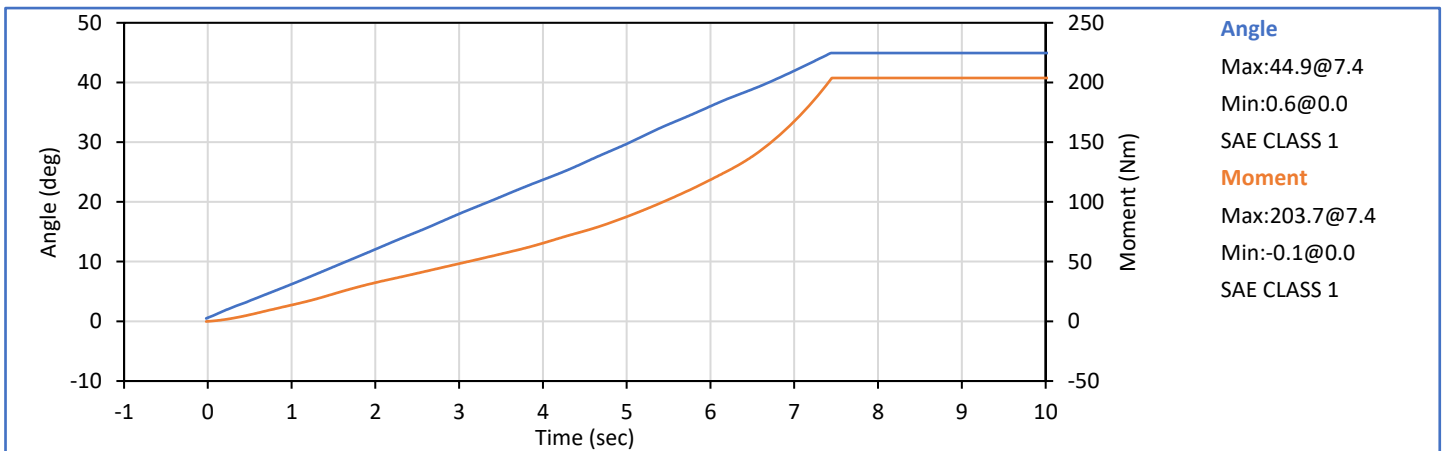
Tested Parameter	Units	Spec. Low	Spec. High	Result	Pass/Fail
Laboratory Temperature	°C	18.9	25.6	21.1	Pass
Laboratory Relative Humidity	%	10	70	46	Pass
Right Hip Rotation Rate	deg/s	5.0	10.0	5.9	Pass
Right Femur Torque at 30°	Nm	0.0	95.0	88.7	Pass
Right Hip Rotation at 203 Nm	deg	40.0	50.0	44.9	Pass
<b>Overall Test Results</b>					<b>Pass</b>

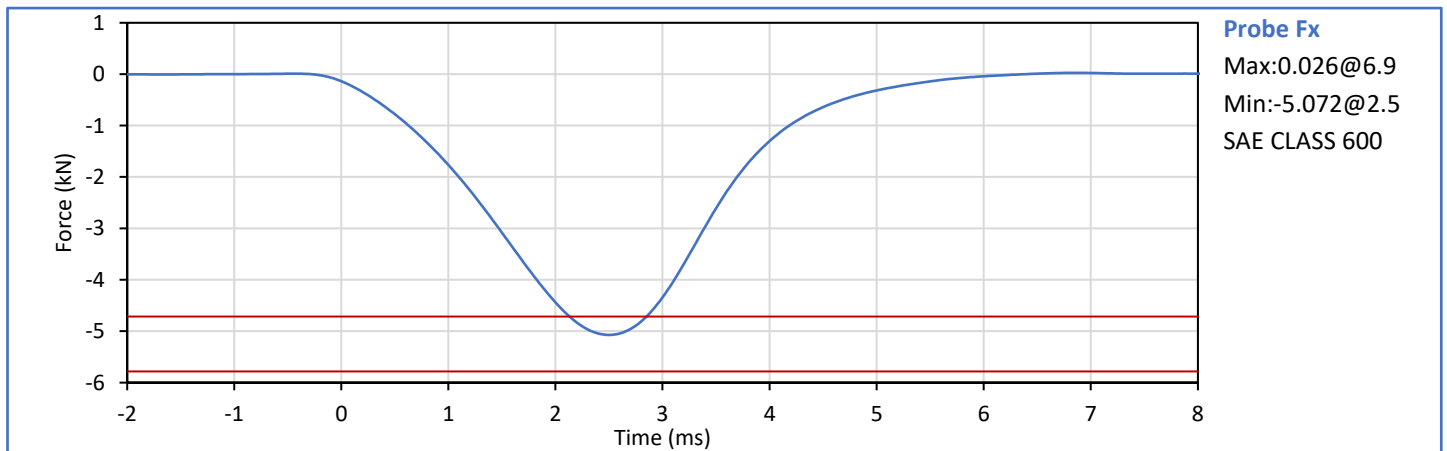
Tested Parameter	Units	Spec. Low	Spec. High	Result	Pass/Fail
Laboratory Temperature	°C	18.9	25.6	21.7	Pass
Laboratory Relative Humidity	%	10	70	51	Pass
Probe Velocity	m/s	2.070	2.130	2.103	Pass
Peak Resistive Force	kN	-5.782	-4.715	-5.072	Pass
Overall Test Results					Pass

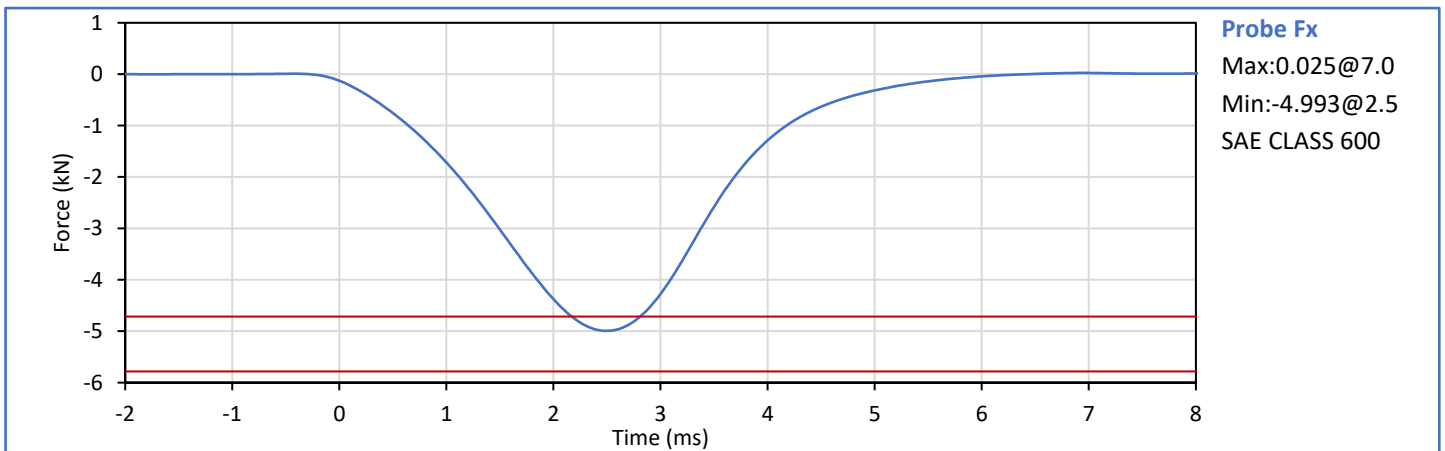
Tested Parameter	Units	Spec. Low	Spec. High	Result	Pass/Fail
Laboratory Temperature	°C	18.9	25.6	21.8	Pass
Laboratory Relative Humidity	%	10	70	50	Pass
Probe Velocity	m/s	2.070	2.130	2.105	Pass
Peak Resistive Force	kN	-5.782	-4.715	-4.993	Pass
<b>Overall Test Results</b>					<b>Pass</b>
