REPORT NUMBER: SideNCAPMDB-MGA-22-032

**NEW CAR ASSESSMENT PROGRAM (NCAP)
Moving Deformable Barrier Side Impact Test**

**MAZDA TOYOTA MANUFACTURING U.S.A. INC.
2022 Toyota Corolla Cross LE 5-Door SUV
NHTSA No.: O20225102**

**MGA RESEARCH CORPORATION
5000 Warren Road
Burlington, WI 53105**

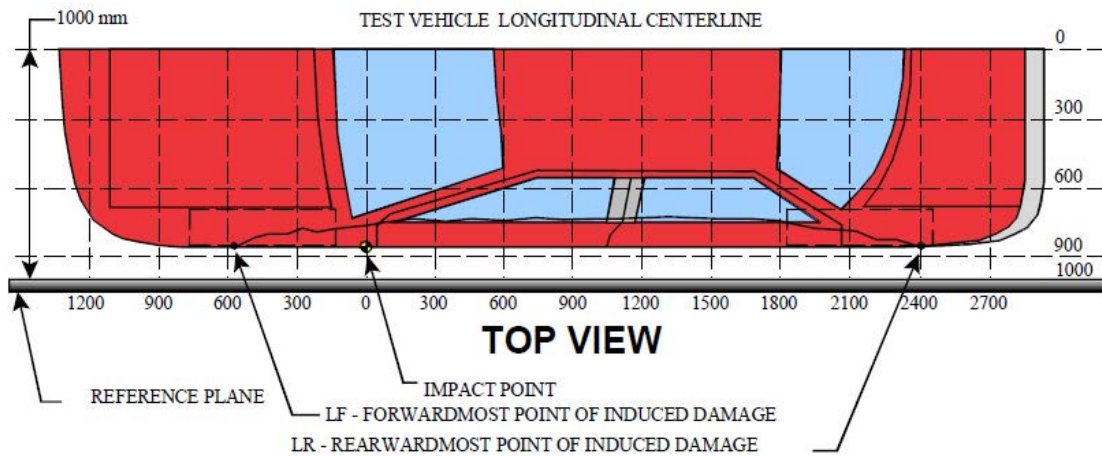
**DATA SHEET NO. 13
VEHICLE AND MDB DAMAGE PROFILE DISTANCES**

VEHICLE DAMAGE PROFILE DISTANCES

DPD	Distance from Impact Point (mm)	Level	Post-Test (mm)	Pre-Test (mm)	Max. Static Crush (mm)
1	50	3	208	207	1
2	430	3	340	212	128
3	810	3	372	212	160
4	1190	3	310	217	93
5	1570	3	403	218	185
6	1950	3	219	216	3

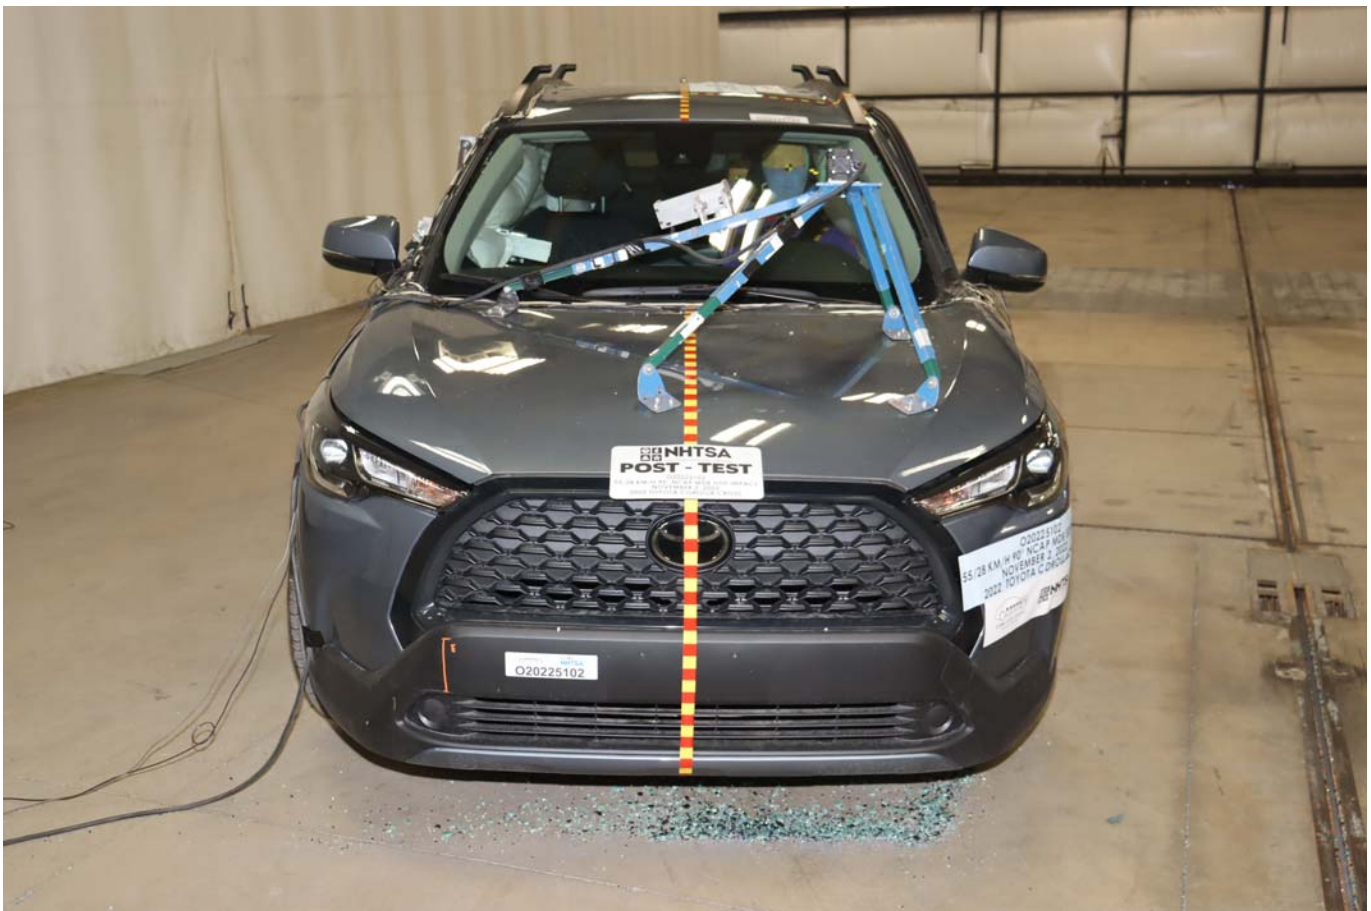
Photo No. 004 - Post-Test Frontal View of Test Vehicle

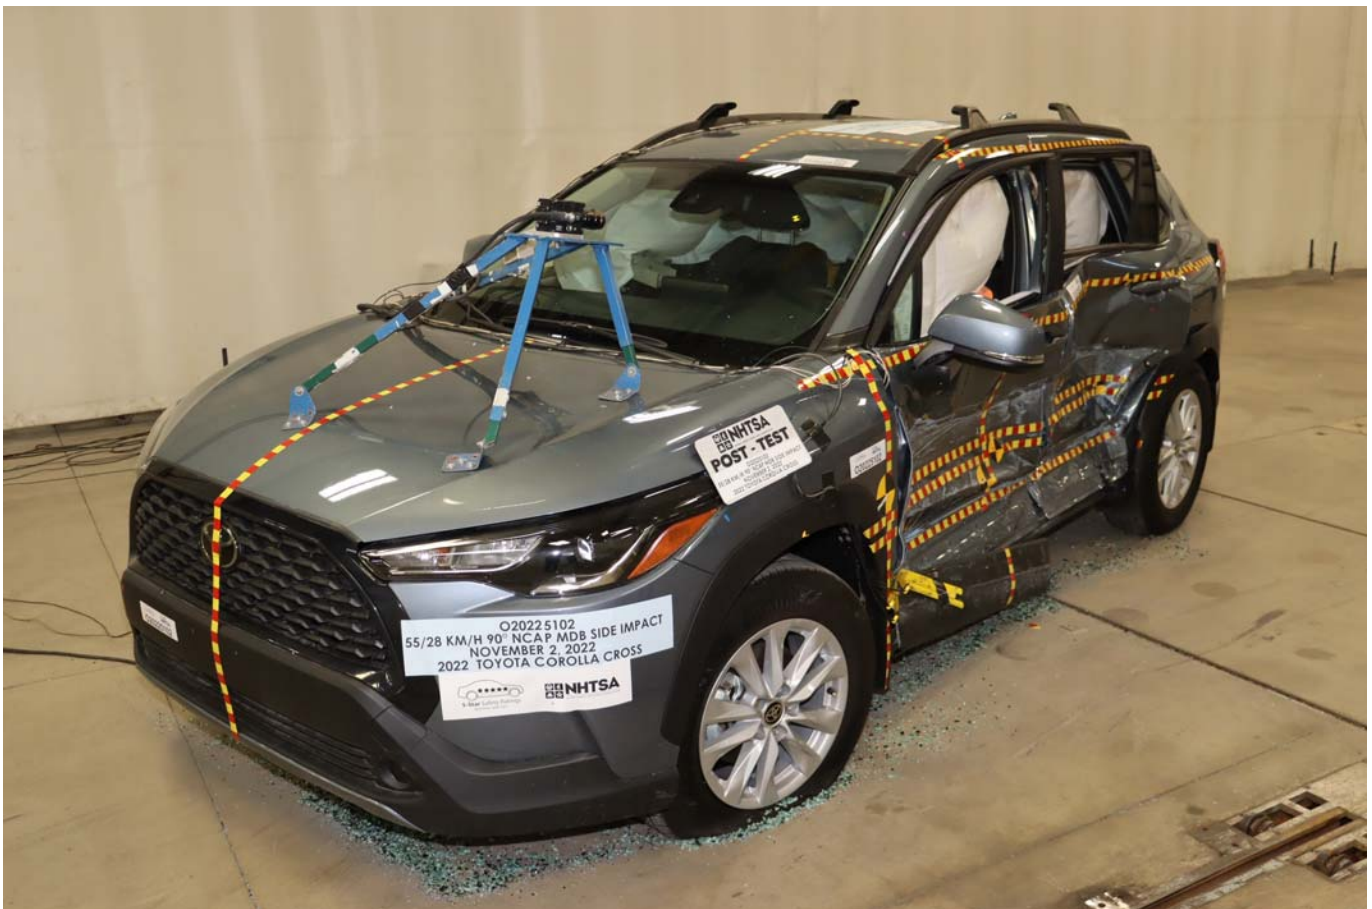
Photo No. 006 - Post-Test Left Front Three-Quarter View of Test Vehicle

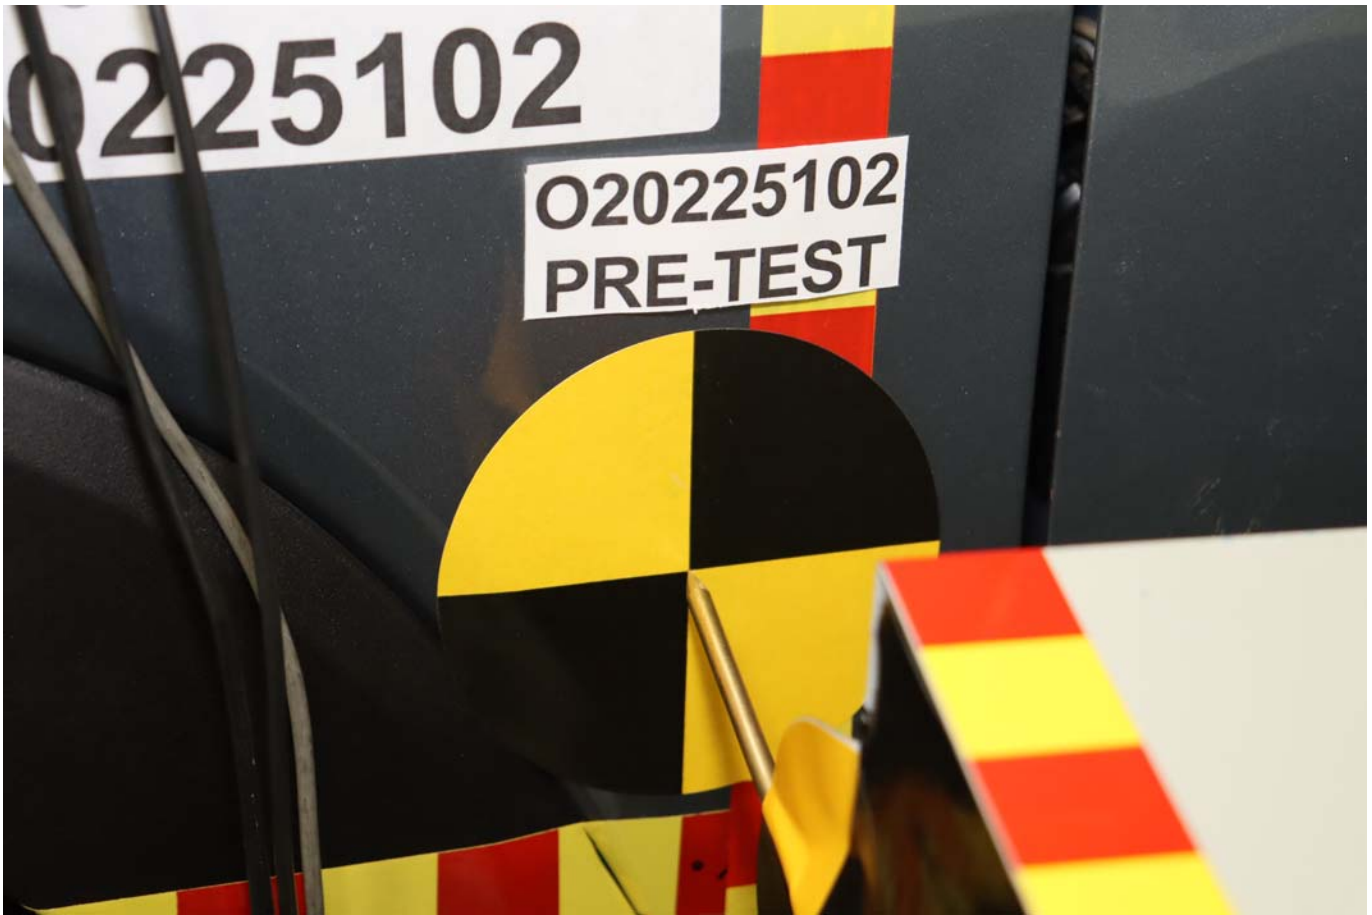
Photo No. 019 - Pre-Test Close-Up View of Impact Point Target

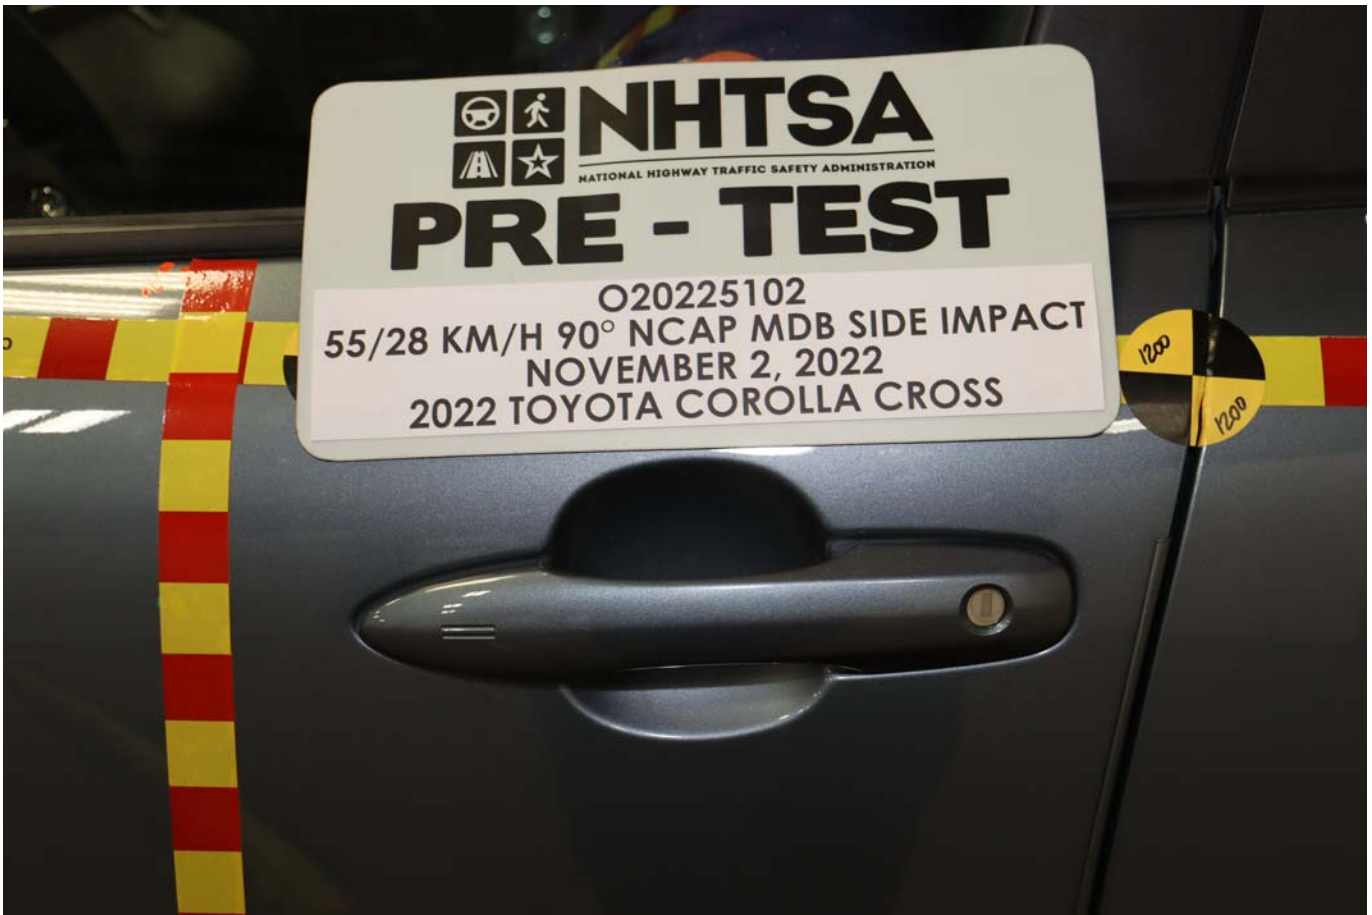
Photo No. 021 - Pre-Test Left Front Door Latch Close-Up

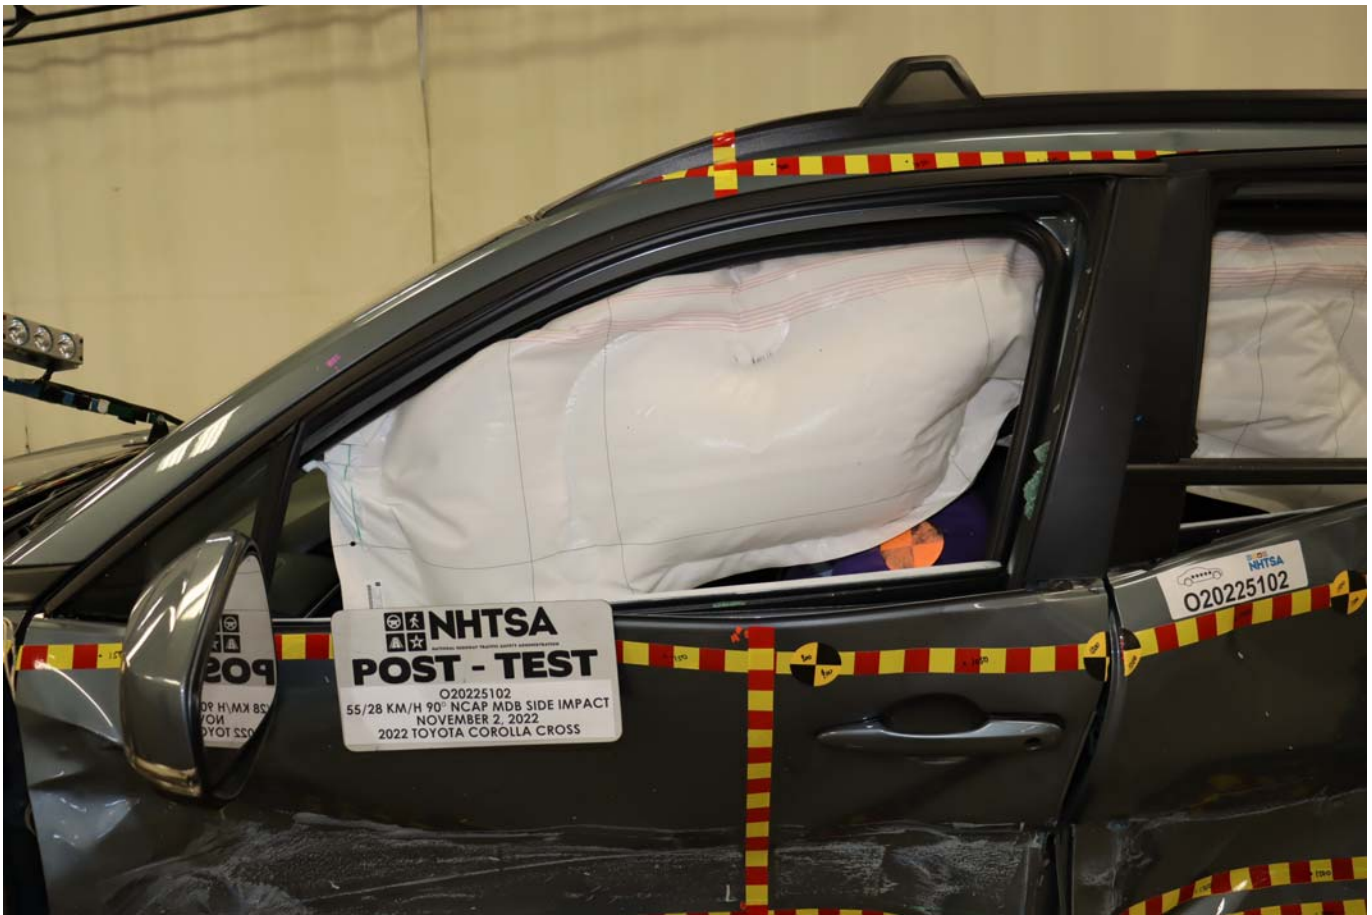
Photo No. 029 - Post-Test Left Side View of Driver Dummy Shoulder and Door Top View

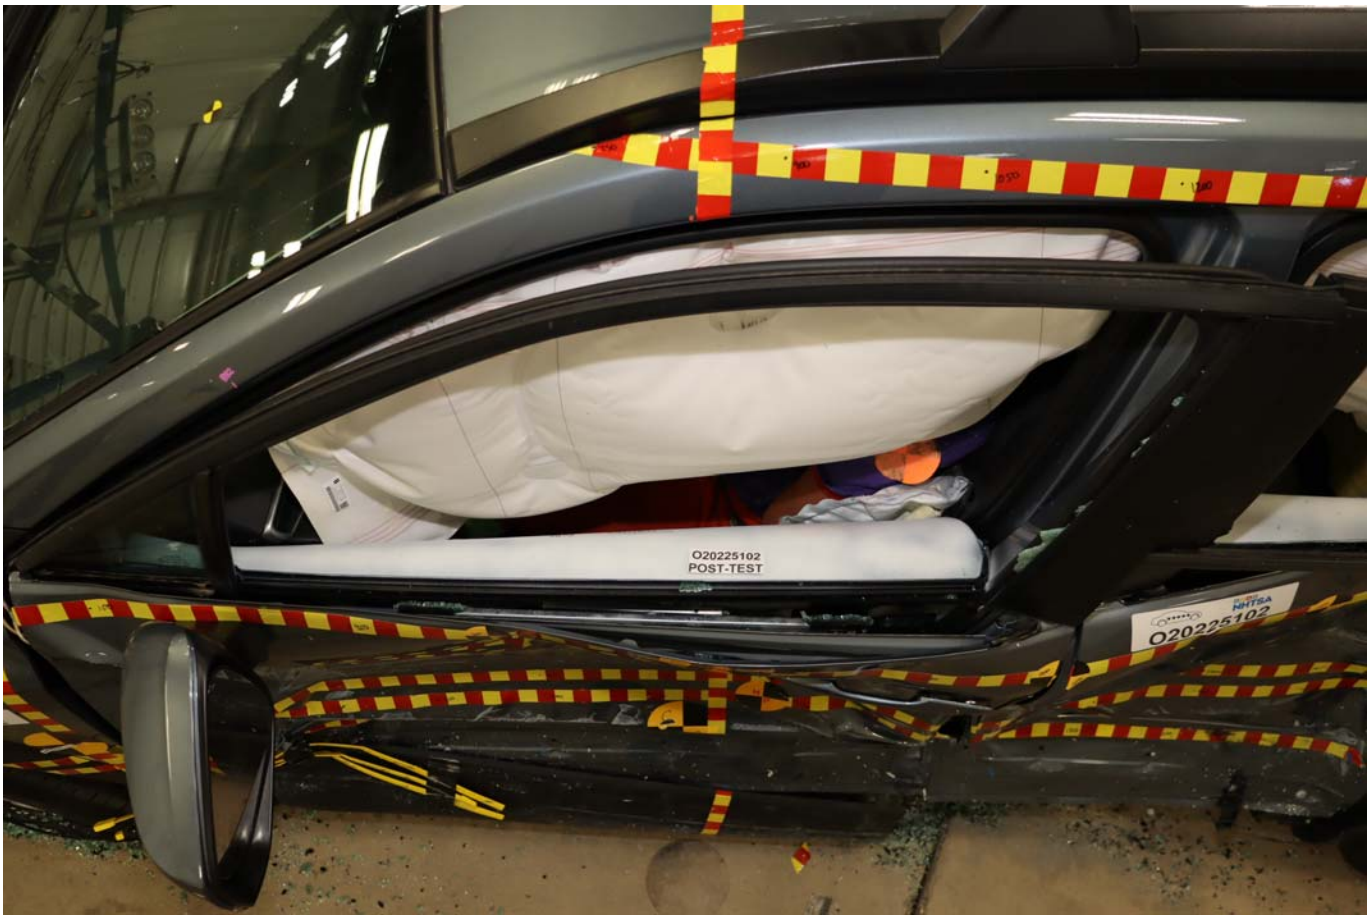
Photo No. 043 - Post-Test Driver Dummy and Door Clearance View

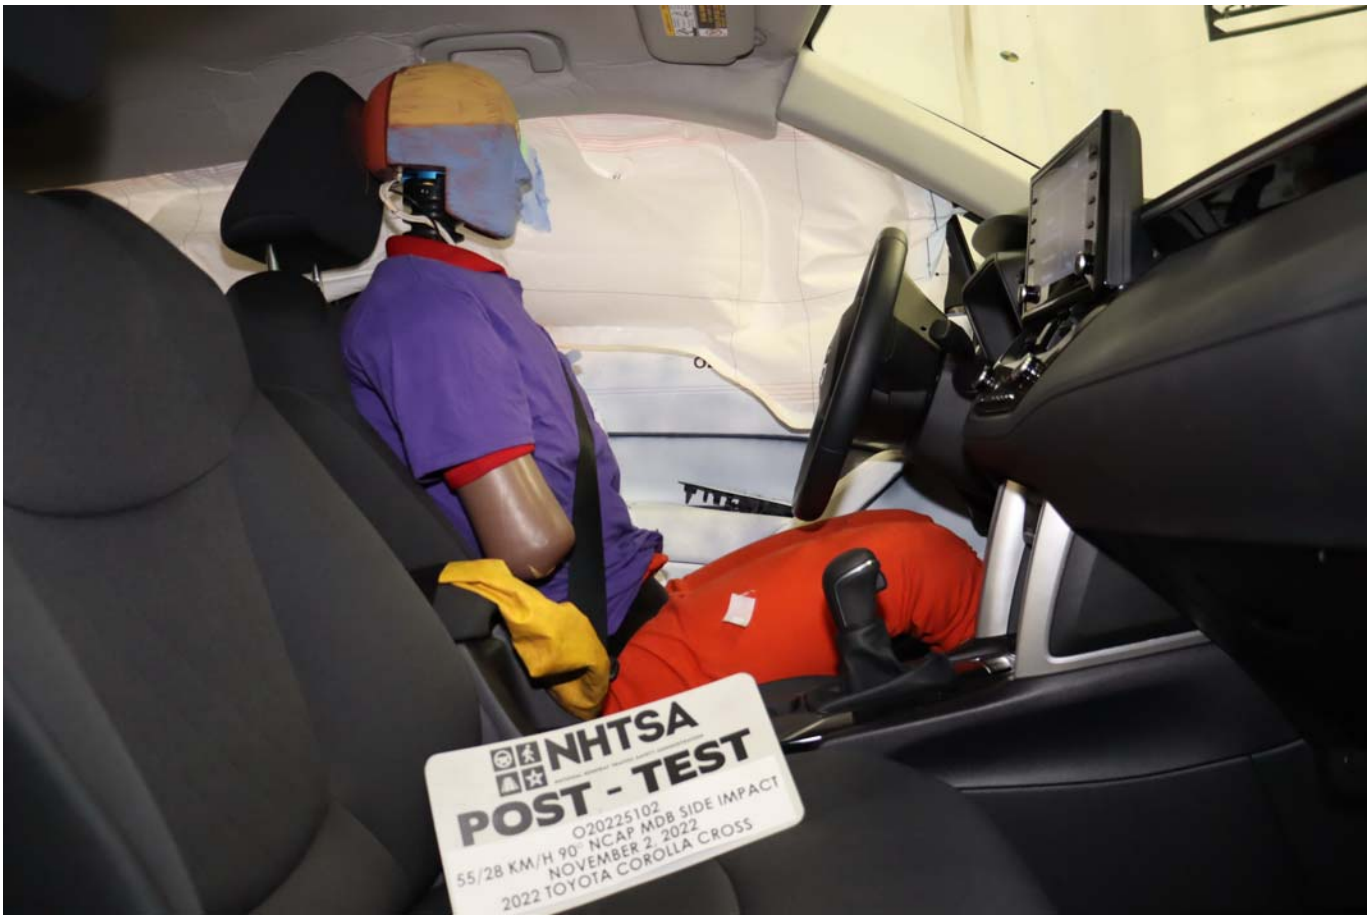
Photo No. 045 - Post-Test Right Side View of Driver Dummy and Front Seat of Occupant Compartment

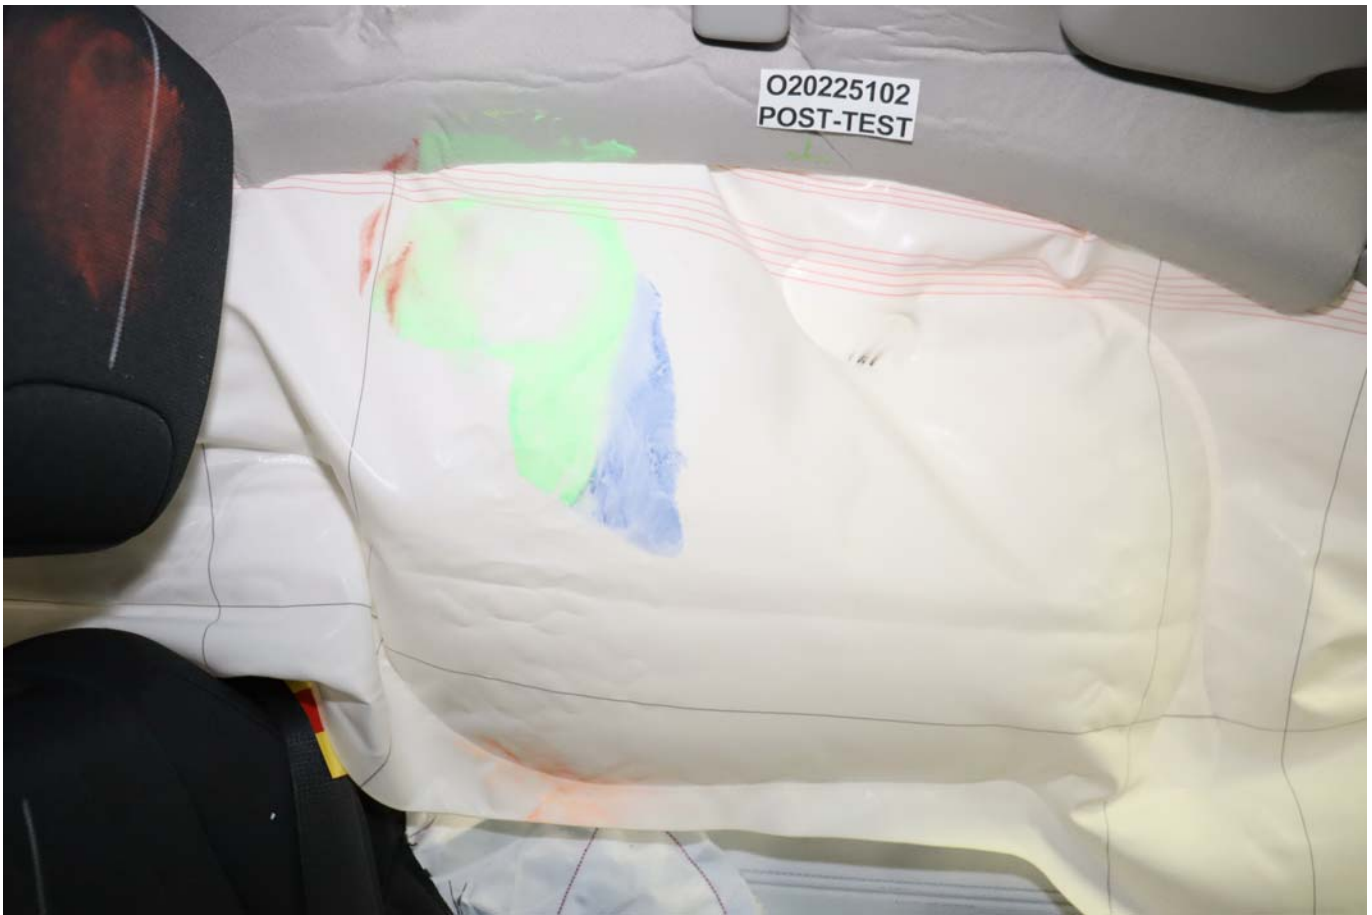
Photo No. 049 - Post-Test Driver Dummy Close-up Head Contact with Side Airbag View

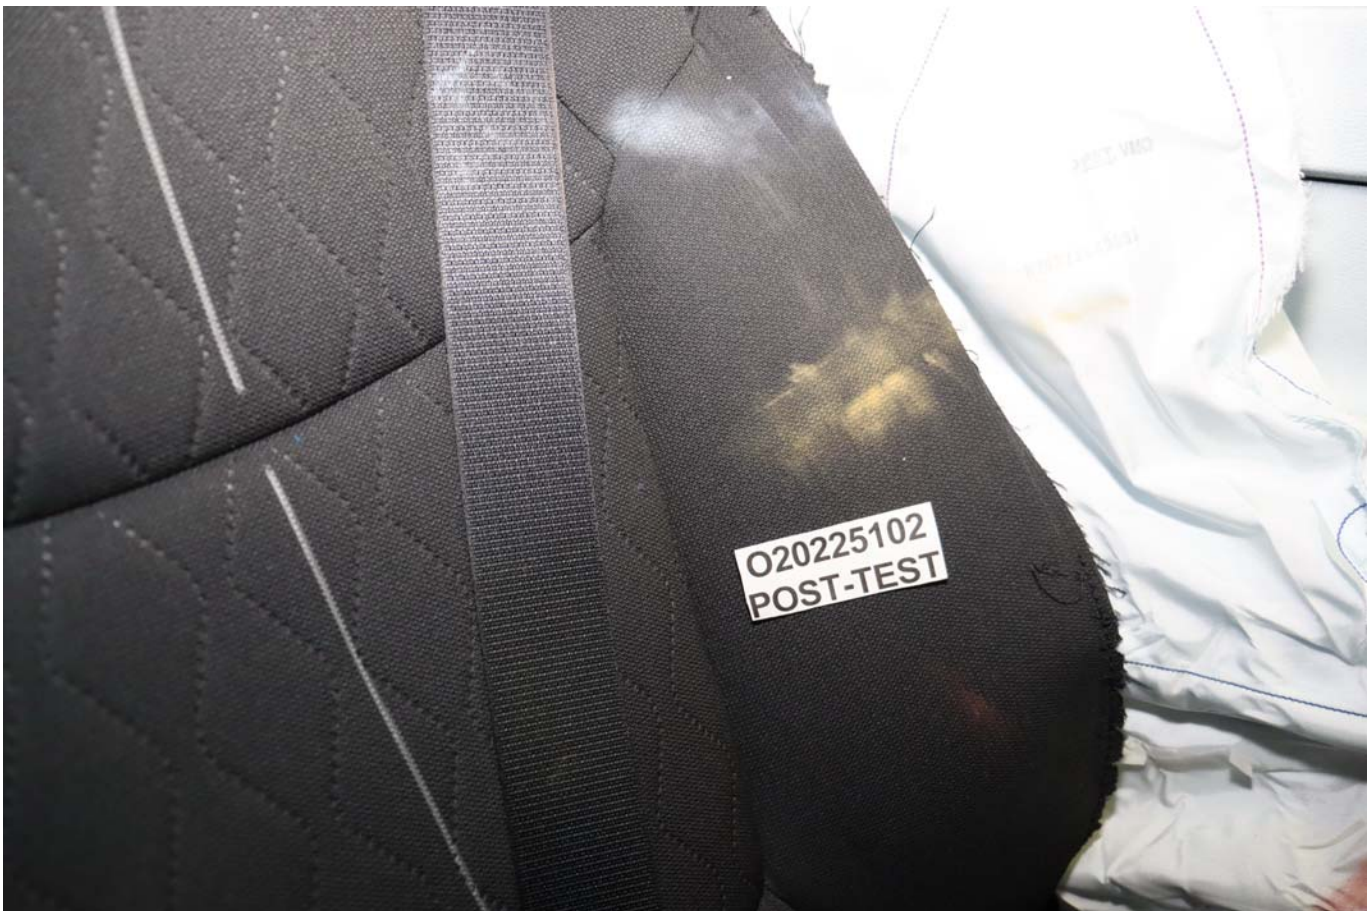
Photo No. 050 - Post-Test Driver Dummy Close-up Torso Contact with Vehicle Interior View

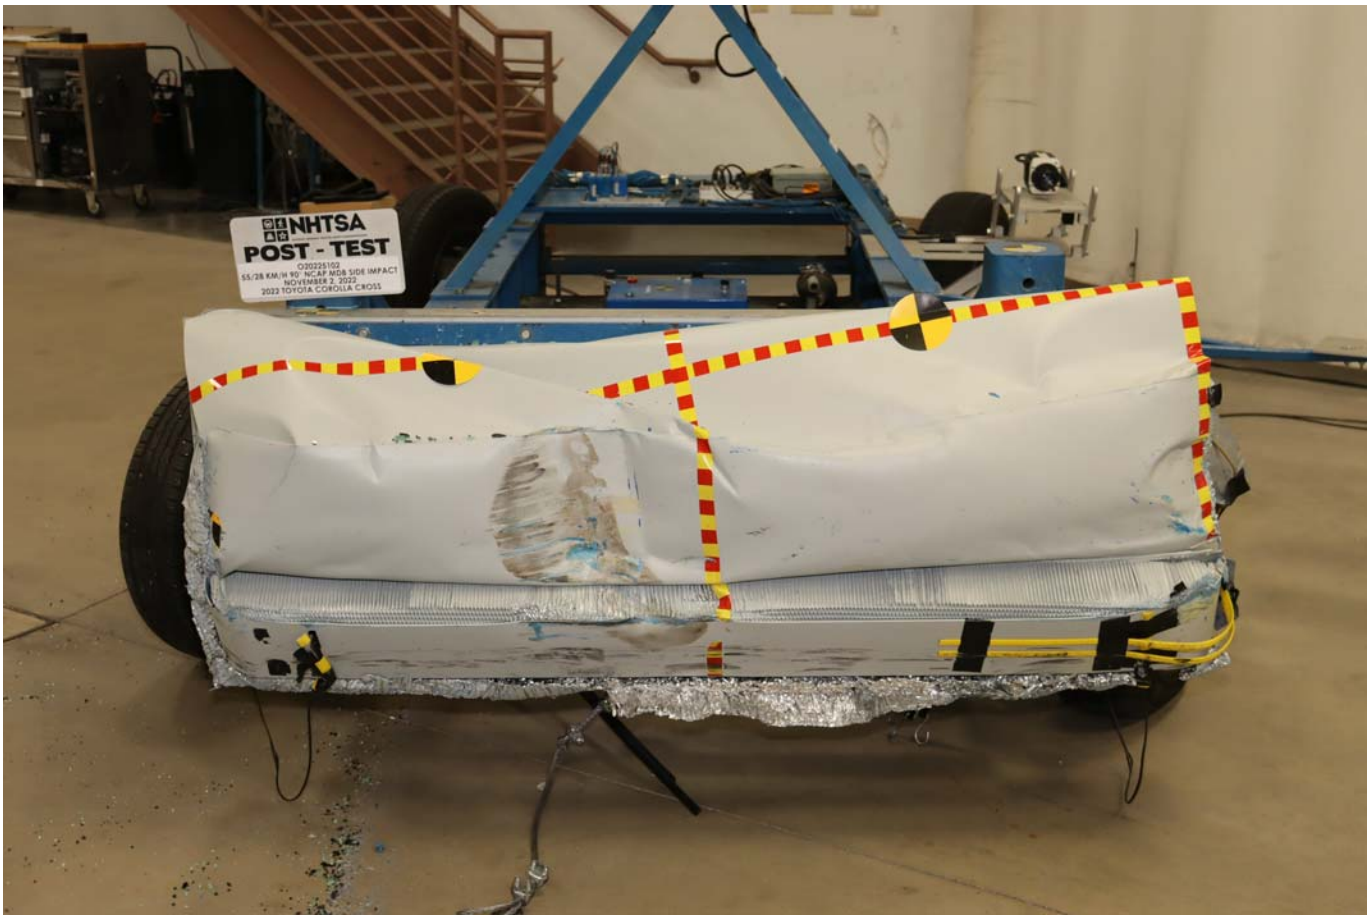
Photo No. 085 - Post-Test Front View of MDB Impactor Face

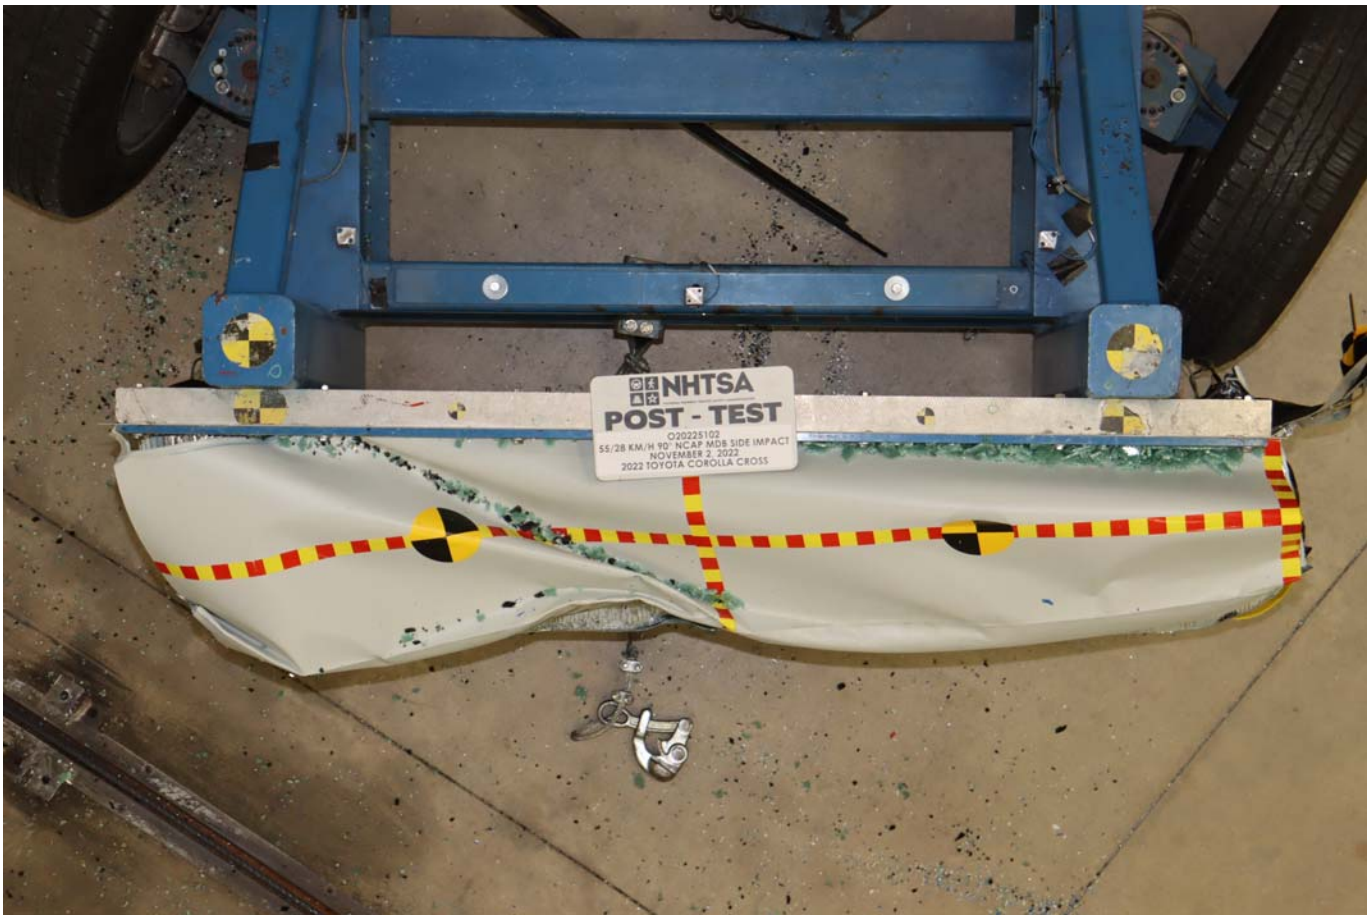
Photo No. 087 - Post-Test Top View of MDB Impactor Face

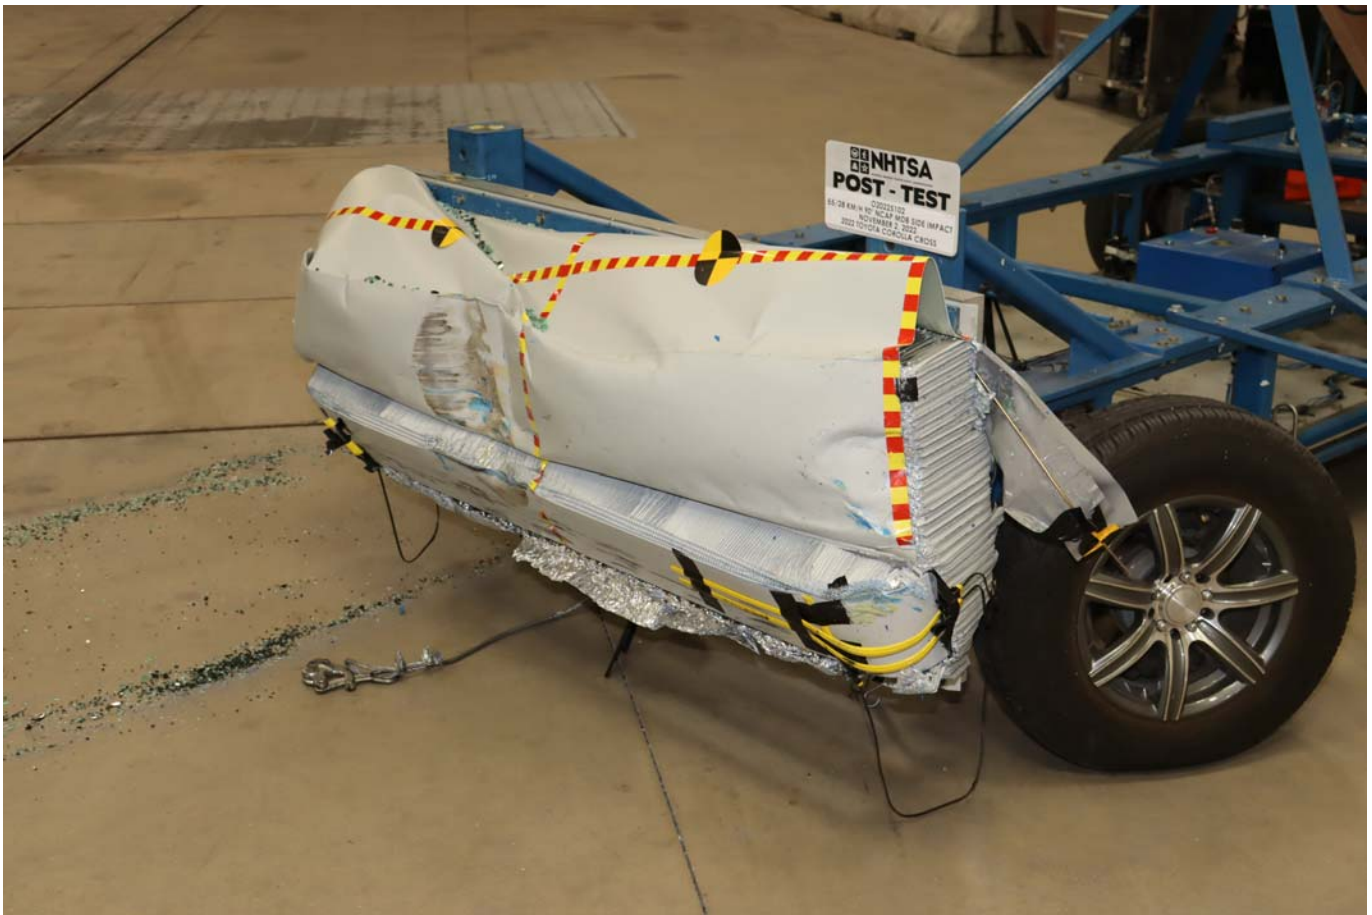
Photo No. 089 - Post-Test Left Side View of MDB Impactor Face

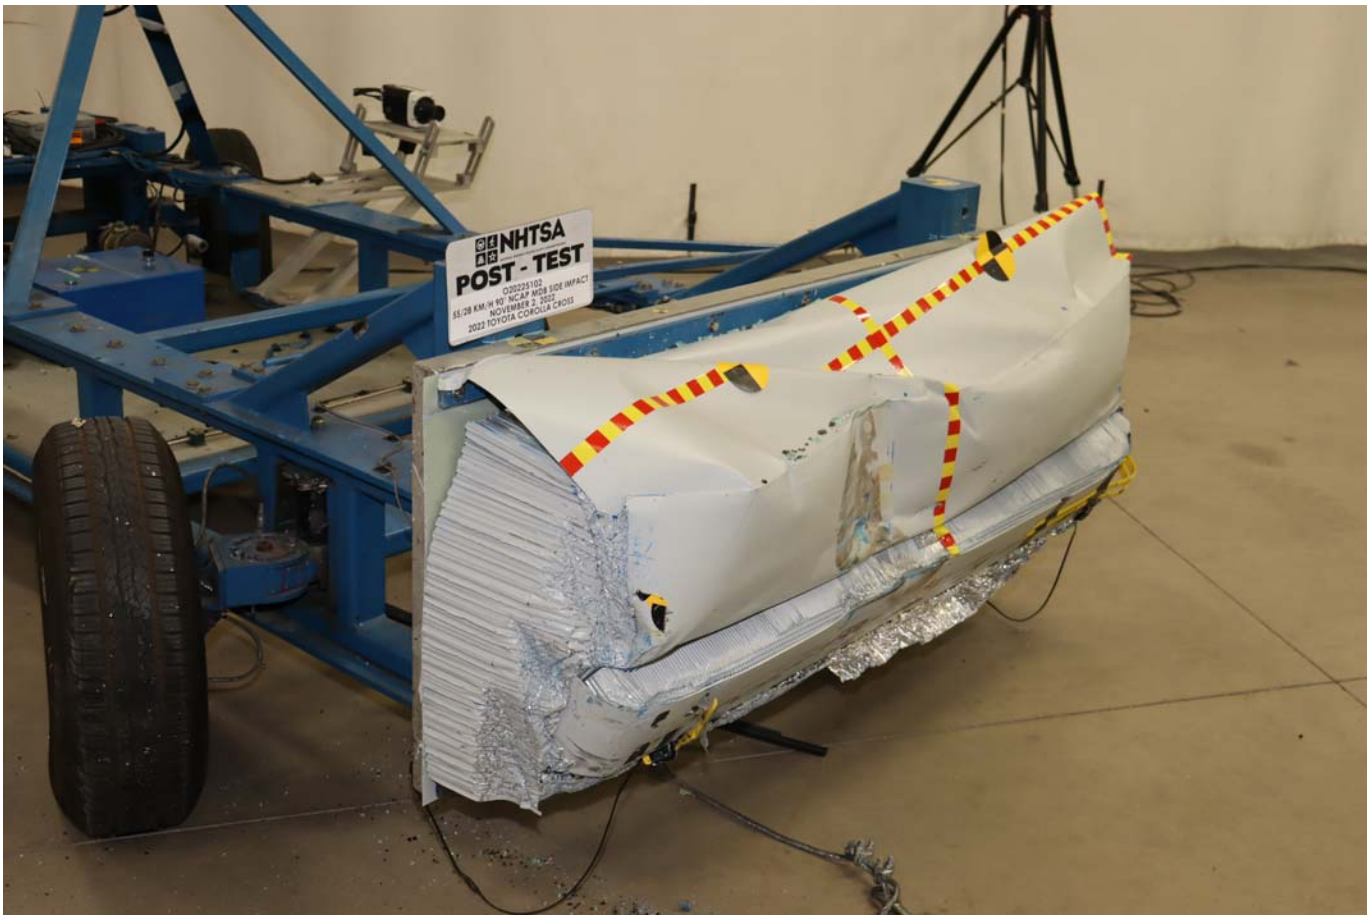
Photo No. 091 - Post-Test Right Side View of MDB Impactor Face

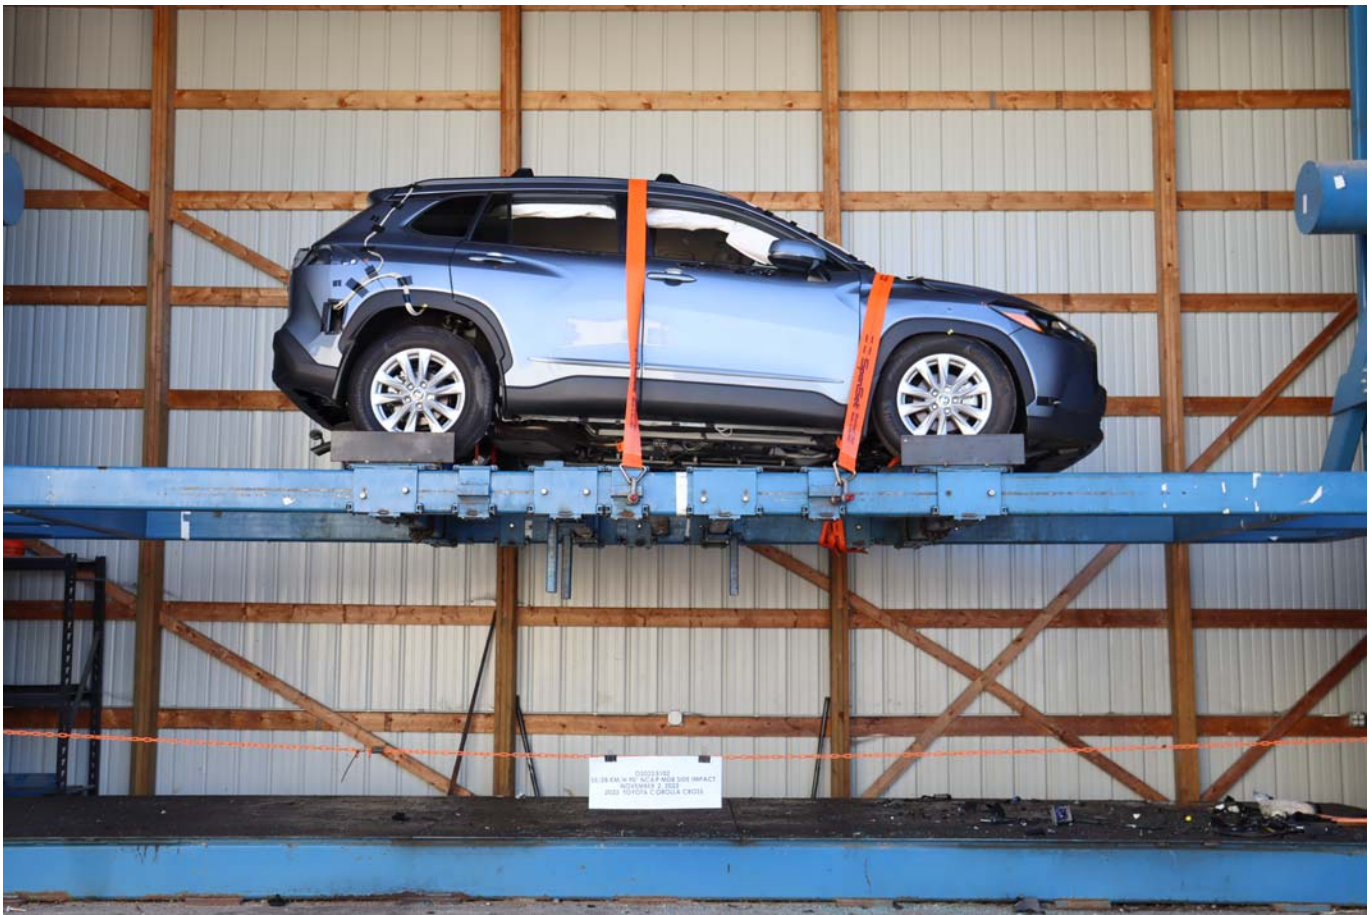
Photo No. 096 - FMVSS Photo No. 301 Static Rollover 0 Degrees

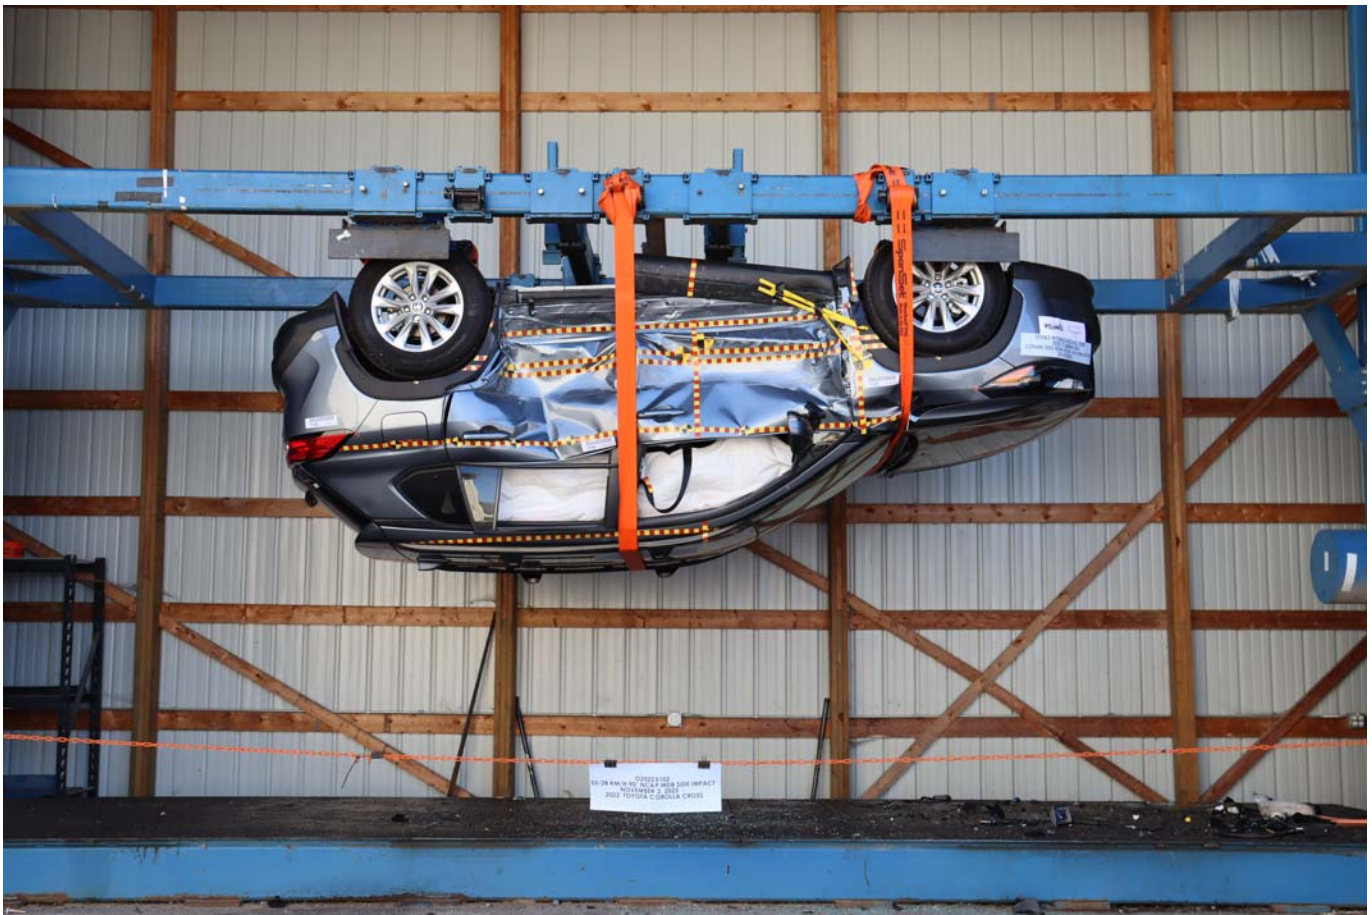
Photo No. 098 - FMVSS Photo No. 301 Static Rollover 180 Degrees

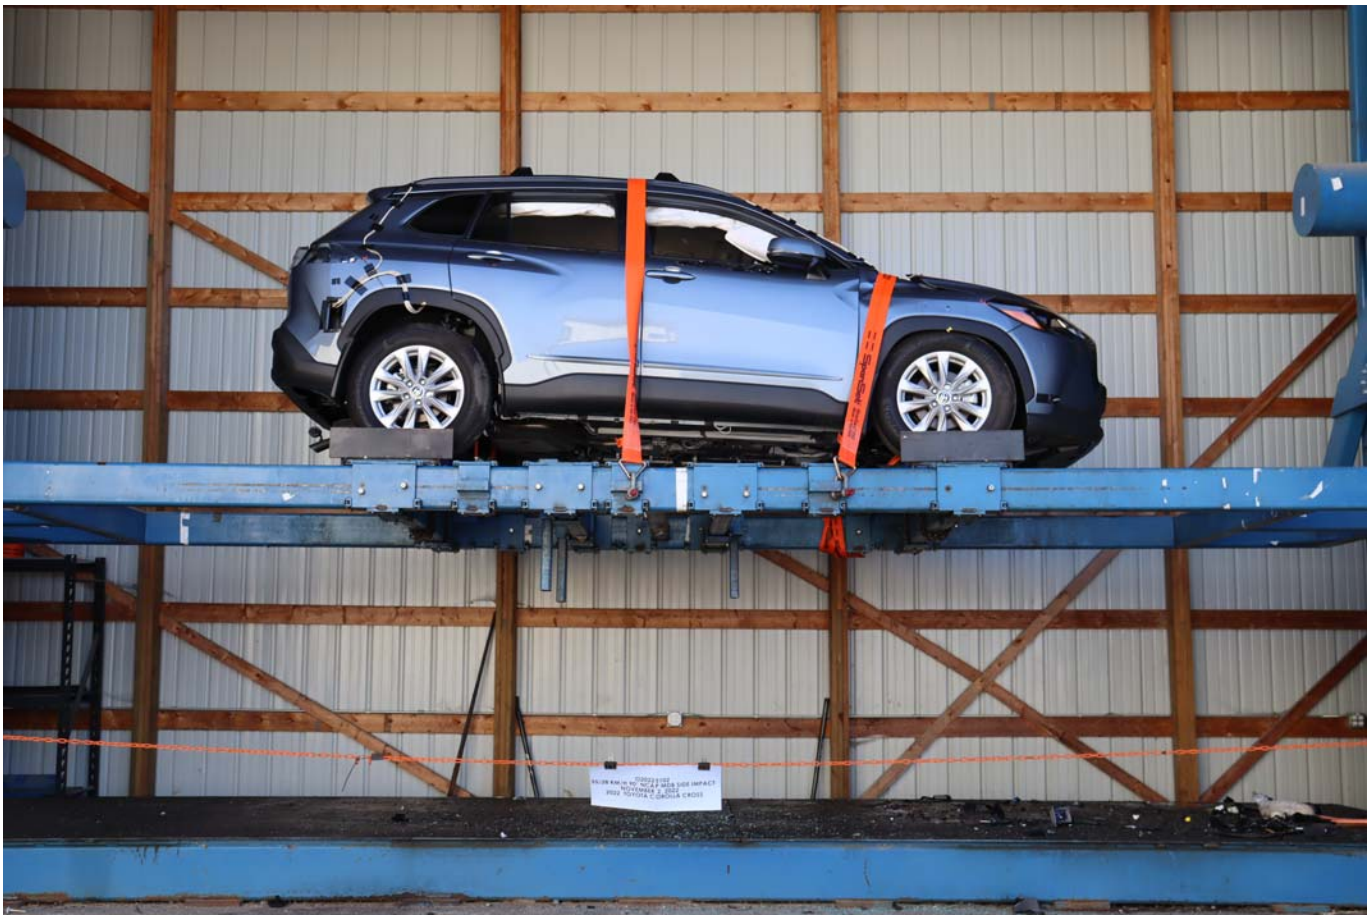
Photo No. 100 - FMVSS Photo No. 301 Static Rollover 360 Degrees
