**REPORT NUMBER: NCAP-MGA-22-035**

**NEW CAR ASSESSMENT PROGRAM (NCAP)  
Frontal Barrier Impact Test**

**FORD MOTOR CO.  
2022 Ford Ranger XLT SuperCab 4x4 Pickup Truck  
NHTSA No.: M20220212**

**FINAL REPORT**

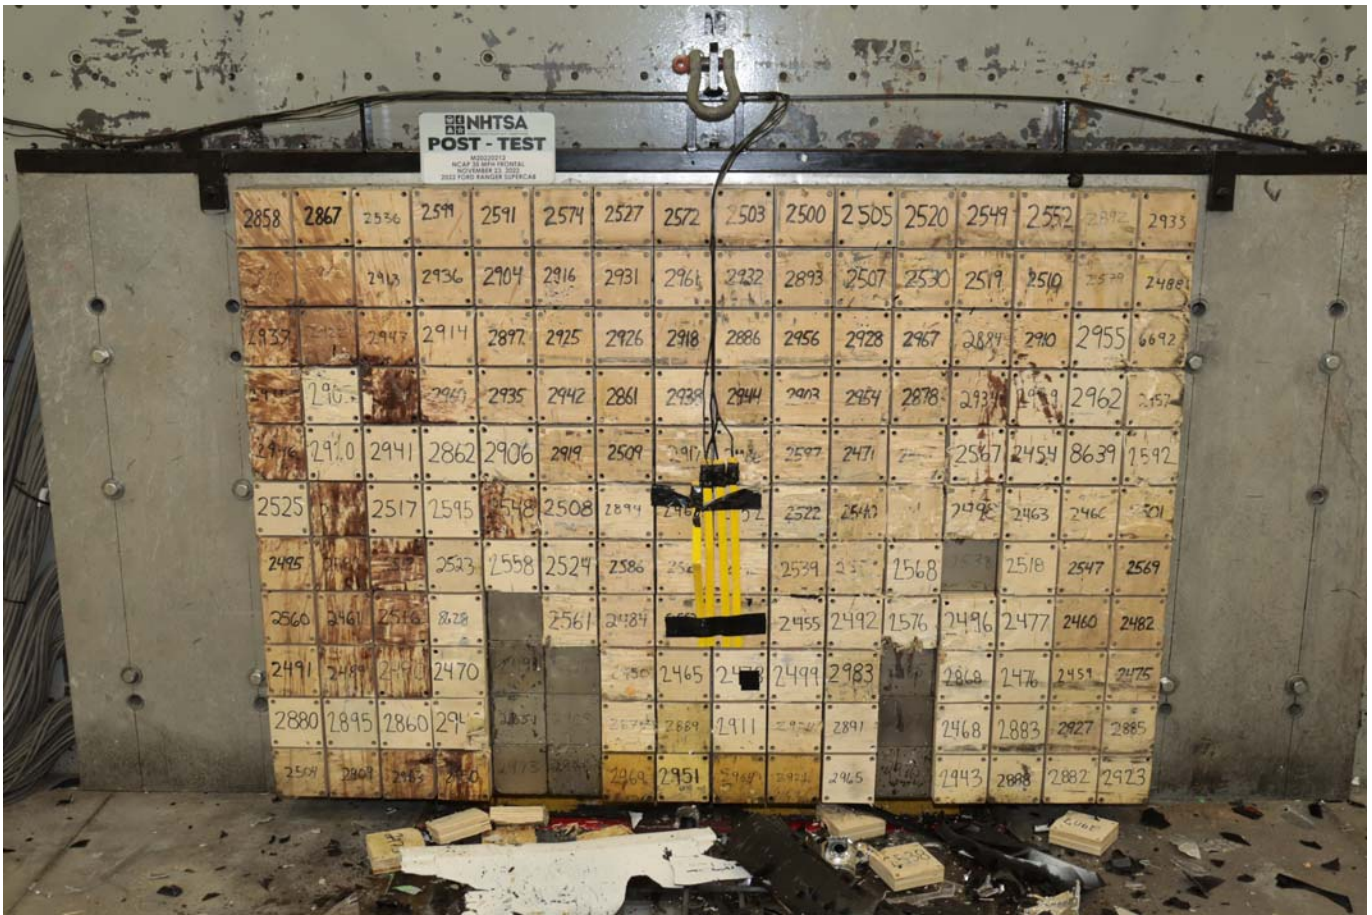
Photo No. 003 - Post-Test Load Cell Wall

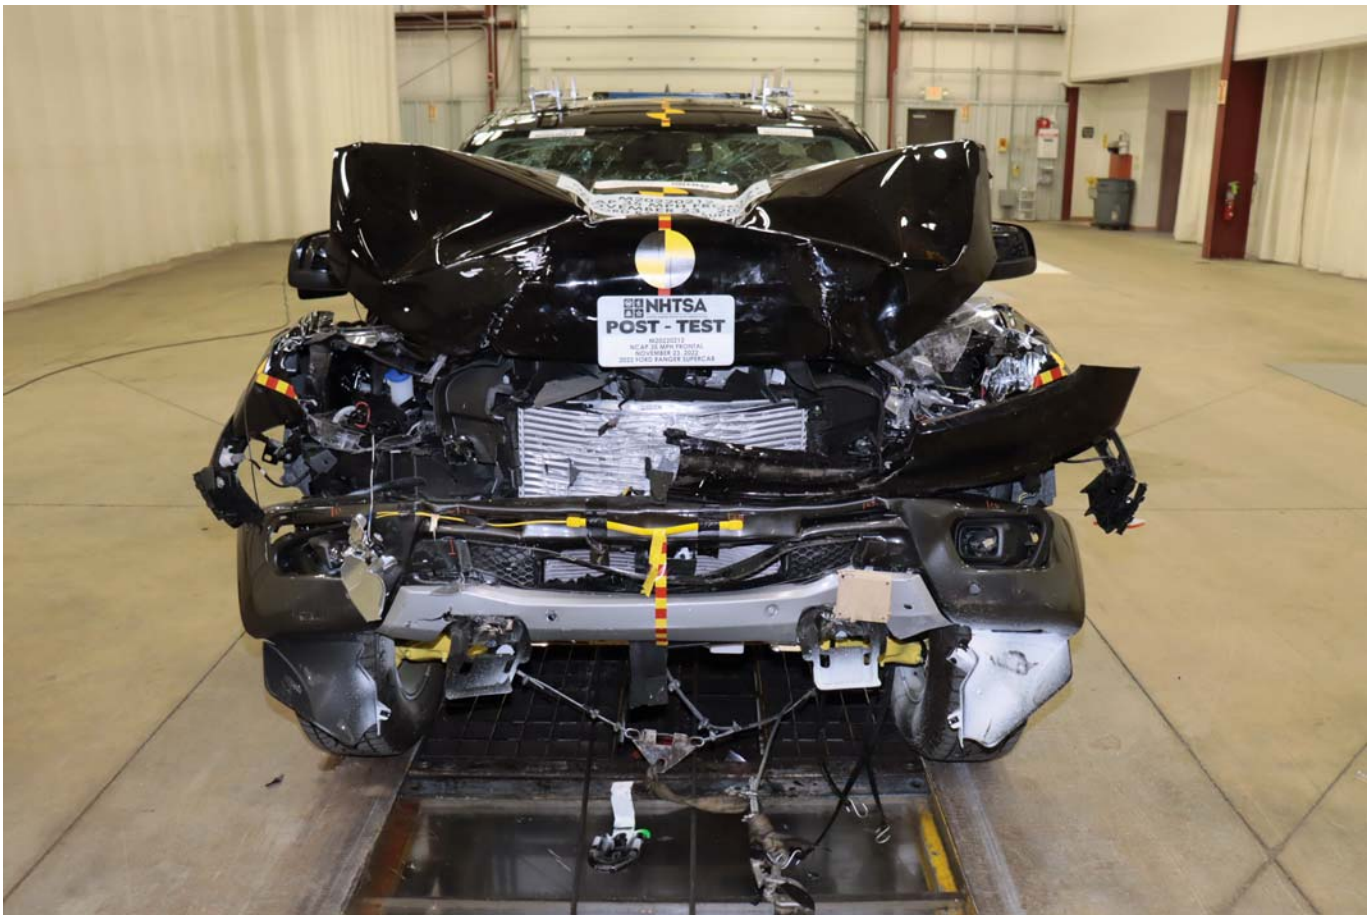
Photo No. 009 - Post-Test Front View of Test Vehicle

The maximum static crush of the vehicle was 707 mm located to the right of the vehicle centerline and both the driver and passenger side doors remained closed during the impact event and were operable after the impact.

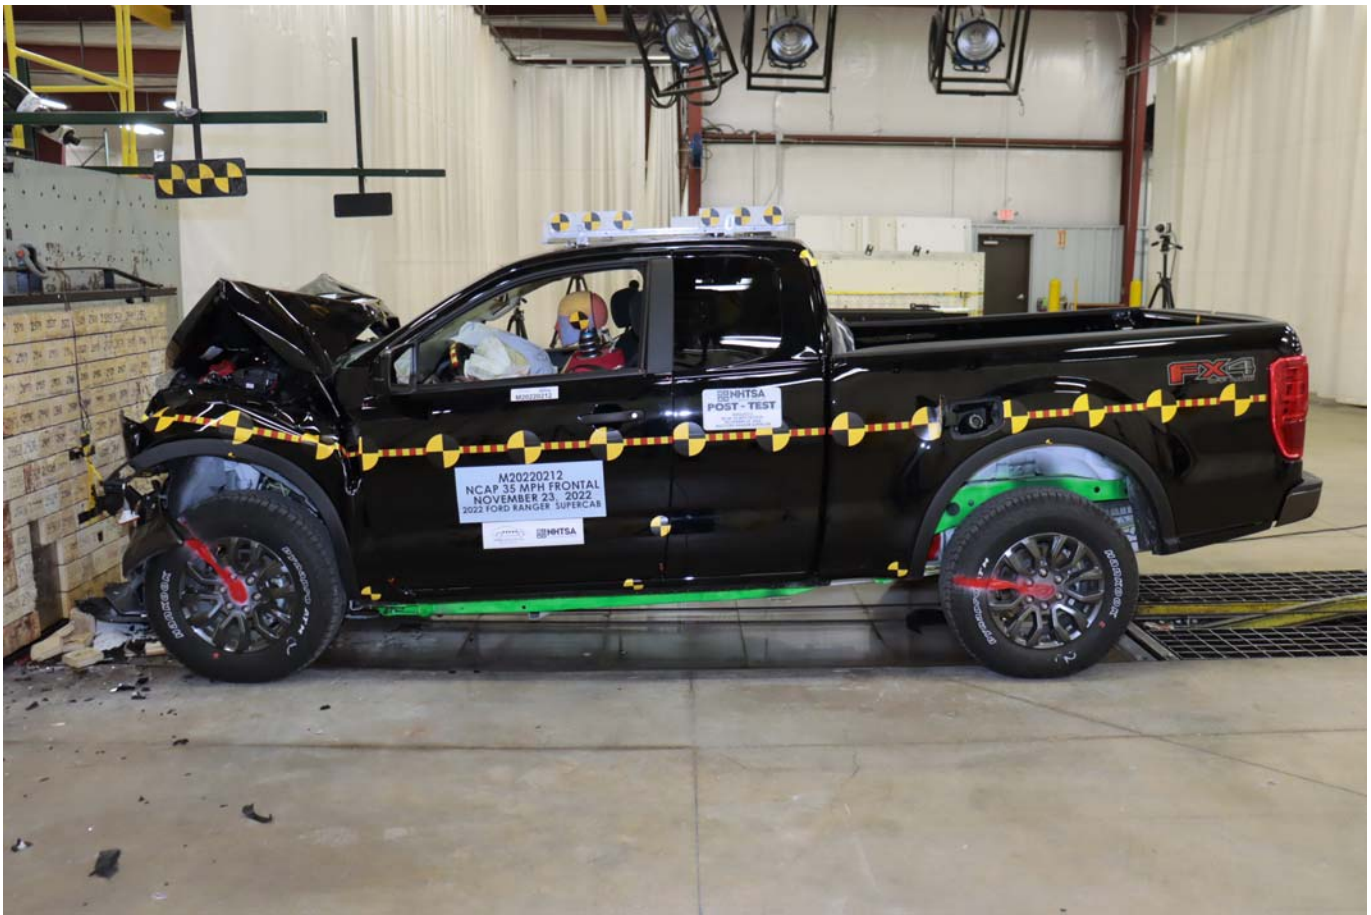
Photo No. 011 - Post-Test Left View of Test Vehicle

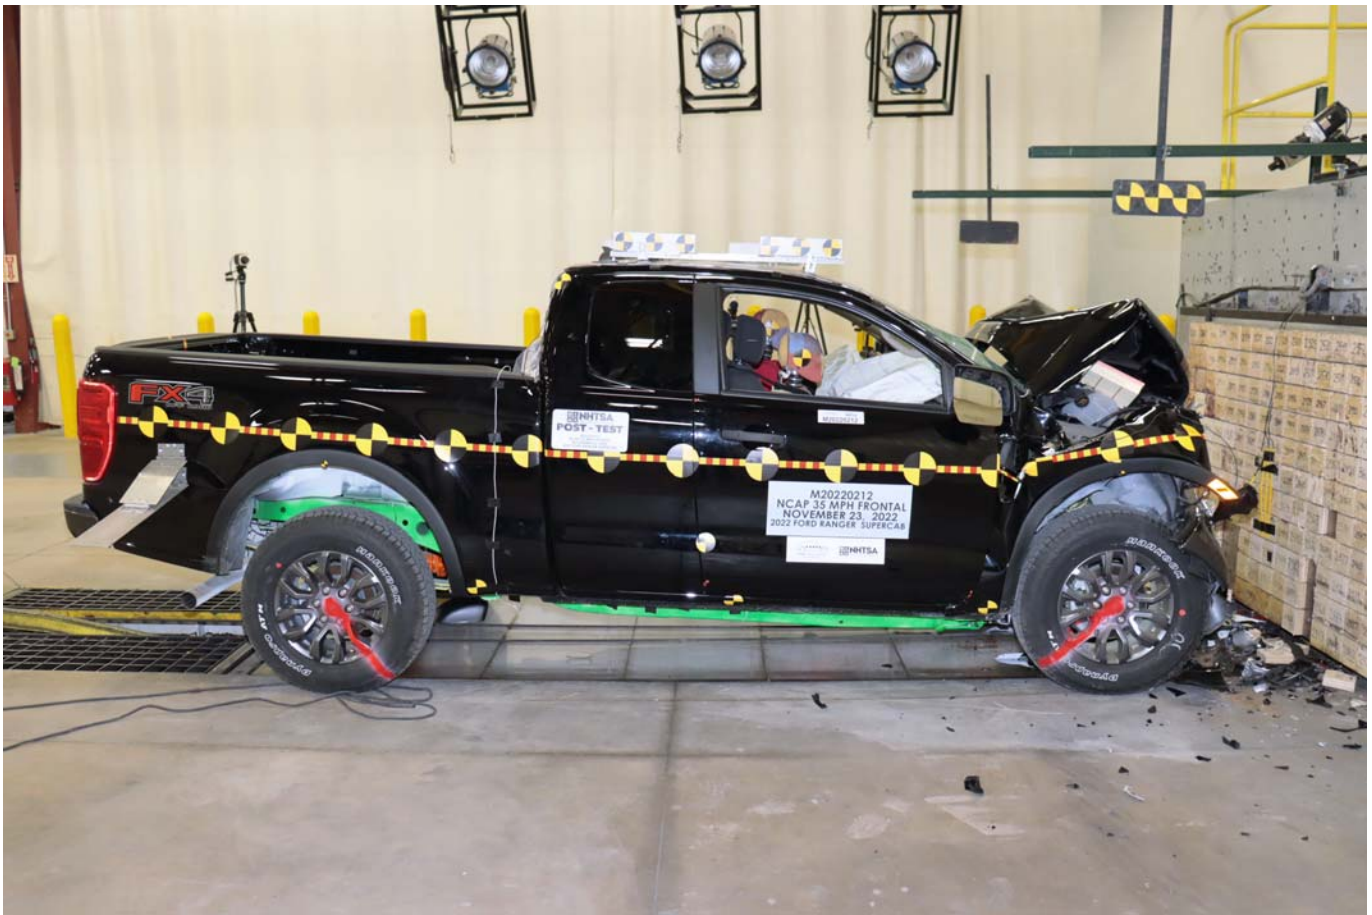
Photo No. 013 - Post-Test Right View of Test Vehicle

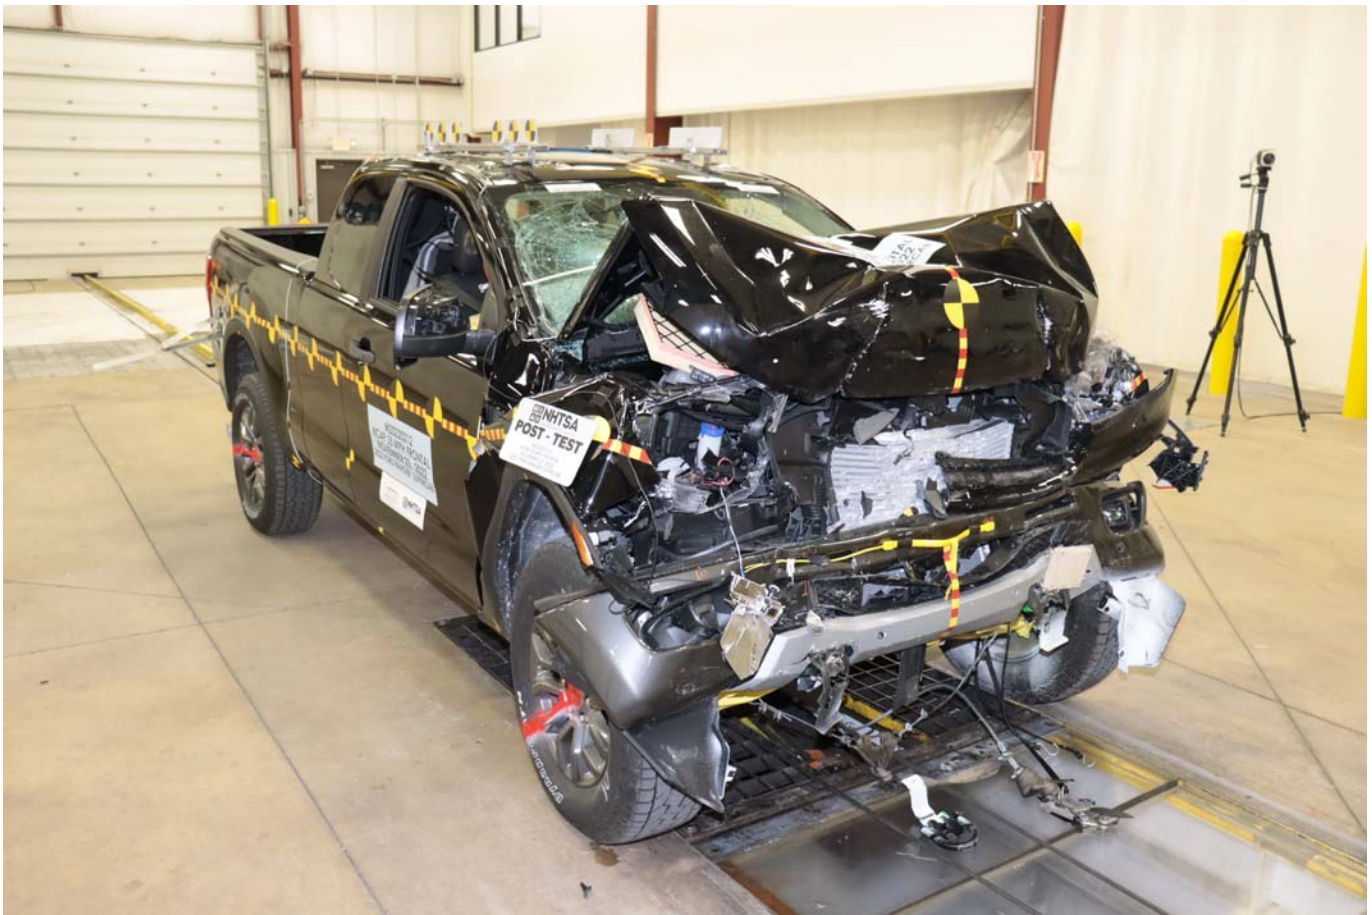
Photo No. 015 - Post-Test Right Front 3-4 View

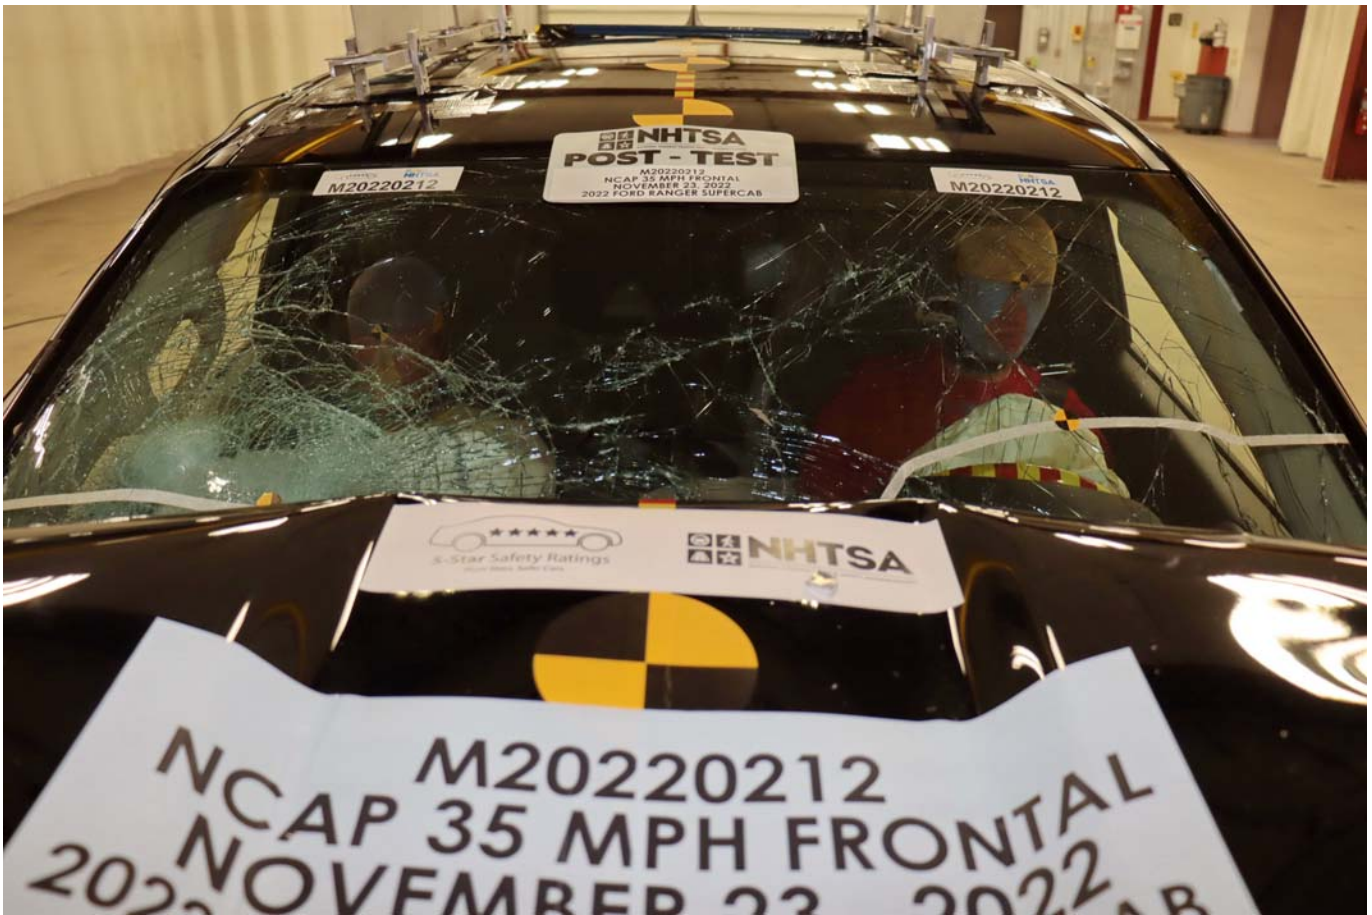
Photo No. 019 - Post-Test Windshield View

Critical Areas of Performance	Observations and Conclusions
Windshield Damage	Cracked by passenger frontal airbag and hood corners
Window Damage	None
Other Notable Effects	None

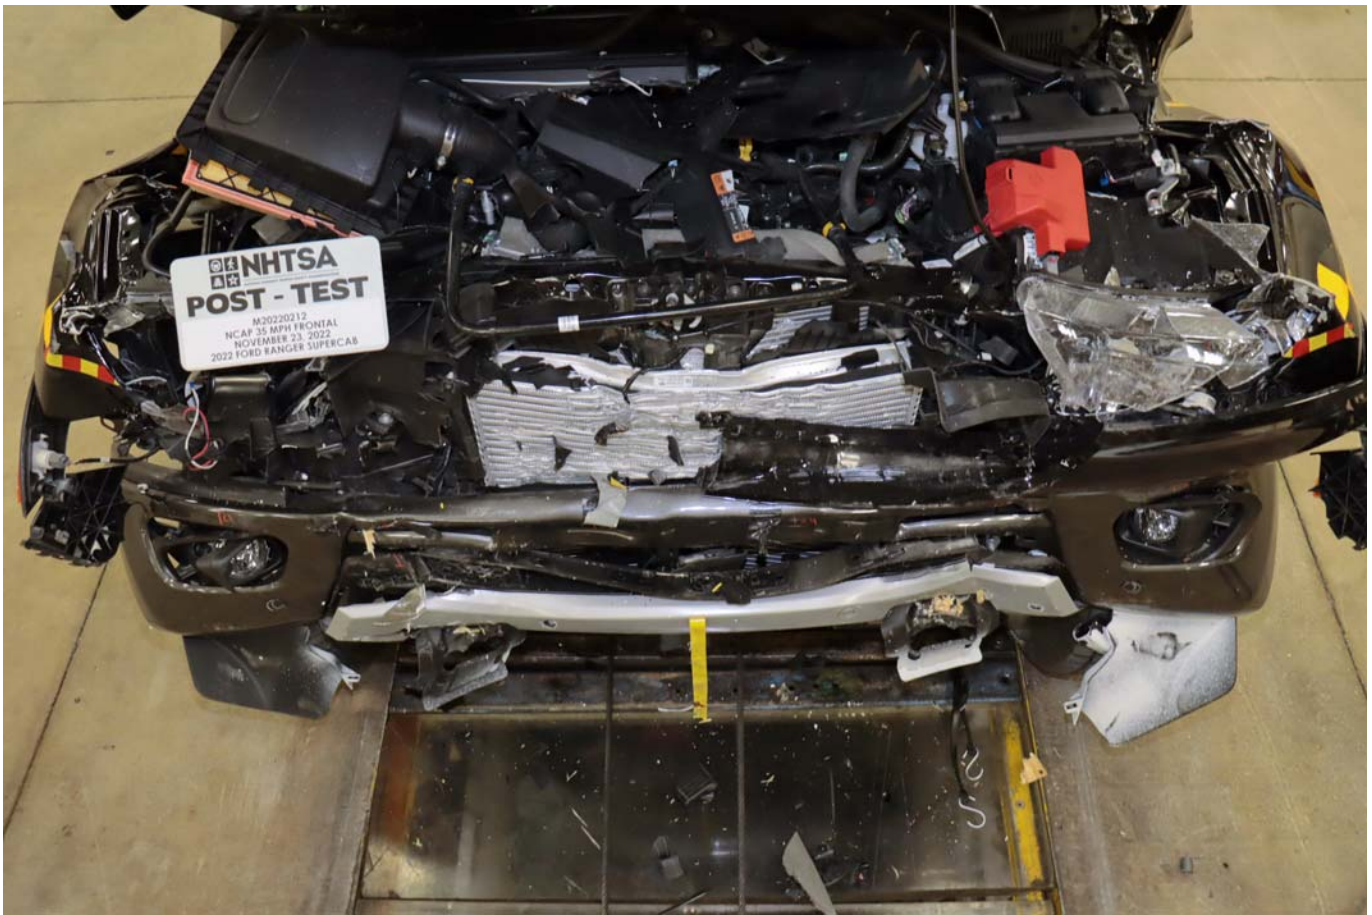
Photo No. 021 - Post-Test Engine Compartment View

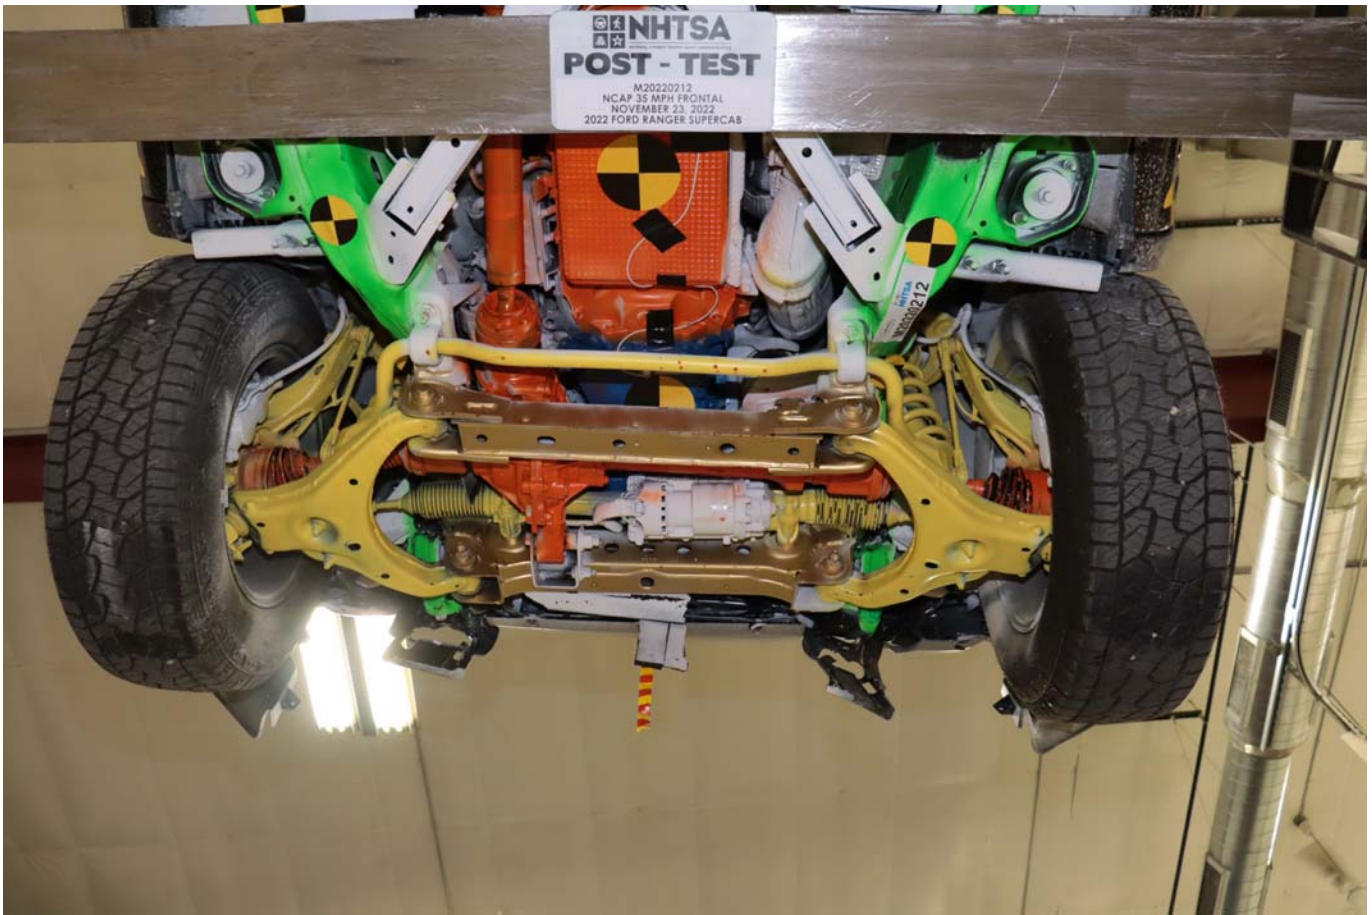
Photo No. 025 - Post-Test Front Underbody View

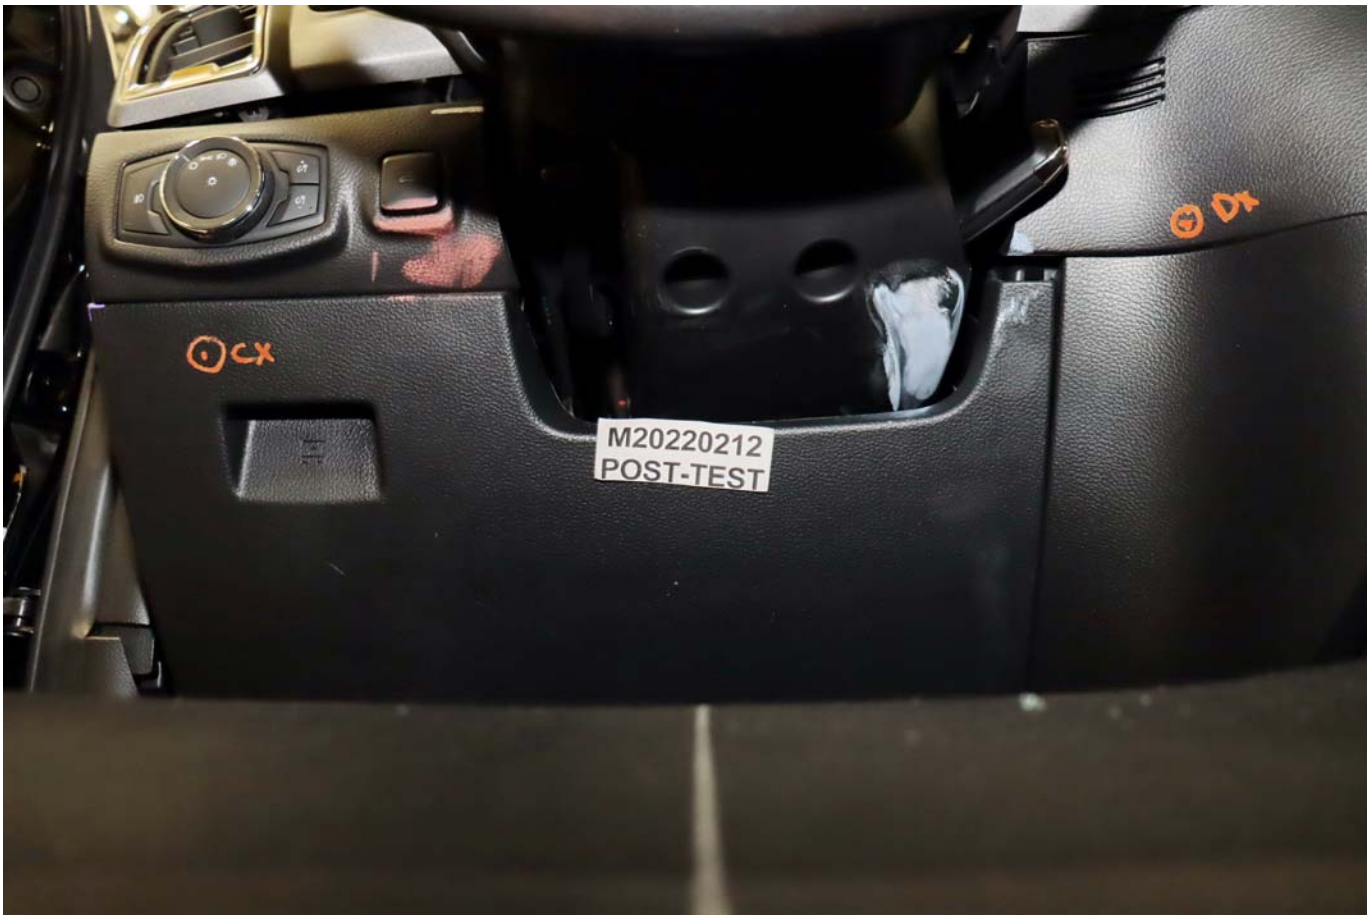
Photo No. 045 - Post-Test Driver's Side Knee Bolster

The driver's visible contact points were as follows: The driver's head contacted the airbag. The driver's head also contacted the headrest. The driver's knees contacted the knee bolster and steering column trim. The passenger's visible contact points were as follows: The passenger's head contacted the airbag. The passenger's head also contacted the headrest. The passenger's knees contacted the glove box and frontal airbag.

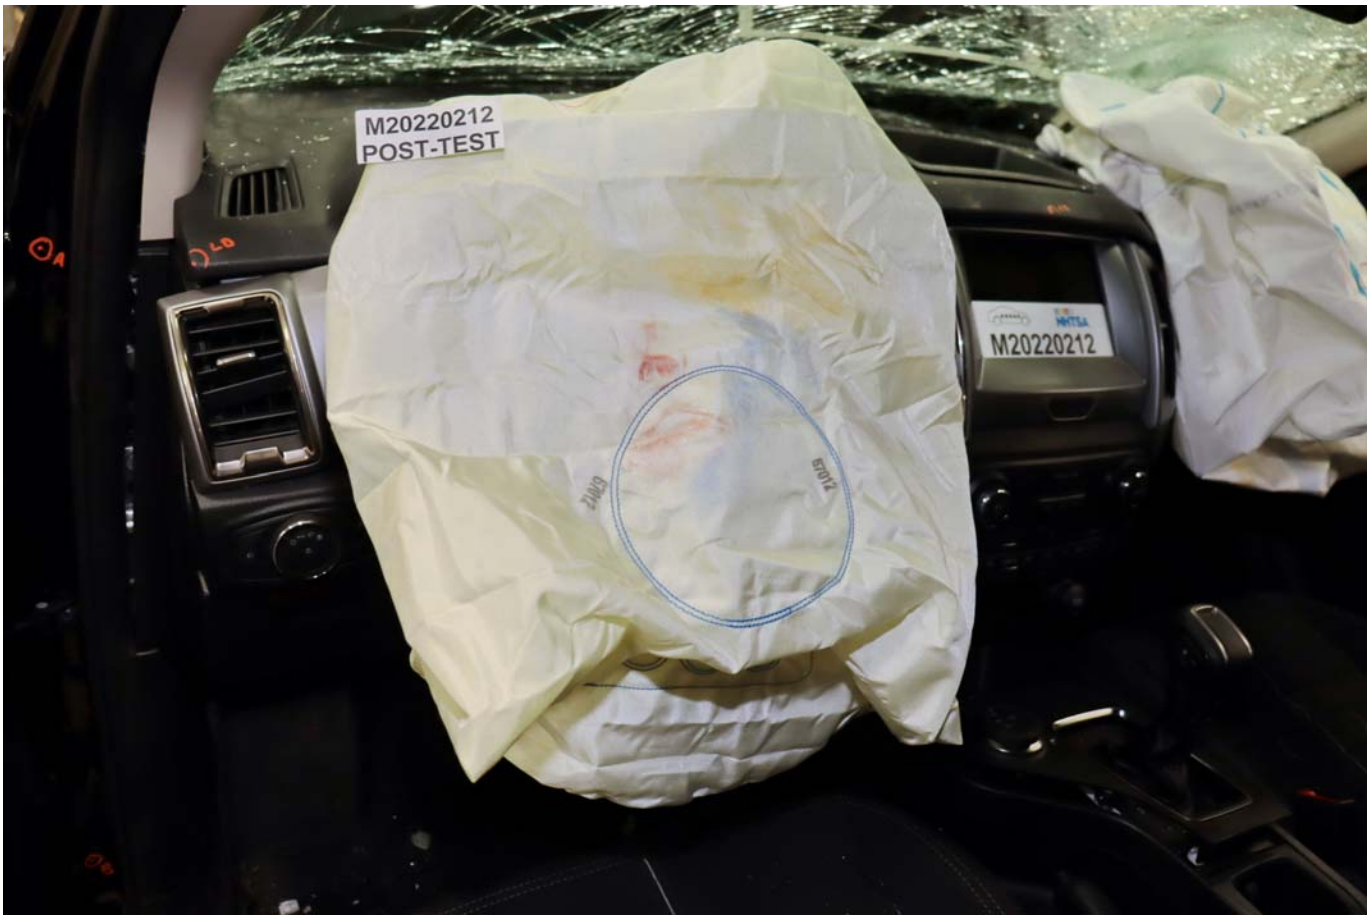
Photo No. 049 - Post-Test Driver Dummy Contact with Airbag

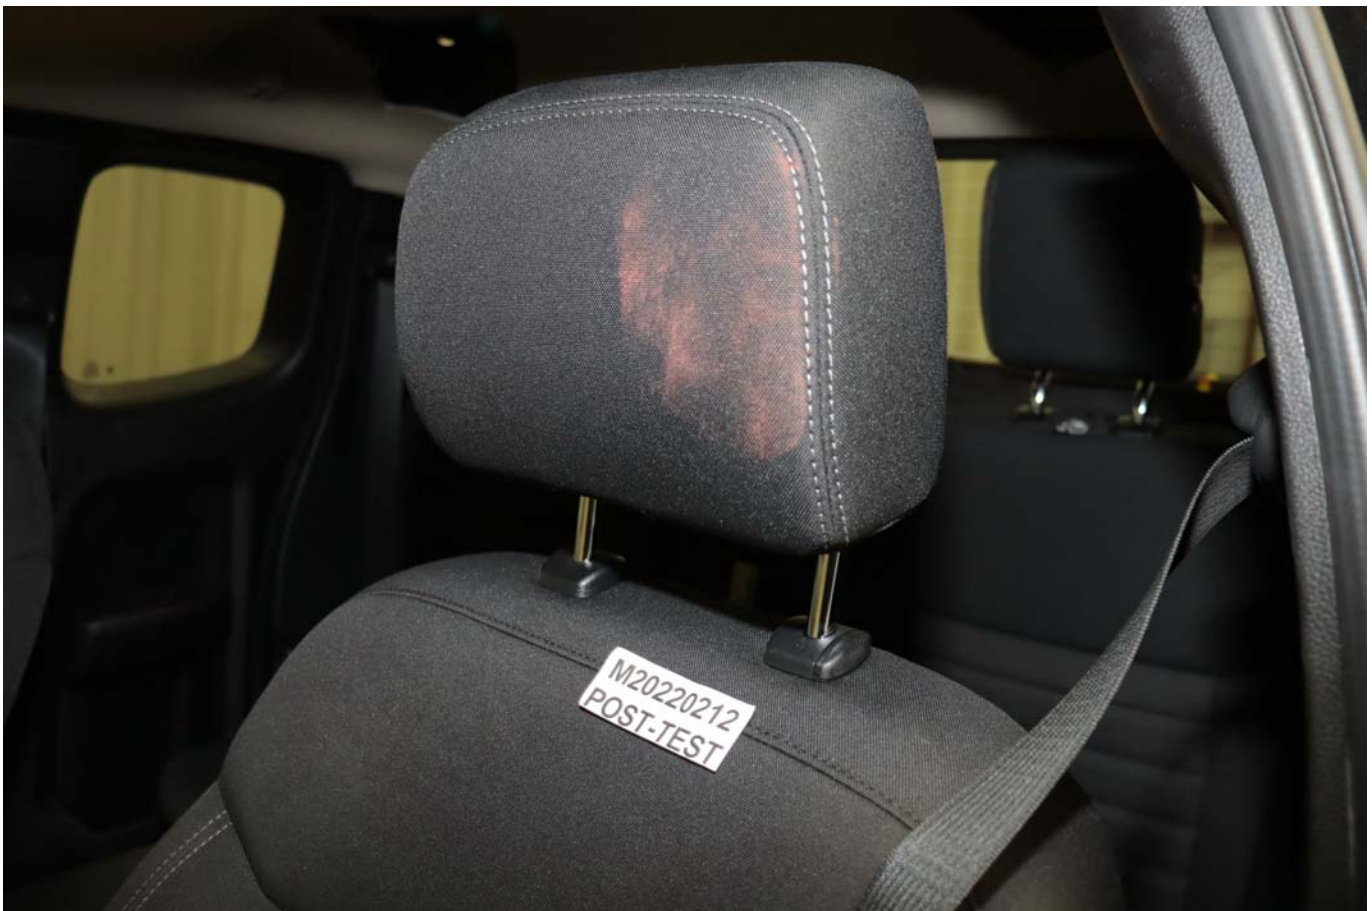
Photo No. 050 - Post-Test Driver Dummy Contact with Headrest

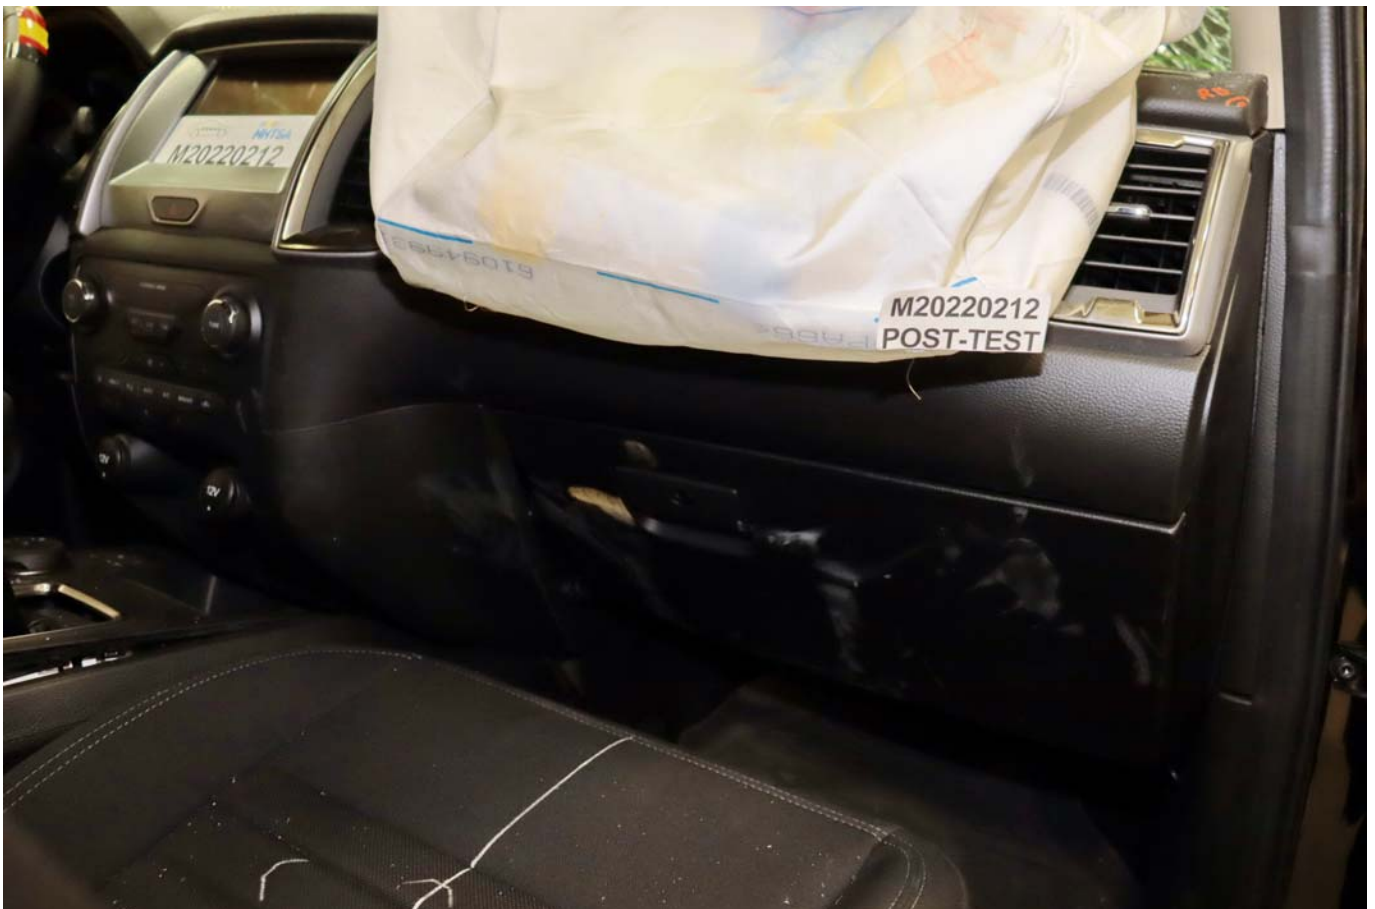
Photo No. 068 - Post-Test Passenger's Side Knee Bolster

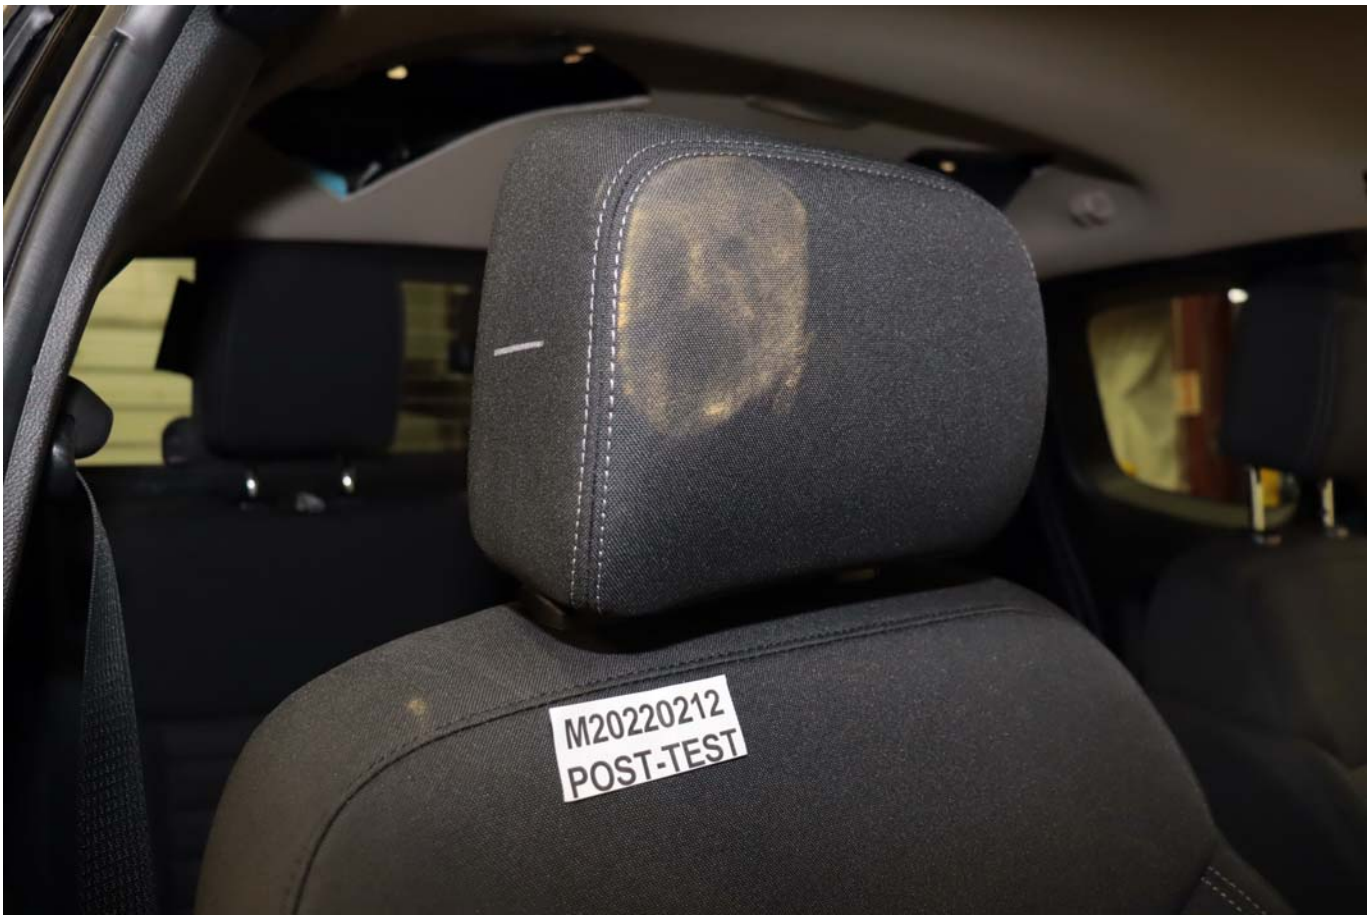
Photo No. 073 - Post-Test Passenger Dummy Contact with Headrest

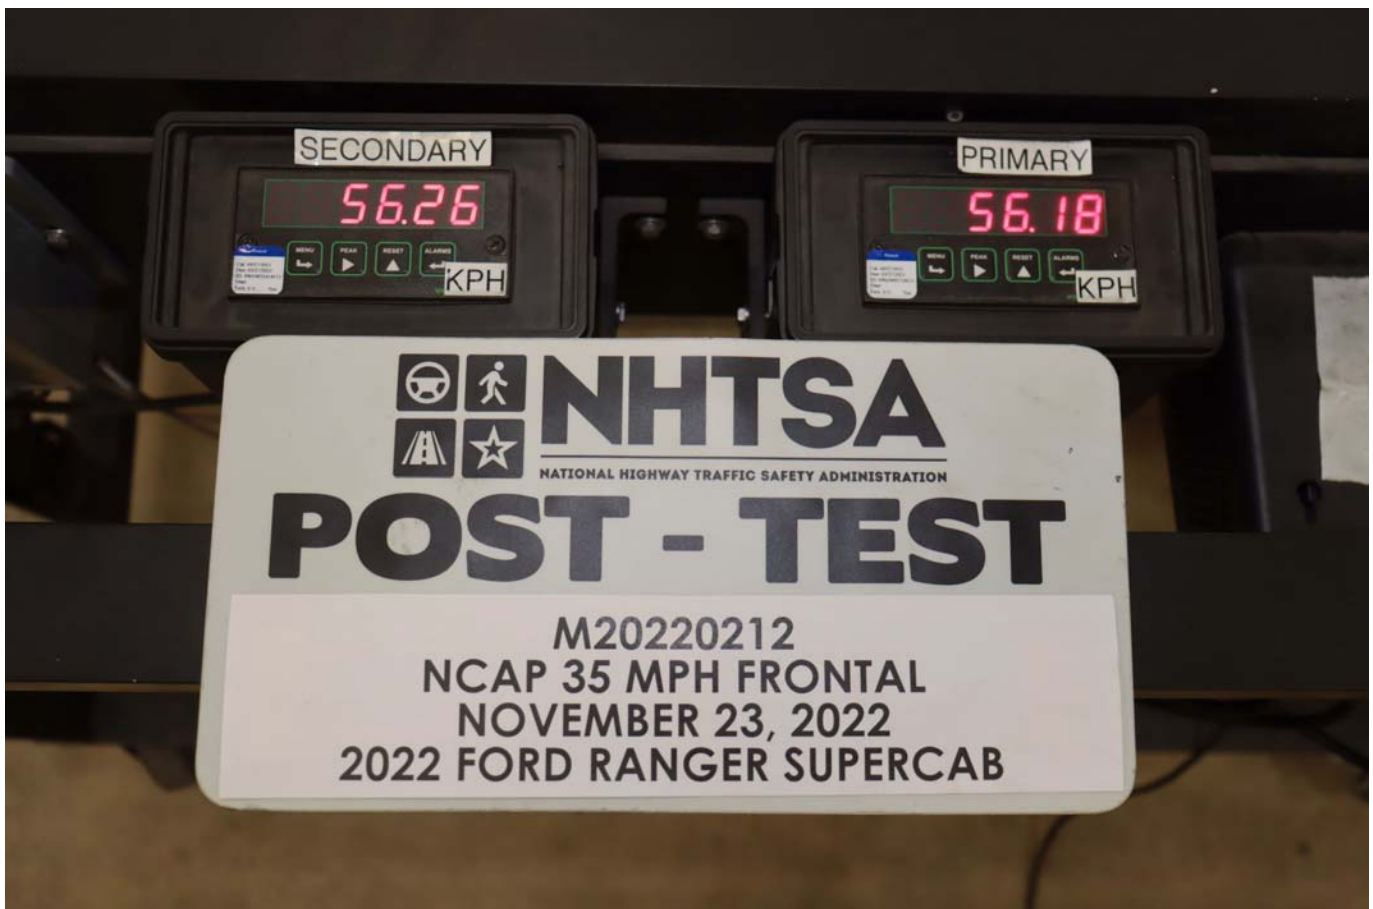
Photo No. 076 - Post-Test Speed Trap Read-Out

A load cell barrier consisting of 176 load cells was impacted by a 2022 Ford Ranger XLT SuperCab 4x4 Pickup Truck at a velocity of 56.18 km/h. The test was performed at MGA Research Corporation on November 23, 2022. Pre-test and post-test photographs of the vehicle and dummies can be found in Appendix A.
