**REPORT NUMBER: NCAP-MGA-22-035**

**NEW CAR ASSESSMENT PROGRAM (NCAP)  
Frontal Barrier Impact Test**

**FORD MOTOR CO.  
2022 Ford Ranger XLT SuperCab 4x4 Pickup Truck  
NHTSA No.: M20220212**

**FINAL REPORT**

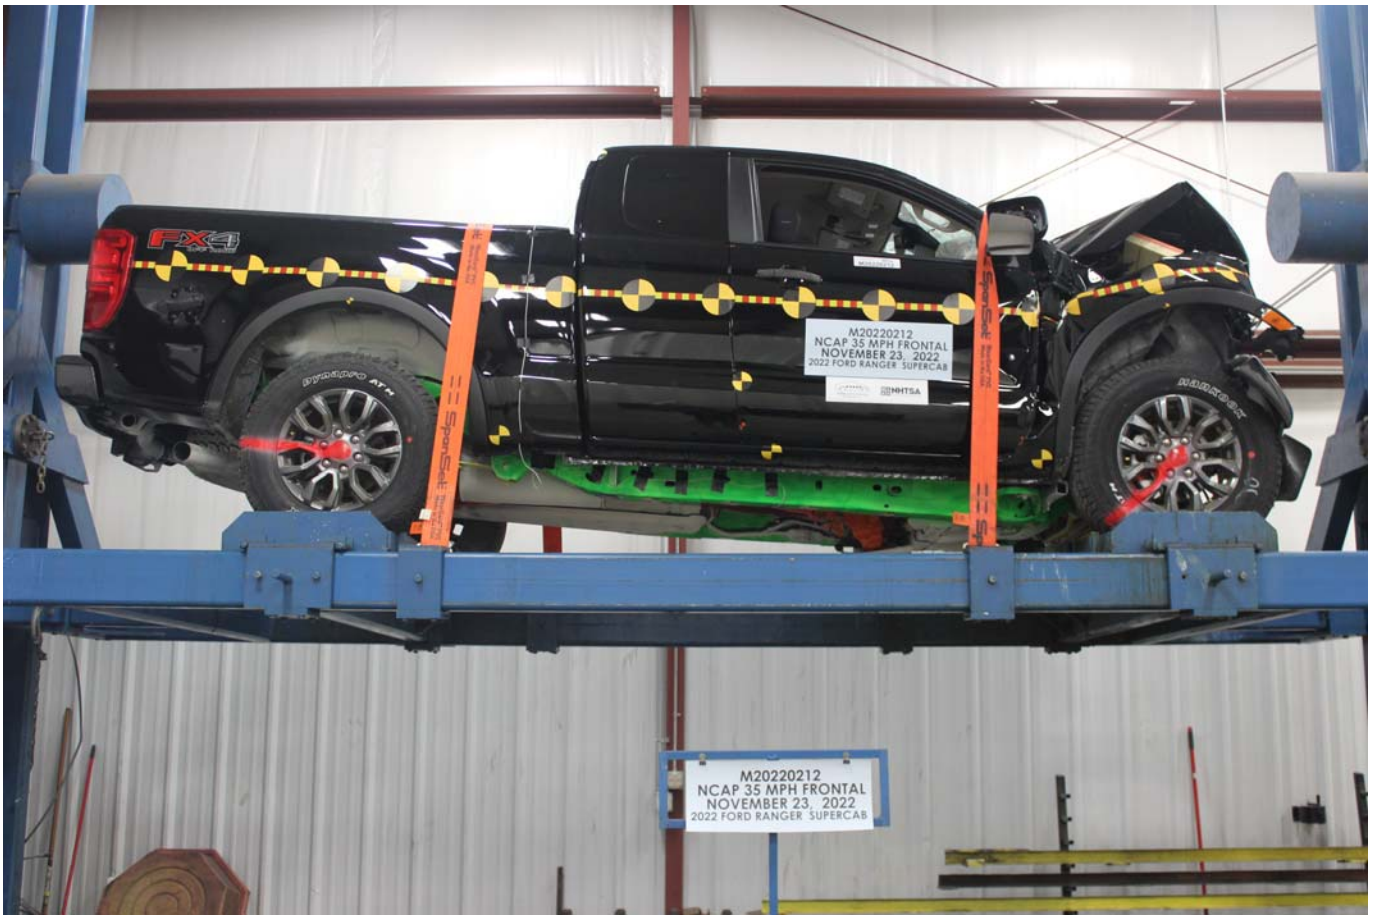
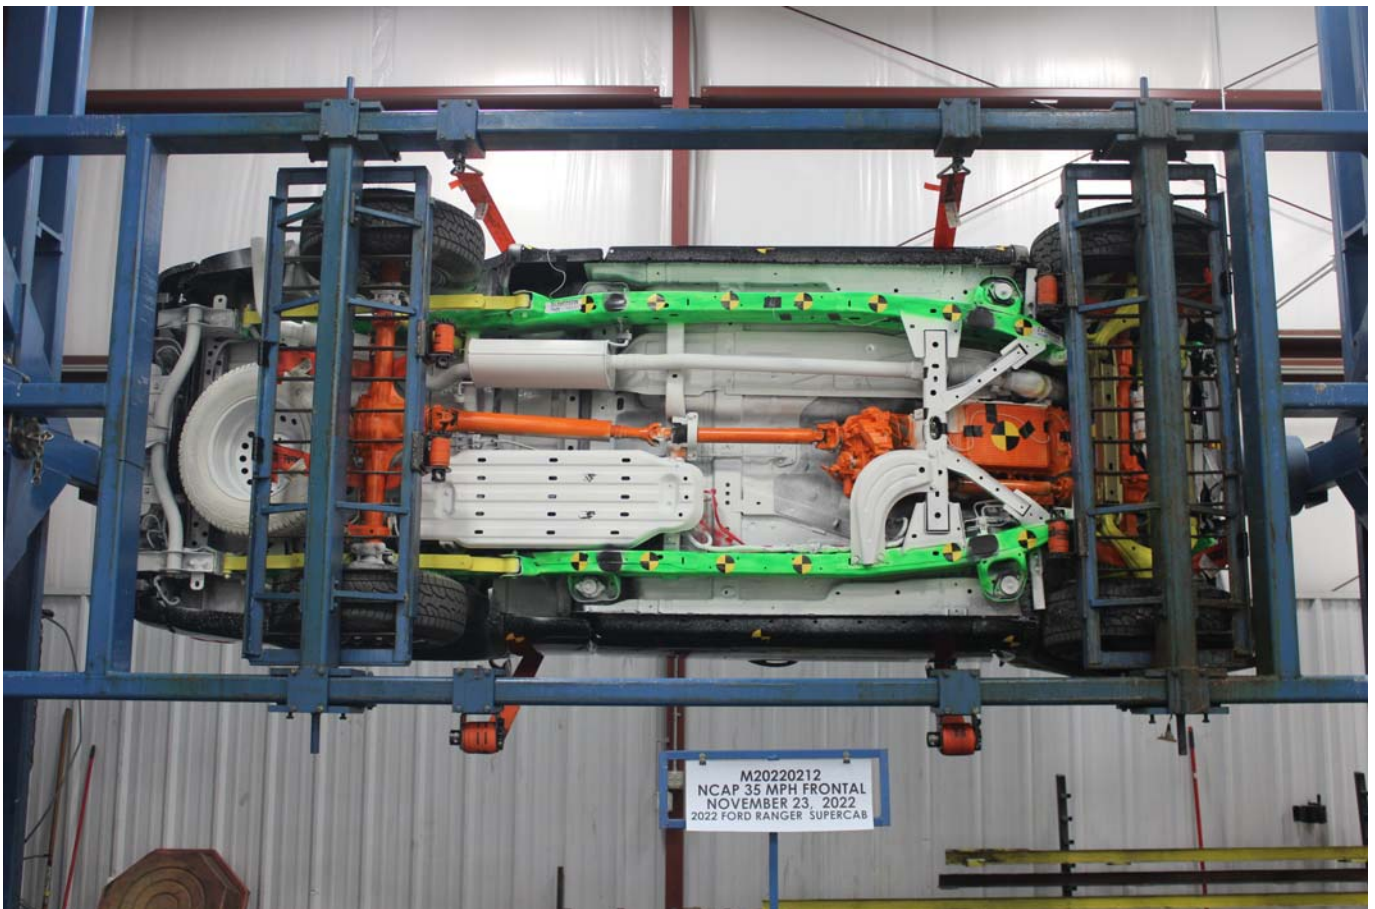
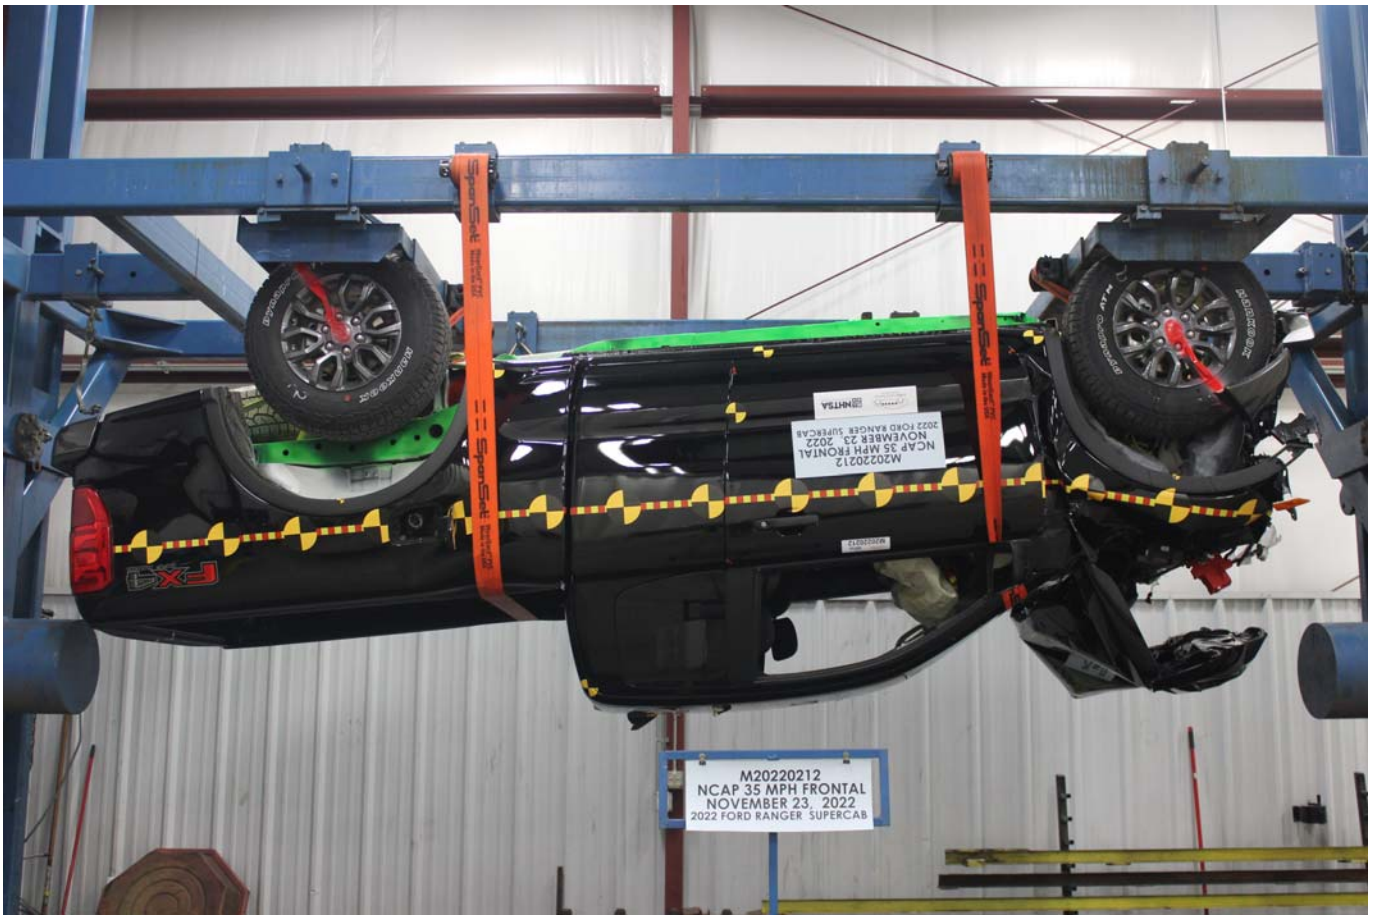
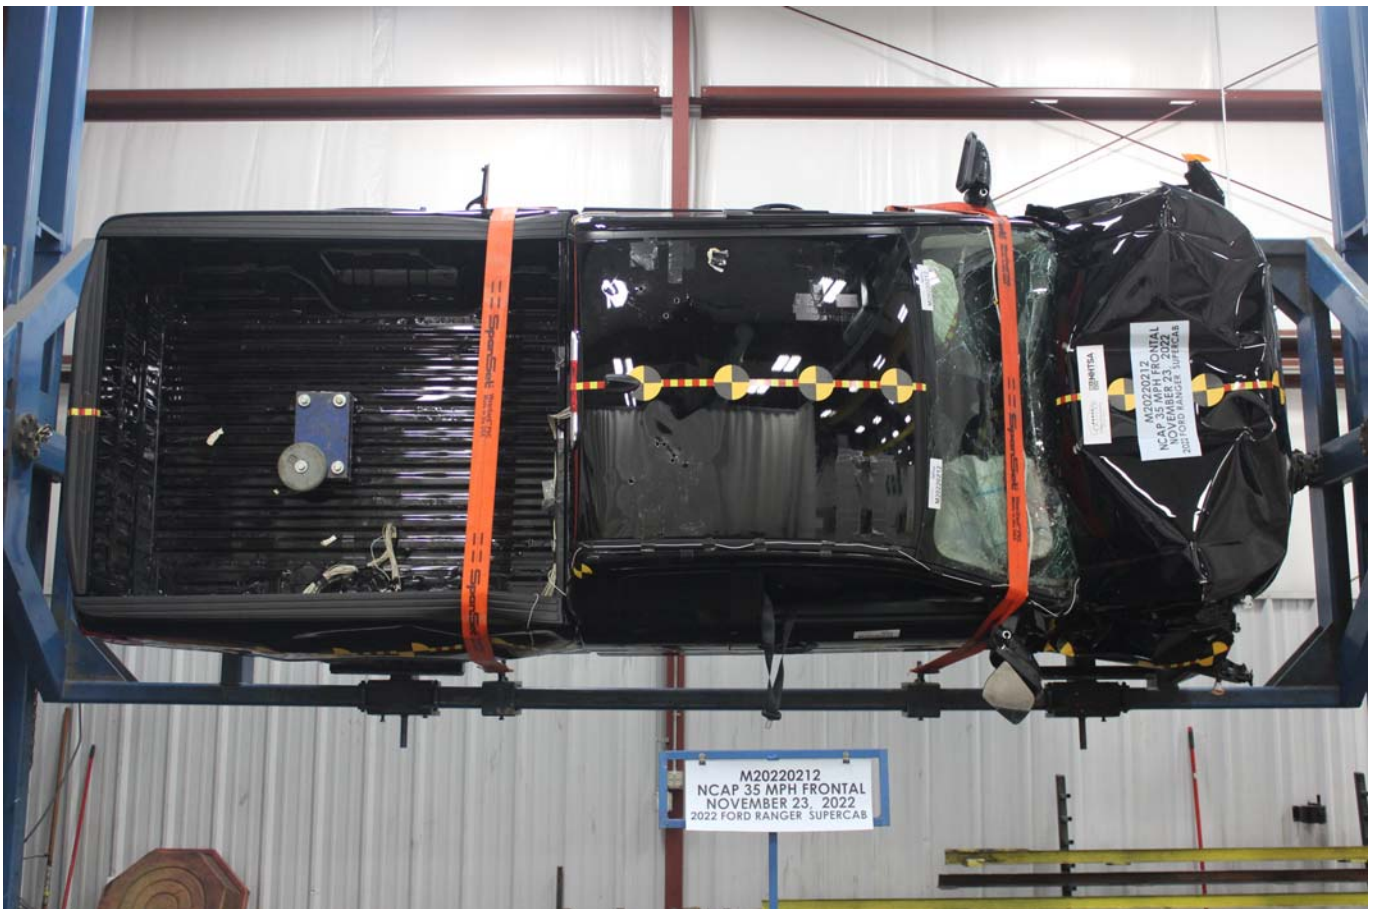
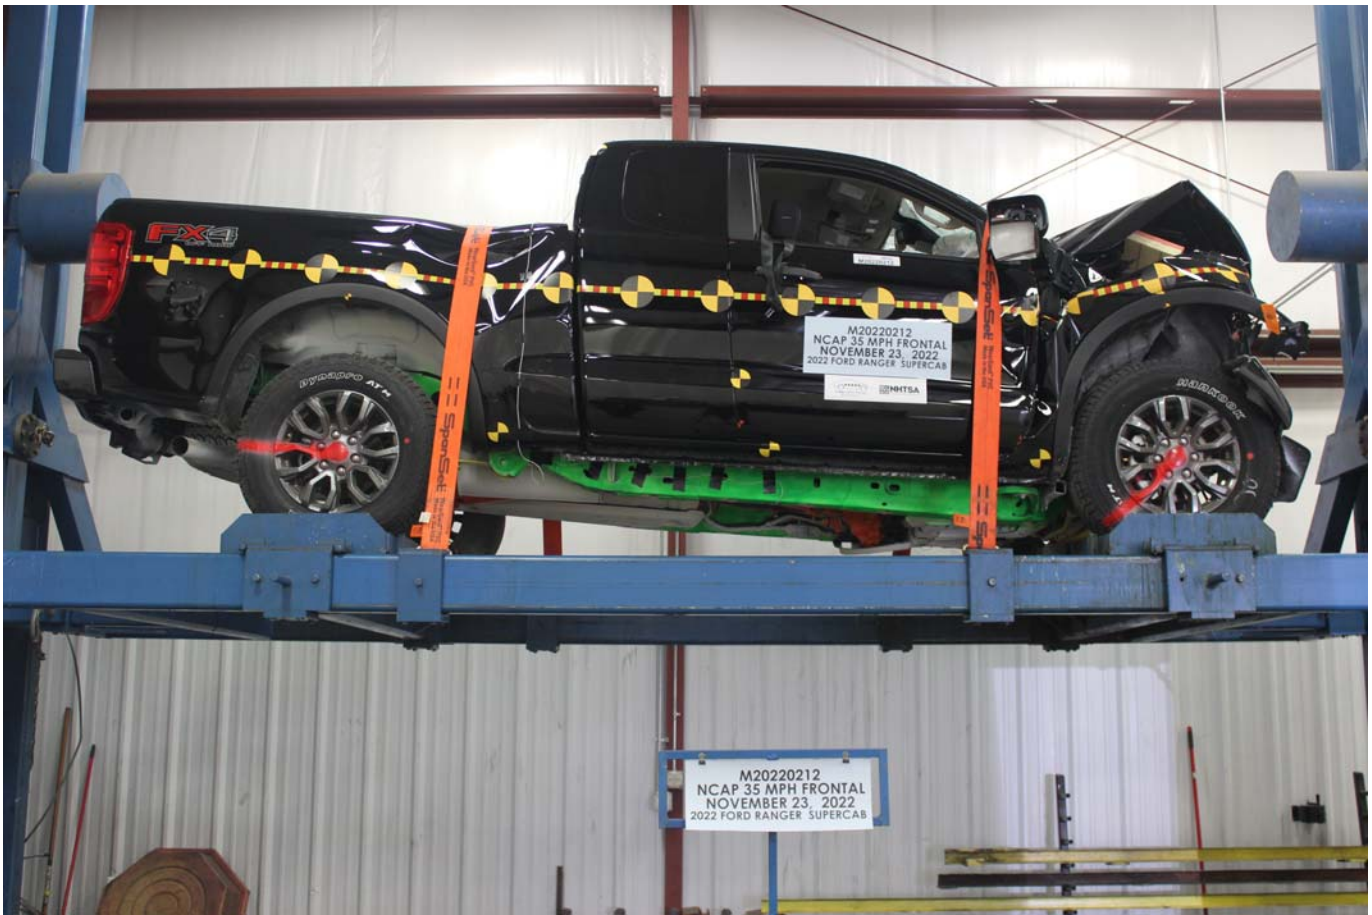
Photo No. 077 - Vehicle at 0 Degrees on Static Rollover Device

Photo No. 078 - Vehicle at 90 Degrees on Static Rollover Device

Photo No. 079 - Vehicle at 180 Degrees on Static Rollover Device

Photo No. 080 - Vehicle at 270 Degrees on Static Rollover Device

Photo No. 081 - Vehicle at 360 Degrees on Static Rollover Device

There was 100 percent windshield retention and no intrusion into the protected zone of the windshield during the event. There was no Stoddard Solvent leakage after the event or during any phase of the static rollover.
