**REPORT NUMBER: NCAP-KAR-22-010**

**NEW CAR ASSESSMENT PROGRAM (NCAP)  
FRONTAL BARRIER IMPACT TEST**

**SUBARU CORPORATION  
2022 SUBARU WRX 4-DOOR SEDAN**

**FINAL REPORT**

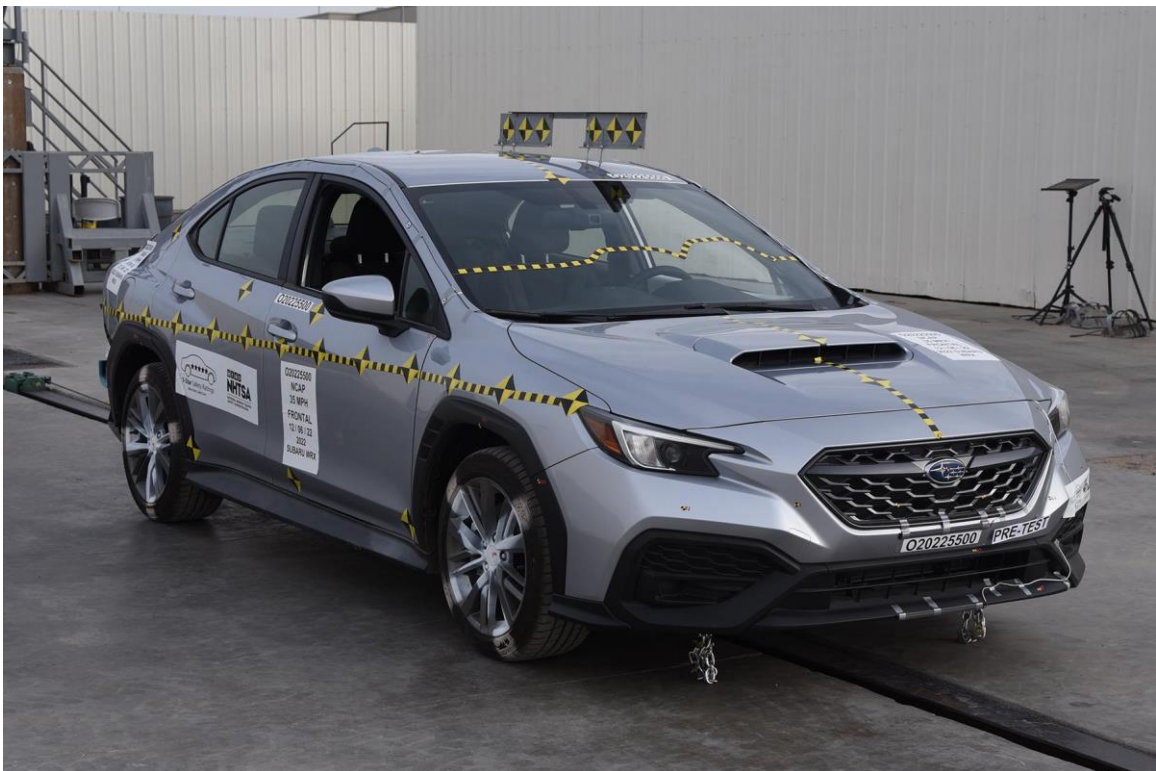
FIGURE 14. Pre-Test Right Front  $\frac{3}{4}$  View

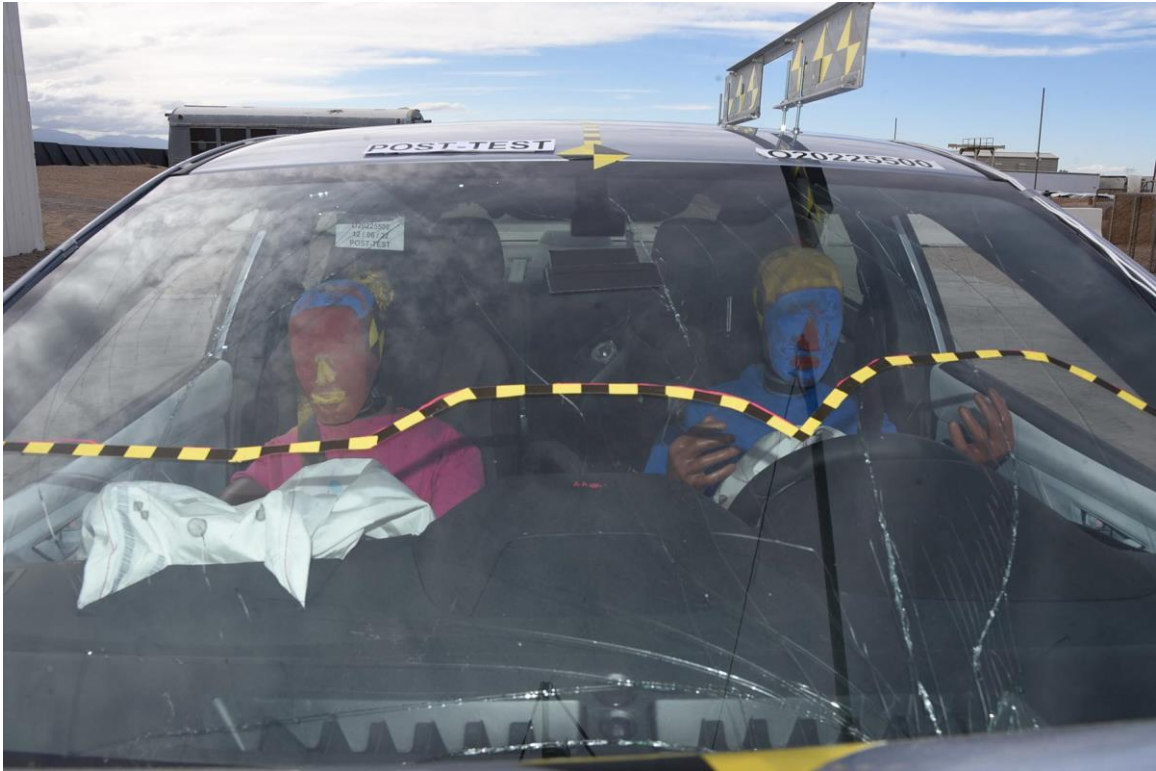
FIGURE 19. Post-Test Windshield View

There was 100 percent windshield retention and intrusion into the protected zone of the windshield during the event. There was no Stoddard solvent leakage after the event or during any phase of the static rollover.

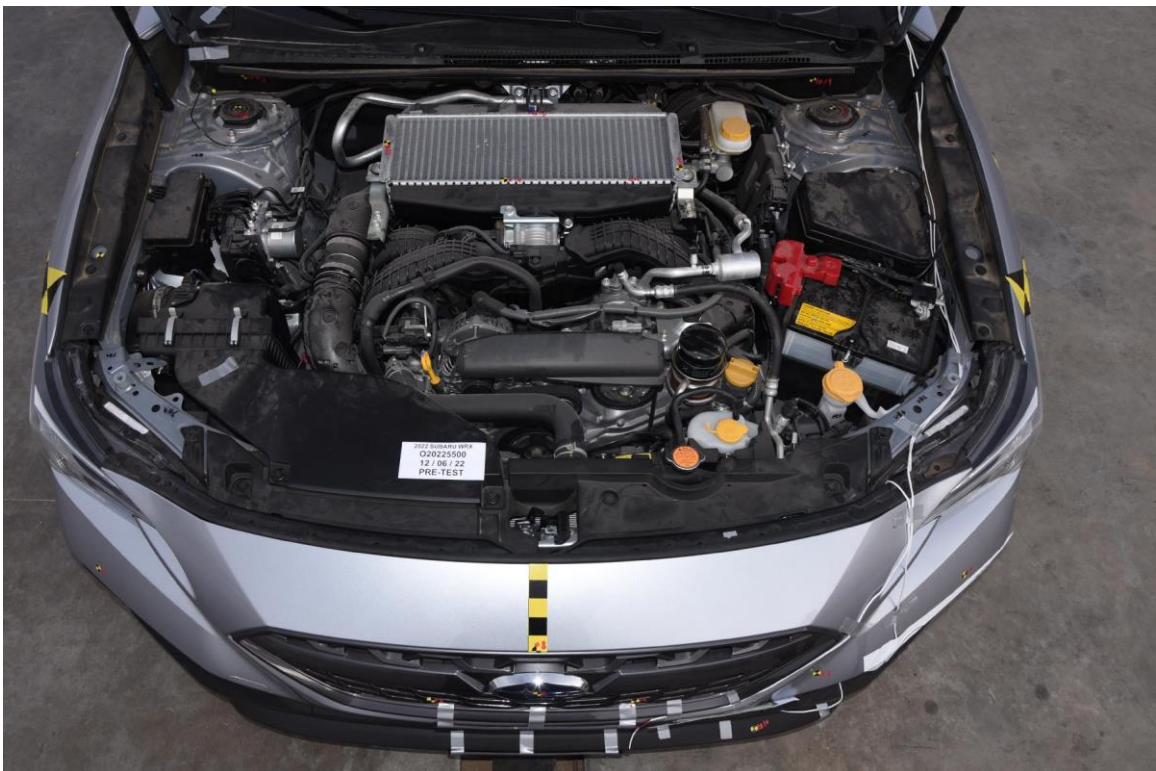
FIGURE 20. Pre-Test Engine Compartment View

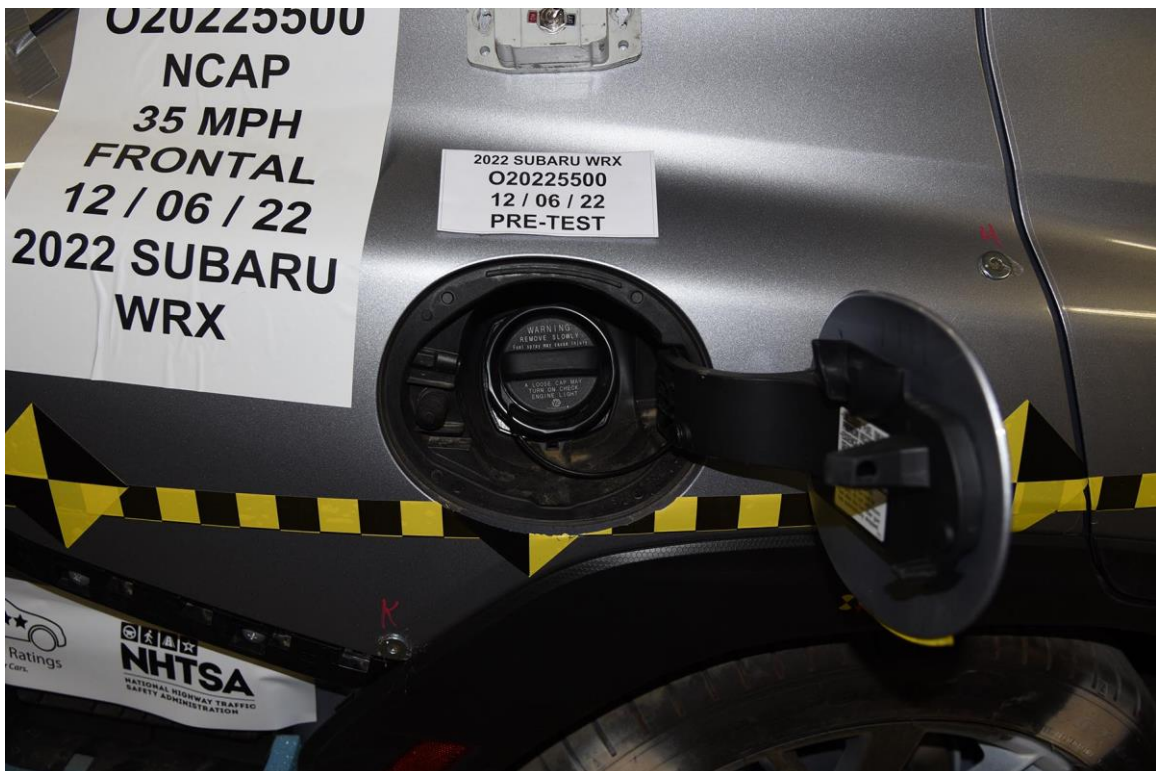
FIGURE 22. Pre-Test Fuel Filler Cap View

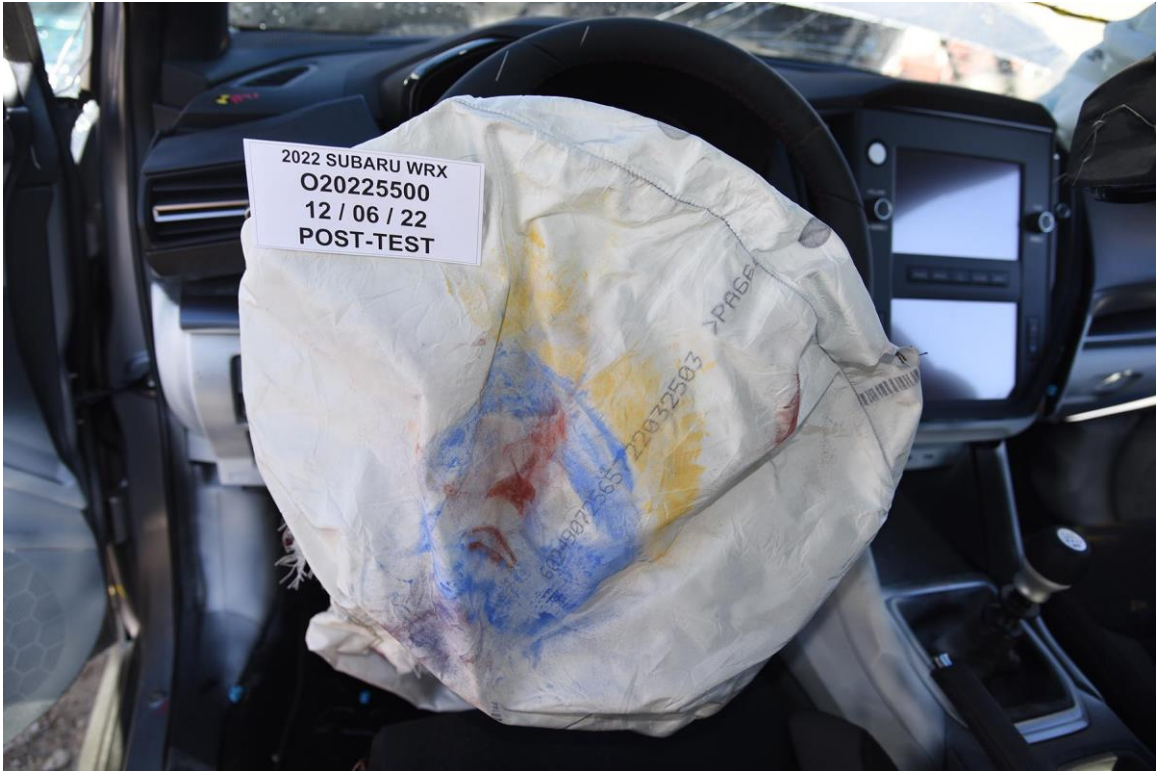
FIGURE 49. Post-Test Driver Dummy Contact with Airbag

The driver's visible contact points were as follows: the driver ATD's head contacted the frontal airbag and headrest. The upper and lower torso contacted the frontal airbag. Both left and right knees contacted the knee airbag.

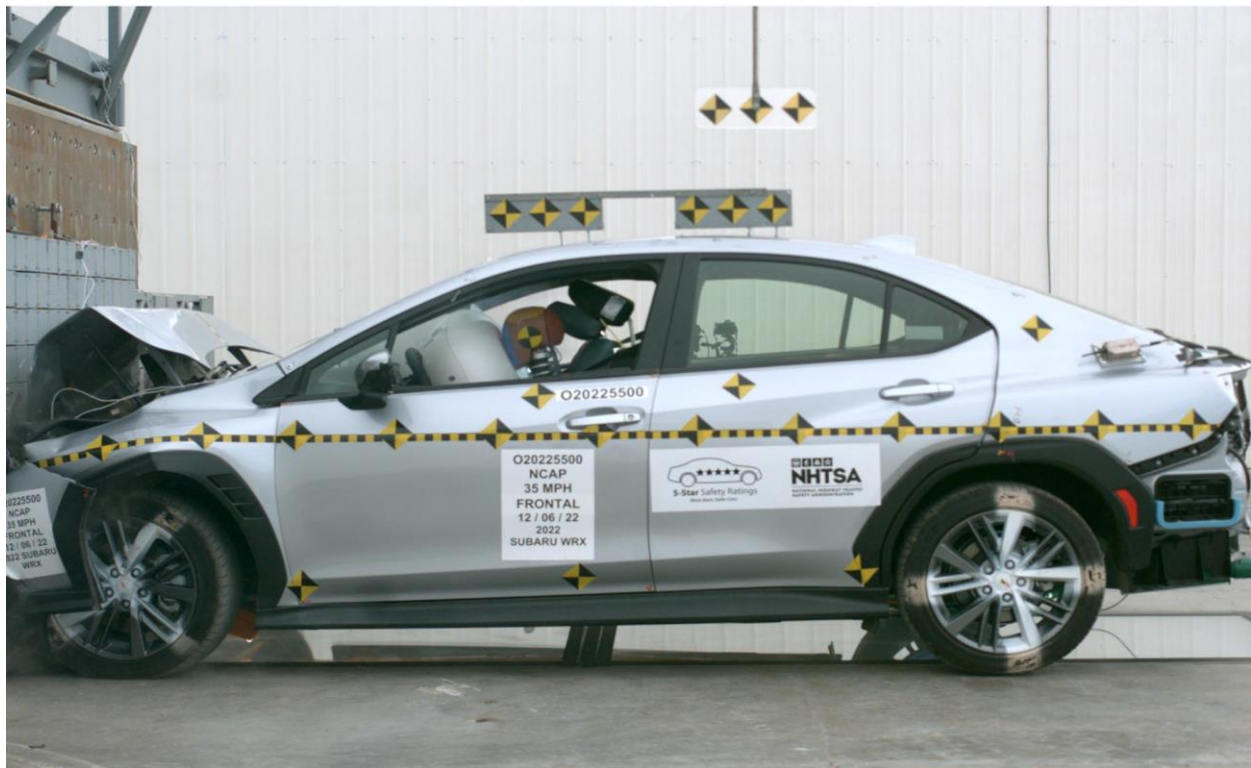
FIGURE 82. 2022 Subaru WRX Frontal Impact Event
