REPORT NUMBER: SideNCAPMDB-KAR-22-011

**NEW CAR ASSESSMENT PROGRAM (NCAP)
MOVING DEFORMABLE BARRIER SIDE IMPACT TEST**

**SUBARU CORPORATION
2022 SUBARU WRX PREMIUM 4-DOOR SEDAN**

NHTSA No: O20225502

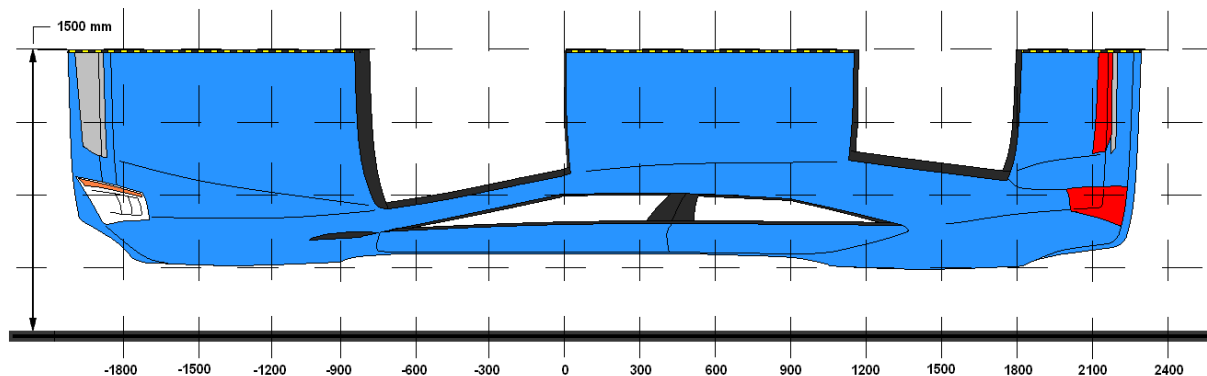
VEHICLE AND MDB DAMAGE PROFILE DISTANCES

VEHICLE DAMAGE PROFILE DISTANCES

DPD	Distance From Impact Point (mm)	Level	Pre-Test (mm)	Post-Test (mm)	Crush (mm)
1	2250	4	605	570	-35
2	1800	4	625	775	150
3	1200	3	602	792	190
4	600	2	605	773	168
5	0	3	600	723	123
6	-450	4	678	678	0
