**REPORT NUMBER: SINCAP-CAL-22-008**

**NEW CAR ASSESSMENT PROGRAM (NCAP)  
MOVING DEFORMABLE BARRIER SIDE IMPACT TEST**

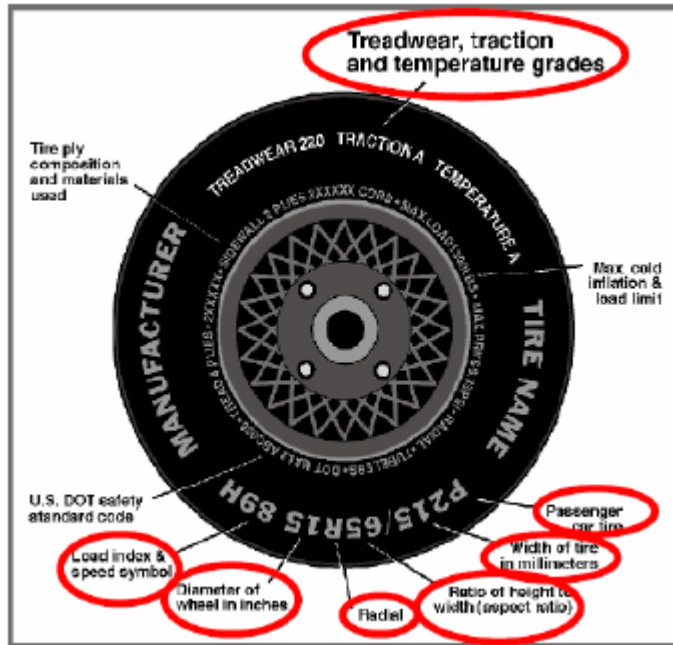
**TIRE SIDEWALL INFORMATION**

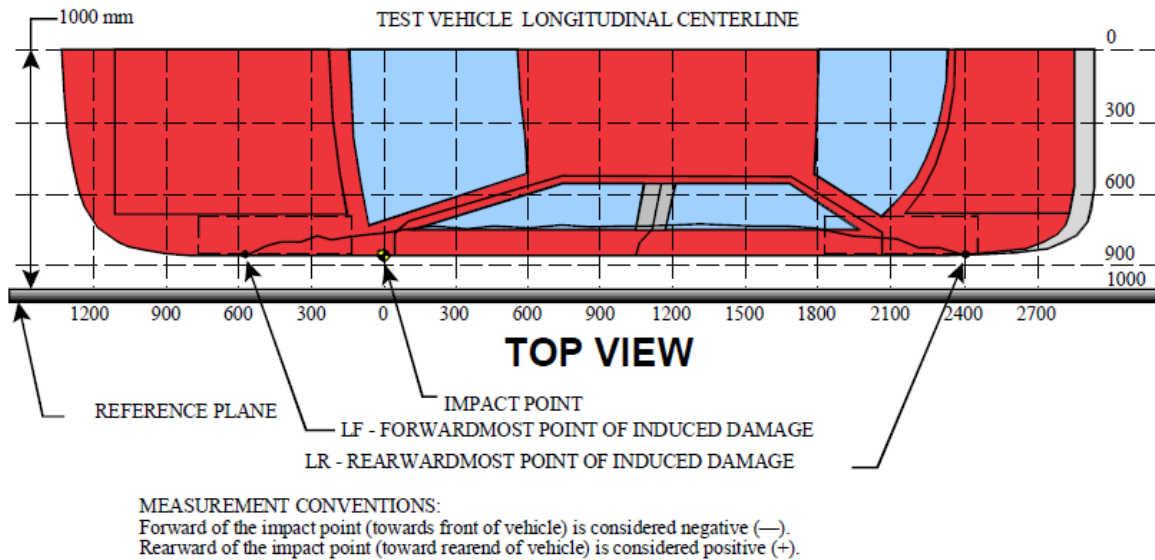
**VEHICLE DAMAGE PROFILE DISTANCES**

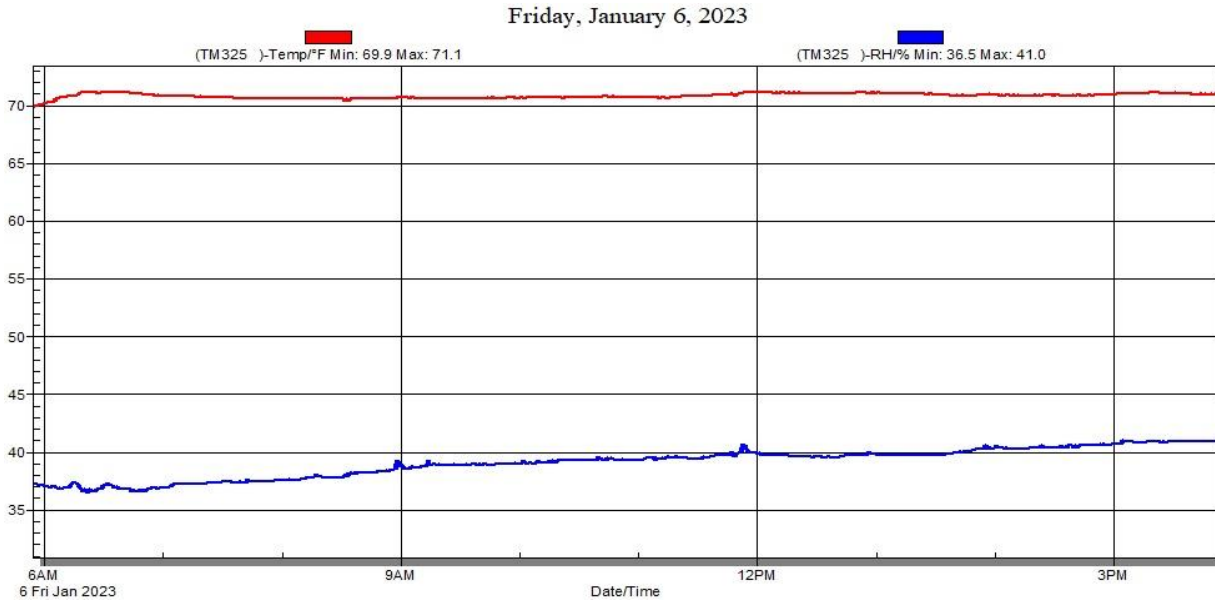
***Temperature and Humidity Stabilization Chart/Data for Dummies and Test Vehicle***

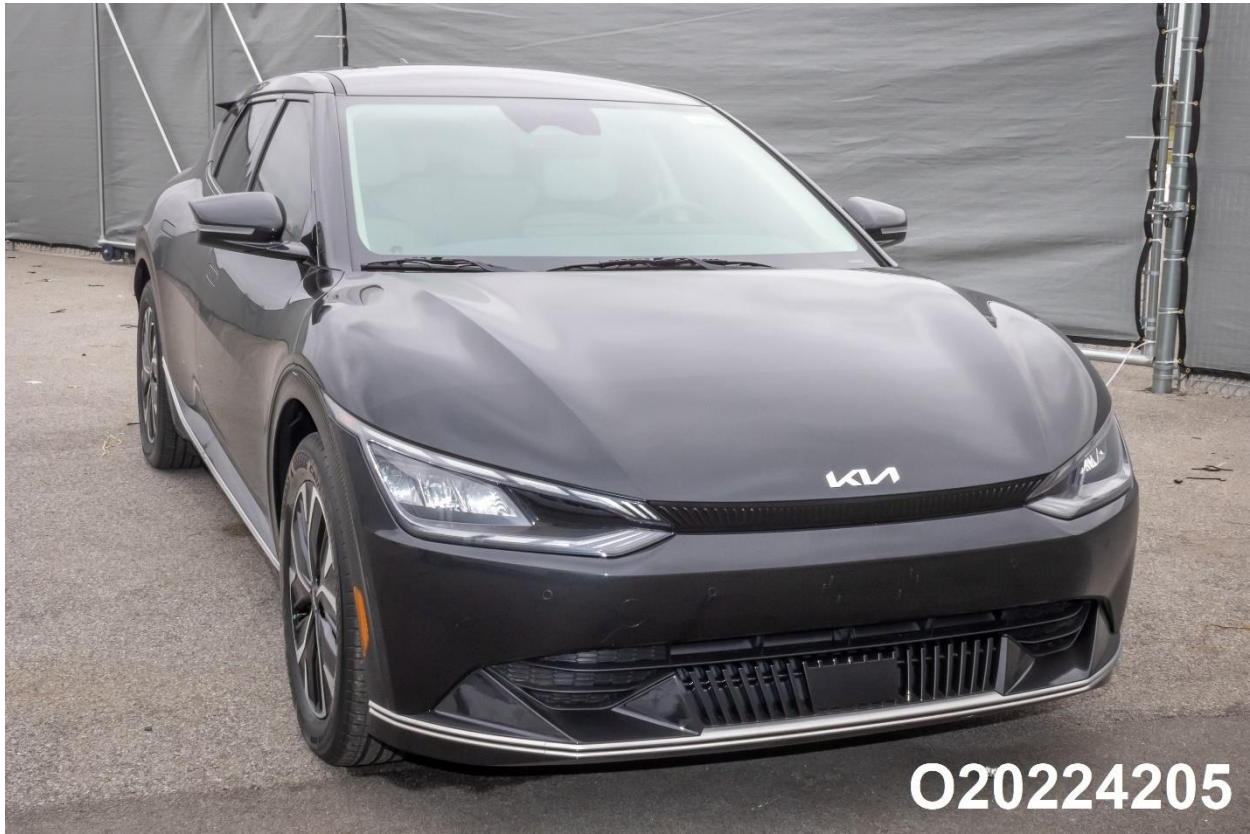
**Figure A-1: As-Delivered Right Front 3/4 View of Test Vehicle**

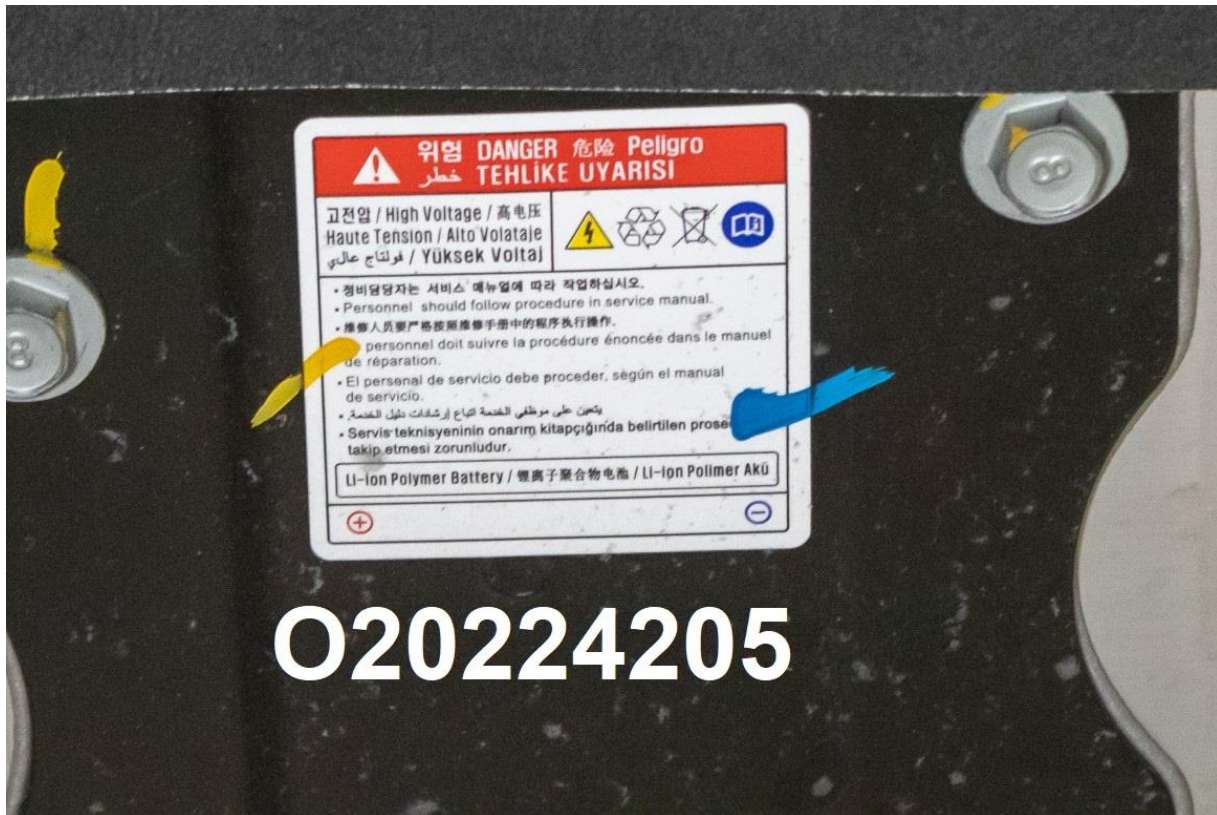
**Figure A-104: Left Rear Passenger Head Restraint Use and Adjustment Information from Vehicle Owner's Manual-Rear Restraints Not Adjustable**

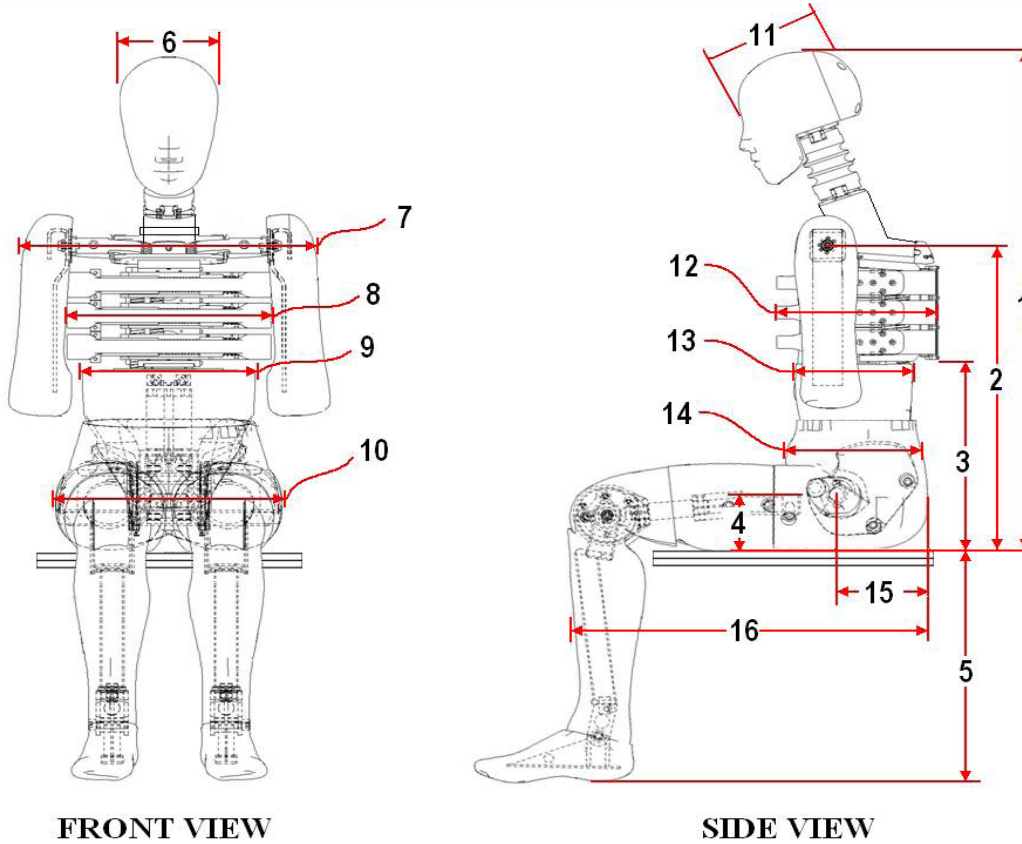
Dim. No.	Description	Specification (mm)		Result (mm)	Pass/Fail
1	Sitting Height	900	918	908	Pass
2	Seat to Shoulder Joint	558	572	567	Pass
3	Seat to Lower Face of Thoracic Spine Box	346	356	350	Pass
4	Seat to Hip Joint (center of bolt)	97	103	99	Pass
5	Sole to Seat, Sitting	333	451	420	Pass
6	Head Width	152	158	157	Pass
7	Shoulder/Arm Width	461	479	469	Pass
8	Thorax Width	322	332	329	Pass
9	Abdomen Width	273	287	280	Pass
10	Pelvis Lap Width	359	373	365	Pass
11	Head Depth	196	206	203	Pass
12	Thorax Depth	262	272	268	Pass
13	Abdomen Depth	194	204	200	Pass
14	Pelvis Depth	235	245	240	Pass
15	Back of Buttocks to Hip Joint (center of bolt)	150	160	157	Pass
16	Back of Buttocks to Front Knee	597	615	606	Pass

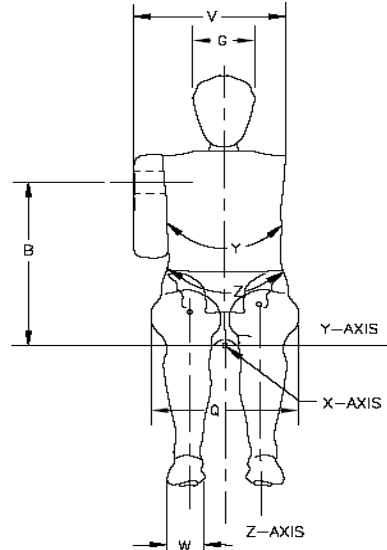
Dummy Serial Number: 300

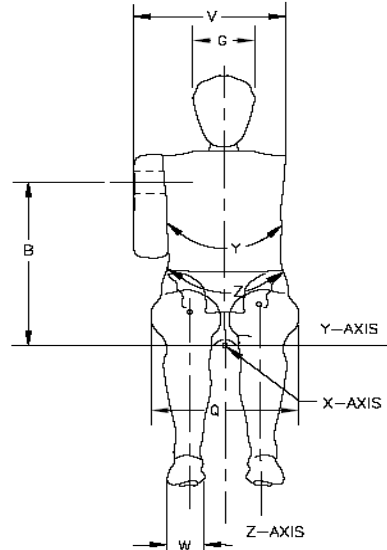
Dummy Serial Number: 300
