REPORT NUMBER: SideNCAPMDB-MGA-23-005

**NEW CAR ASSESSMENT PROGRAM (NCAP)
Moving Deformable Barrier Side Impact Test**

**HONDA DE MEXICO S.A. DE C.V.
2023 Honda HR-V LX 5-Door SUV
NHTSA No.: O20235305**

**MGA RESEARCH CORPORATION
5000 Warren Road
Burlington, WI 53105**

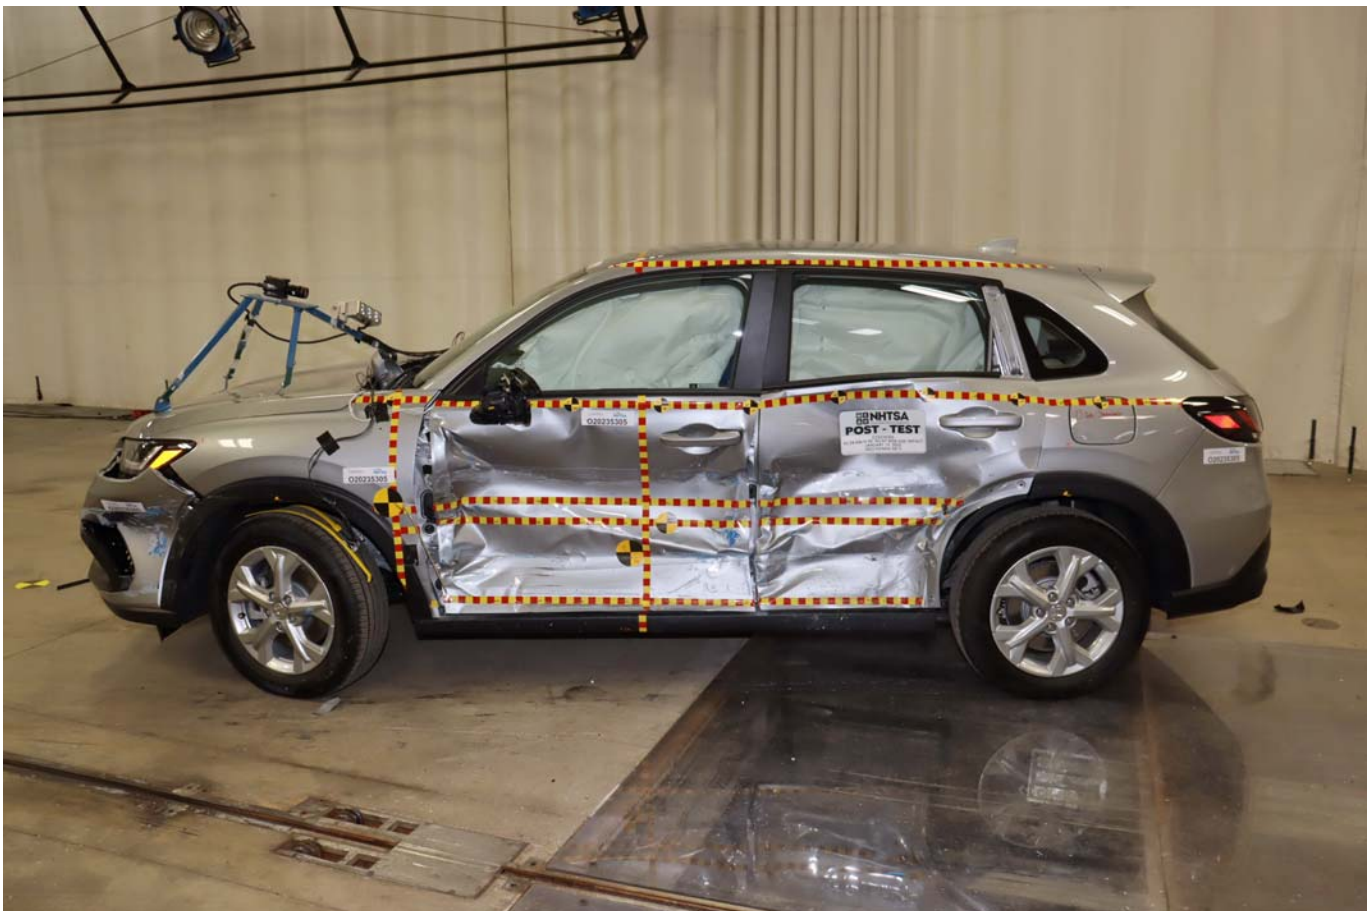
Photo No. 008 - Post-Test Left Side View of Test Vehicle

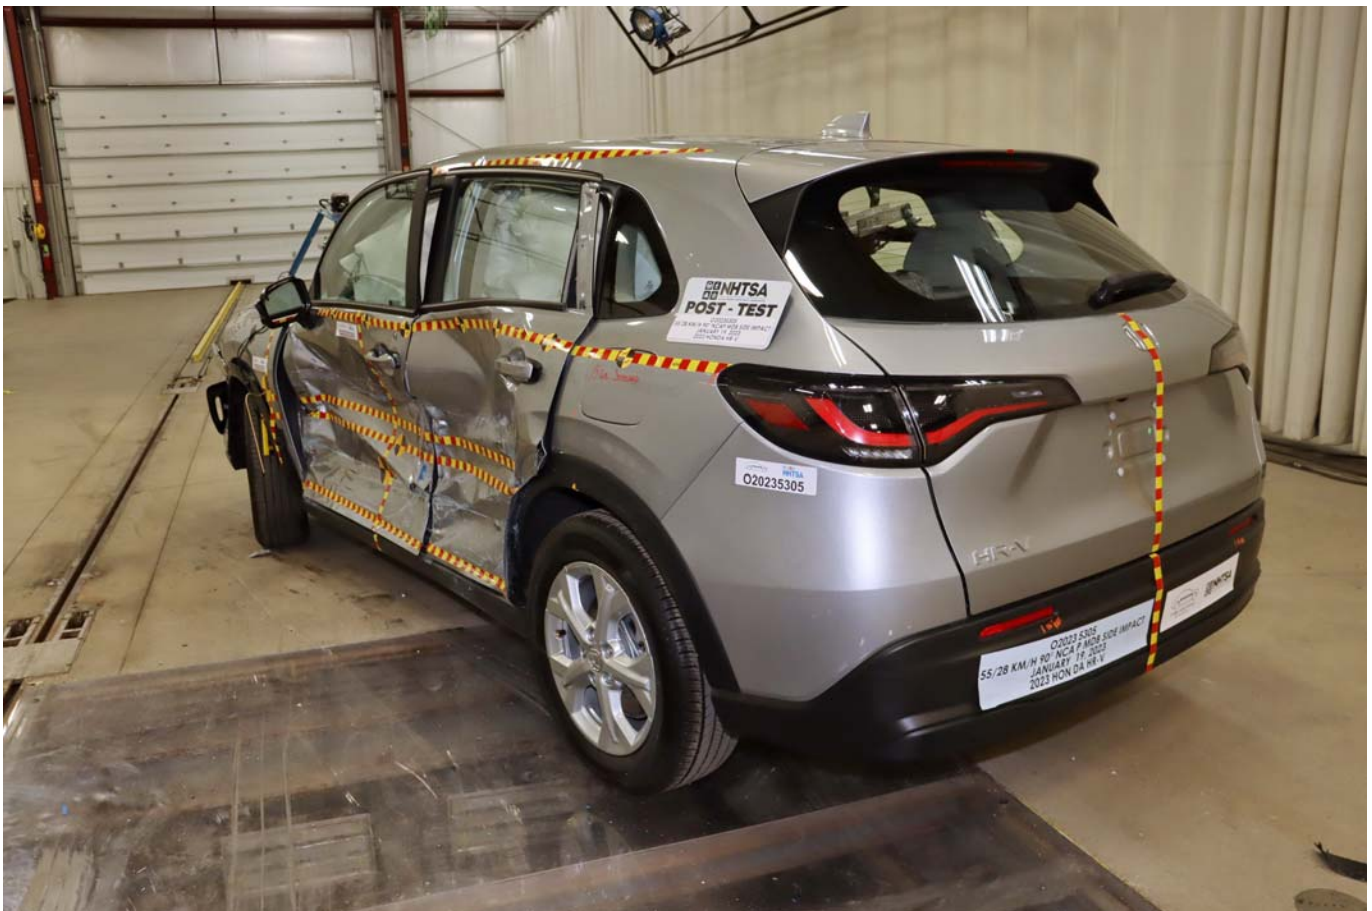
Photo No. 010 - Post-Test Left Three-Quarter Rear View of Test Vehicle

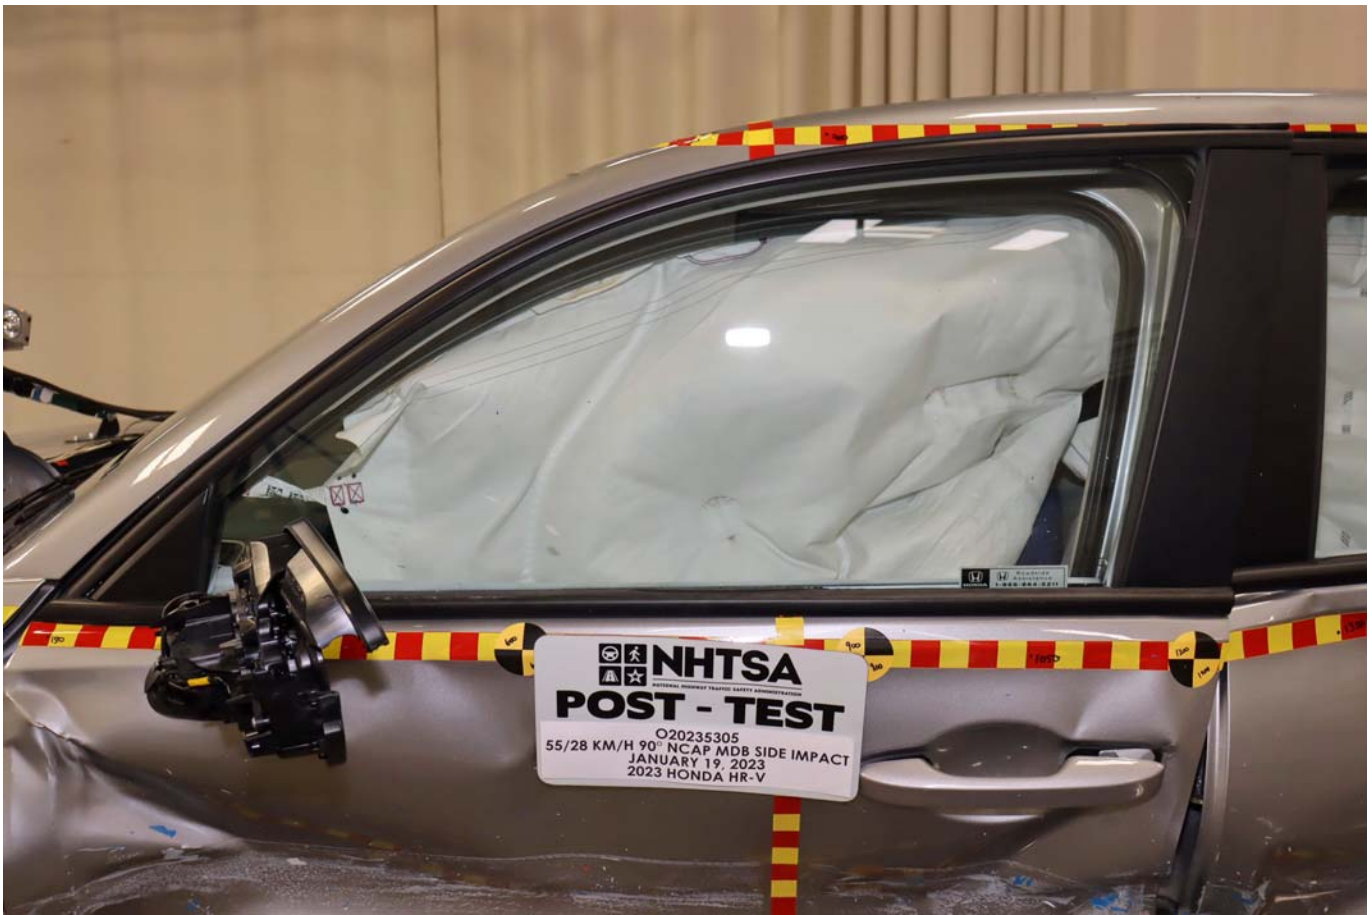
Photo No. 029 - Post-Test Left Side View of Driver Dummy Shoulder and Door Top View

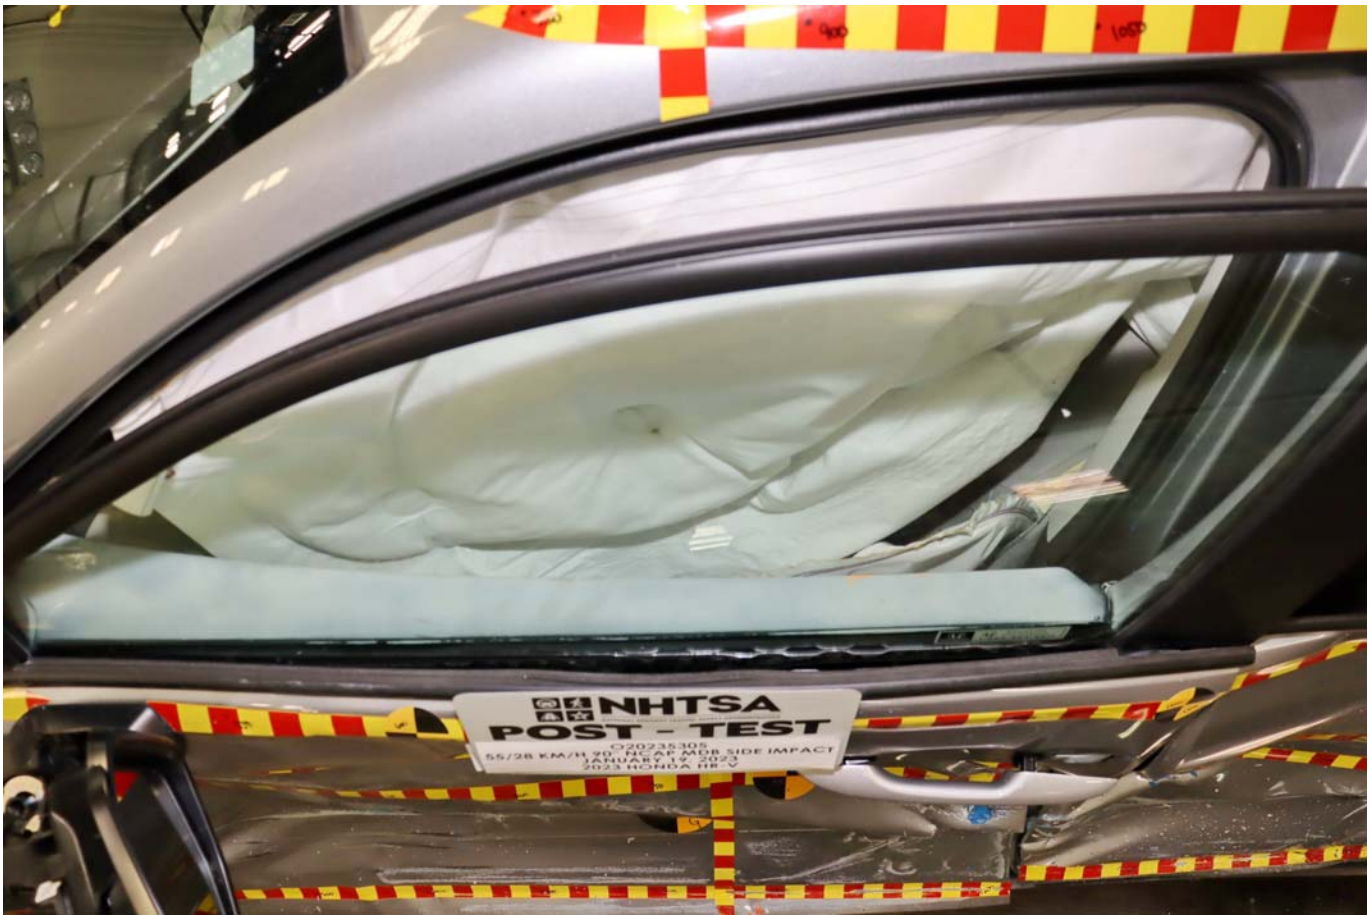
Photo No. 043 - Post-Test Driver Dummy and Door Clearance View

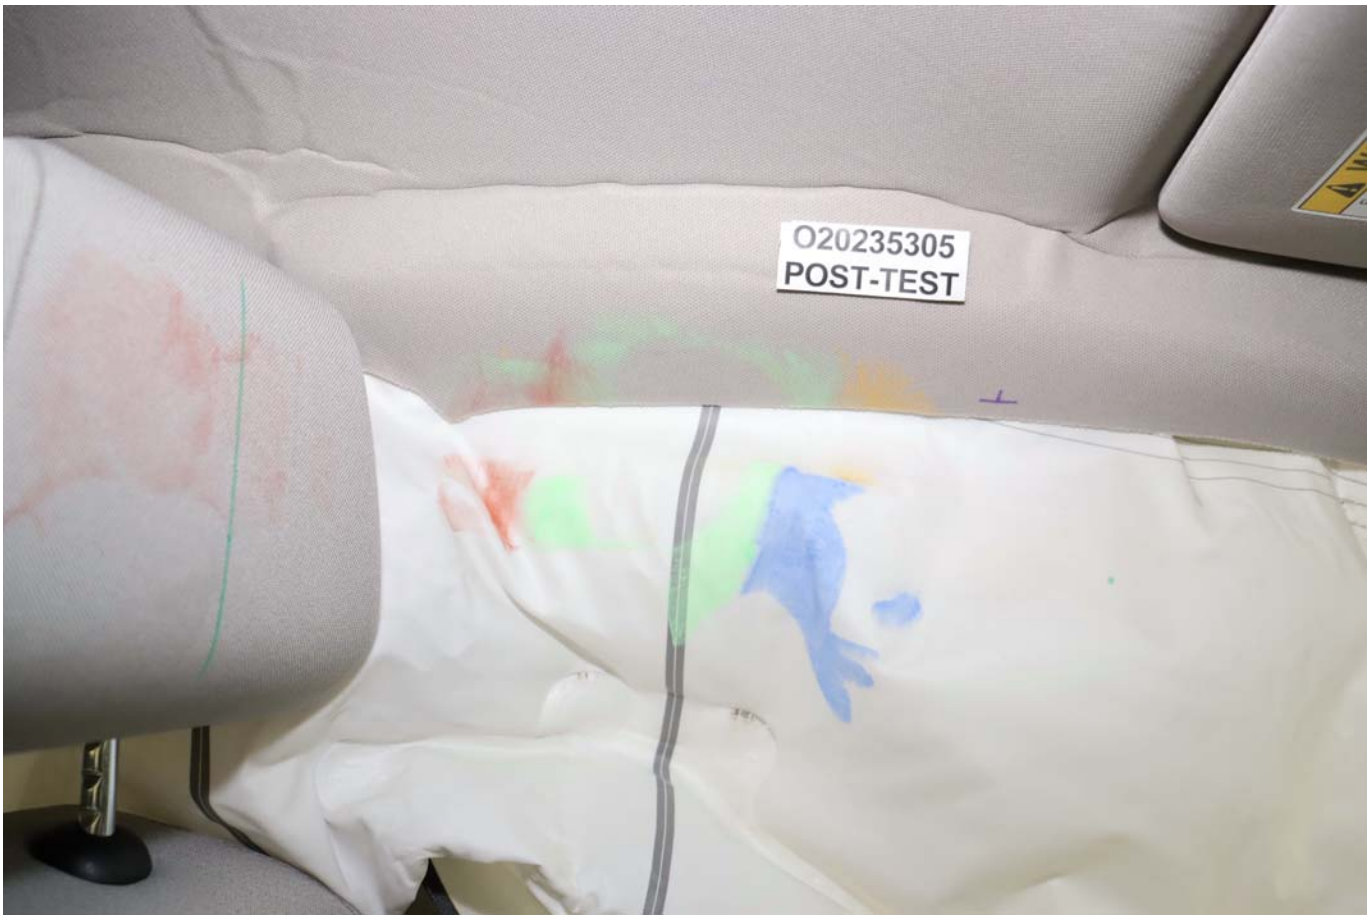
Photo No. 049 - Post-Test Driver Dummy Close-up Head Contact with Side Airbag View

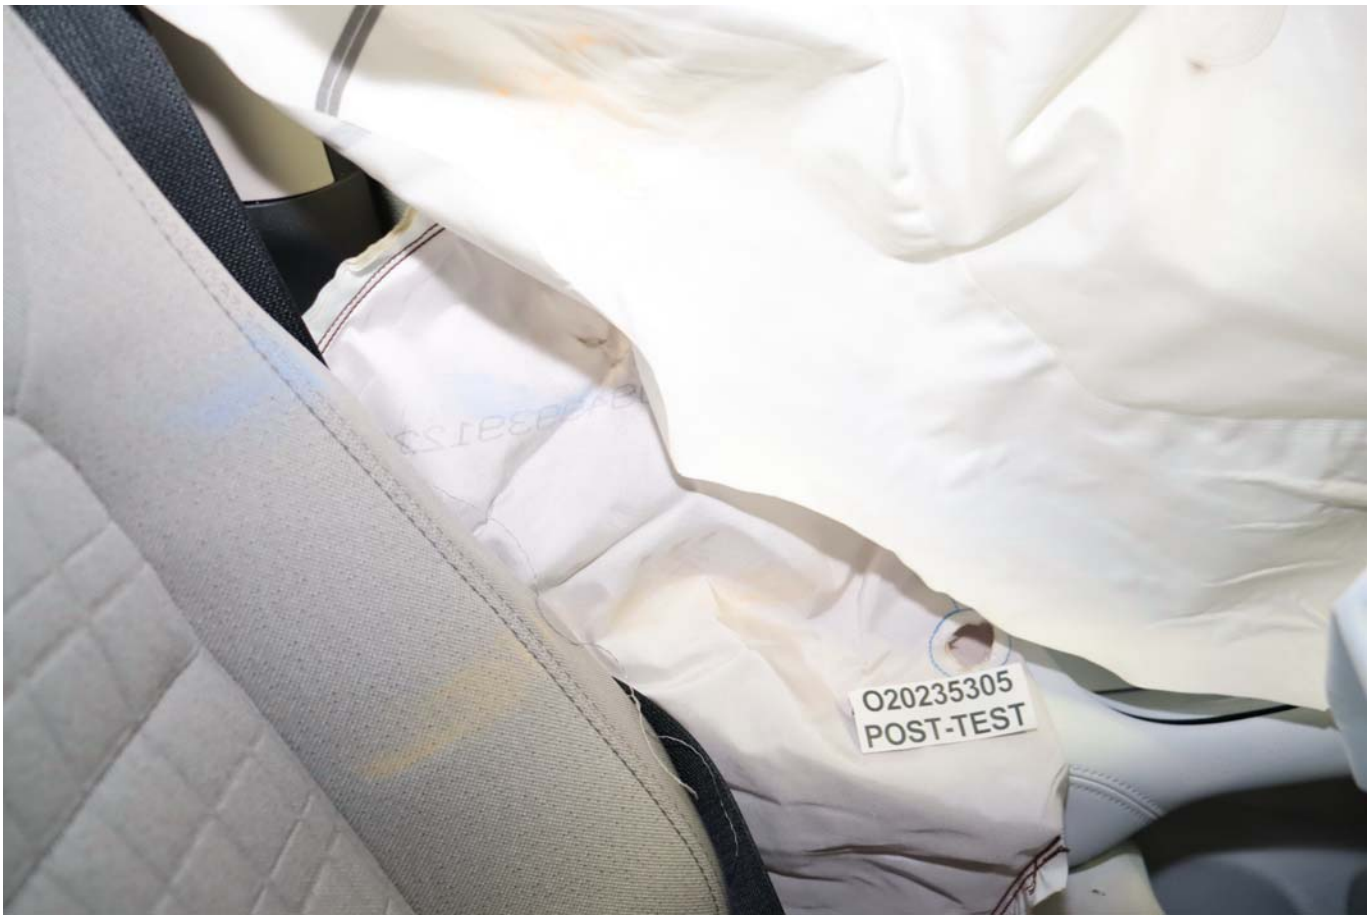
Photo No. 051 - Post-Test Driver Dummy Close-up Torso Contact with Side Airbag View

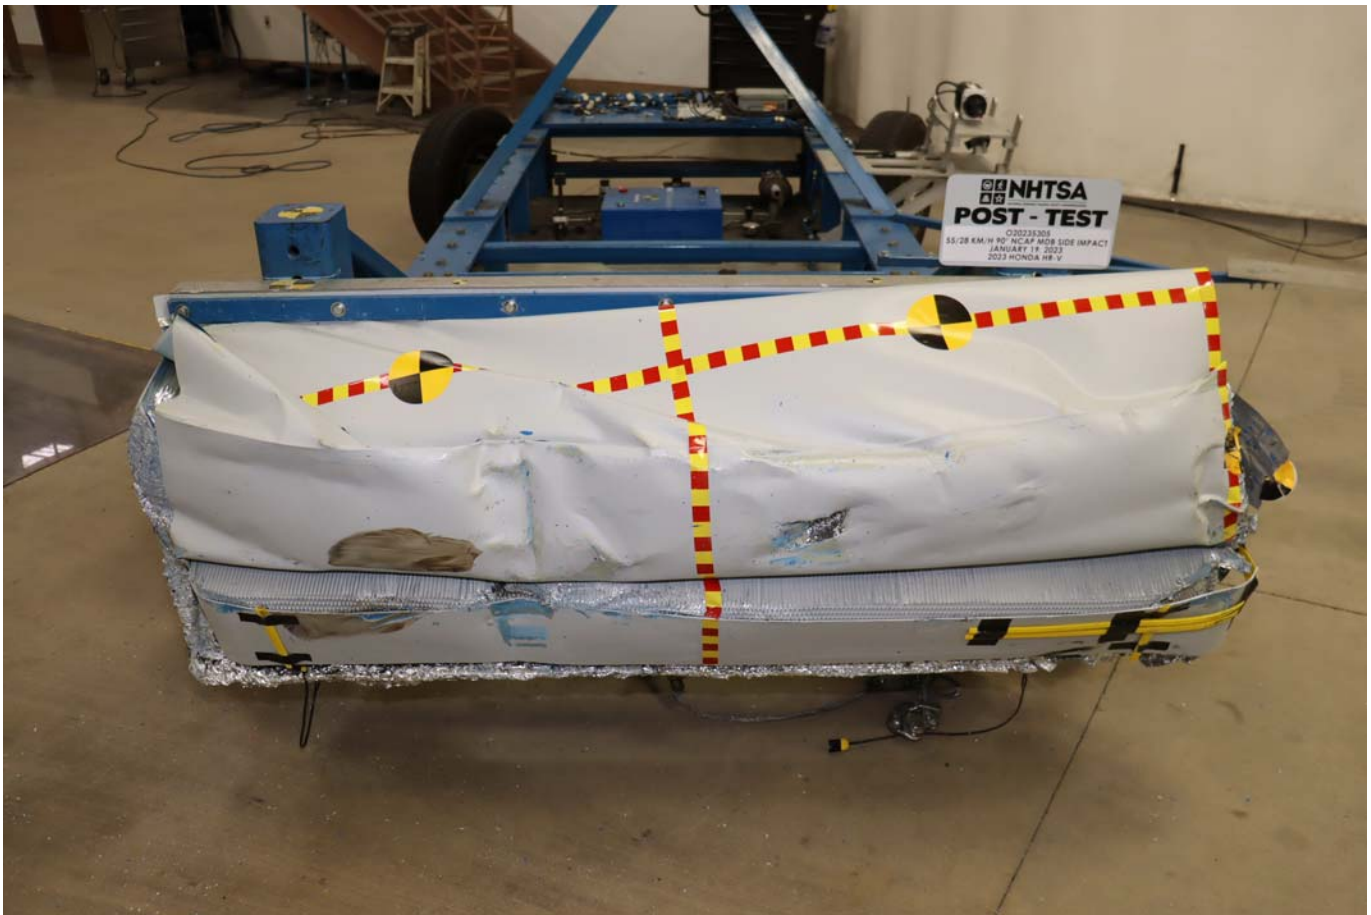
Photo No. 085 - Post-Test Front View of MDB Impactor Face

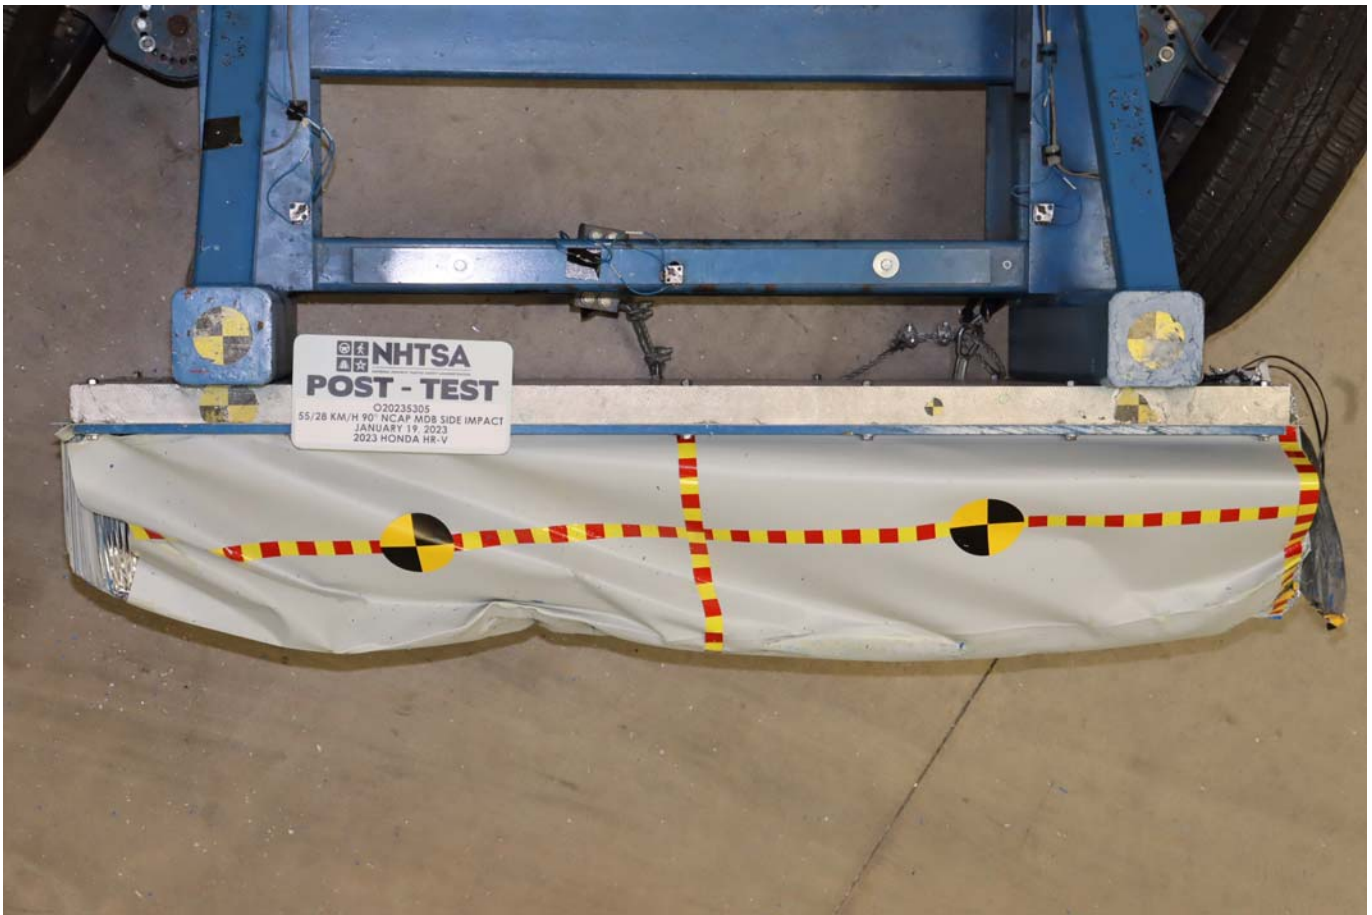
Photo No. 087 - Post-Test Top View of MDB Impactor Face

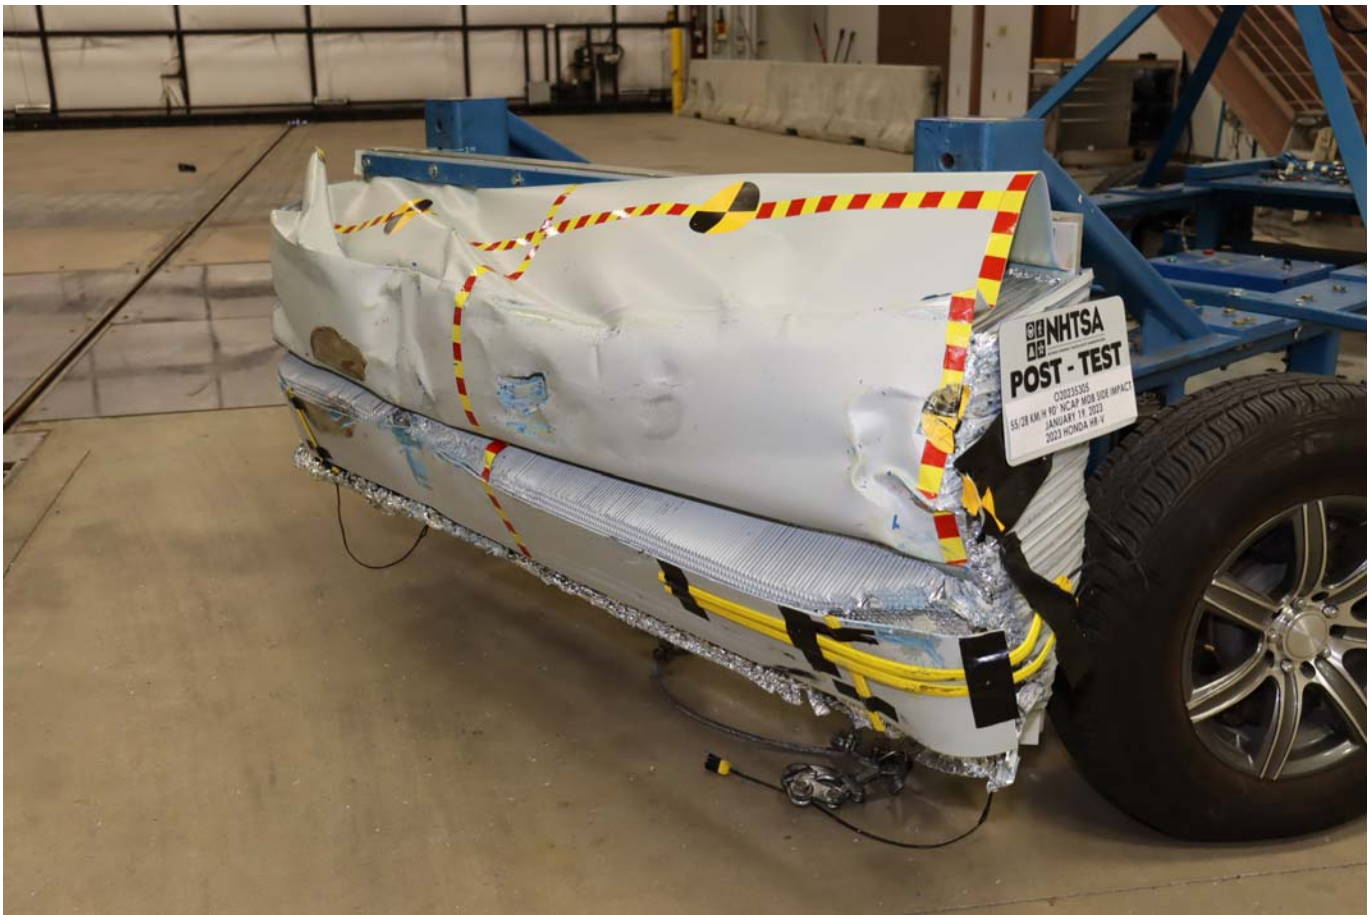
Photo No. 089 - Post-Test Left Side View of MDB Impactor Face

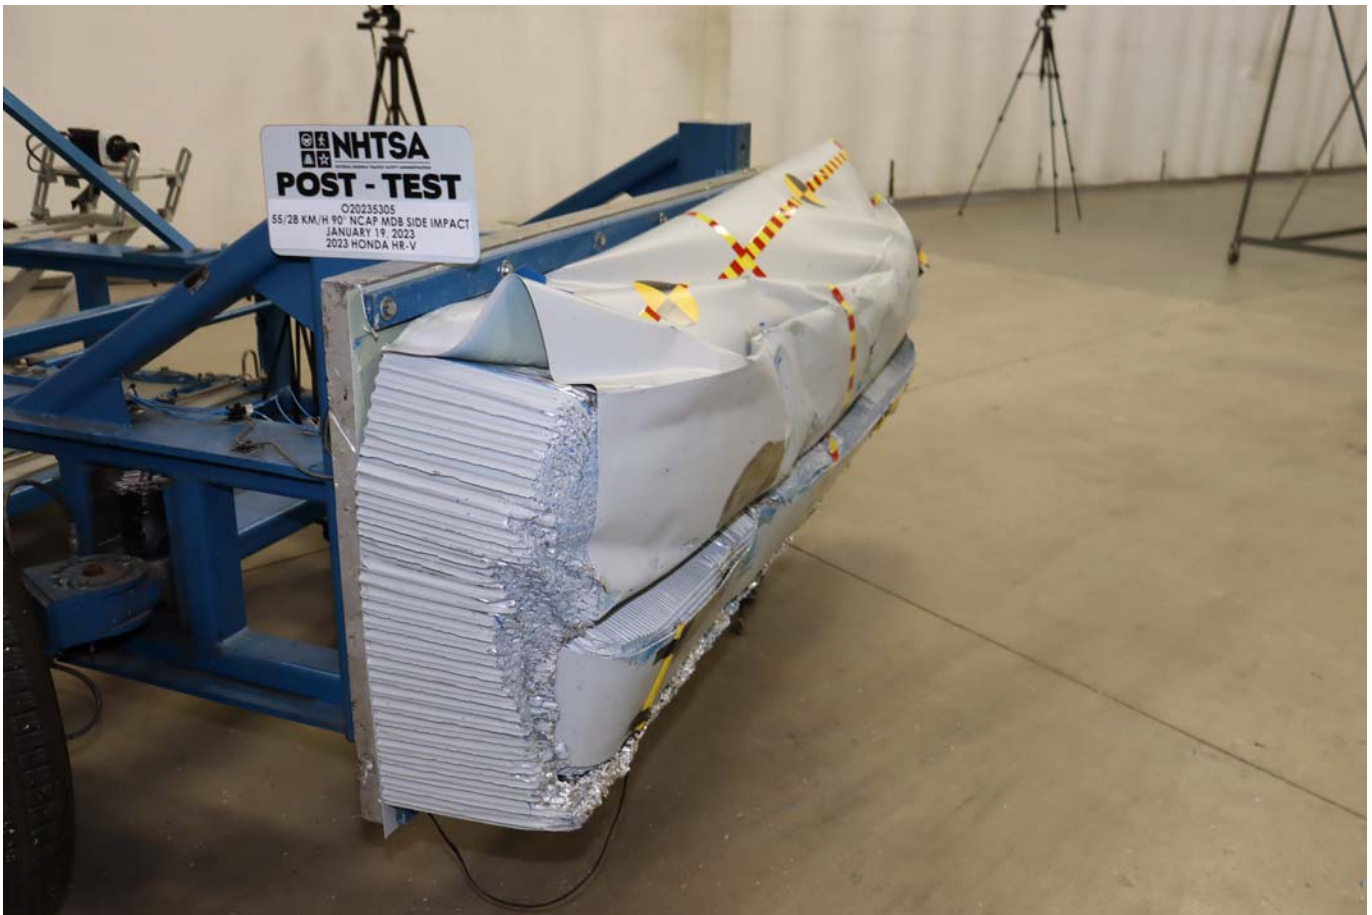
Photo No. 091 - Post-Test Right Side View of MDB Impactor Face

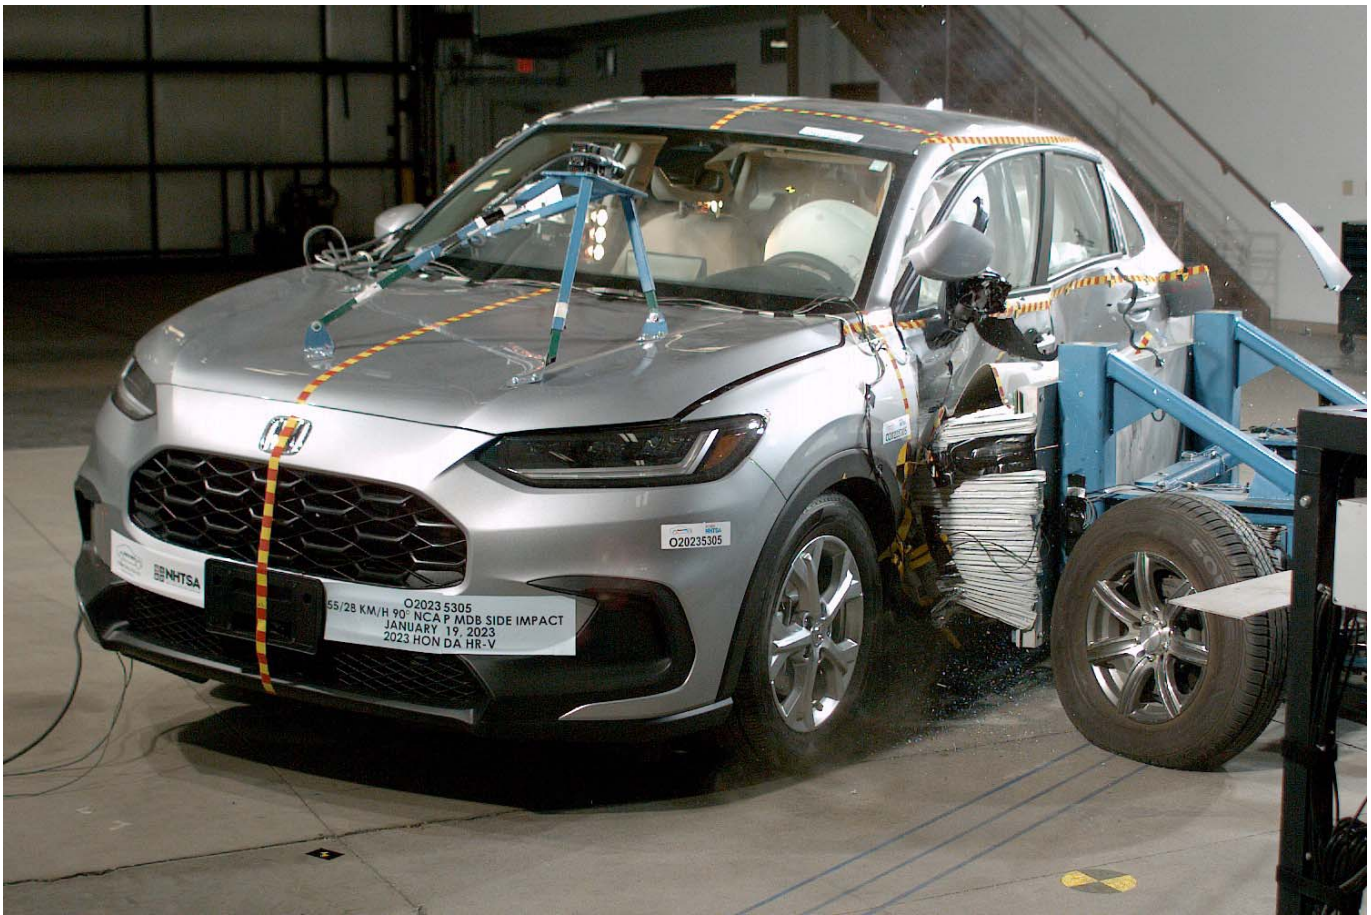
Photo No. 101 - Impact Event
