REPORT NUMBER: SideNCAPMDB-KAR-23-002

**NEW CAR ASSESSMENT PROGRAM (NCAP)
MOVING DEFORMABLE BARRIER SIDE IMPACT TEST**

**FCA US LLC
2023 JEEP GRAND CHEROKEE ALTITUDE 5-DOOR SUV**

NHTSA No: M20230301

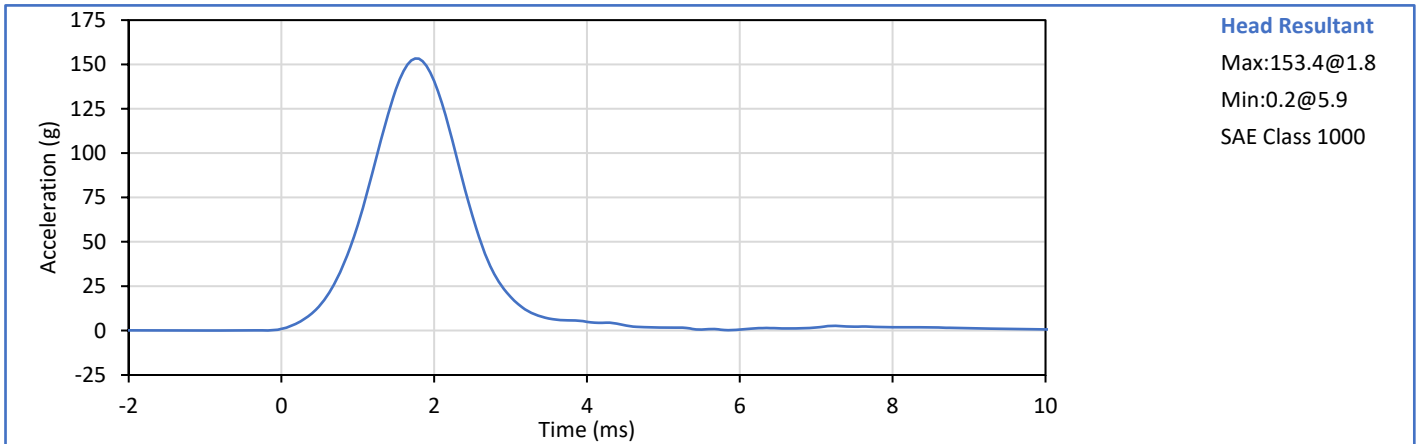
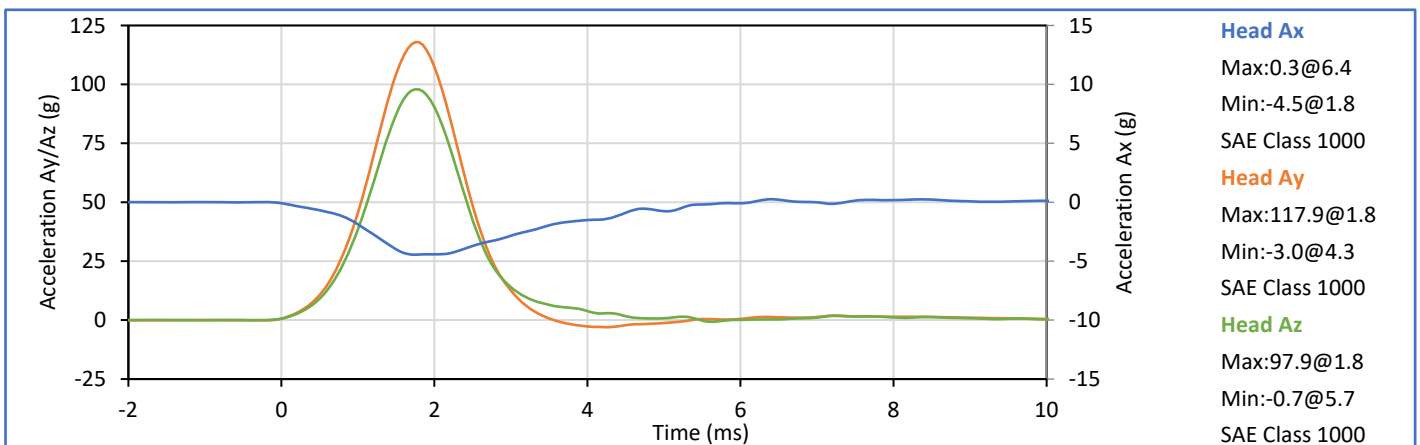
Tested Parameter	Units	Spec. Low	Spec. High	Result	Pass/Fail
Laboratory Temperature	°C	18.9	25.6	21.2	Pass
Laboratory Relative Humidity	%	10	70	30	Pass
Peak Resultant Acceleration	g	125.0	155.0	153.4	Pass
Peak Head Ax	g	-15.0	15.0	0.3	Pass
Oscillations After Main Pulse	%	0.0	15.0	1.7	Pass
Is Acceleration Unimodal?	Yes/No	Yes		Yes	Pass
Overall Test Results					Pass

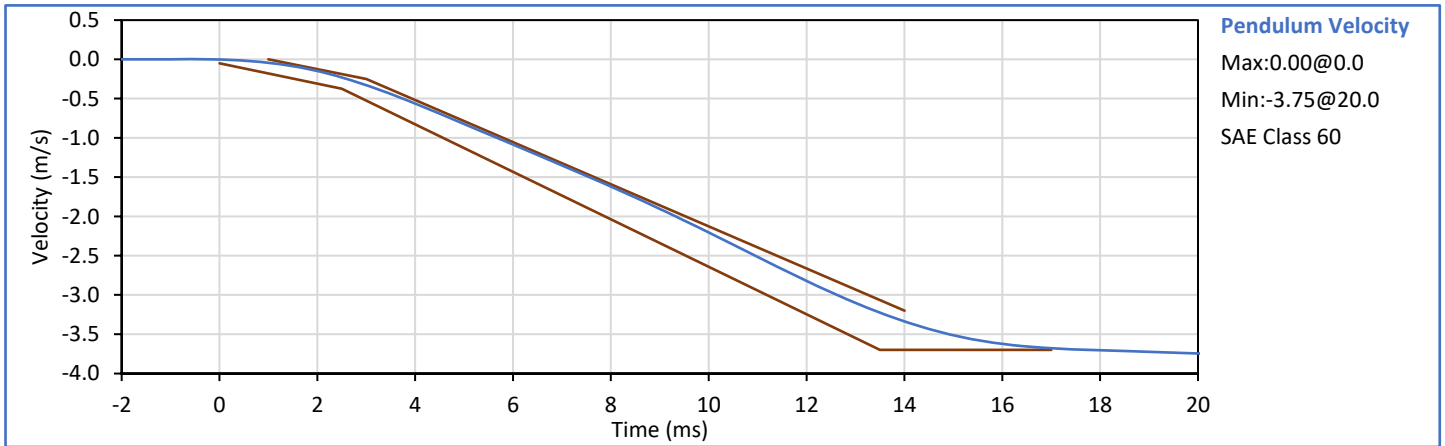
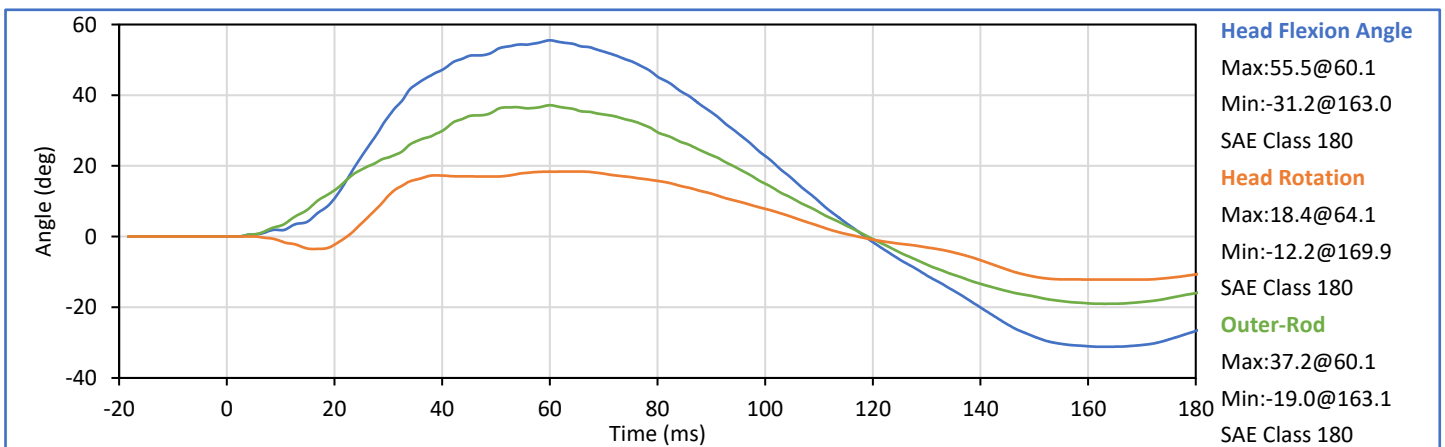
Tested Parameter	Units	Spec. Low	Spec. High	Result	Pass/Fail
Laboratory Temperature	°C	20.6	22.2	21.1	Pass
Laboratory Relative Humidity	%	10	70	29	Pass
Pendulum Velocity	m/s	3.30	3.50	3.50	Pass
Peak Headform Flexion	deg	49.0	59.0	55.5	Pass
Time of Peak Headform Flexion	ms	54.0	66.0	60.1	Pass
Flexion Decay (Peak to zero)	ms	53.0	88.0	58.5	Pass
Overall Test Results					Pass

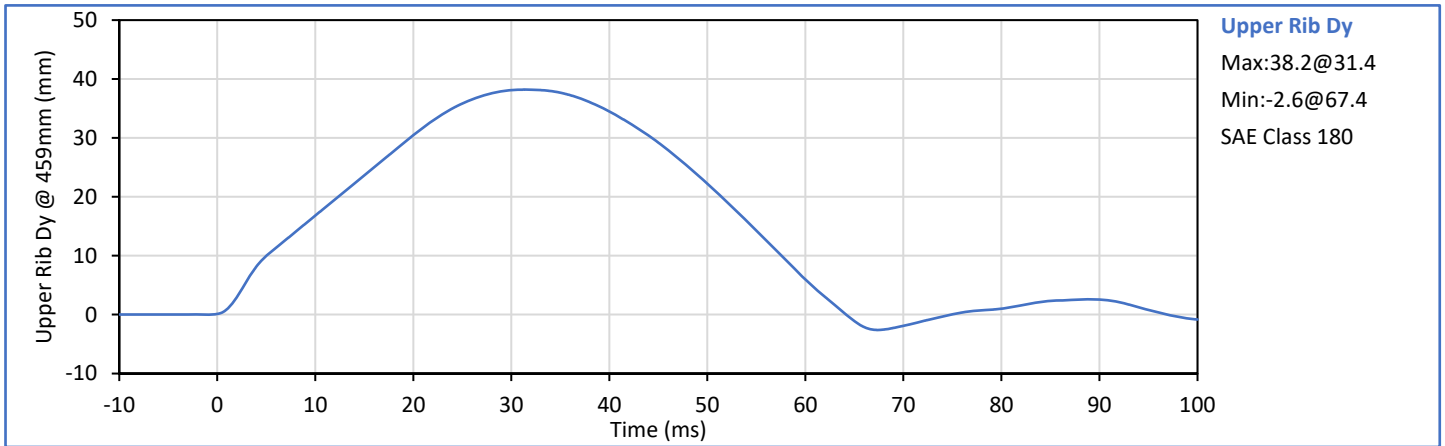
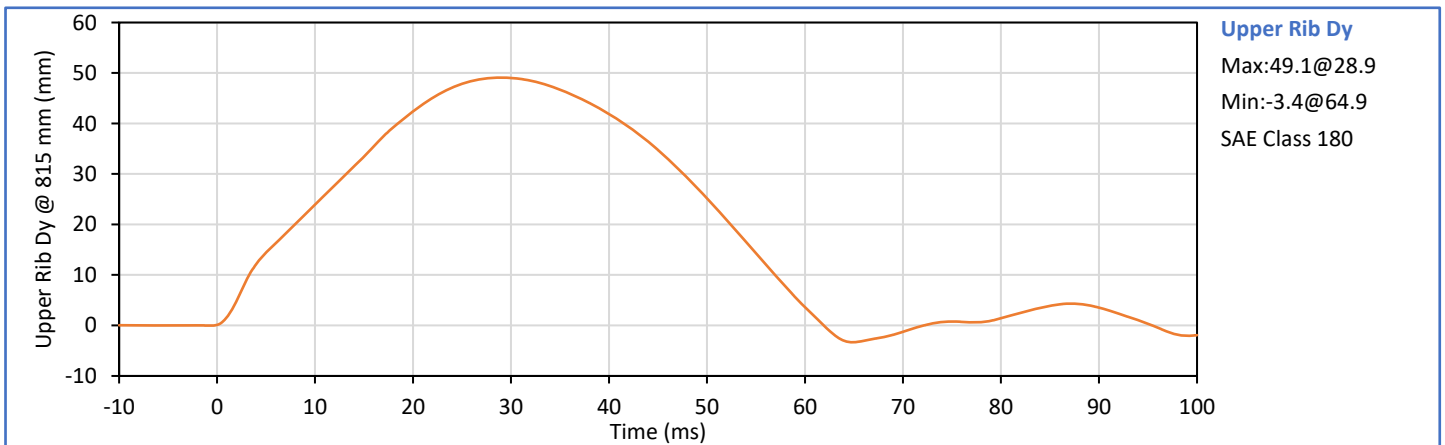
Tested Parameter	Units	Spec. Low	Spec. High	Result	Pass/Fail
Laboratory Temperature	°C	20.6	22.2	21.2	Pass
Laboratory Relative Humidity	%	10	70	30	Pass
Upper Rib Dy @ 459mm	mm	36.0	40.0	38.2	Pass
Upper Rib Dy @ 815mm	mm	46.0	51.0	49.1	Pass
Overall Test Results					Pass

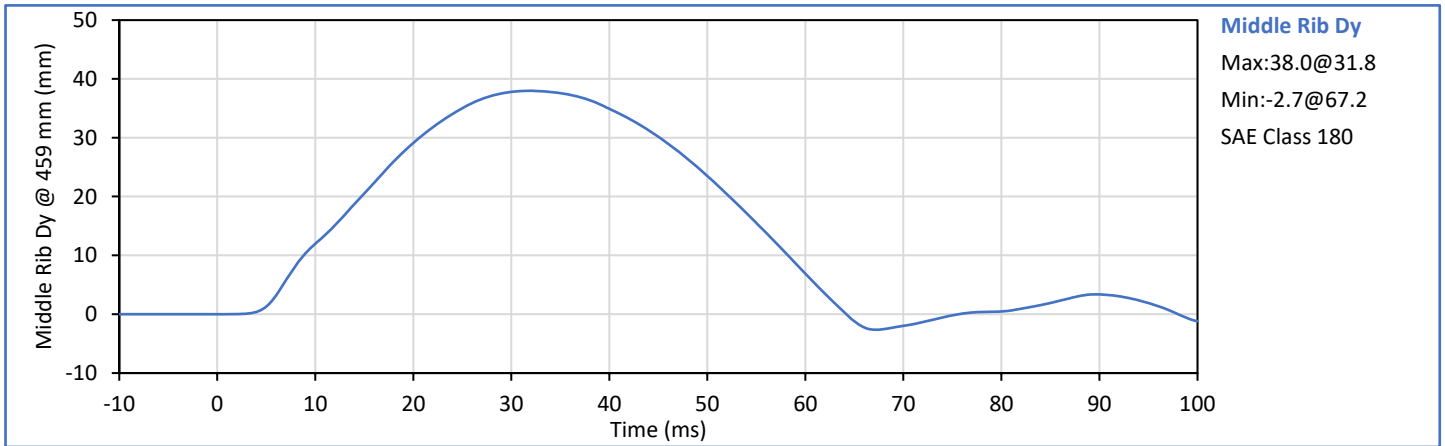
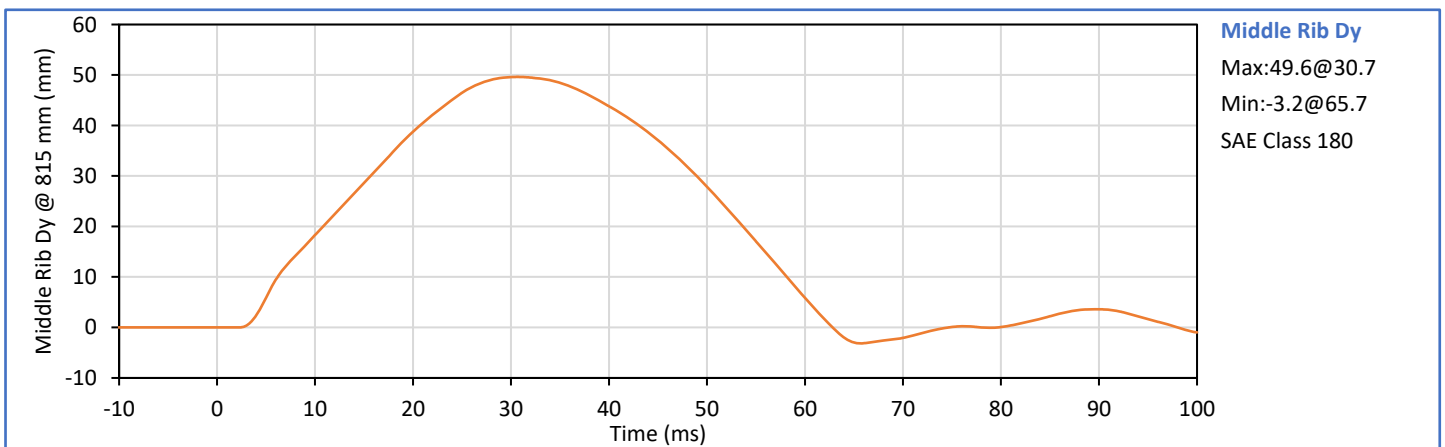
Tested Parameter	Units	Spec. Low	Spec. High	Result	Pass/Fail
Laboratory Temperature	°C	20.6	22.2	21.2	Pass
Laboratory Relative Humidity	%	10	70	31	Pass
Middle Rib Dy @ 459mm	mm	36.0	40.0	38.0	Pass
Middle Rib Dy @ 815mm	mm	46.0	51.0	49.6	Pass
Overall Test Results					Pass

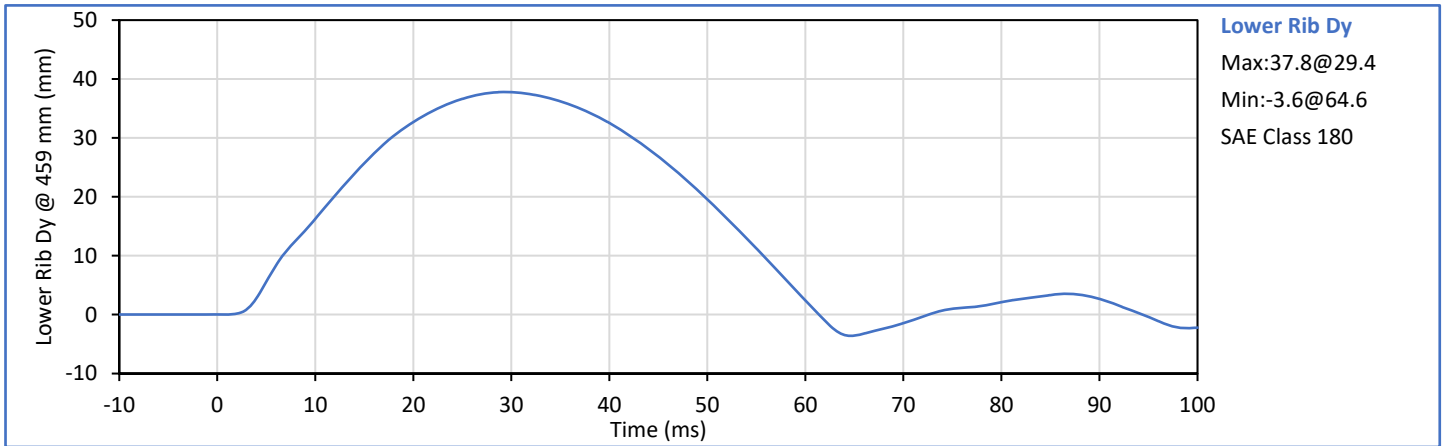
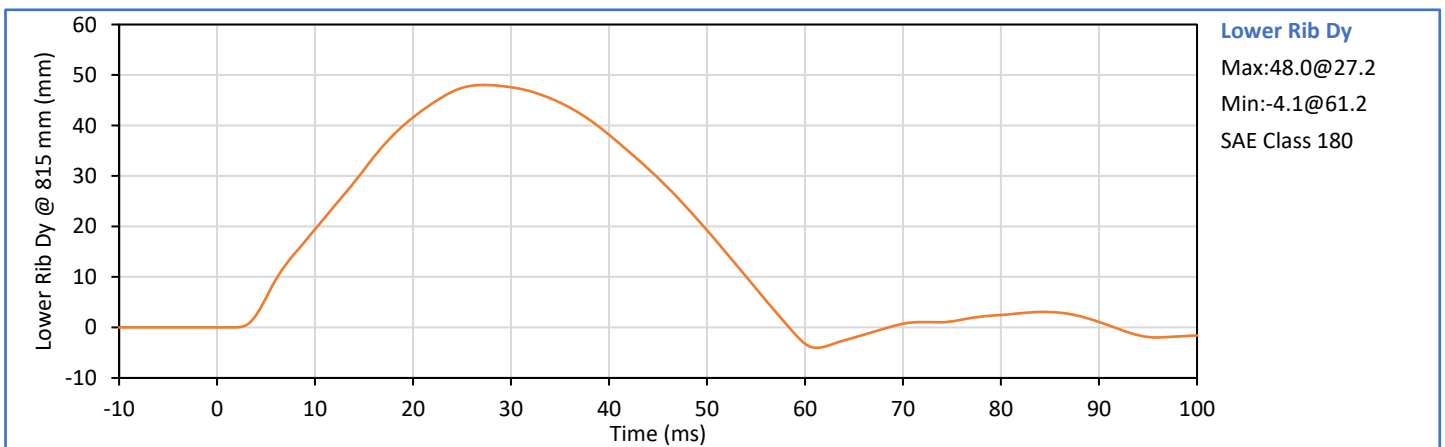
Tested Parameter	Units	Spec. Low	Spec. High	Result	Pass/Fail
Laboratory Temperature	°C	20.6	22.2	21.4	Pass
Laboratory Relative Humidity	%	10	70	30	Pass
Lower Rib Dy @ 459mm	mm	36.0	40.0	37.8	Pass
Lower Rib Dy @ 815mm	mm	46.0	51.0	48.0	Pass
Overall Test Results					Pass
