**REPORT NUMBER: SideNCAPPole-KAR-23-005
NEW CAR ASSESSMENT PROGRAM (NCAP)
SIDE IMPACT POLE TEST**

**HYUNDAI MOTOR MANUFACTURING ALABAMA, LLC
2023 HYUNDAI SANTA CRUZ 4-DOOR TRUCK**

NHTSA No: M20234201

**PREPARED BY:
APPLUS IDIADA KARCO ENGINEERING, LLC.
9270 HOLLY ROAD
ADELANTO, CA 92301**

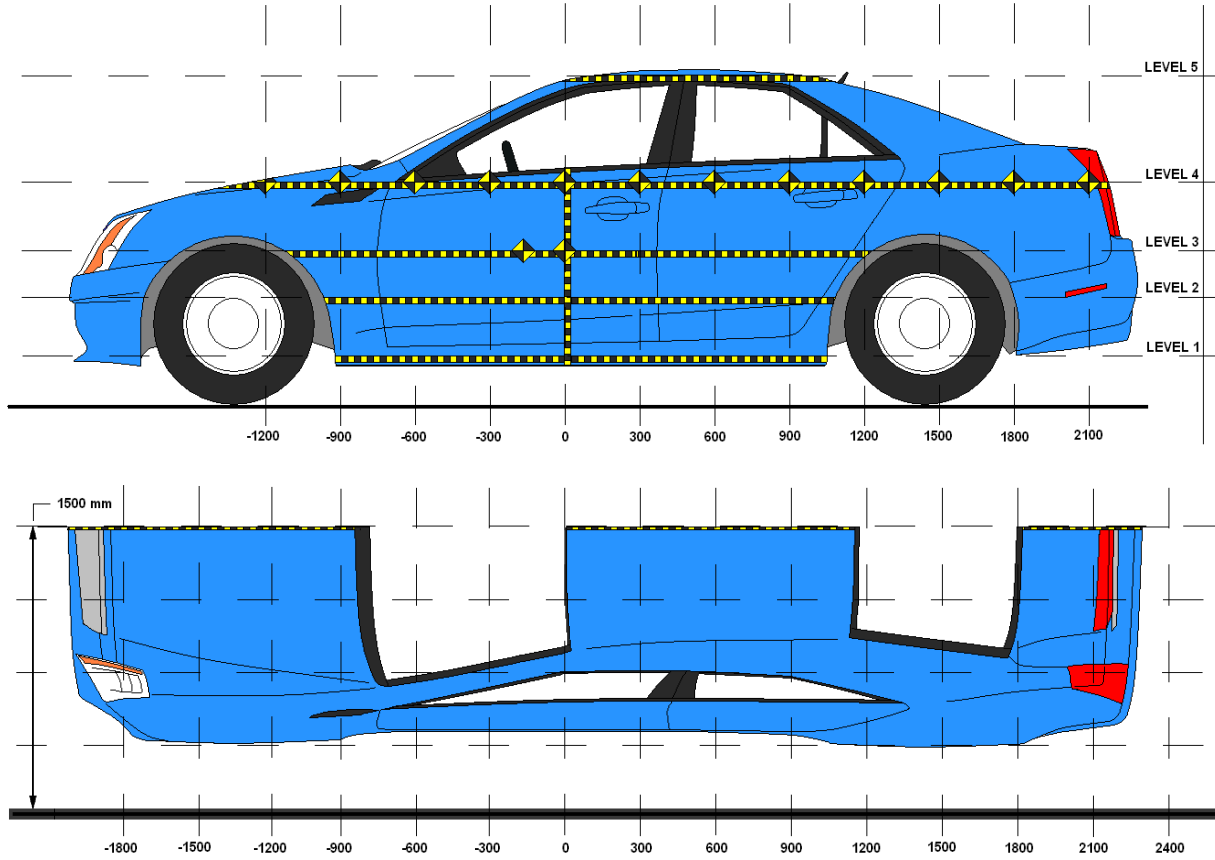
NOTE: All measurements in mm with tolerance of ± 3 mm

MAXIMUM EXTERIOR CRUSH MEASUREMENTS

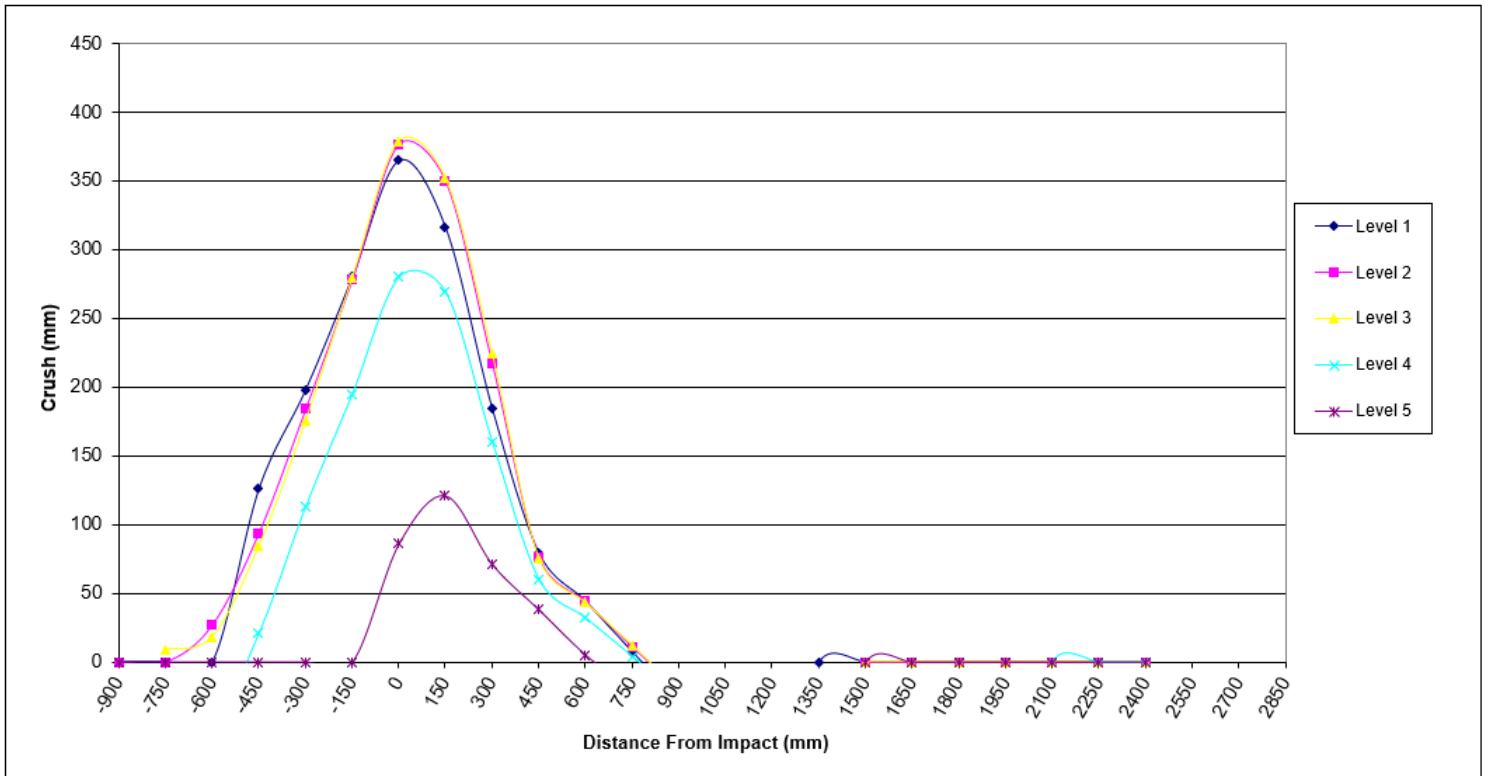
DATA SHEET NO. 11

VEHICLE DAMAGE PROFILE DISTANCES

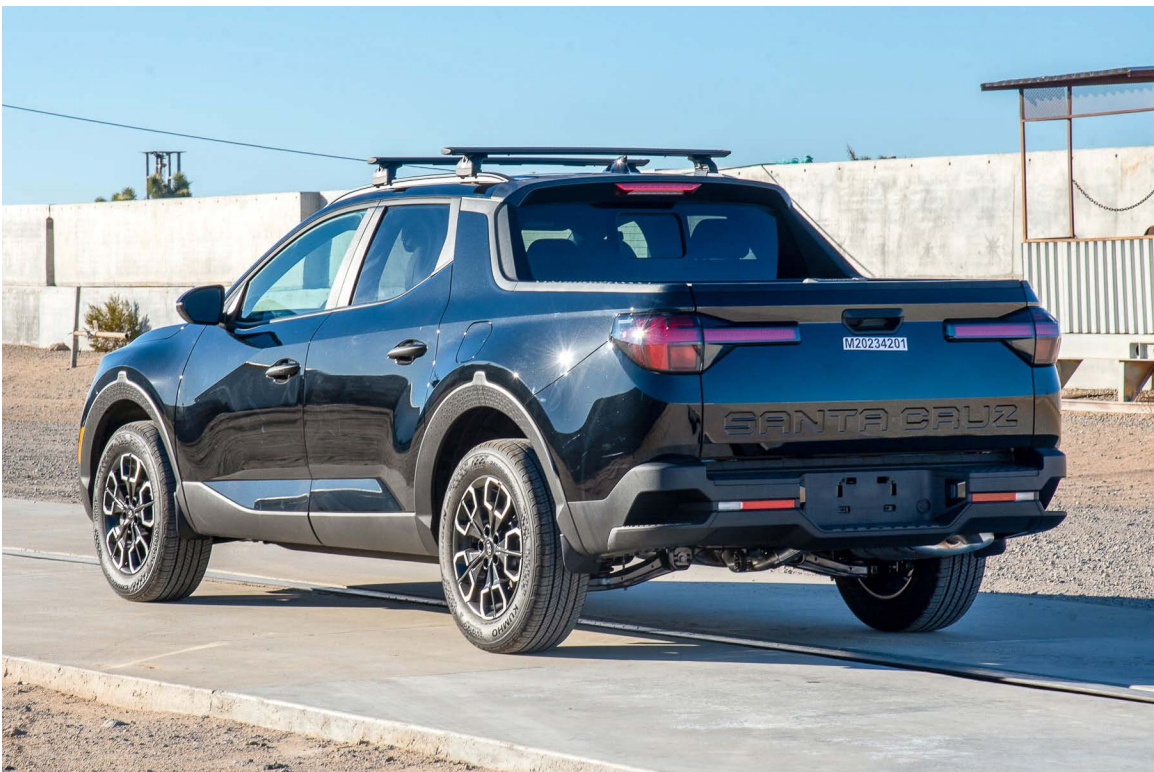
FIGURE 2. As-Delivered Left Rear 3/4 View of Test Vehicle

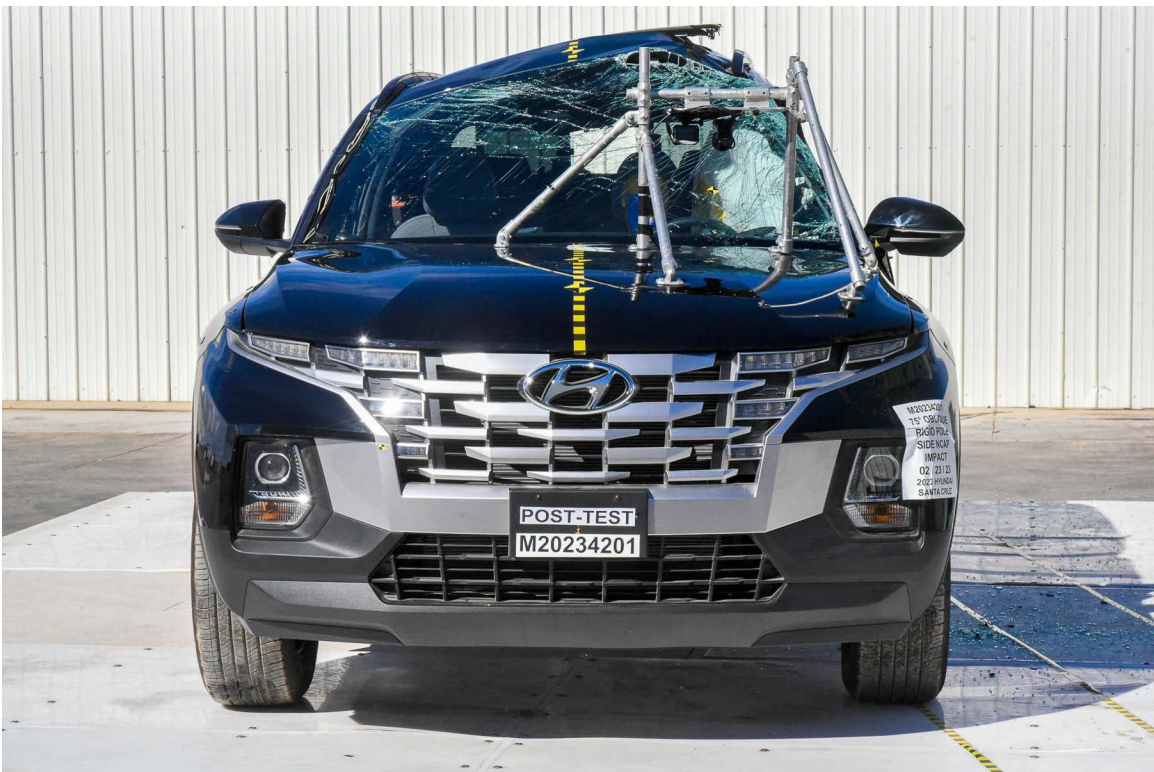
FIGURE 4. Post-Test Frontal View of Test Vehicle

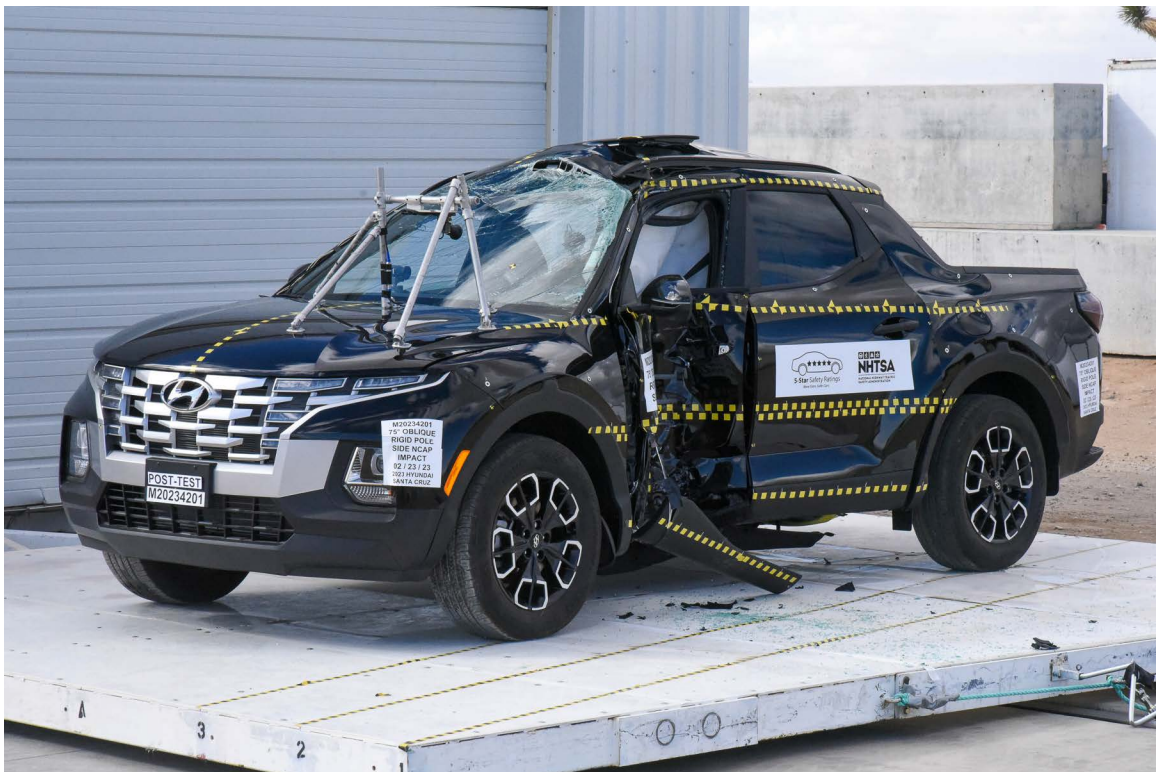
FIGURE 6. Post-Test Left Front 3/4 View of Test Vehicle

Both struck side doors of the vehicle were jammed shut. There was no separation at the hinges or latches. The remaining doors remained closed and latched. There were no ATD values that exceeded limits.

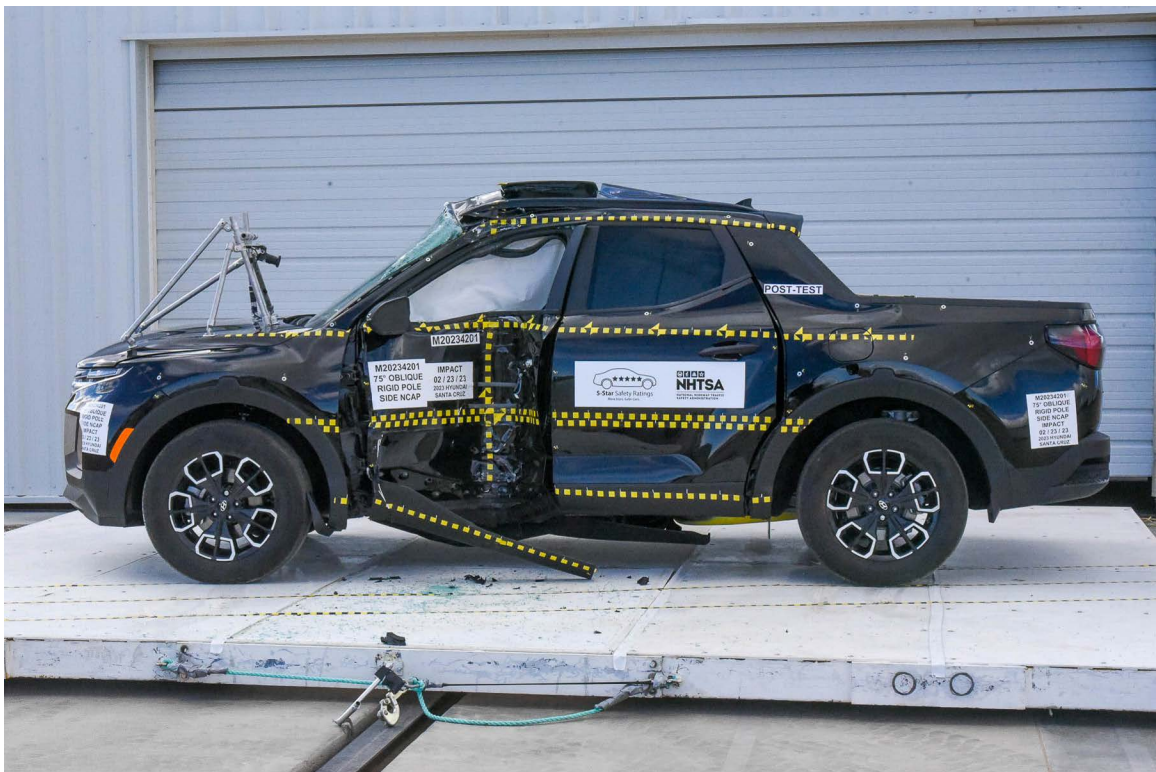
FIGURE 8. Post-Test Left Side View of Test Vehicle

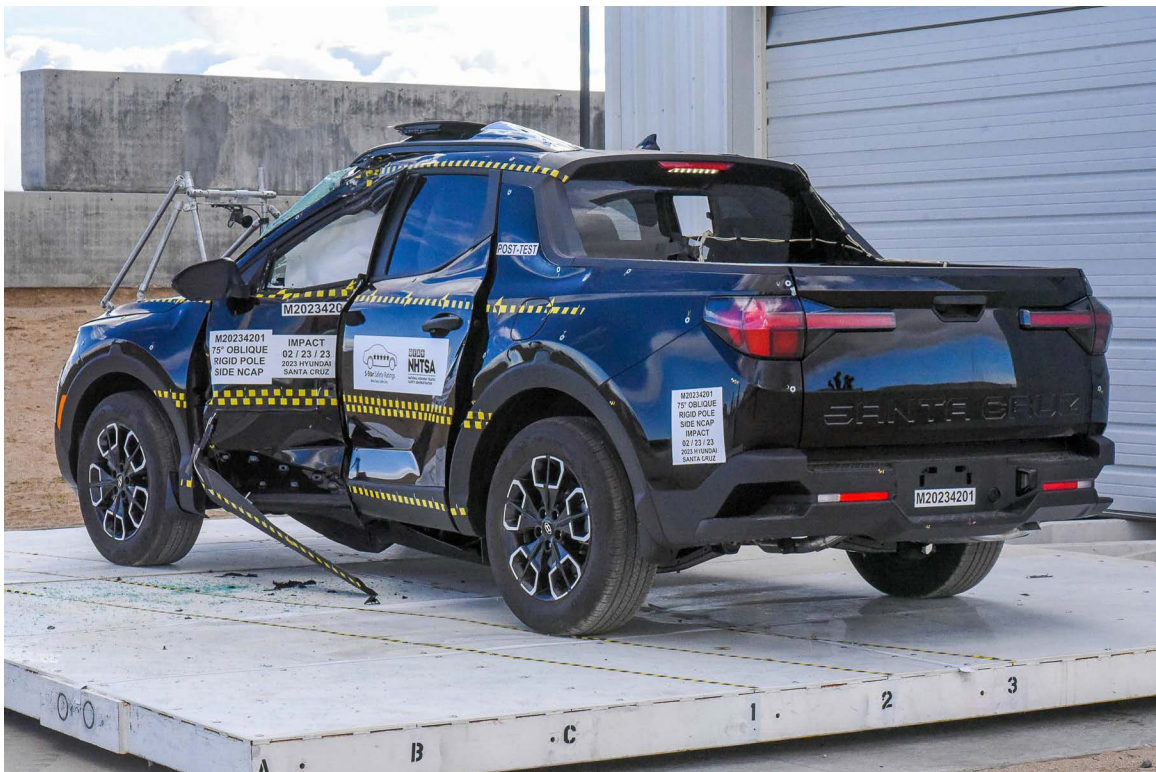
FIGURE 10. Post-Test Left Rear 3/4 View of Test Vehicle

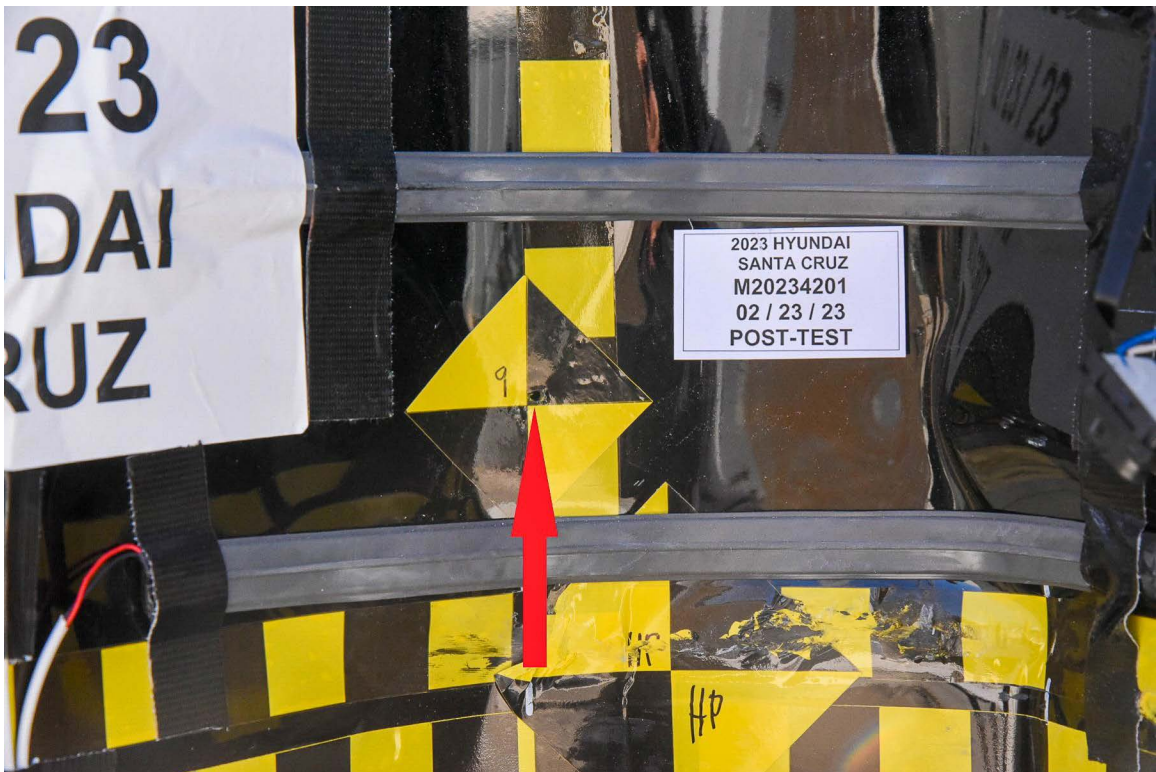
FIGURE 20. Post-Test Close-Up View of Impact Point Target Showing Impact Location

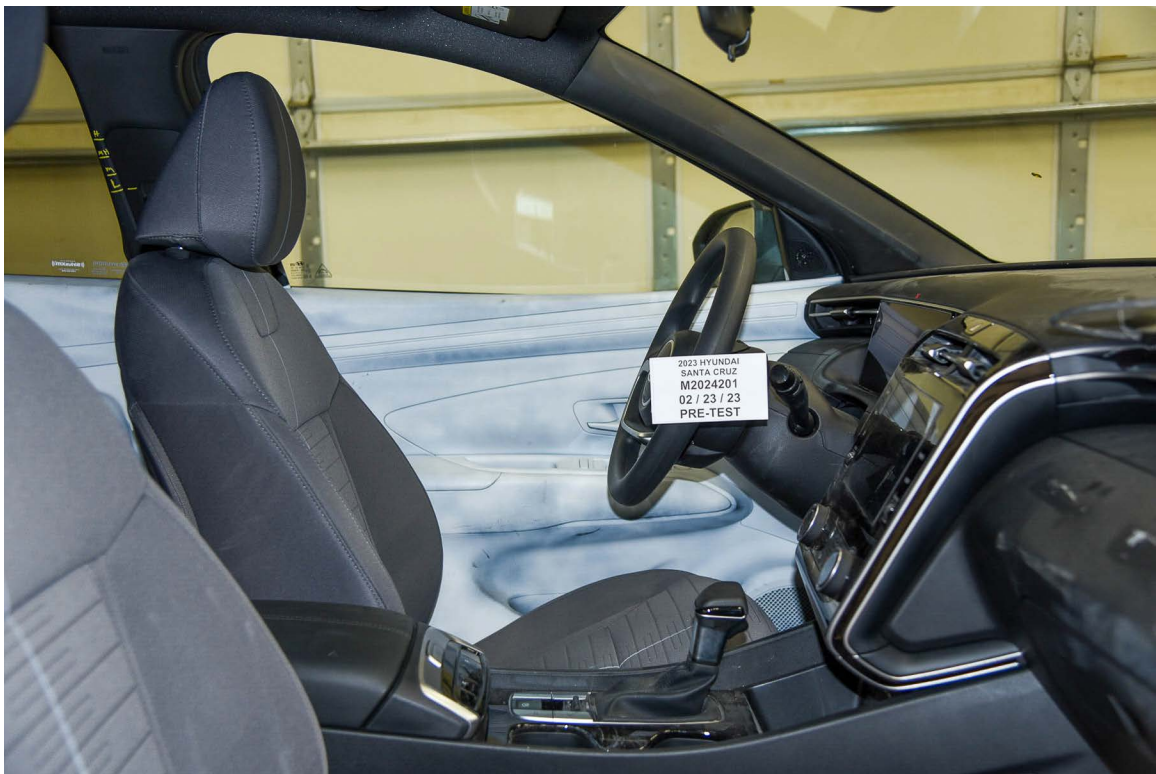
FIGURE 44. Pre-Test Inner Door Panel View
Incorrect Placard. Correct NHTSA No. M20234201

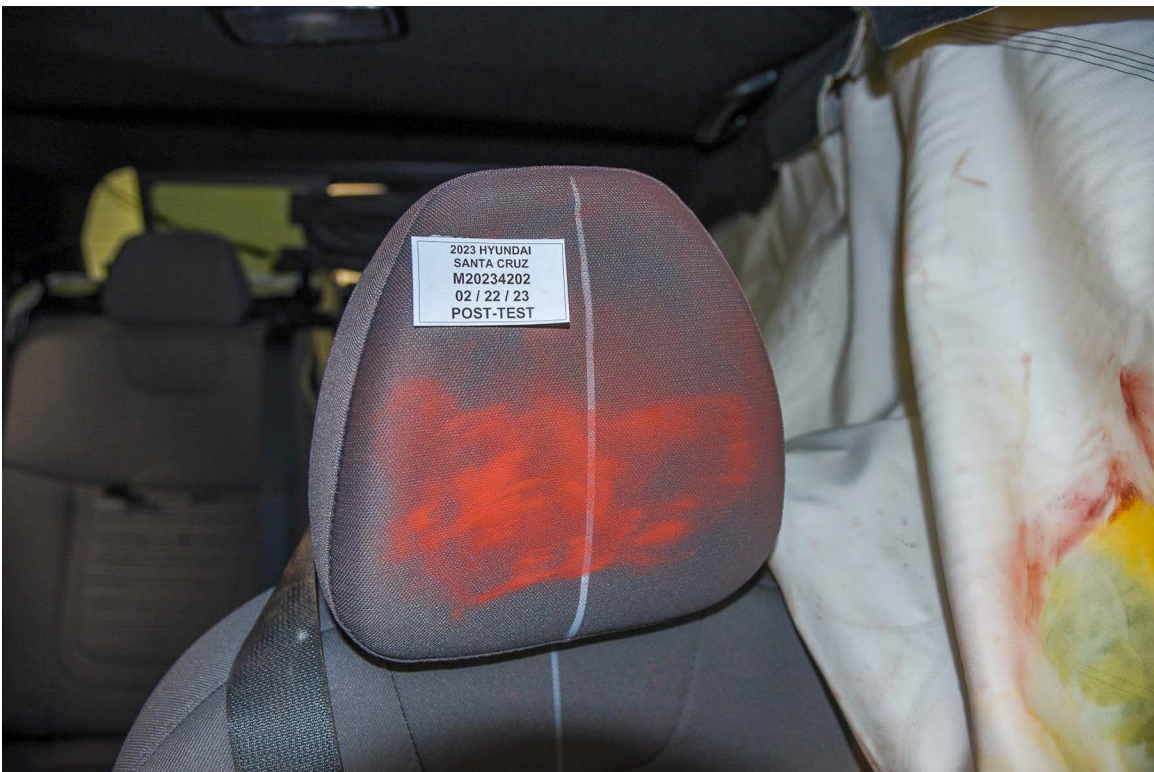
FIGURE 46. Post-Test Dummy Close-Up Head Contact With Vehicle Interior View.
Incorrect Placard. Correct NHTSA No. M20234201 and Test Date 2/23/23

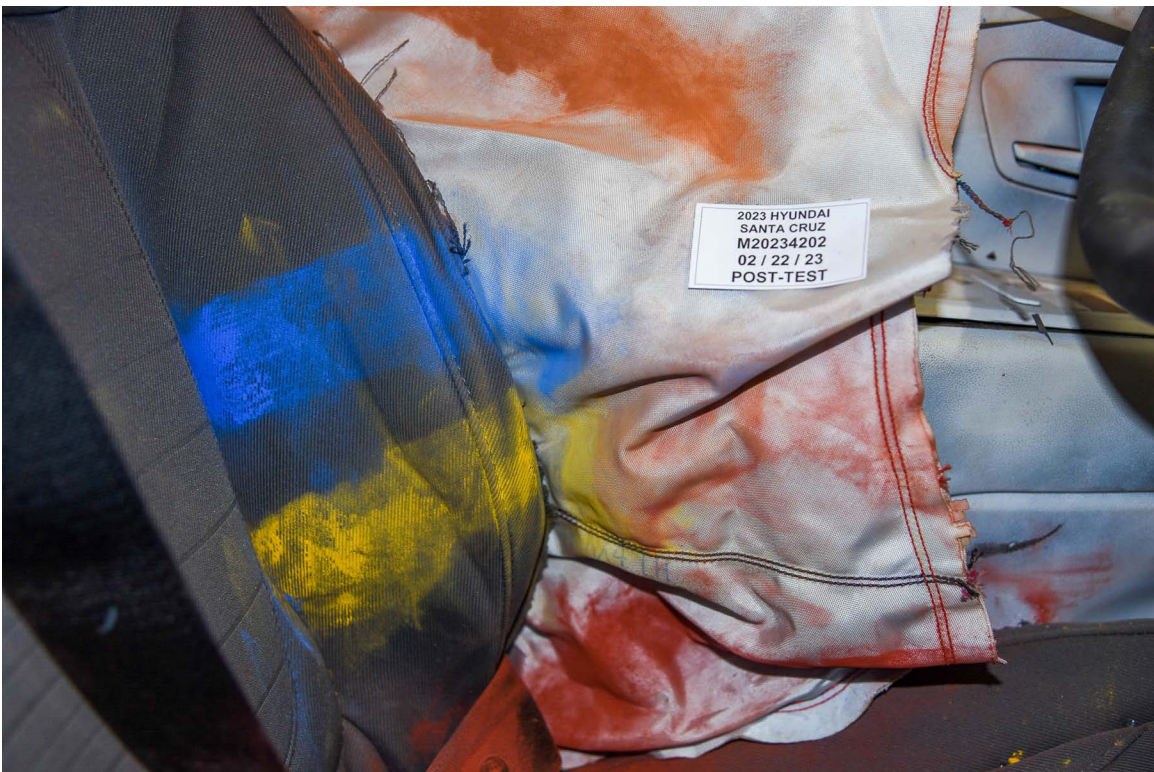
FIGURE 48. Post-Test Dummy Close-Up Torso Contact With Vehicle Interior View.
Incorrect Placard. Correct NHTSA No. M20234201 and Test Date 2/23/23

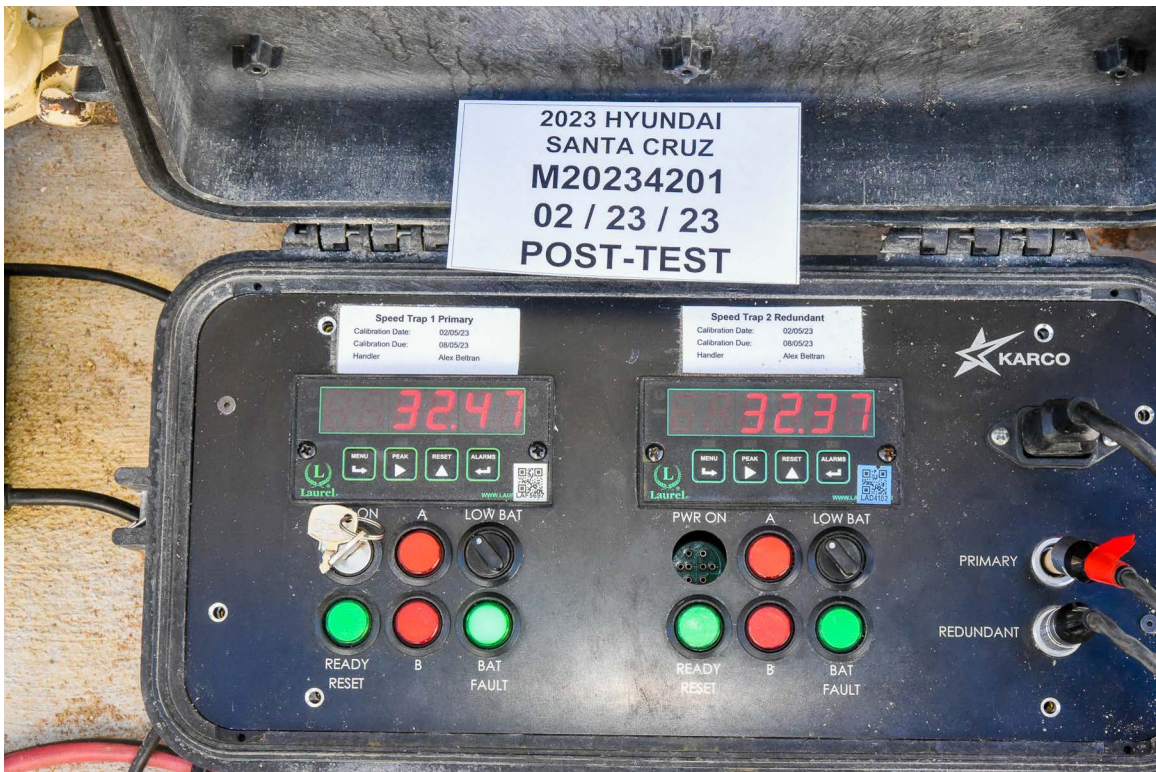
FIGURE 64. Post-Test Primary and Redundant Speed Trap Read-Out

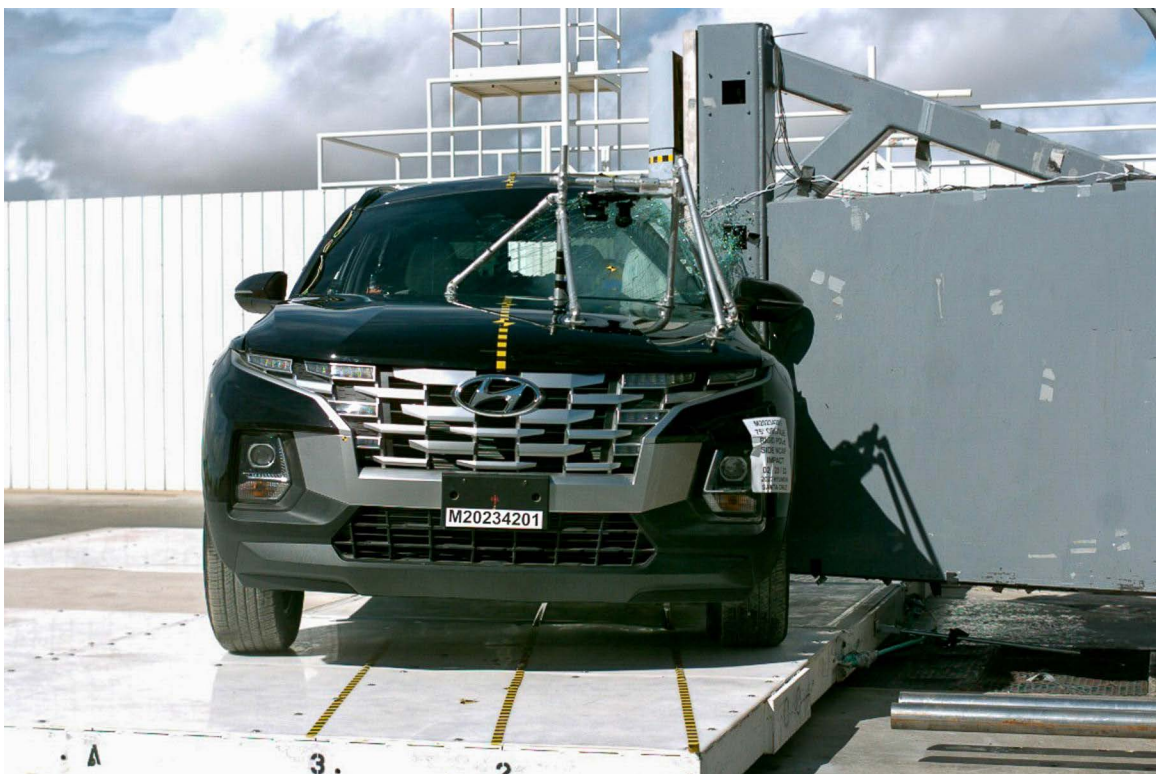
FIGURE 70. Impact Event
