**REPORT NUMBER: NCAP-MGA-23-007**

**NEW CAR ASSESSMENT PROGRAM (NCAP)  
Frontal Barrier Impact Test**

**FORD MOTOR CO.  
2023 Ford Explorer XLT 4WD 5-Door SUV  
NHTSA No.: M20230200**

**MGA RESEARCH CORPORATION  
5000 Warren Road  
Burlington, WI 53105**

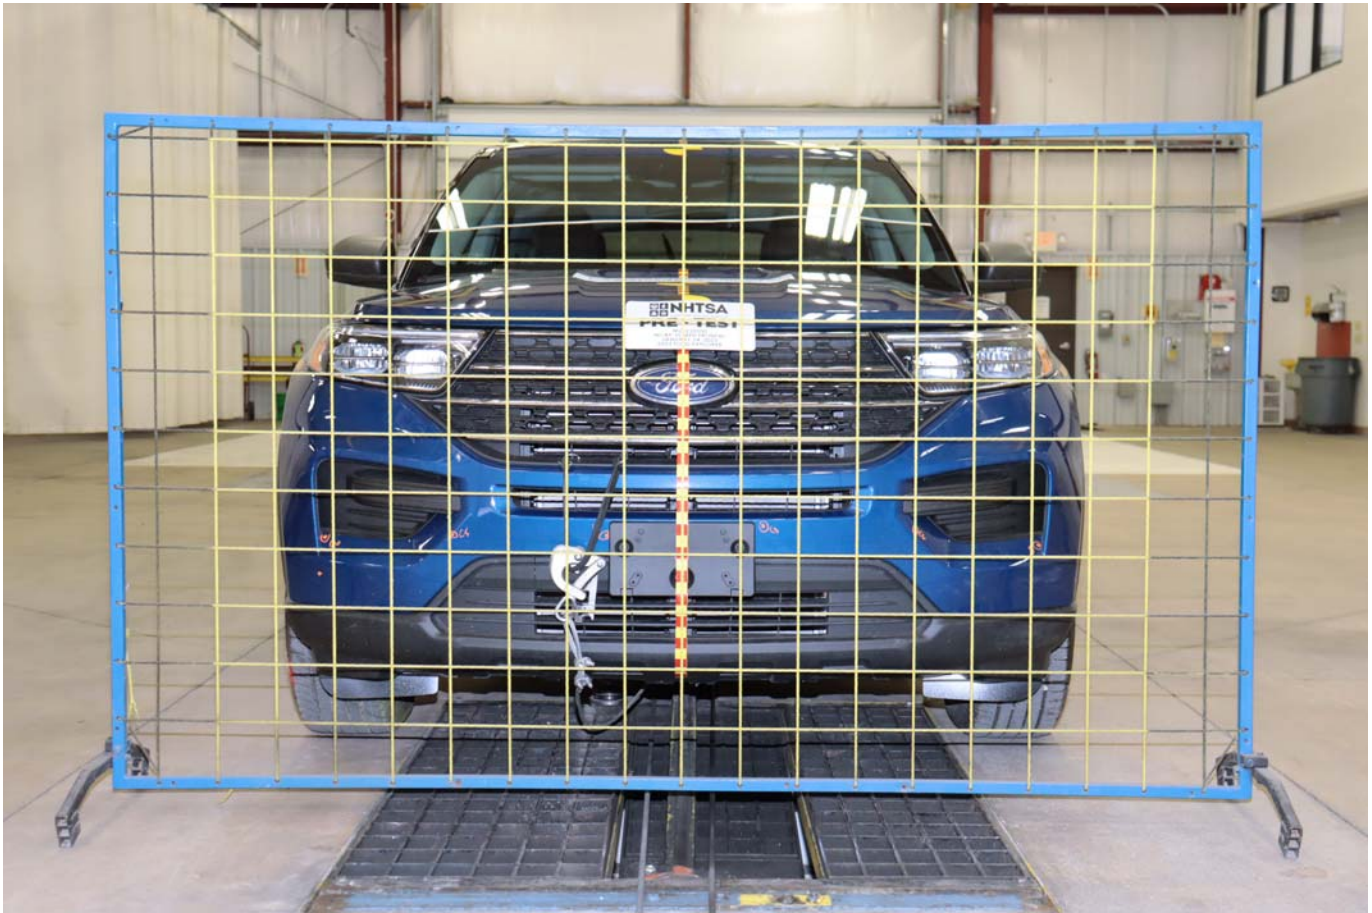
Photo No. 001 - Load Cell Location

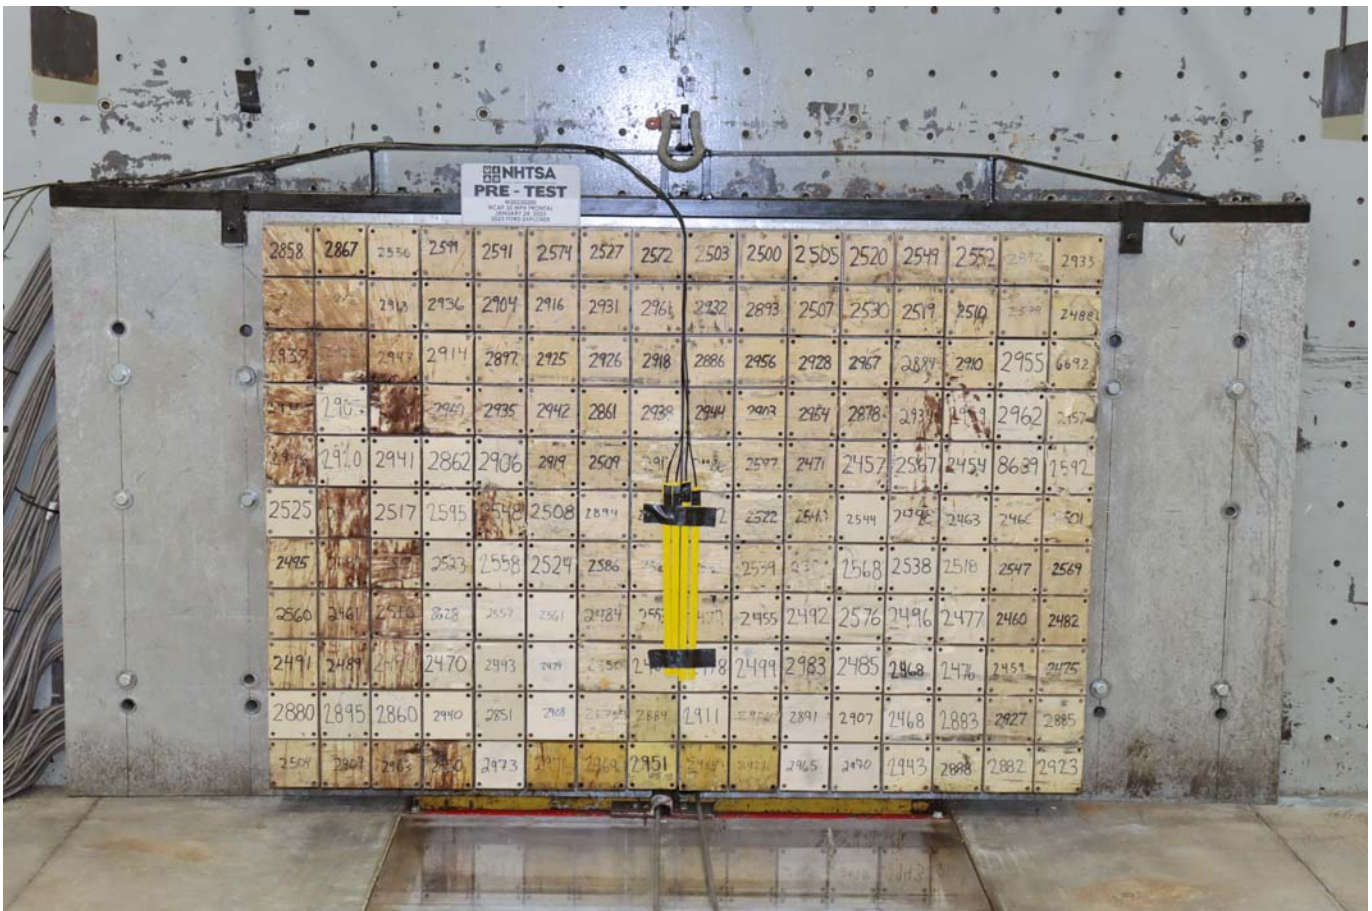
Photo No. 002 - Pre-Test Load Cell Wall

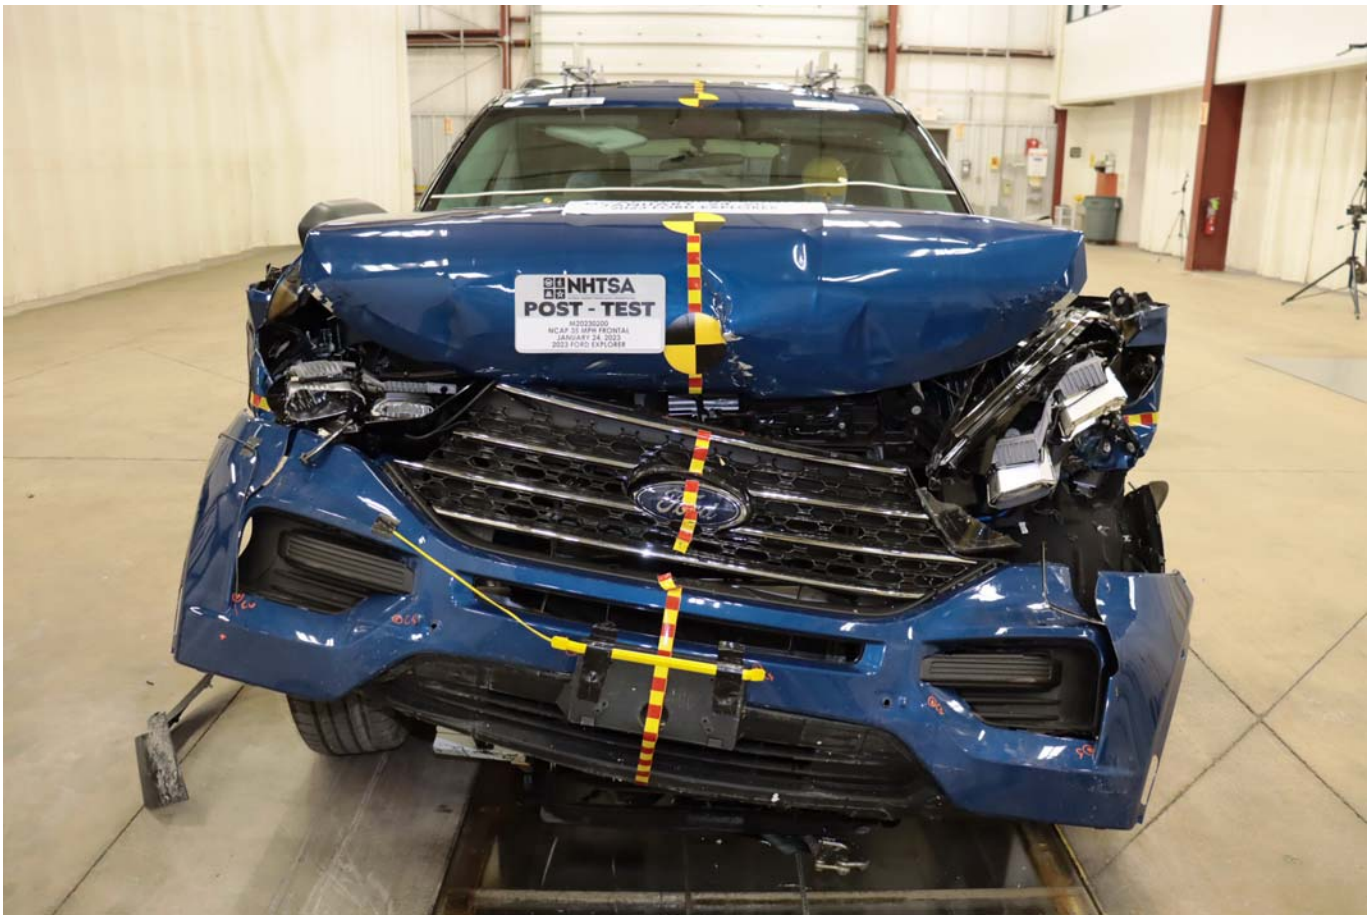
Photo No. 009 - Post-Test Front View of Test Vehicle

The maximum static crush of the vehicle was 639 mm located at the vehicle centerline and both the driver and passenger side doors remained closed during the impact event and were operable after the impact.

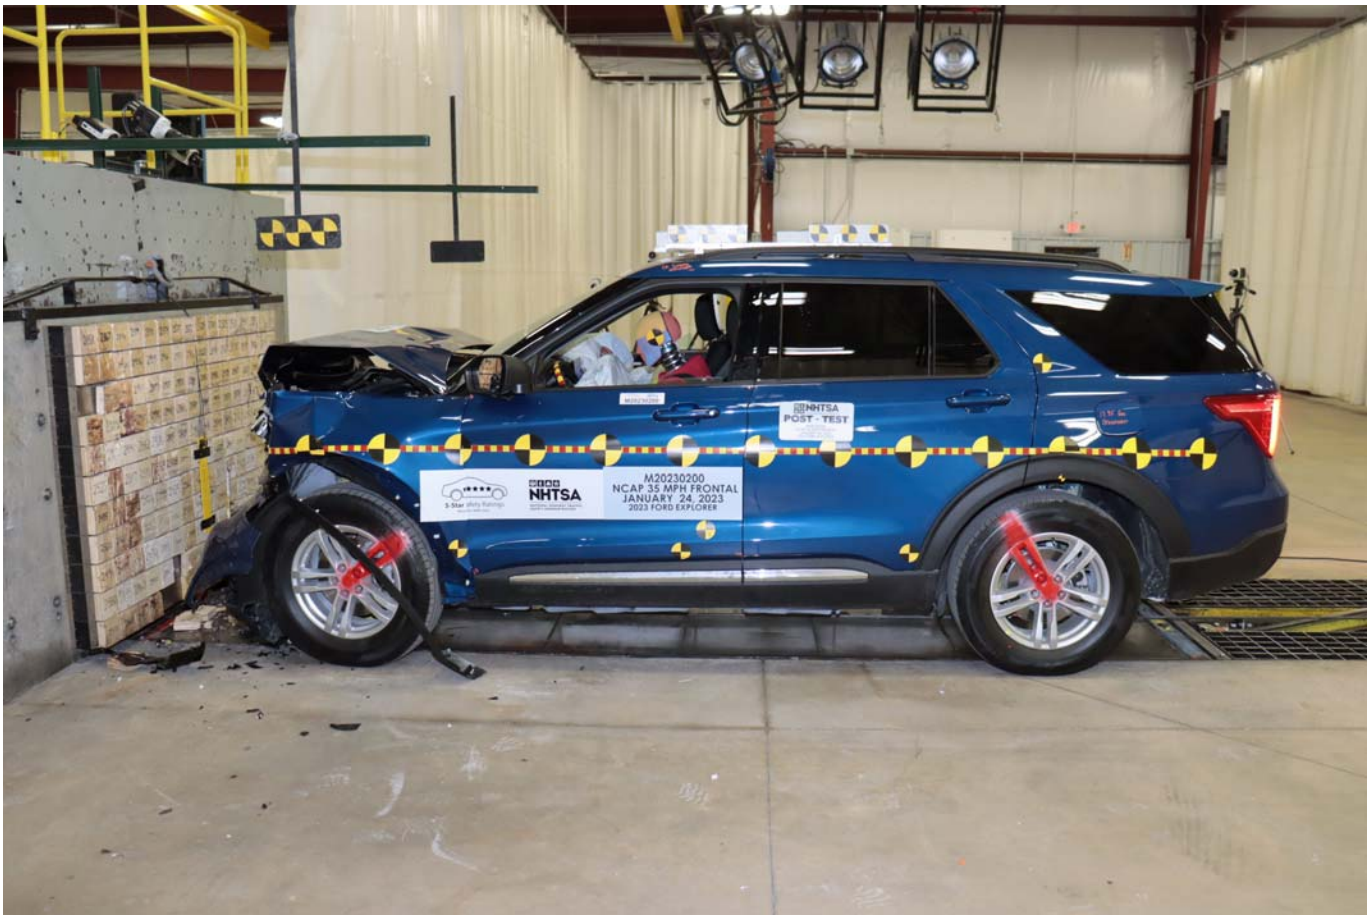
Photo No. 011 - Post-Test Left View of Test Vehicle

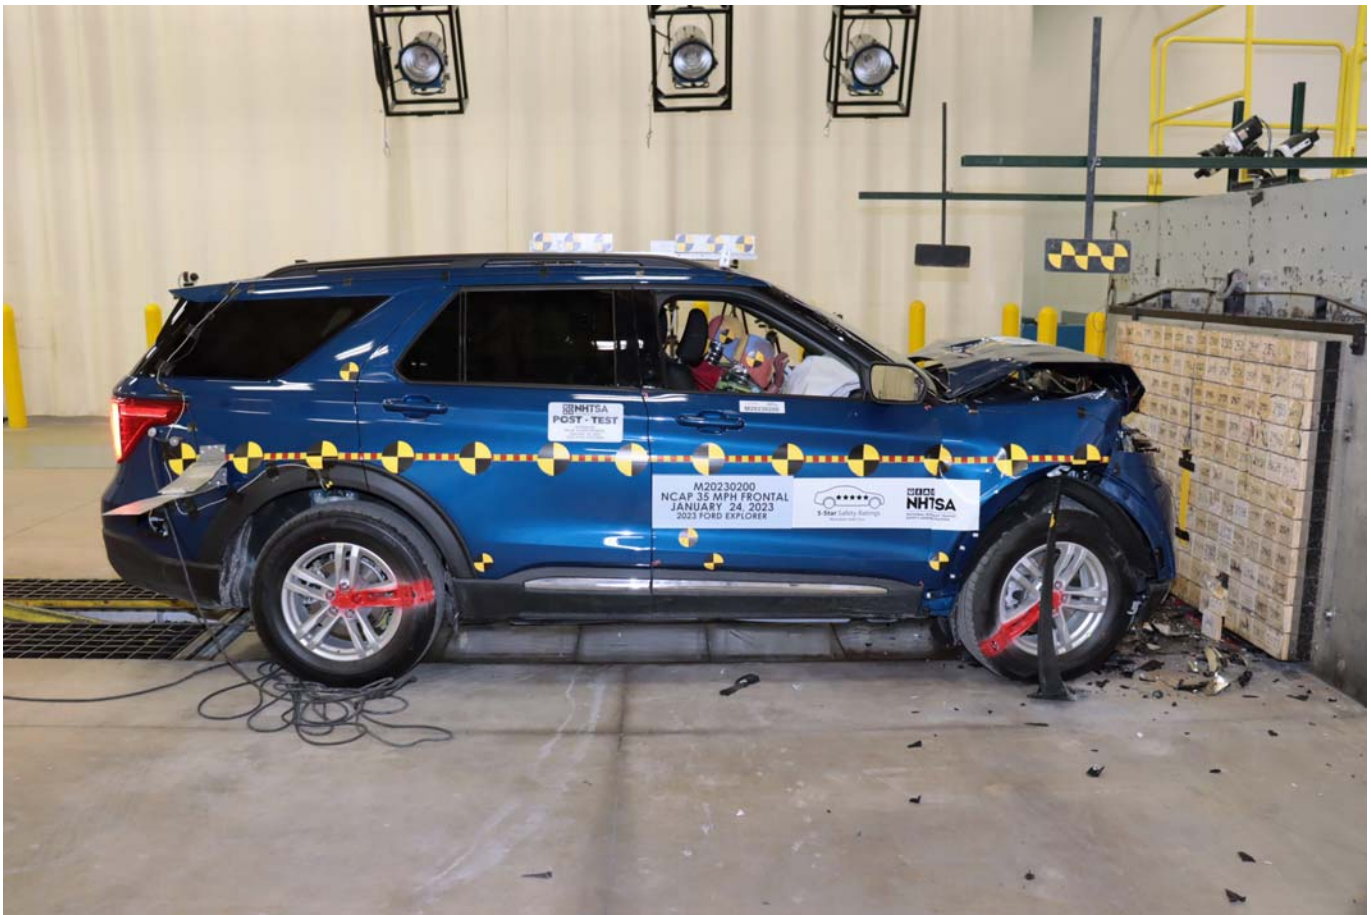
Photo No. 013 - Post-Test Right View of Test Vehicle

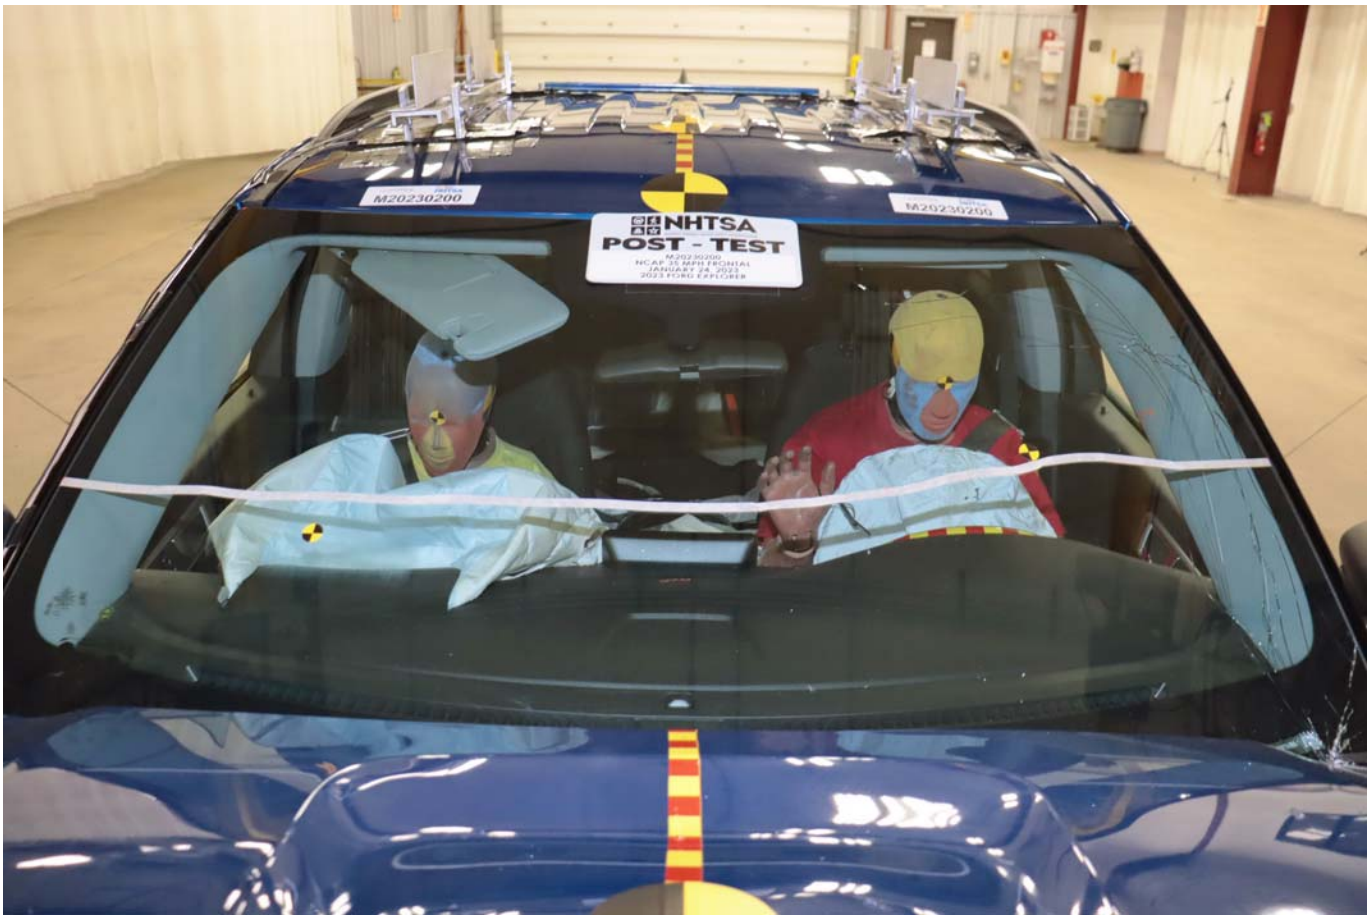
Photo No. 019 - Post-Test Windshield View

There was 100 percent windshield retention and no intrusion into the protected zone of the windshield during the event. There was no Stoddard Solvent leakage after the event or during any phase of the static rollover.

Critical Areas of Performance	Observations and Conclusions
Windshield Damage	Small crack on driver side from hood contact
Window Damage	None
Other Notable Effects	None

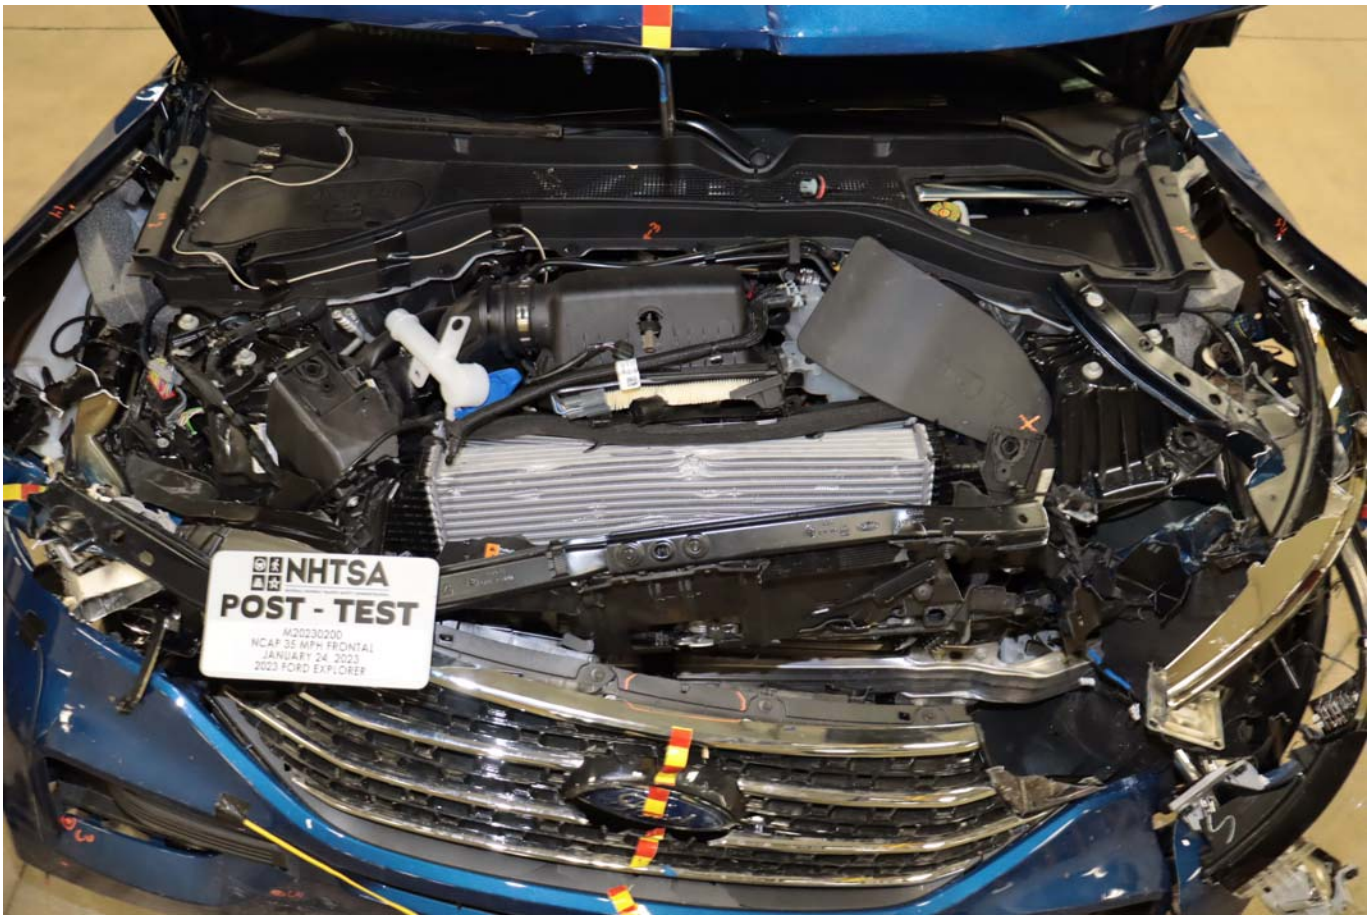
Photo No. 021 - Post-Test Engine Compartment View

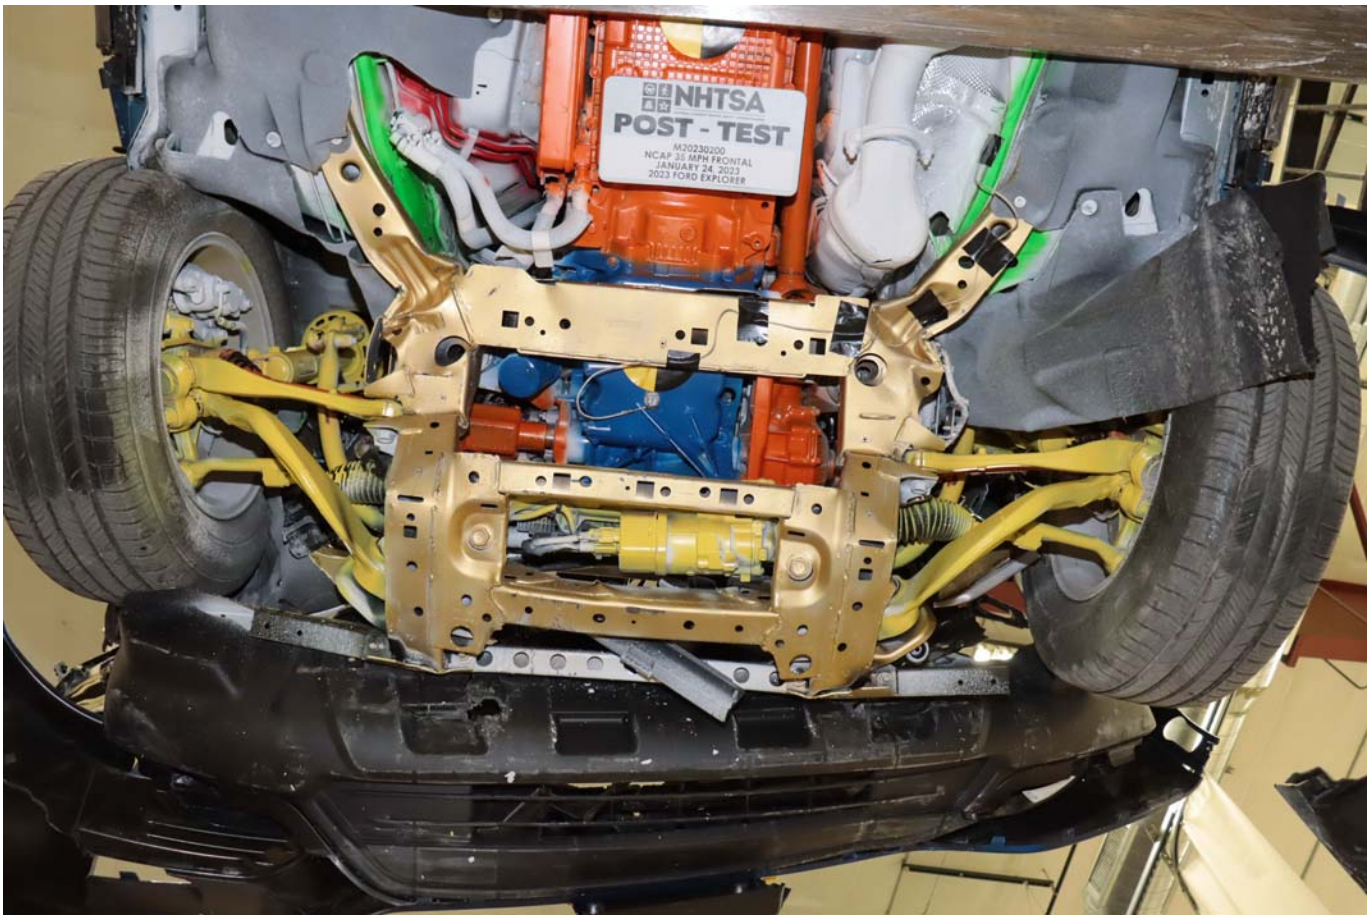
Photo No. 025 - Post-Test Front Underbody View

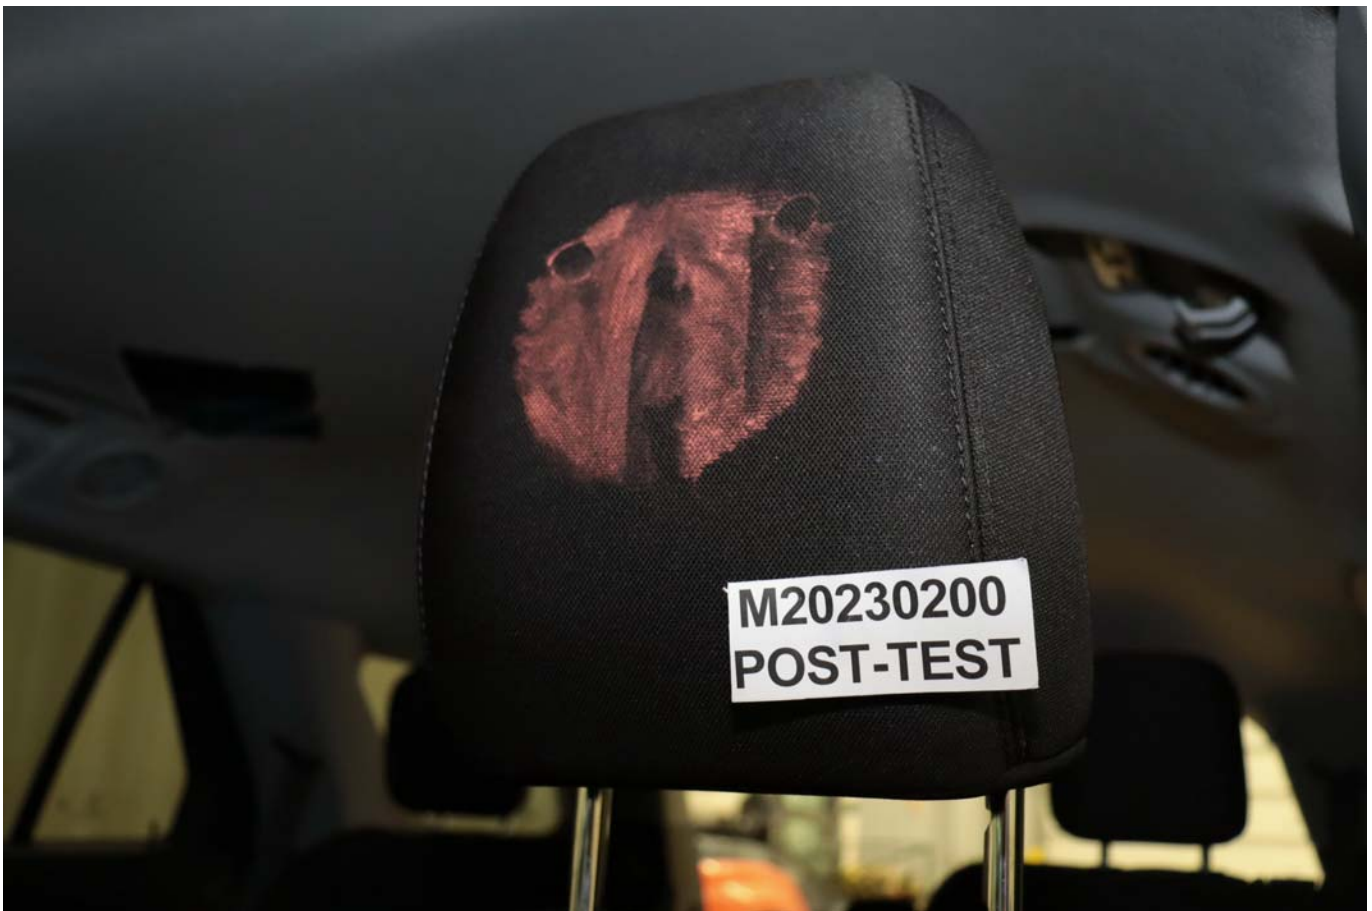
Photo No. 050 - Post-Test Driver Dummy Contact with Headrest

The driver's visible contact points were as follows: The driver's head contacted the airbag. The driver's head also contacted the headrest. The driver's knees contacted the knee airbag.  
 The passenger's visible contact points were as follows: The passenger's head contacted the airbag. The passenger's head also contacted the headrest. The passenger's knees contacted the knee airbag.

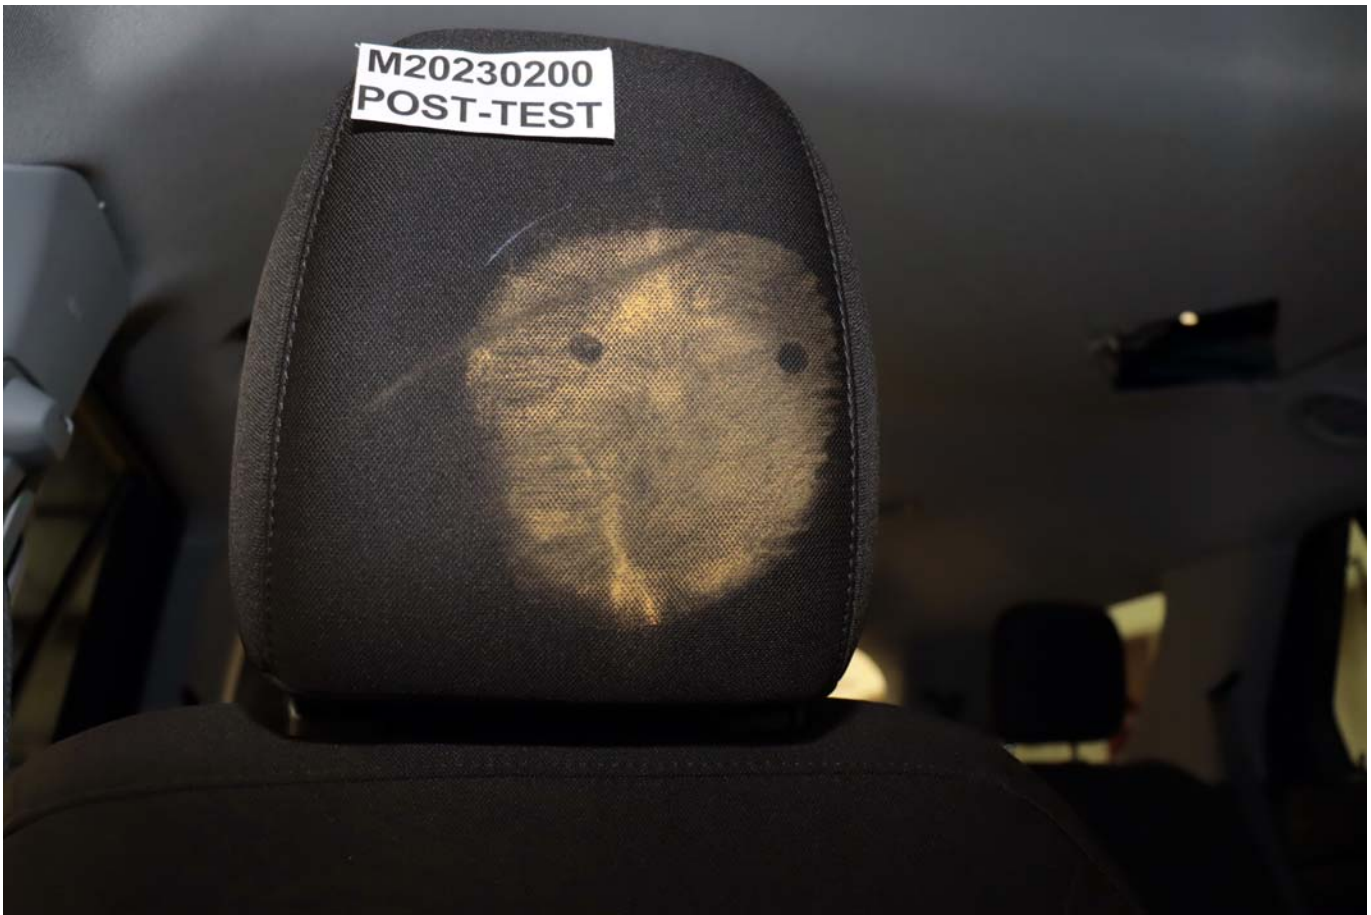
Photo No. 073 - Post-Test Passenger Dummy Contact with Headrest

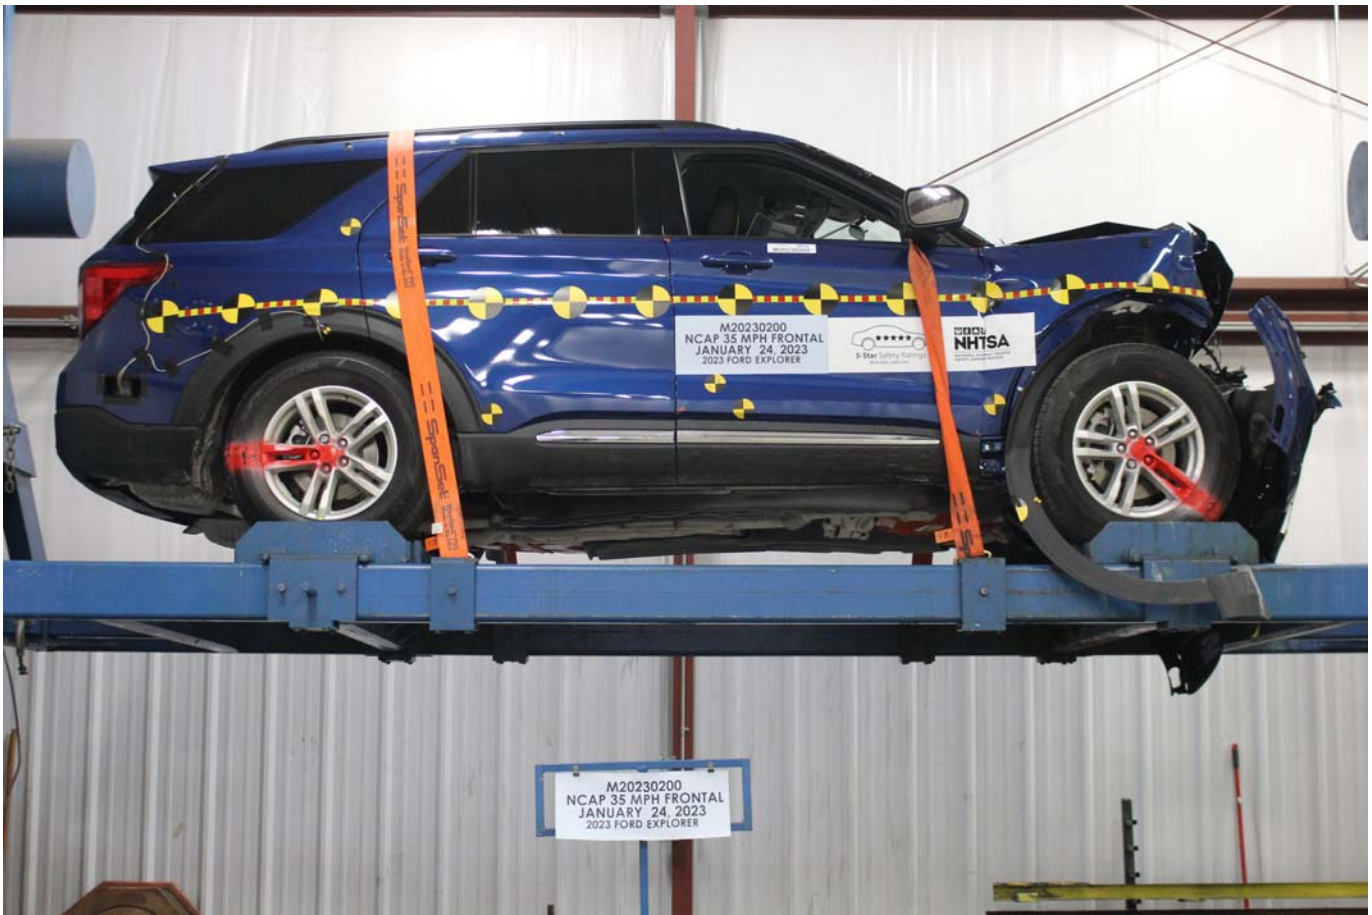
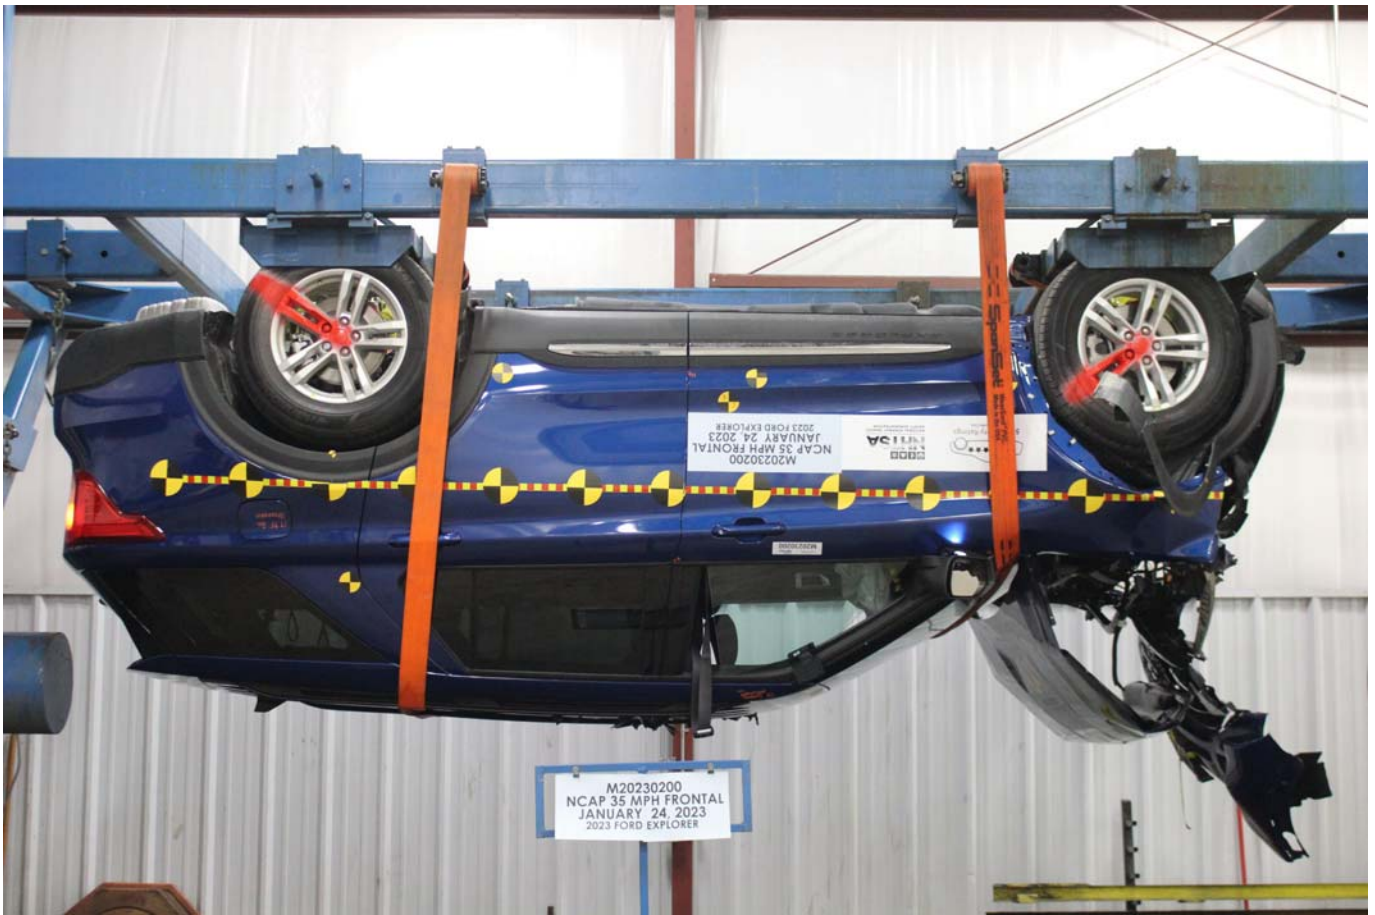
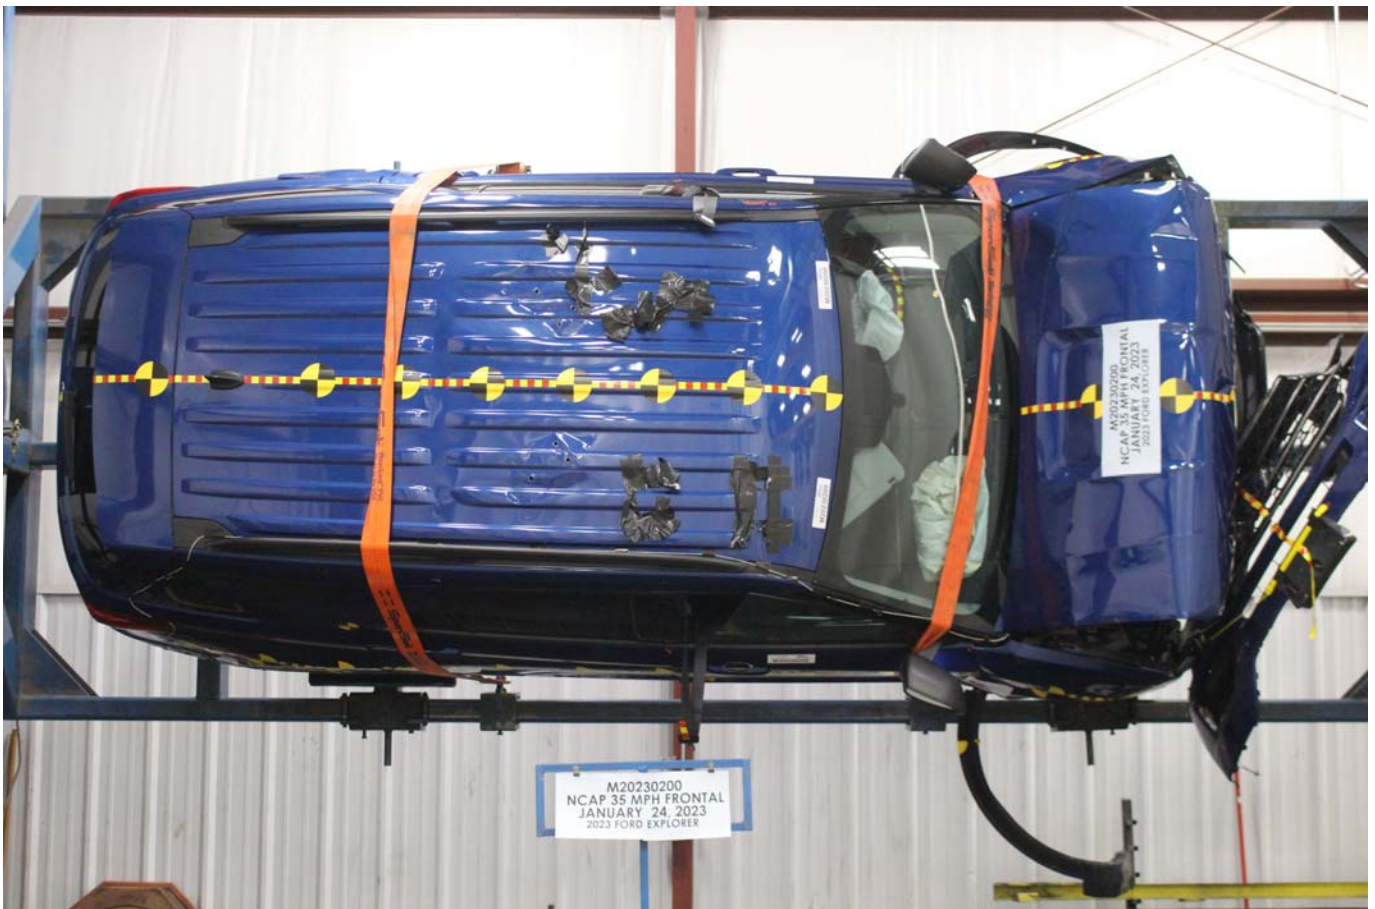
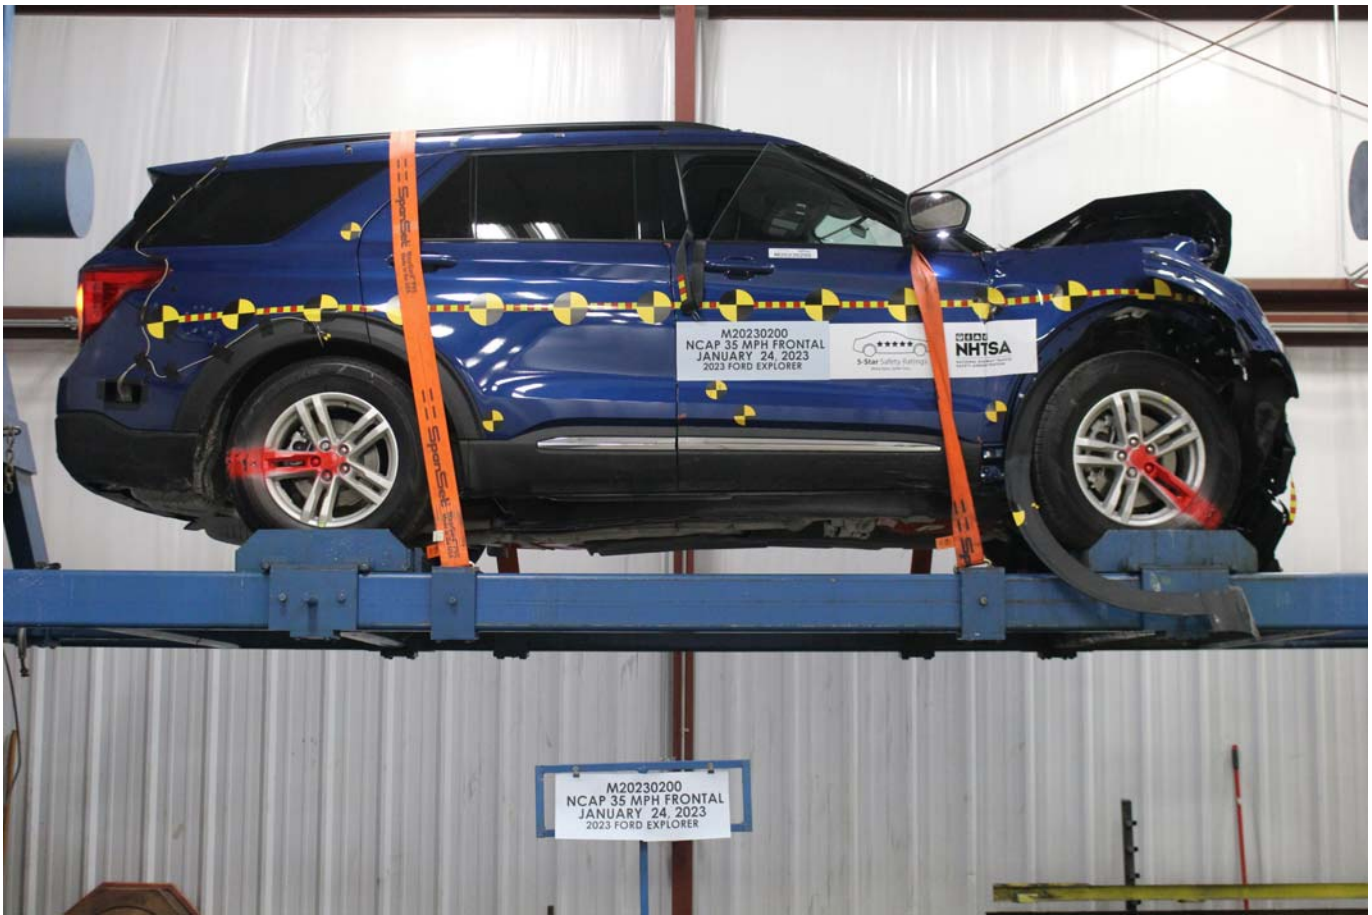
Photo No. 077 - Vehicle at 0 Degrees on Static Rollover Device

Photo No. 079 - Vehicle at 180 Degrees on Static Rollover Device

Photo No. 080 - Vehicle at 270 Degrees on Static Rollover Device

Photo No. 081 - Vehicle at 360 Degrees on Static Rollover Device
