**REPORT NUMBER: SideNCAPPole-MGA-23-006**

**NEW CAR ASSESSMENT PROGRAM (NCAP)  
Side Impact Pole Test**

**HONDA DE MEXICO S.A. DE C.V.  
2023 Honda HR-V LX 5-Door SUV  
NHTSA No.: O20235304**

**MGA RESEARCH CORPORATION  
5000 Warren Road  
Burlington, WI 53105**

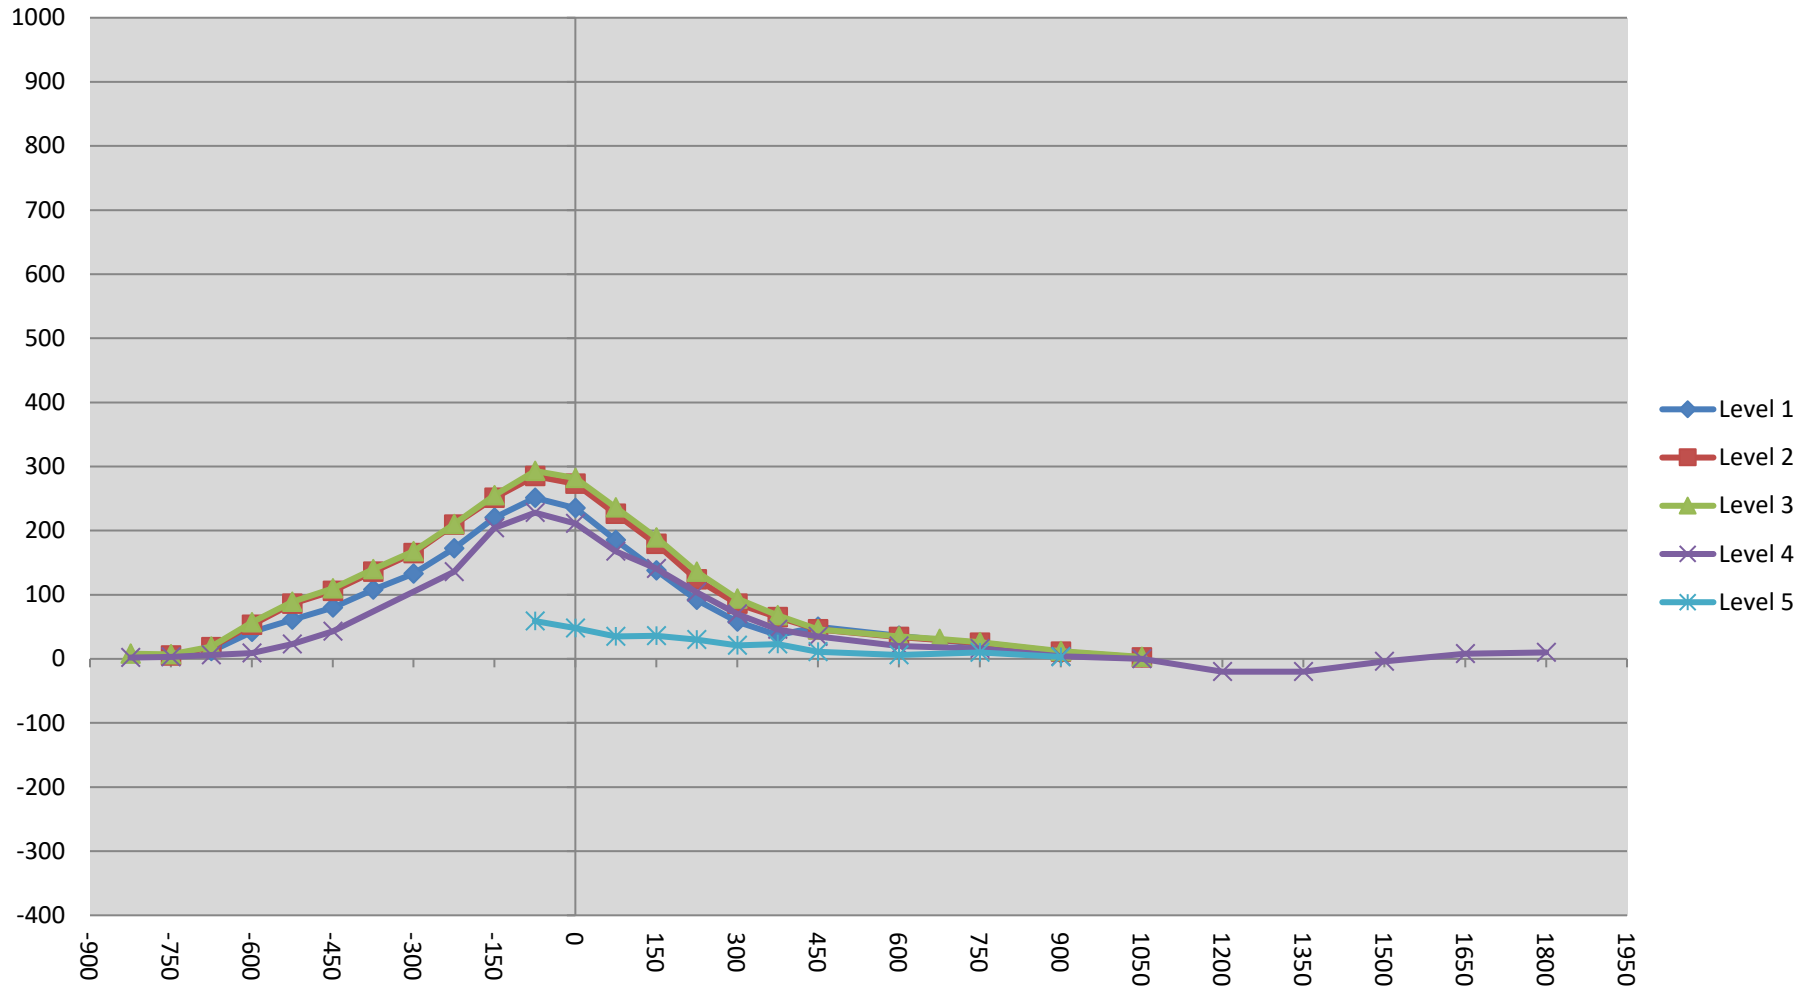
Pre-test measurements are taken when the vehicle is in the “As Tested” weight condition. Vehicle measurements forward of the vertical impact reference line are negative. The crush profile grid is established prior to the test based on an estimated impact point.

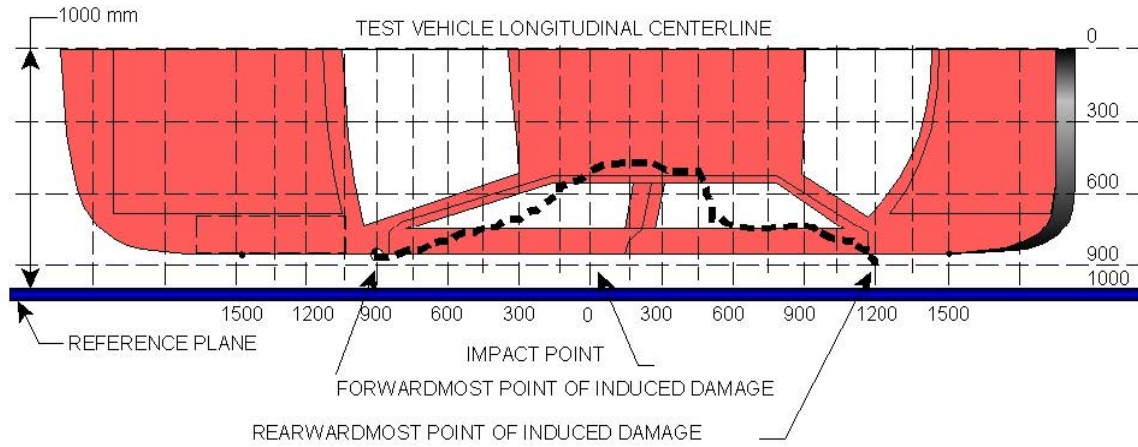
**VEHICLE DAMAGE PROFILE DISTANCES**

DPD	Distance from Impact Point (mm)	Level	Pre-Test (mm)	Post-Test (mm)	Max. Static Crush (mm)
1	1100	3	200	179	-21
2	740	3	197	229	32
3	380	3	202	254	52
4	20	3	196	459	263
5	-340	3	190	349	159
6	-700	3	183	188	5

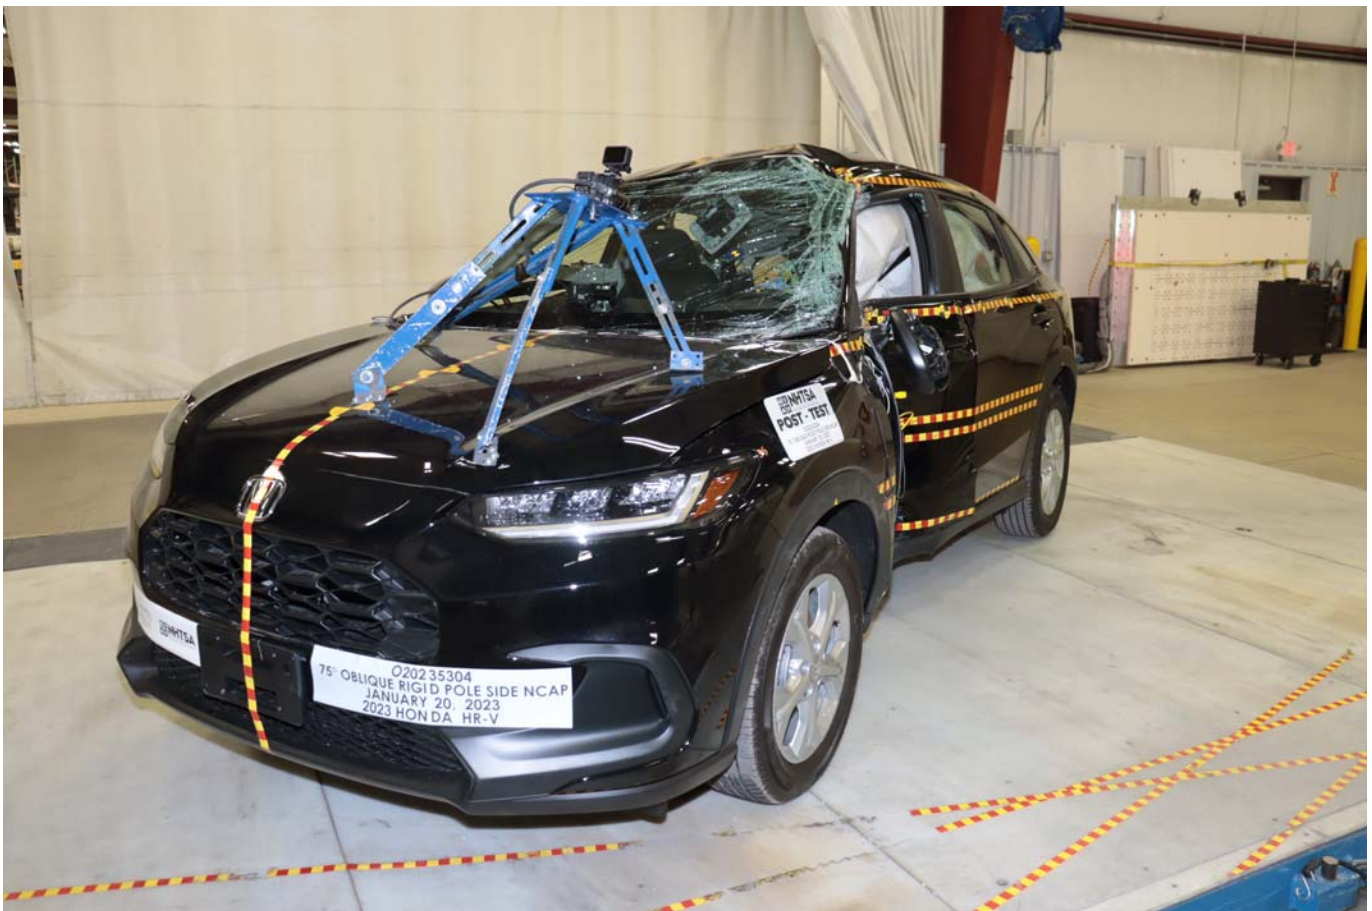
Photo No. 006 - Post-Test Left Front Three-Quarter View of Test Vehicle

Critical Areas of Performance	Observations and Conclusions
Pillar Performance	No Separation
Sill Separation	No Separation
Windshield Damage	Cracked
Side Window Damage	LF window broken
Other Notable Effects	None

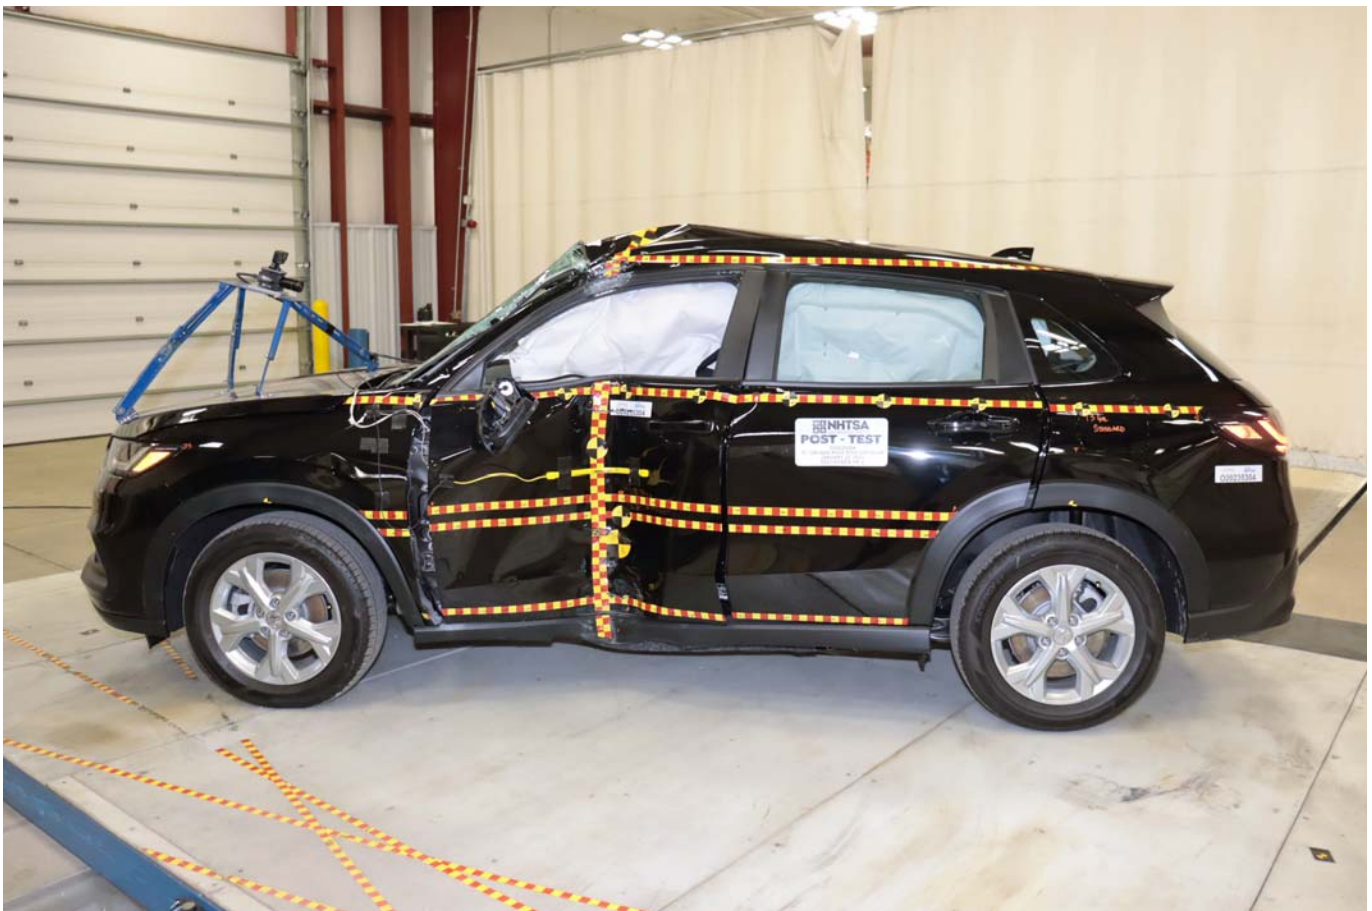
Photo No. 008 - Post-Test Left Side View of Test Vehicle

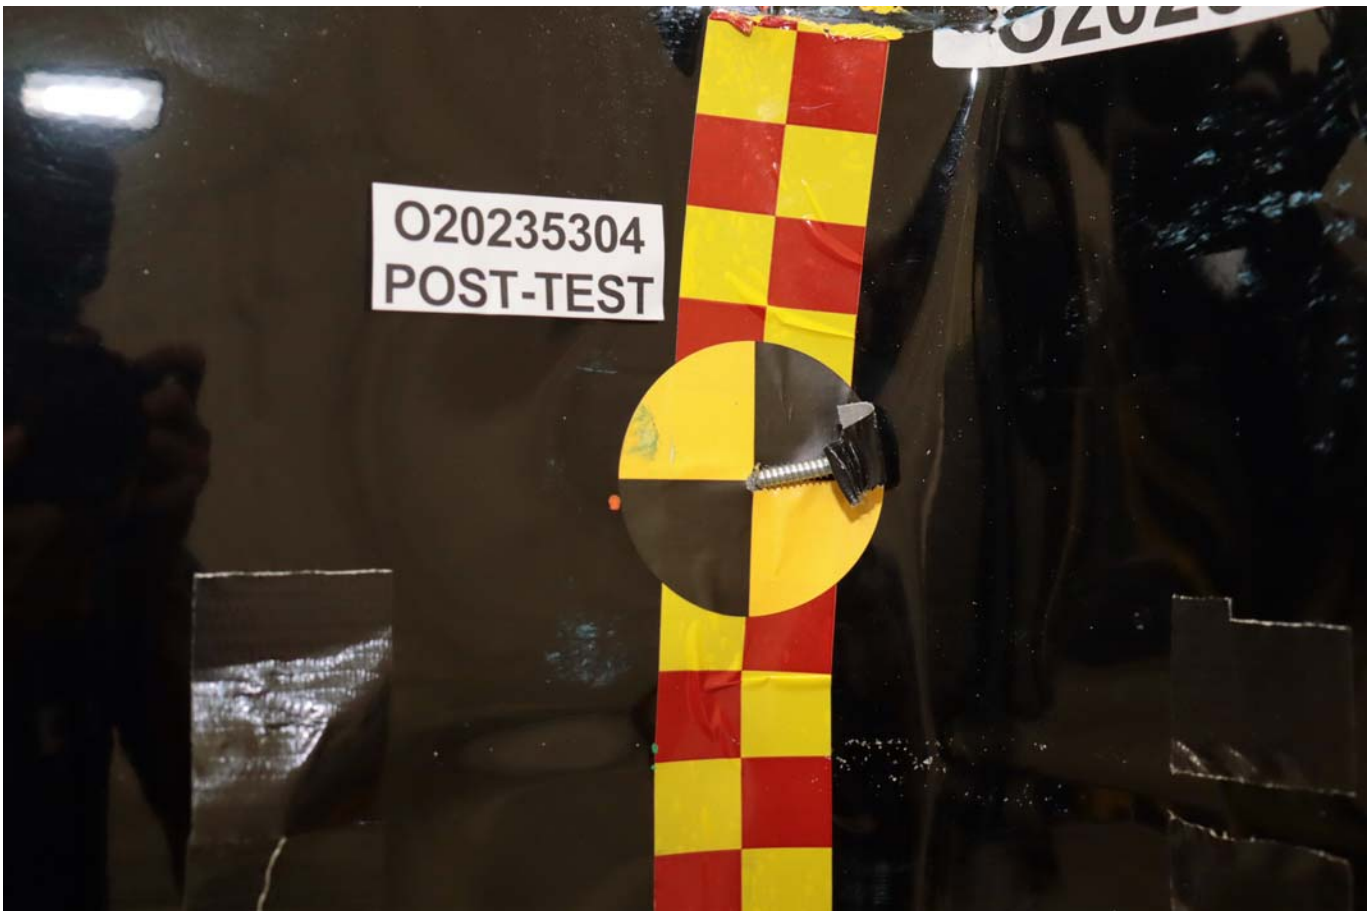
Photo No. 020 - Post-Test Close-Up View of Impact Point Target Showing Impact Location

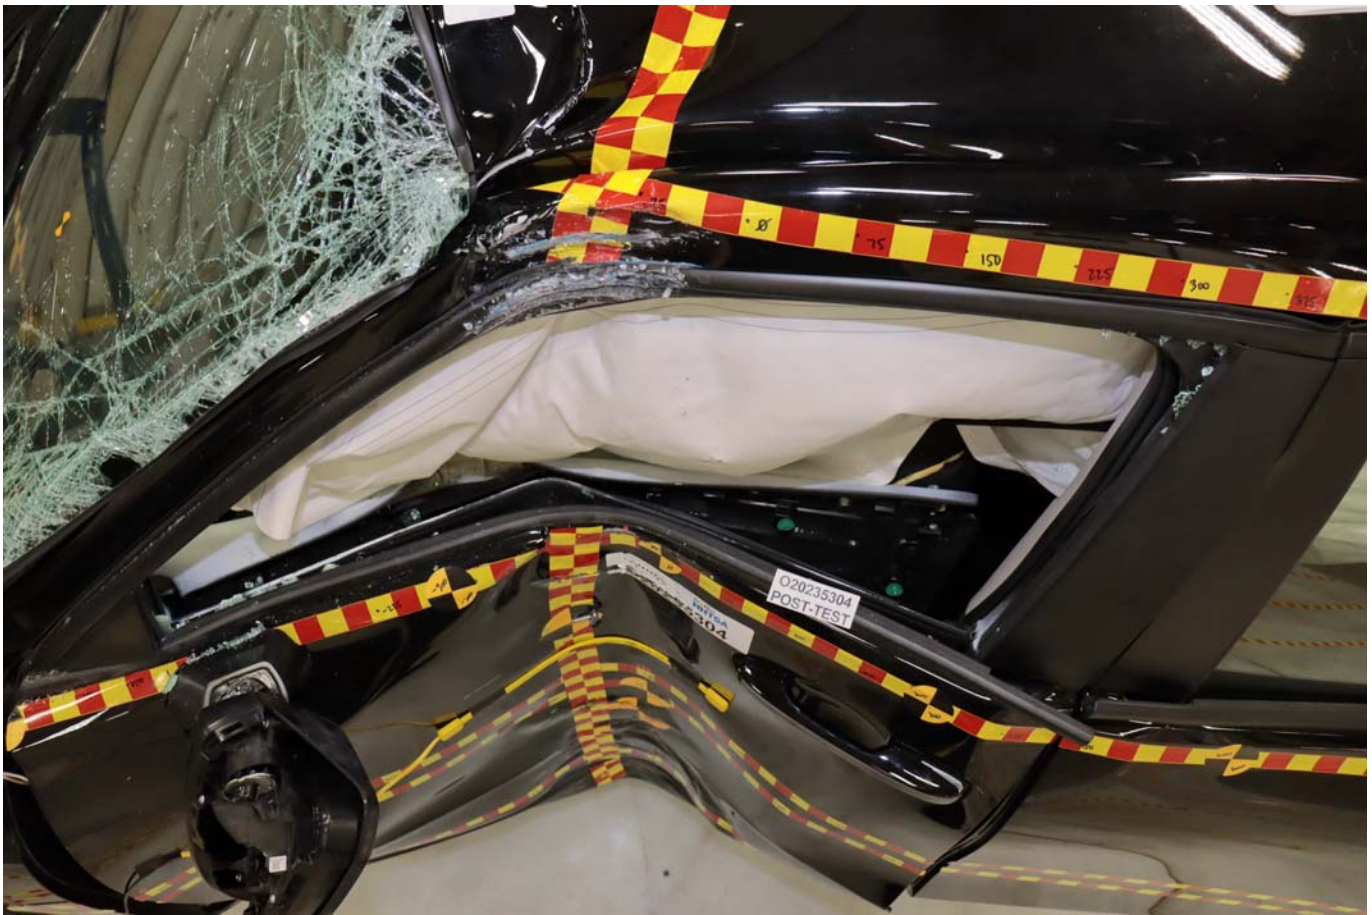
Photo No. 041 - Post-Test Dummy and Door Clearance View

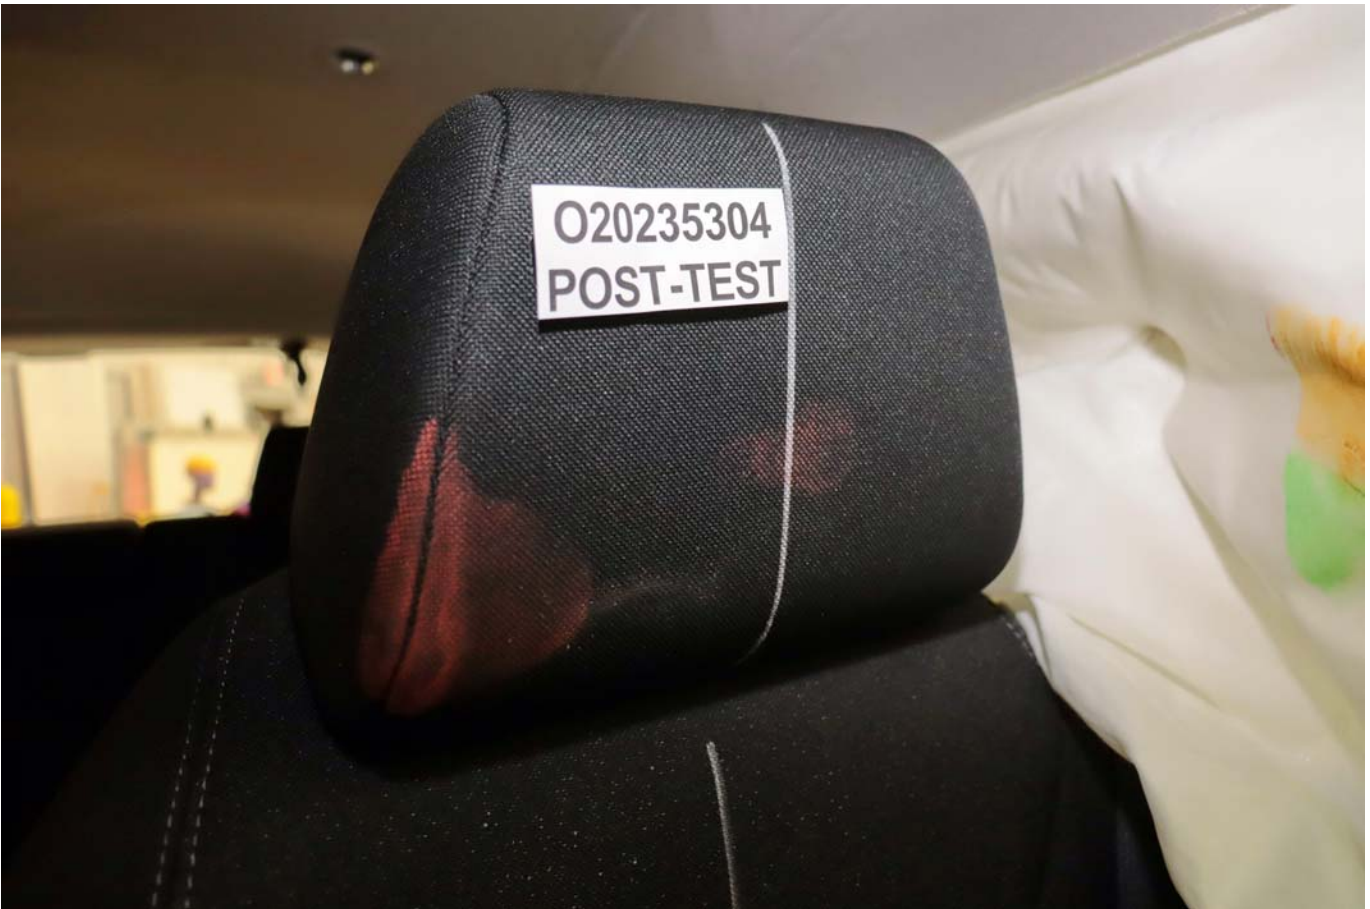
Photo No. 046 - Post-Test Dummy Close-Up Head Contact with Vehicle Interior View

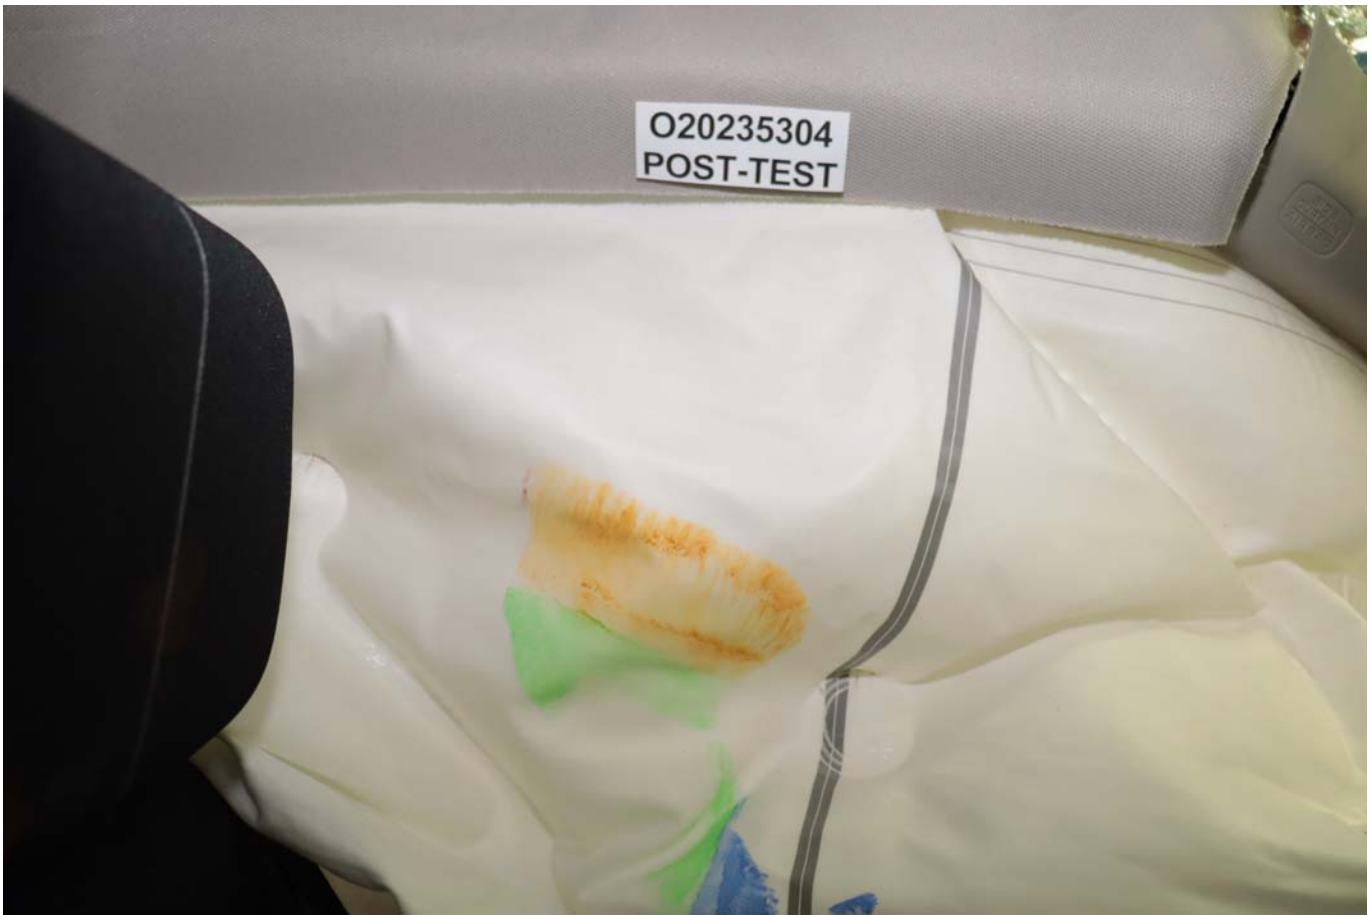
Photo No. 047 - Post-Test Dummy Close-Up Head Contact with Side Air Bag View

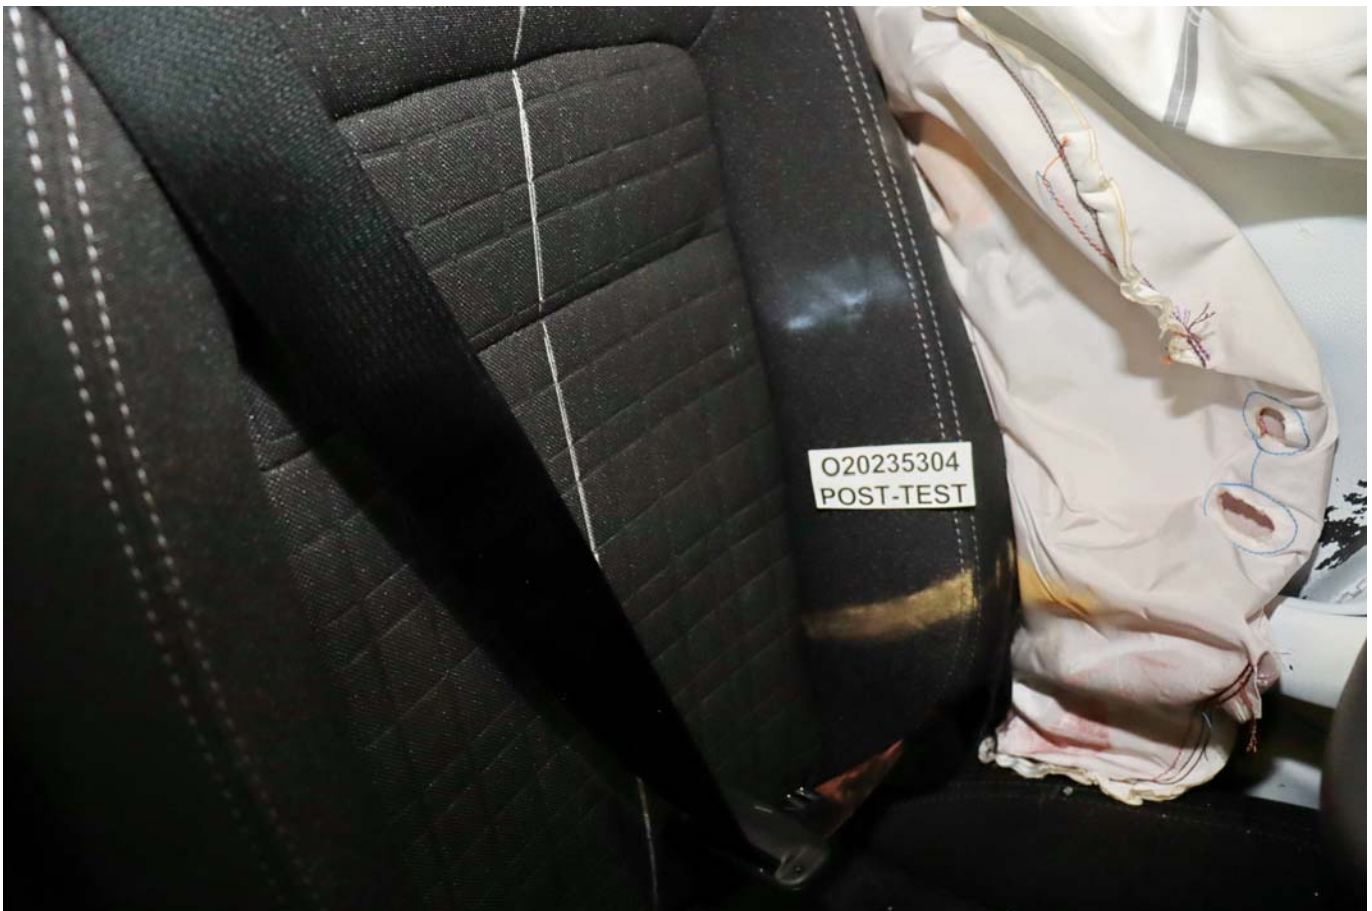
Photo No. 048 - Post-Test Dummy Close-Up Torso Contact with Vehicle Interior View

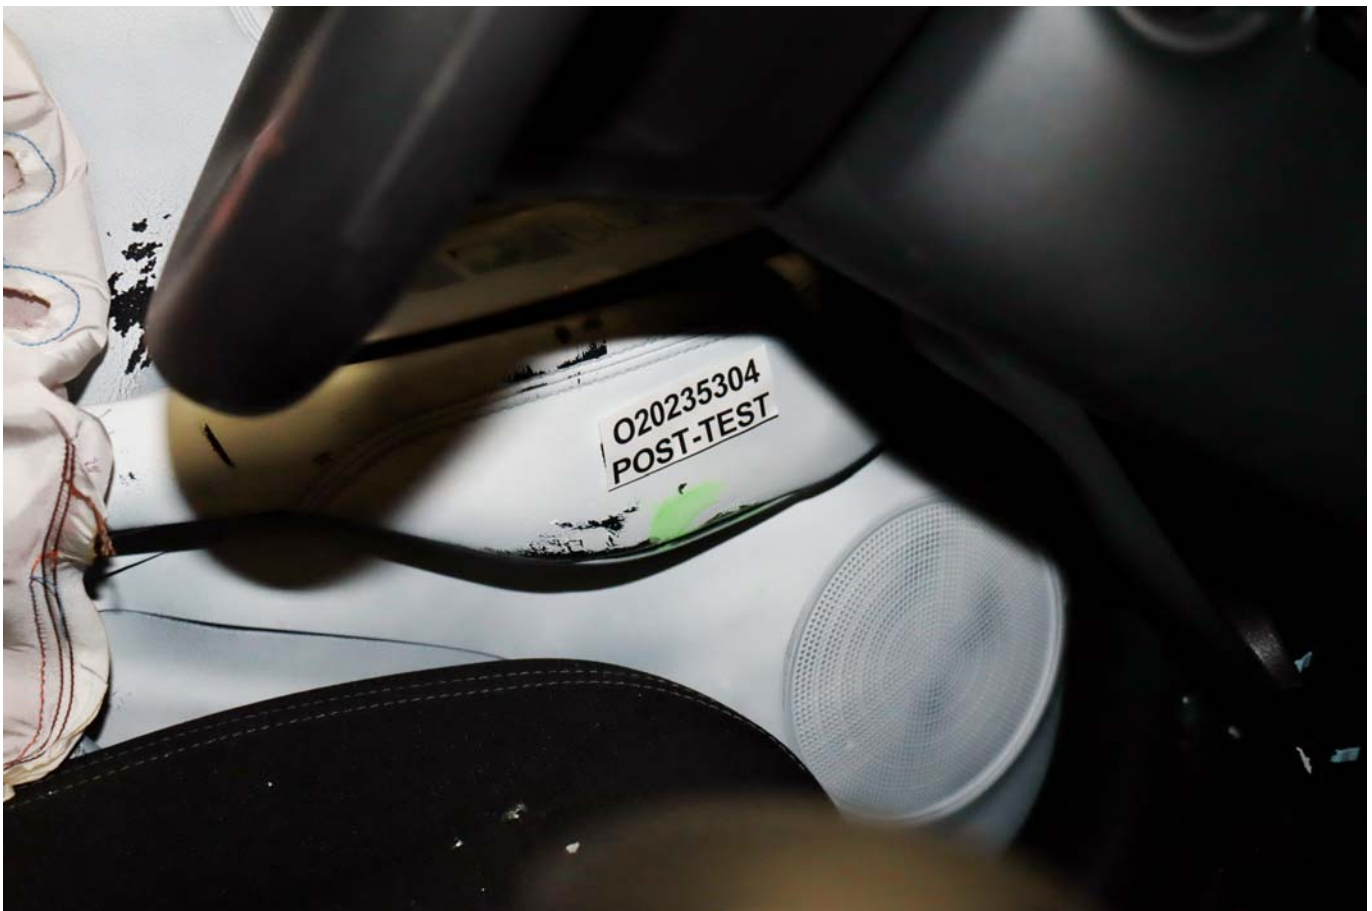
Photo No. 052 - Post-Test Dummy Close-Up Knee Contact with Vehicle Interior View

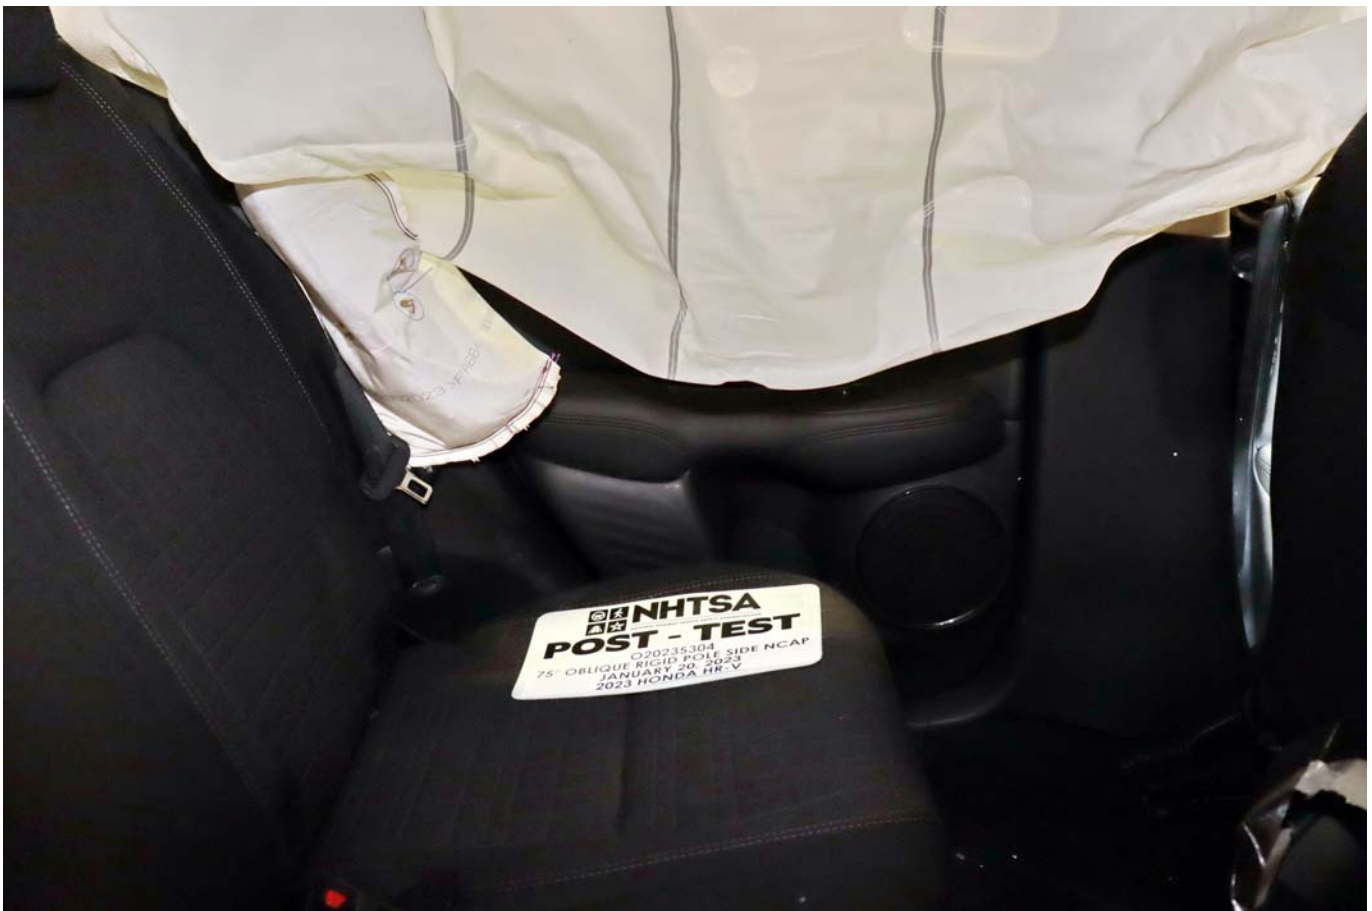
Photo No. 054 - Post-Test Inner Rear Passenger Torso Air Bag Deployment View

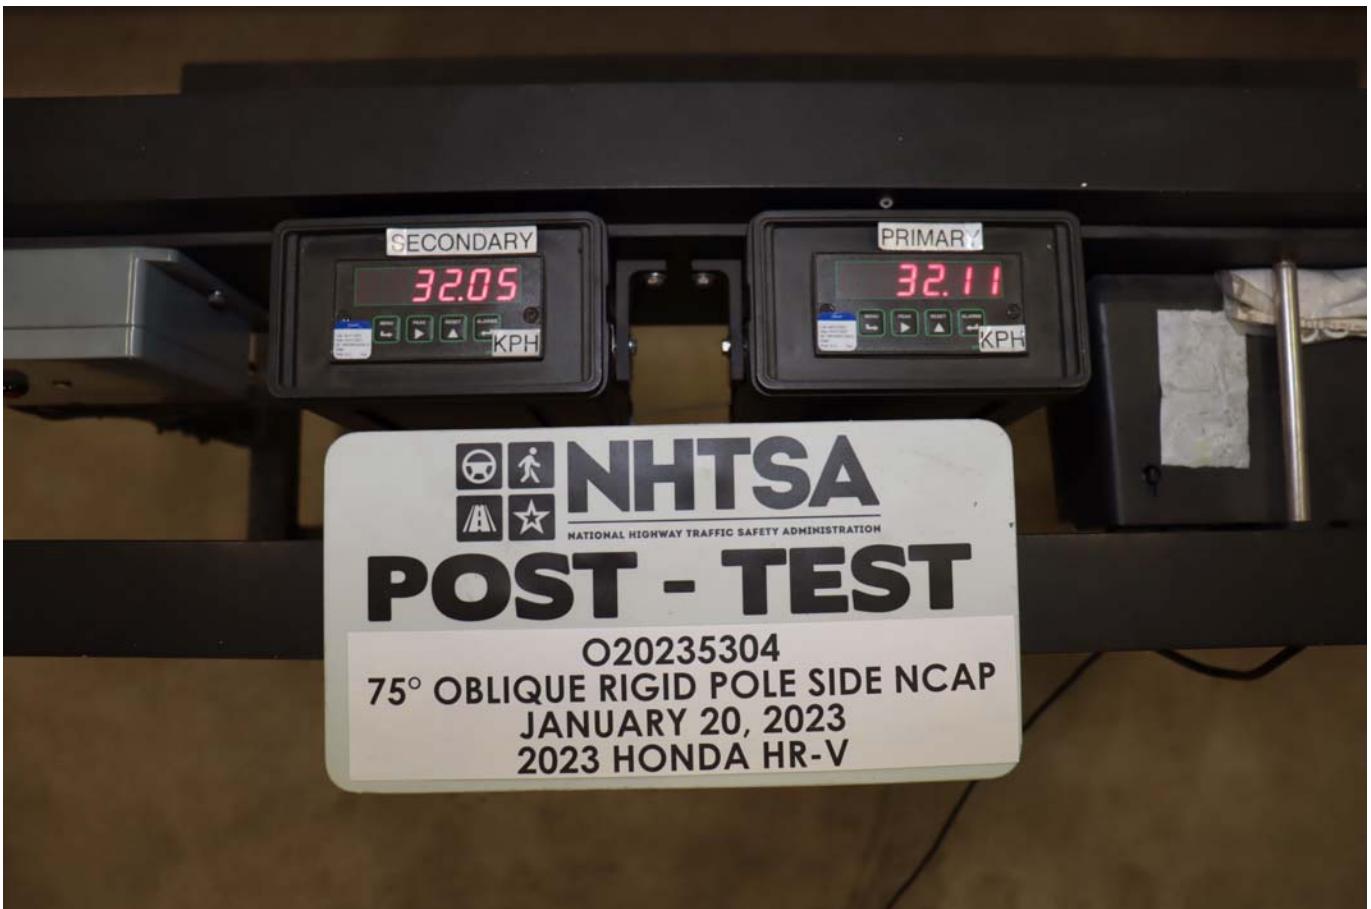
Photo No. 064 - Post-Test Primary and Redundant Speed Trap Read-Out

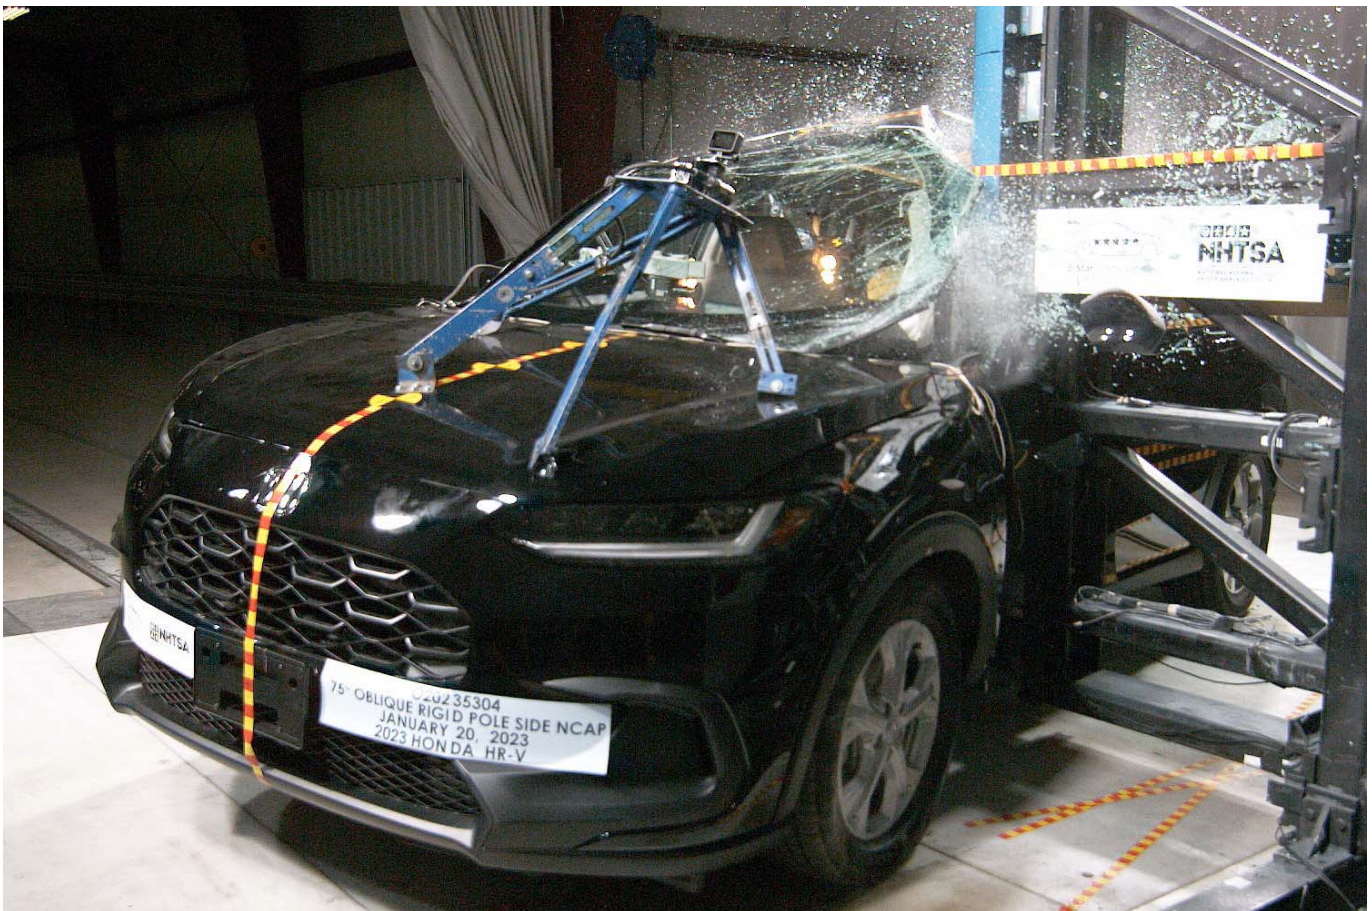
Photo No. 070 - Impact Event

A rigid pole side impact test was conducted on a 2023 Honda HR-V LX 5-Door SUV. The subject vehicle was towed into the rigid pole at an angle of 75° and a velocity of 32.11 km/h. The test was conducted by MGA Research Corporation in Burlington, Wisconsin on January 20, 2023. Pre-test and post-test photographs of the test vehicle and side impact dummy (SID-IIs) are included in Appendix A of this report.

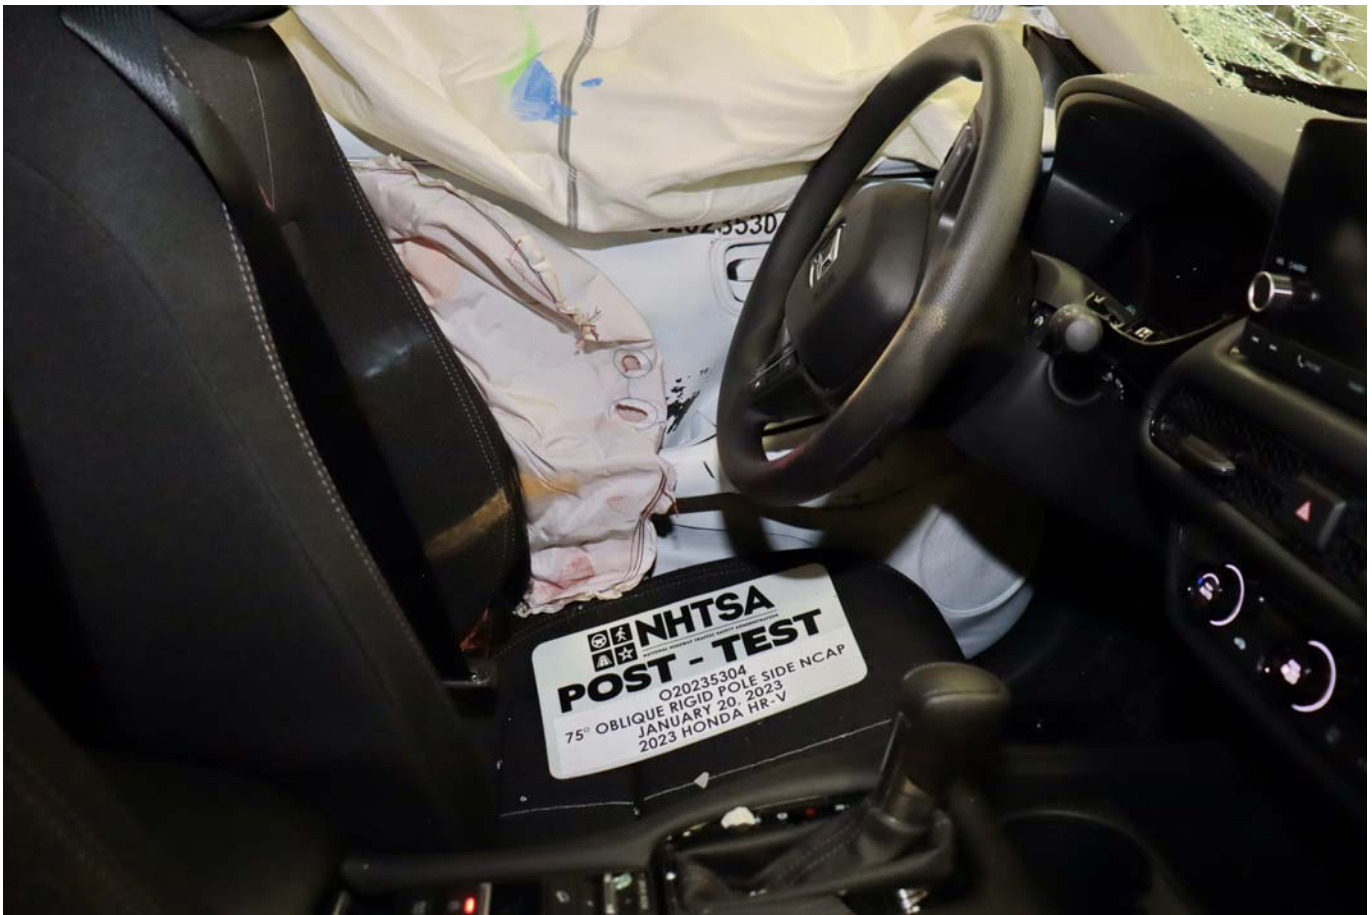
Photo No. 073 - Post-Test View of Shattered Vehicle Inner Door Panel
