REPORT NUMBER: SideNCAPPole-MGA-22-036

**NEW CAR ASSESSMENT PROGRAM (NCAP)
Side Impact Pole Test**

**FORD MOTOR CO.
2022 Ford Ranger XL SuperCab
NHTSA No.: M20220213**

FINAL REPORT

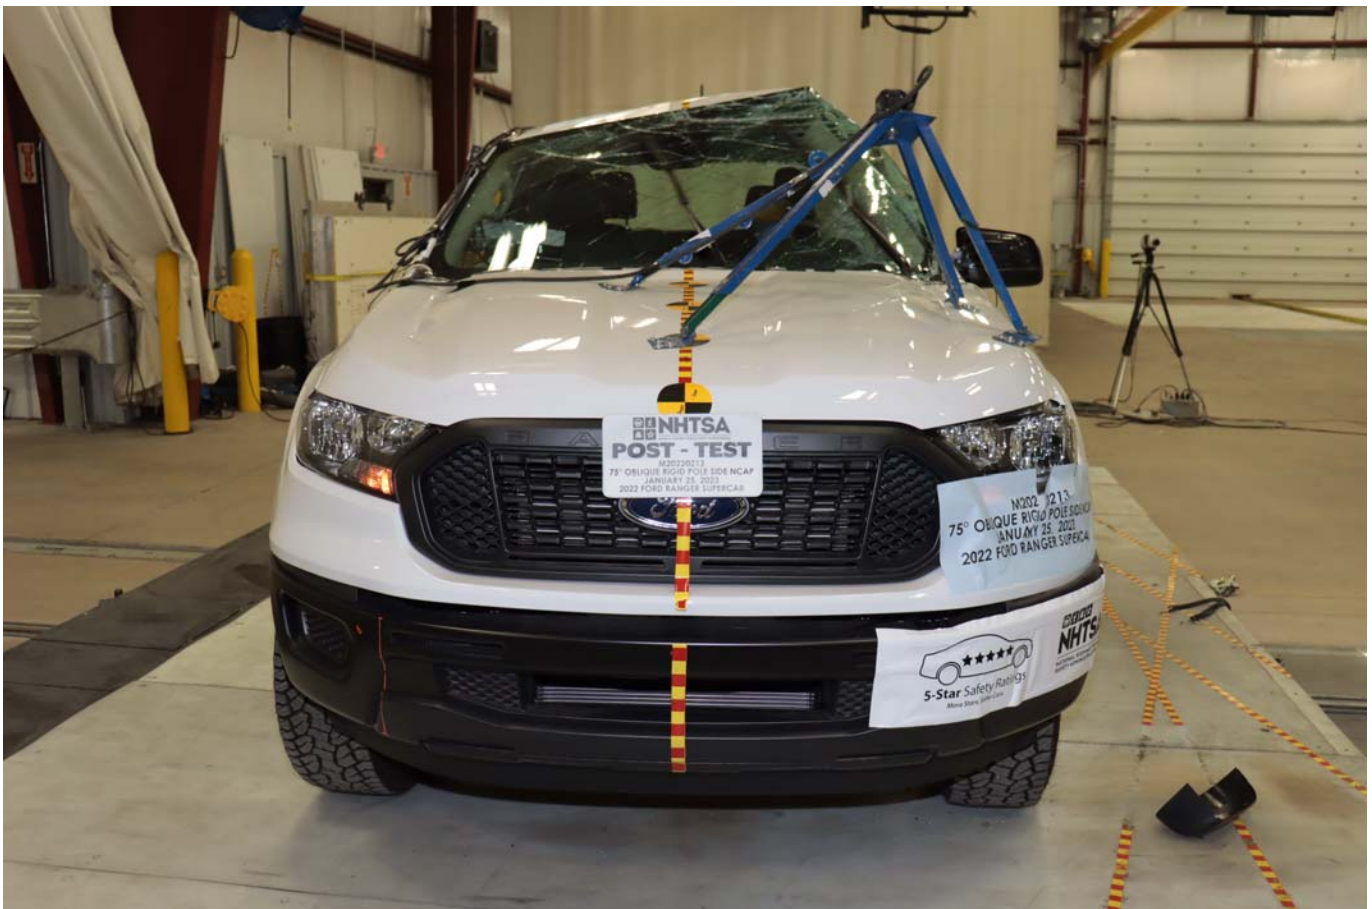
Photo No. 004 - Post-Test Frontal View of Test Vehicle

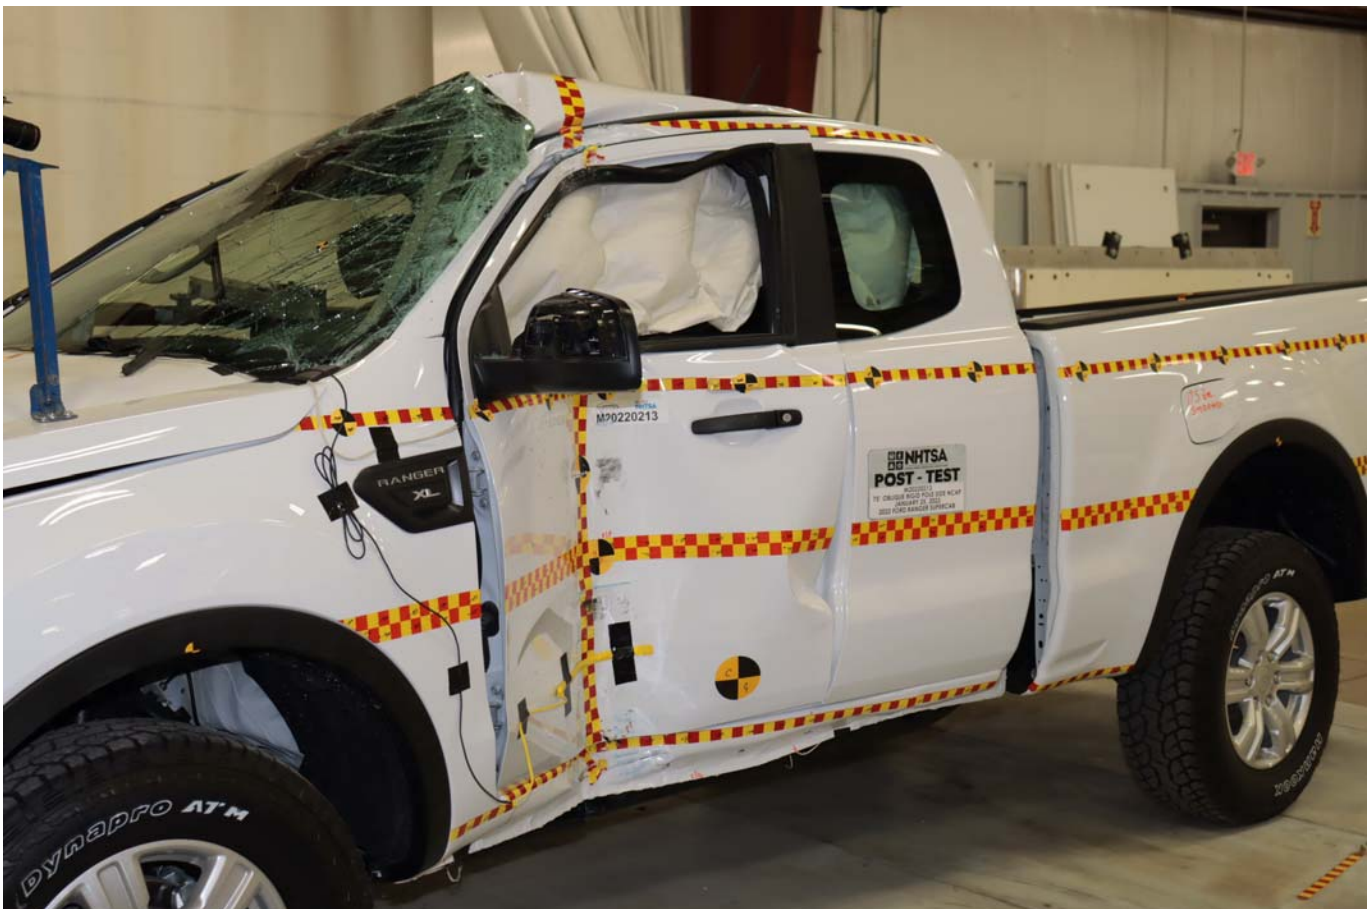
Photo No. 006 - Post-Test Left Front Three-Quarter View of Test Vehicle

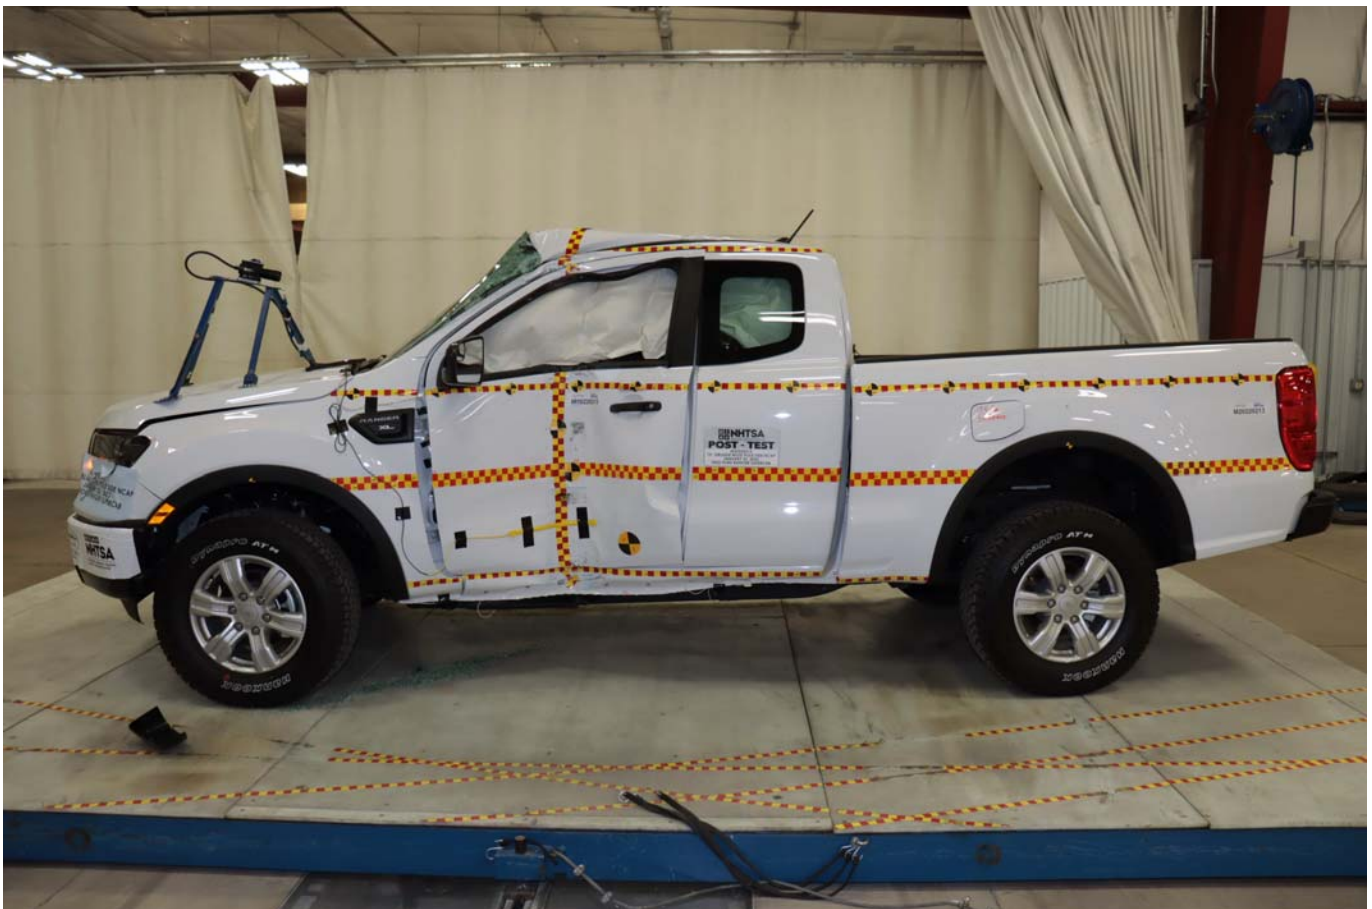
Photo No. 008 - Post-Test Left Side View of Test Vehicle

Critical Areas of Performance	Observations and Conclusions
Pillar Performance	No Separation
Sill Separation	No Separation
Windshield Damage	Cracked
Side Window Damage	LF window broken
Other Notable Effects	None

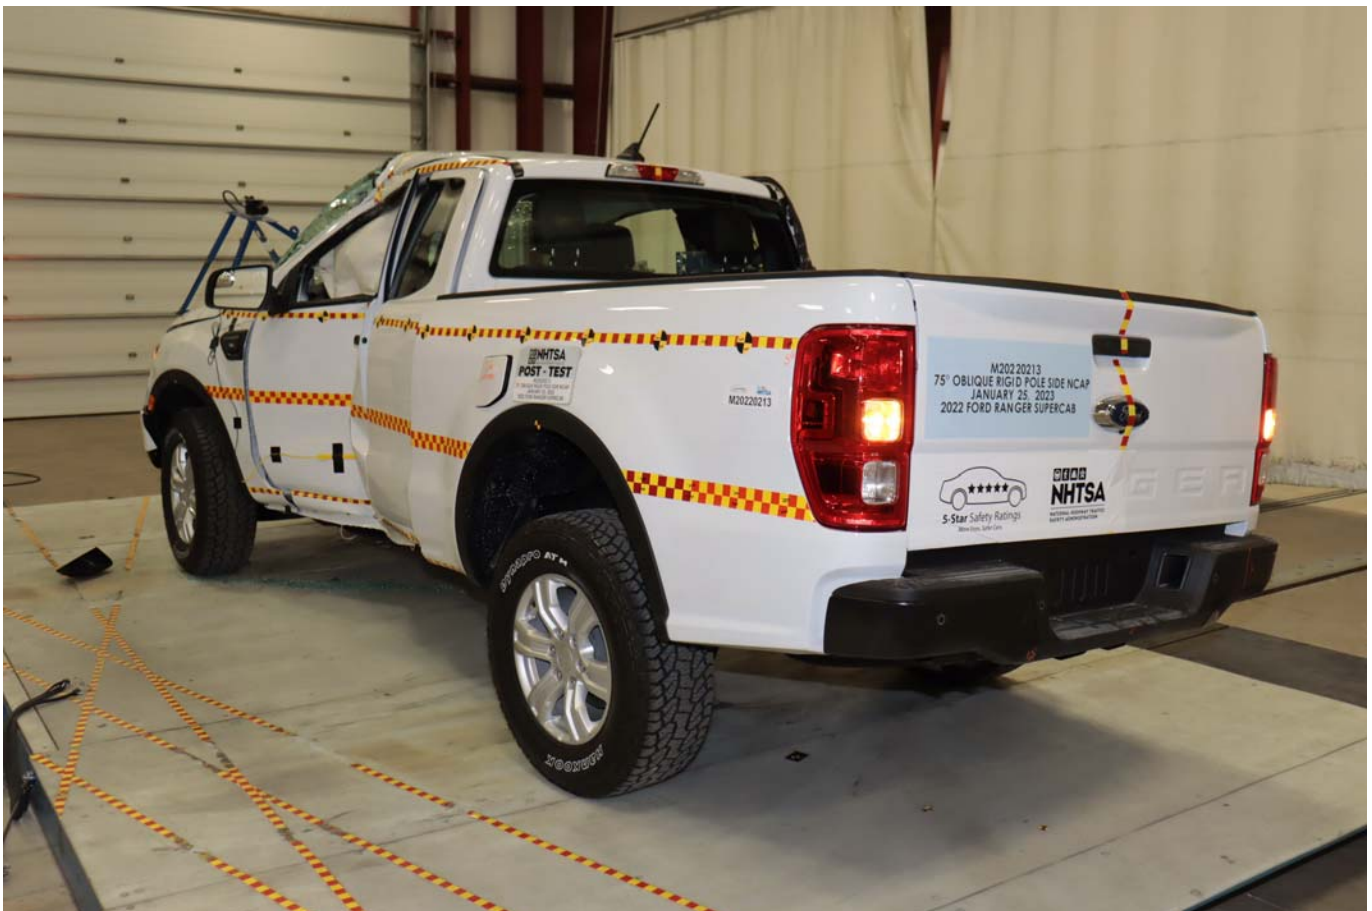
Photo No. 010 - Post-Test Left Rear Three-Quarter View of Test Vehicle

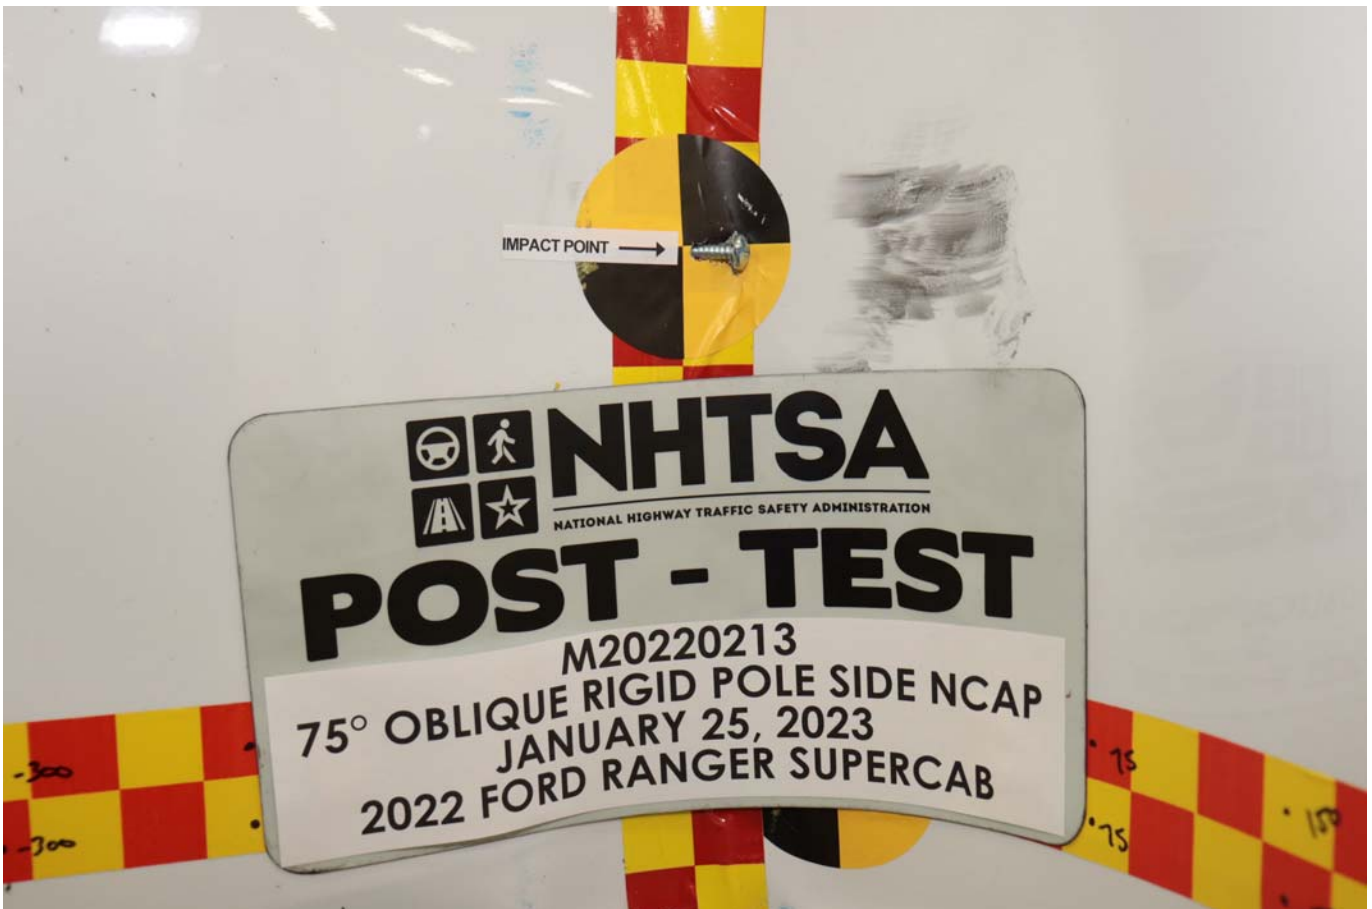
Photo No. 020 - Post-Test Close-Up View of Impact Point Target Showing Impact Location

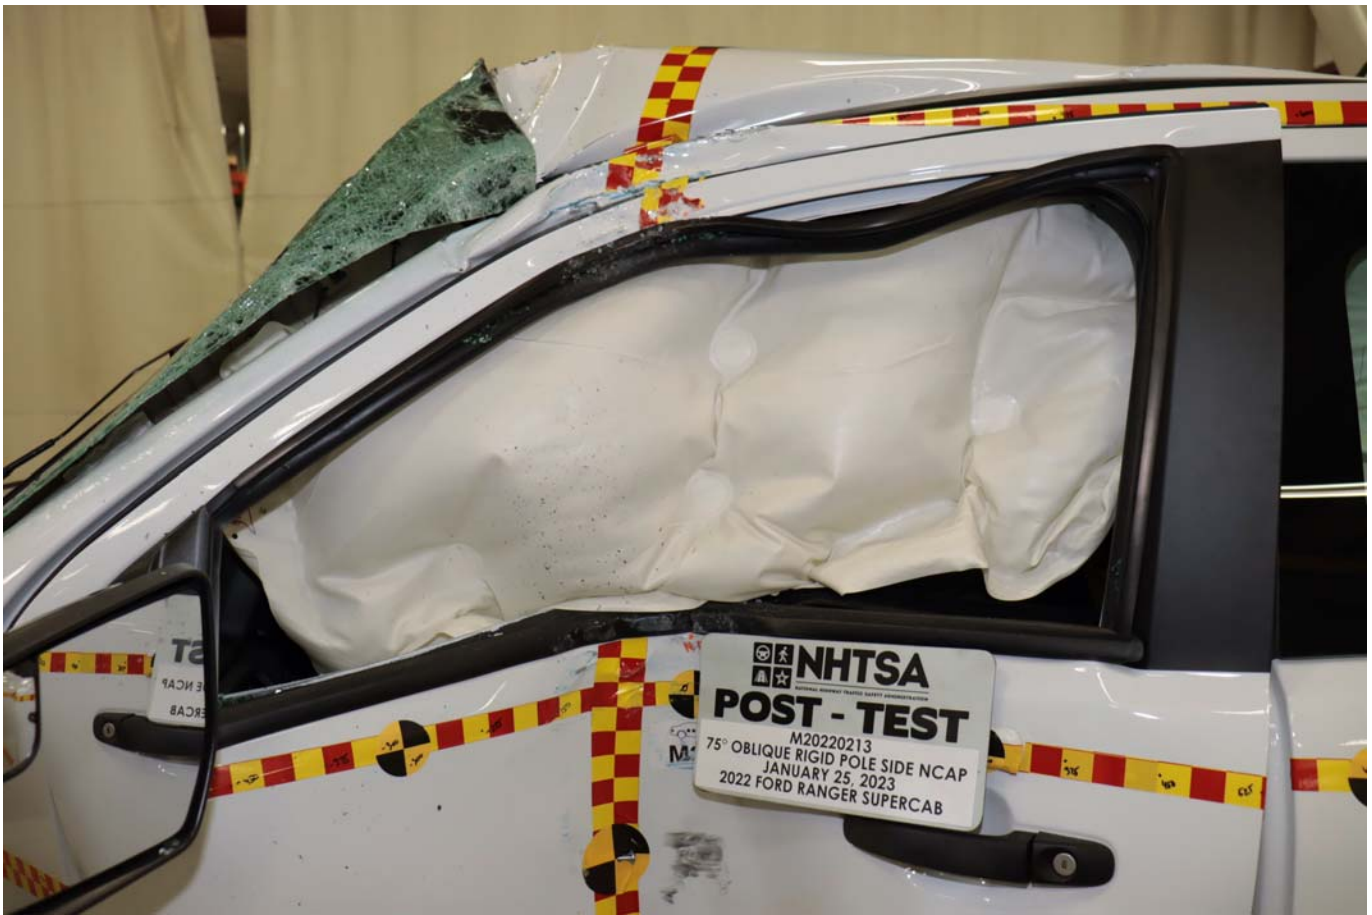
Photo No. 025 - Post-Test Left Side View of Dummy Shoulder and Door Top View

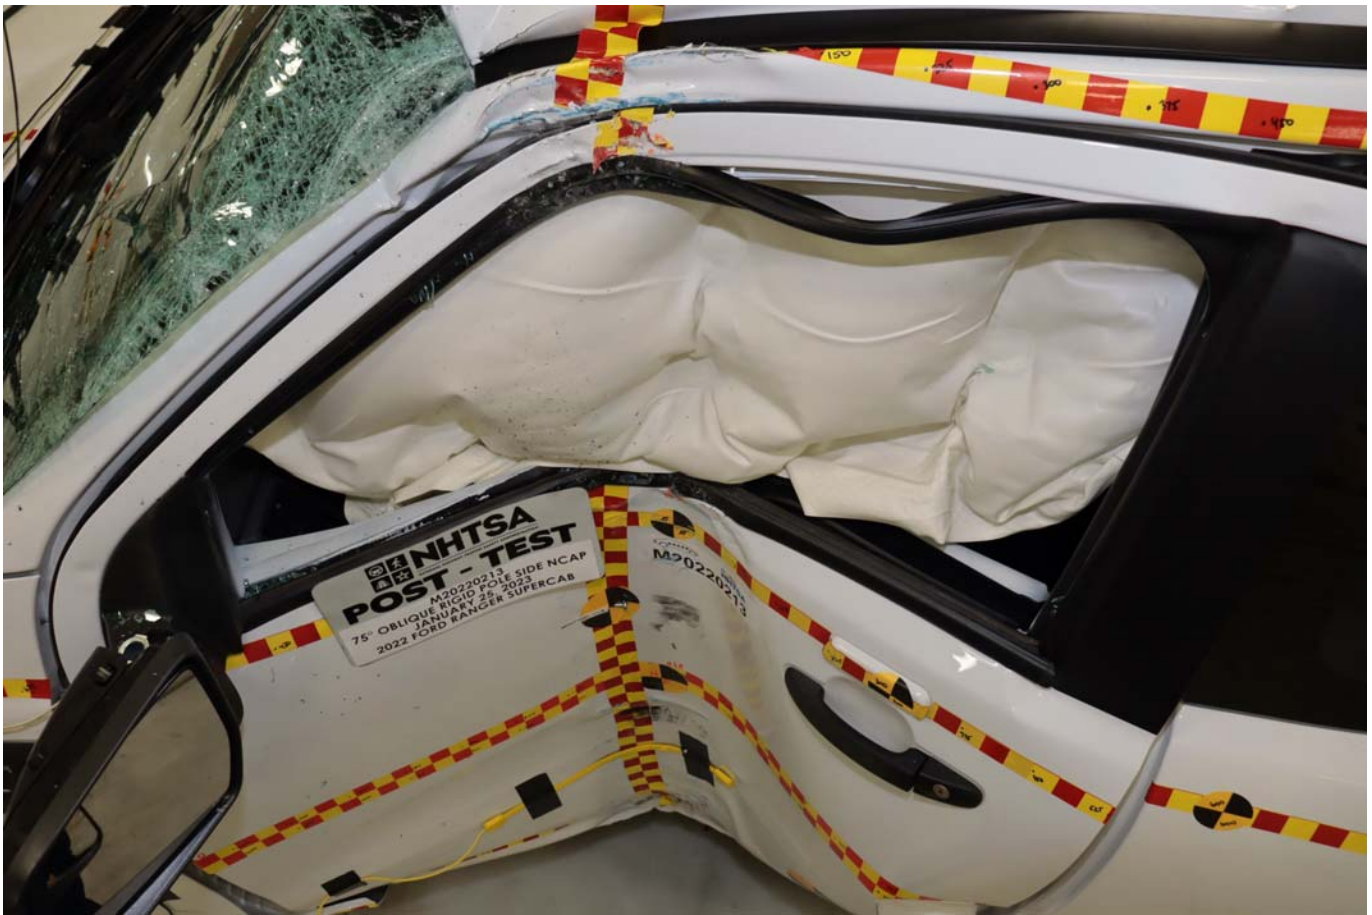
Photo No. 041 - Post-Test Dummy and Door Clearance View

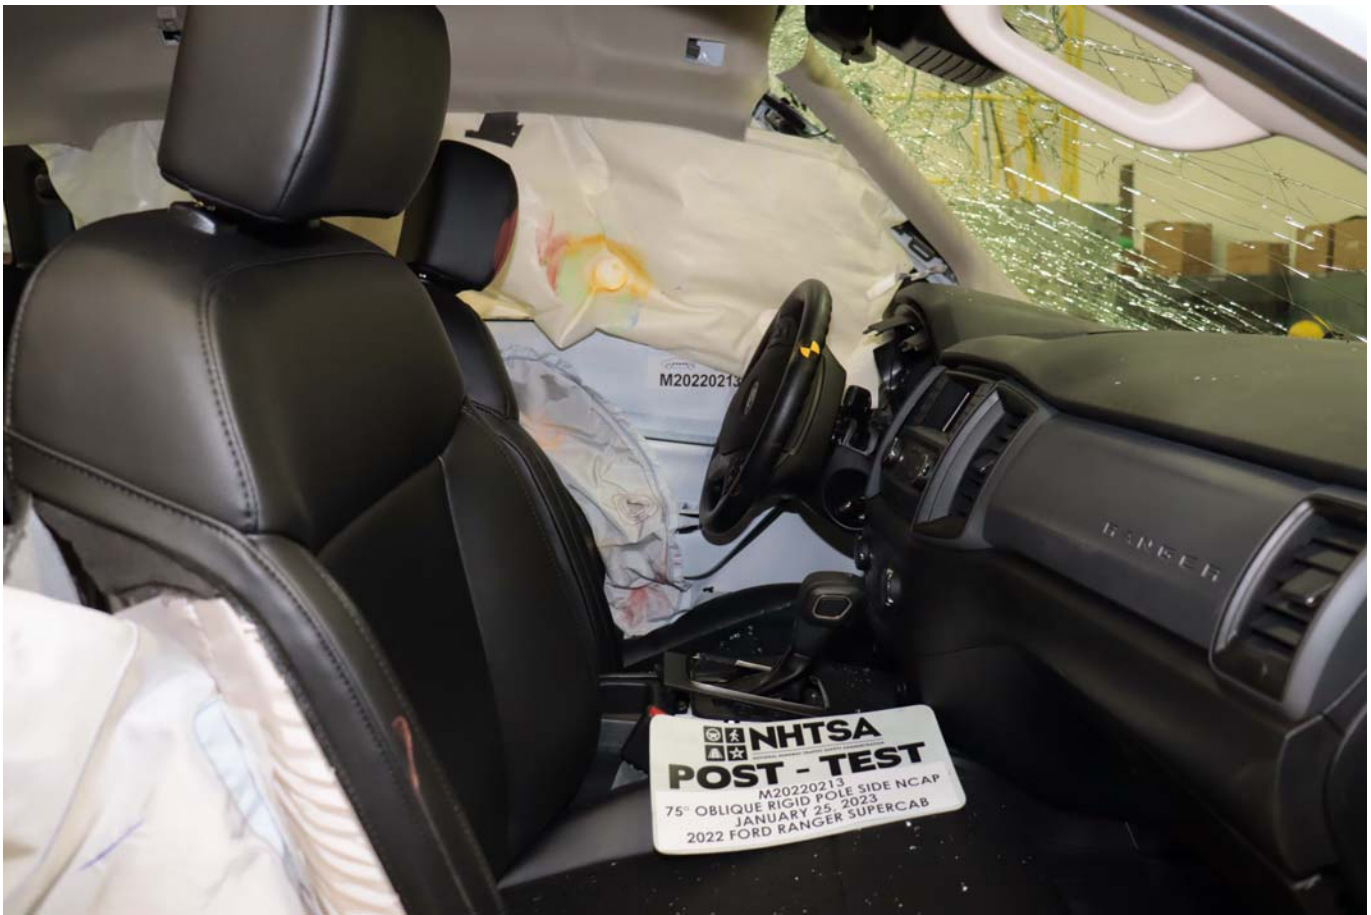
Photo No. 045 - Post-Test Inner Door Panel View Showing Dummy Contact Location

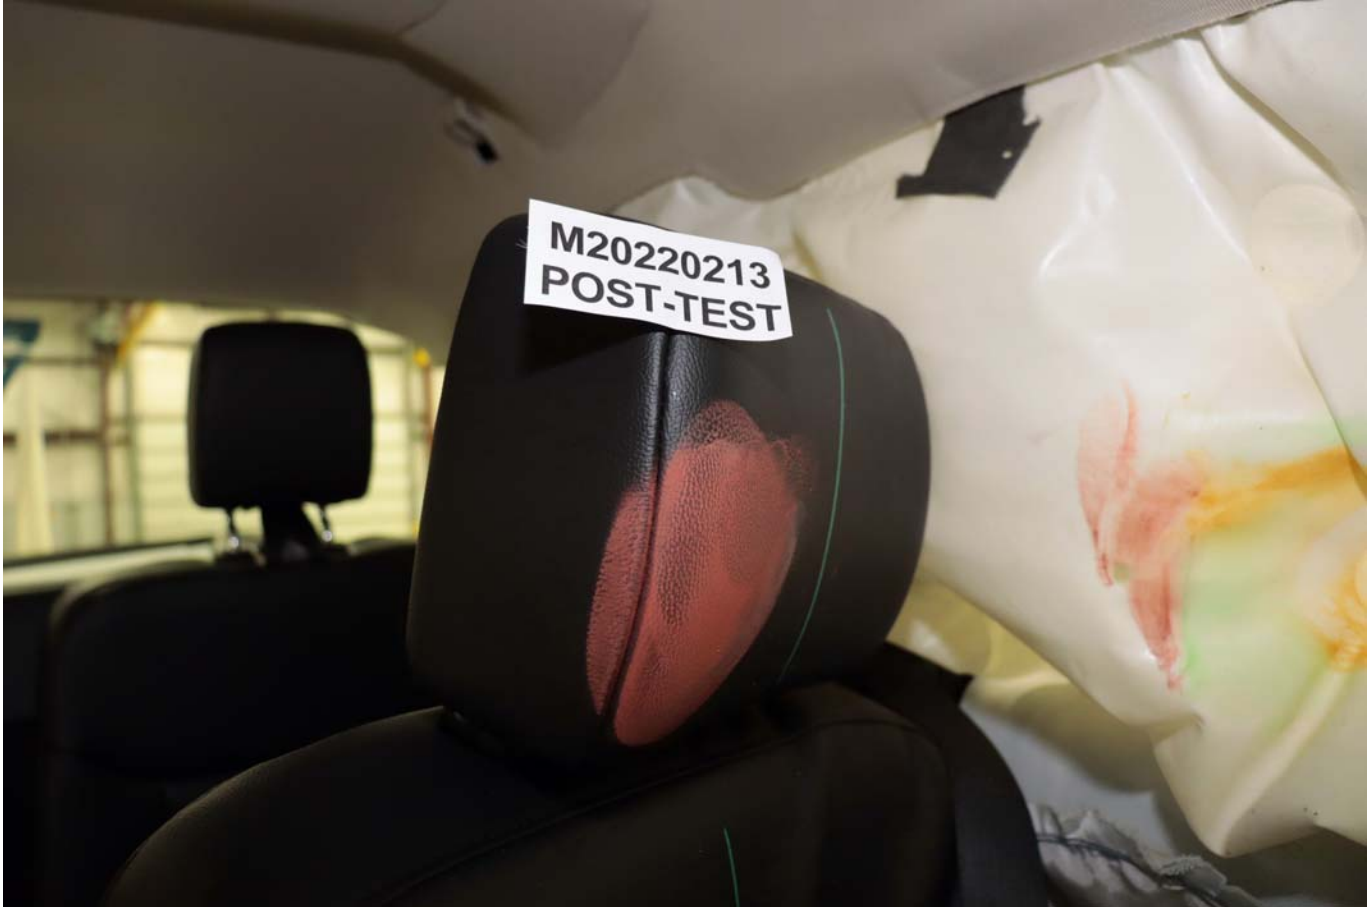
Photo No. 046 - Post-Test Dummy Close-Up Head Contact with Vehicle Interior View

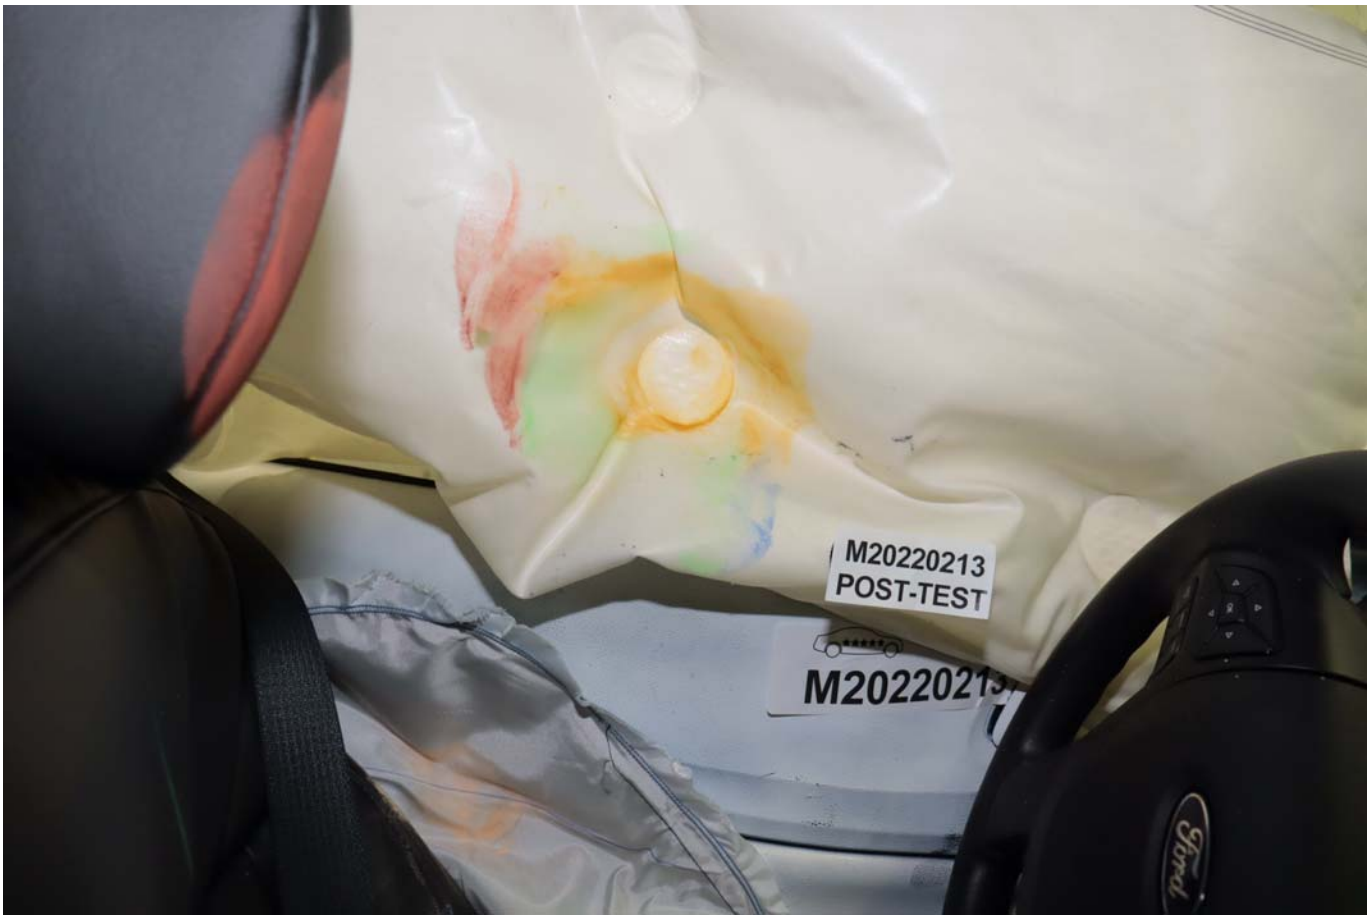
Photo No. 047 - Post-Test Dummy Close-Up Head Contact with Side Air Bag View

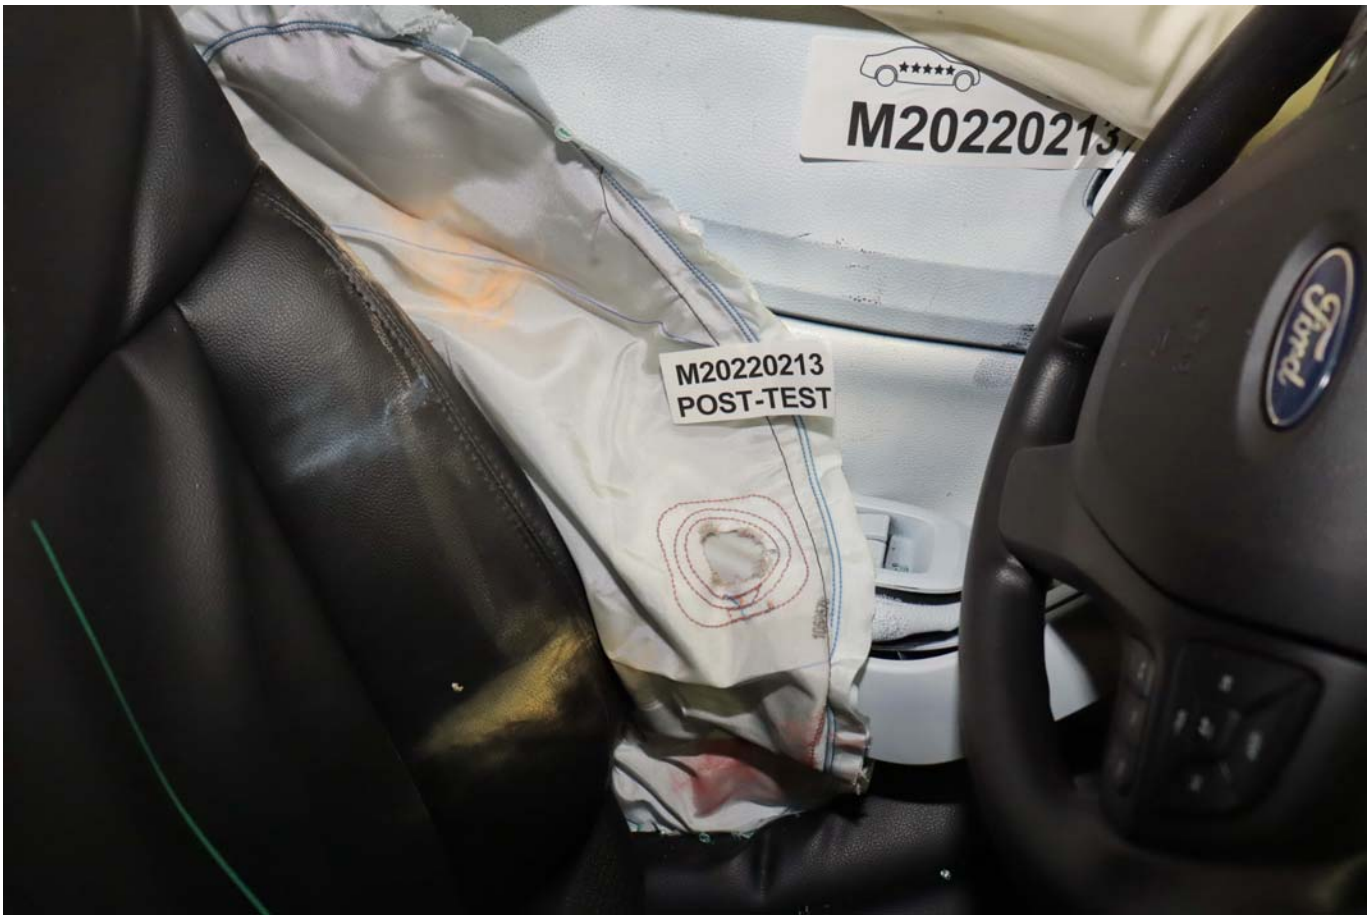
Photo No. 049 - Post-Test Dummy Close-Up Torso Contact with Side Air Bag View

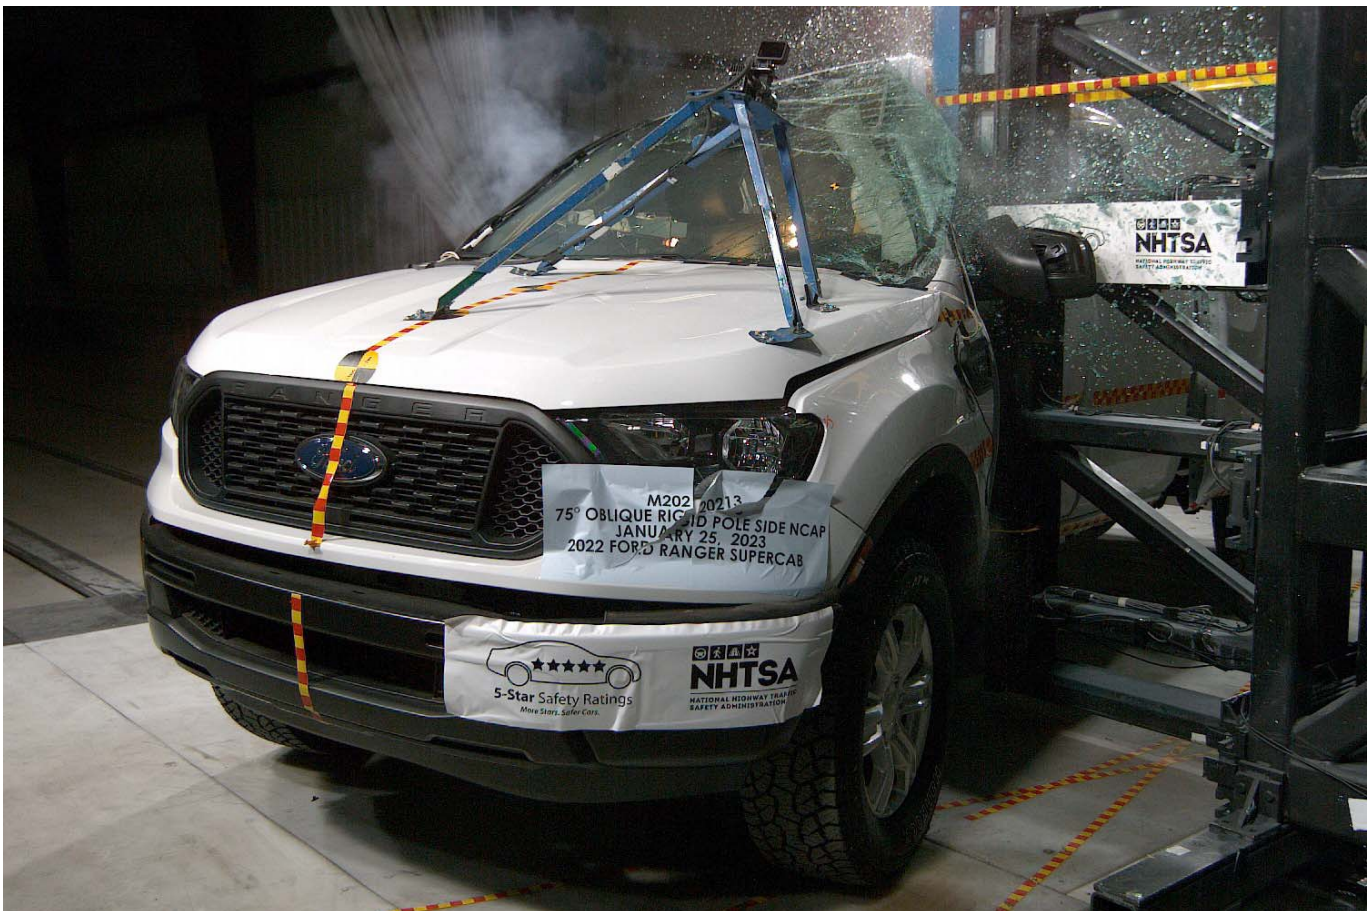
Photo No. 070 - Impact Event

A rigid pole side impact test was conducted on a 2022 Ford Ranger XL SuperCab. The subject vehicle was towed into the rigid pole at an angle of 75° and a velocity of 32.24 km/h. The test was conducted by MGA Research Corporation in Burlington, Wisconsin on January 25, 2023. Pre-test and post-test photographs of the test vehicle and side impact dummy (SID-IIs) are included in Appendix A of this report.

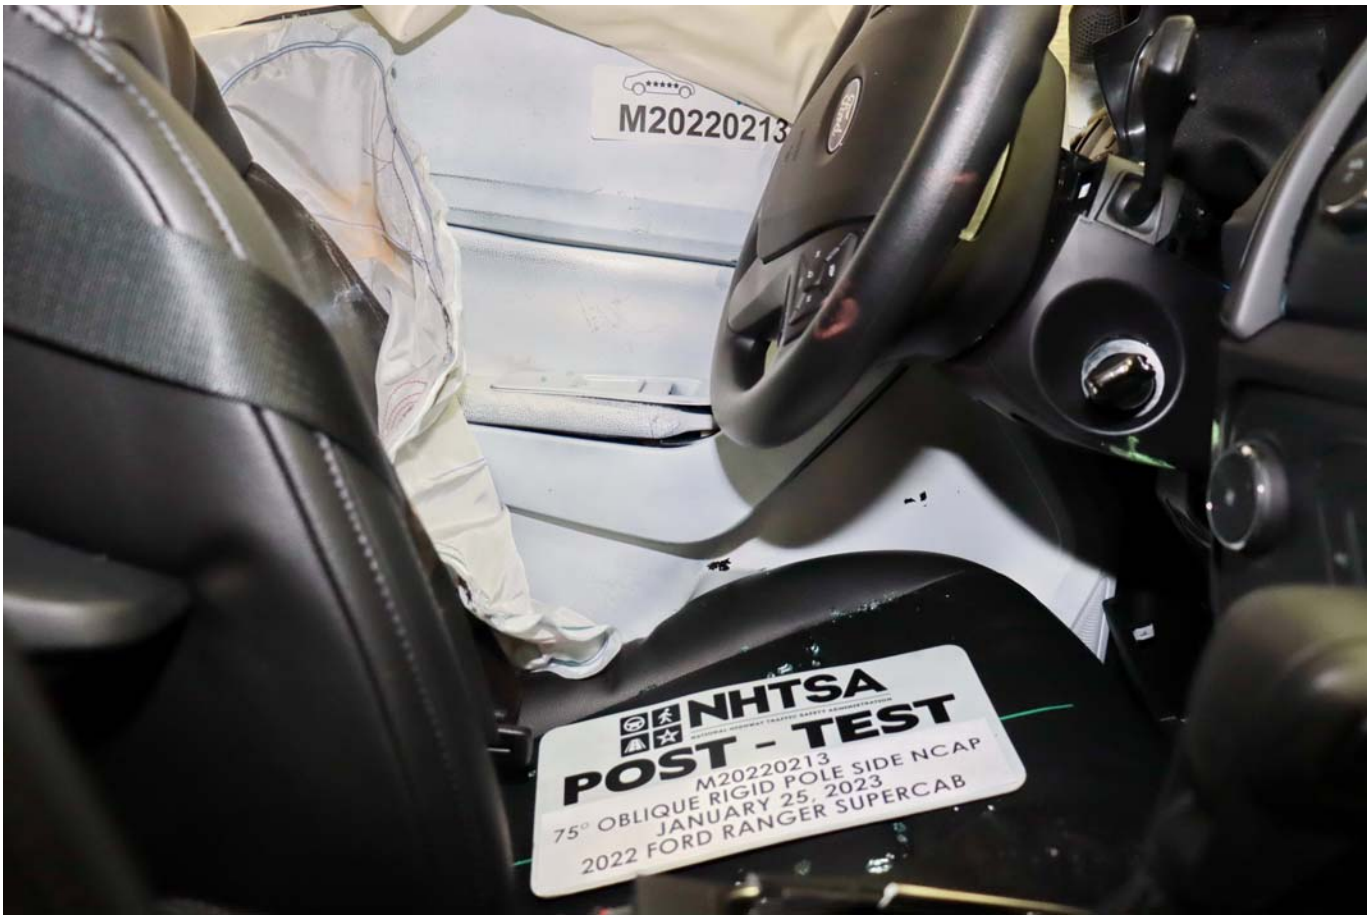
Photo No. 073 - Post-Test View of Shattered Vehicle Inner Door Panel
