REPORT NUMBER: SideNCAPMDB-KAR-23-004

**NEW CAR ASSESSMENT PROGRAM (NCAP)
MOVING DEFORMABLE BARRIER SIDE IMPACT TEST**

**HYUNDAI MOTOR MANUFACTURING ALABAMA, LLC
2023 HYUNDAI SANTA CRUZ 4-DOOR TRUCK**

NHTSA No: M20234202

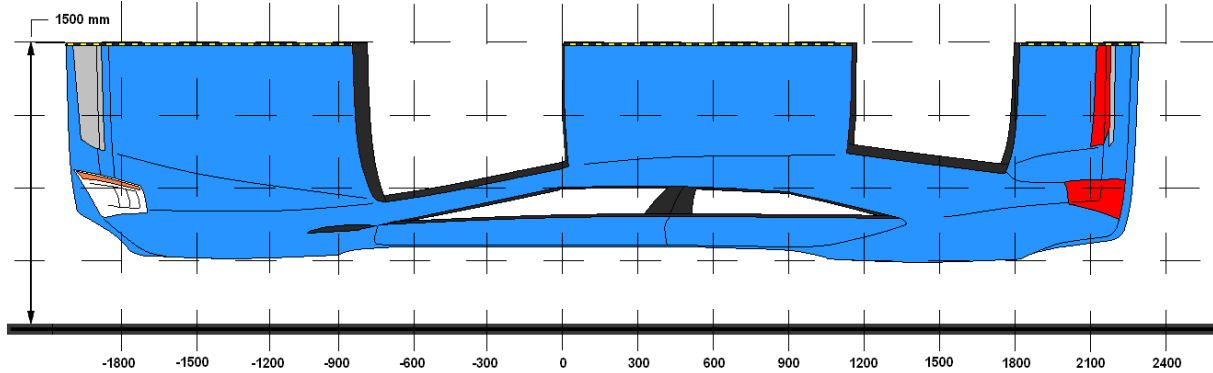
VEHICLE AND MDB DAMAGE PROFILE DISTANCES

VEHICLE DAMAGE PROFILE DISTANCES

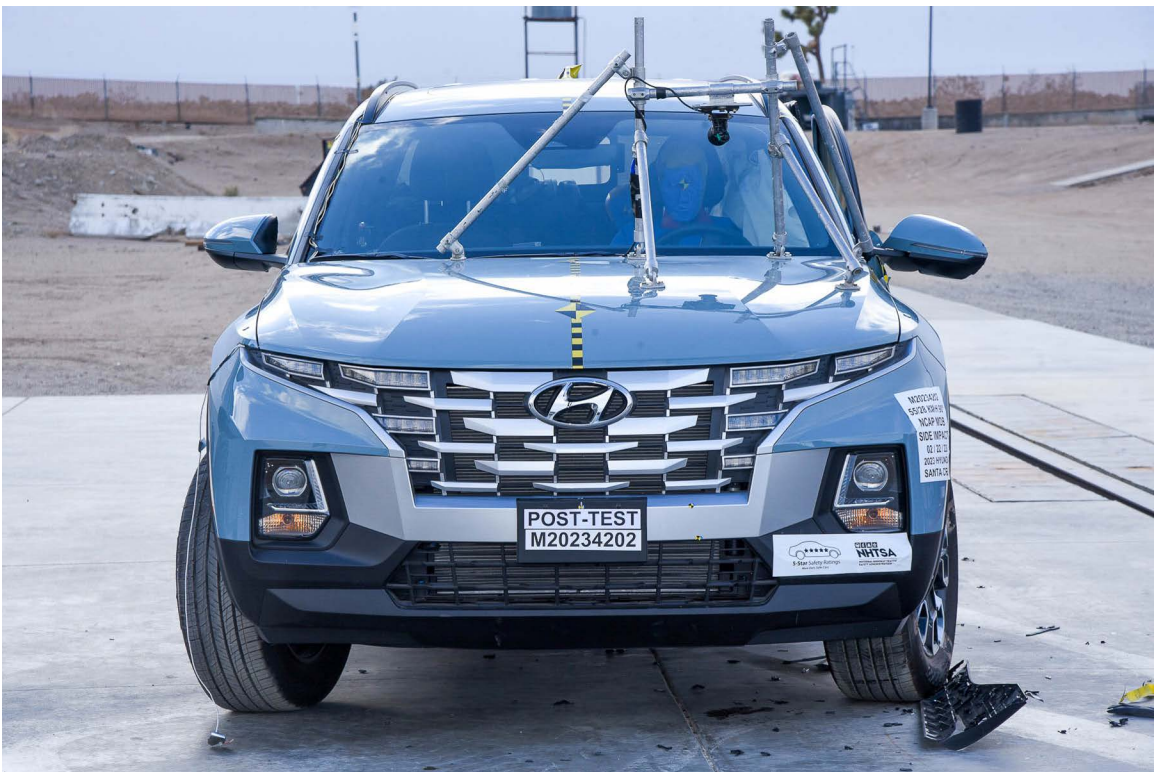
FIGURE 3. Pre-Test Frontal View of Test Vehicle

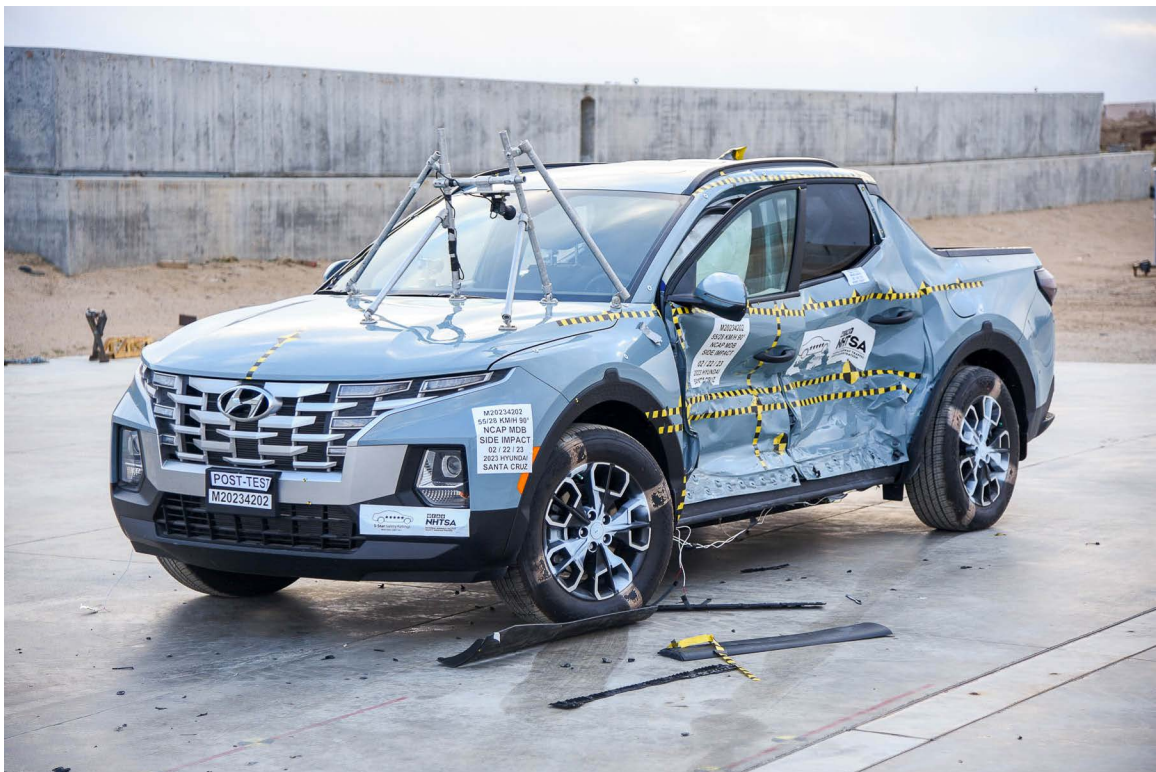
FIGURE 5. Pre-Test Left Front 3/4 View of Test Vehicle

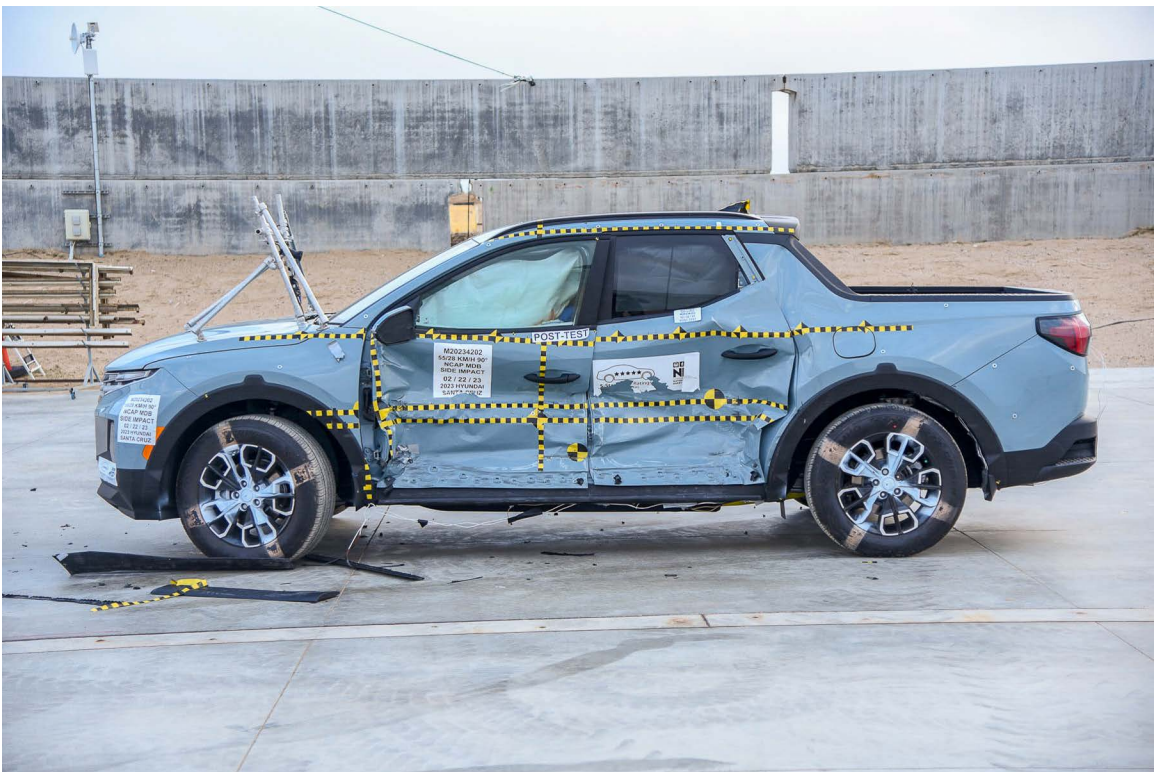
FIGURE 7. Pre-Test Left Side View of Test Vehicle

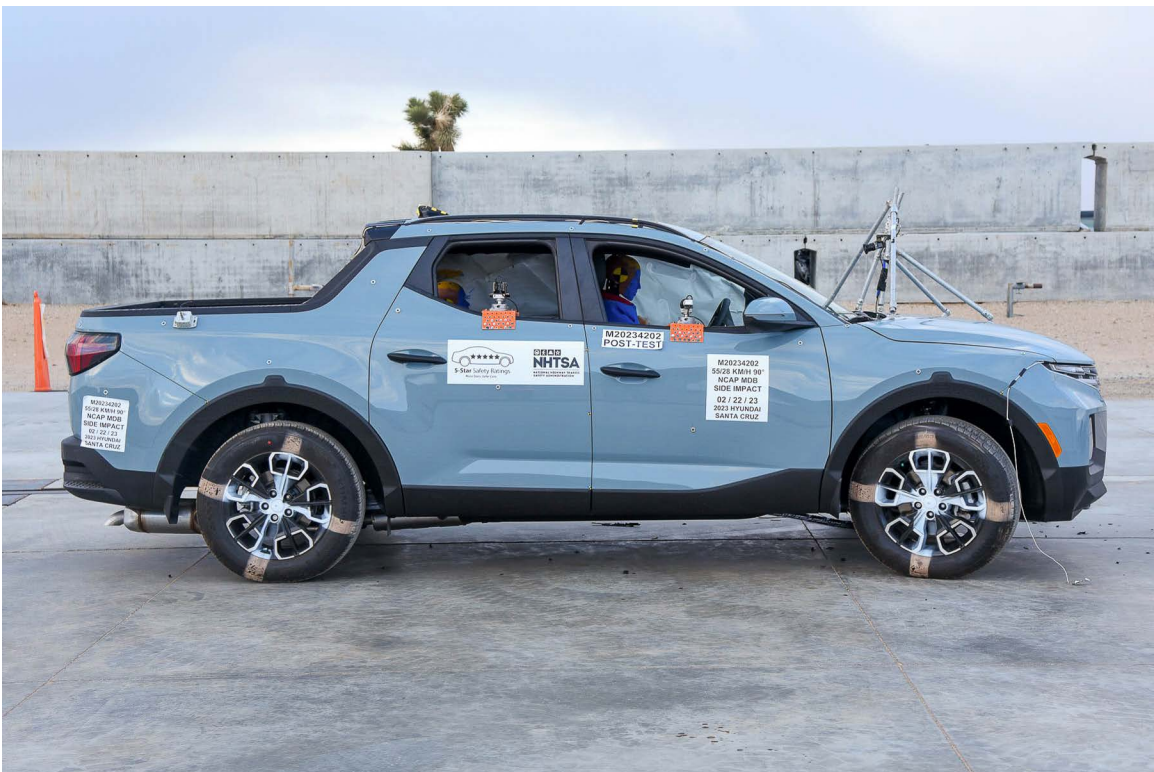
FIGURE 13. Pre-Test Right Side View of Test Vehicle

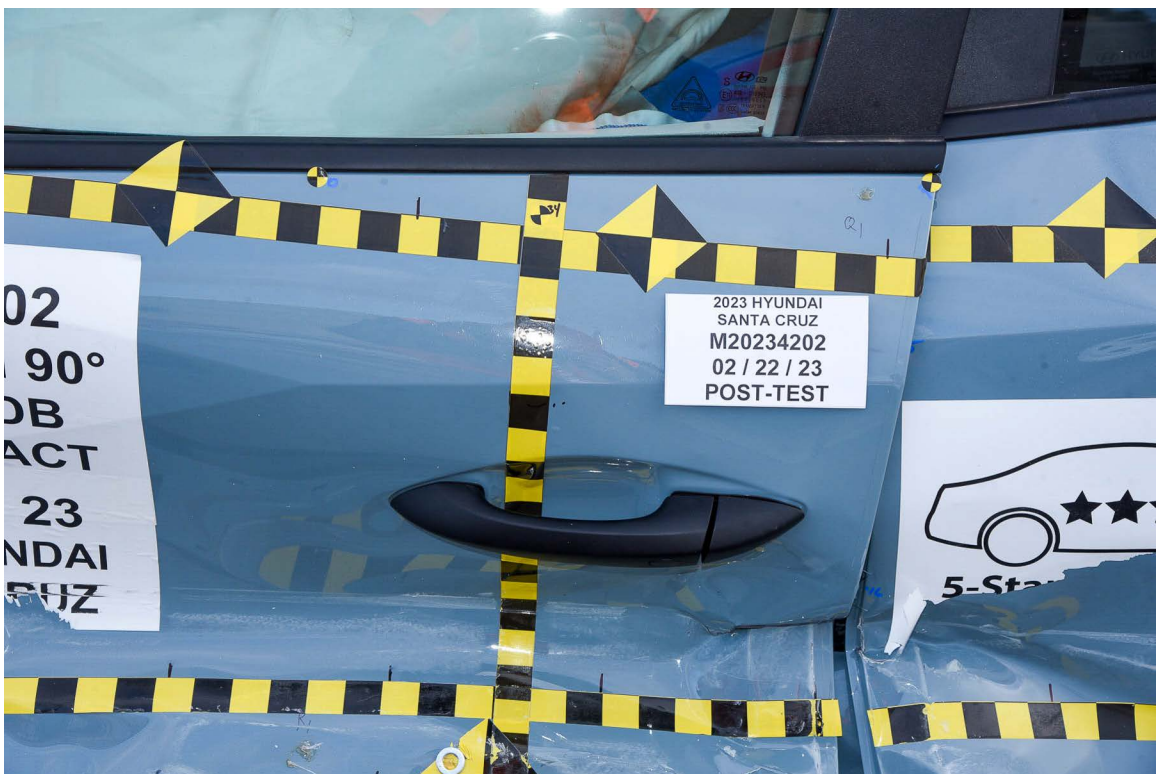
FIGURE 21. Pre-Test Left Front Door Latch Close-Up

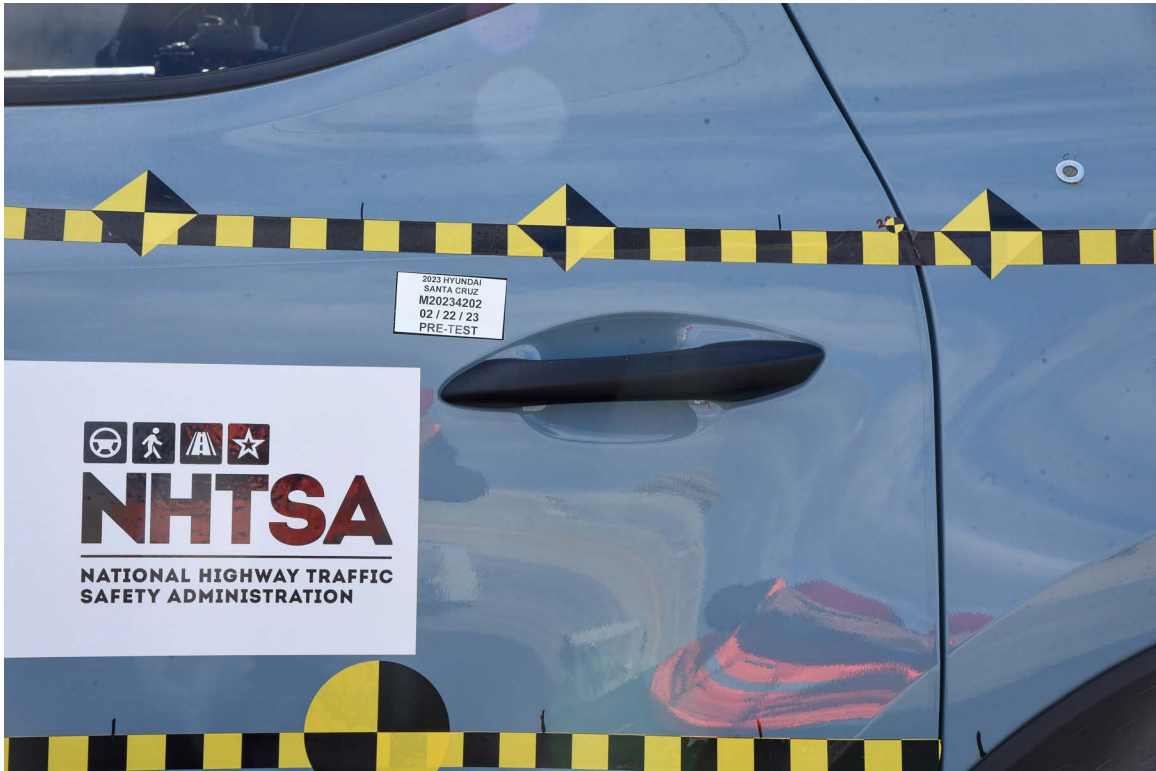
FIGURE 22. Post-Test Left Front Door Latch Close-Up

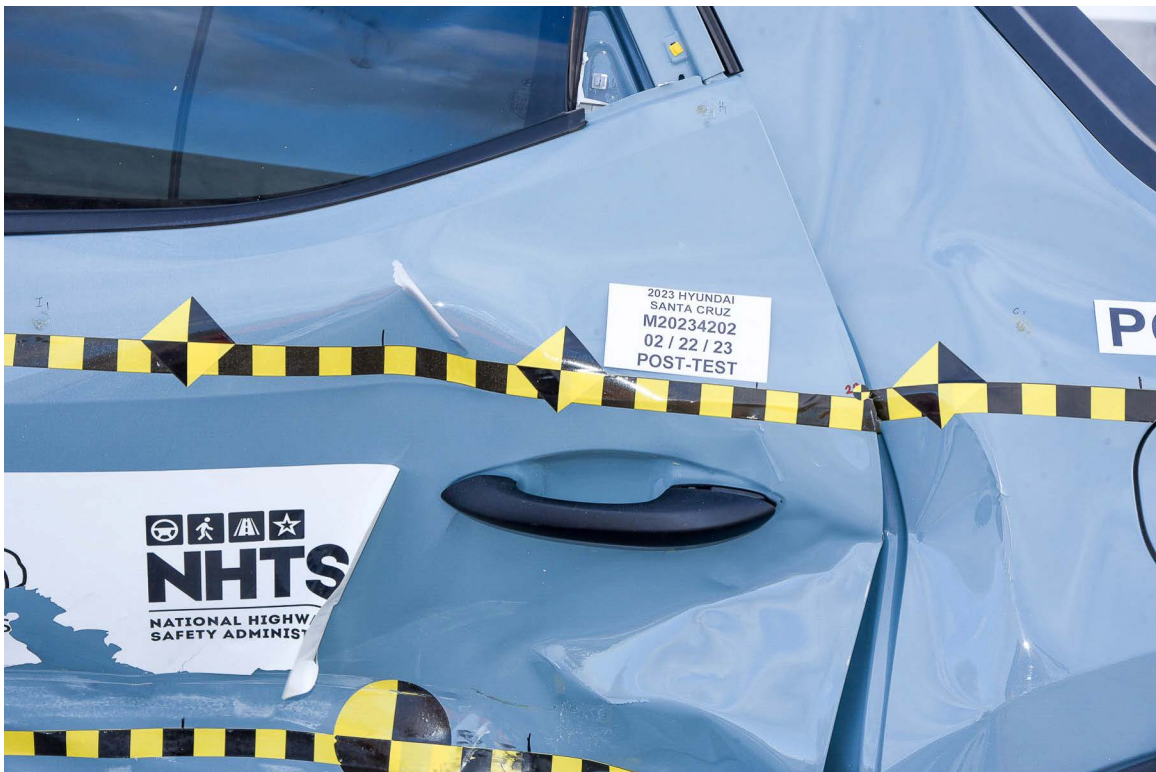
FIGURE 23. Pre-Test Left Rear Door Latch Close-Up

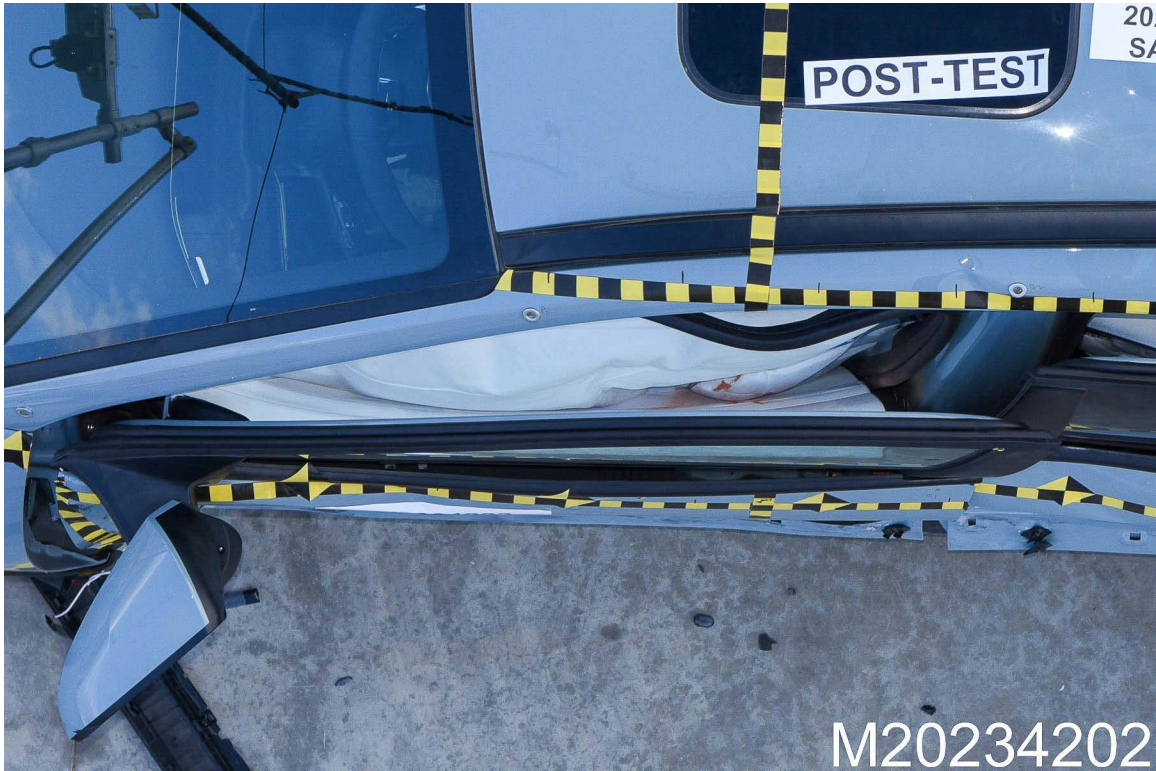
FIGURE 42. Pre-Test Driver Dummy and Door Clearance View

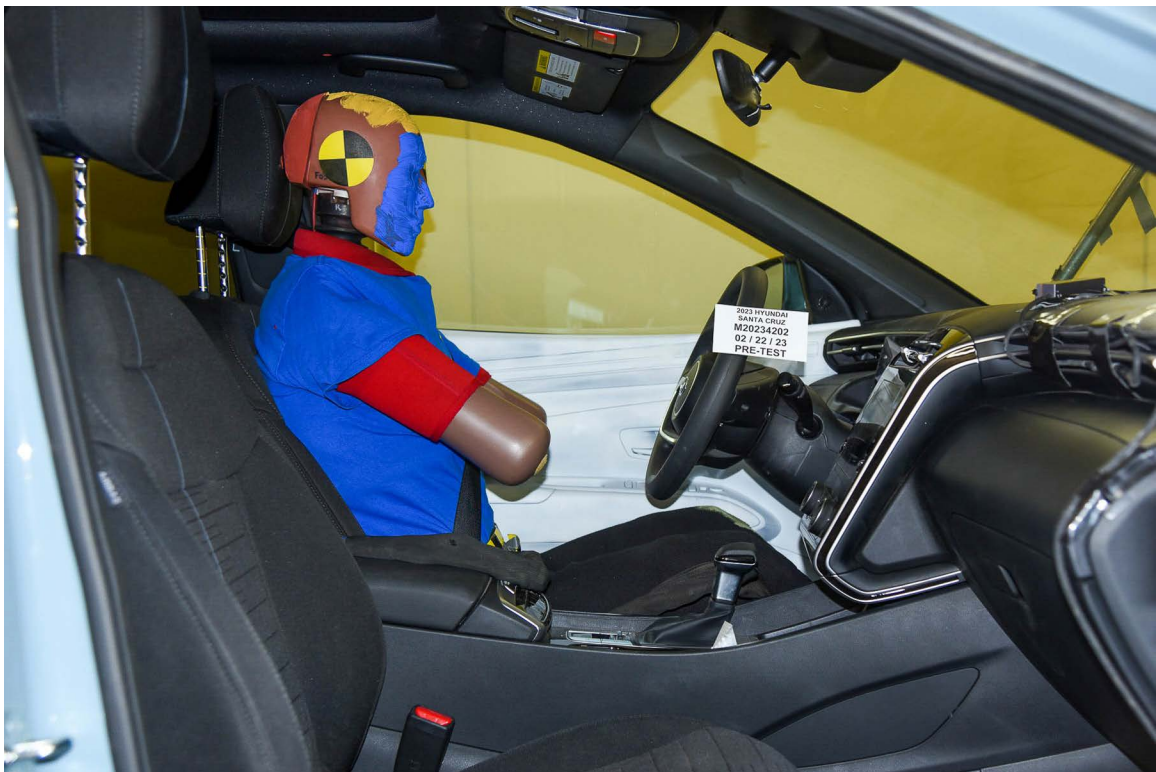
FIGURE 43. Post-Test Driver Dummy and Door Clearance View

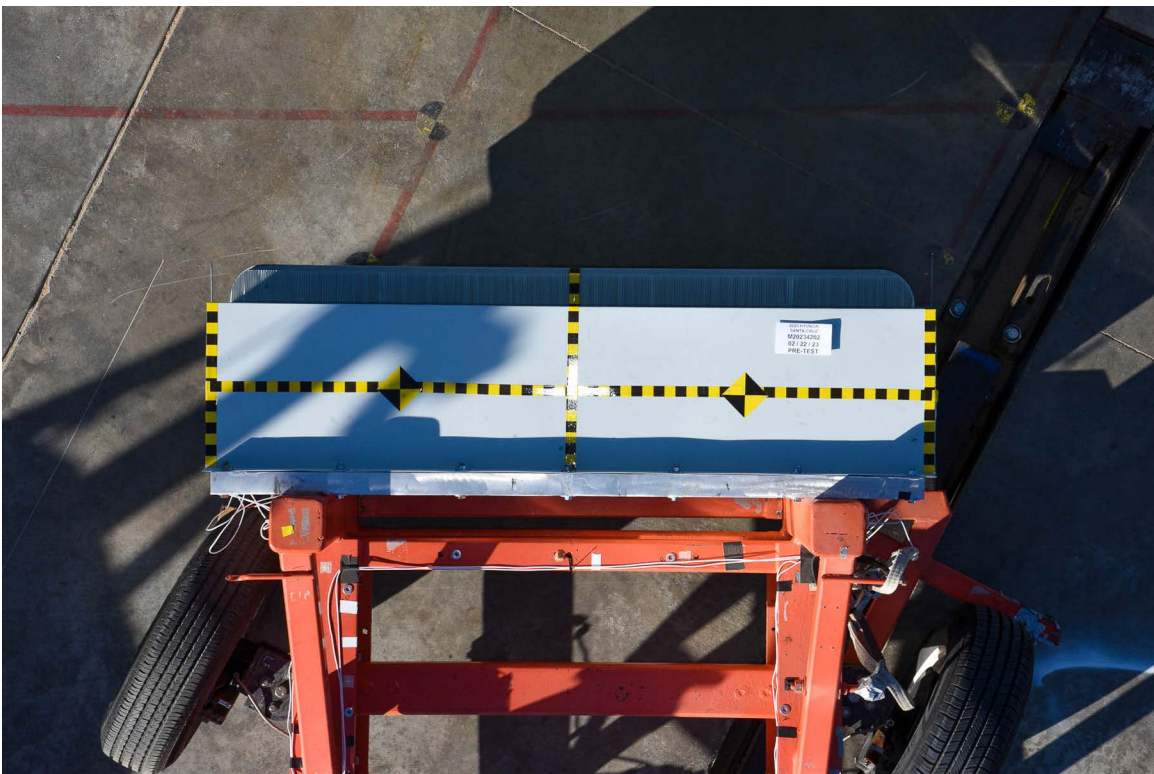
FIGURE 85. Post-Test Front View of MDB Impactor Face
