**REPORT NUMBER: NCAP-MGA-22-037**

**NEW CAR ASSESSMENT PROGRAM (NCAP)  
Frontal Barrier Impact Test**

**FORD MOTOR CO.  
2022 Ford F-150 Lightning 4x4 SuperCrew  
NHTSA No.: M20220204**

**FINAL REPORT**

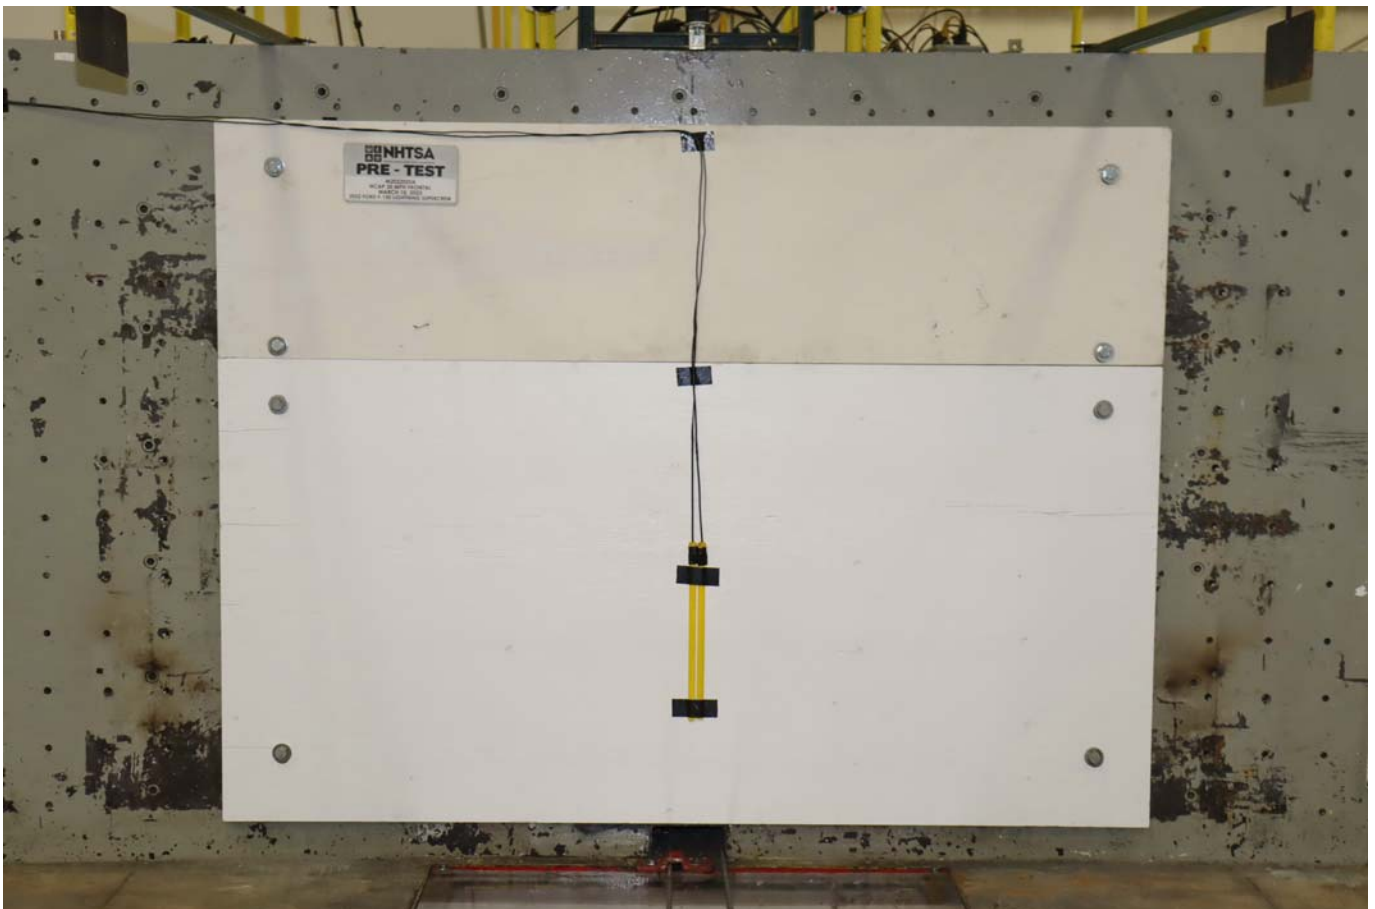
Photo No. 002 - Pre-Test Load Cell Wall

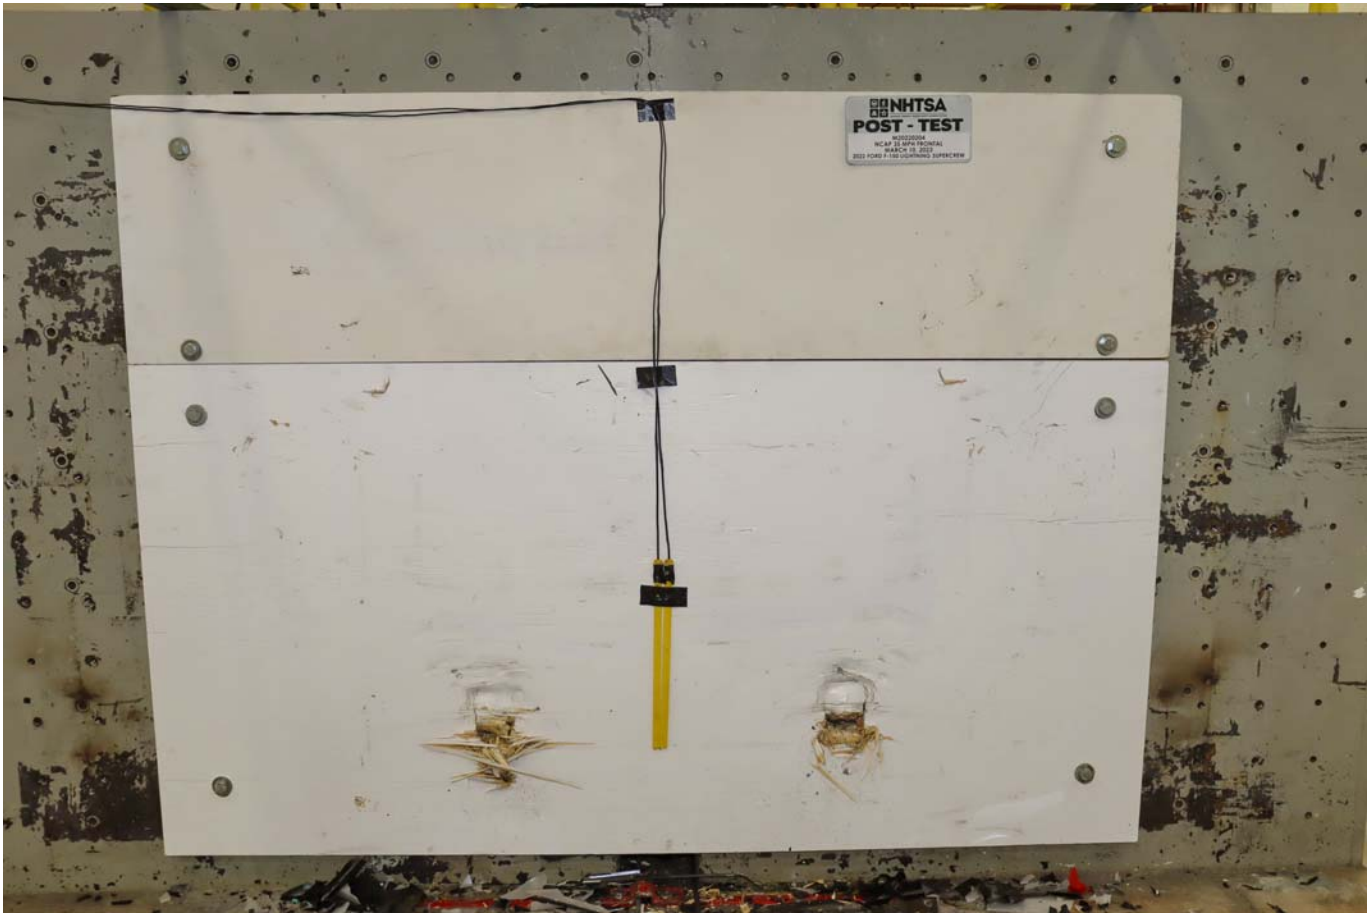
Photo No. 003 - Post-Test Load Cell Wall

A load cell barrier consisting of 176 load cells was impacted by a 2022 Ford F-150 Lightning 4x4 SuperCrew at a velocity of 56.92 km/h. The test was performed at MGA Research Corporation on March 10, 2023. Pre-test and post-test photographs of the vehicle and dummies can be found in Appendix A.

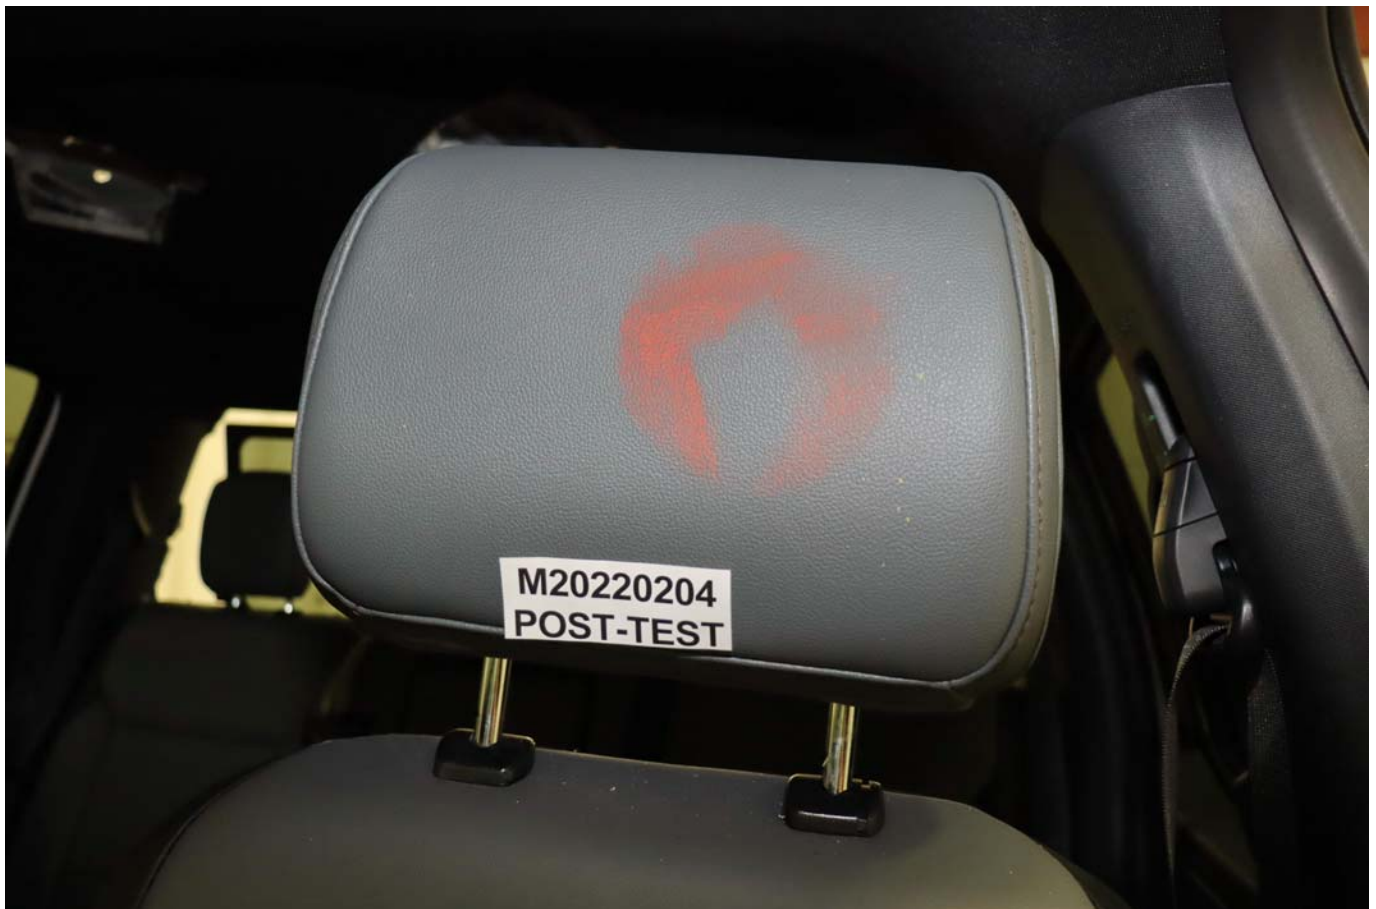
Photo No. 050 - Post-Test Driver Dummy Contact with Headrest

The driver's visible contact points were as follows: The driver's head contacted the airbag. The driver's head also contacted the headrest. The driver's knees contacted the knee airbag.

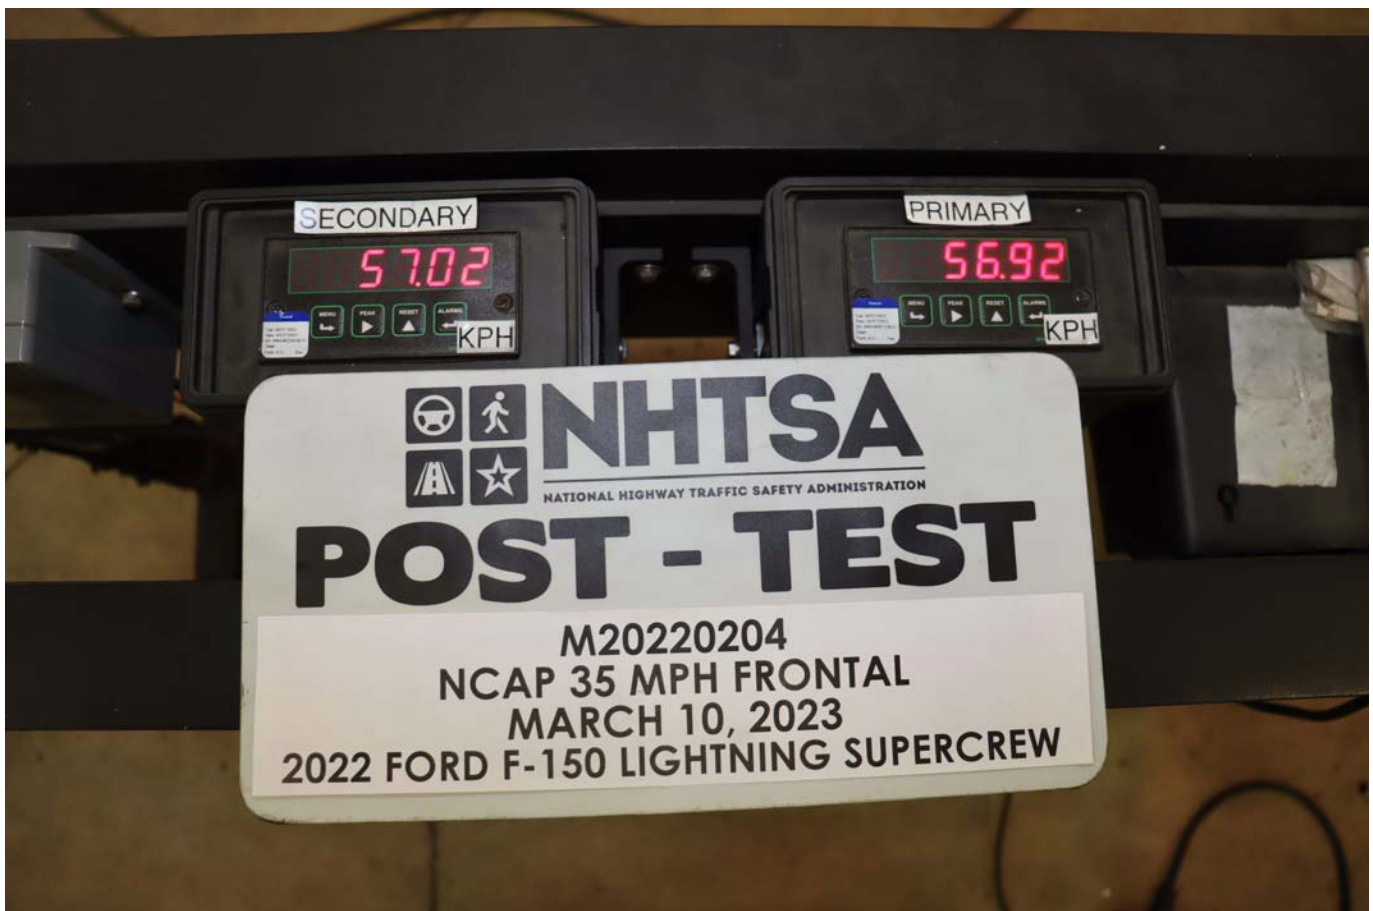
Photo No. 076 - Post-Test Speed Trap Read-Out

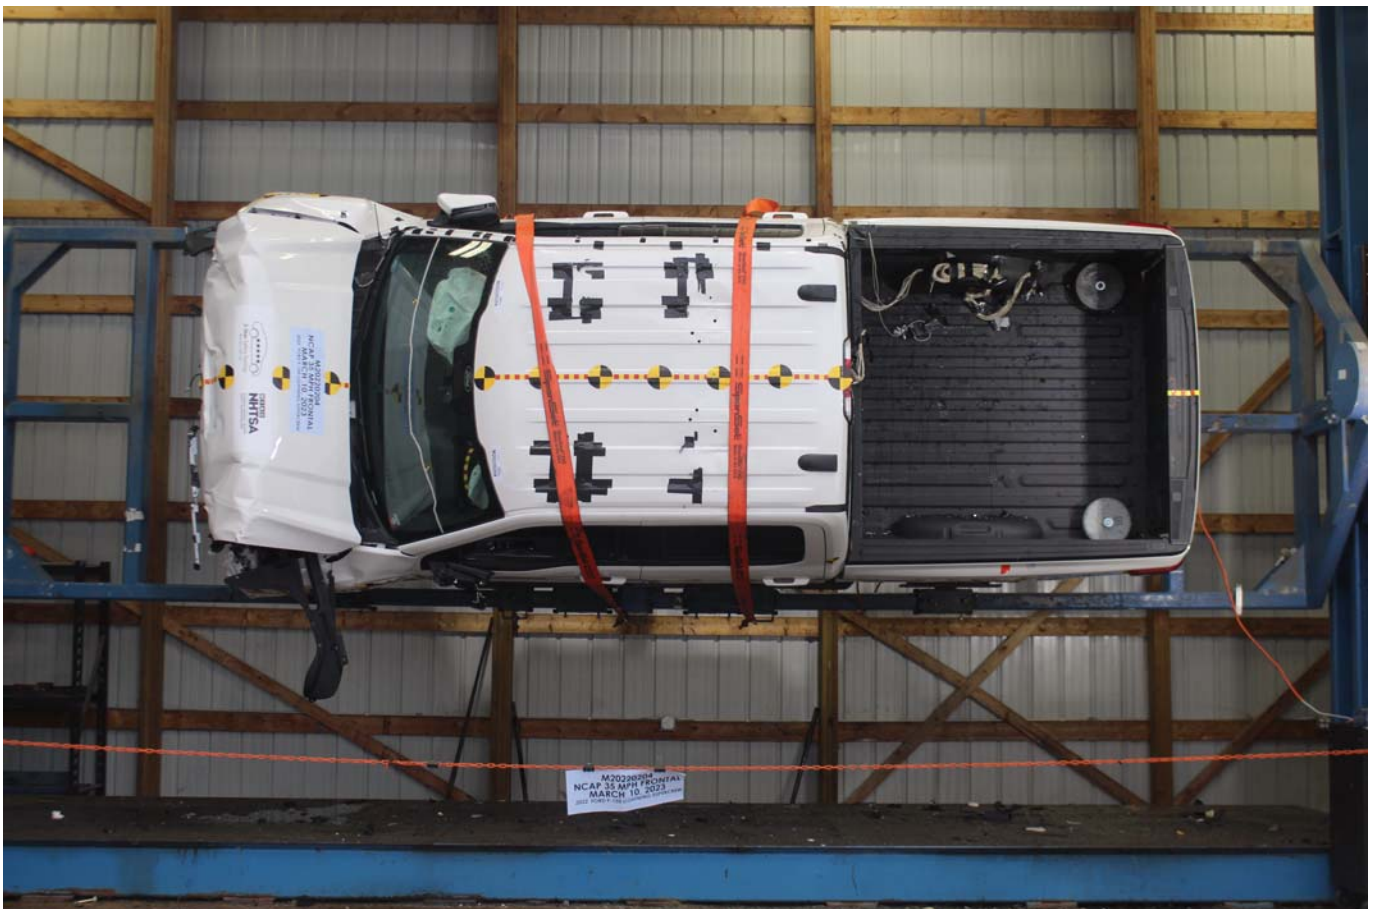
Photo No. 078 - Vehicle at 90 Degrees on Static Rollover Device

There was 100 percent windshield retention and no intrusion into the protected zone of the windshield during the event. There was no Stoddard Solvent or battery electrolyte leakage and no loss of high-voltage battery isolation after the event or during any phase of the static rollover.

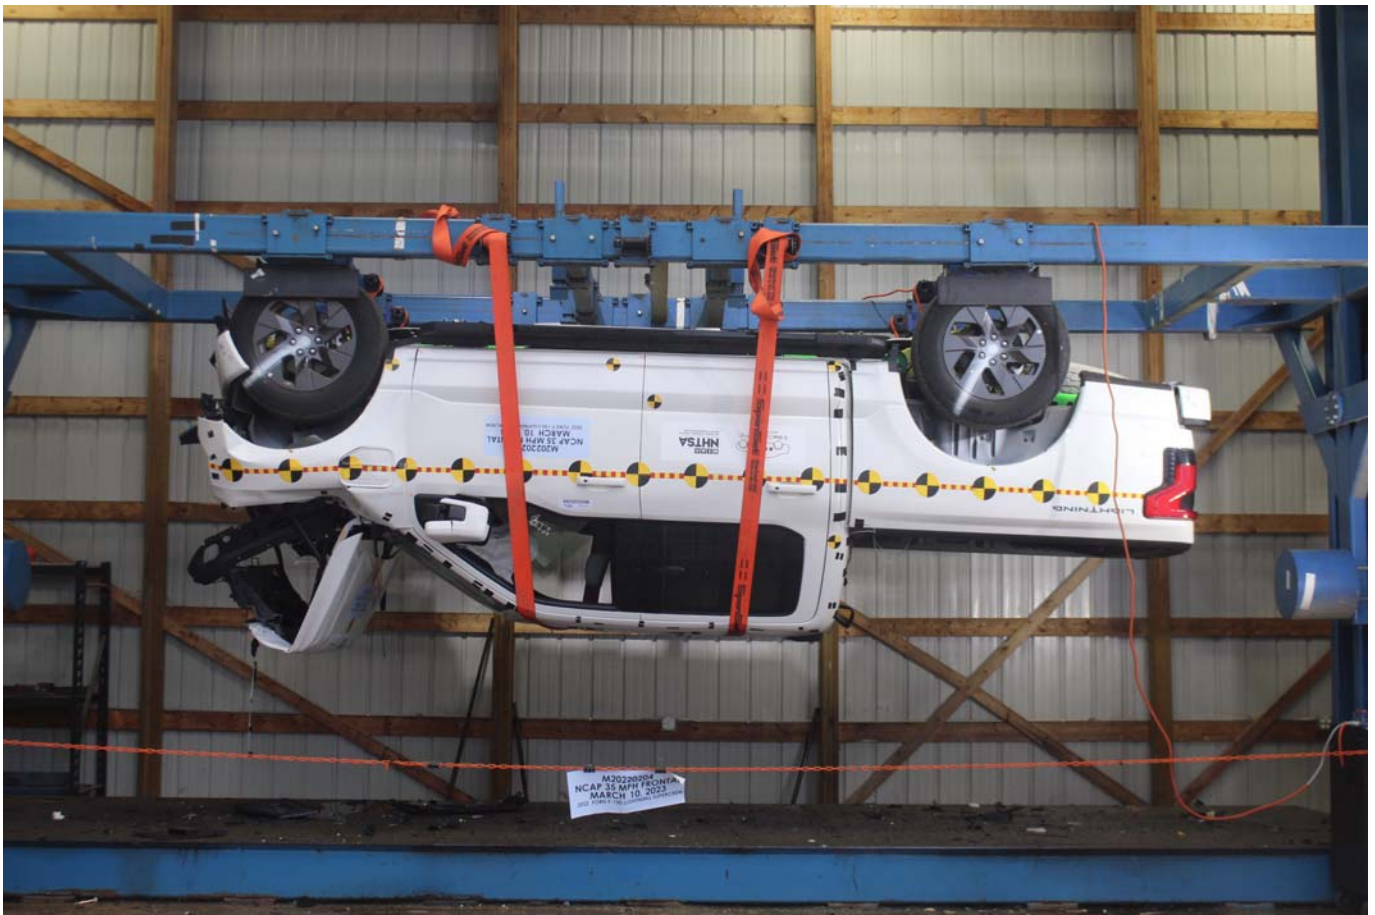
Photo No. 079 - Vehicle at 180 Degrees on Static Rollover Device

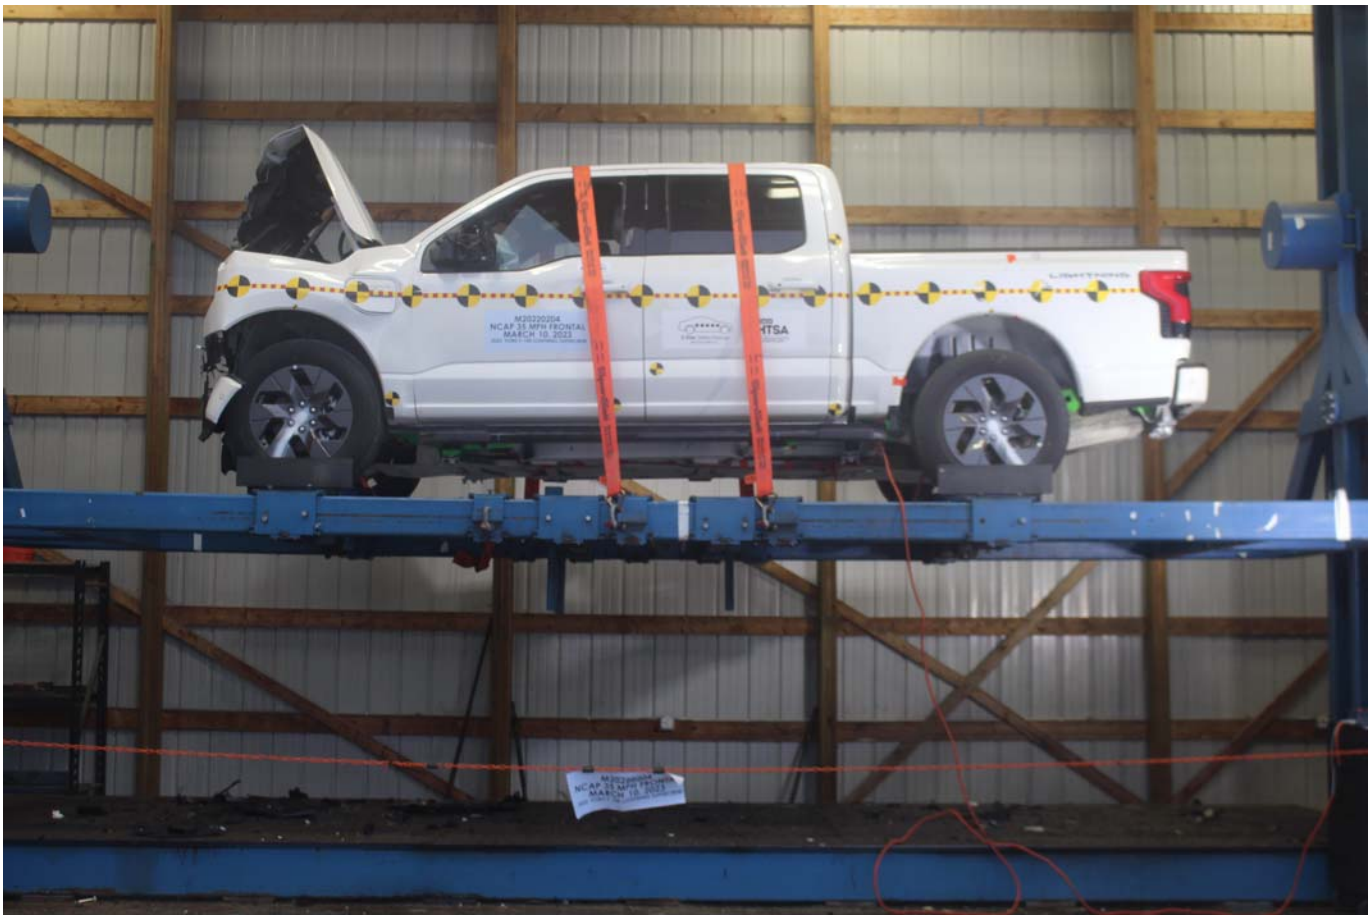
Photo No. 081 - Vehicle at 360 Degrees on Static Rollover Device

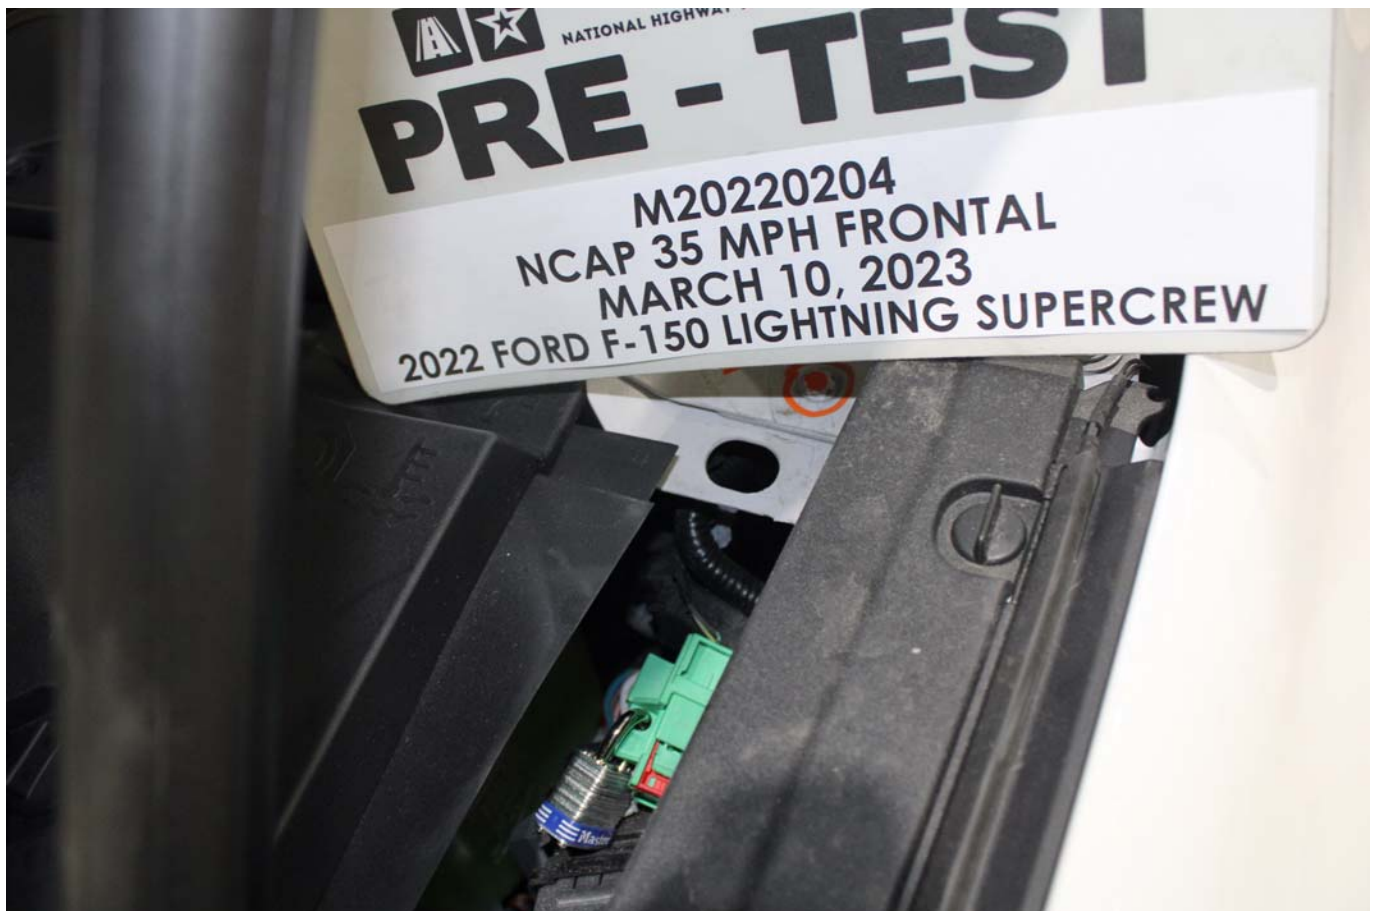
Photo No. 305-07 - Manual High Voltage Service Disconnect Removed

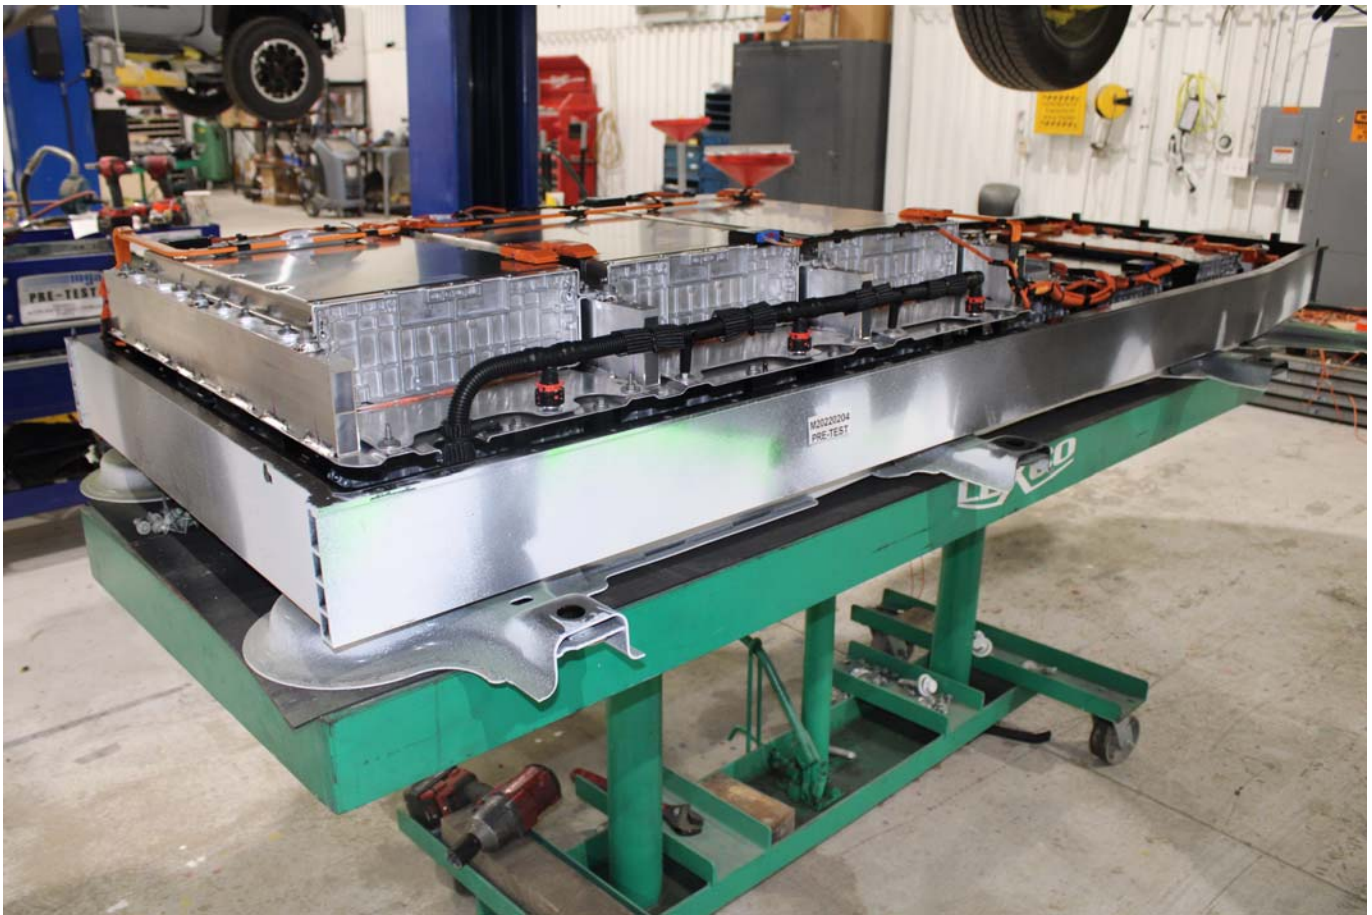
Photo No. 305-14 - Pre-Impact View of Propulsion Battery Module(s)

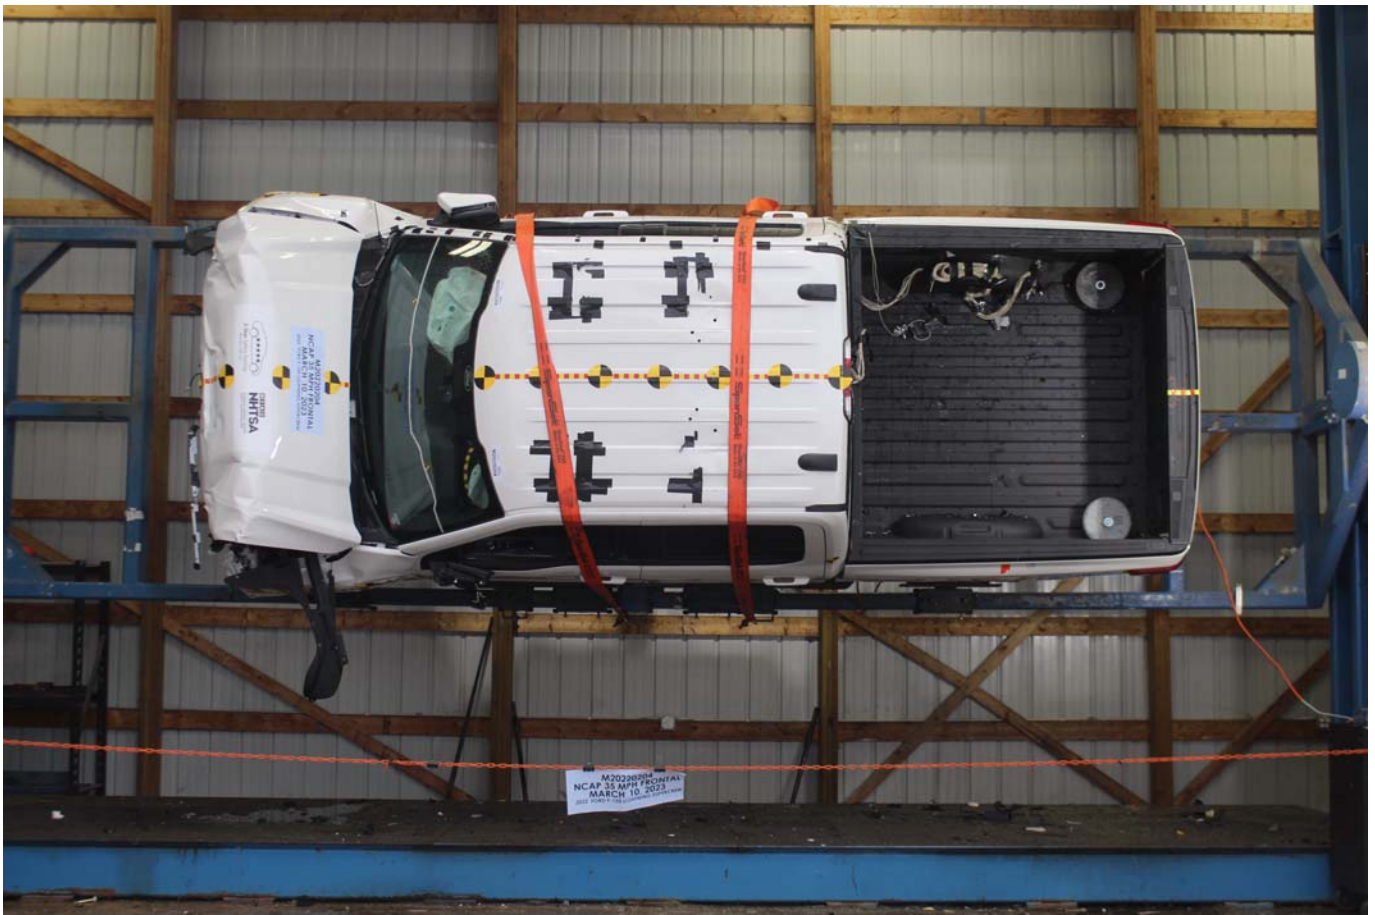
Photo No. 305-28 - FMVSS No. 305 Static Rollover at 90 Degrees

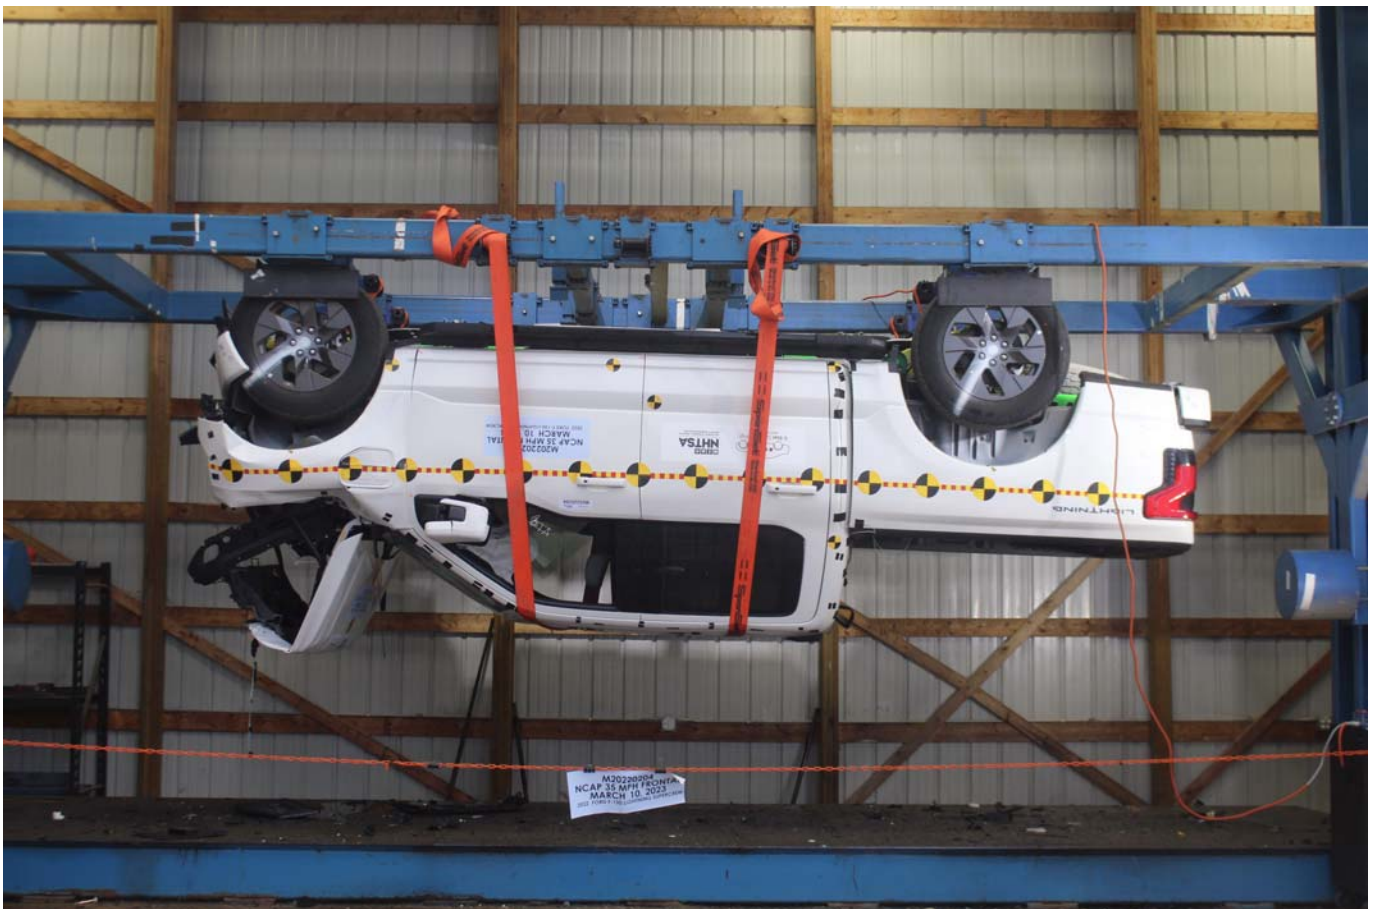
Photo No. 305-29 - FMVSS No. 305 Static Rollover at 180 Degrees
