**REPORT NUMBER: SideNCAPPole-MGA-23-012**

**NEW CAR ASSESSMENT PROGRAM (NCAP)  
Side Impact Pole Test**

**KIA GEORGIA, INC.  
2023 Kia Telluride EX 5-Door SUV  
NHTSA No.: M20234209**

**MGA RESEARCH CORPORATION  
5000 Warren Road  
Burlington, WI 53105**

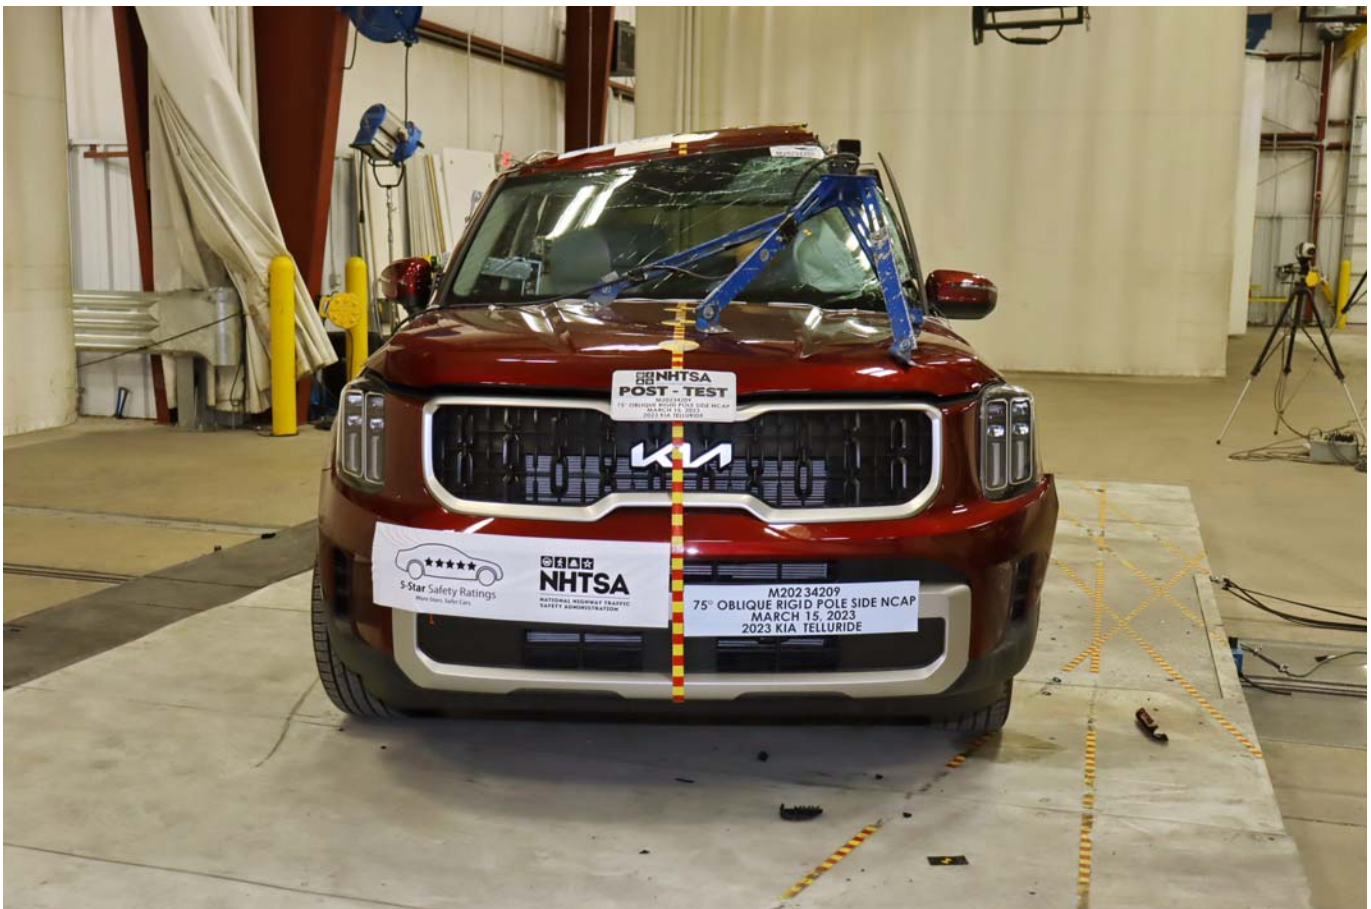
Photo No. 004 - Post-Test Frontal View of Test Vehicle

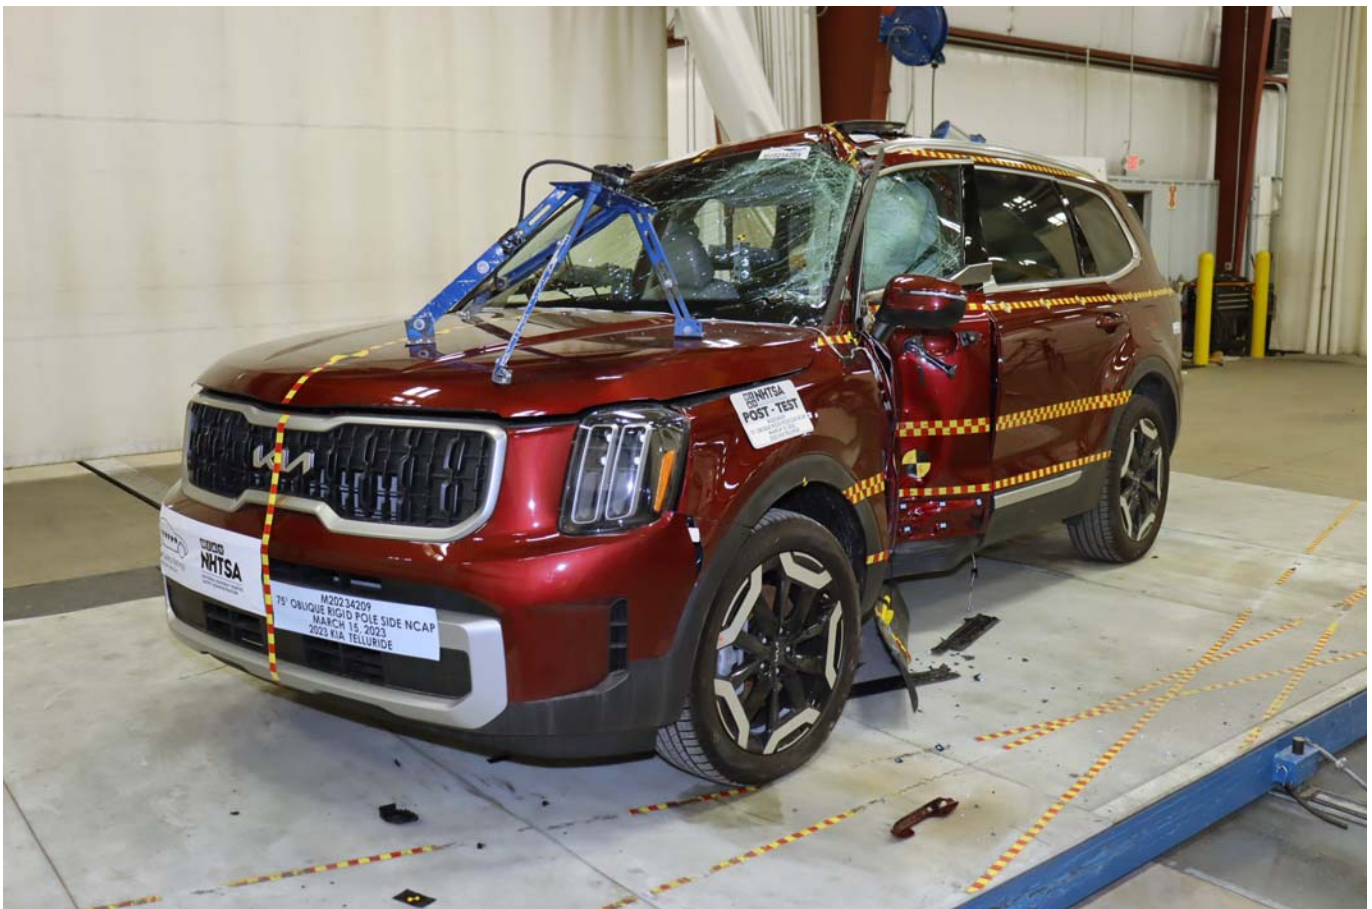
Photo No. 006 - Post-Test Left Front Three-Quarter View of Test Vehicle

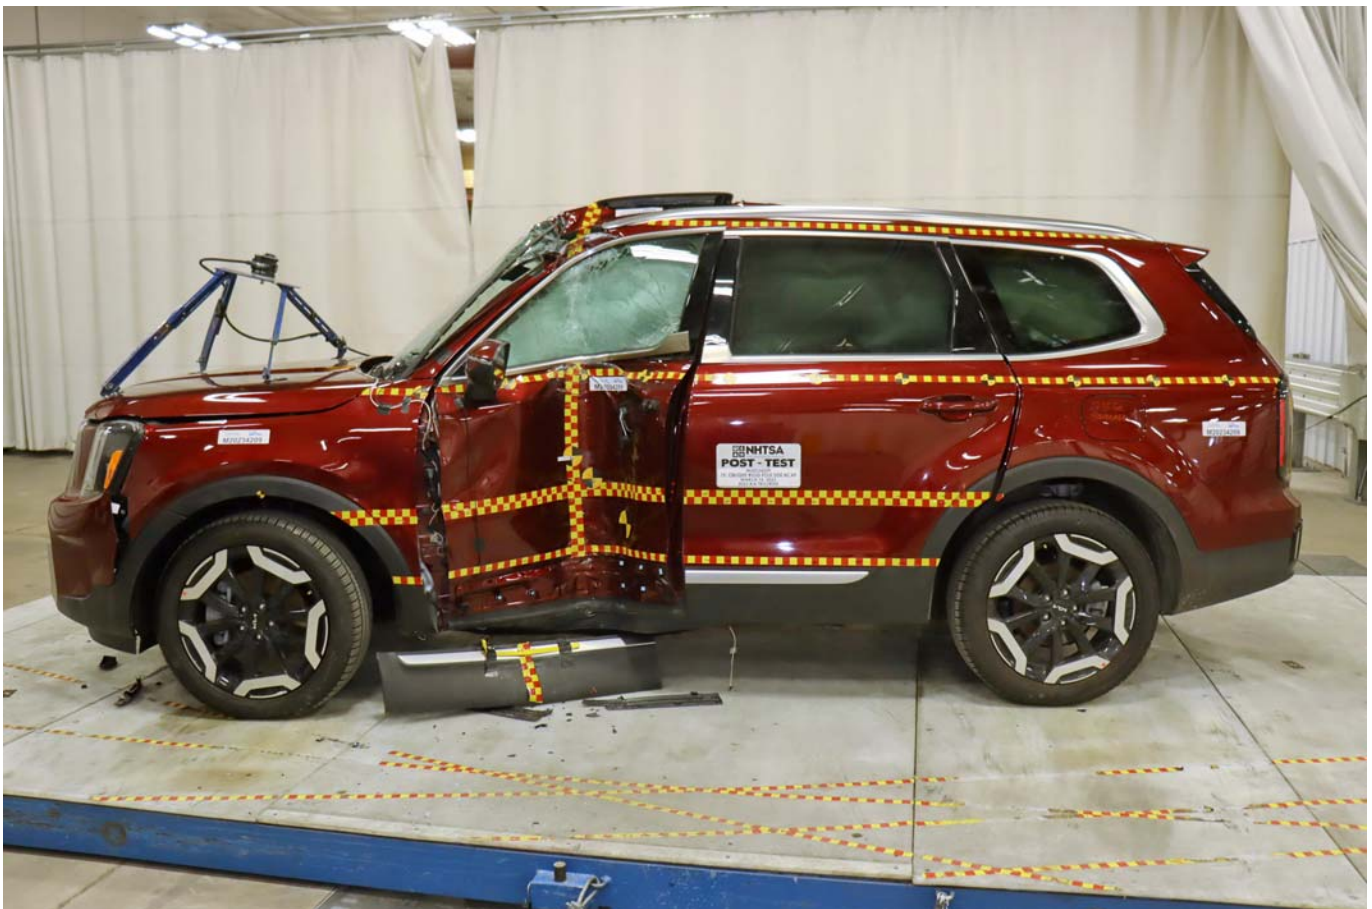
Photo No. 008 - Post-Test Left Side View of Test Vehicle

| Critical Areas of Performance | Observations and Conclusions |
|---|---|
| Windshield Damage | Broken |
| Side Window Damage | LF window cracked |

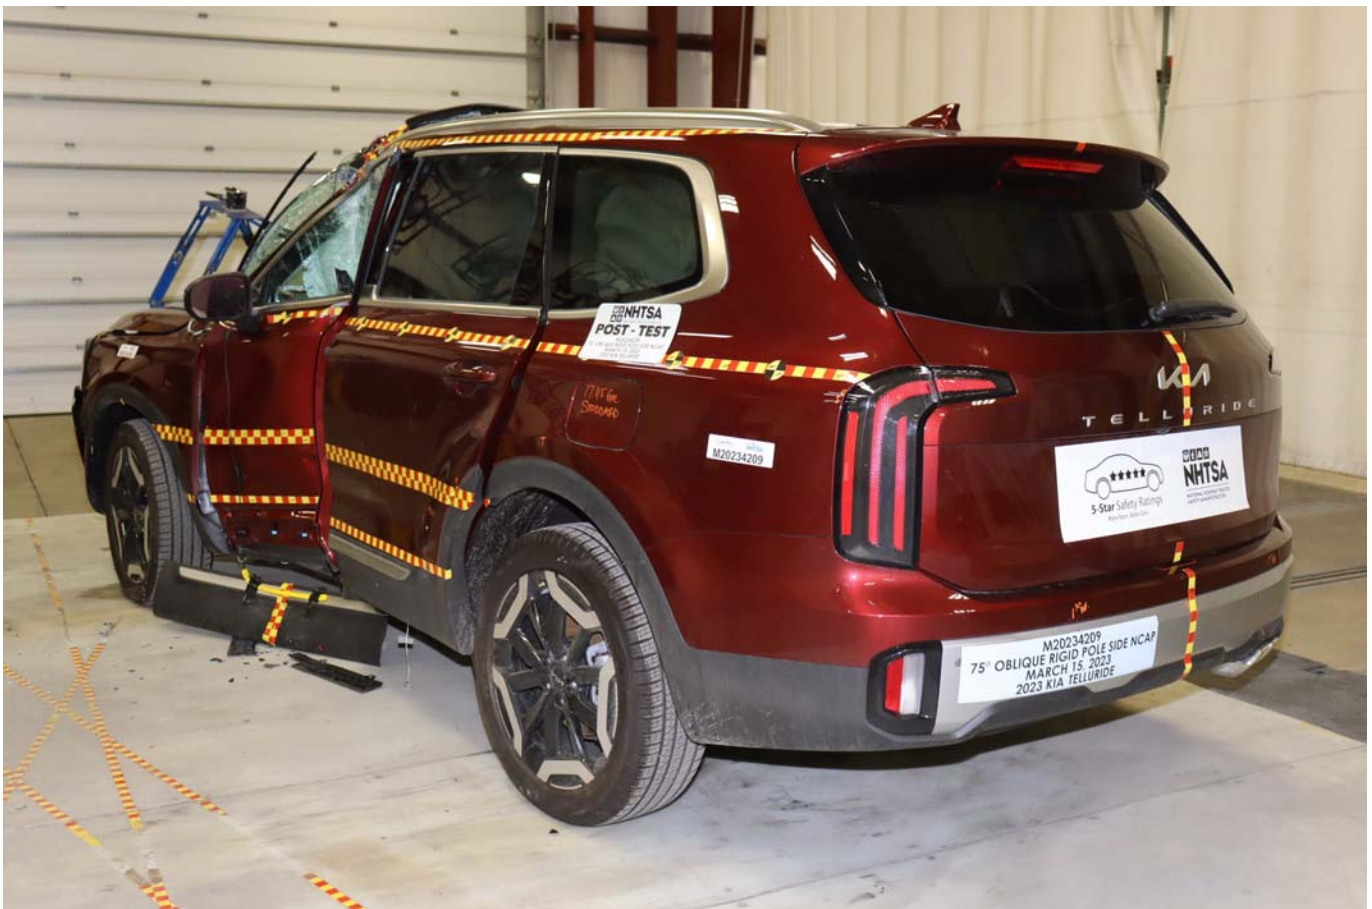
Photo No. 010 - Post-Test Left Rear Three-Quarter View of Test Vehicle

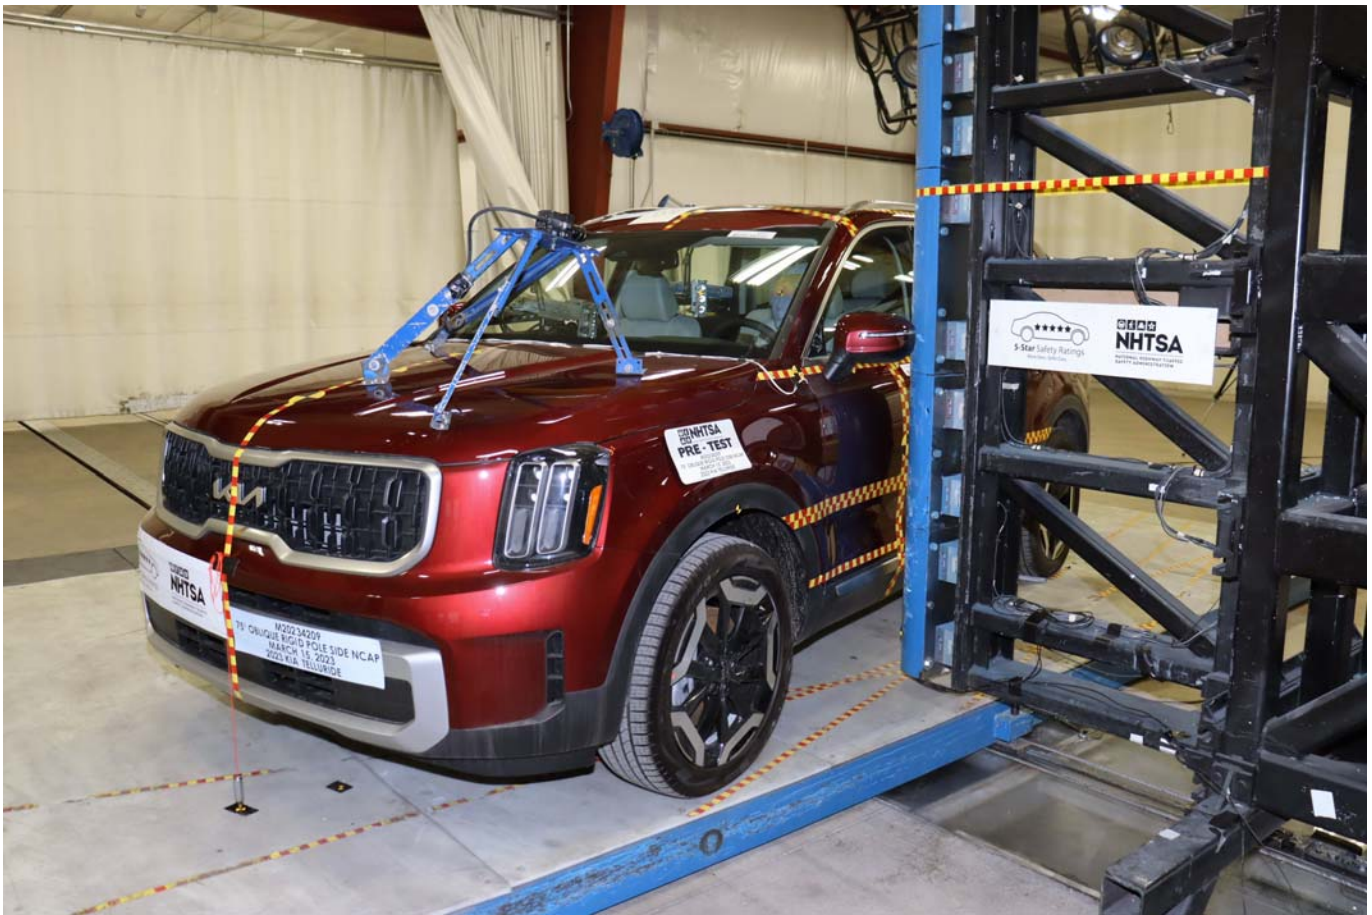
Photo No. 017 - Pre-Test Left Side View of Pole Positioned Against Side of Vehicle

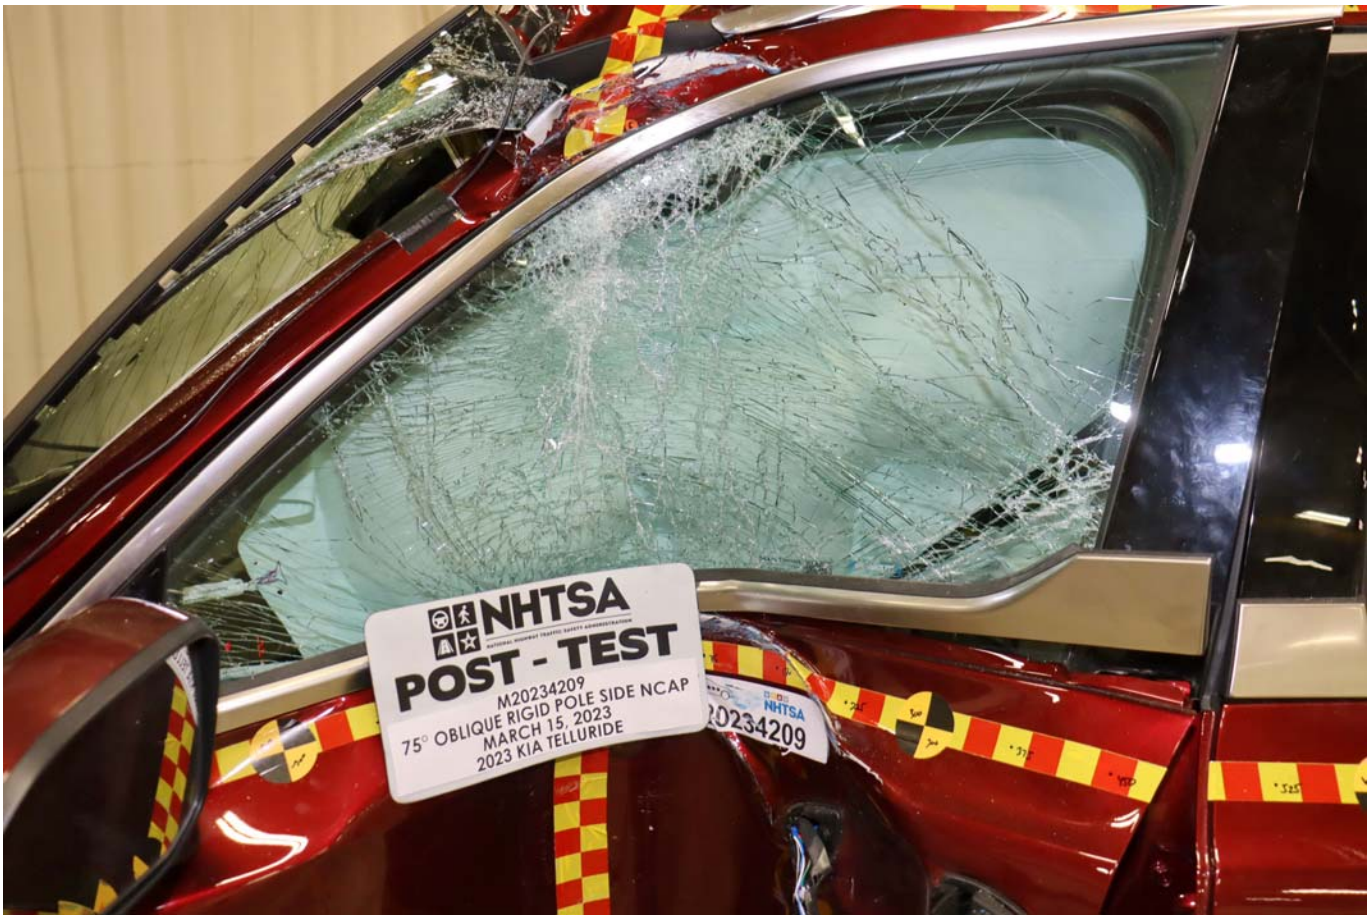
Photo No. 025 - Post-Test Left Side View of Dummy Shoulder and Door Top View

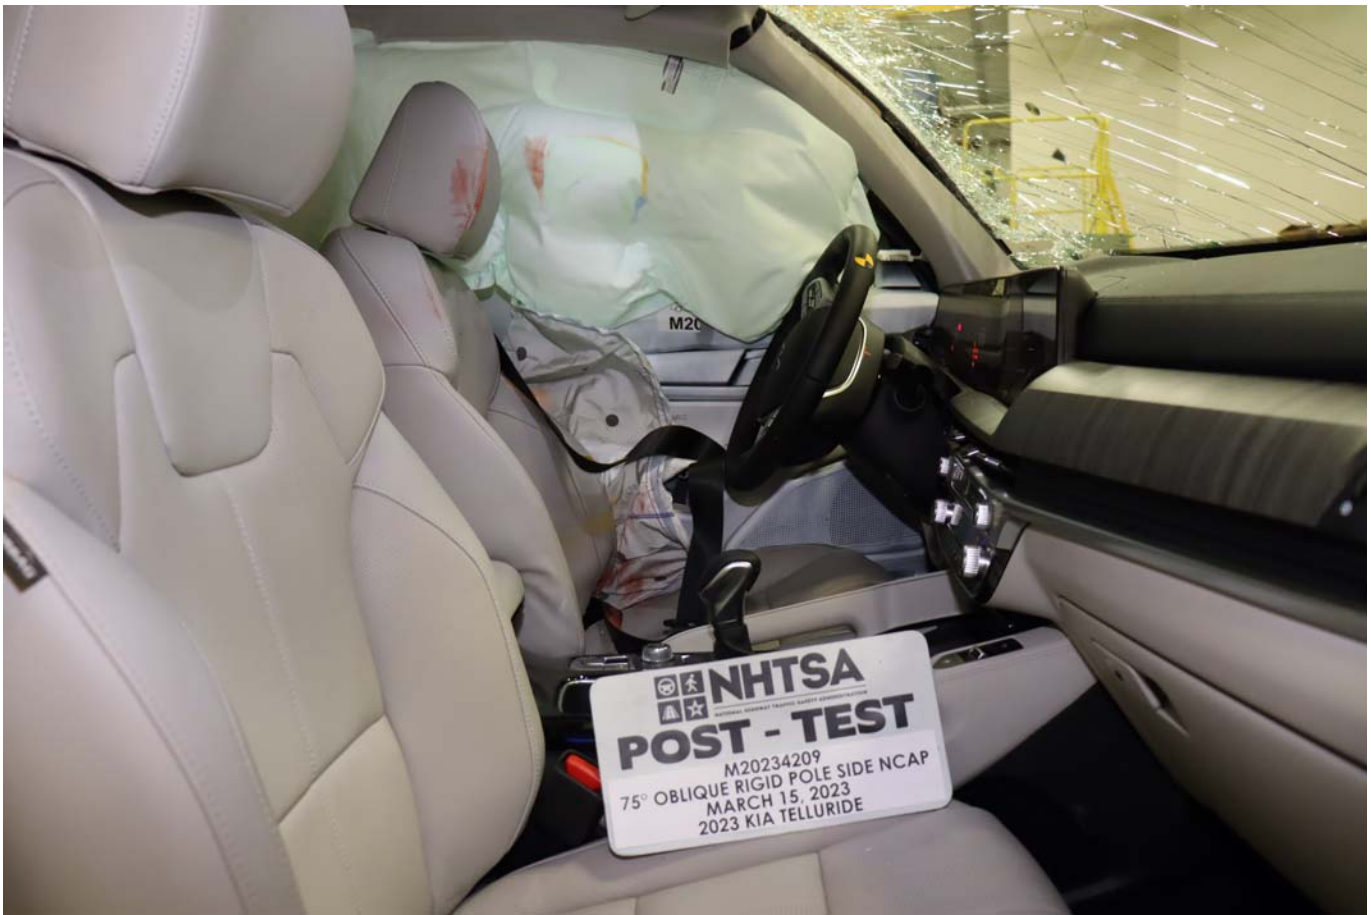
Photo No. 045 - Post-Test Inner Door Panel View Showing Dummy Contact Location

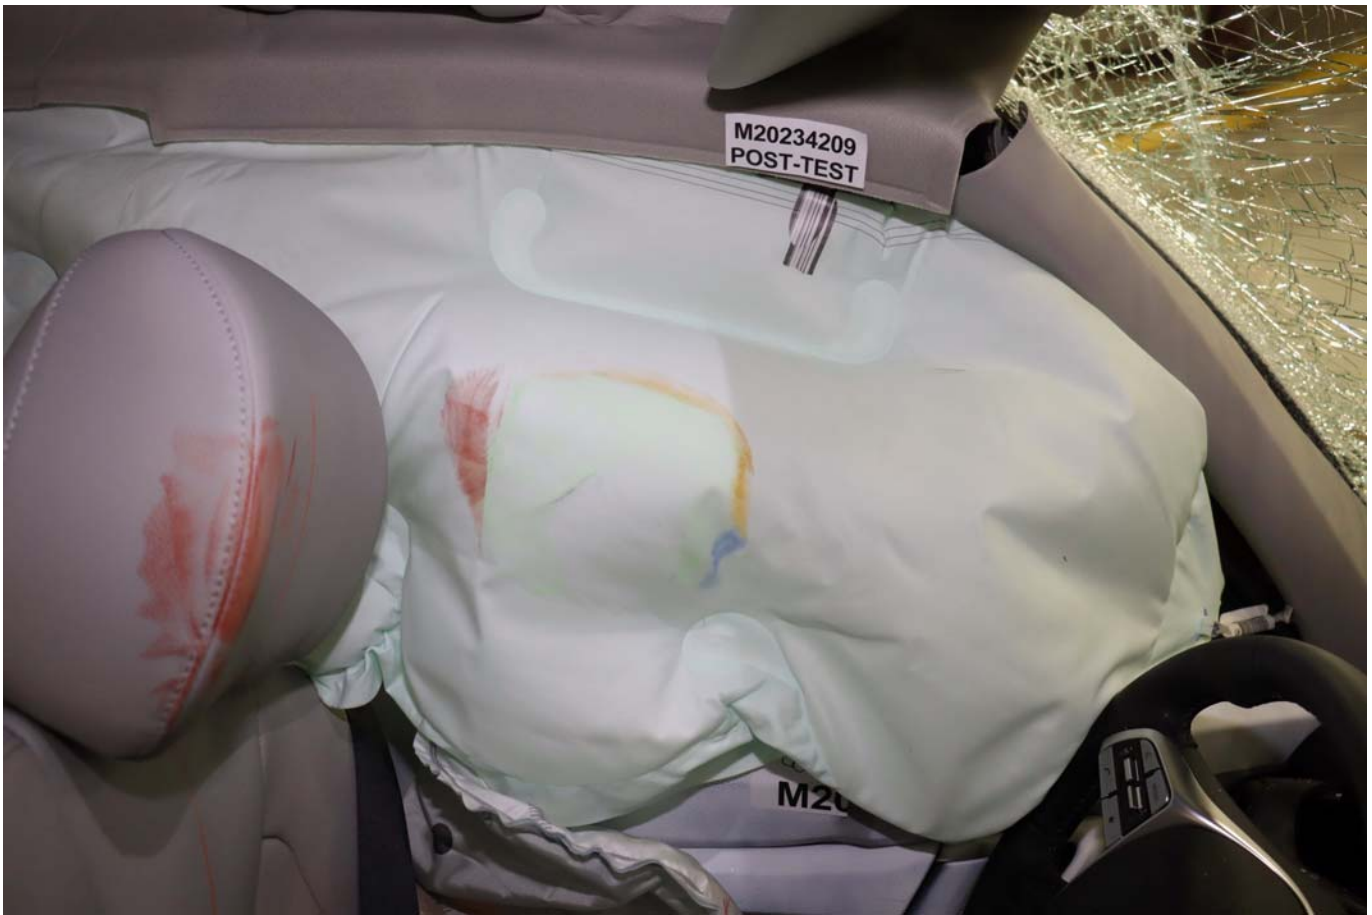
Photo No. 047 - Post-Test Dummy Close-Up Head Contact with Side Air Bag View

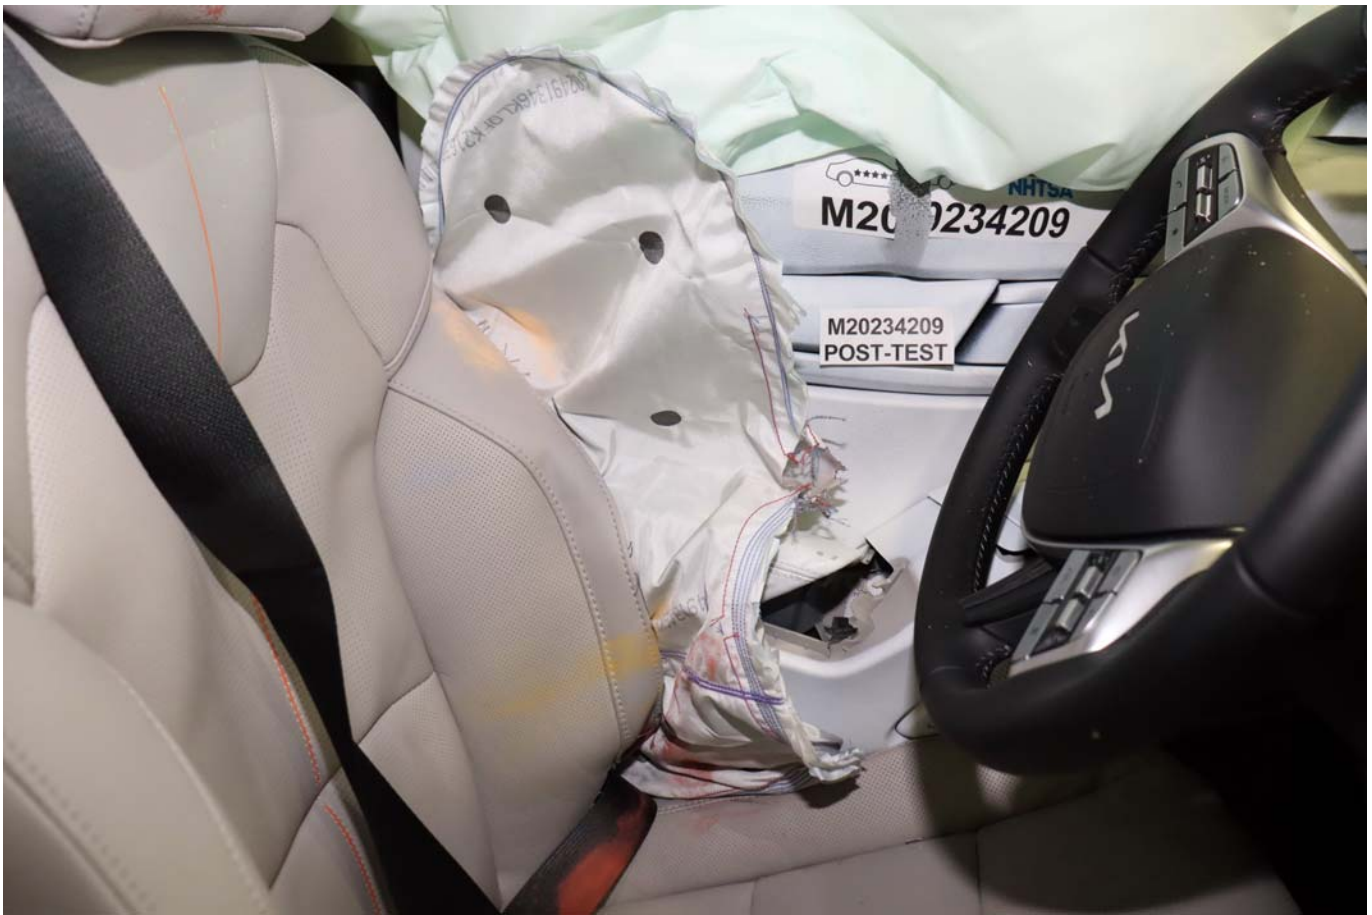
Photo No. 049 - Post-Test Dummy Close-Up Torso Contact with Side Air Bag View

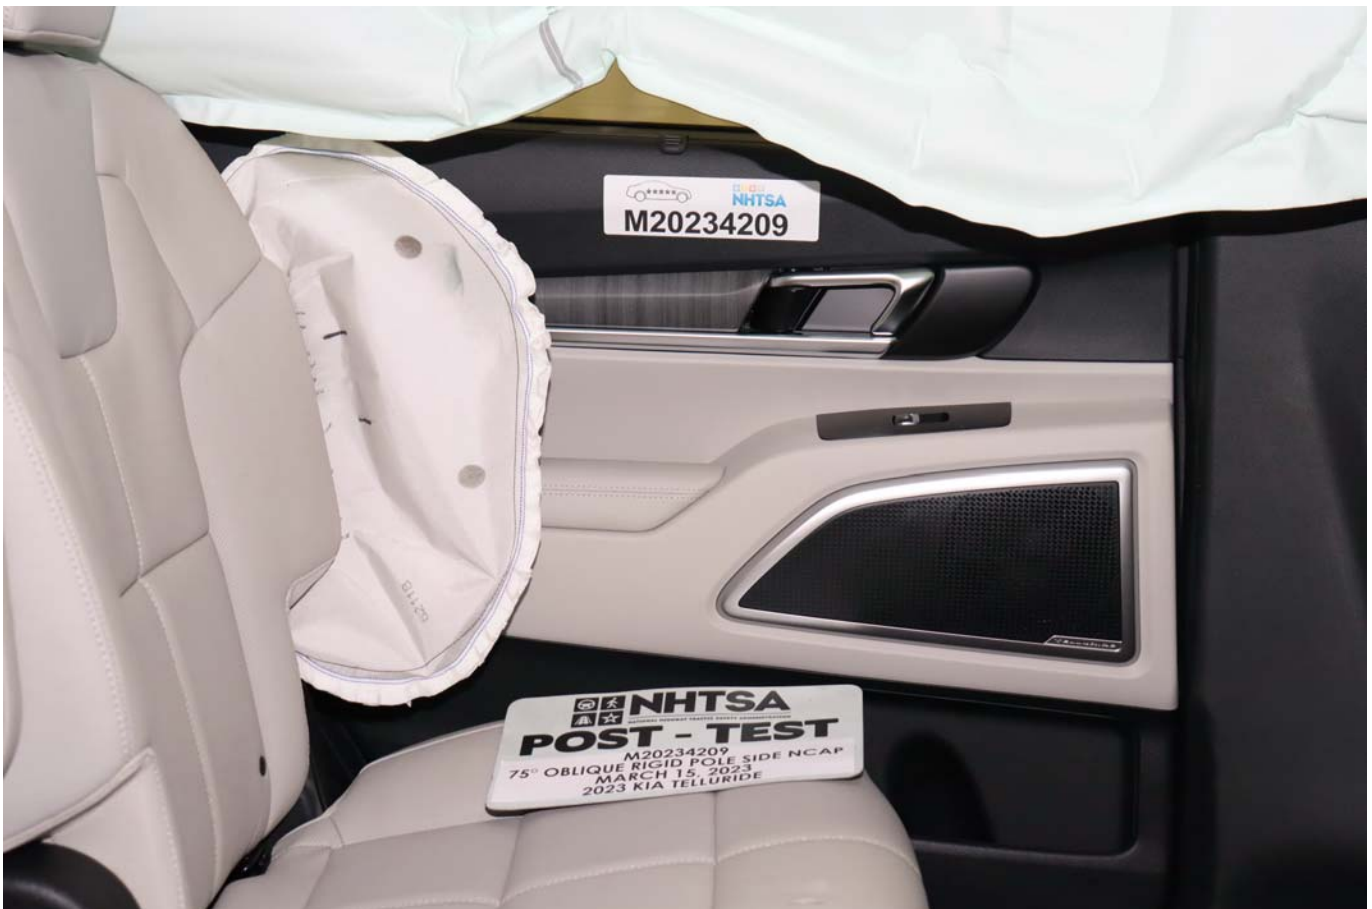
Photo No. 054 - Post-Test Inner Rear Passenger Torso Air Bag Deployment View

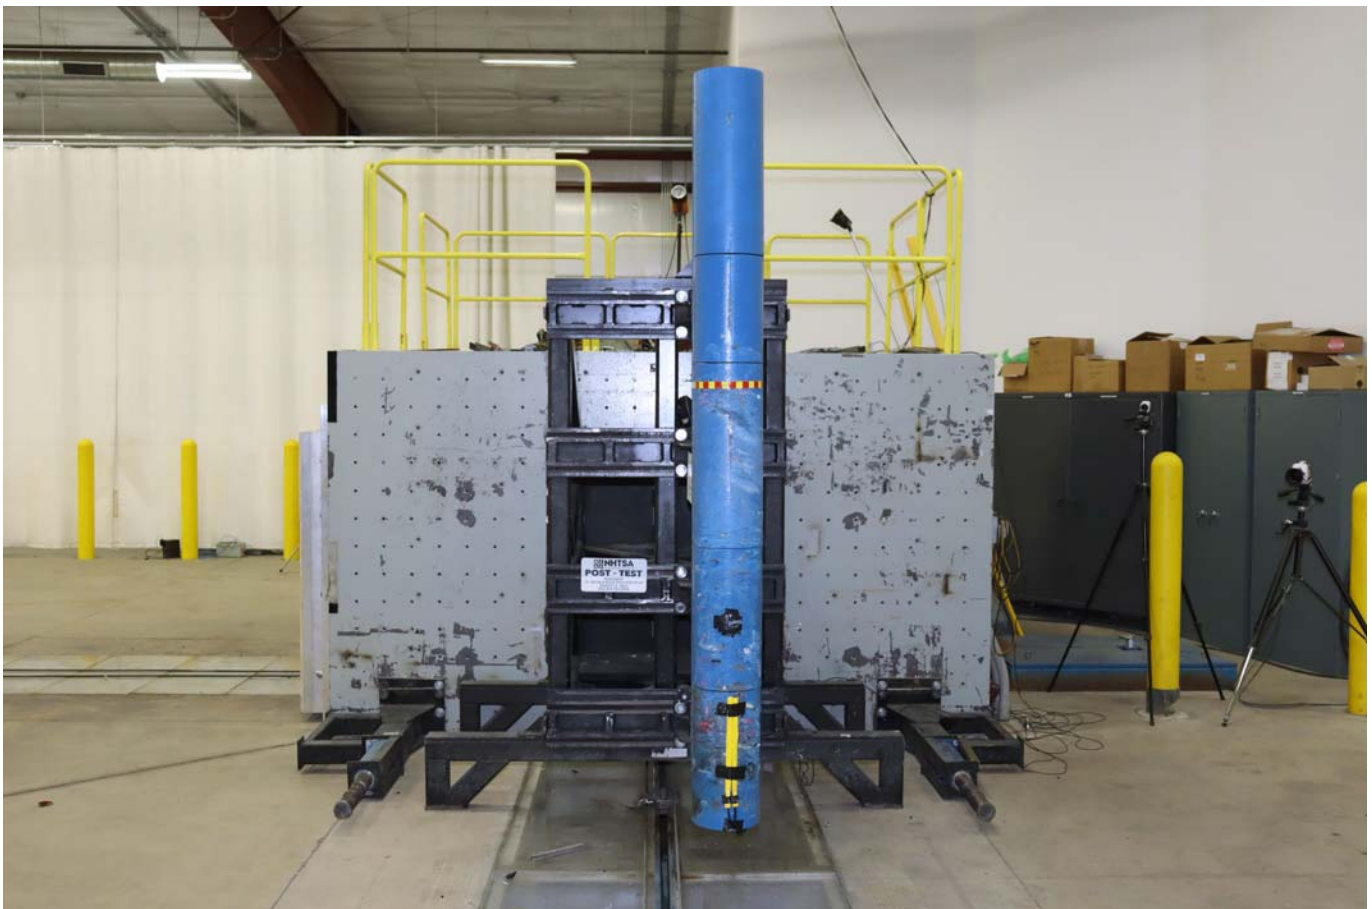
Photo No. 060 - Post-Test Pole Barrier Front View

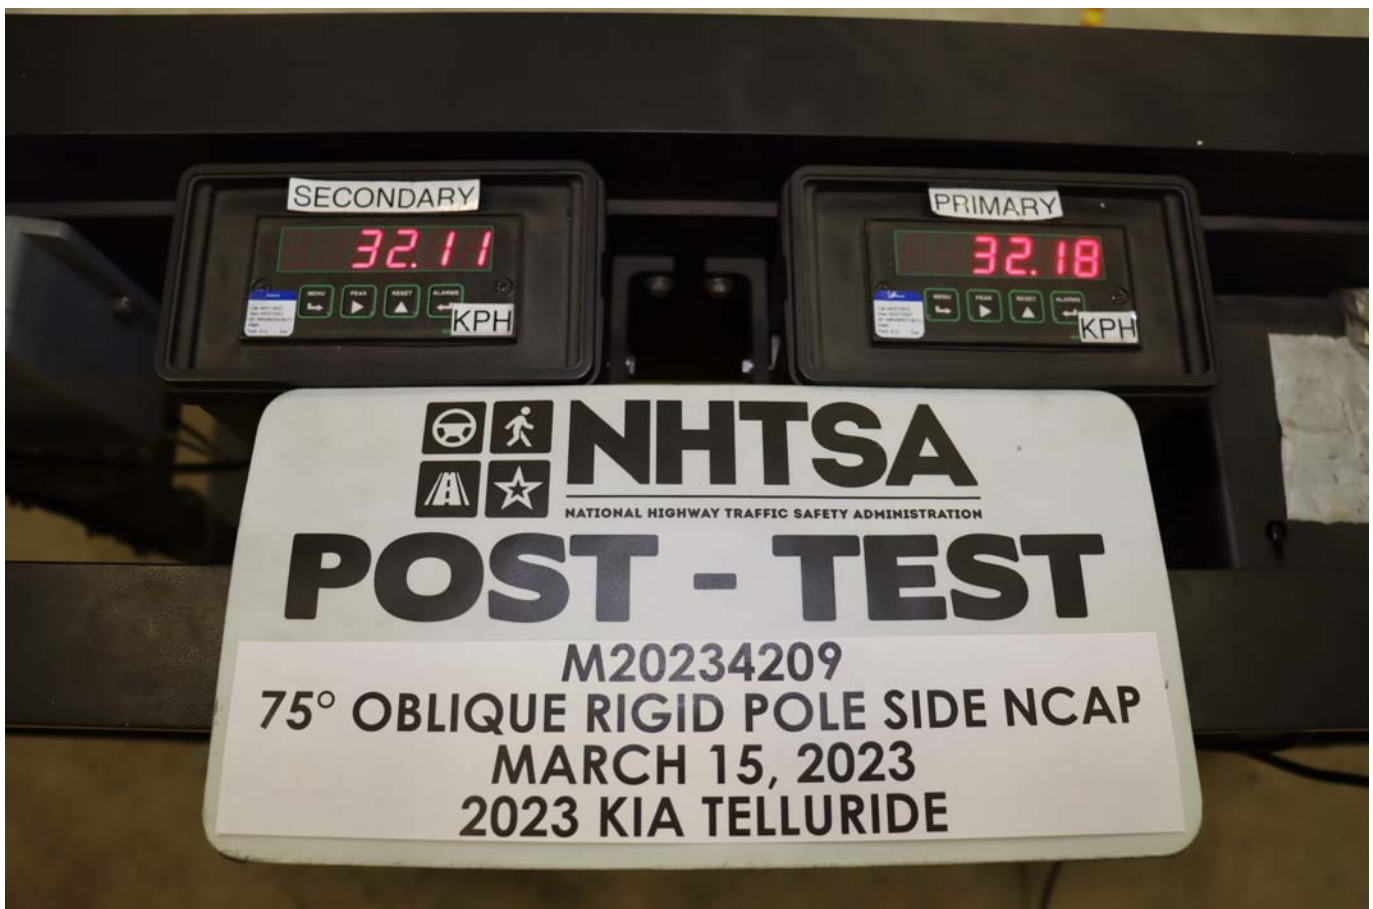
Photo No. 064 - Post-Test Primary and Redundant Speed Trap Read-Out

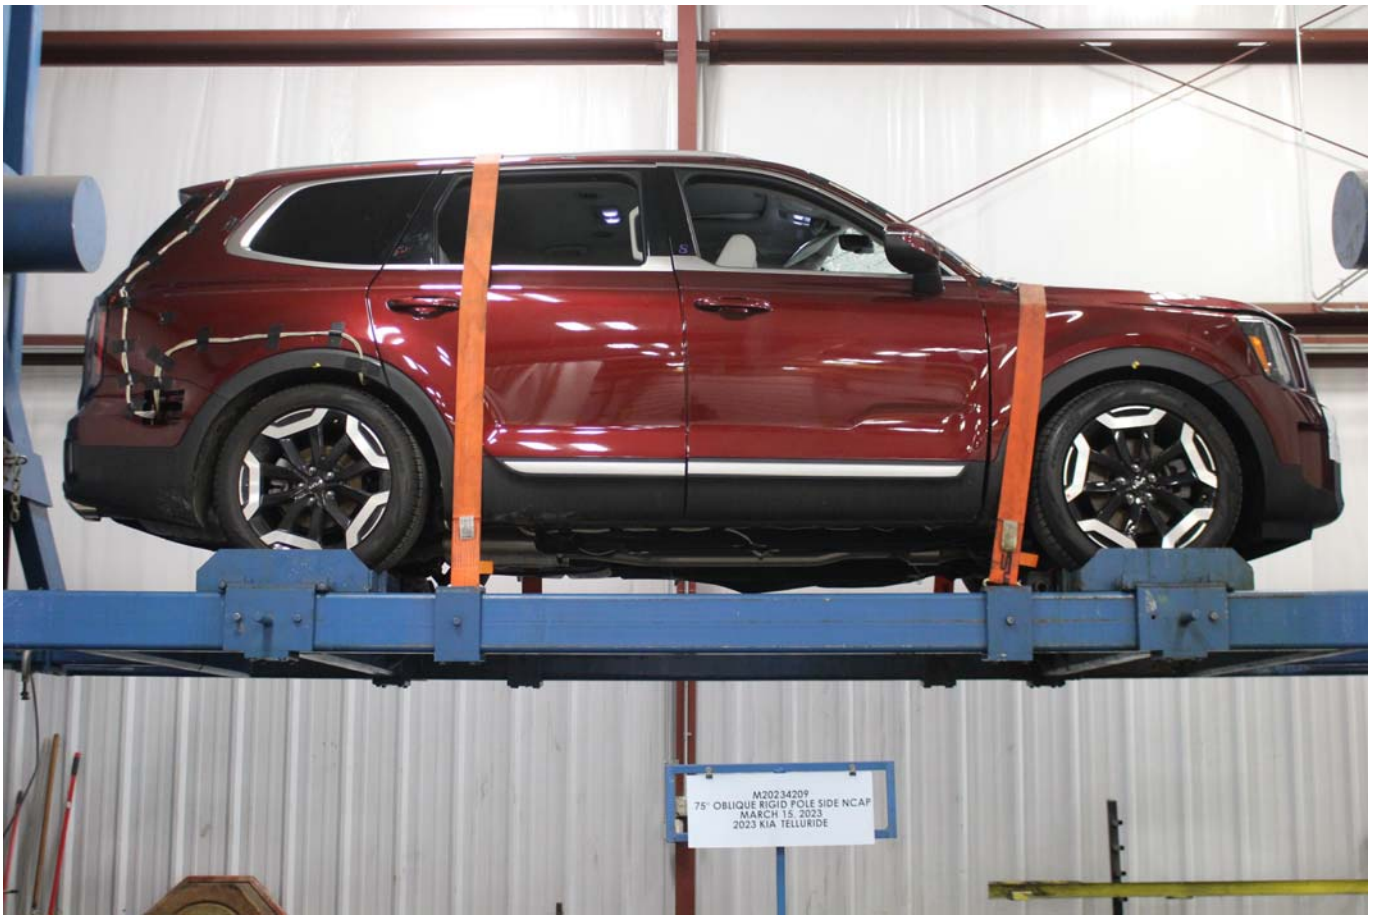
Photo No. 065 - FMVSS Photo No. 301 Static Rollover 0 Degrees

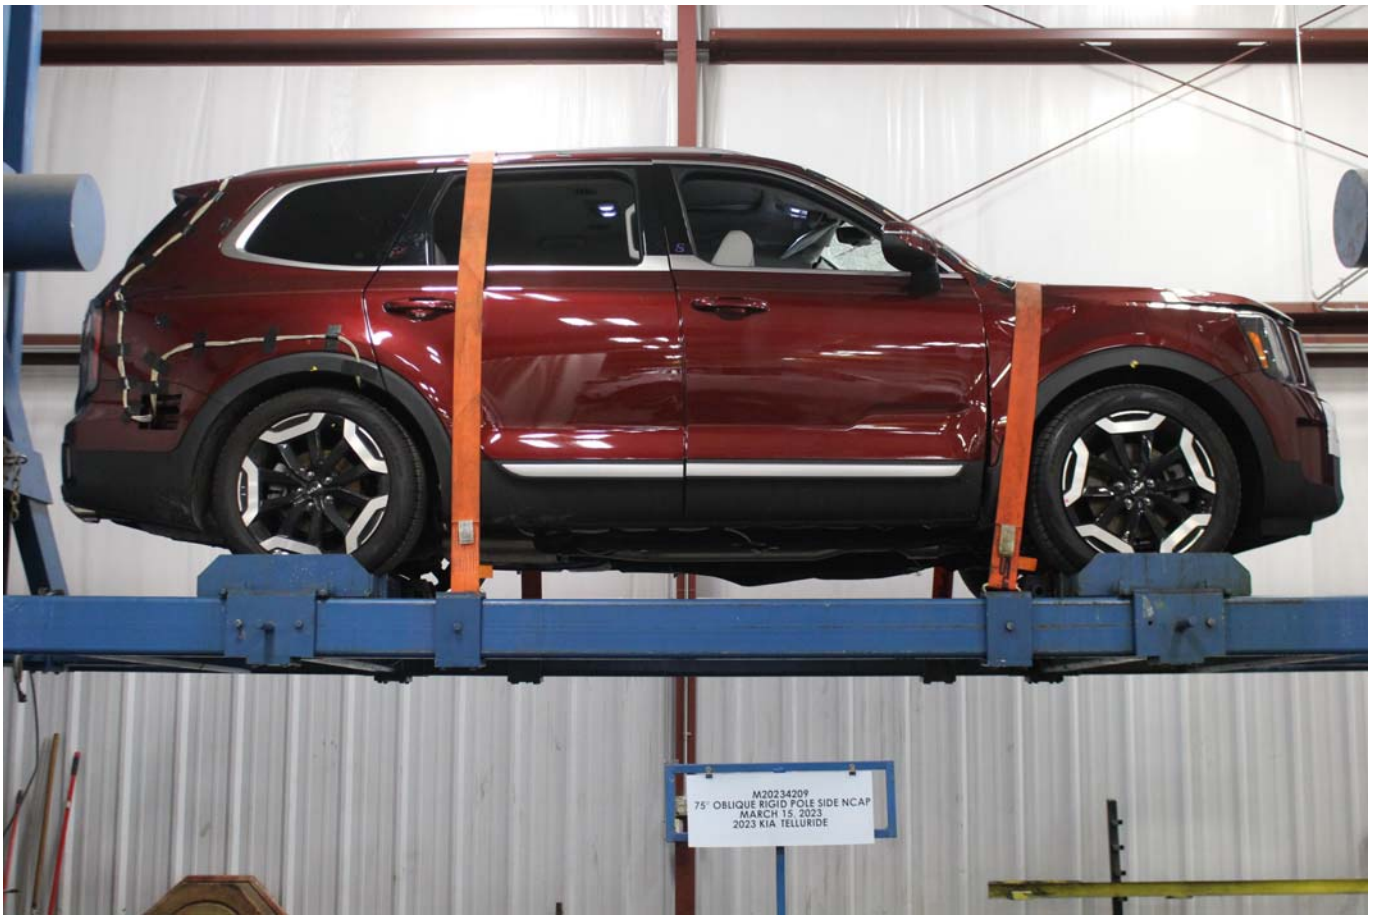
Photo No. 069 - FMVSS Photo No. 301 Static Rollover 360 Degrees

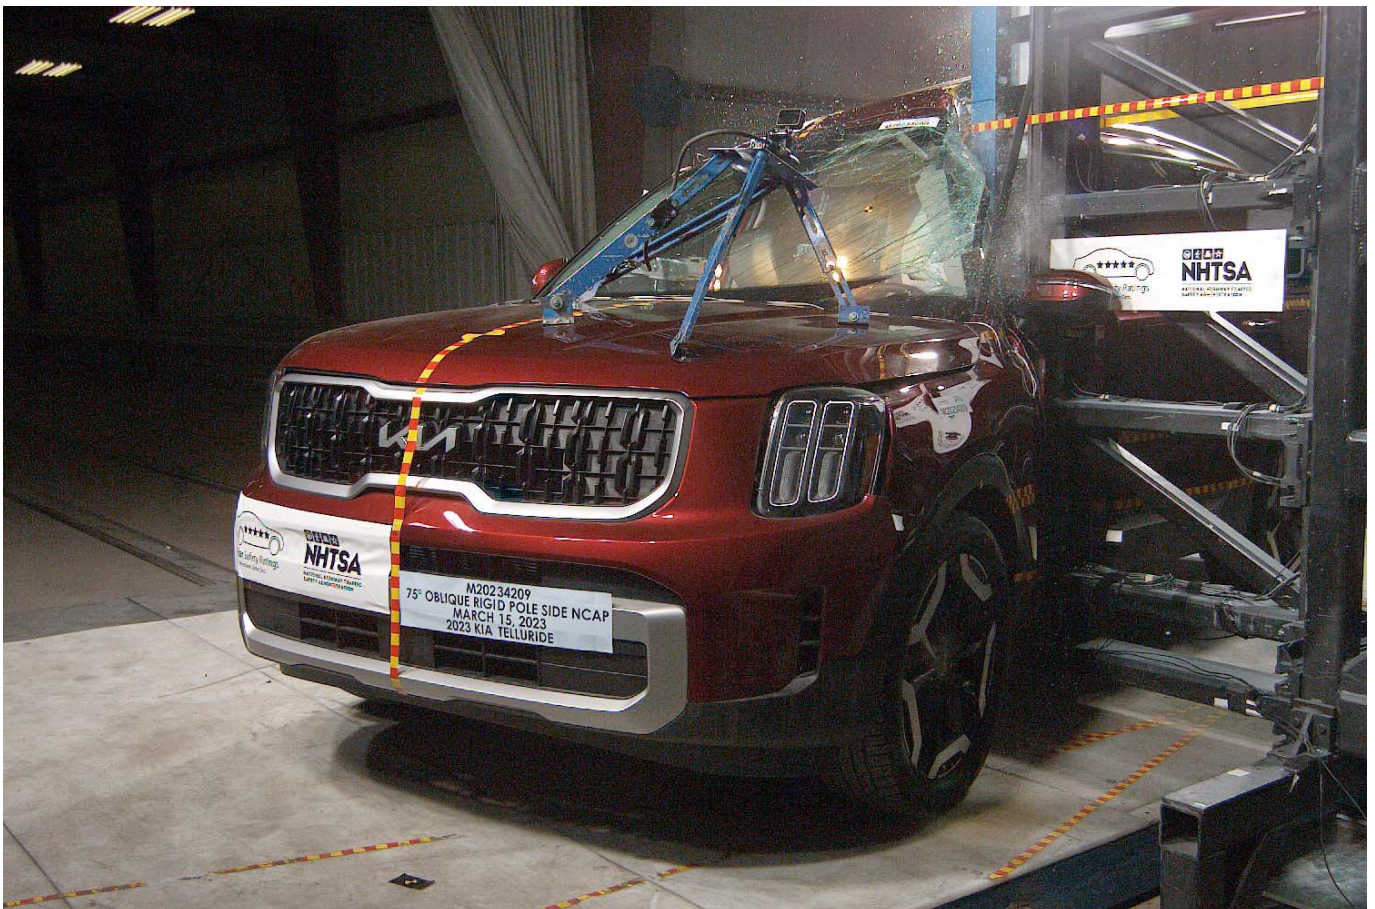
Photo No. 070 - Impact Event

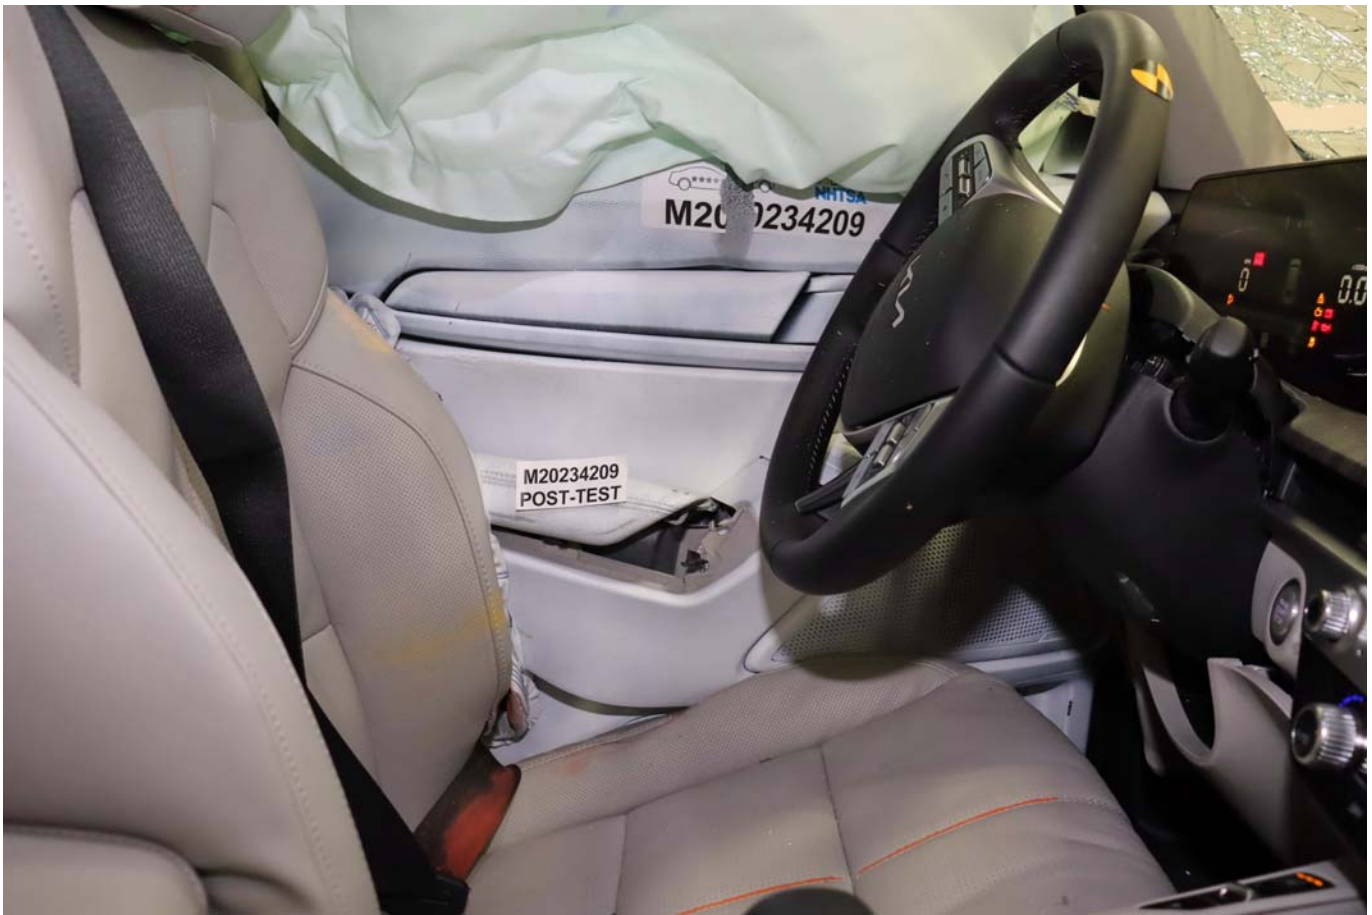
Photo No. 073 - Post-Test View of Shattered Vehicle Inner Door Panel
