**REPORT NUMBER: SideNCAPMDB-MGA-22-038**

**NEW CAR ASSESSMENT PROGRAM (NCAP)  
Moving Deformable Barrier Side Impact Test**

**FORD MOTOR CO.  
2022 Ford F-150 Lightning 4x4 SuperCrew  
NHTSA No.: M20220206**

**MGA RESEARCH CORPORATION  
5000 Warren Road  
Burlington, WI 53105**

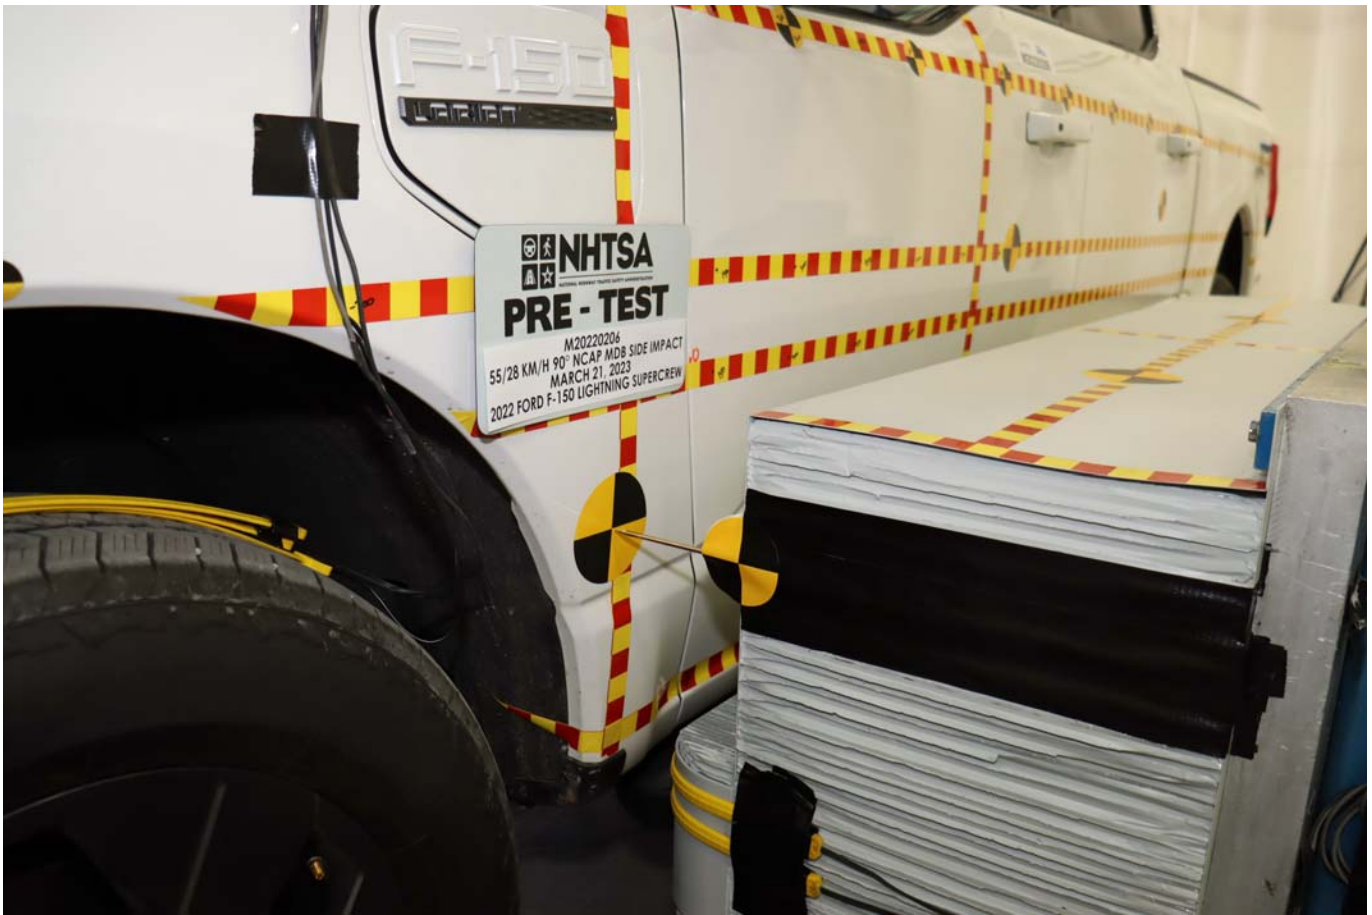
Photo No. 019 - Pre-Test Close-Up View of Impact Point Target

Photo No. 020 - Post-Test Close-Up View of Impact Point Target

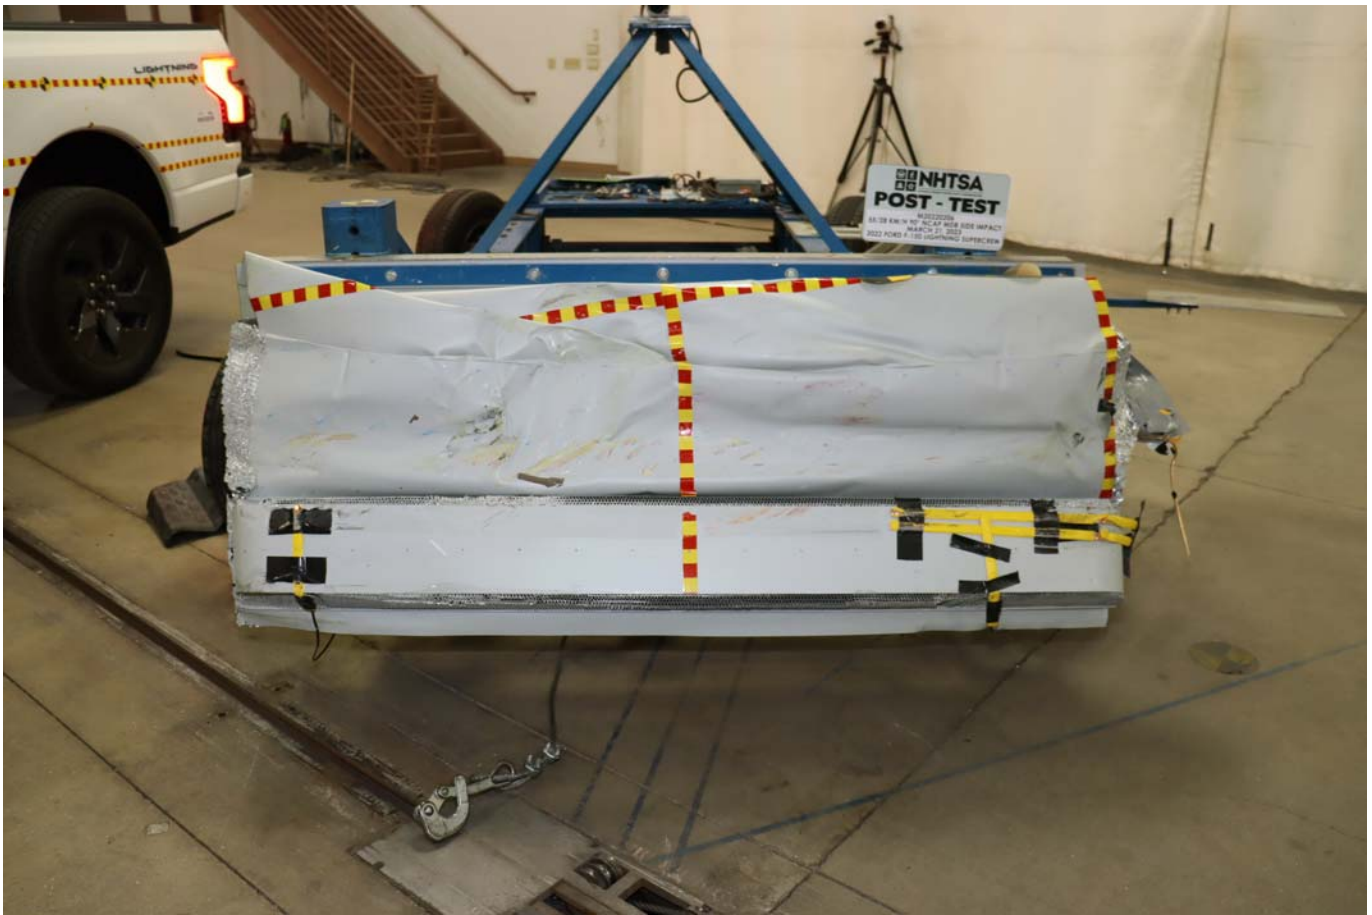
Photo No. 085 - Post-Test Front View of MDB Impactor Face

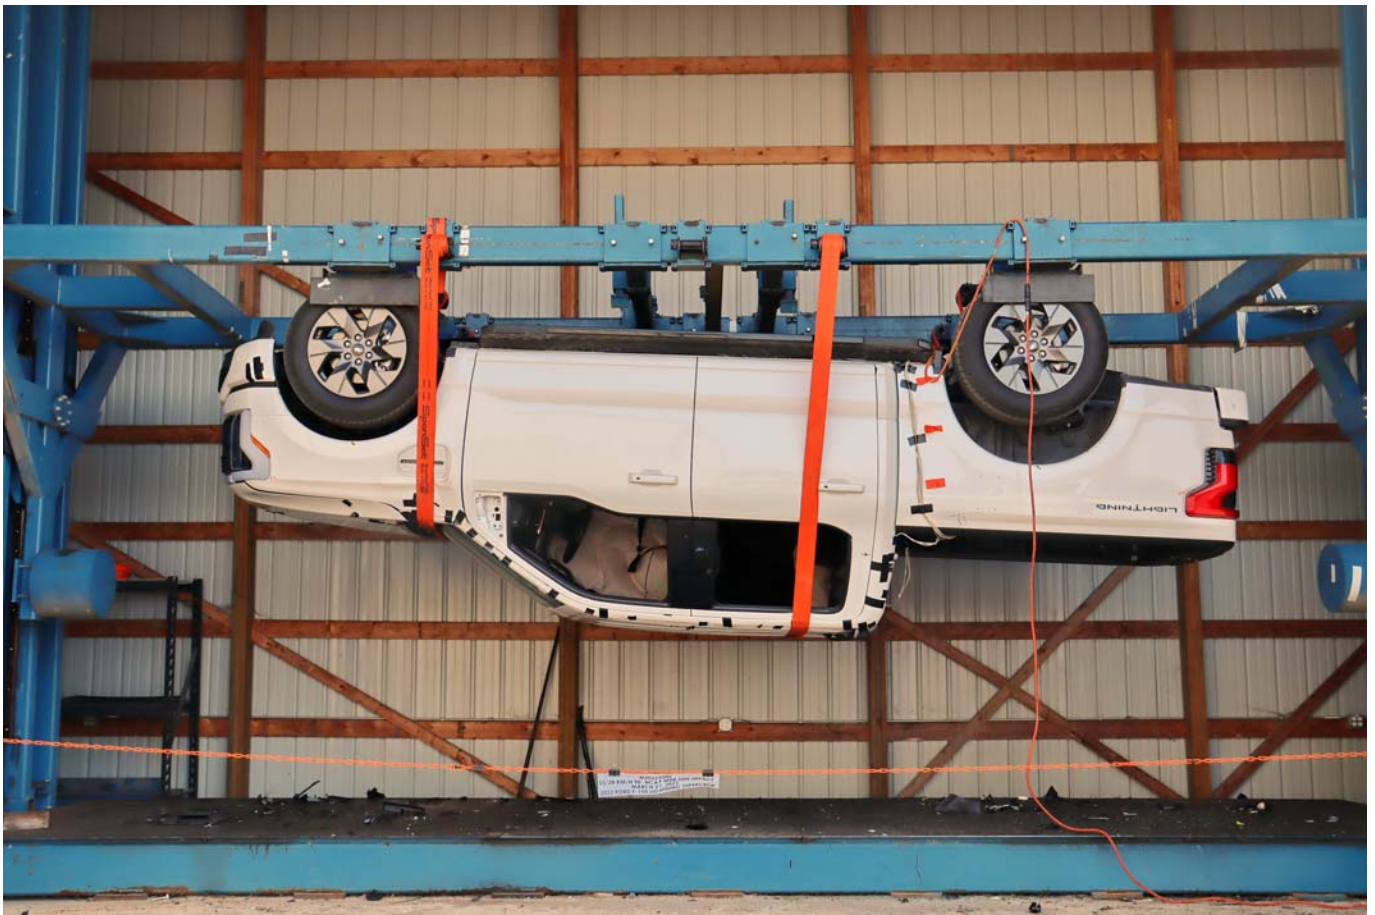
Photo No. 305-29 - FMVSS No. 305 Static Rollover at 180 Degrees
