**REPORT NUMBER: NCAP-MGA-23-009**

**NEW CAR ASSESSMENT PROGRAM (NCAP)  
Frontal Barrier Impact Test**

**KIA CORPORATION  
2023 Kia Niro EX Touring 5-Door SUV  
NHTSA No.: M20234211**

**FINAL REPORT**

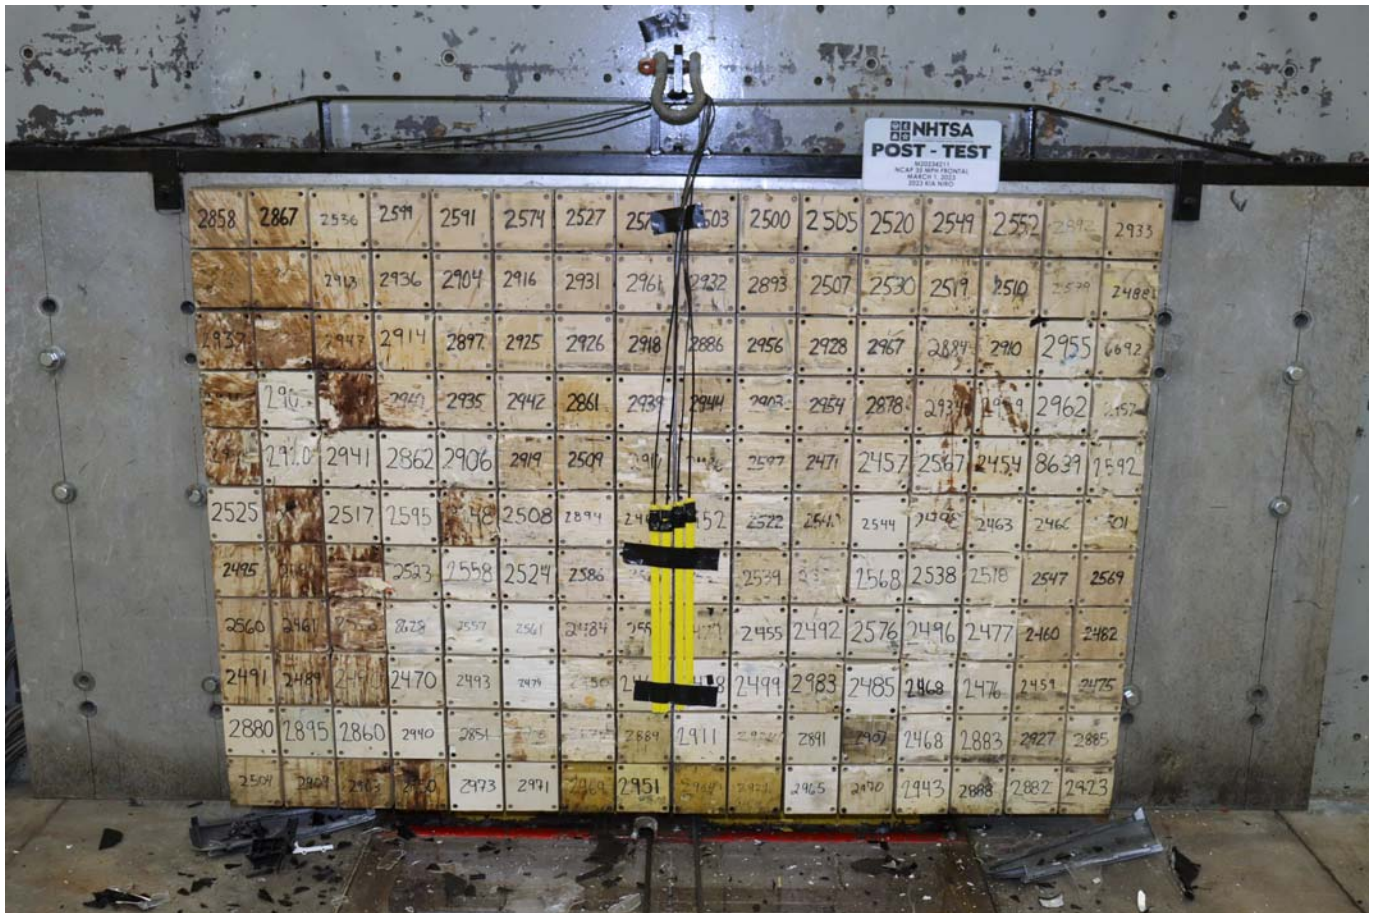
Photo No. 003 - Post-Test Load Cell Wall

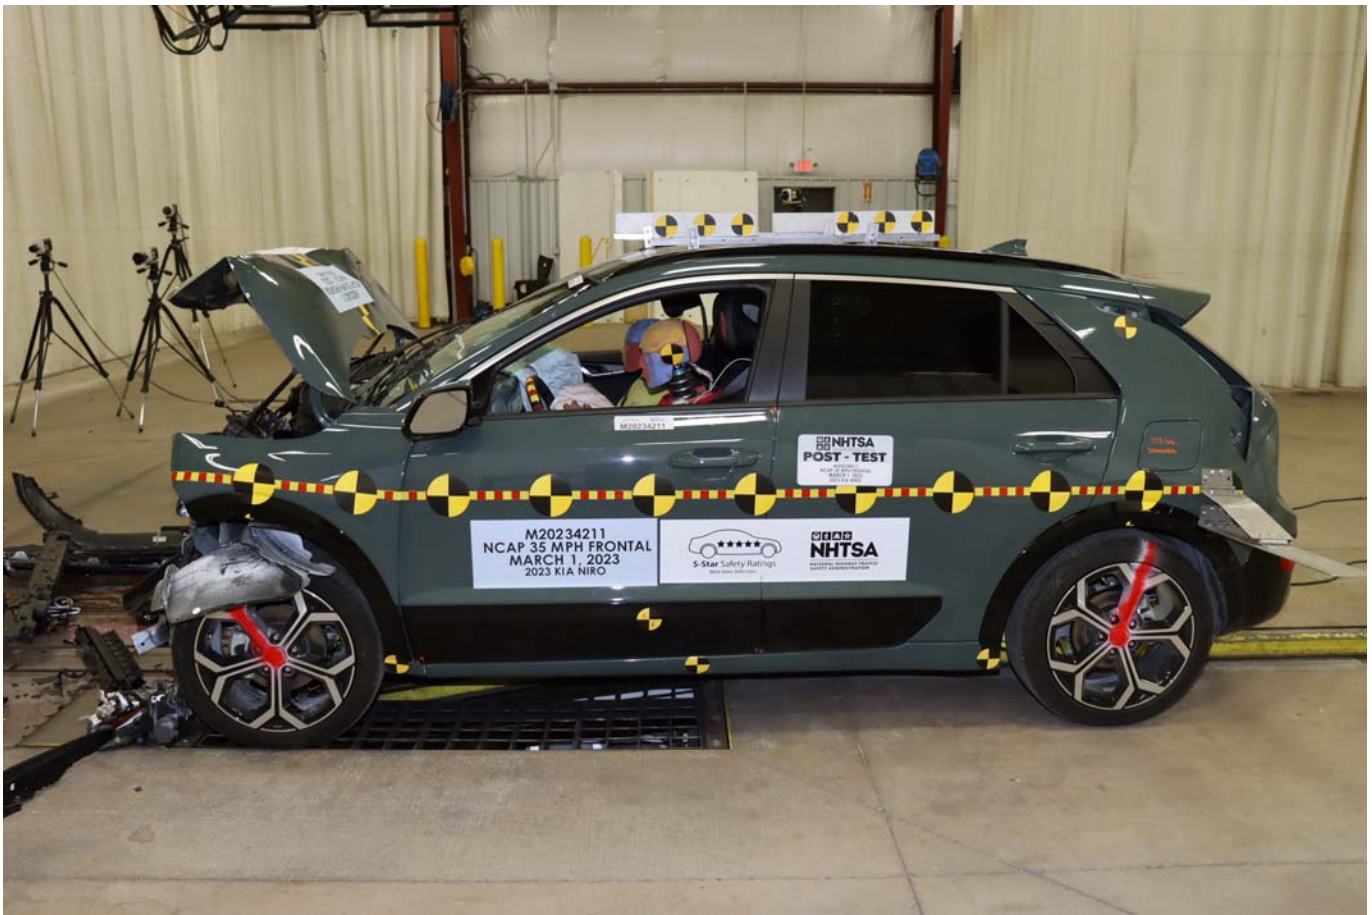
Photo No. 011 - Post-Test Left View of Test Vehicle

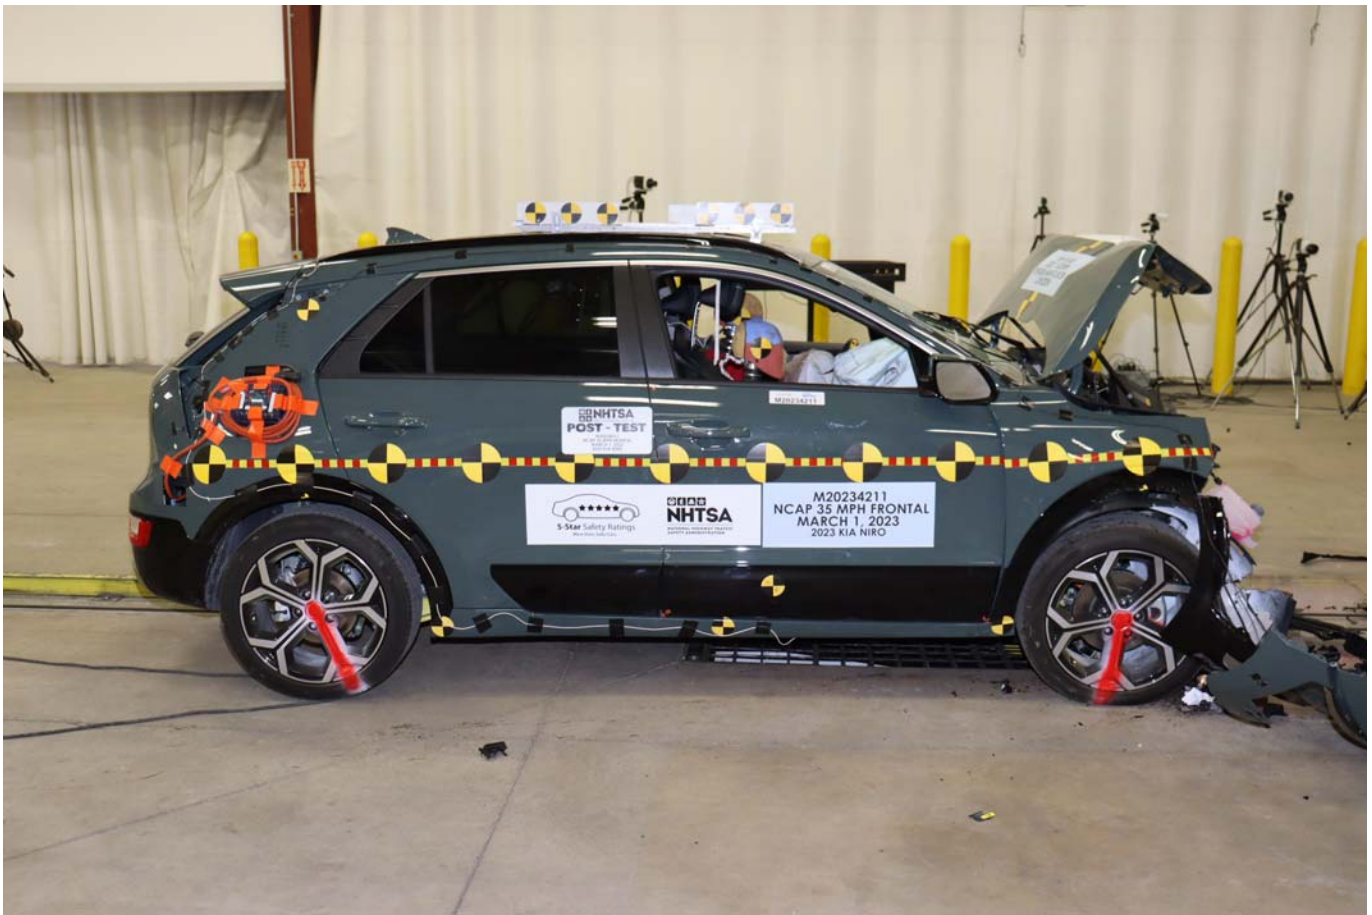
Photo No. 013 - Post-Test Right View of Test Vehicle

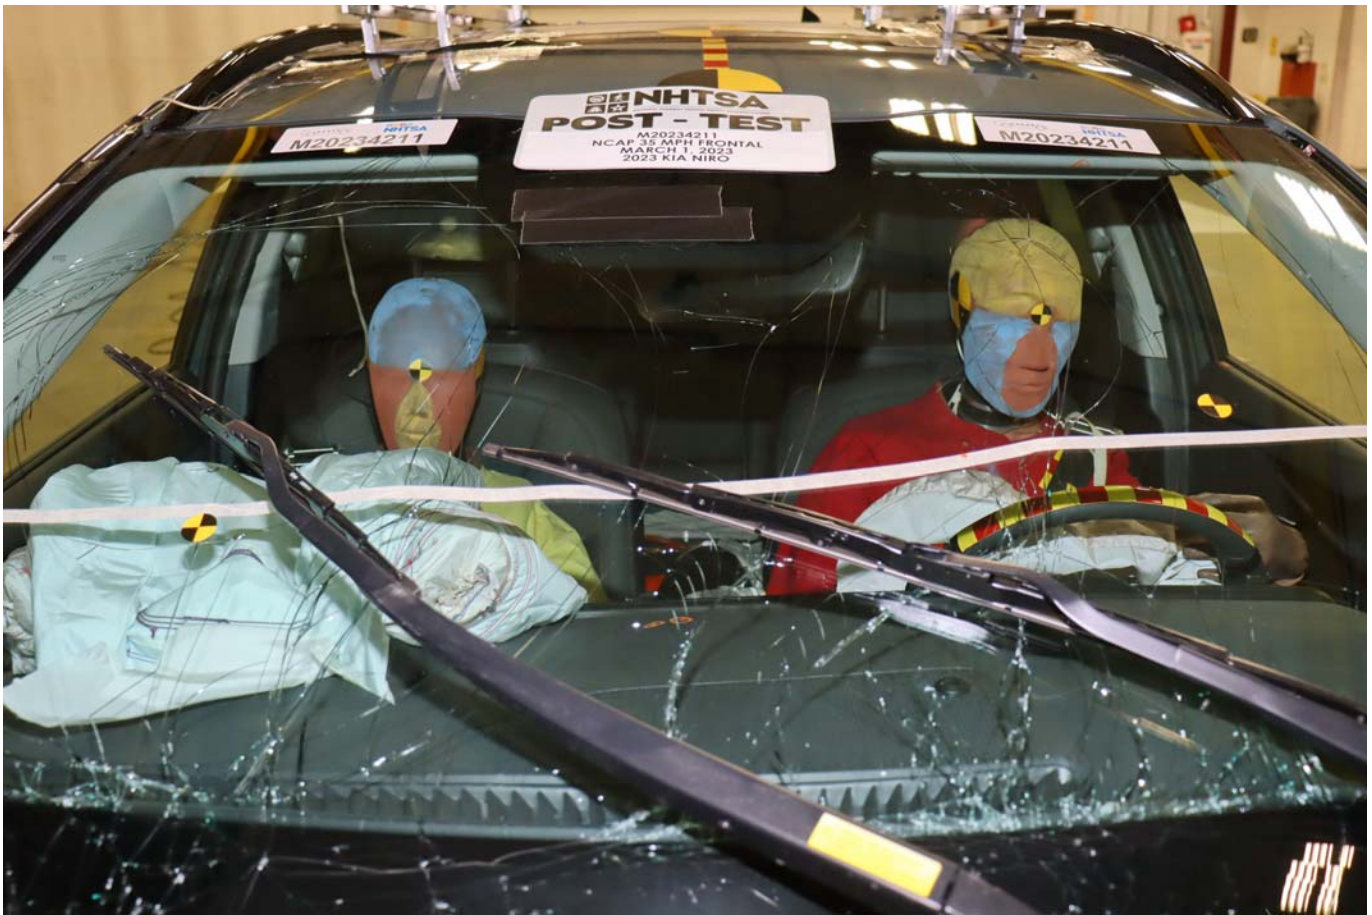
Photo No. 019 - Post-Test Windshield View

There was 100 percent windshield retention and no intrusion into the protected zone of the windshield during the event. There was no Stoddard Solvent or battery electrolyte leakage and no loss of high-voltage battery isolation after the event or during any phase of the static rollover.

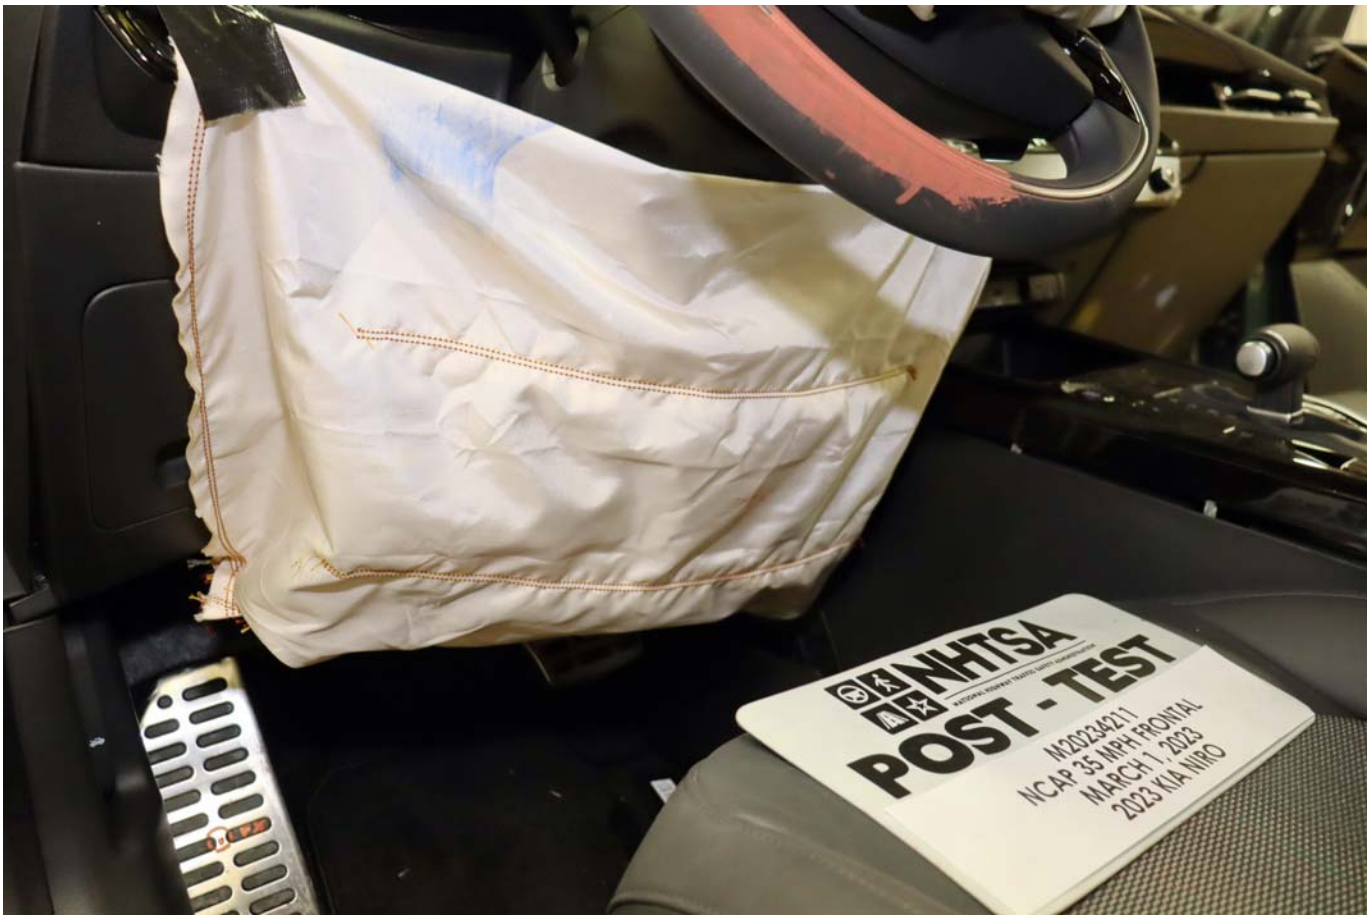
Photo No. 045 - Post-Test Driver's Side Knee Bolster

The driver's visible contact points were as follows: The driver's head contacted the airbag. The driver's head also contacted the headrest. The driver's knees contacted the knee airbag.

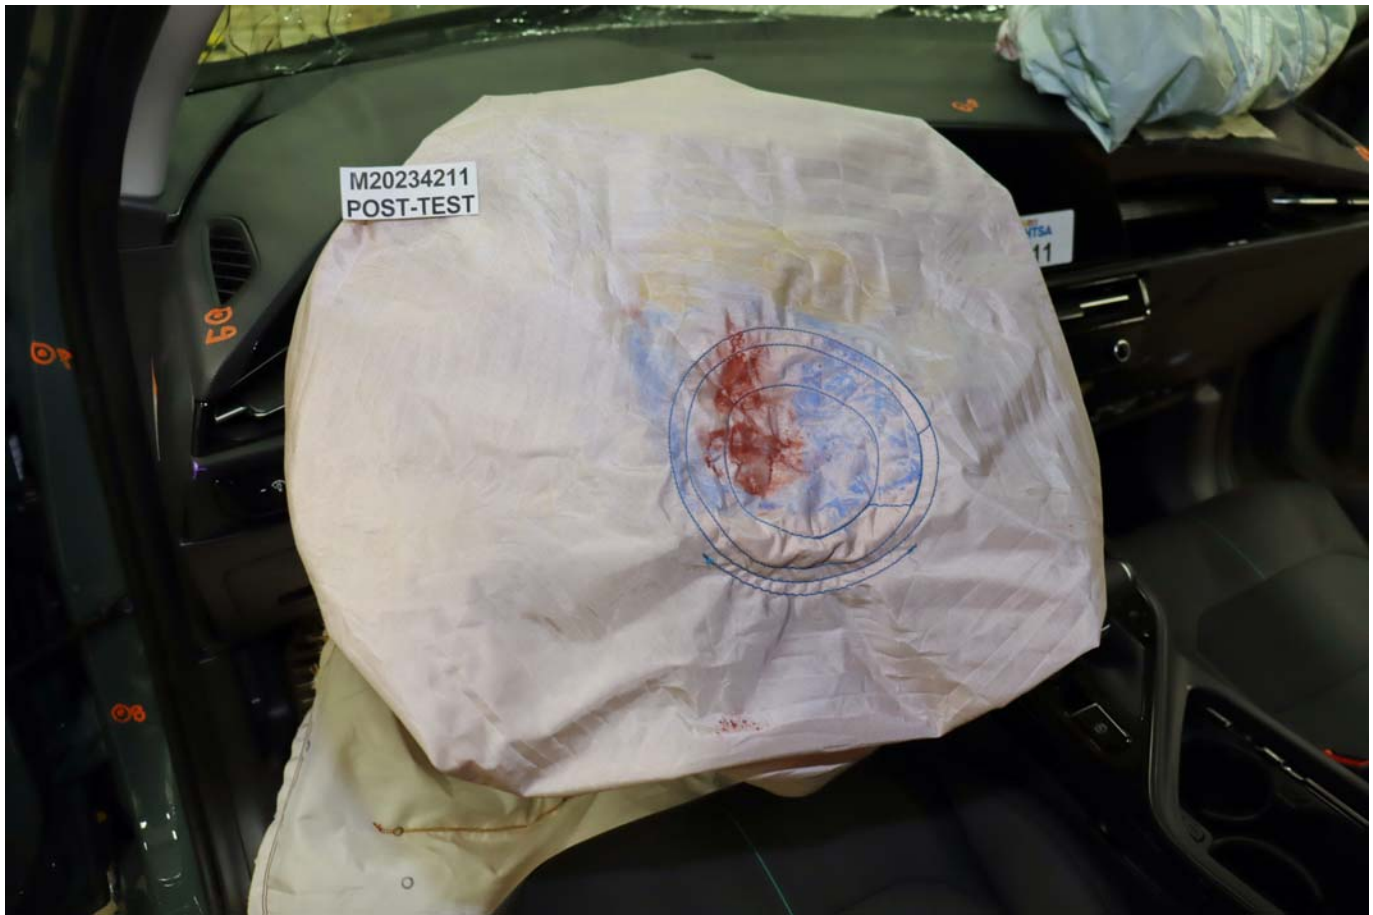
Photo No. 049 - Post-Test Driver Dummy Contact with Airbag

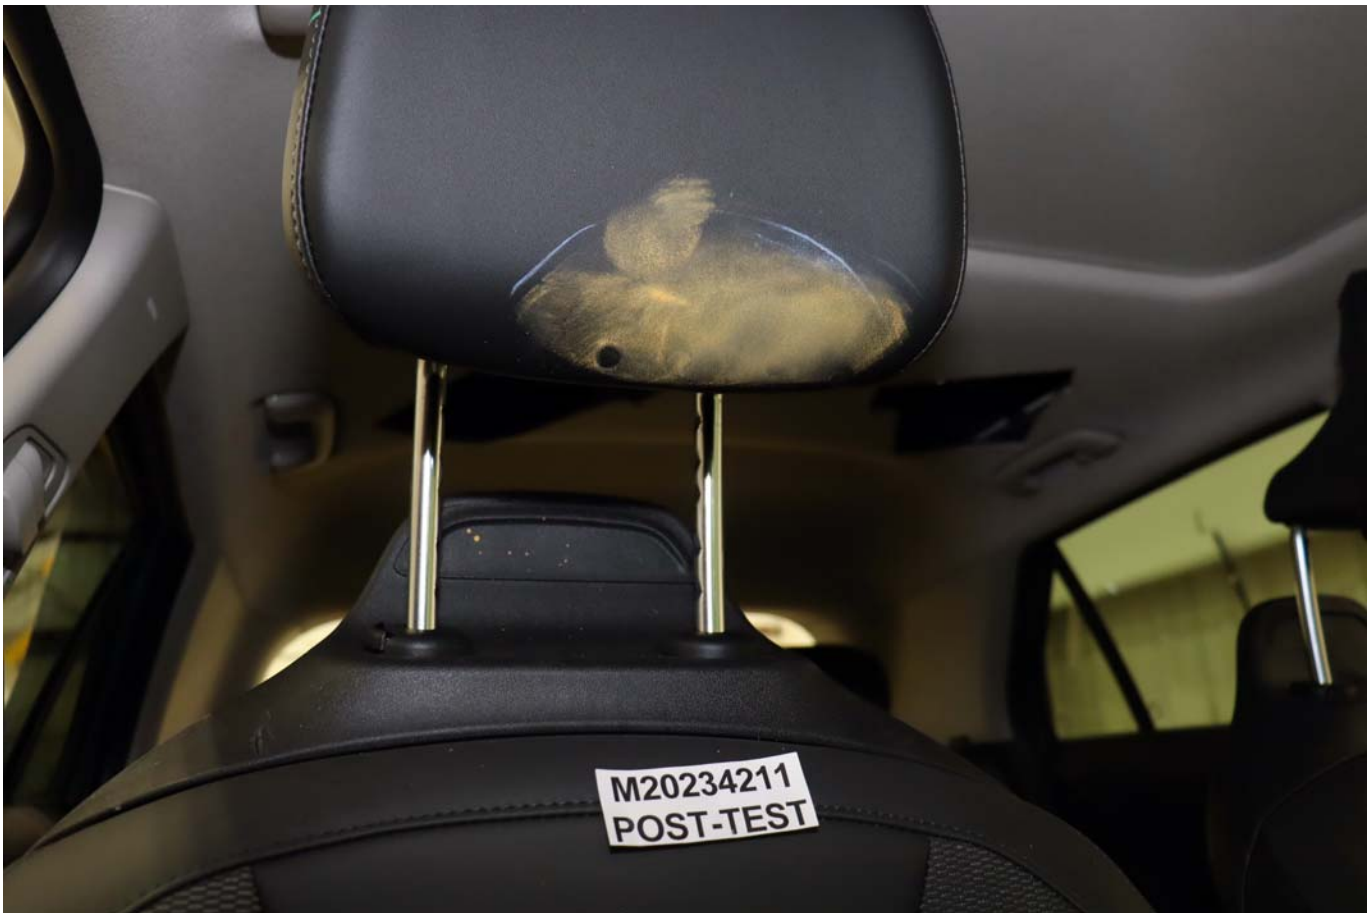
Photo No. 073 - Post-Test Passenger Dummy Contact with Headrest

The passenger's visible contact points were as follows: The passenger's head contacted the airbag. The passenger's head also contacted the headrest. The passenger's knees contacted the glove box.

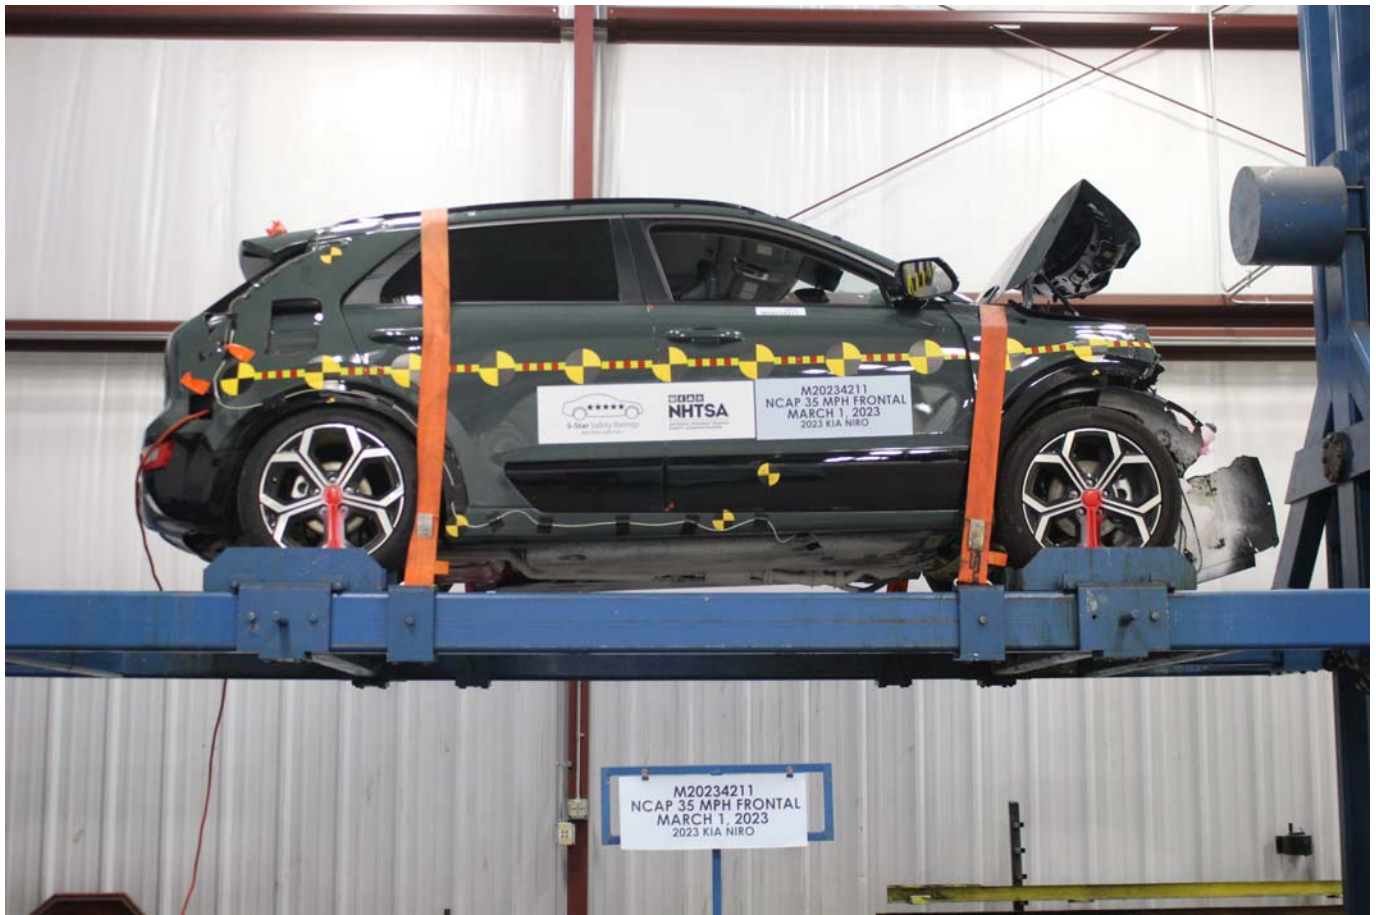
Photo No. 077 - Vehicle at 0 Degrees on Static Rollover Device

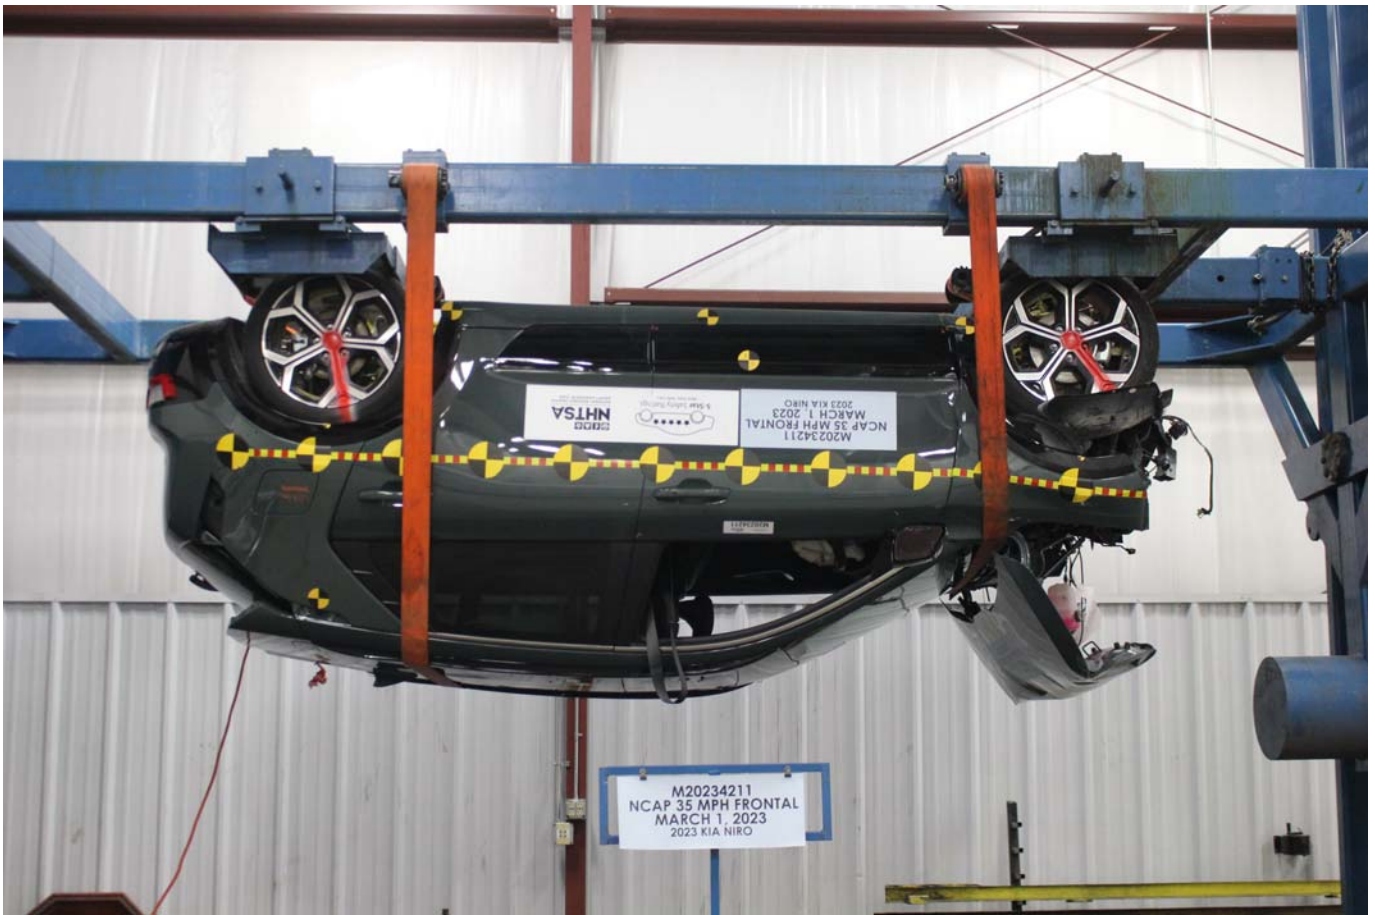
Photo No. 079 - Vehicle at 180 Degrees on Static Rollover Device

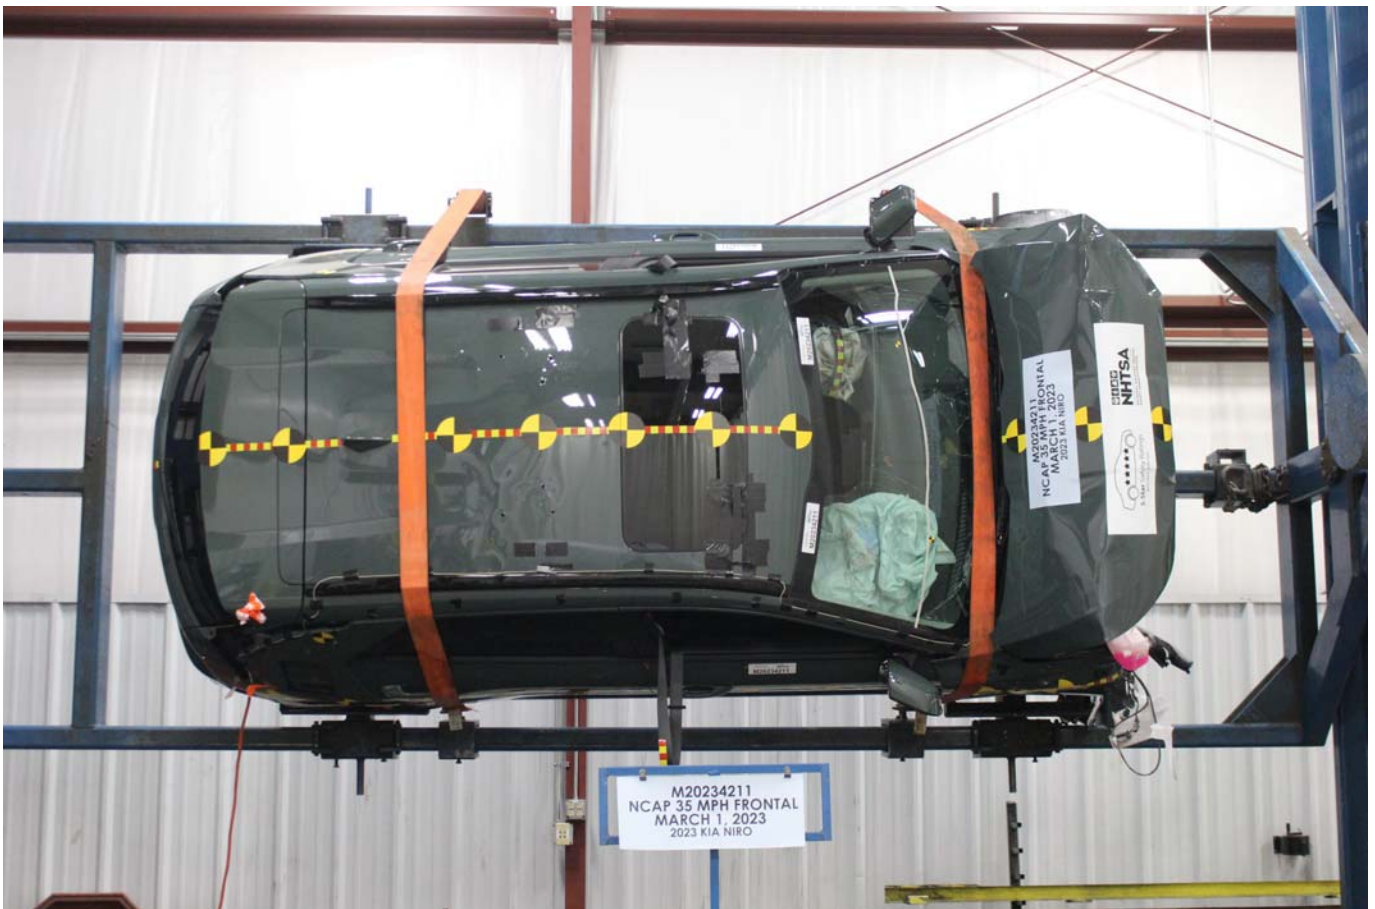
Photo No. 080 - Vehicle at 270 Degrees on Static Rollover Device

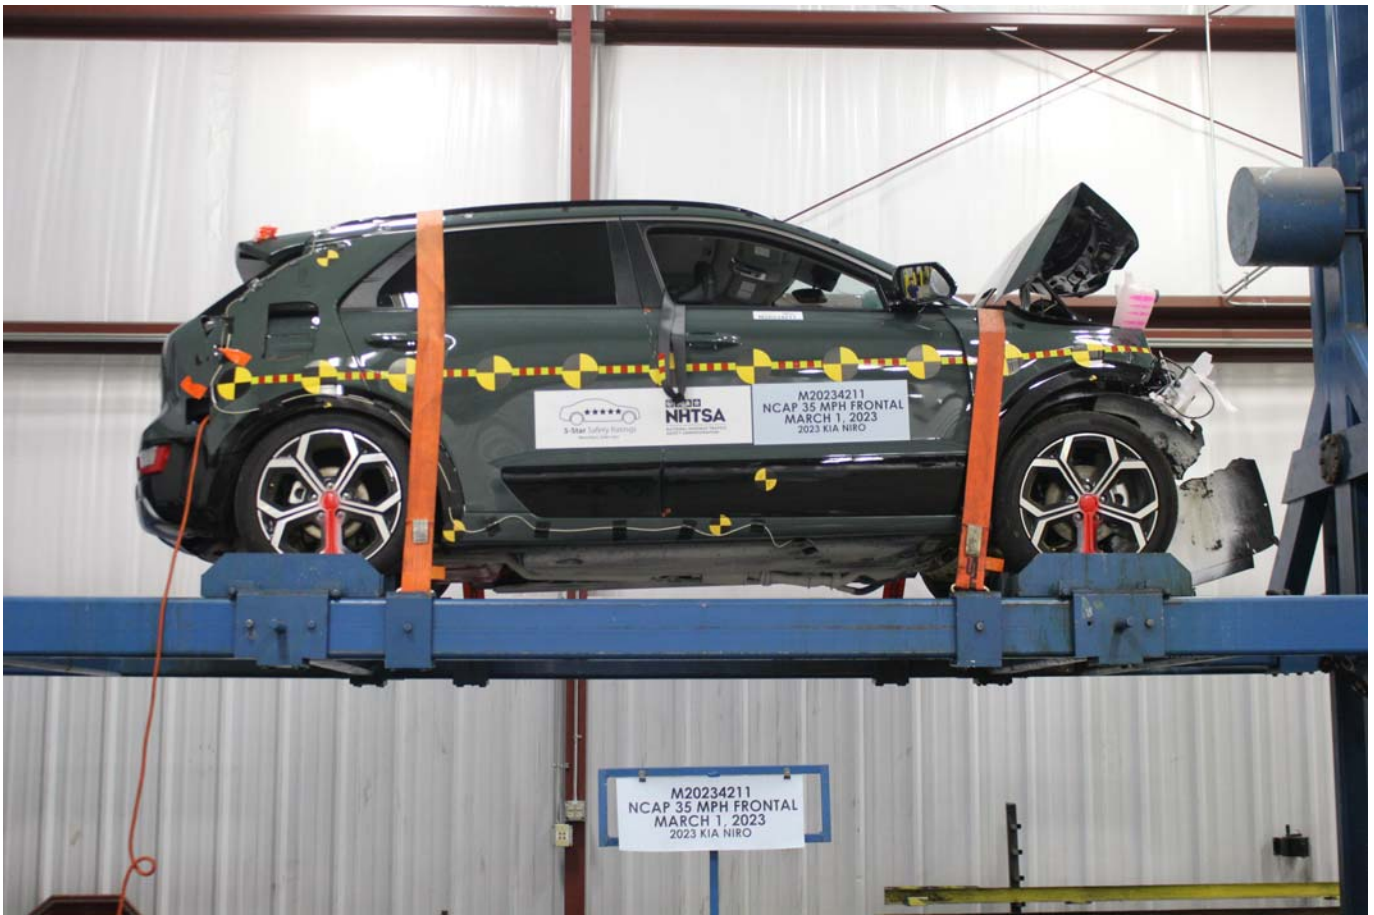
Photo No. 081 - Vehicle at 360 Degrees on Static Rollover Device

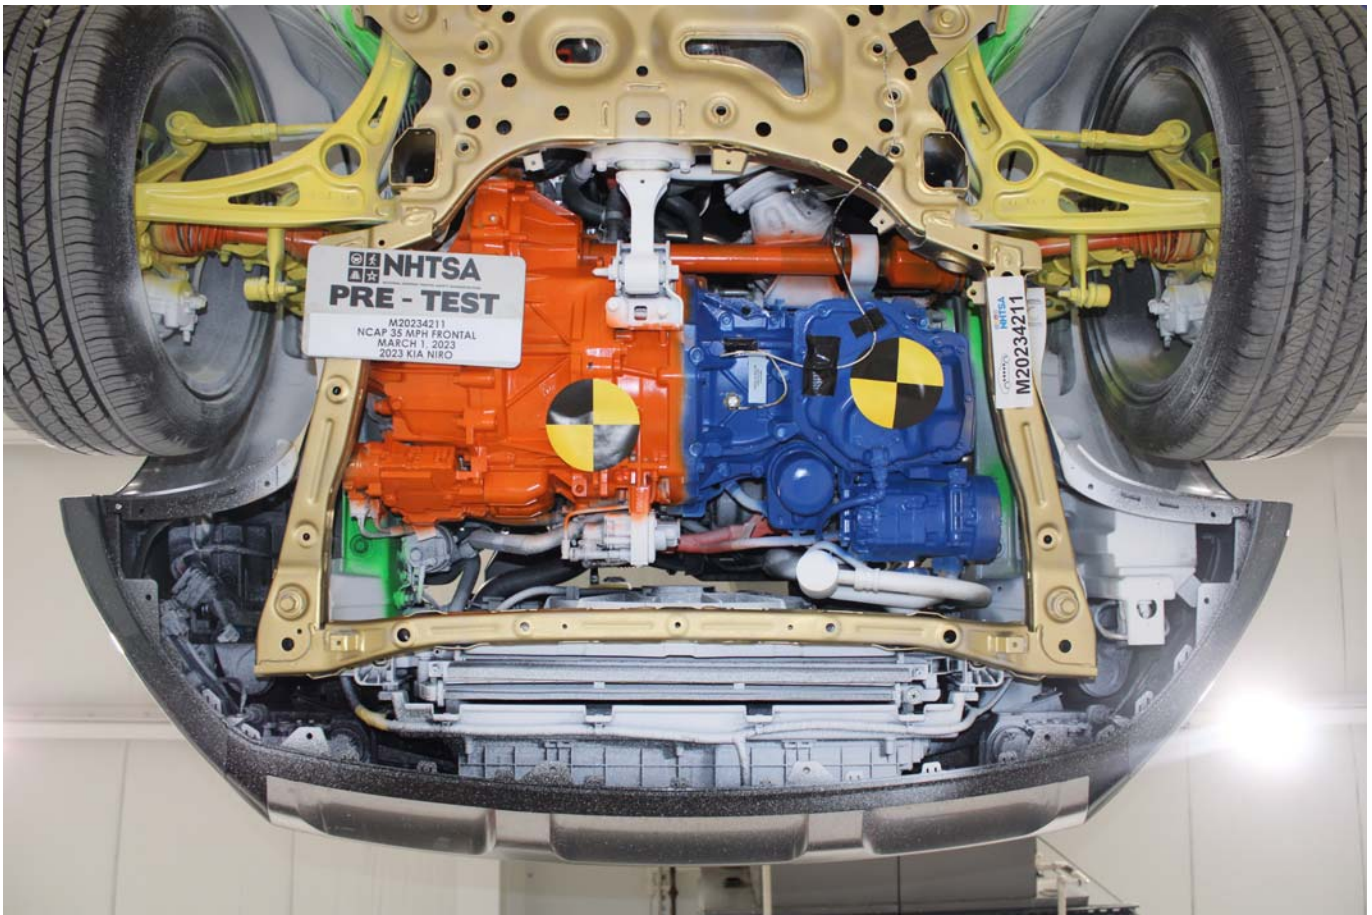
Photo No. 305-16 - Pre-Impact View of Electric Propulsion Drive

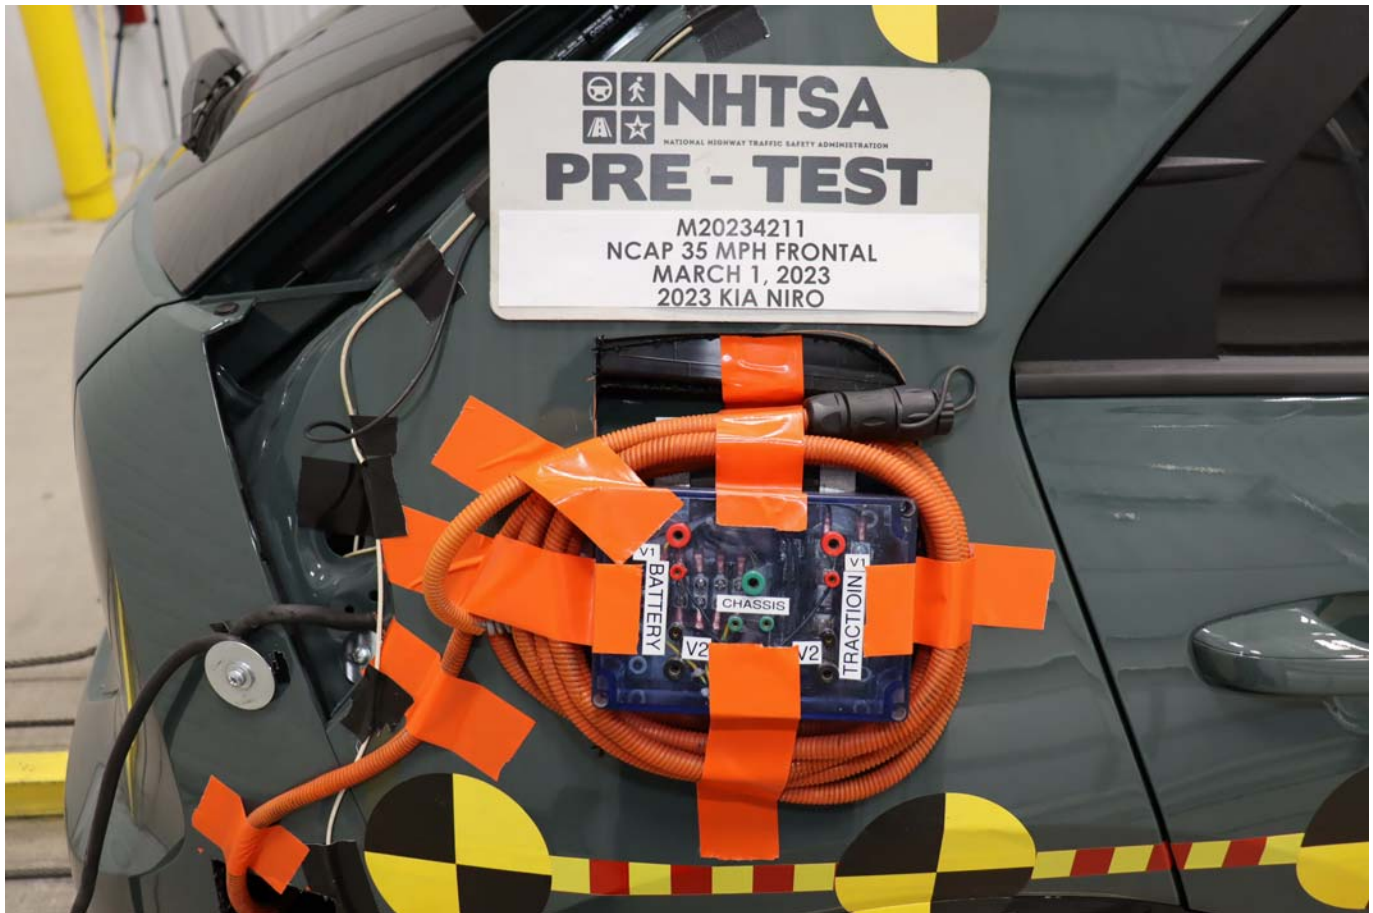
Photo No. 305-24 - Pre-Impact View of Installed Test Interface Port

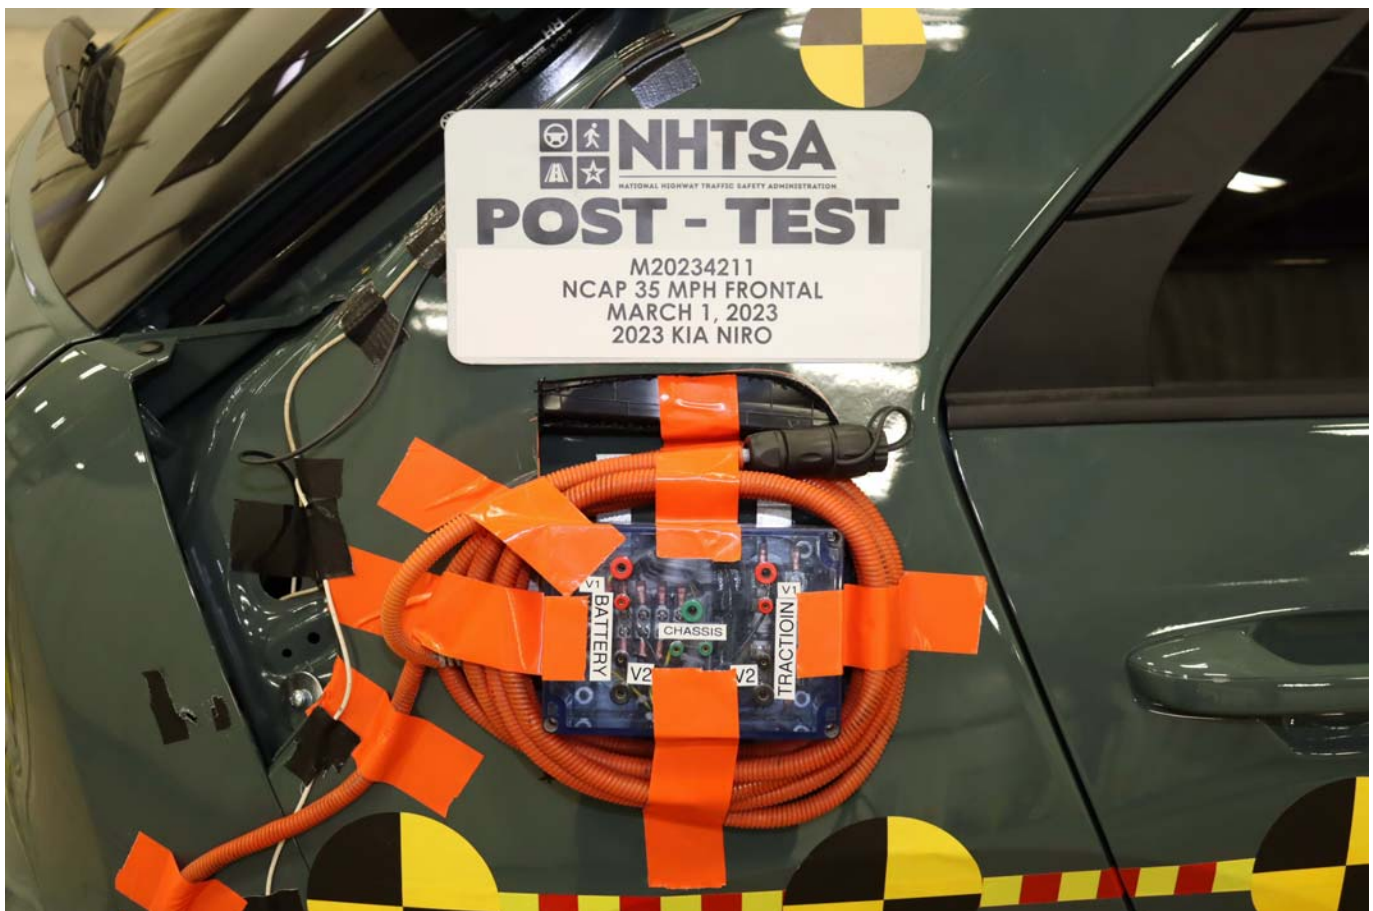
Photo No. 305-25 - Post-Impact View of Installed Test Interface Port
