**REPORT NUMBER: SideNCAPMDB-MGA-23-010**

**NEW CAR ASSESSMENT PROGRAM (NCAP)  
Moving Deformable Barrier Side Impact Test**

**KIA CORPORATION  
2023 Kia Niro EX 5-Door SUV  
NHTSA No.: M20234213**

**FINAL REPORT**

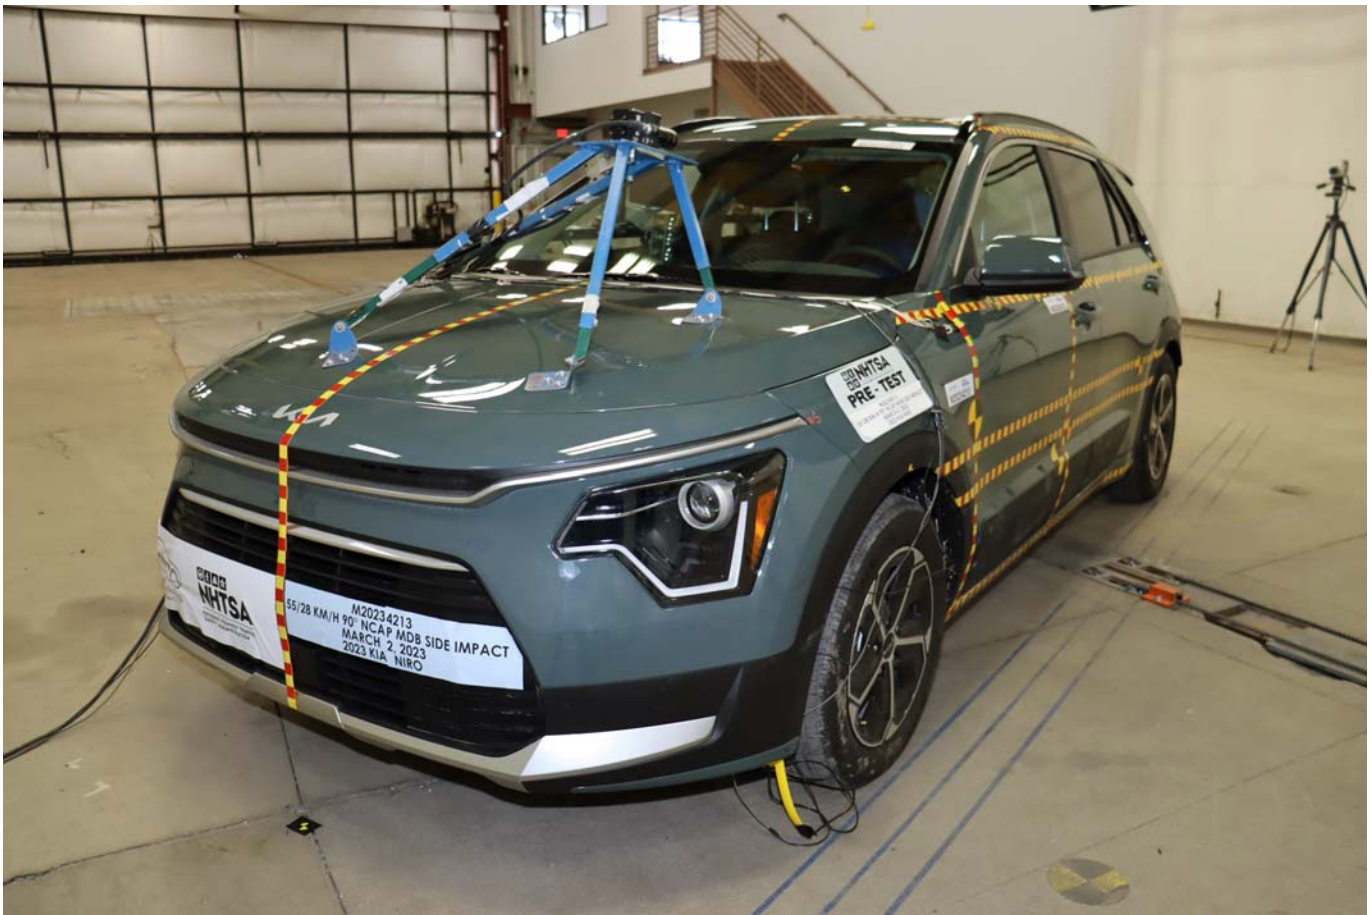
Photo No. 005 - Pre-Test Left Front Three-Quarter View of Test Vehicle

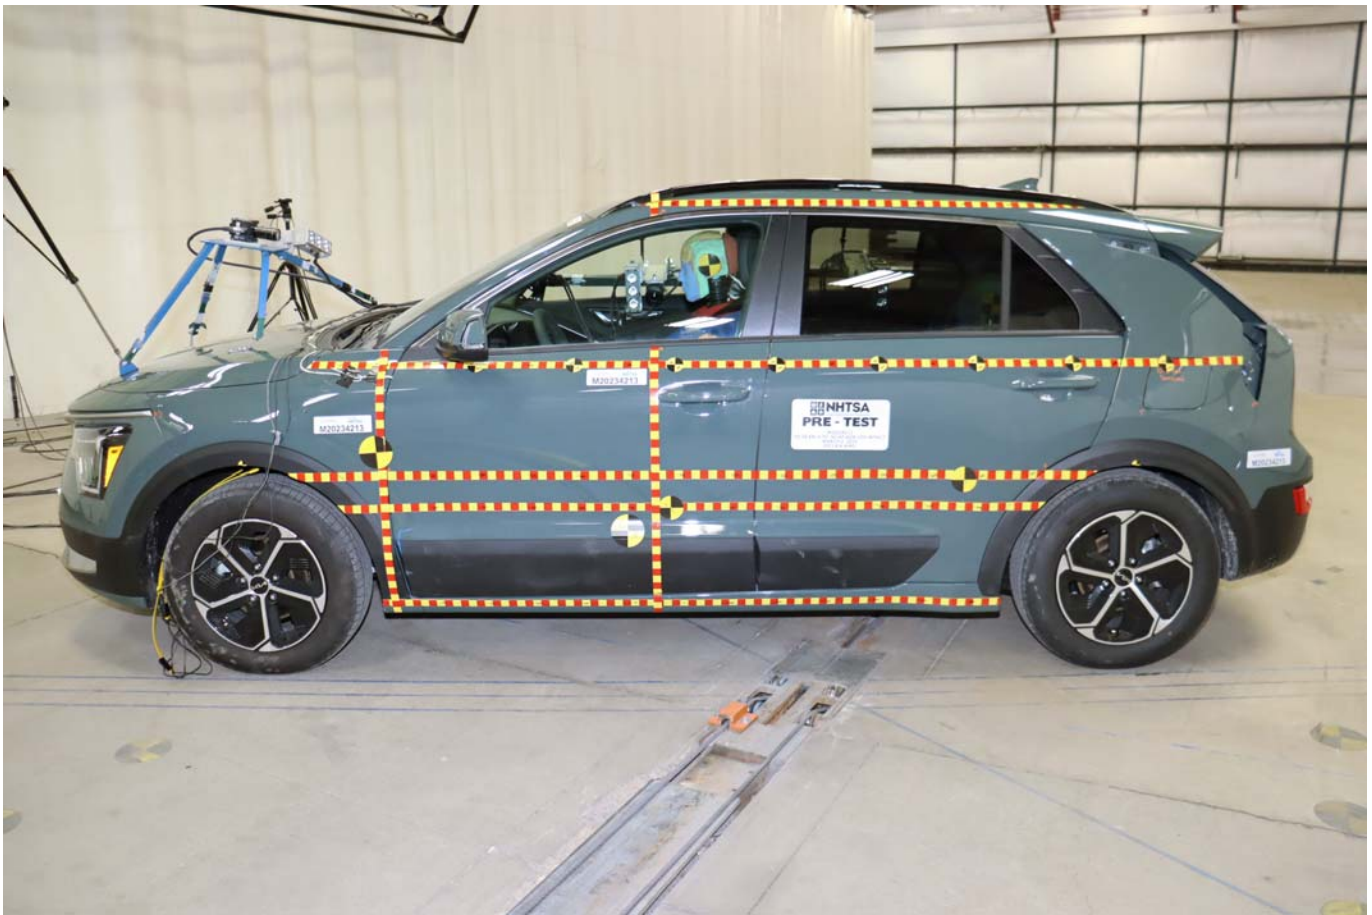
Photo No. 007 - Pre-Test Left Side View of Test Vehicle

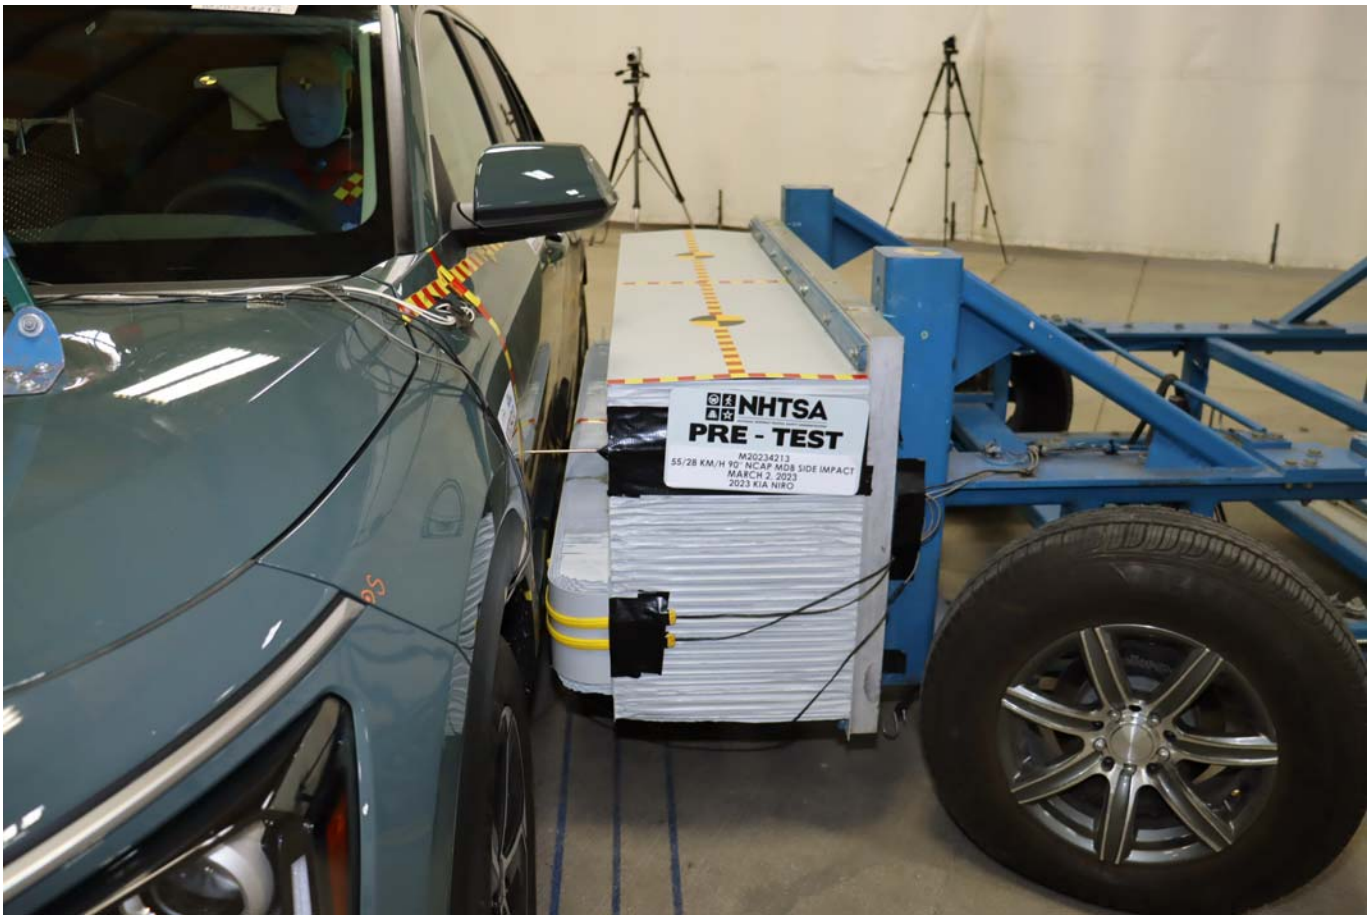
Photo No. 017 - Pre-Test Left Side View of MDB Positioned Against Side of Test Vehicle

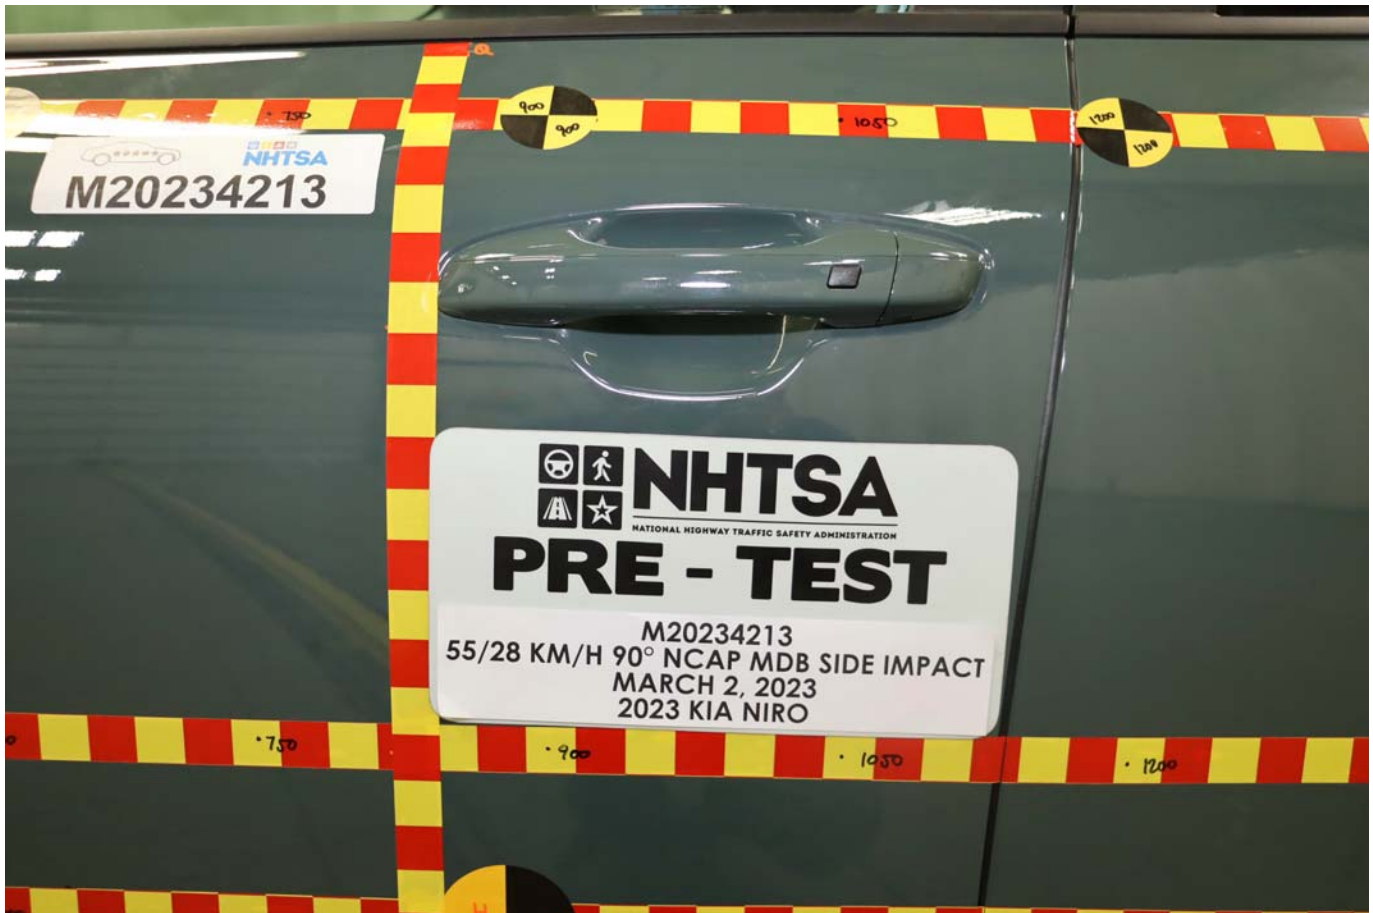
Photo No. 021 - Pre-Test Left Front Door Latch Close-Up

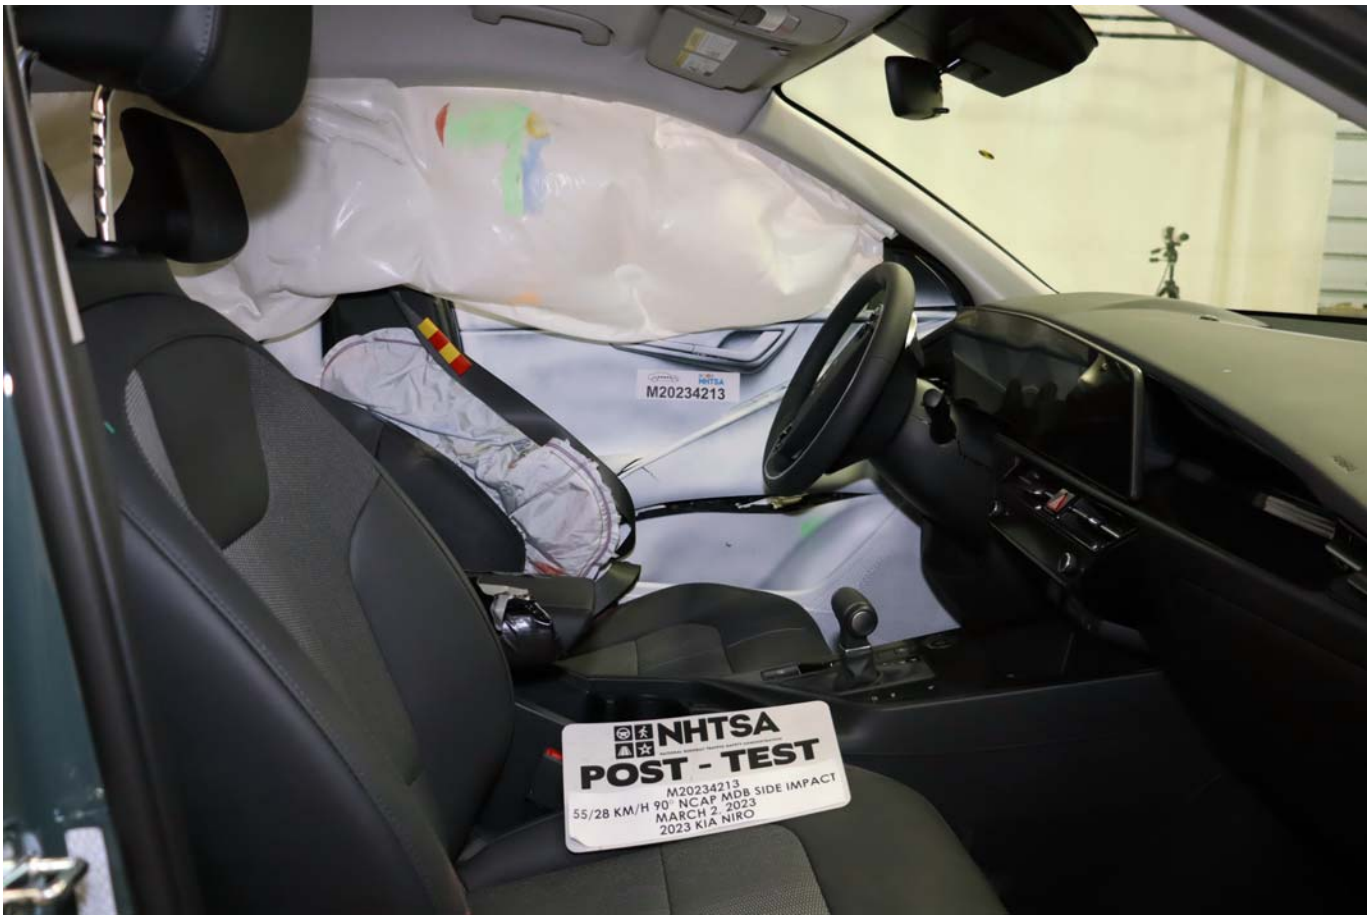
Photo No. 047 - Post-Test Driver Inner Door Panel View

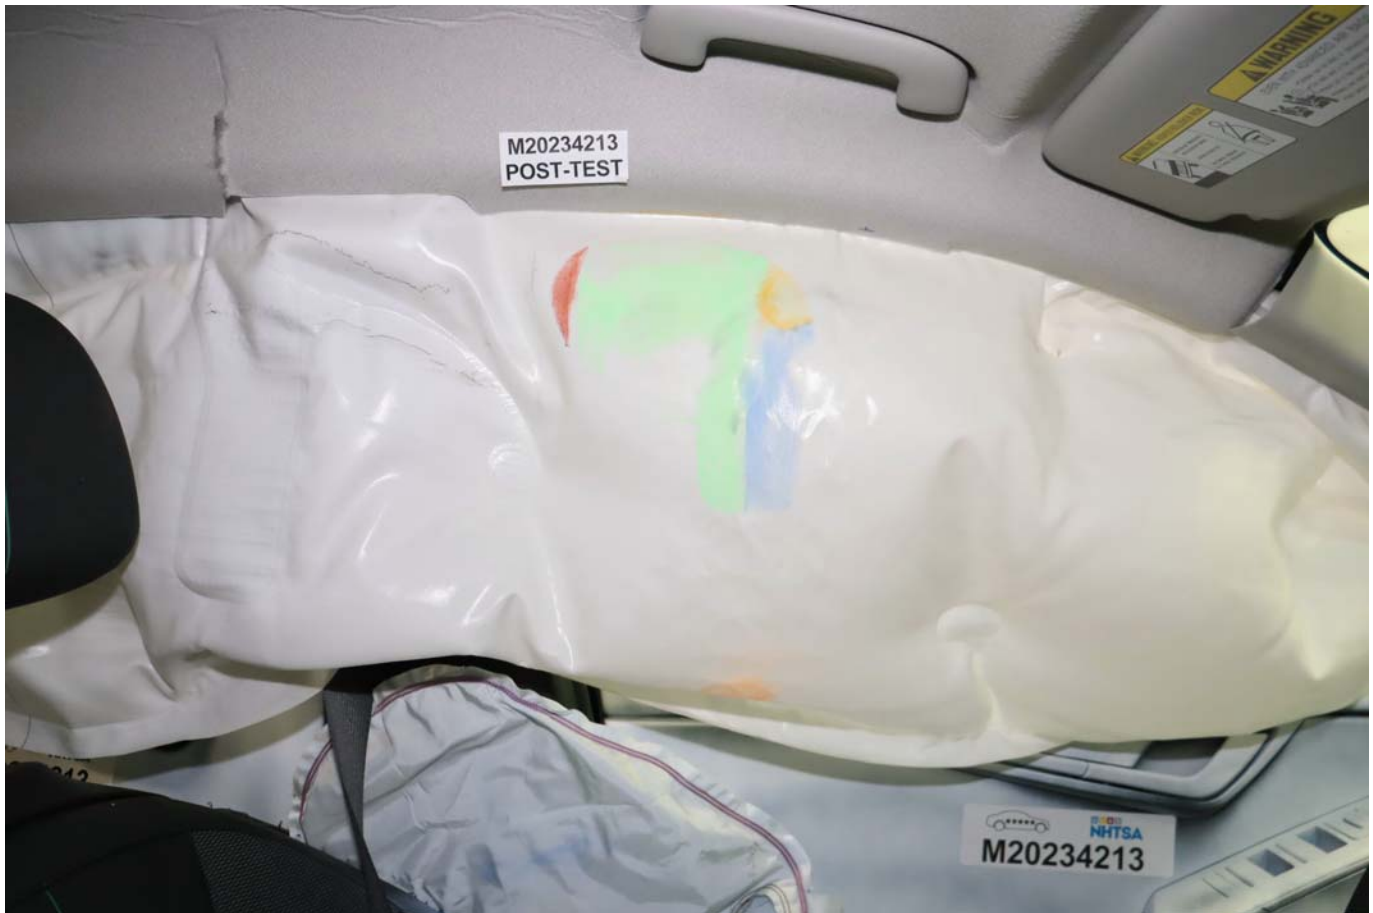
Photo No. 049 - Post-Test Driver Dummy Close-up Head Contact with Side Airbag View

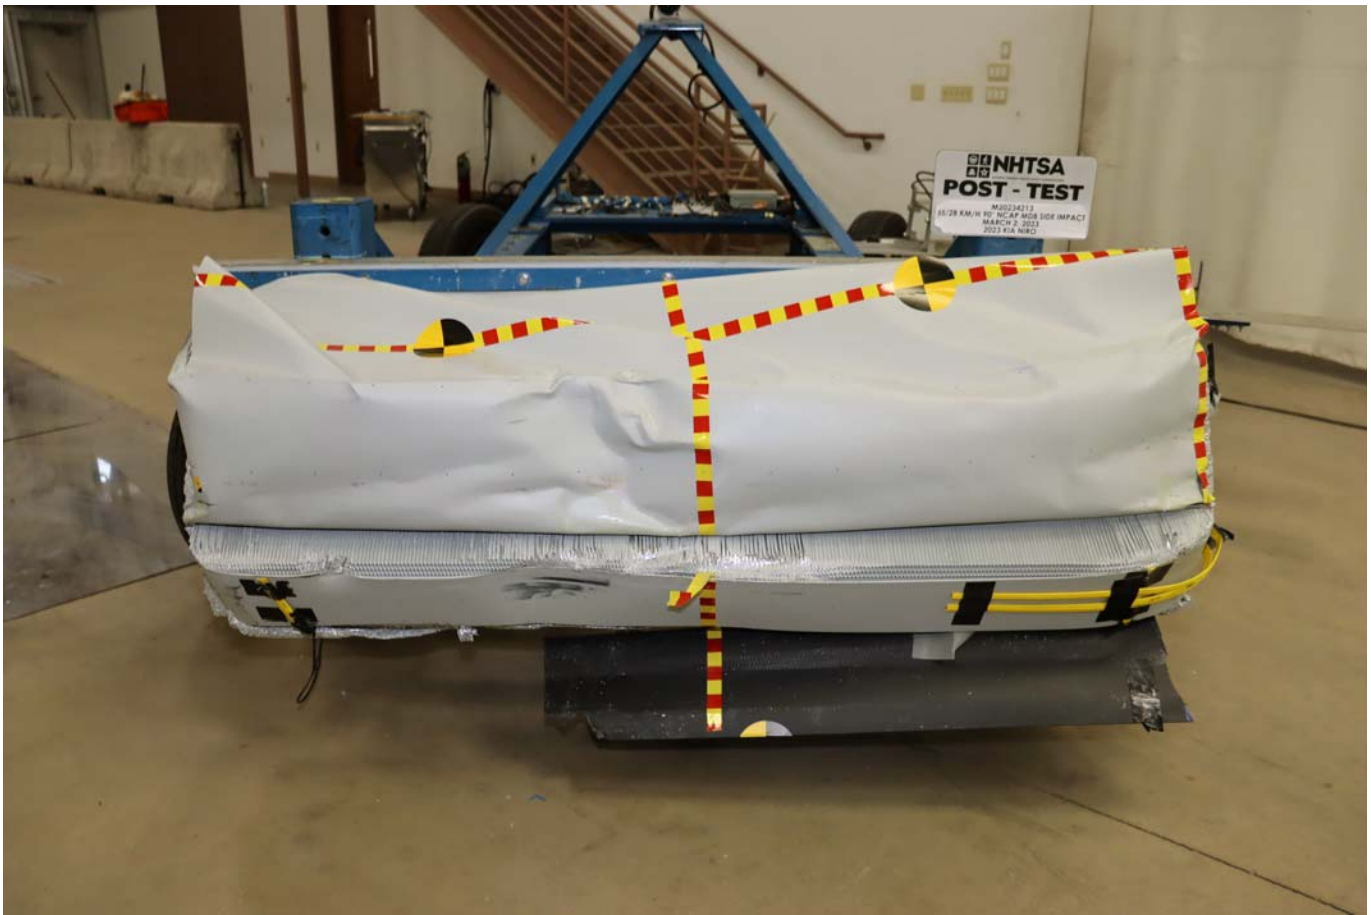
Photo No. 085 - Post-Test Front View of MDB Impactor Face

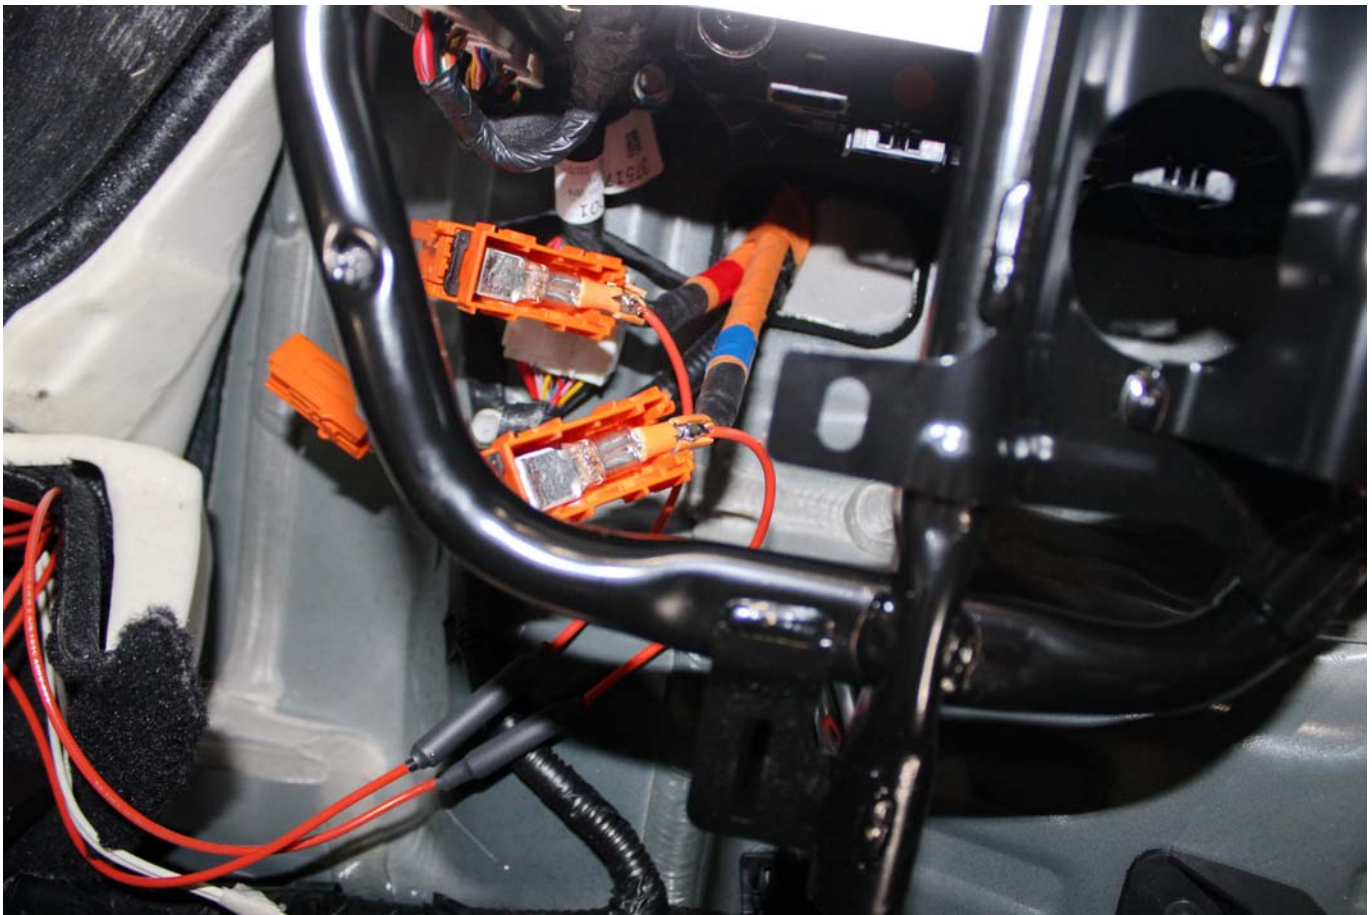
Photo No. 305-23 - Pre-Impact Close-Up View of High Voltage Leads Attached
