FINAL REPORT NUMBER: SPNCAP-TRC-23-003

**NEW CAR ASSESSMENT PROGRAM (NCAP)
SIDE IMPACT POLE TEST**

**HYUNDAI MOTOR COMPANY
2023 Hyundai Kona Electric
NHTSA NUMBER: M20234215**

**PREPARED BY:
Transportation Research Center Inc.
10820 State Route 347
P. O. Box B-67
East Liberty, OH 43319**

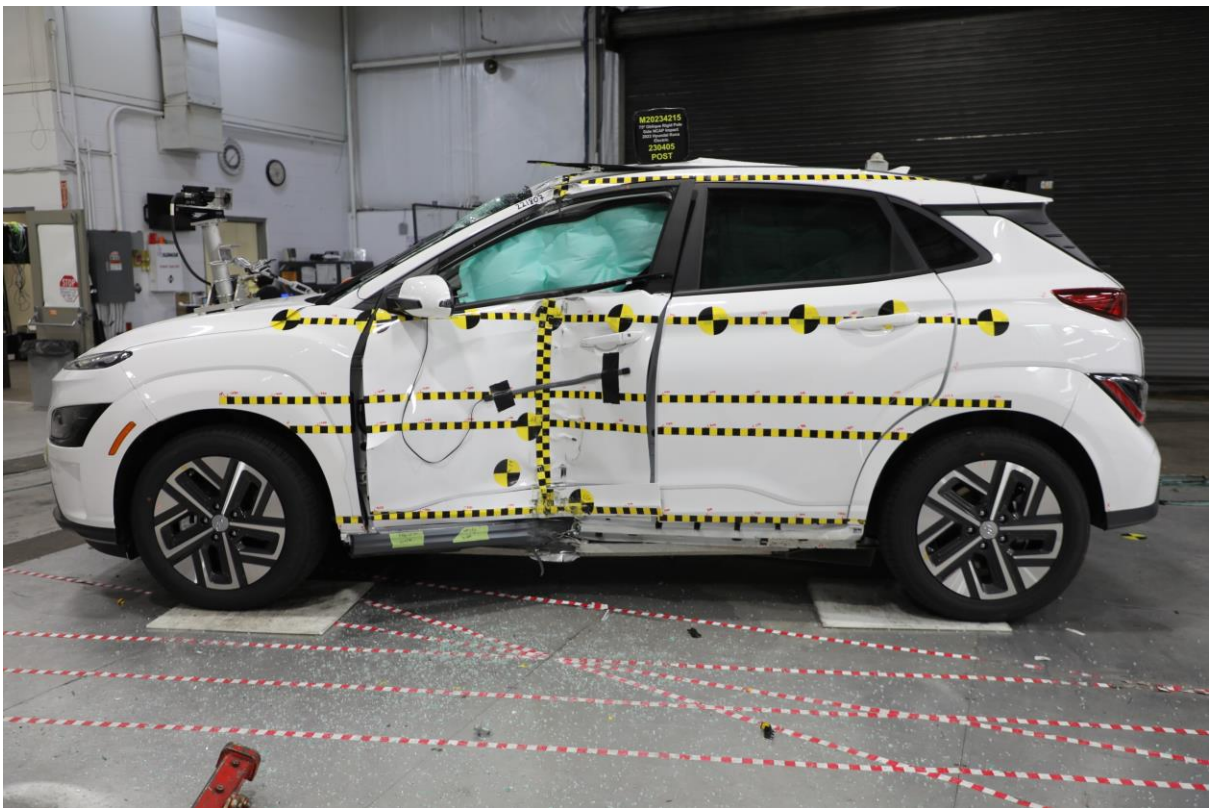
No. 008 Post-Test Left Side View of Test Vehicle

Critical Areas of Performance	Observations and Conclusions
Pillar Performance	Good
Sill Separation	None
Windshield Damage	Cracked
Side Window Damage	Blown out
Other Notable Effects	None

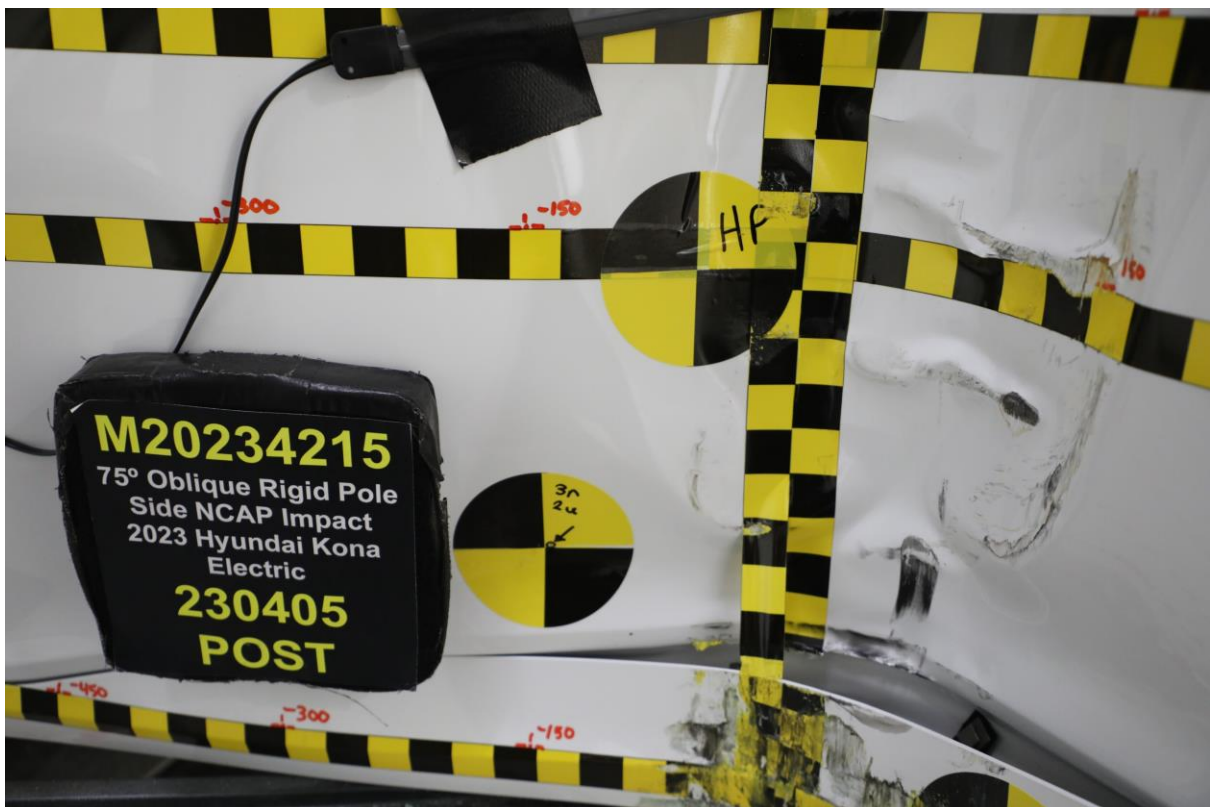
No. 020 Post-Test Close-Up View of Impact Point Target Showing Impact Location

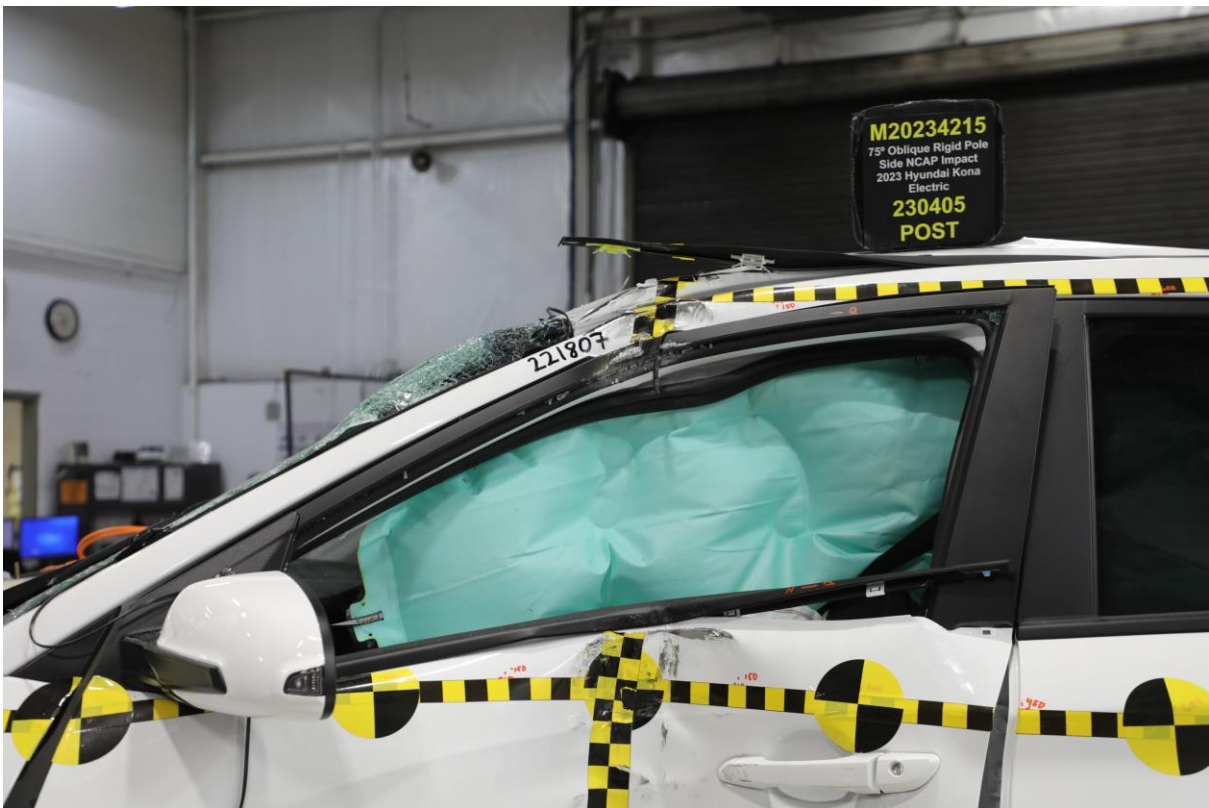
No. 025 Post-Test Left Side View of Dummy Shoulder and Door Top View

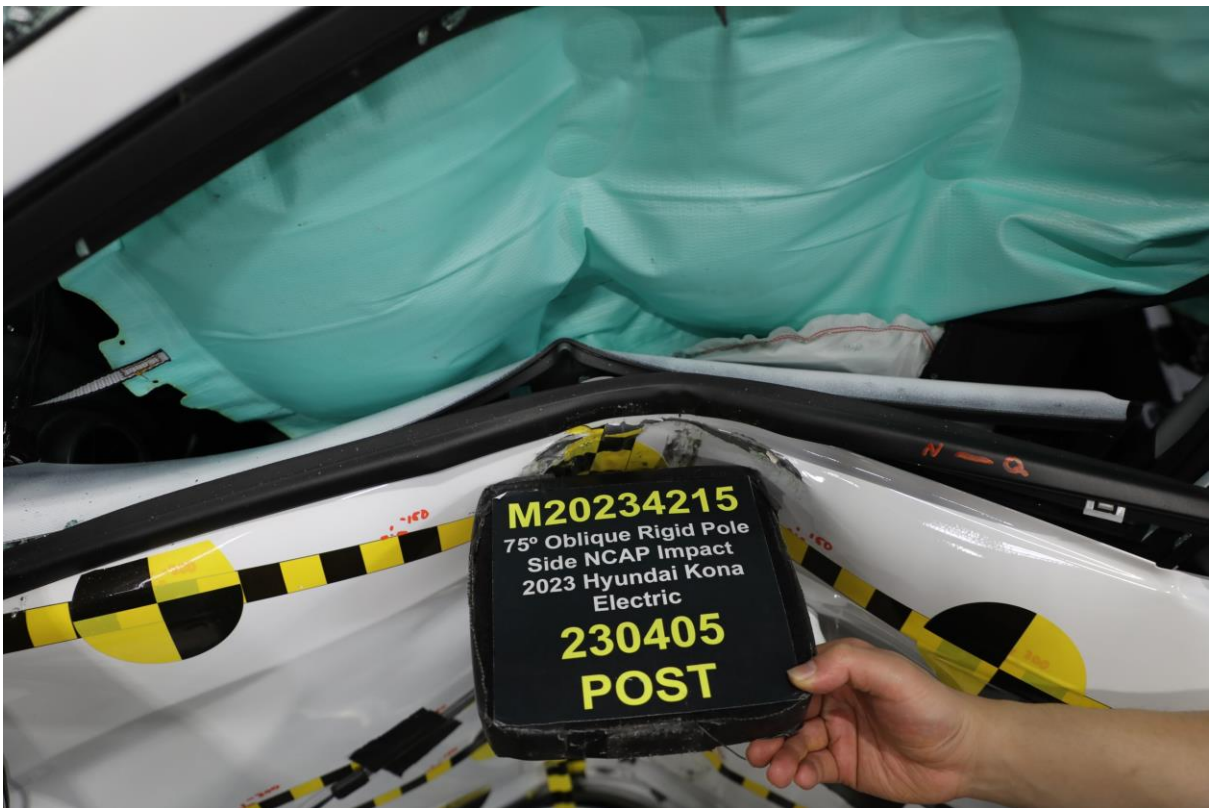
No. 041 Post-Test Dummy and Door Clearance View

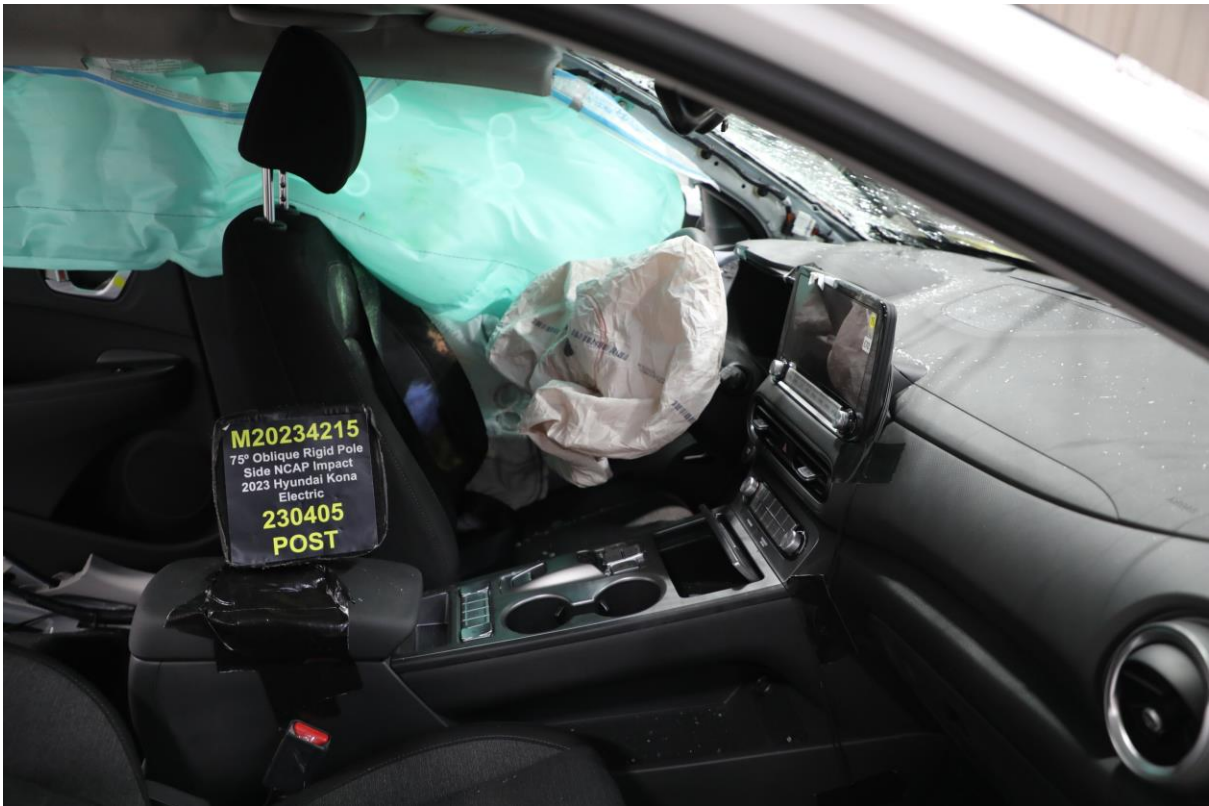
No. 045 Post-Test Inner Door Panel View Showing Dummy Contact Location

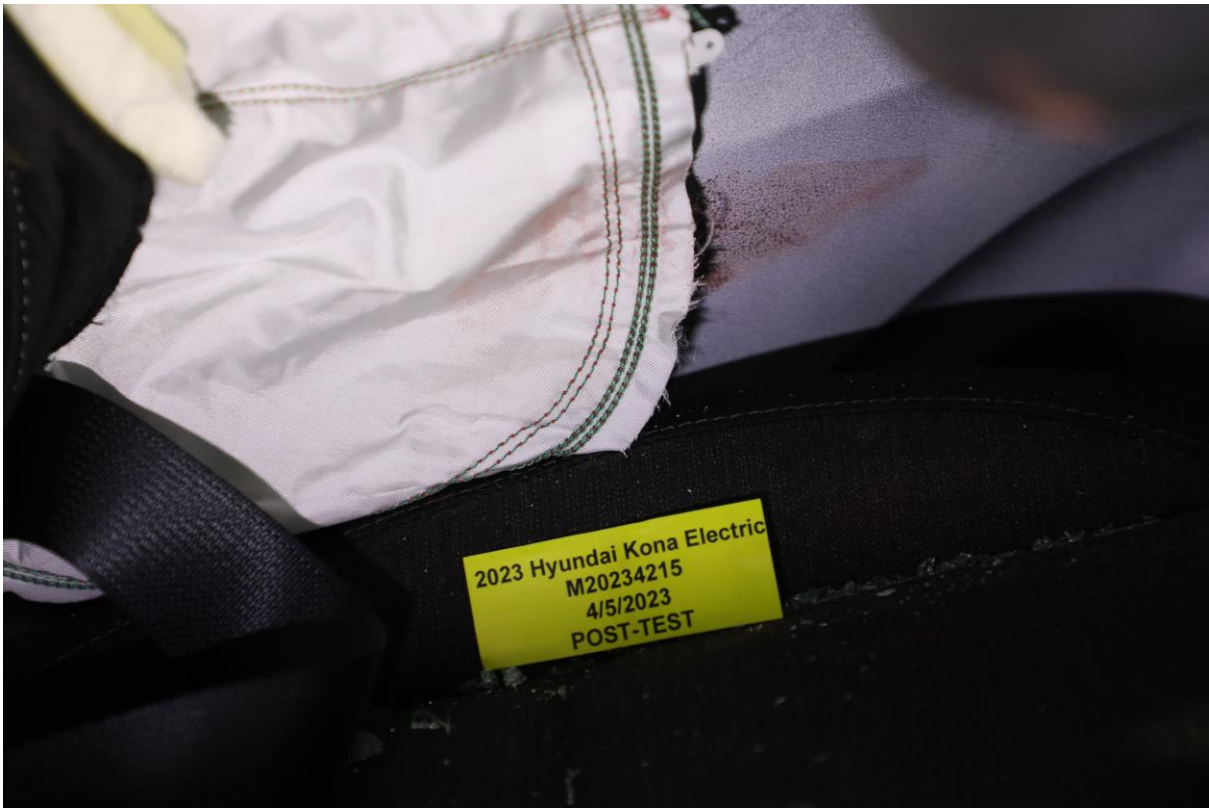
No. 051 Post-Test Dummy Close-Up Pelvis Contact with Side Airbag View

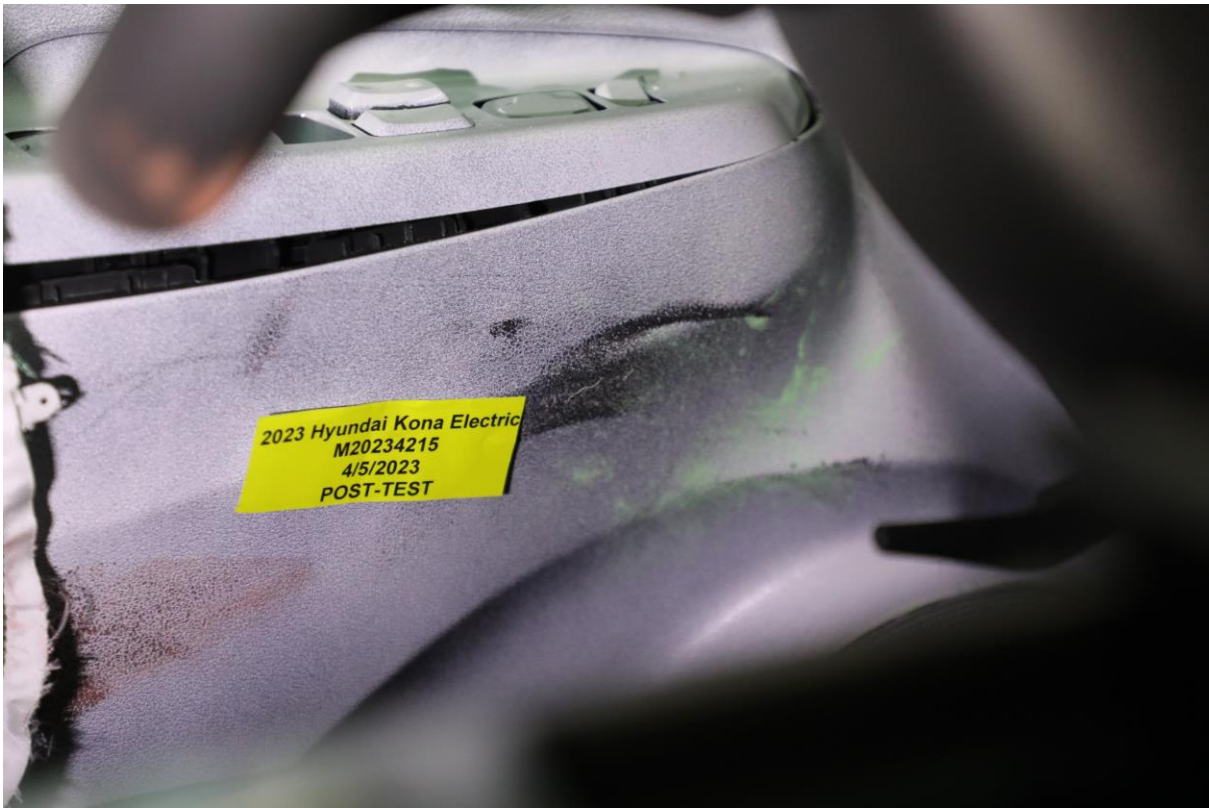
No. 052 Post-Test Dummy Close-Up Knee Contact with Vehicle Interior View

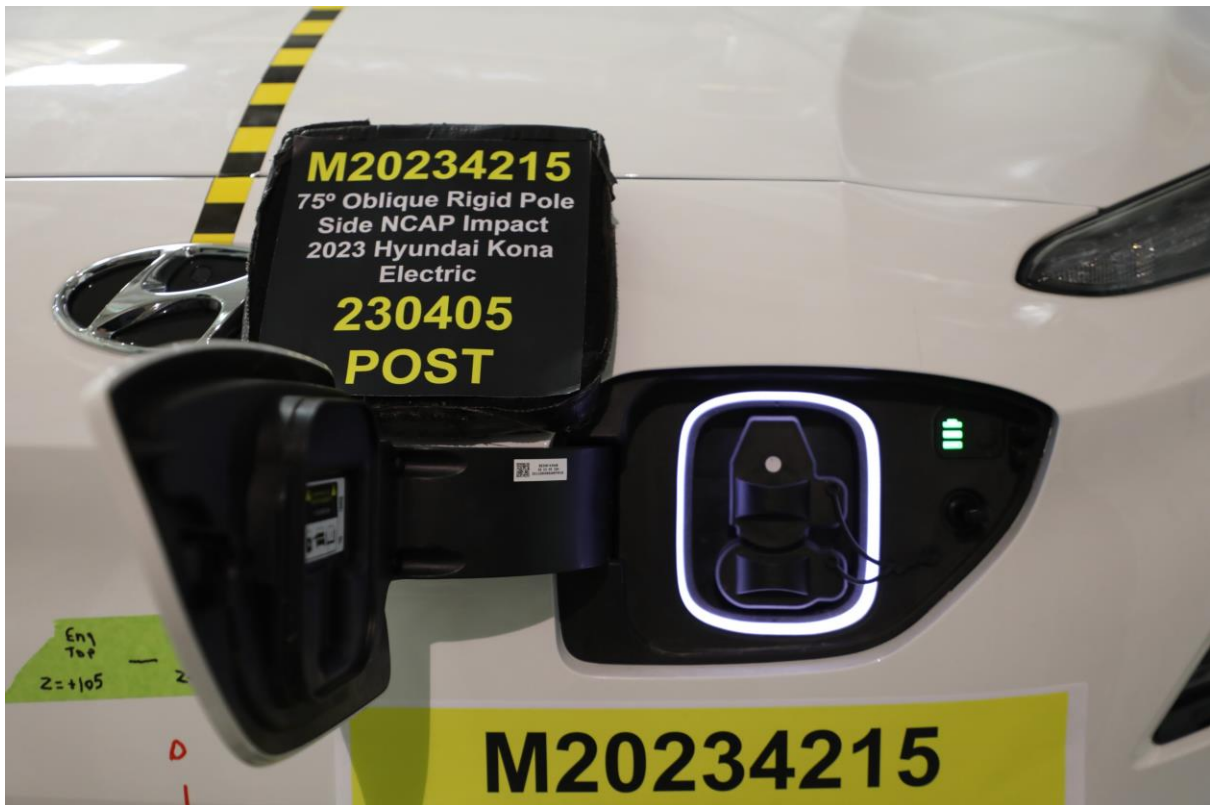
No. 056 Post-Test Charge Port View

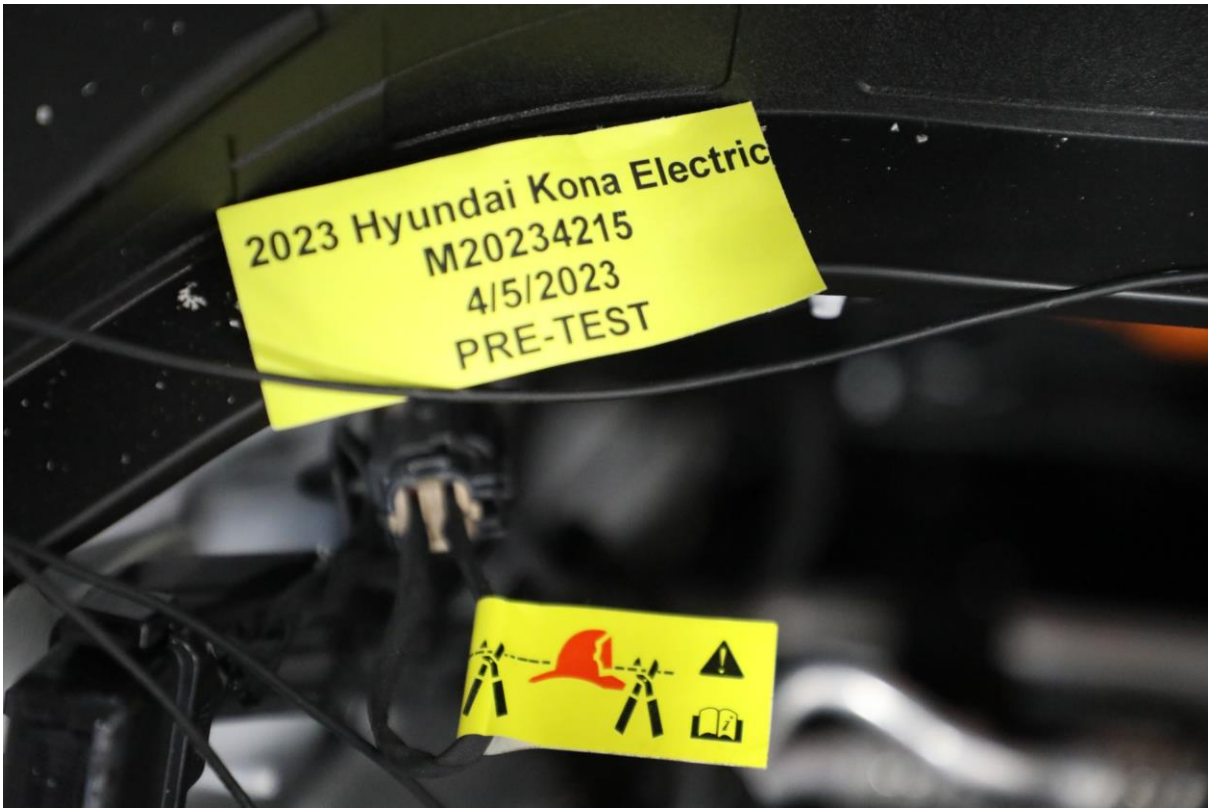
305-06 Manual High Voltage Service Disconnect in Place

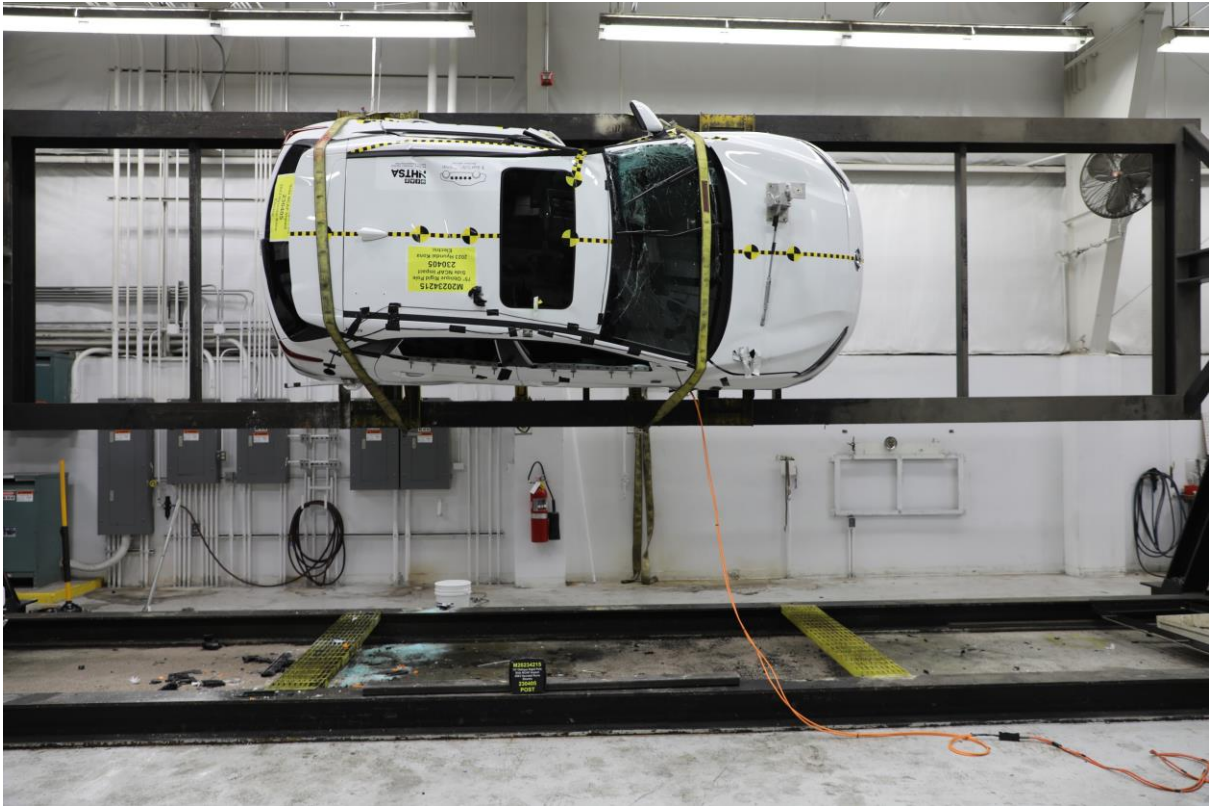
305-28 FMVSS No. 305 Static Rollover at 90°

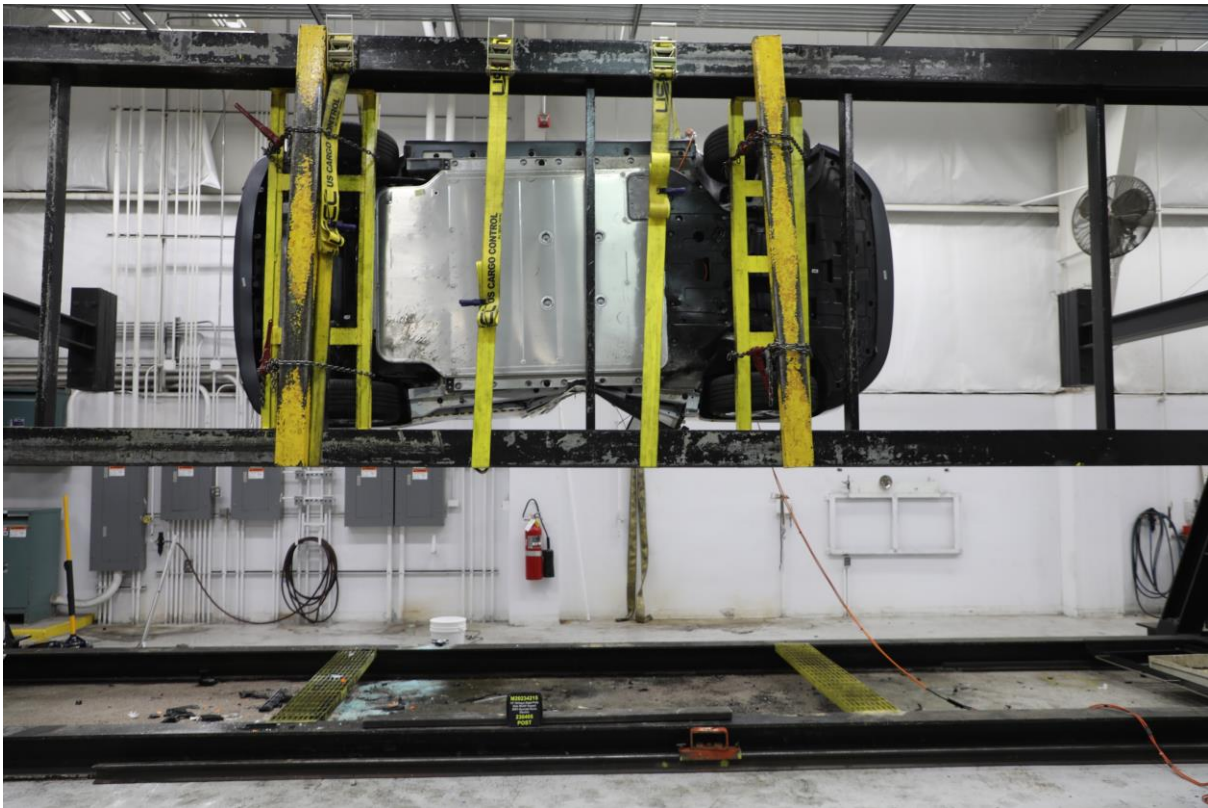
305-30 FMVSS No. 305 Static Rollover at 270°
