**REPORT NUMBER: SideNCAPMDB-MGA-23-015**

**NEW CAR ASSESSMENT PROGRAM (NCAP)  
Moving Deformable Barrier Side Impact Test**

**MAZDA TOYOTA MANUFACTURING, U.S.A., INC.  
2023 Mazda CX-50 S AWD 5-Door SUV  
NHTSA No.: M20235402**

**MGA RESEARCH CORPORATION  
5000 Warren Road  
Burlington, WI 53105**

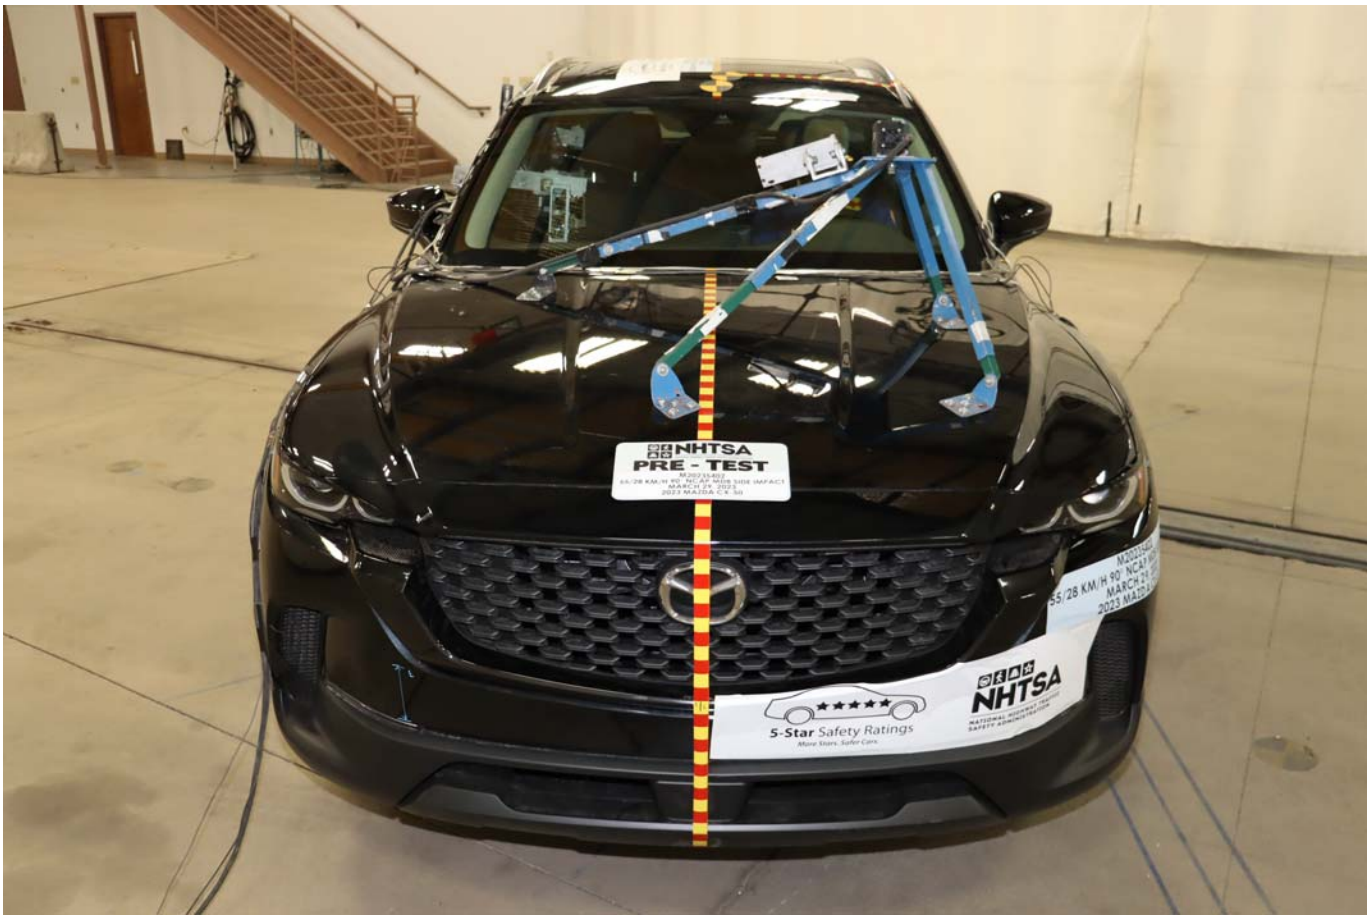
Photo No. 003 - Pre-Test Frontal View of Test Vehicle

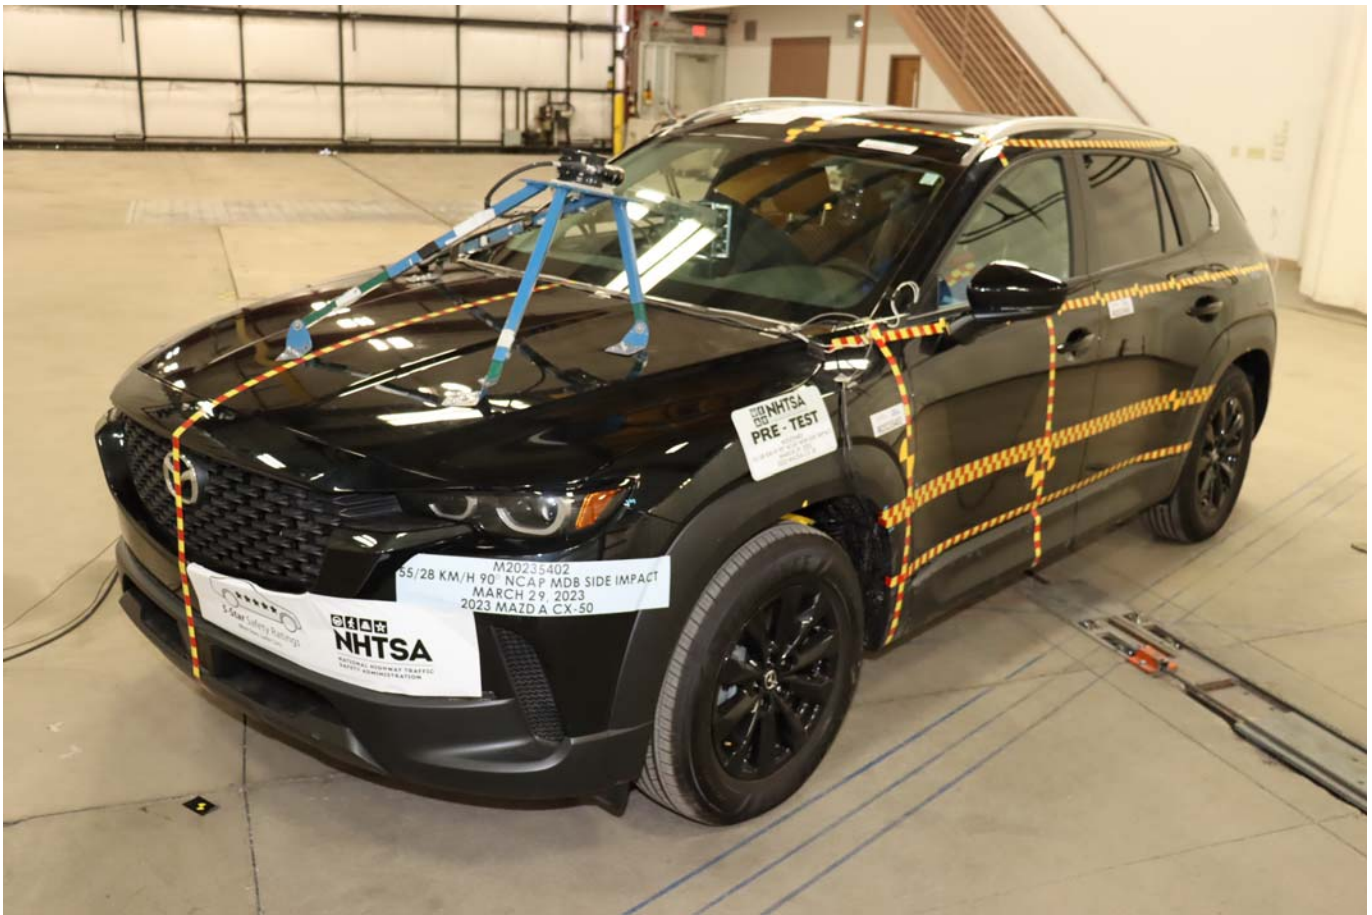
Photo No. 005 - Pre-Test Left Front Three-Quarter View of Test Vehicle

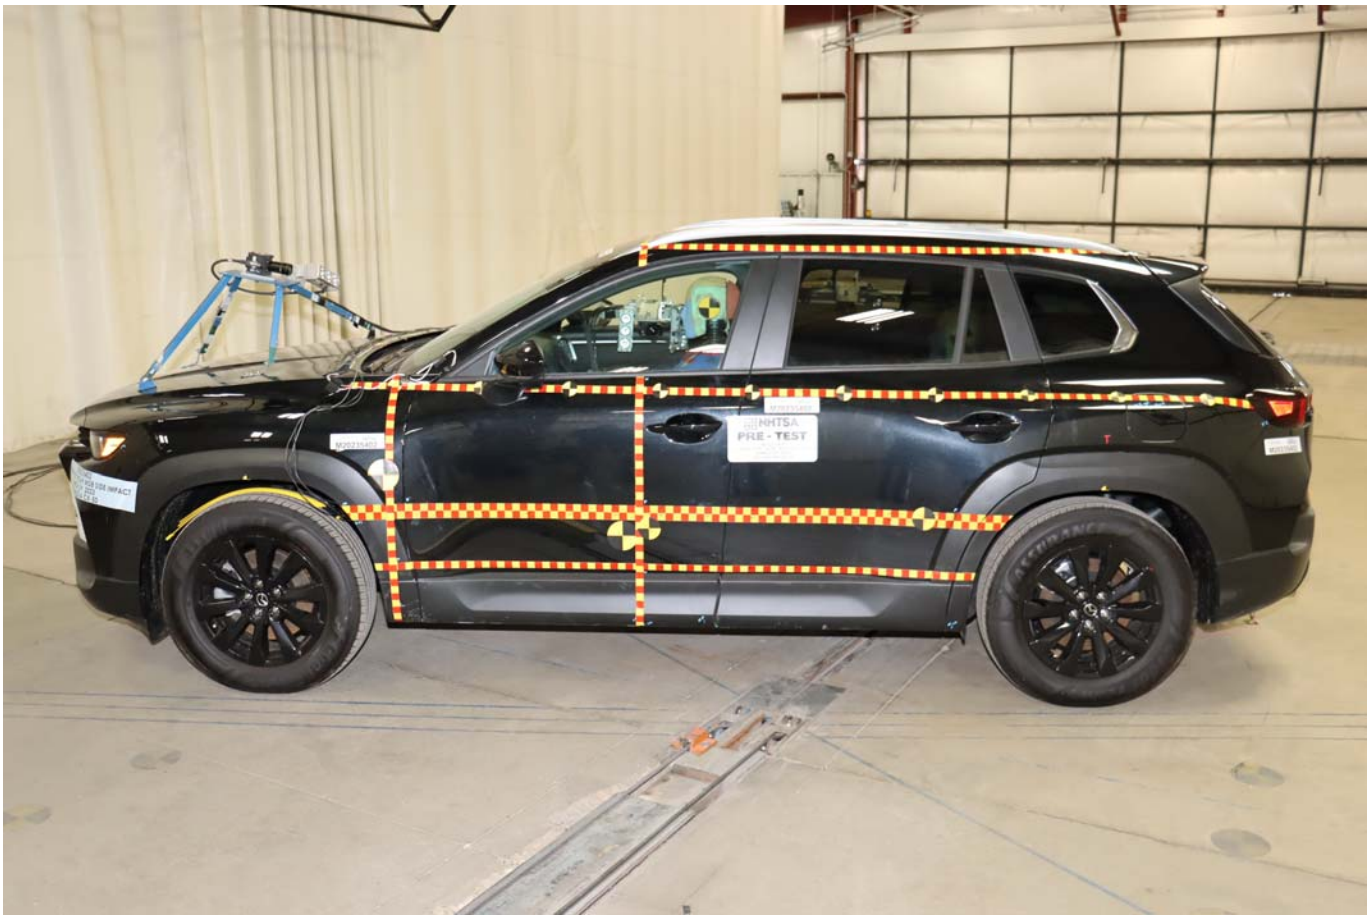
Photo No. 007 - Pre-Test Left Side View of Test Vehicle

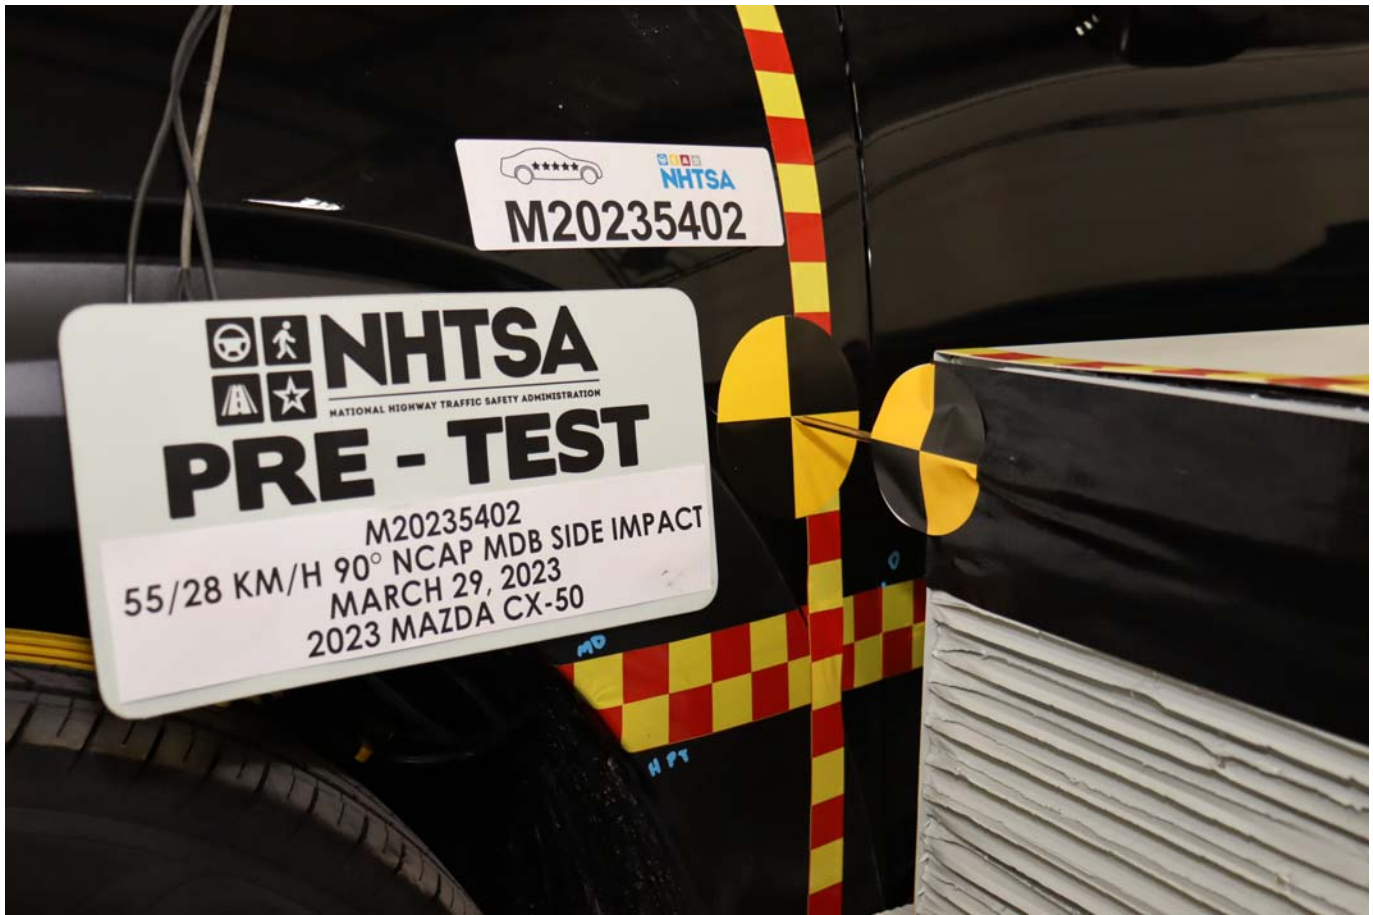
Photo No. 019 - Pre-Test Close-Up View of Impact Point Target

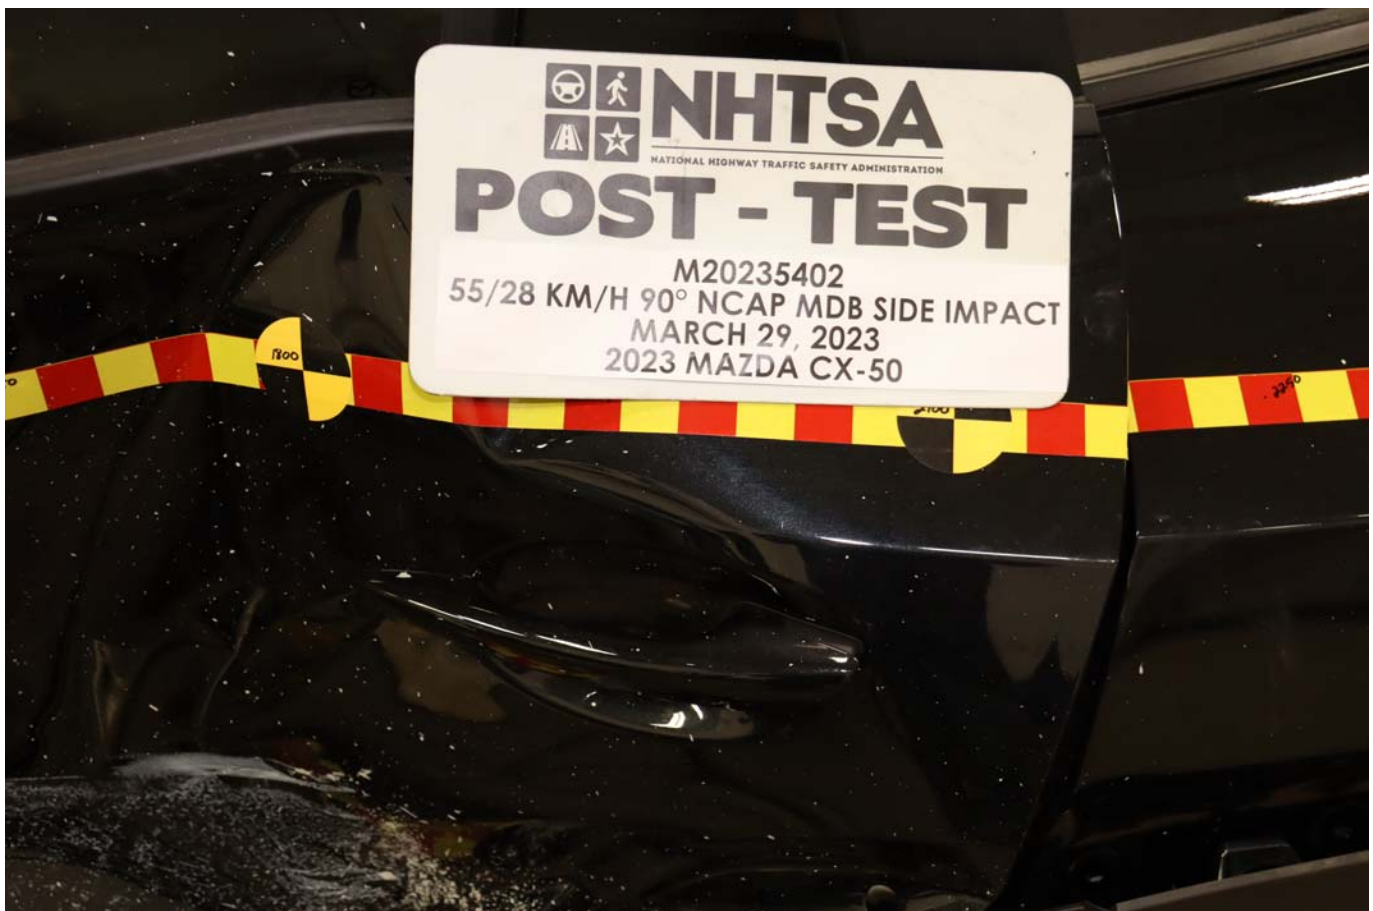
Photo No. 024 - Post-Test Left Rear Door Latch Close-Up

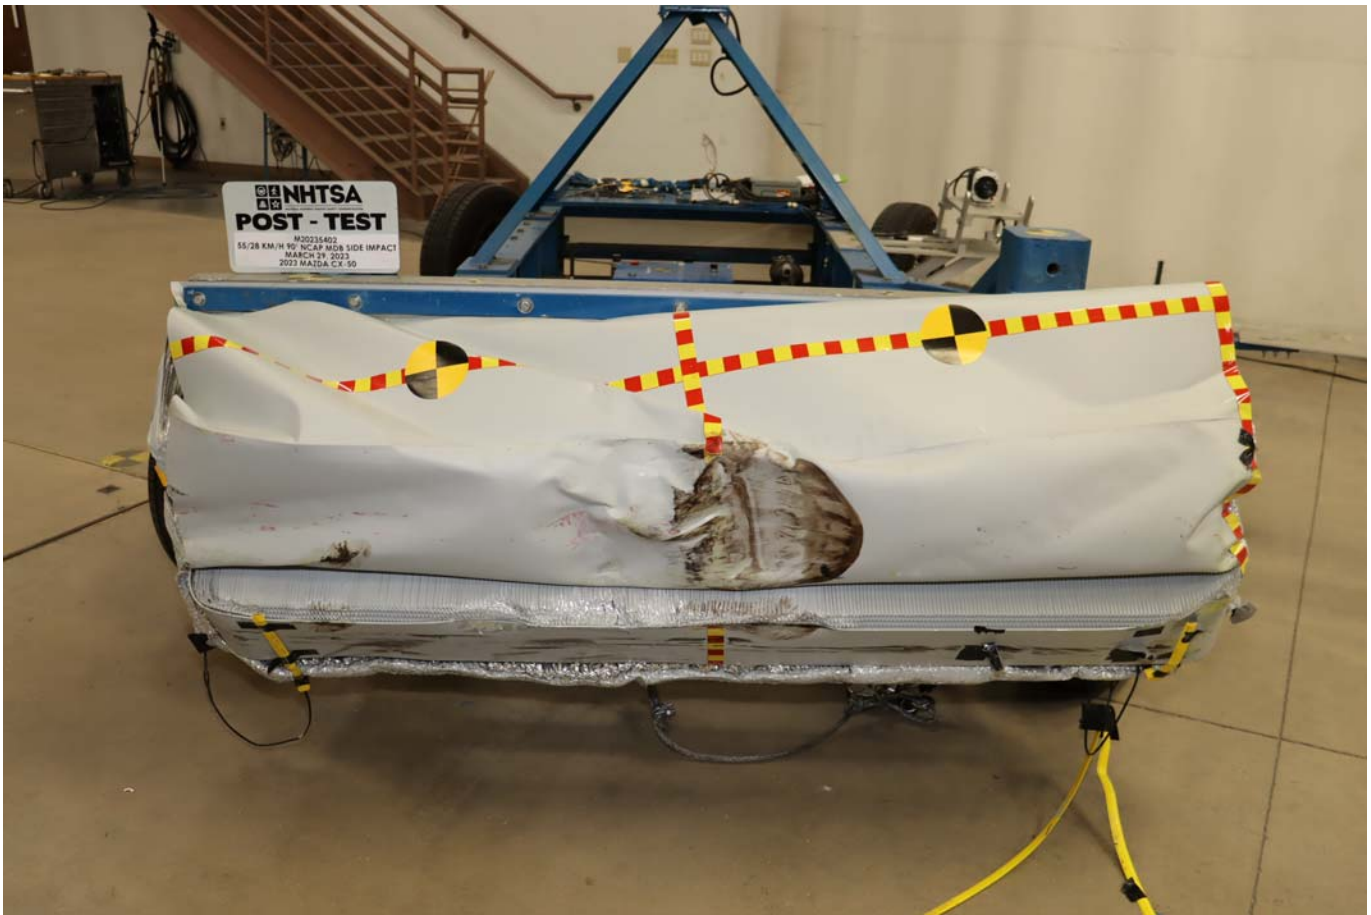
Photo No. 085 - Post-Test Front View of MDB Impactor Face
