**REPORT NUMBER: NCAP-MGA-23-014**

**NEW CAR ASSESSMENT PROGRAM (NCAP)  
Frontal Barrier Impact Test**

**MAZDA TOYOTA MANUFACTURING U.S.A., INC.  
2023 Mazda CX-50 AWD 5-Door SUV  
NHTSA No.: M20235400**

**FINAL REPORT**

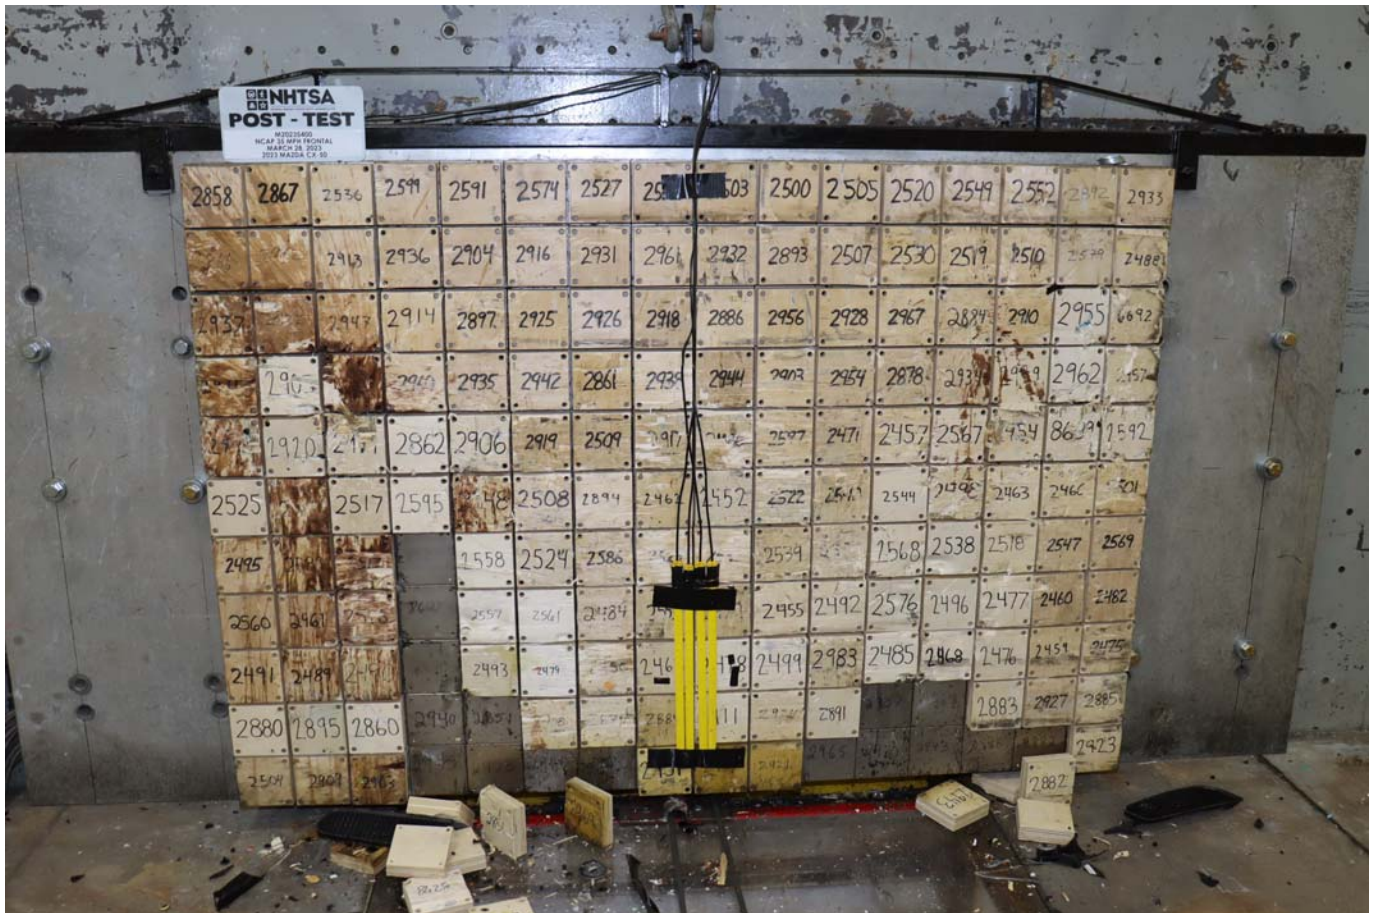
Photo No. 003 - Post-Test Load Cell Wall

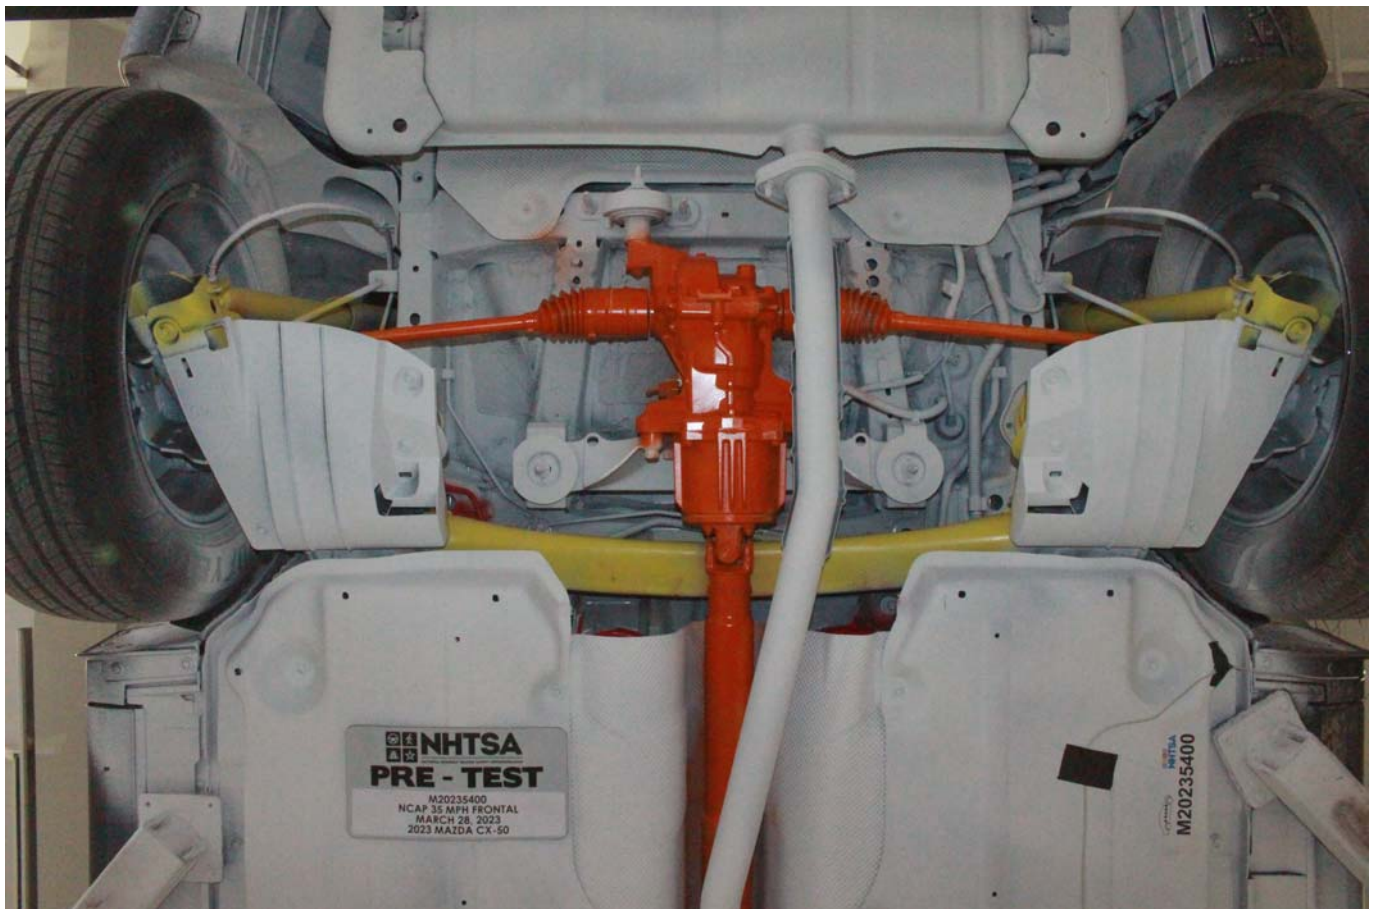
Photo No. 025 - Post-Test Front Underbody View

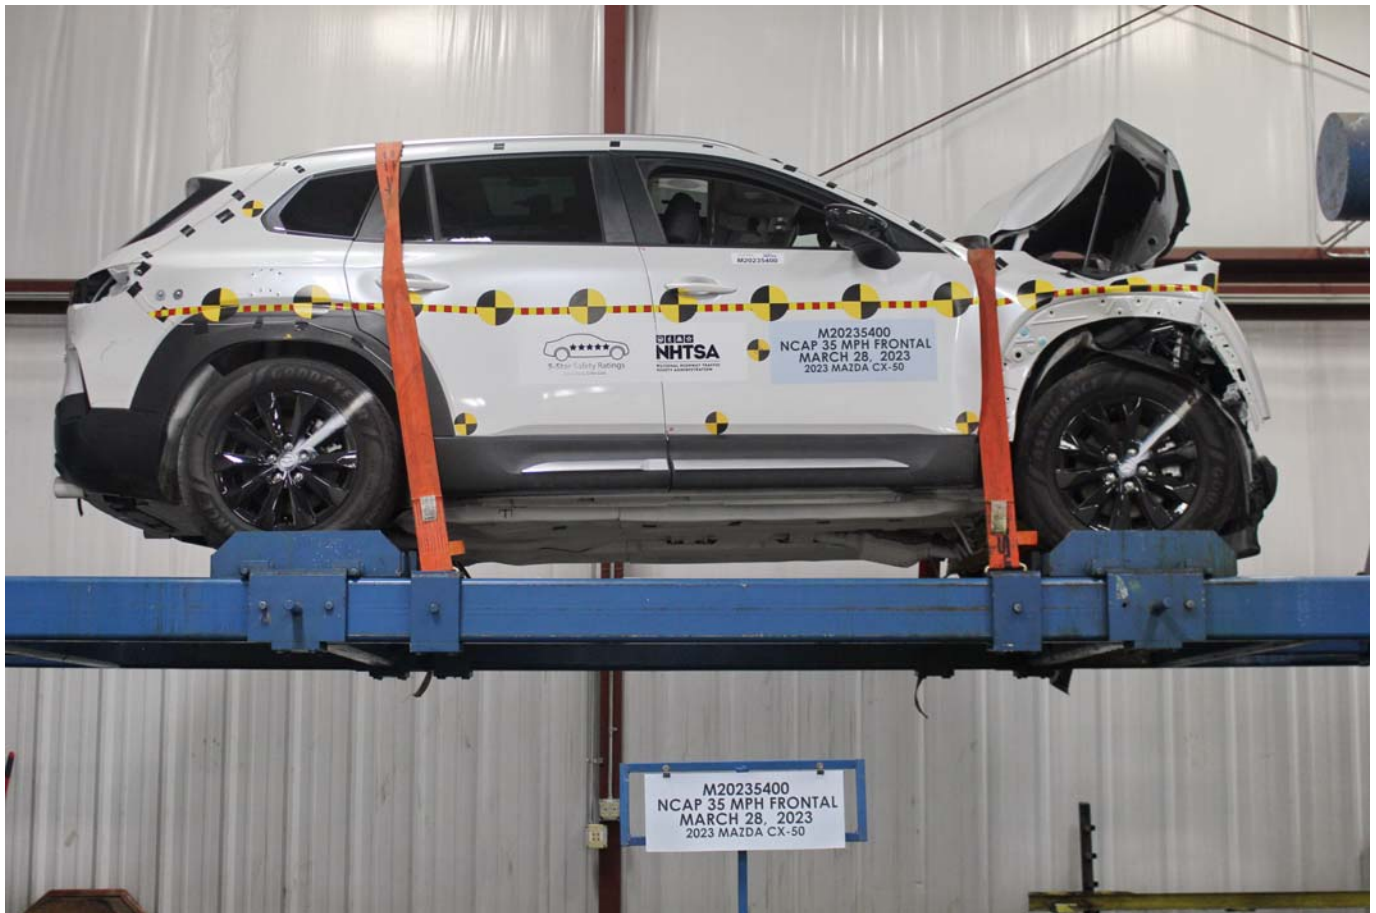
Photo No. 077 - Vehicle at 0 Degrees on Static Rollover Device

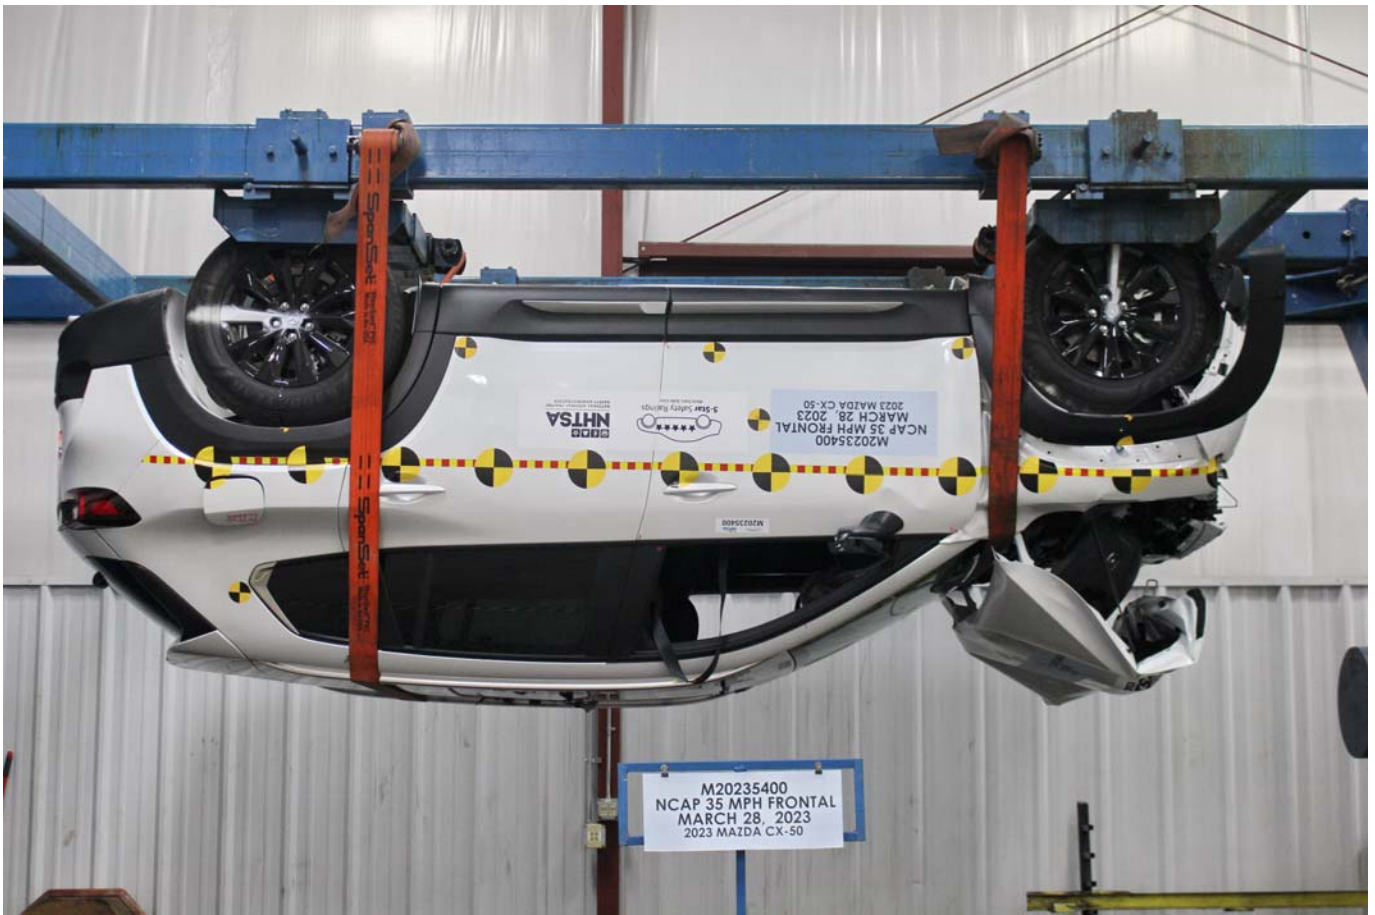
Photo No. 079 - Vehicle at 180 Degrees on Static Rollover Device

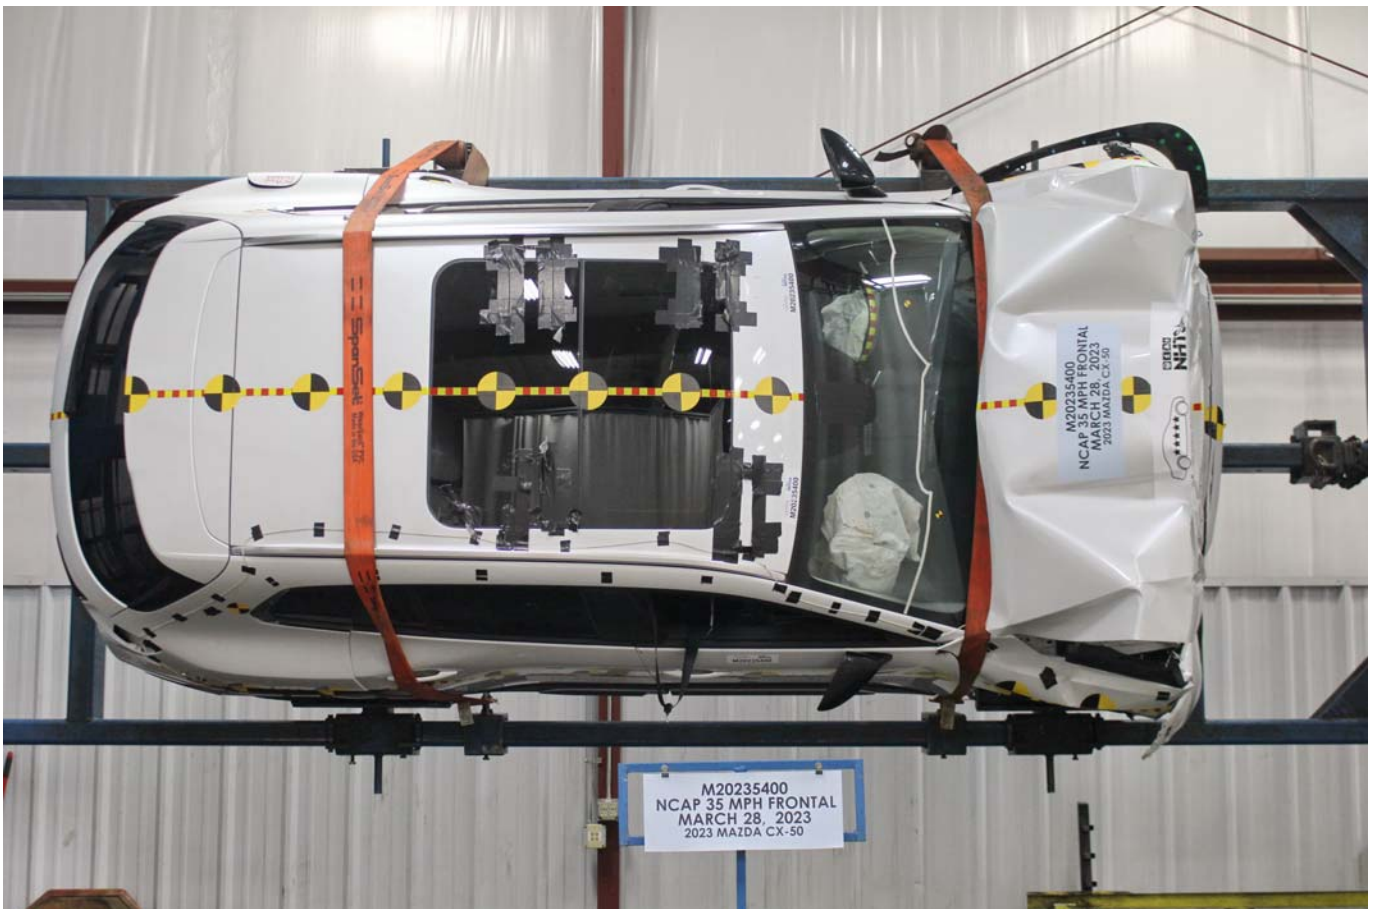
Photo No. 080 - Vehicle at 270 Degrees on Static Rollover Device

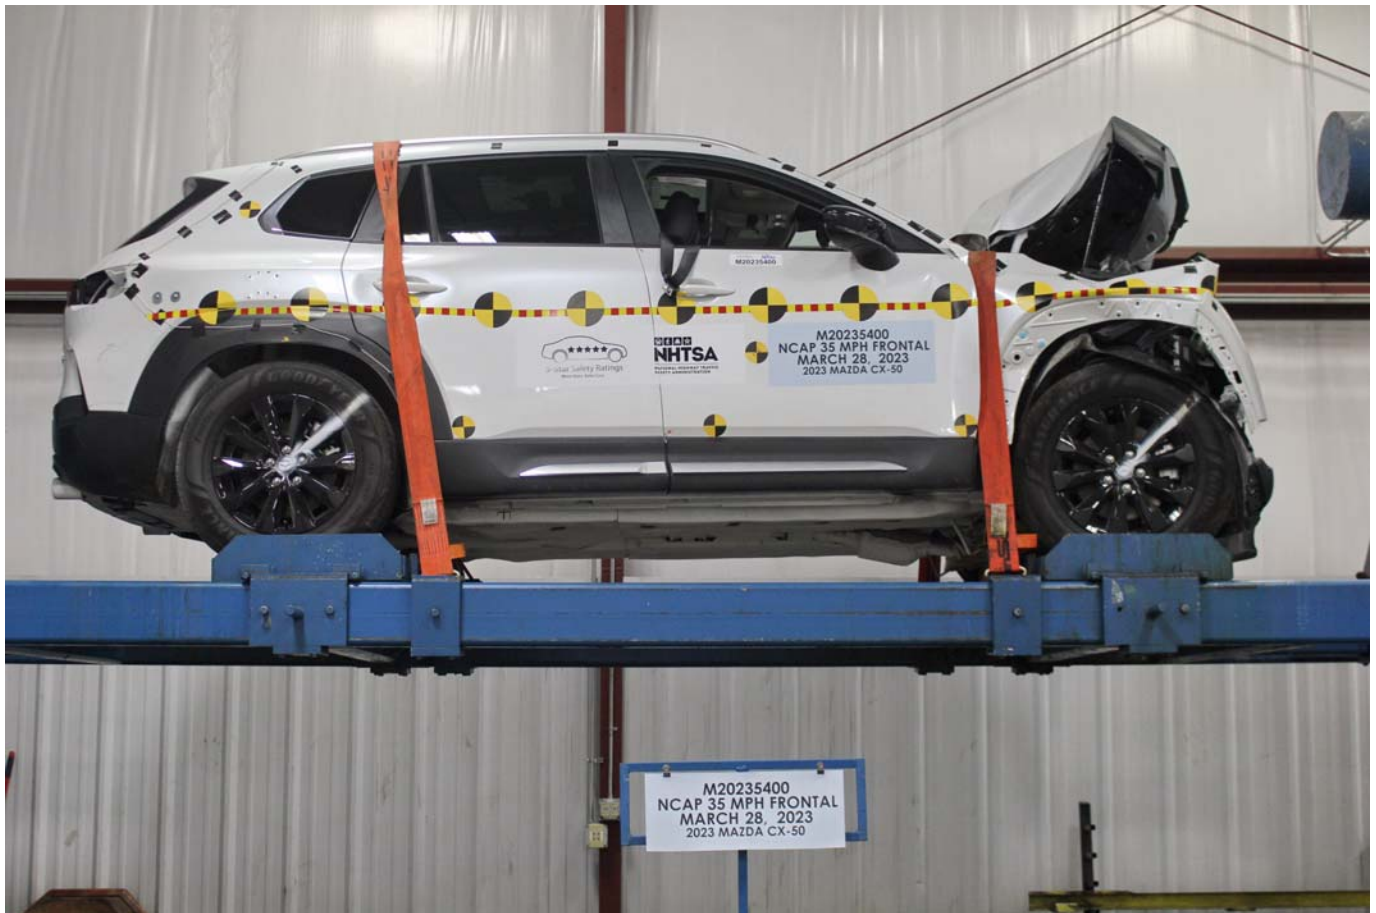
Photo No. 081 - Vehicle at 360 Degrees on Static Rollover Device
