**REPORT NUMBER: SideNCAPPole-KAR-23-009**  
**NEW CAR ASSESSMENT PROGRAM (NCAP)**  
**SIDE IMPACT POLE TEST**

**BAYERISCHE MOTOREN WERKE AG**  
**2023 BMW X1 XDRIVE28I 5-DOOR SUV**

**NHTSA No: M20234101**

**FINAL REPORT**

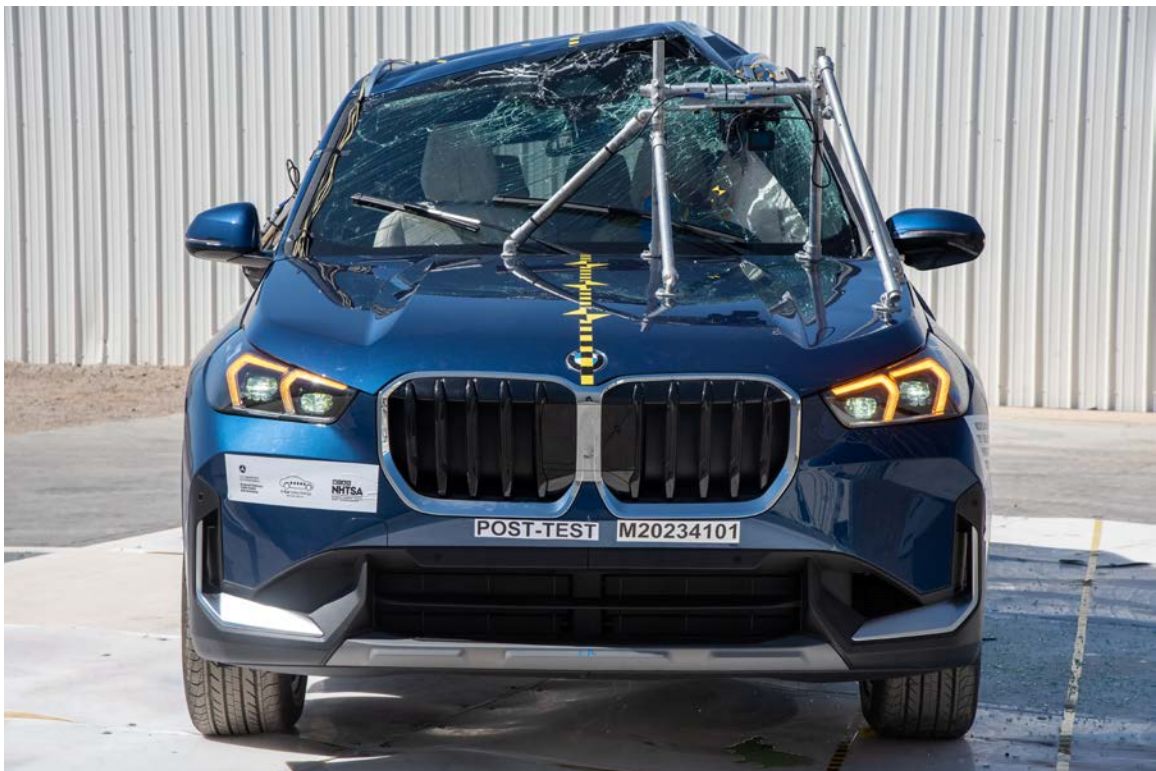
FIGURE 4. Post-Test Frontal View of Test Vehicle

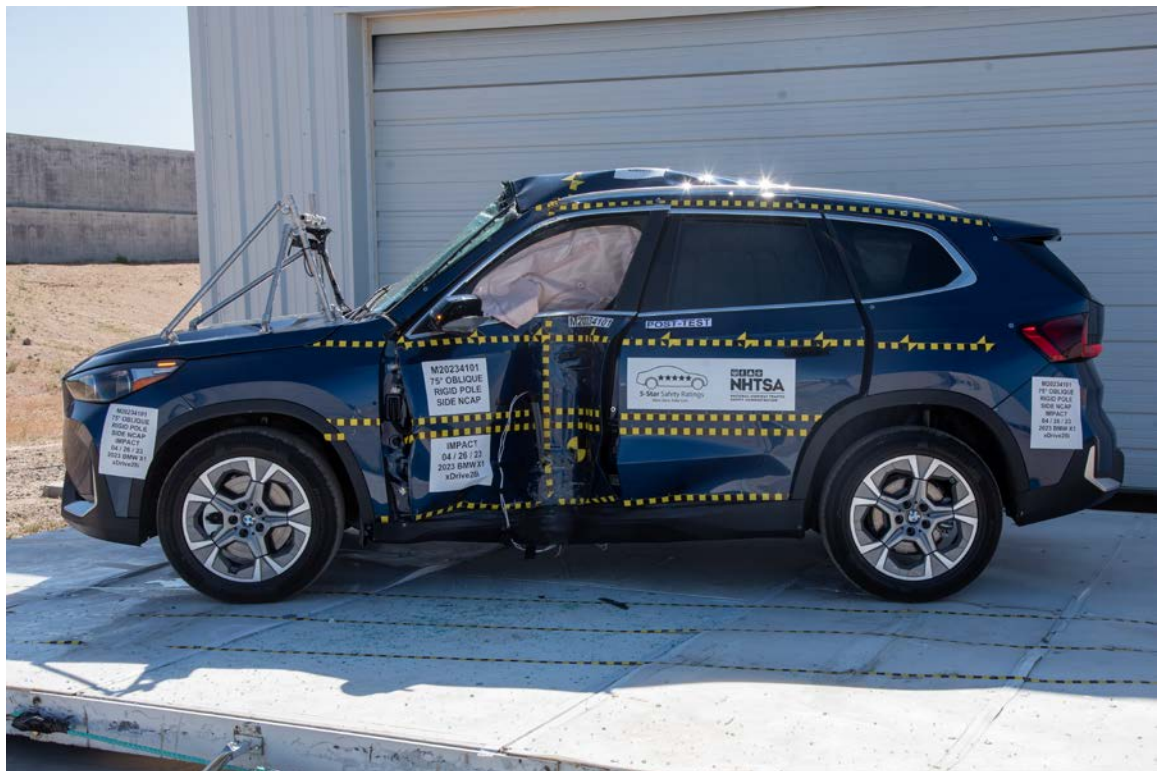
FIGURE 8. Post-Test Left Side View of Test Vehicle

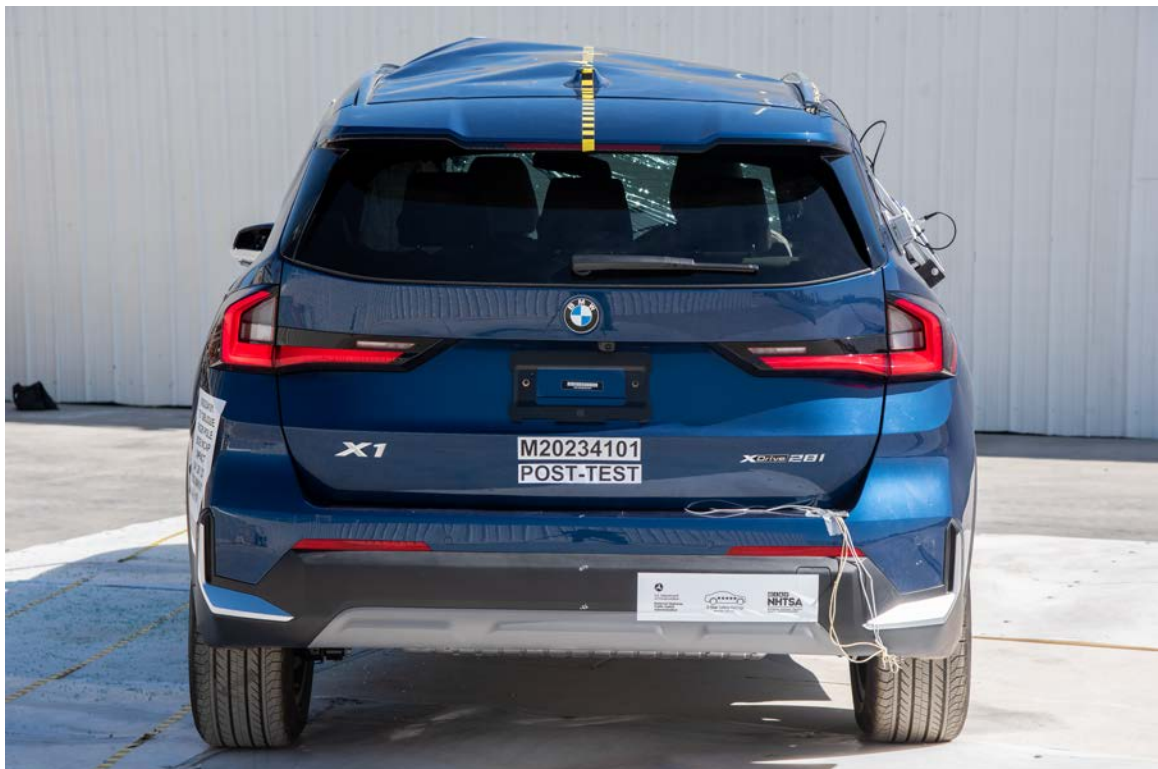
FIGURE 12. Post-Test Rear View of Test Vehicle

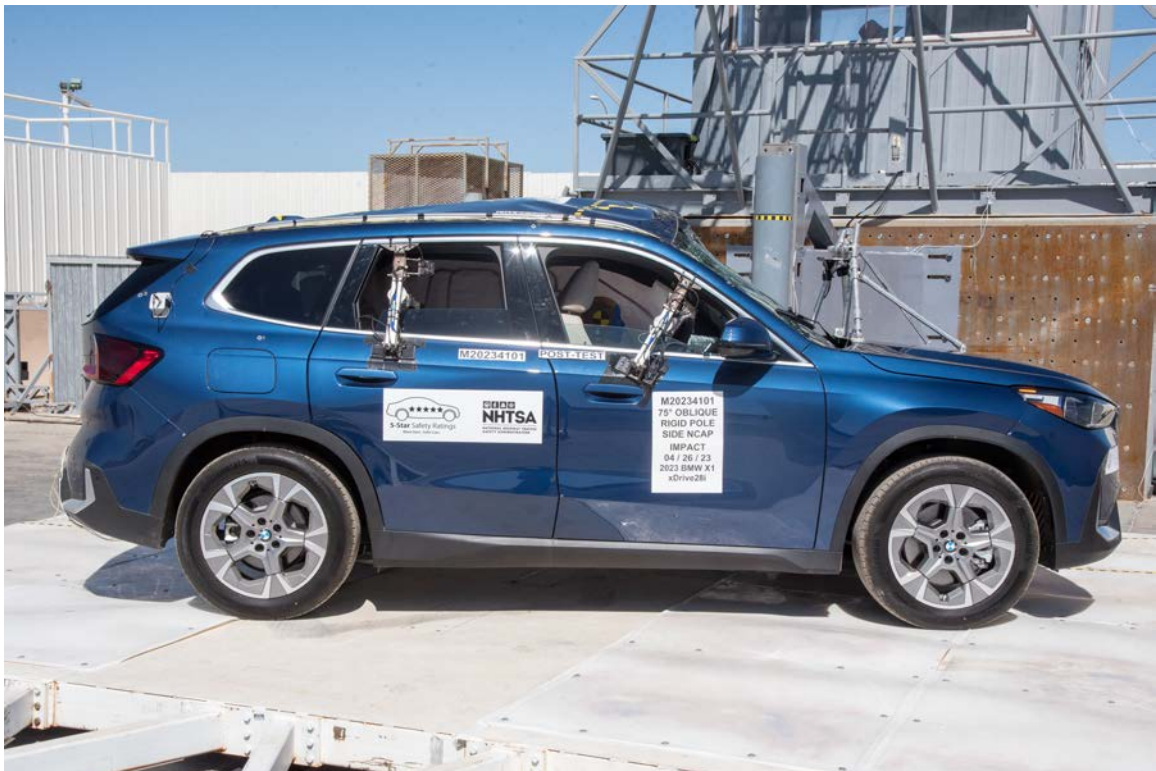
FIGURE 14. Post-Test Right Side View of Test Vehicle

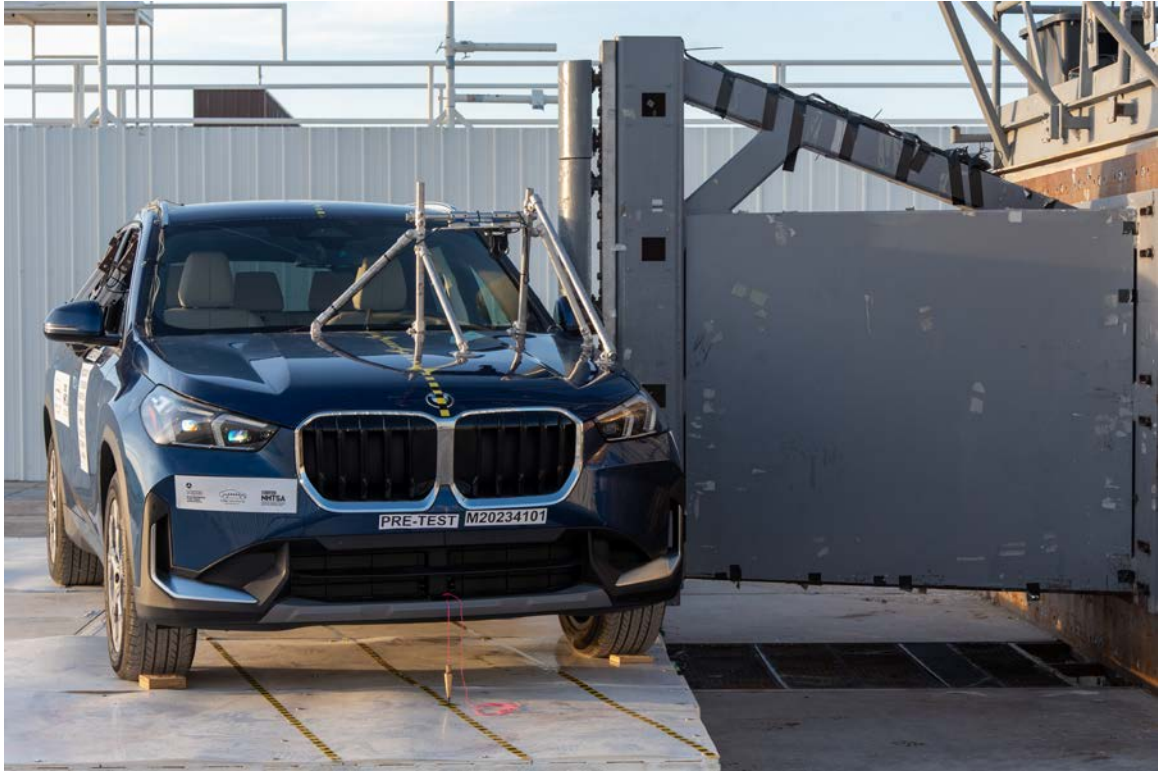
FIGURE 17. Pre-Test Left Side View of Pole Positioned Against Side of Vehicle

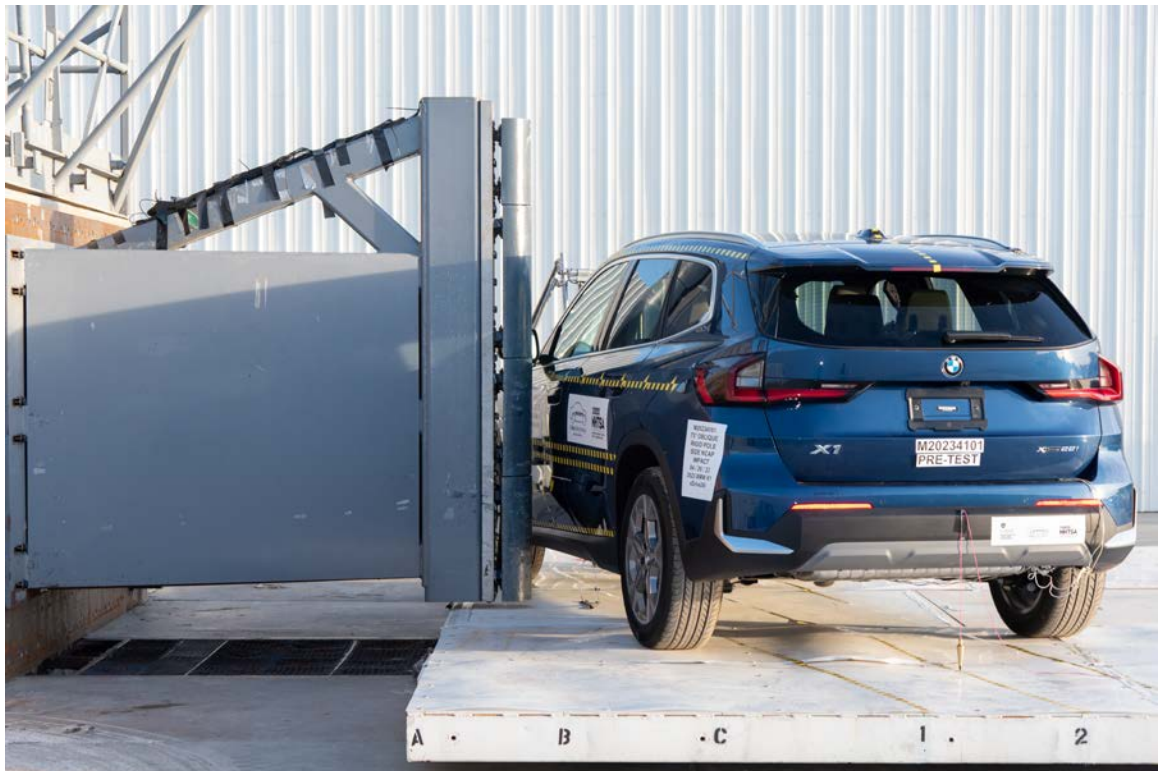
FIGURE 18. Pre-Test Right Side View of Pole Positioned Against Side of Vehicle

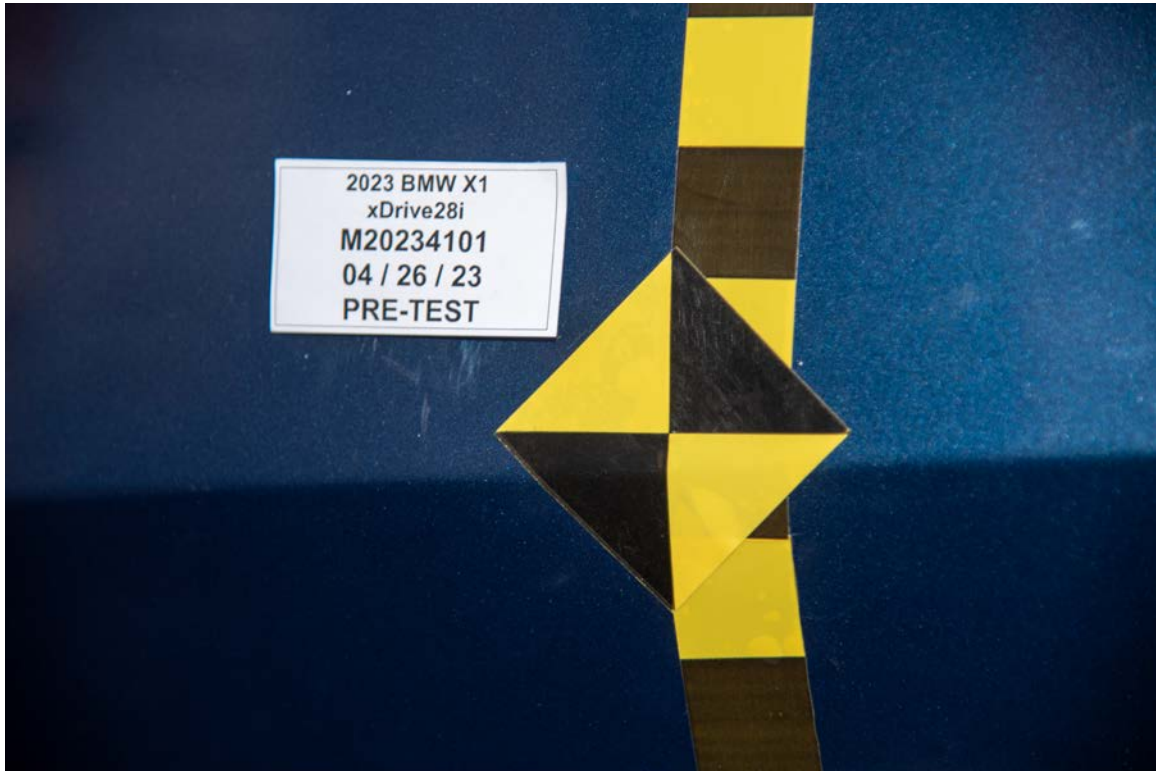
FIGURE 19. Pre-Test Close-Up View of Impact Point Target

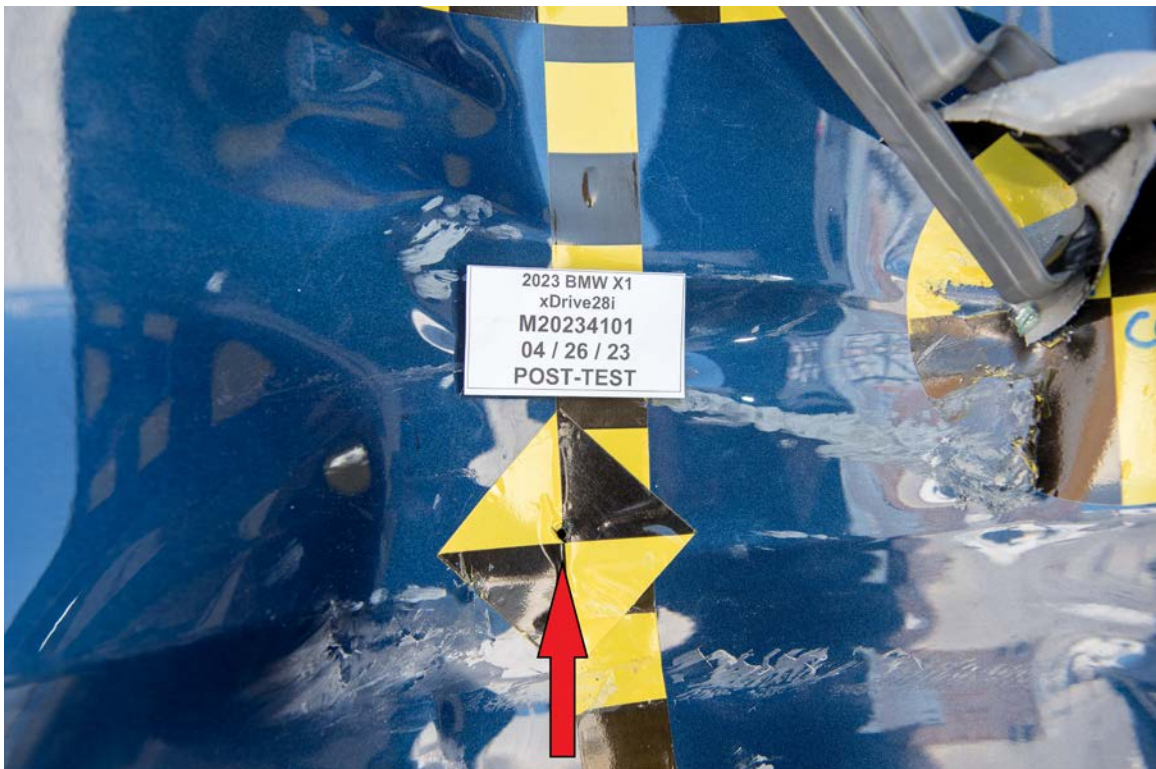
FIGURE 20. Post-Test Close-Up View of Impact Point Target Showing Impact Location

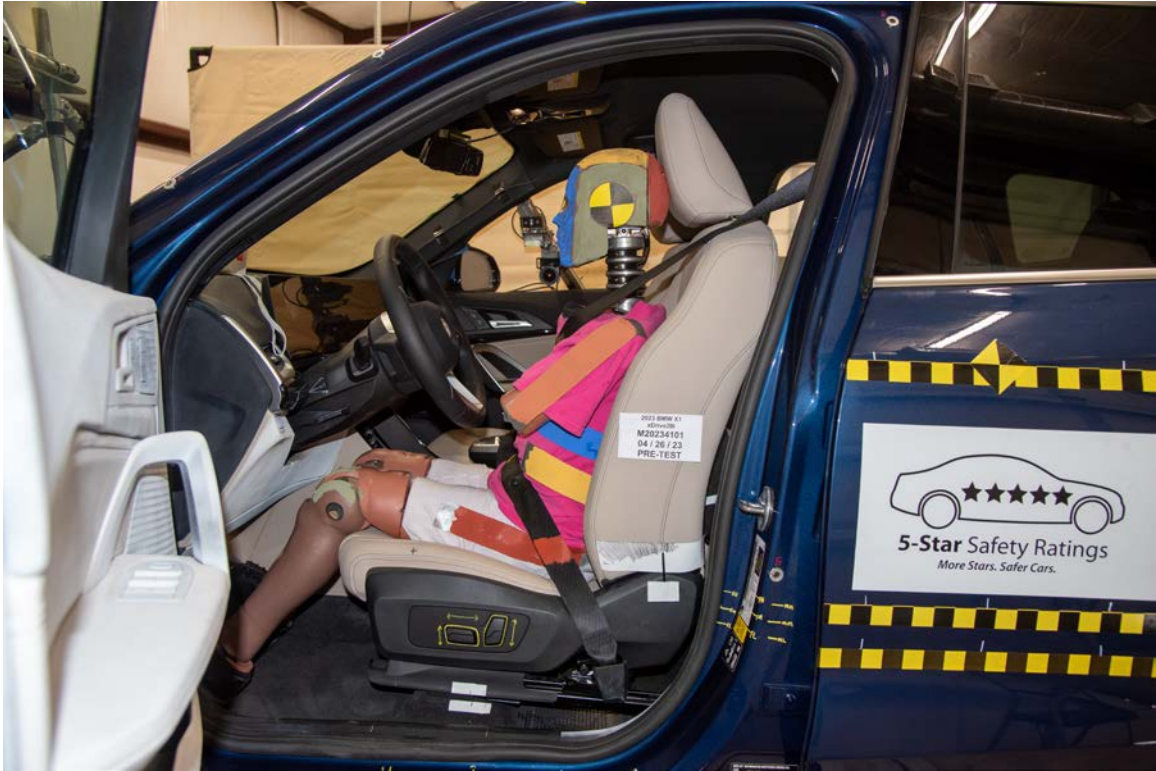
FIGURE 23. Pre-Test Left Side View of Dummy Showing Belt and Chalking

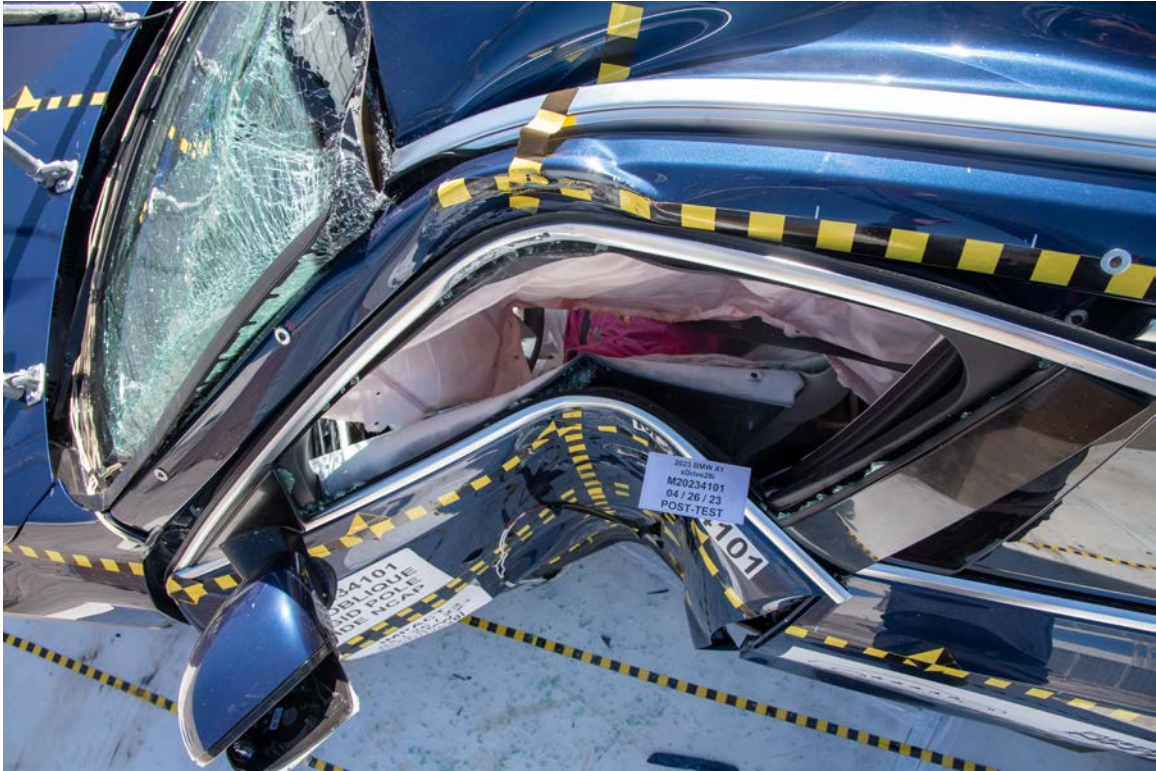
FIGURE 41. Post-Test Dummy and Door Clearance View

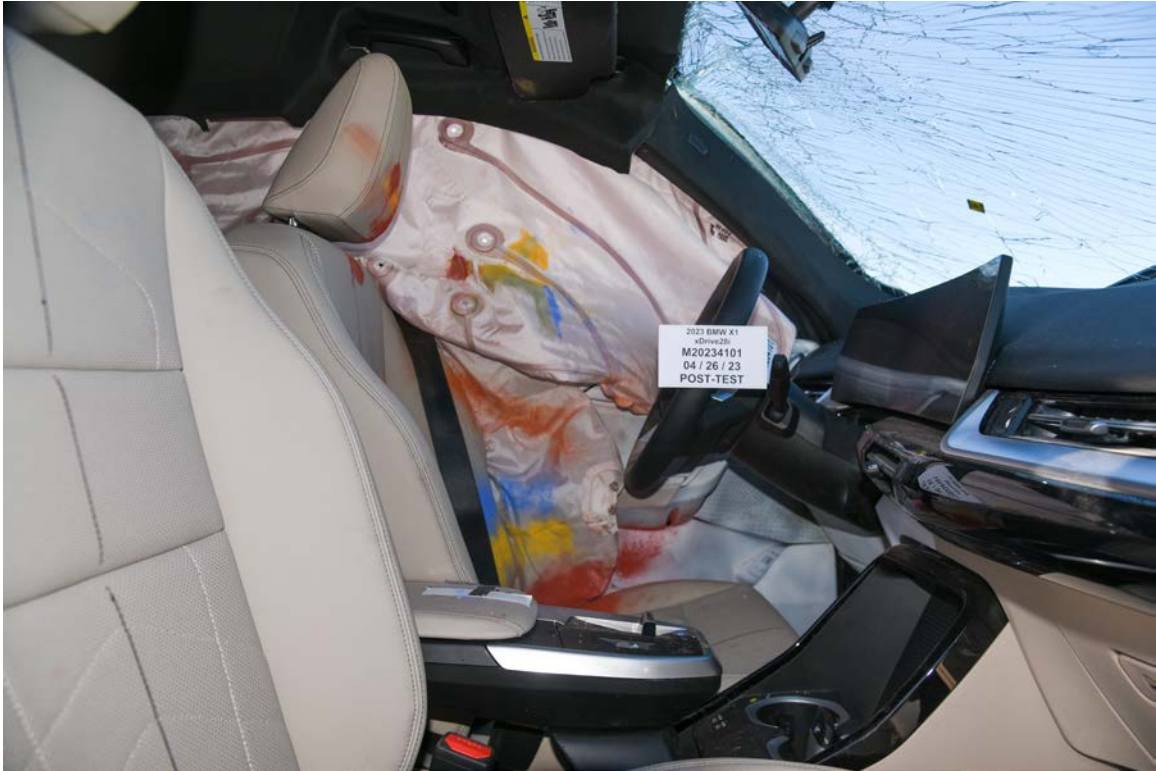
FIGURE 45. Post-Test Inner Door Panel View Showing Dummy Contact Locations

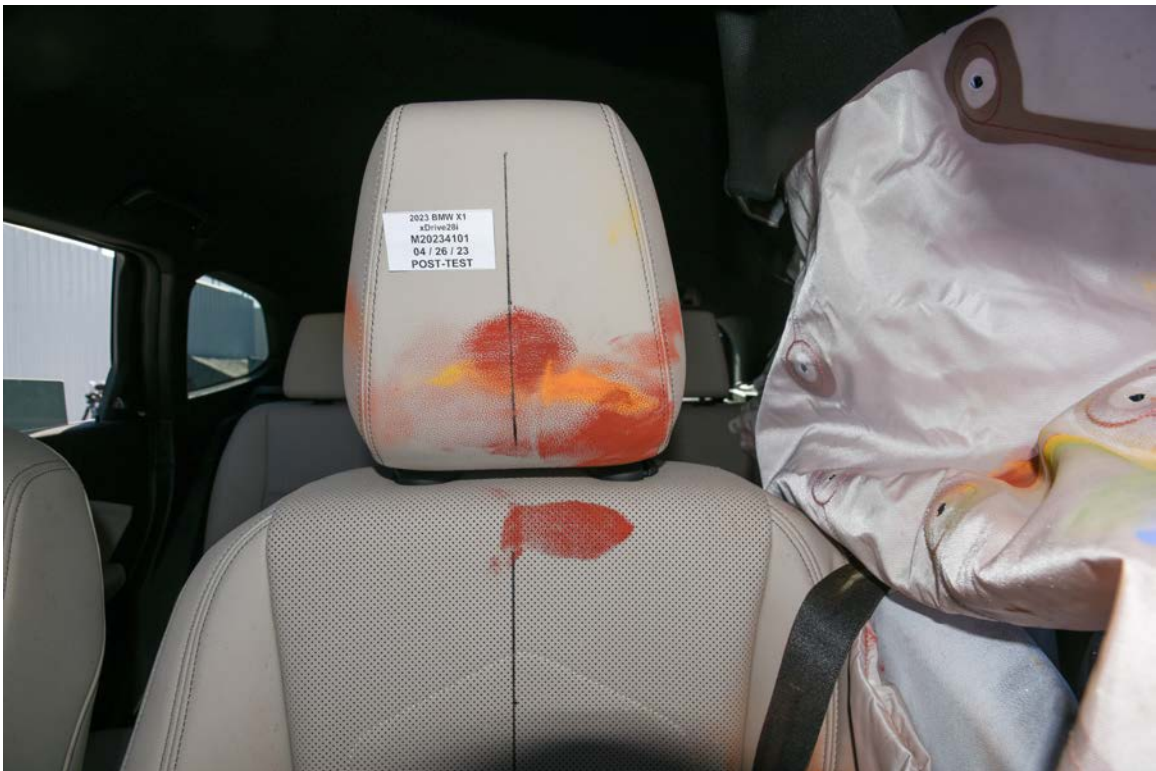
FIGURE 46. Post-Test Dummy Close-Up Head Contact with Vehicle Interior View

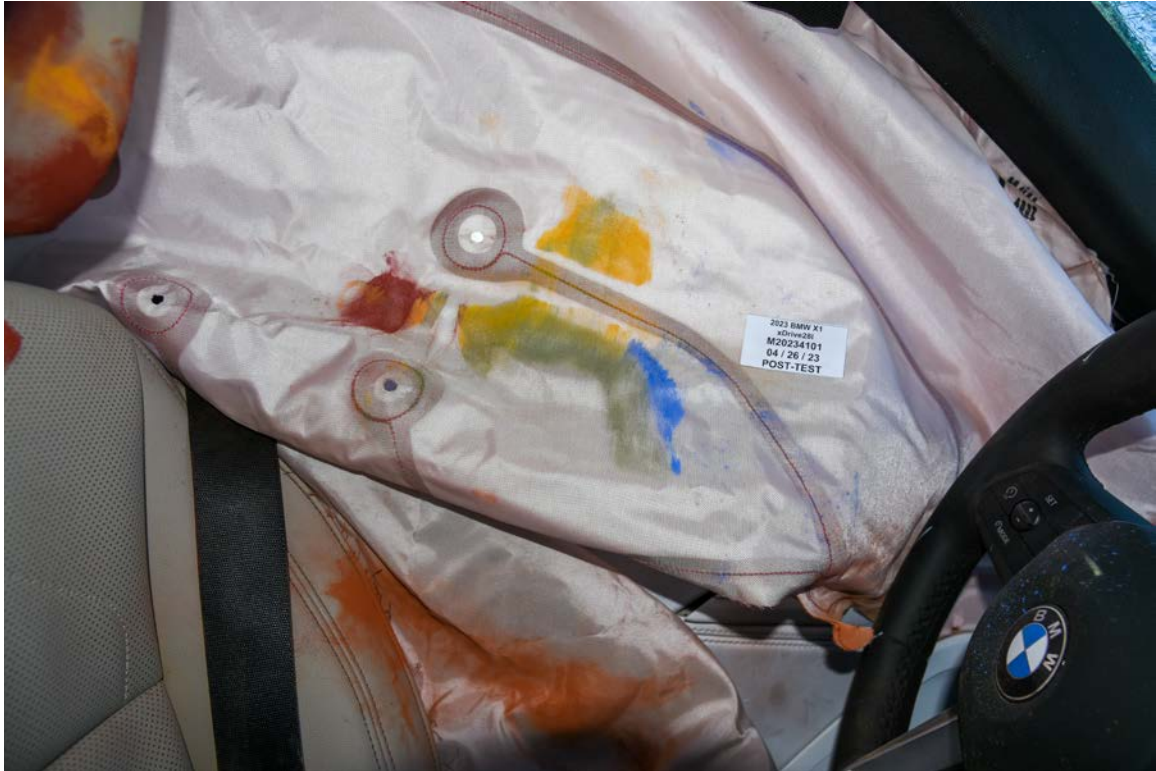
FIGURE 47. Post-Test Dummy Close-Up Head Contact With Side Airbag View

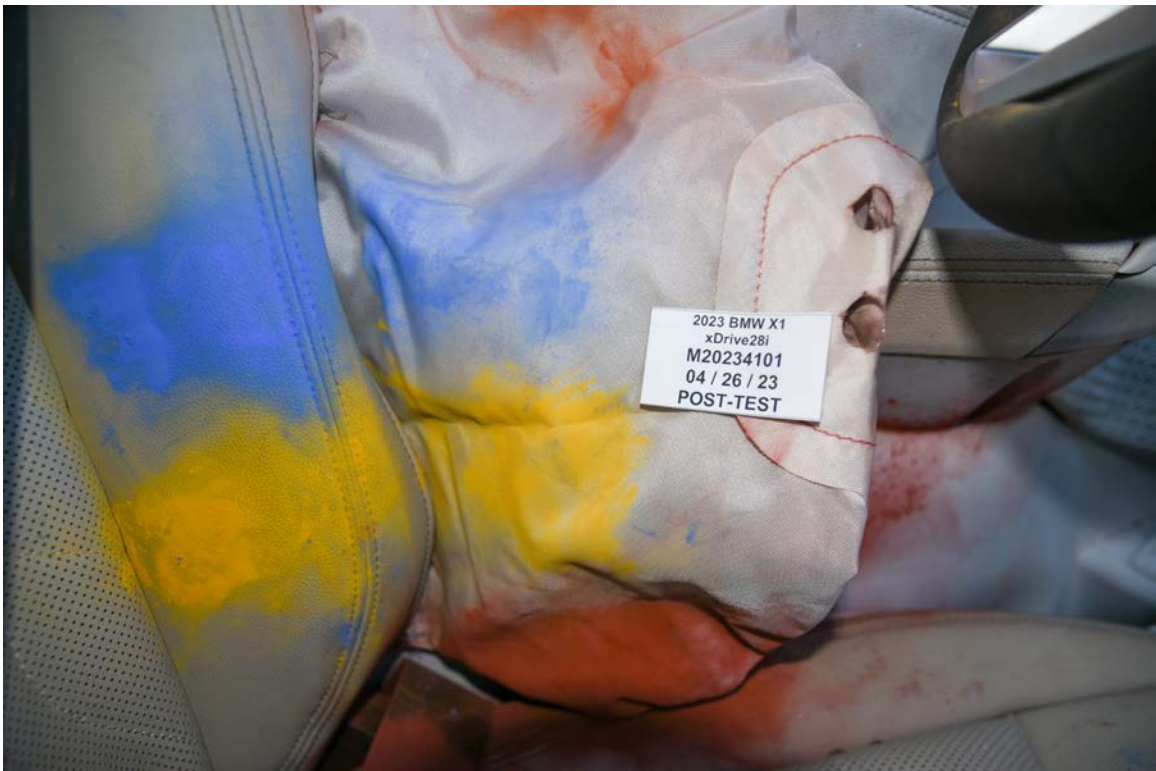
FIGURE 48. Post-Test Dummy Close-Up Torso Contact With Vehicle Interior View

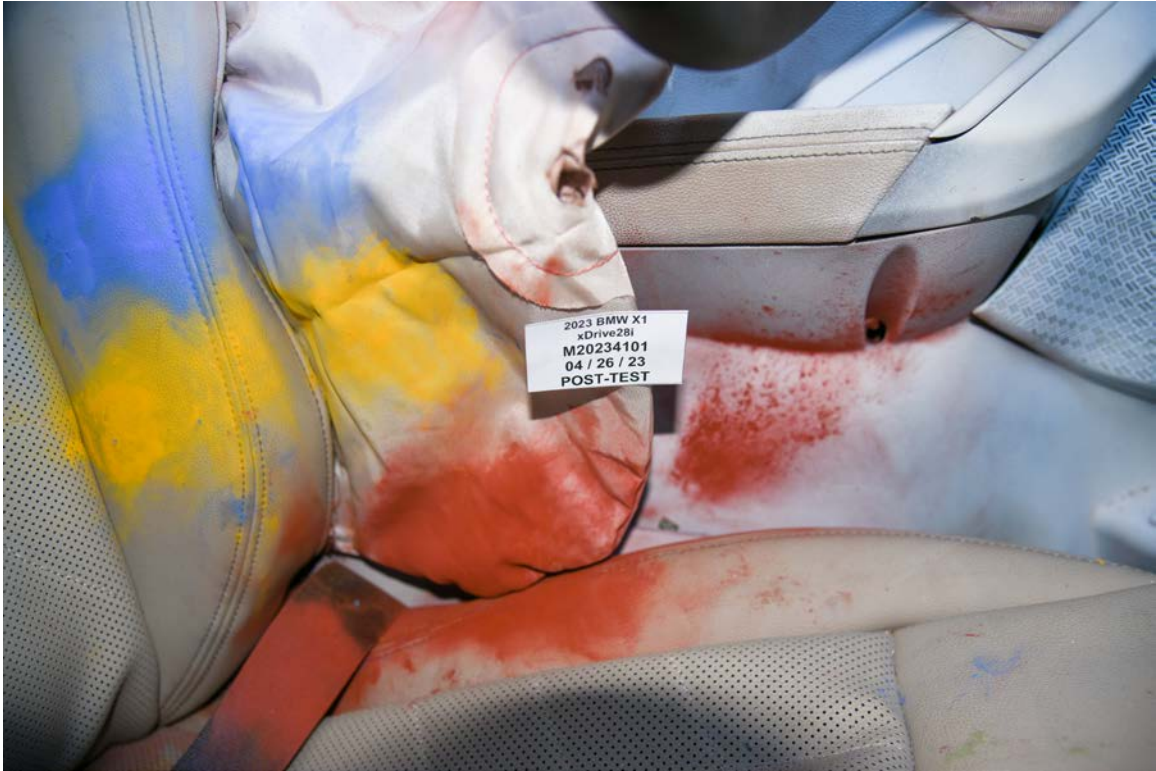
FIGURE 49. Post-Test Dummy Close-Up Torso Contact With Side Airbag View

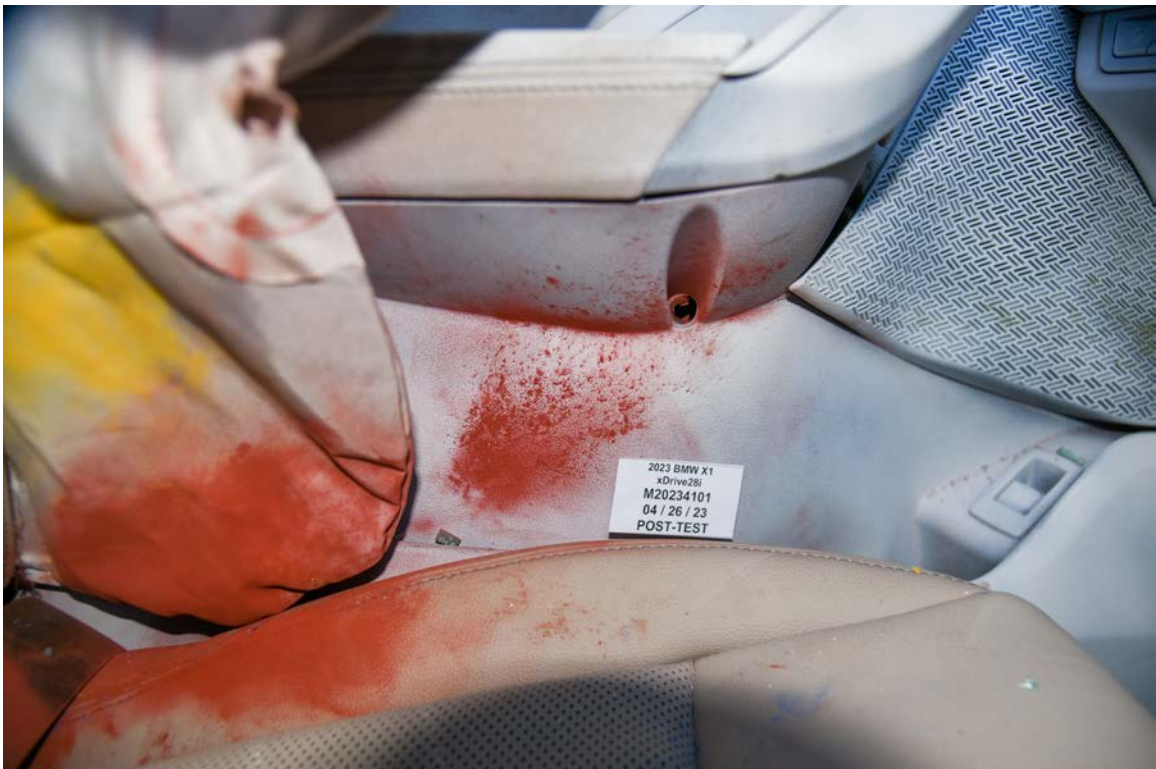
FIGURE 50. Post-Test Dummy Close-Up Pelvis Contact With Vehicle Interior View

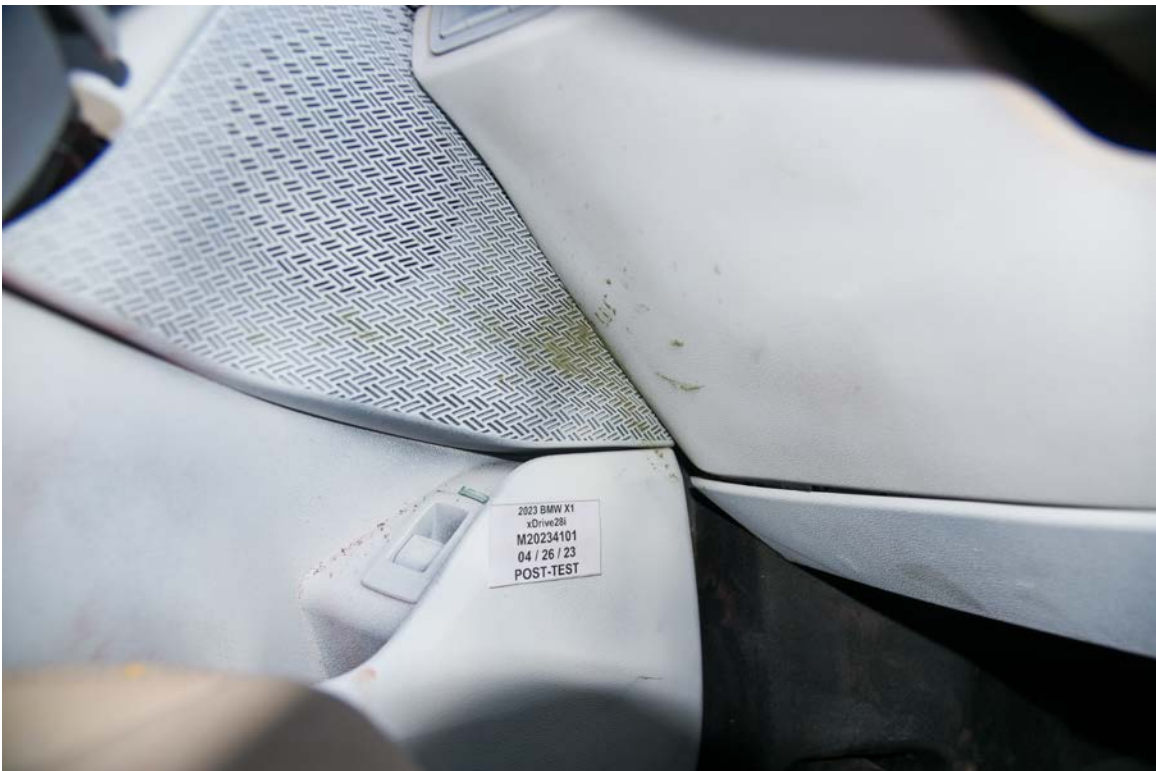
FIGURE 52. Post-Test Dummy Close-Up Knee Contact with Vehicle Interior View

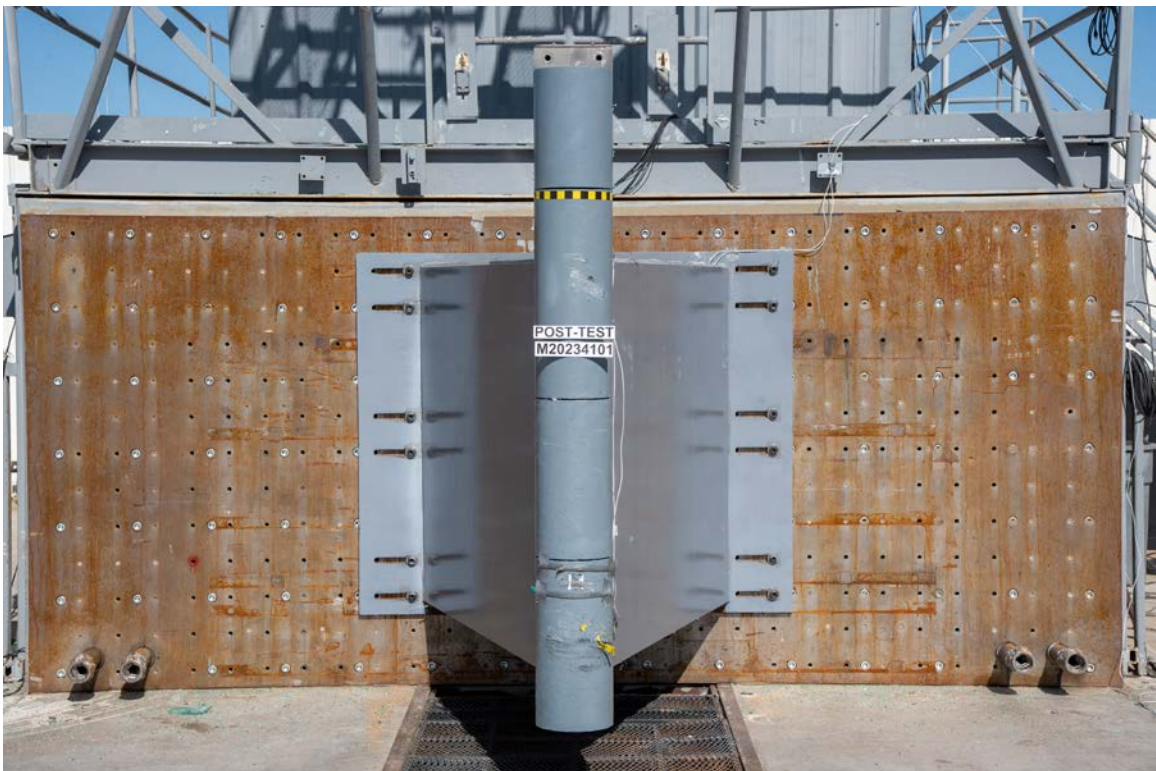
FIGURE 60. Post-Test Pole Barrier Front View

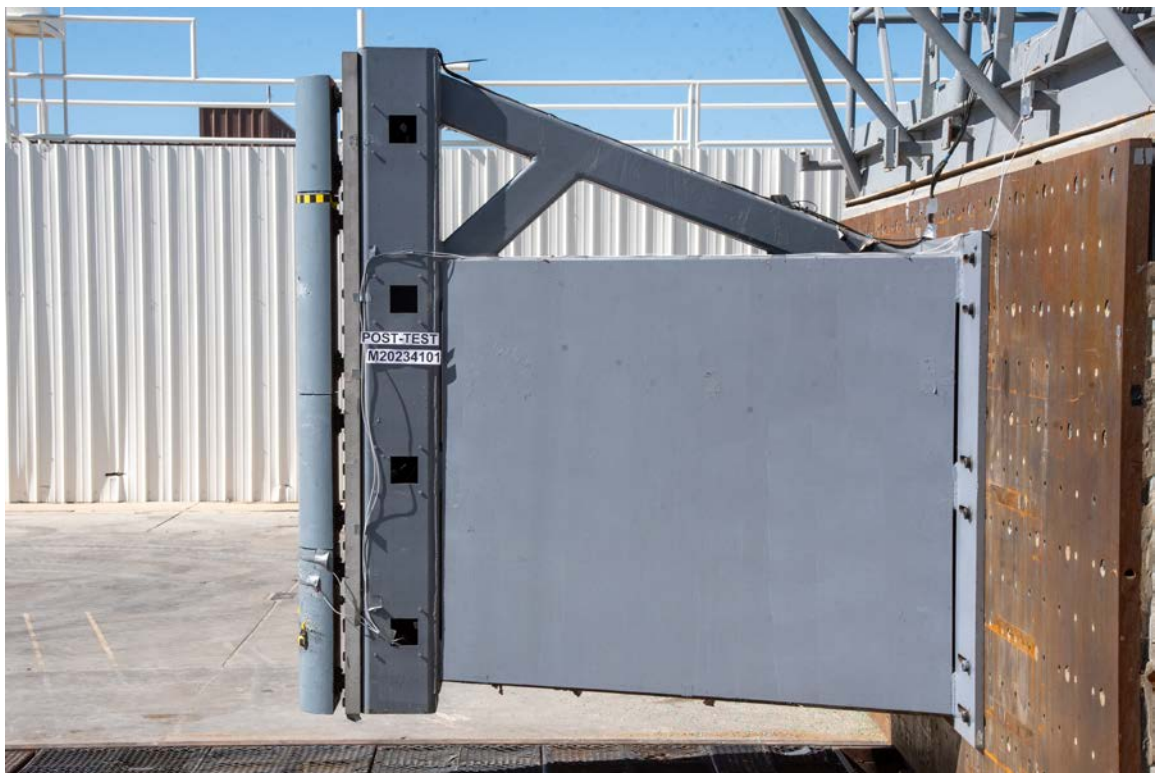
FIGURE 62. Post-Test Pole Barrier Side View

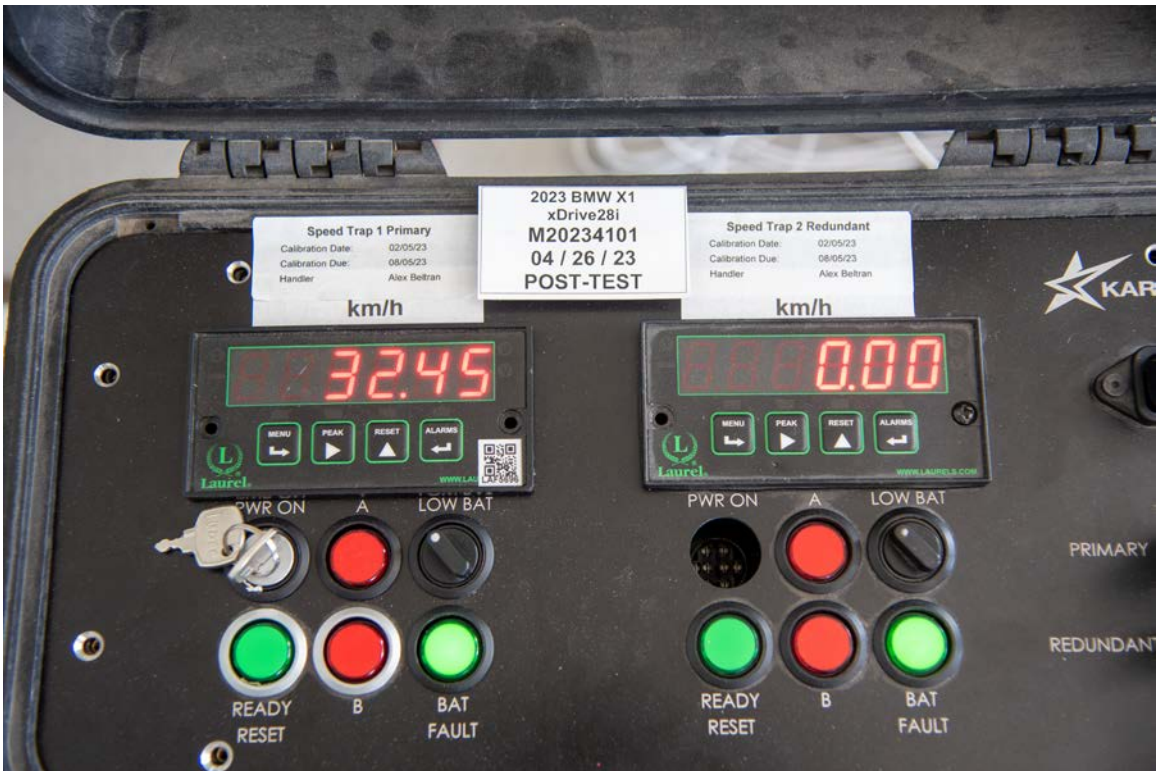
FIGURE 64. Post-Test Primary and Redundant Speed Trap Read-Out

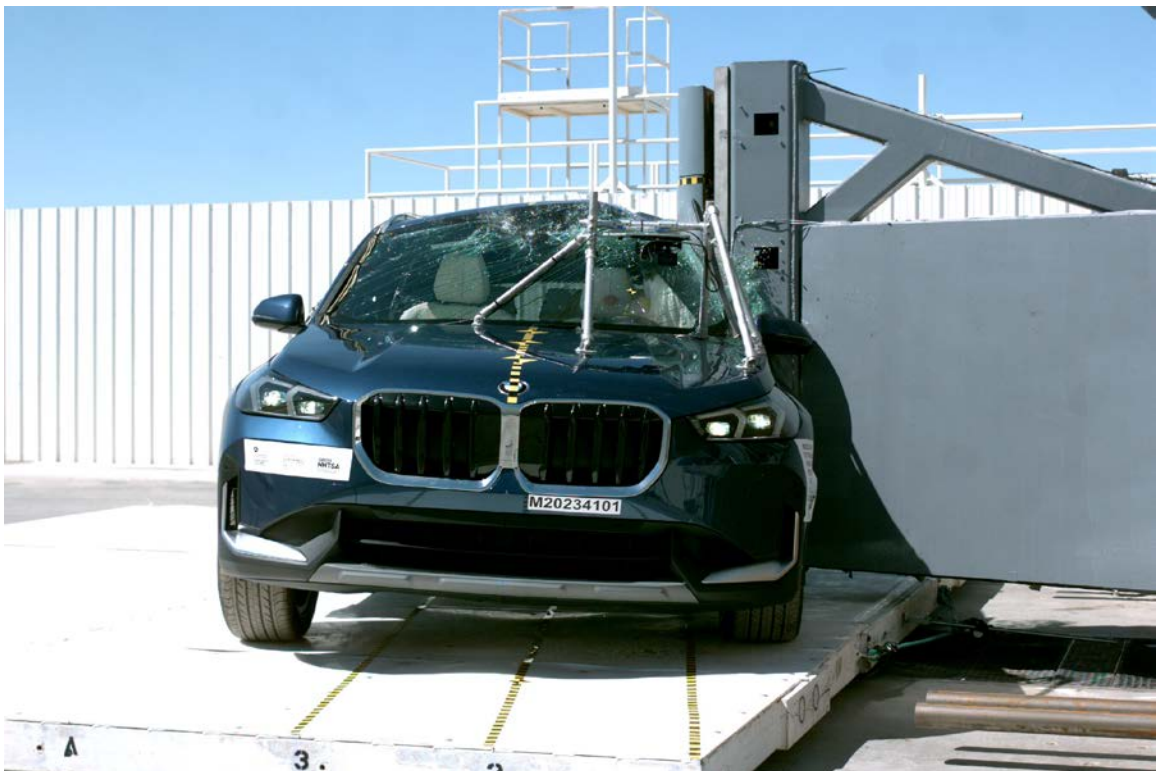
FIGURE 70. Impact Event
