**REPORT NUMBER: SideNCAPPole-MGA-22-041**

**NEW CAR ASSESSMENT PROGRAM (NCAP)  
Side Impact Pole Test**

**TOYOTA MOTOR MANUFACTURING CANADA, INC.  
2022 Lexus NX 250 5-Door SUV  
NHTSA No.: O20225104**

**MGA RESEARCH CORPORATION  
5000 Warren Road  
Burlington, WI 53105**

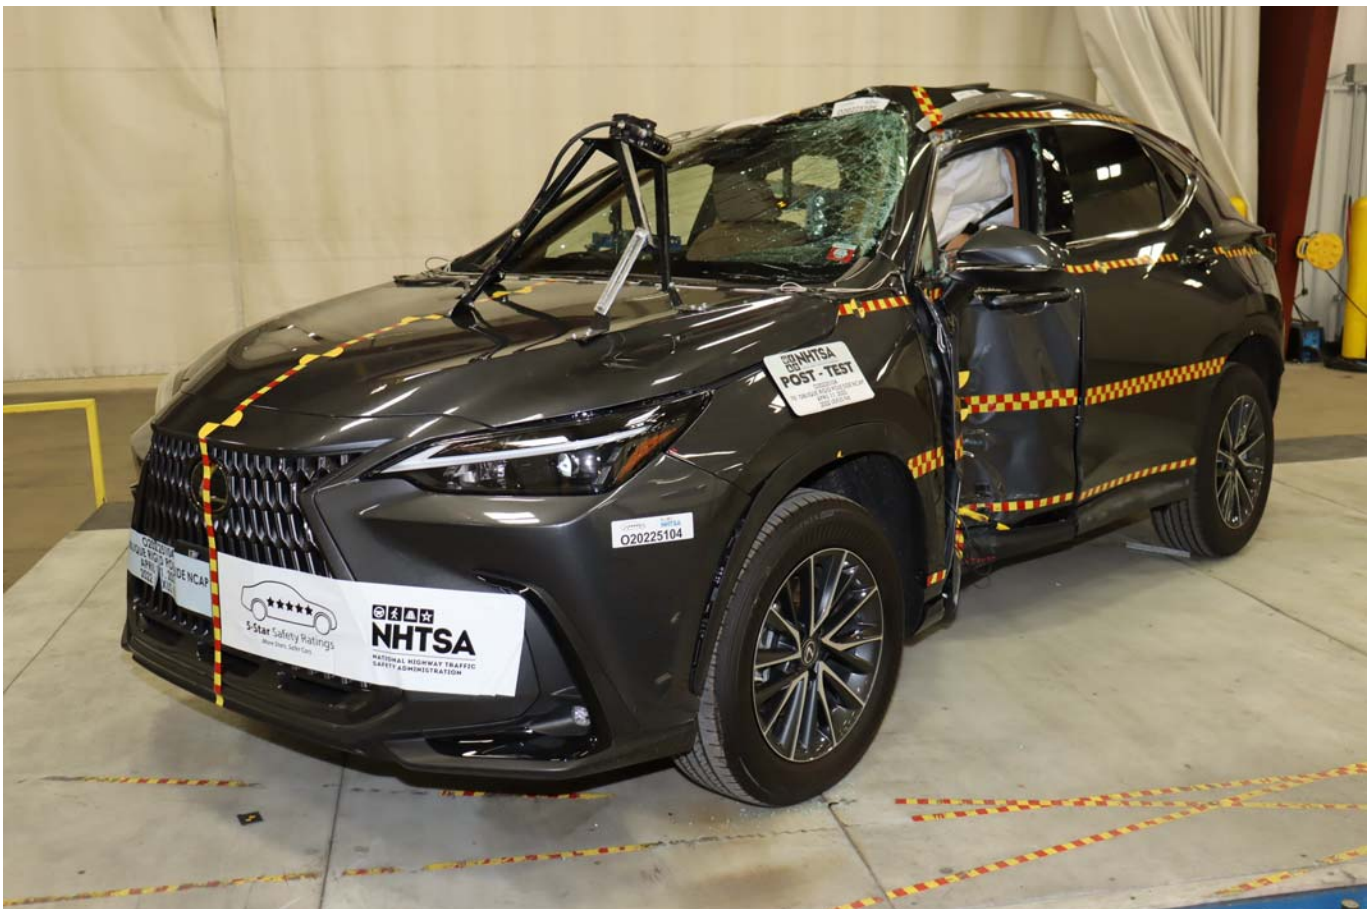
Photo No. 006 - Post-Test Left Front Three-Quarter View of Test Vehicle

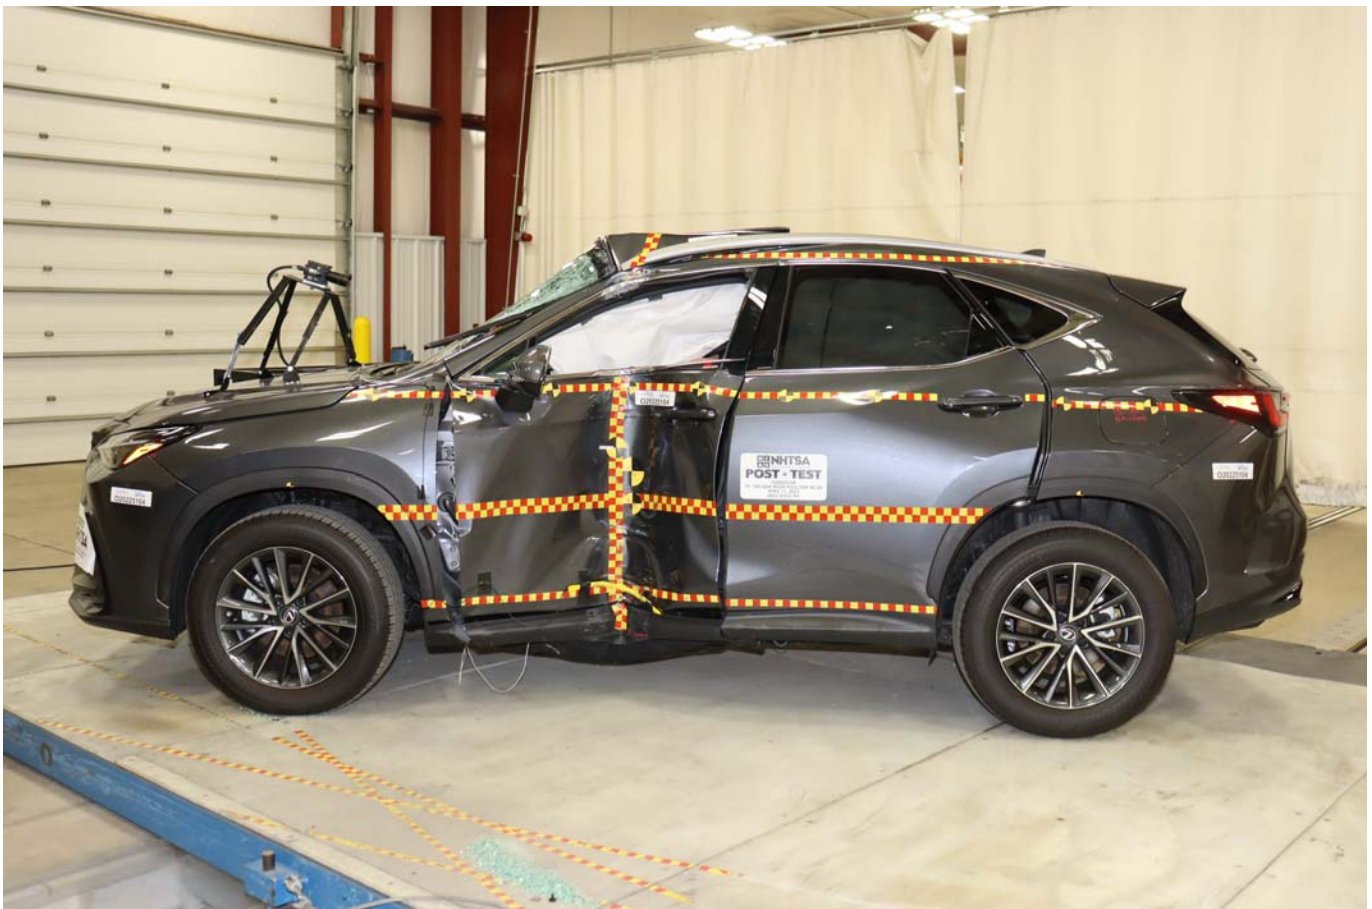
Photo No. 008 - Post-Test Left Side View of Test Vehicle

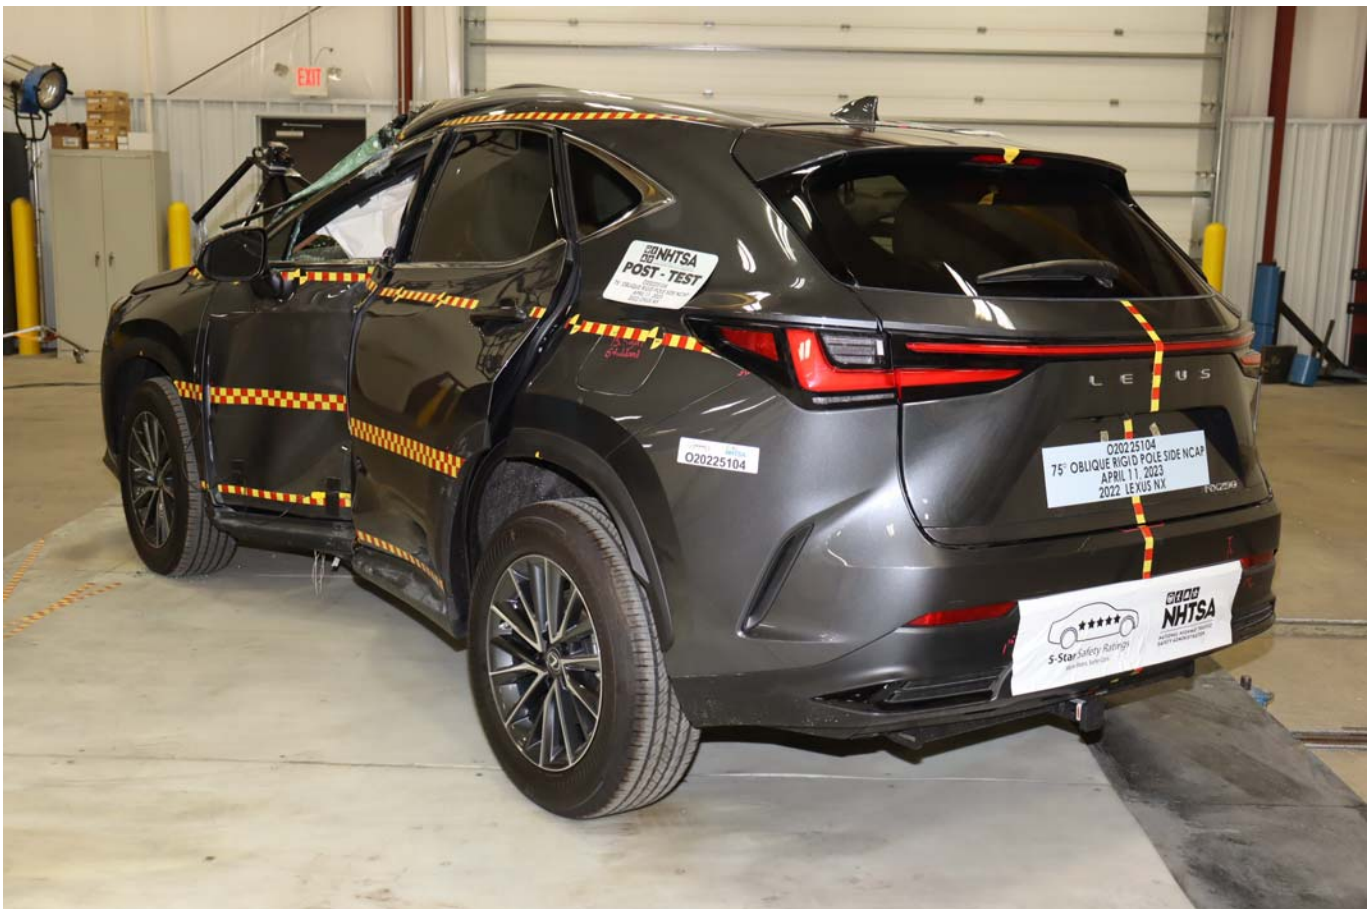
Photo No. 010 - Post-Test Left Rear Three-Quarter View of Test Vehicle

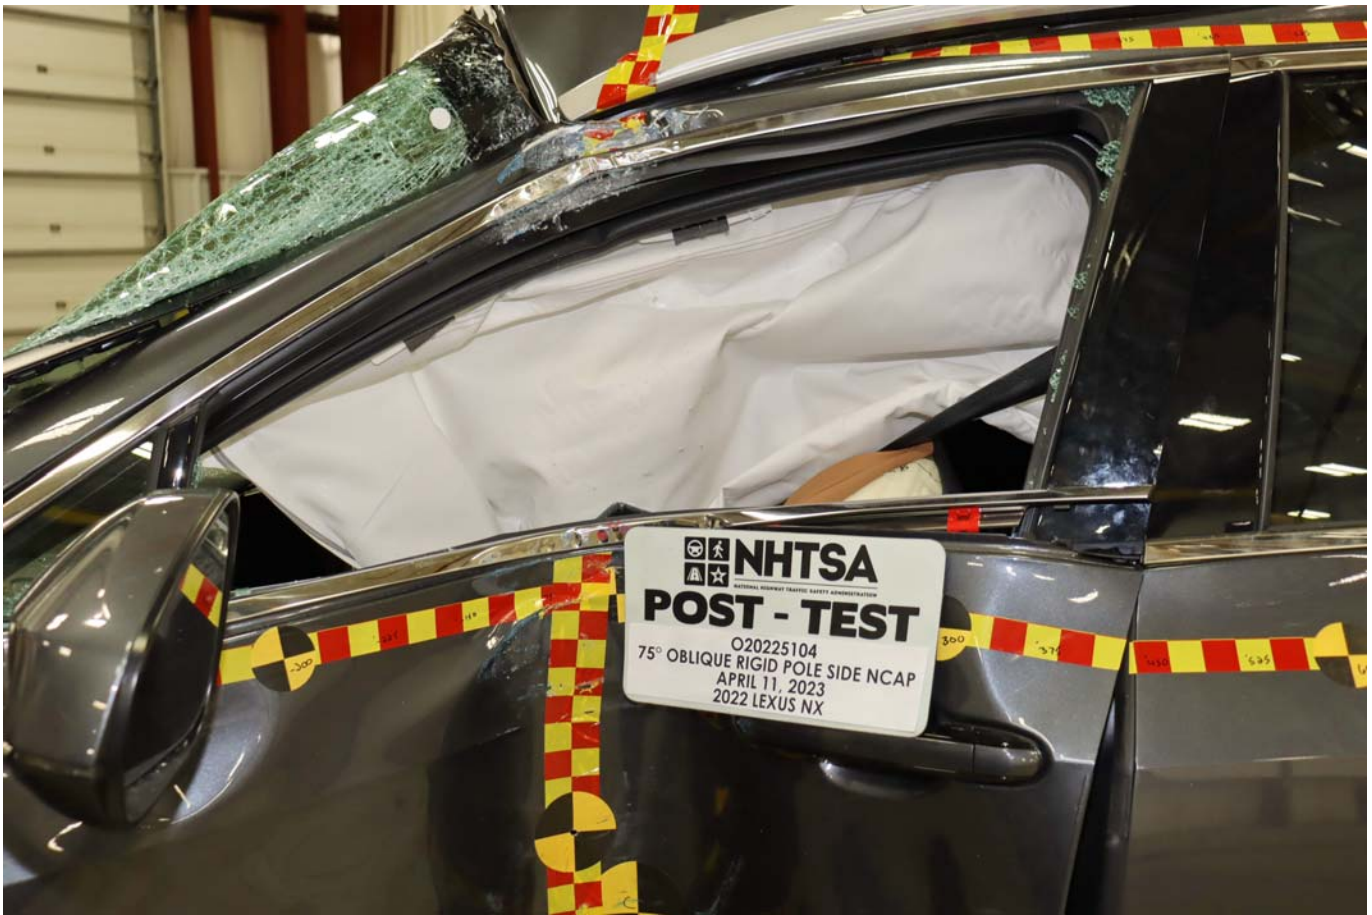
Photo No. 025 - Post-Test Left Side View of Dummy Shoulder and Door Top View

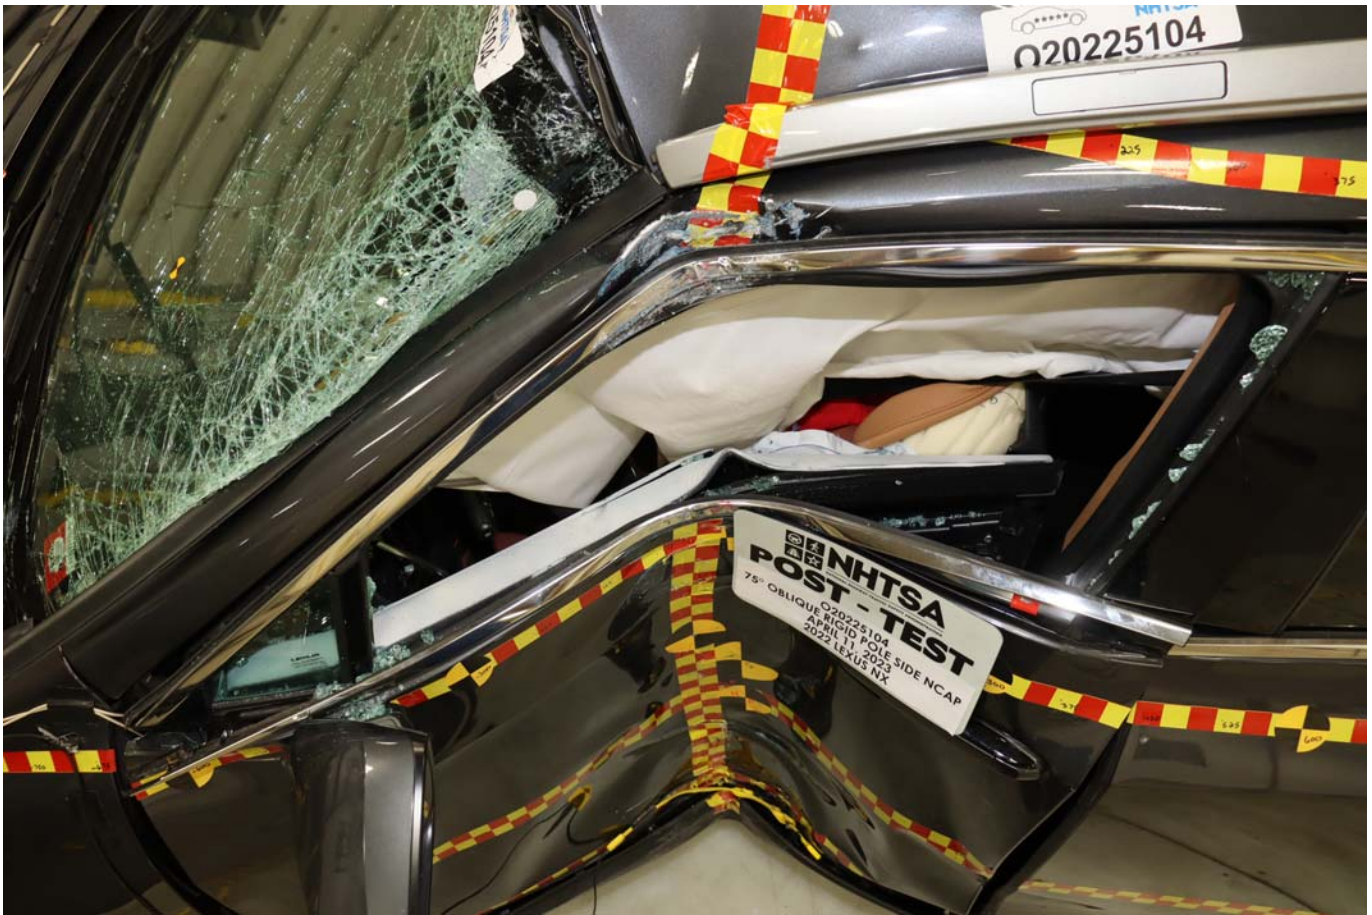
Photo No. 041 - Post-Test Dummy and Door Clearance View

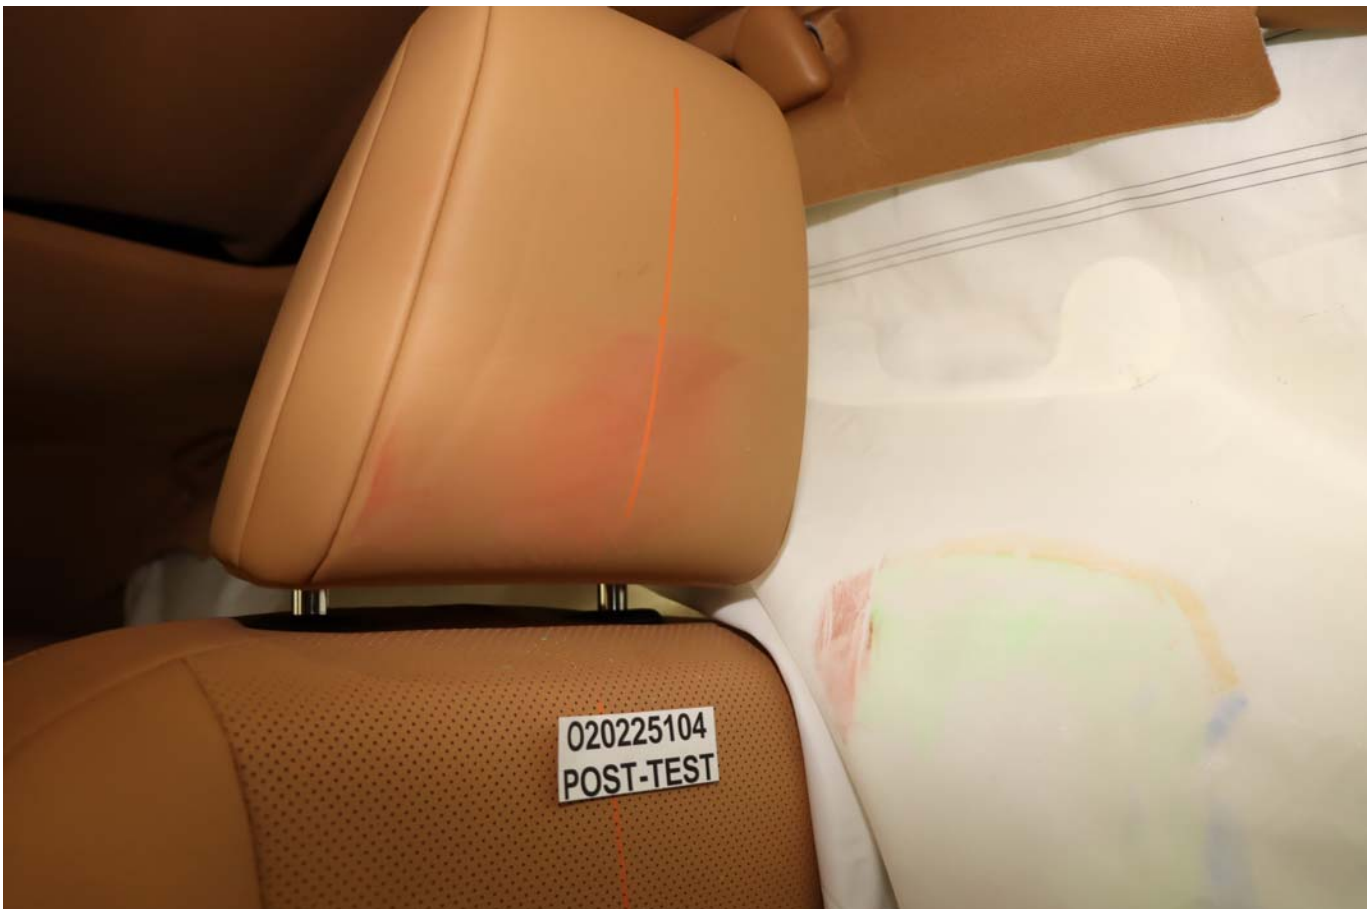
Photo No. 046 - Post-Test Dummy Close-Up Head Contact with Vehicle Interior View

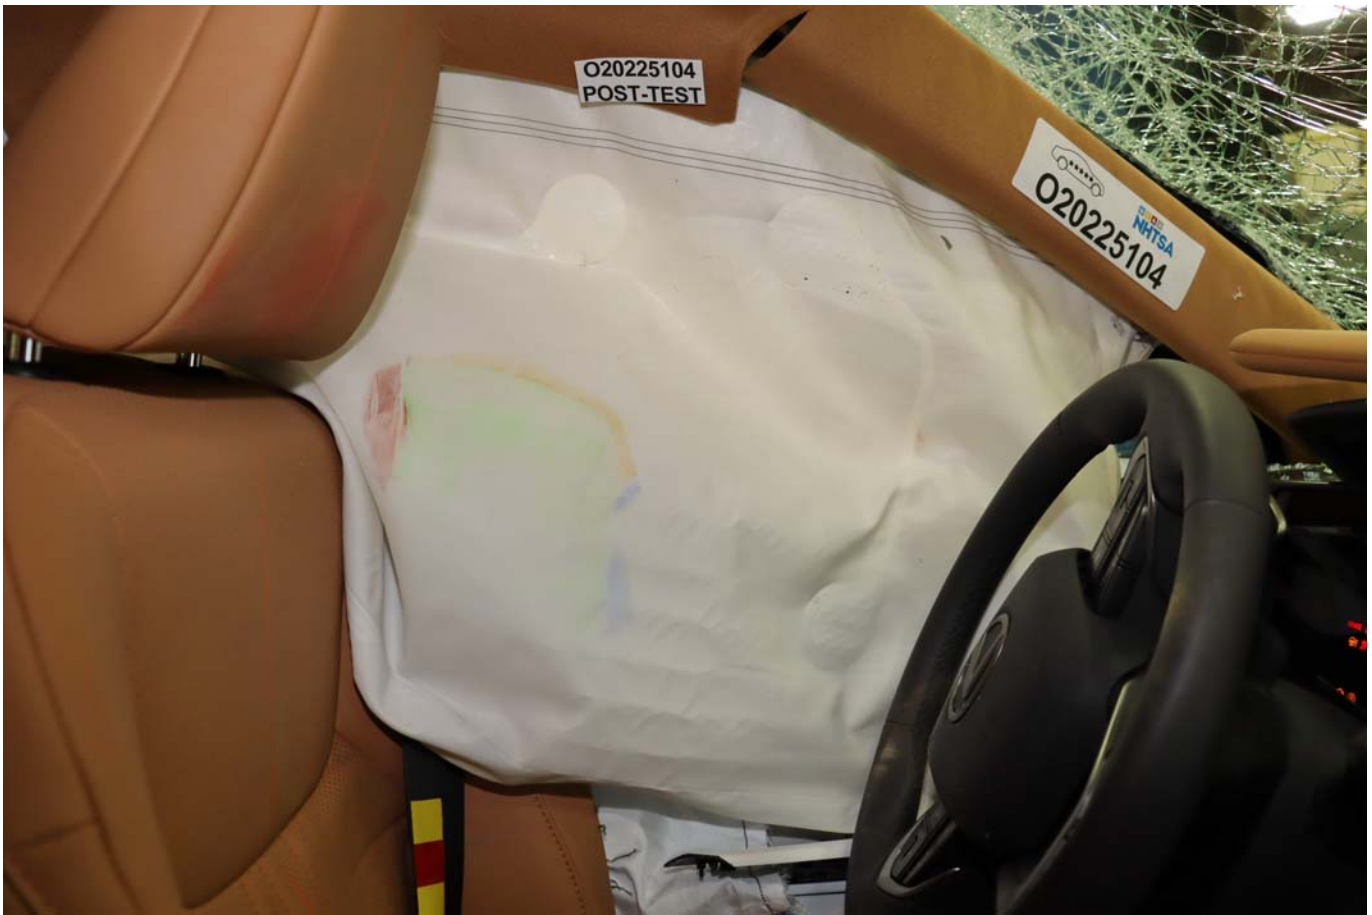
Photo No. 047 - Post-Test Dummy Close-Up Head Contact with Side Air Bag View

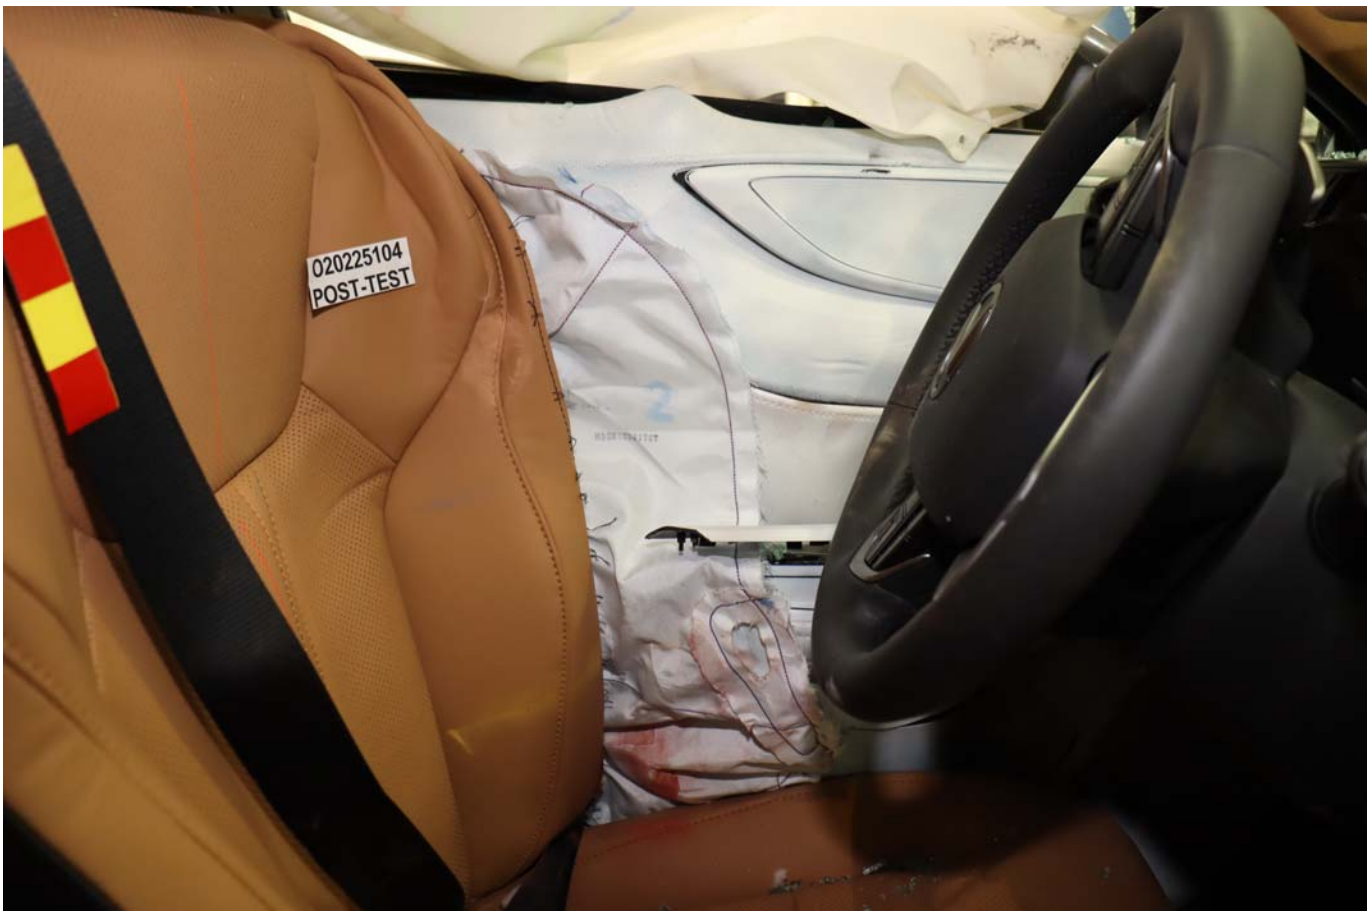
Photo No. 048 - Post-Test Dummy Close-Up Torso Contact with Vehicle Interior View

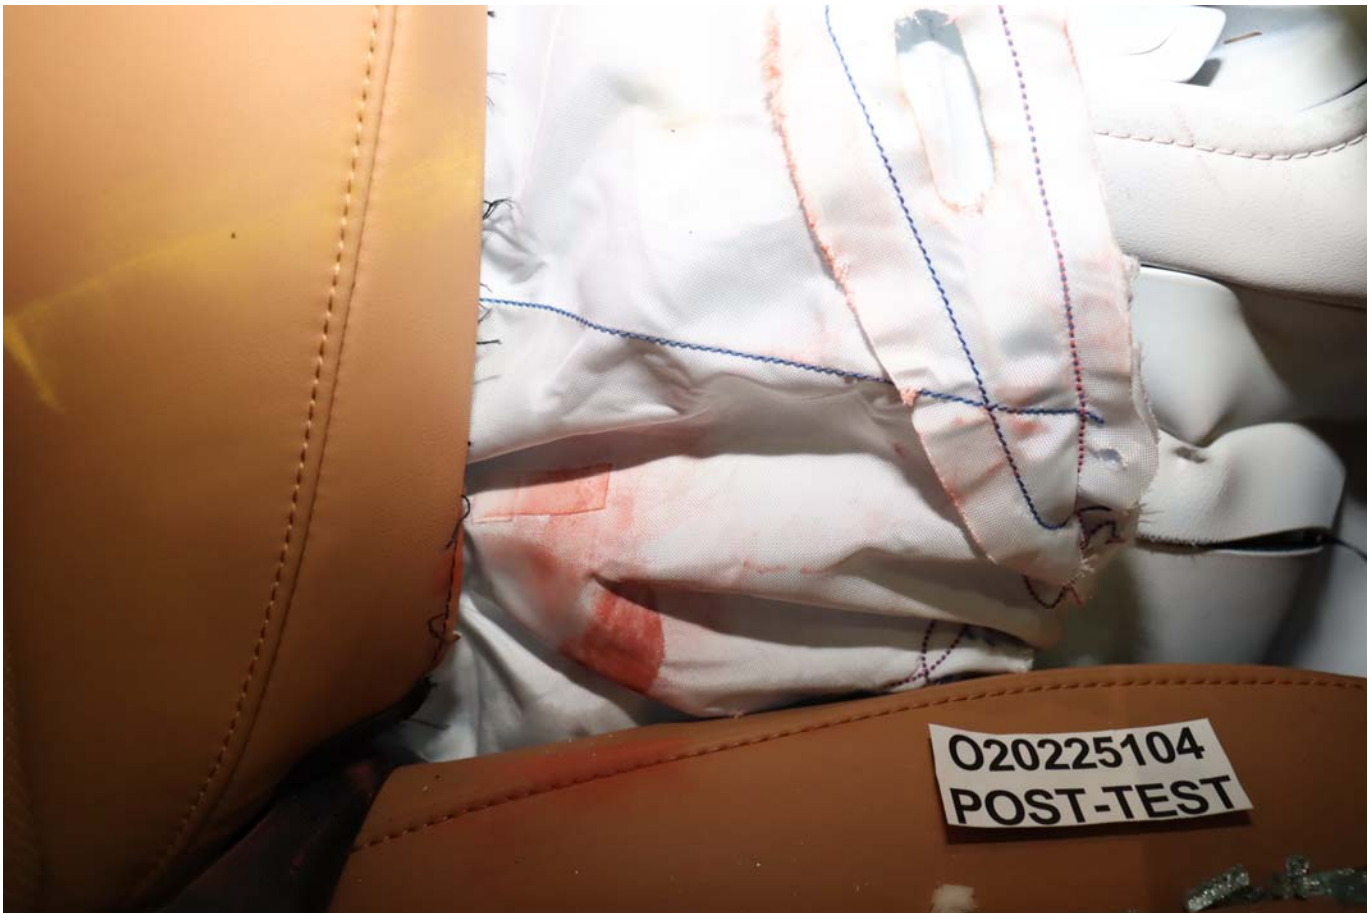
Photo No. 051 - Post-Test Dummy Close-Up Pelvis Contact with Side Air Bag View

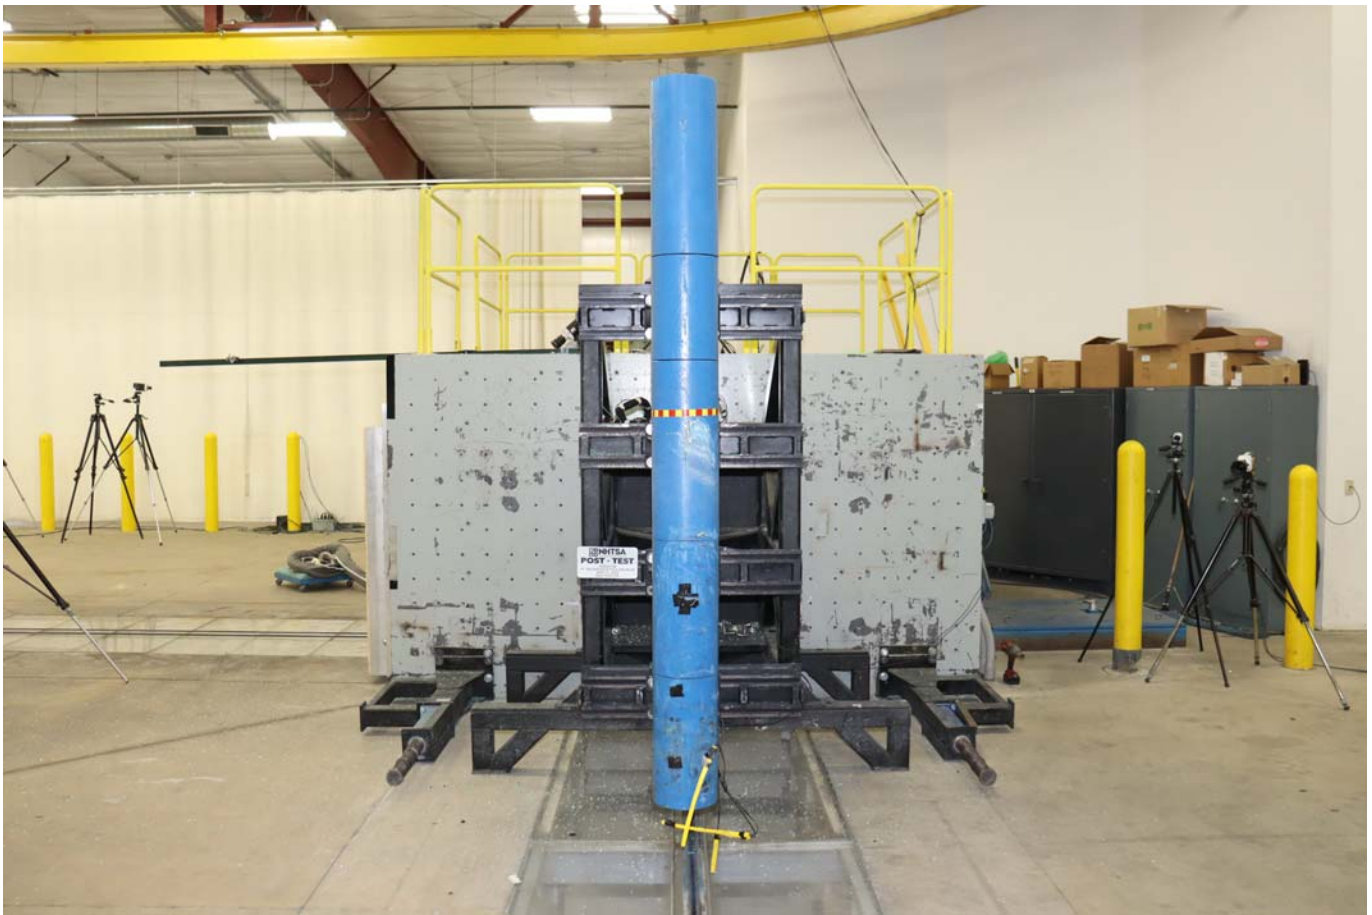
Photo No. 060 - Post-Test Pole Barrier Front View

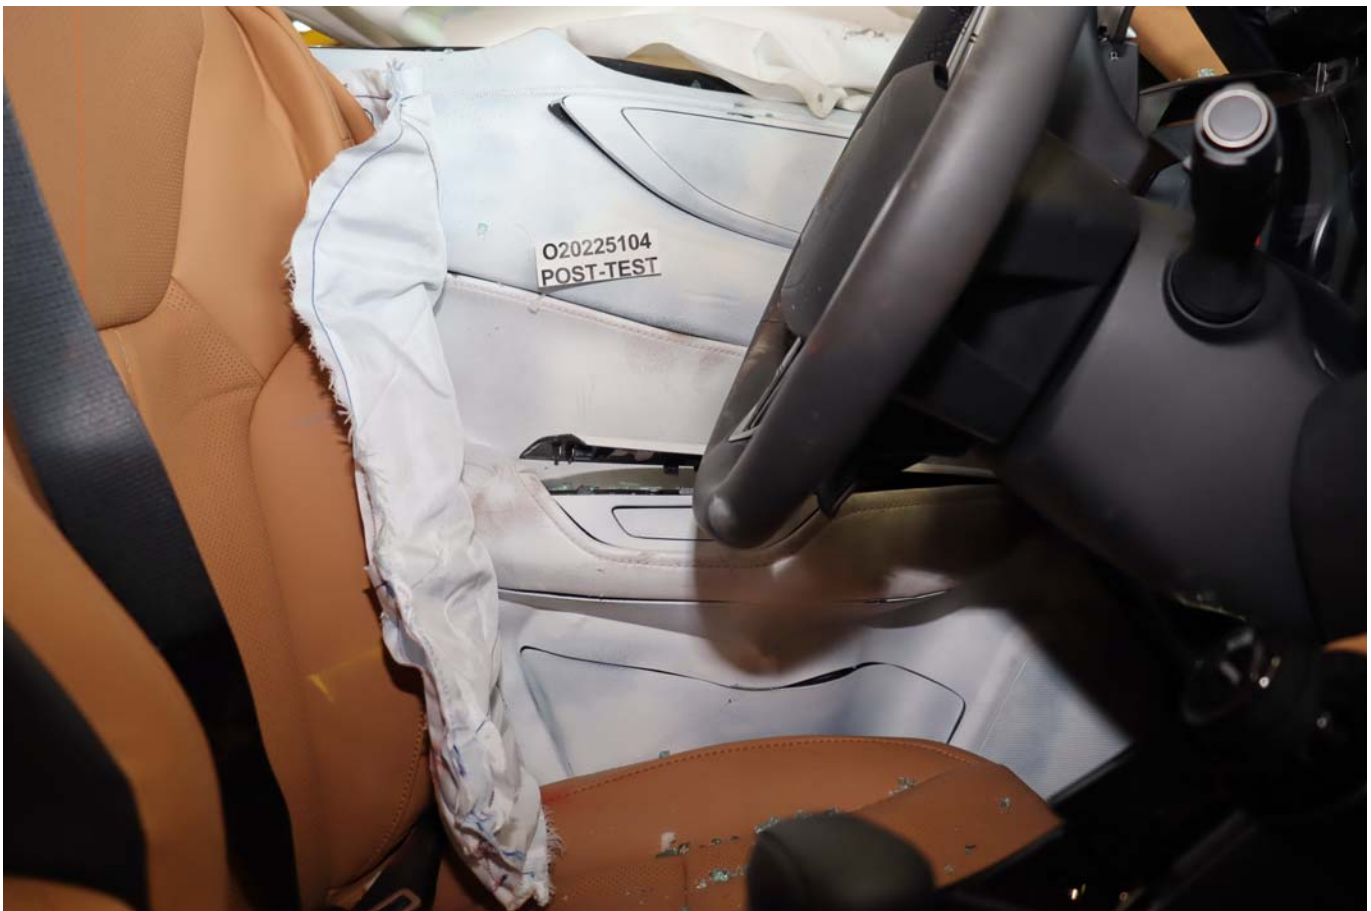
Photo No. 073 - Post-Test View of Shattered Vehicle Inner Door Panel
