**REPORT NUMBER: SideNCAPMDB-MGA-23-020**

**NEW CAR ASSESSMENT PROGRAM (NCAP)  
Moving Deformable Barrier Side Impact Test**

**NISSAN MOTOR CO., LTD.  
2023 Nissan Kicks S 5-Door SUV  
NHTSA No.: O20235200**

**MGA RESEARCH CORPORATION  
5000 Warren Road  
Burlington, WI 53105**

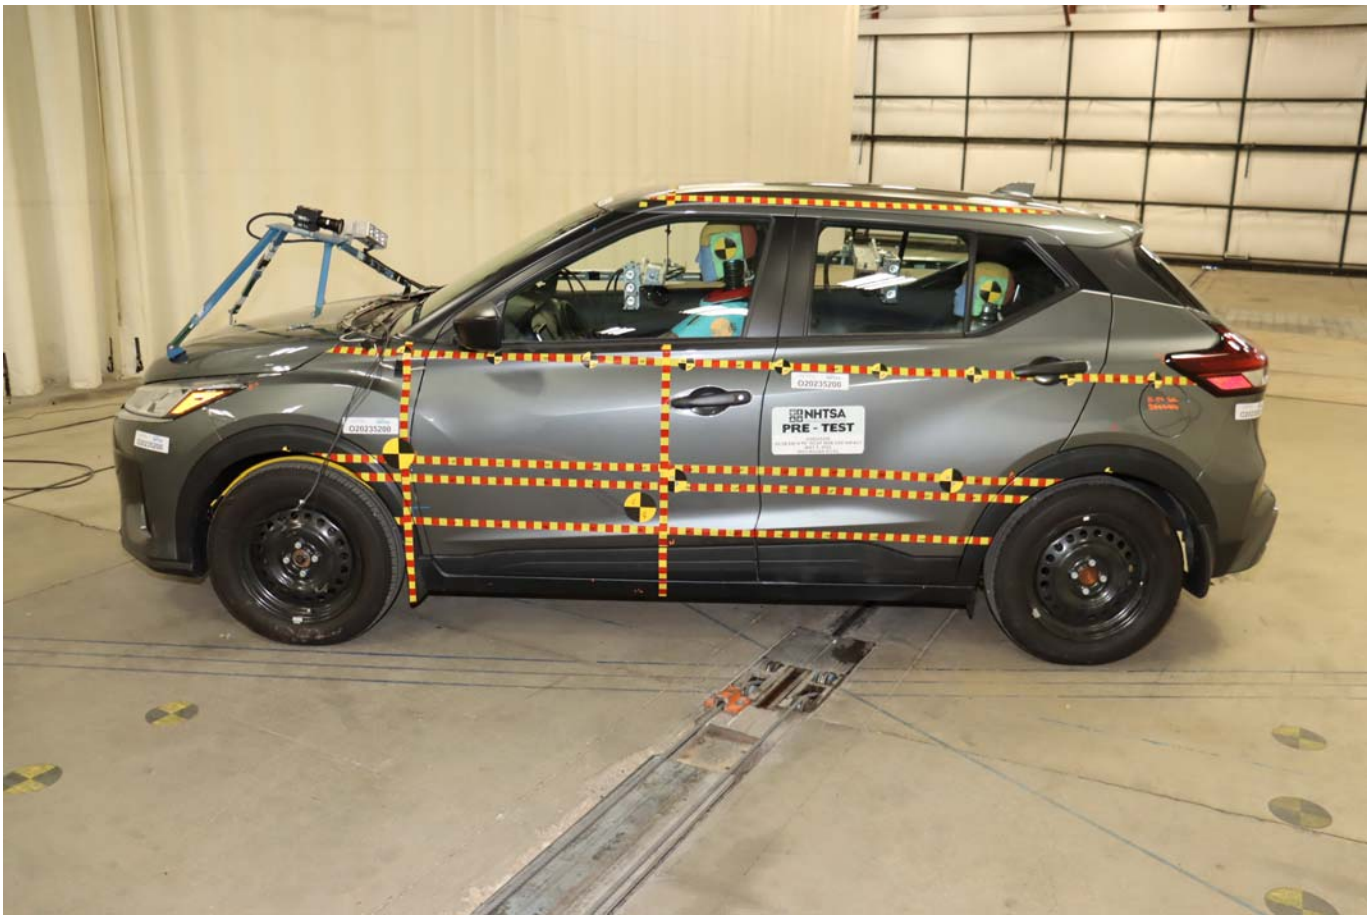
Photo No. 008 - Post-Test Left Side View of Test Vehicle

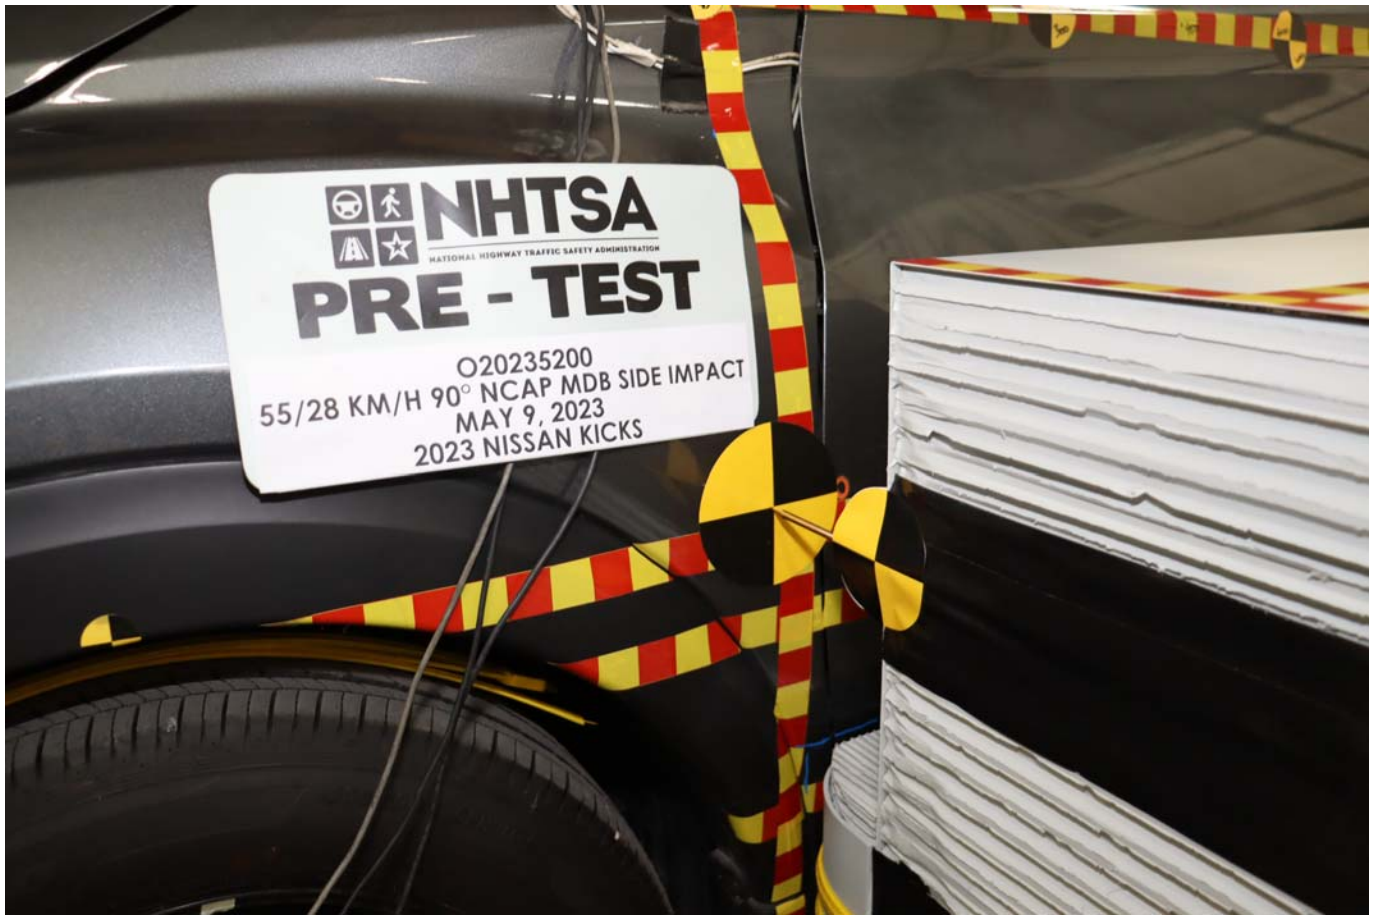
Photo No. 020 - Post-Test Close-Up View of Impact Point Target

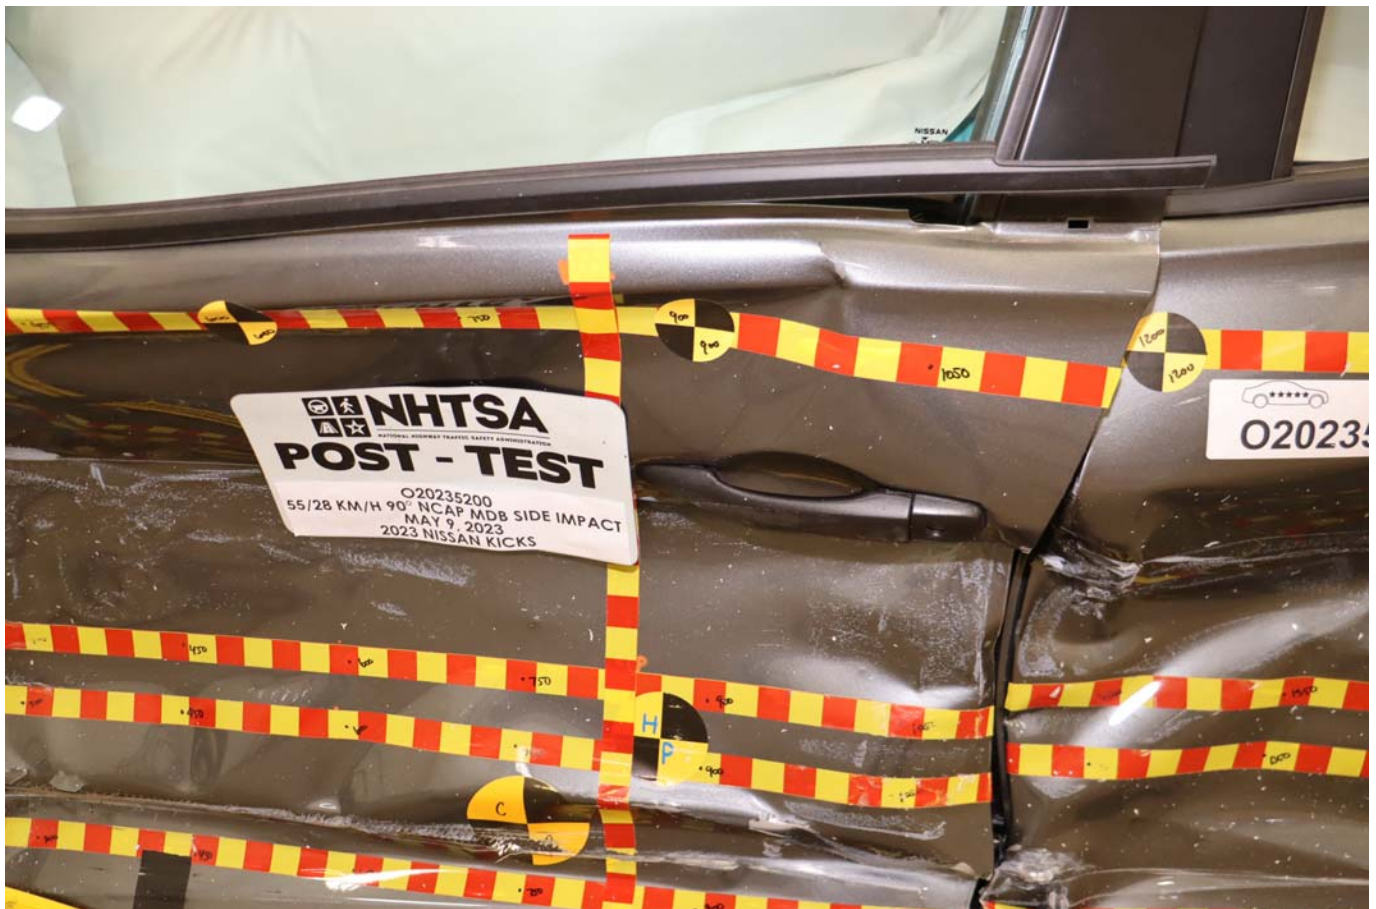
Photo No. 022 - Post-Test Left Front Door Latch Close-Up

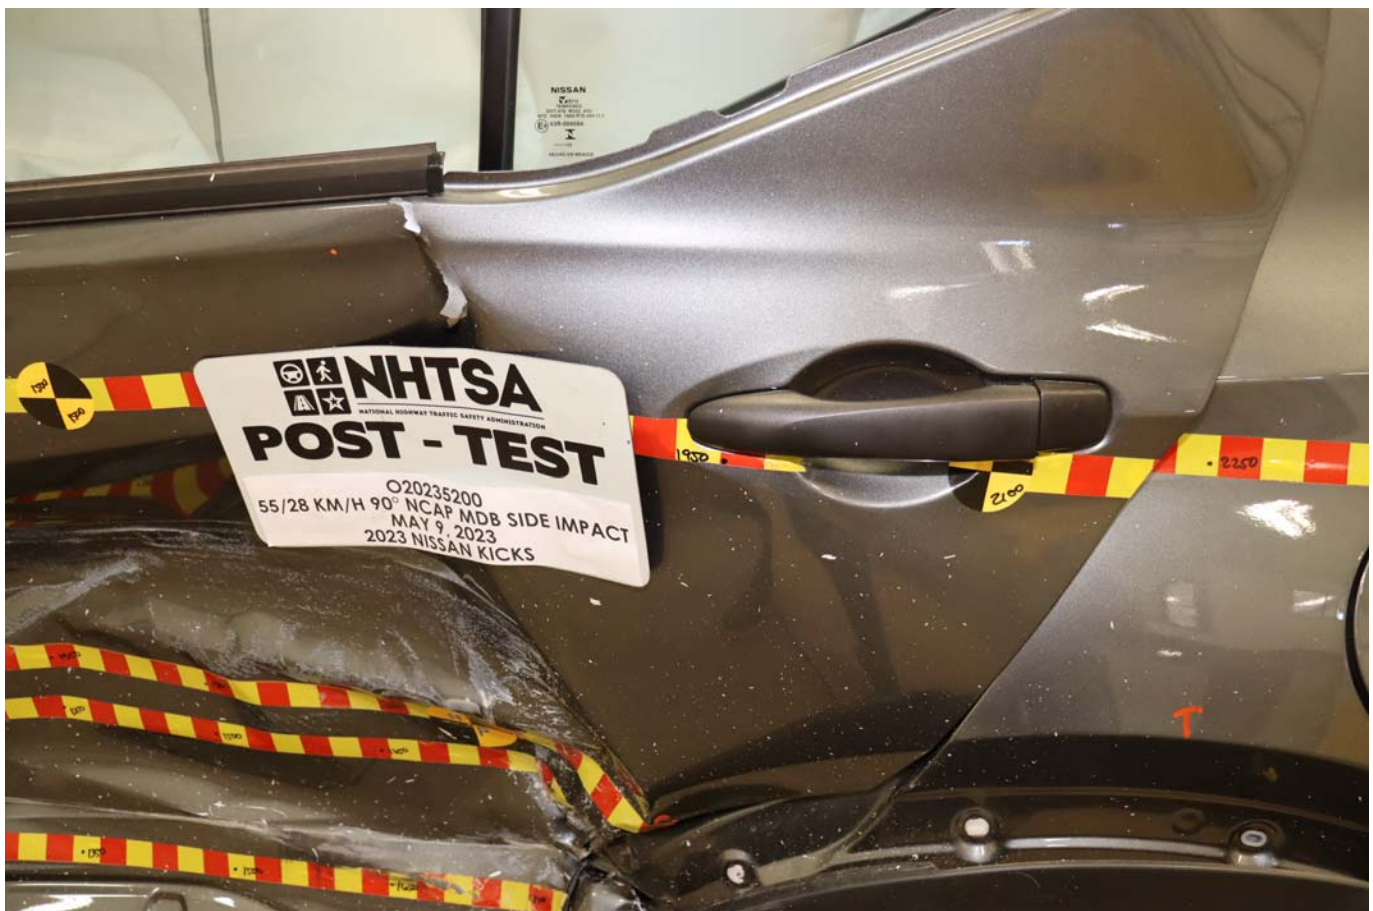
Photo No. 024 - Post-Test Left Rear Door Latch Close-Up

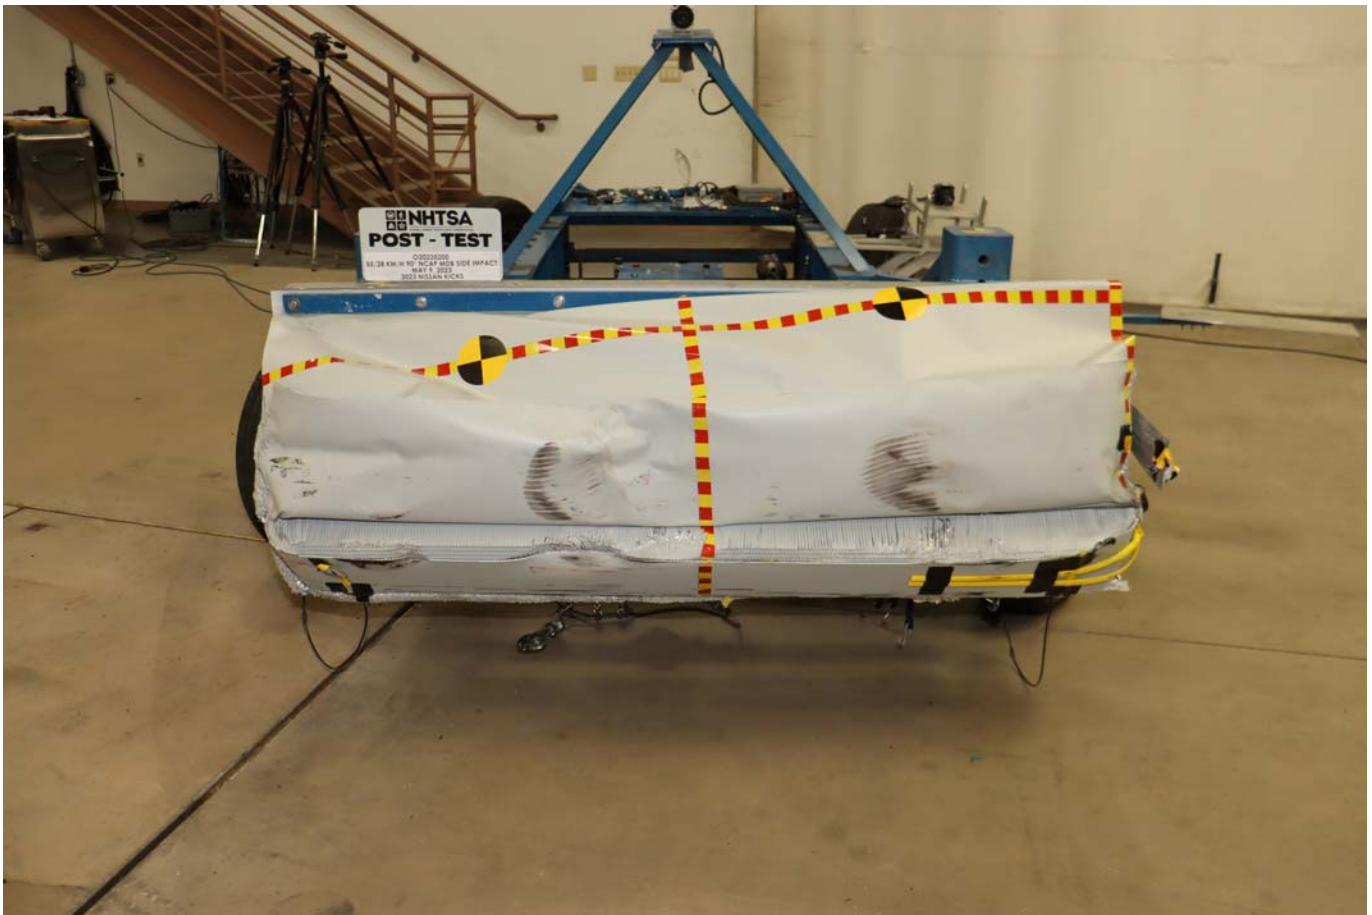
Photo No. 085 - Post-Test Front View of MDB Impactor Face
