**REPORT NUMBER: NCAP-MGA-23-018**

**NEW CAR ASSESSMENT PROGRAM (NCAP)  
Frontal Barrier Impact Test**

**TOYOTA MOTOR CORPORATION  
2023 Subaru Solterra 5-Door SUV  
NHTSA No.: O20235500**

**FINAL REPORT**

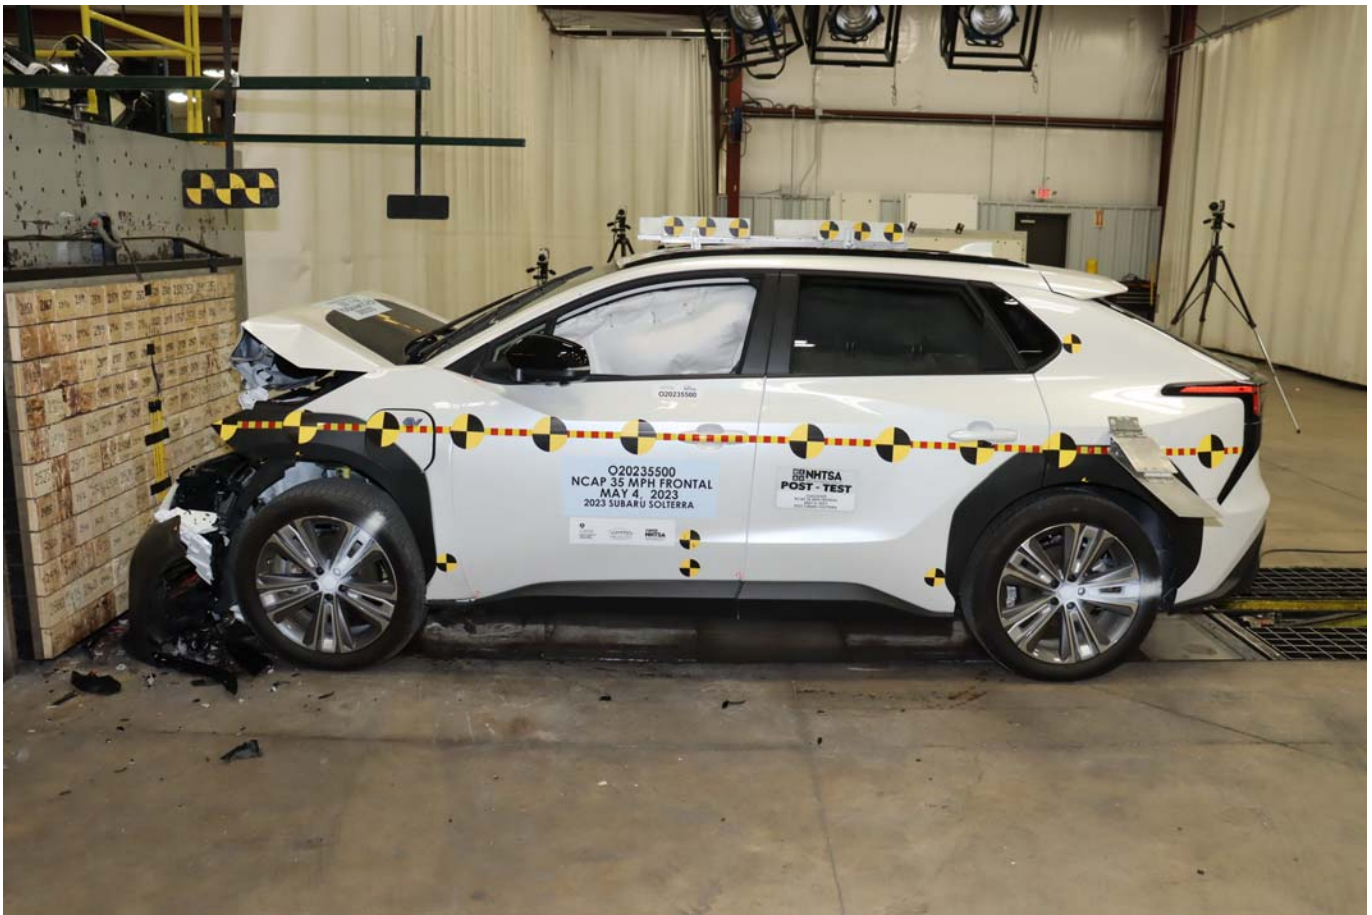
Photo No. 011 - Post-Test Left View of Test Vehicle

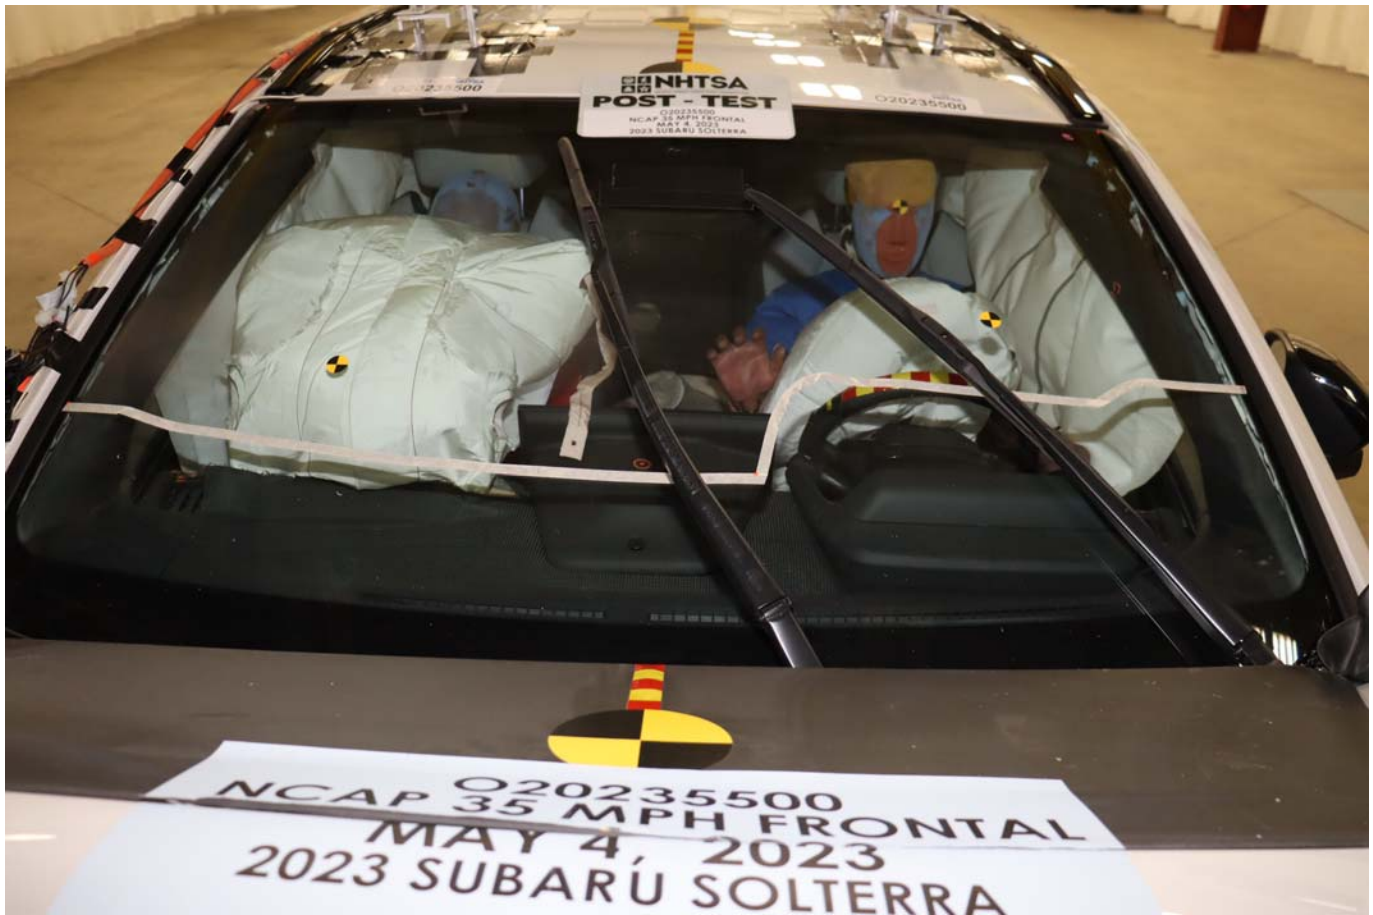
Photo No. 019 - Post-Test Windshield View

There was 100 percent windshield retention and no intrusion into the protected zone of the windshield during the event. There was no Stoddard Solvent or battery electrolyte leakage and no loss of high-voltage battery isolation after the event or during any phase of the static rollover.

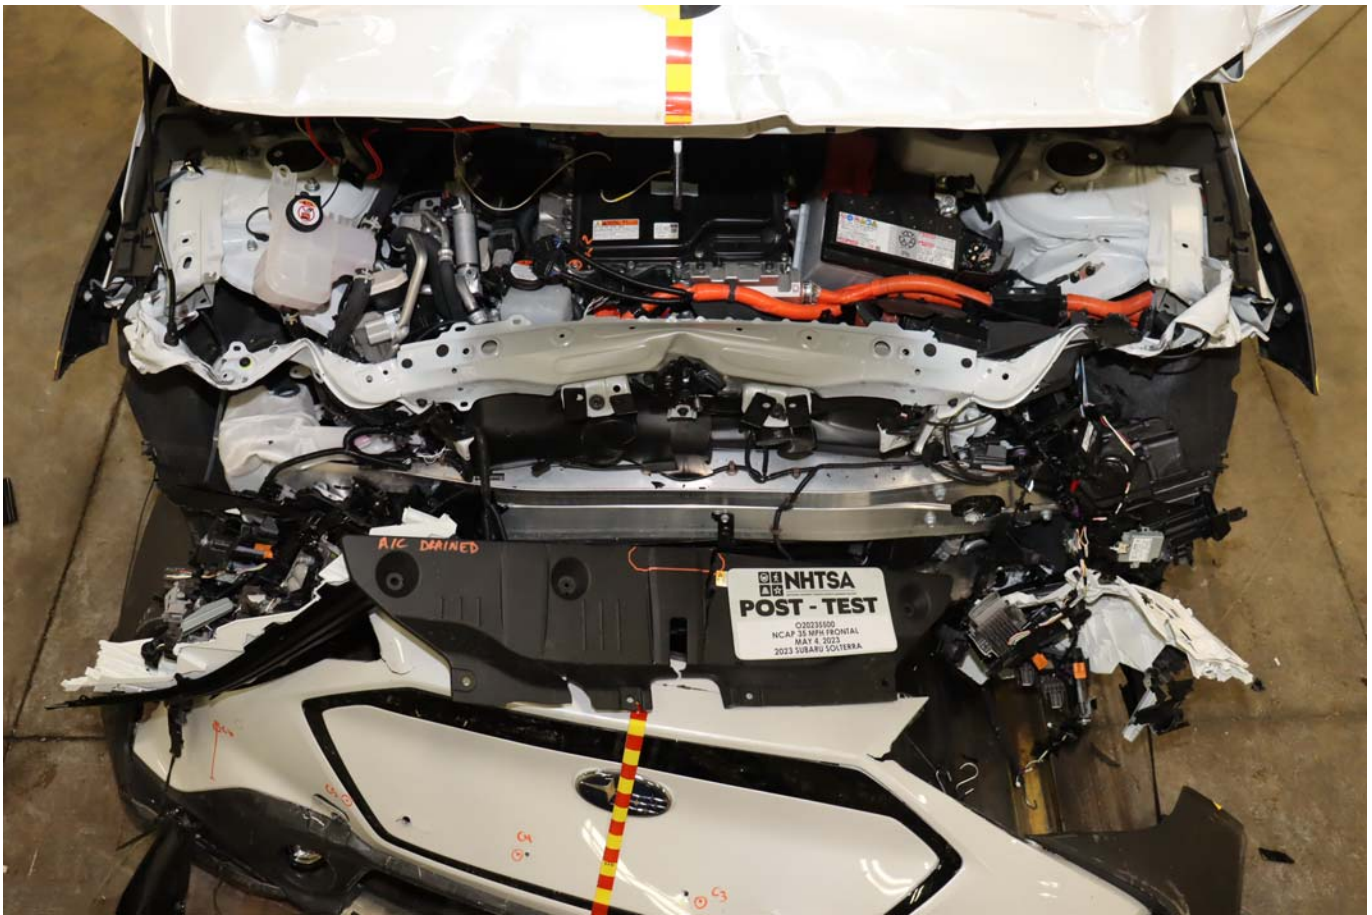
Photo No. 021 - Post-Test Engine Compartment View

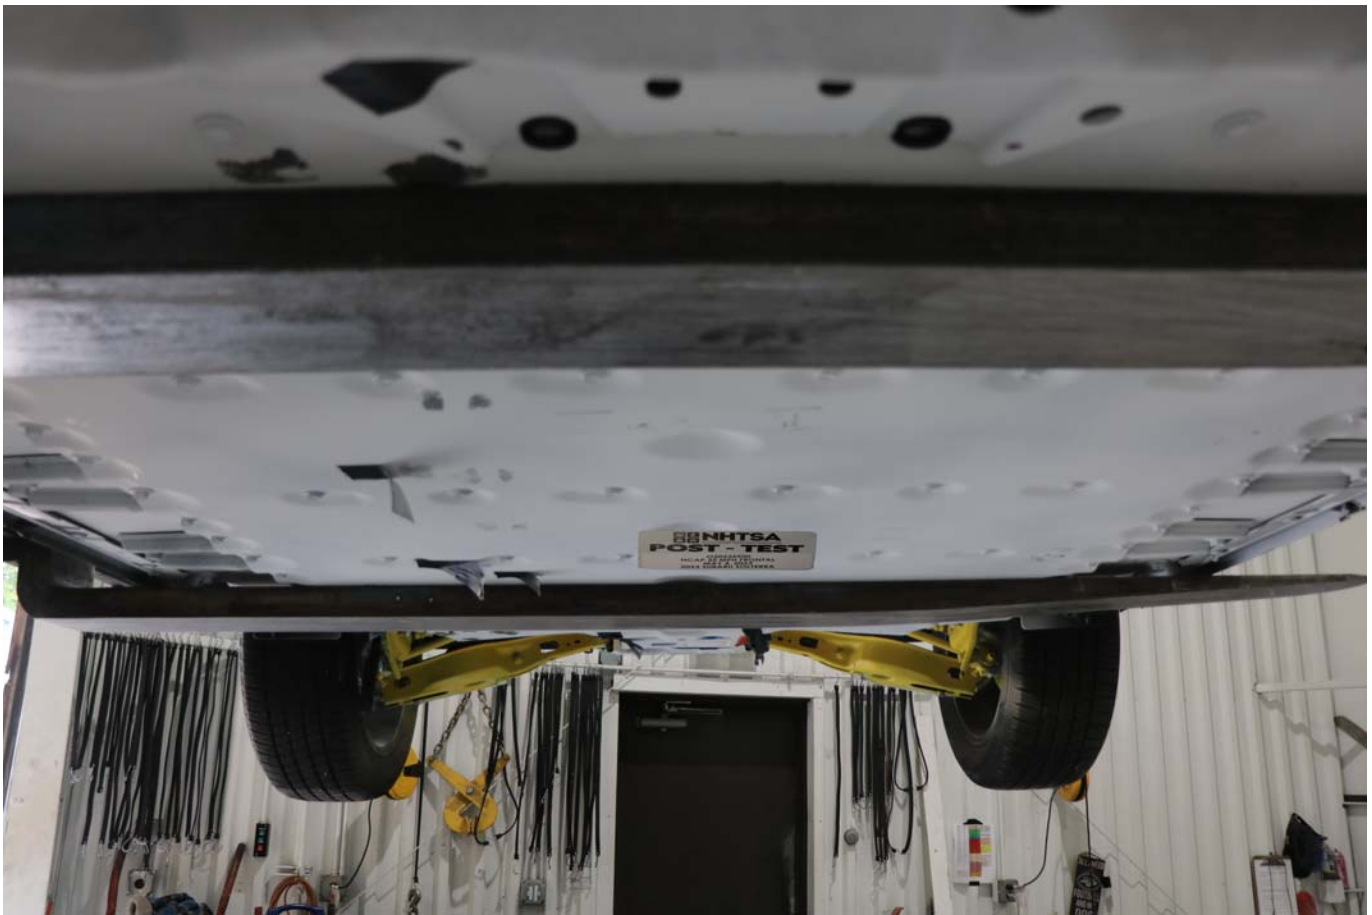
Photo No. 305-10 - Post-Impact Front View of Propulsion Battery

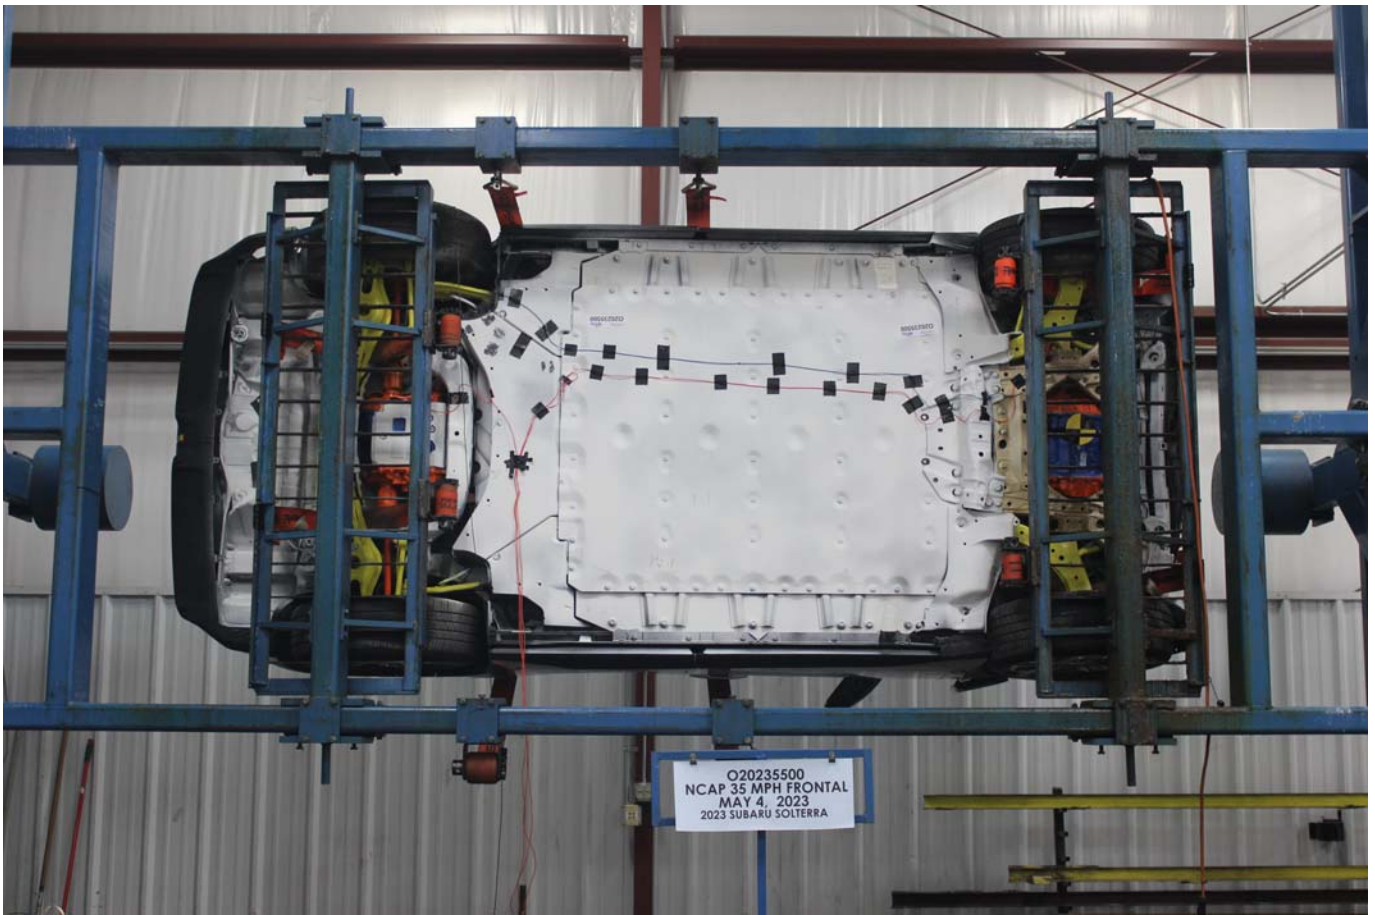
Photo No. 305-28 - FMVSS No. 305 Static Rollover at 90 Degrees

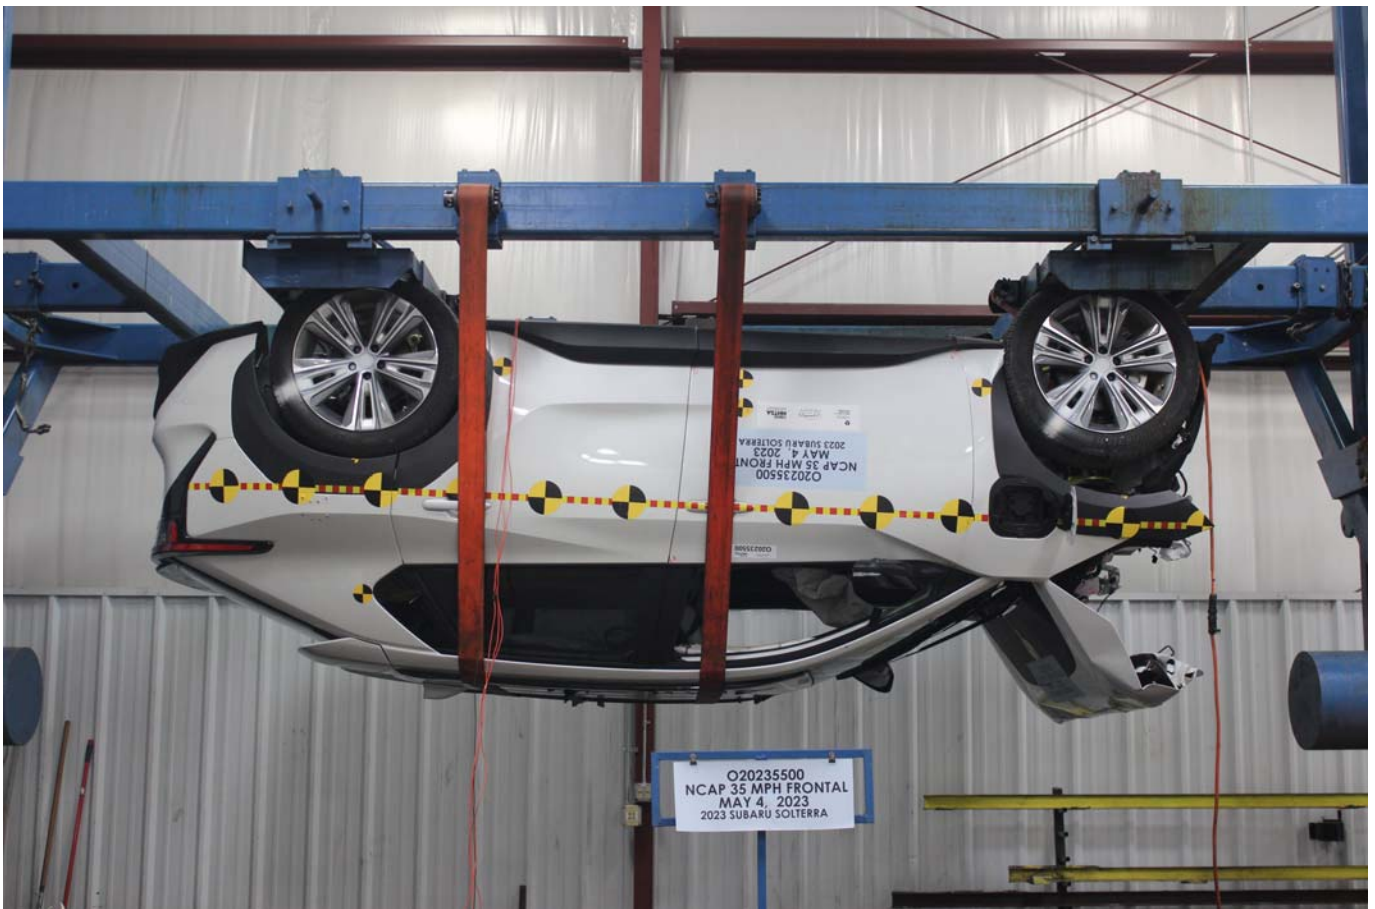
Photo No. 305-29 - FMVSS No. 305 Static Rollover at 180 Degrees

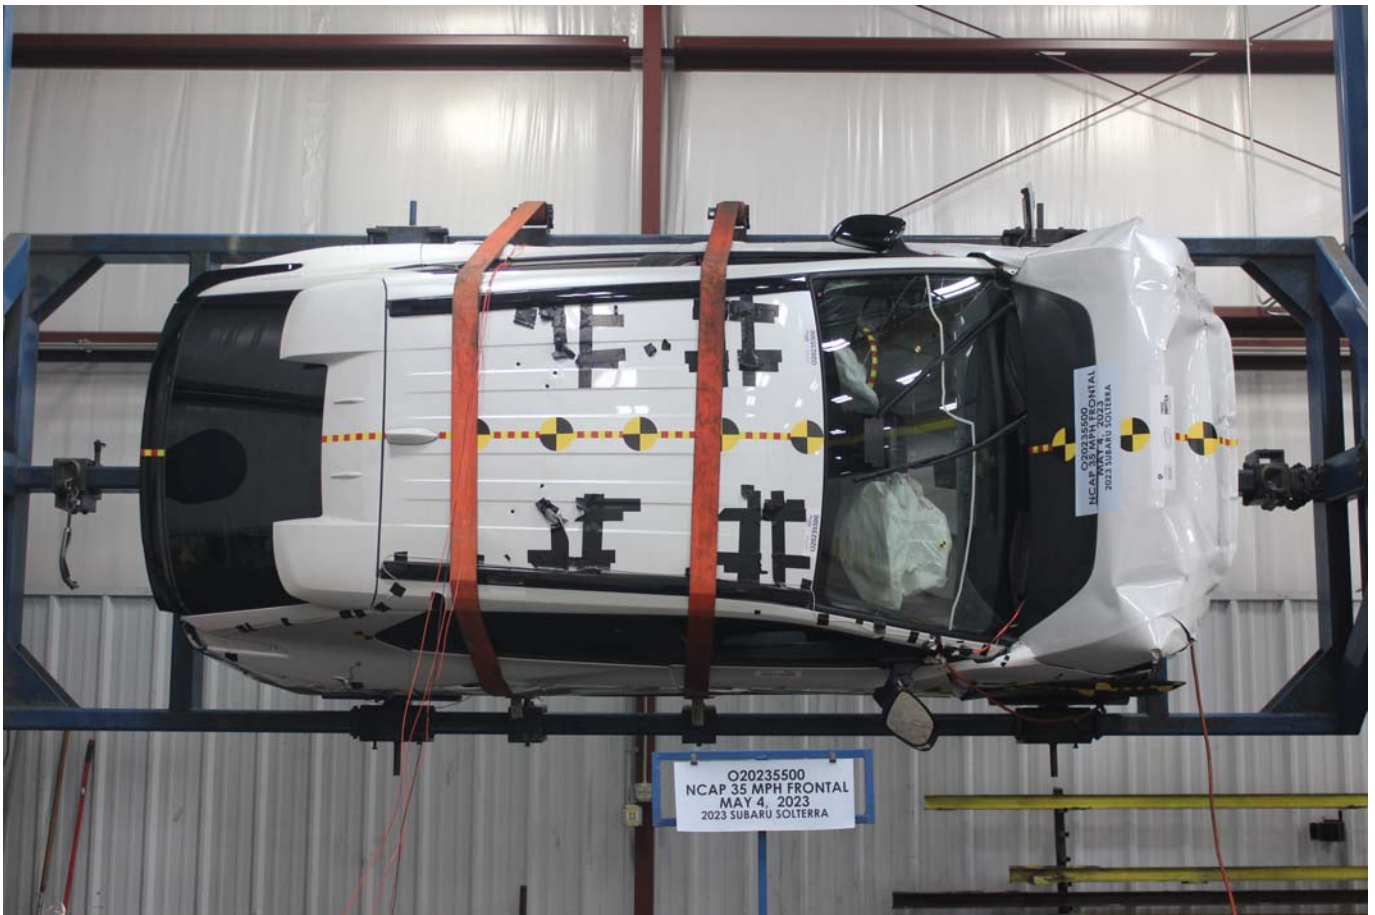
Photo No. 305-30 - FMVSS No. 305 Static Rollover at 270 Degrees

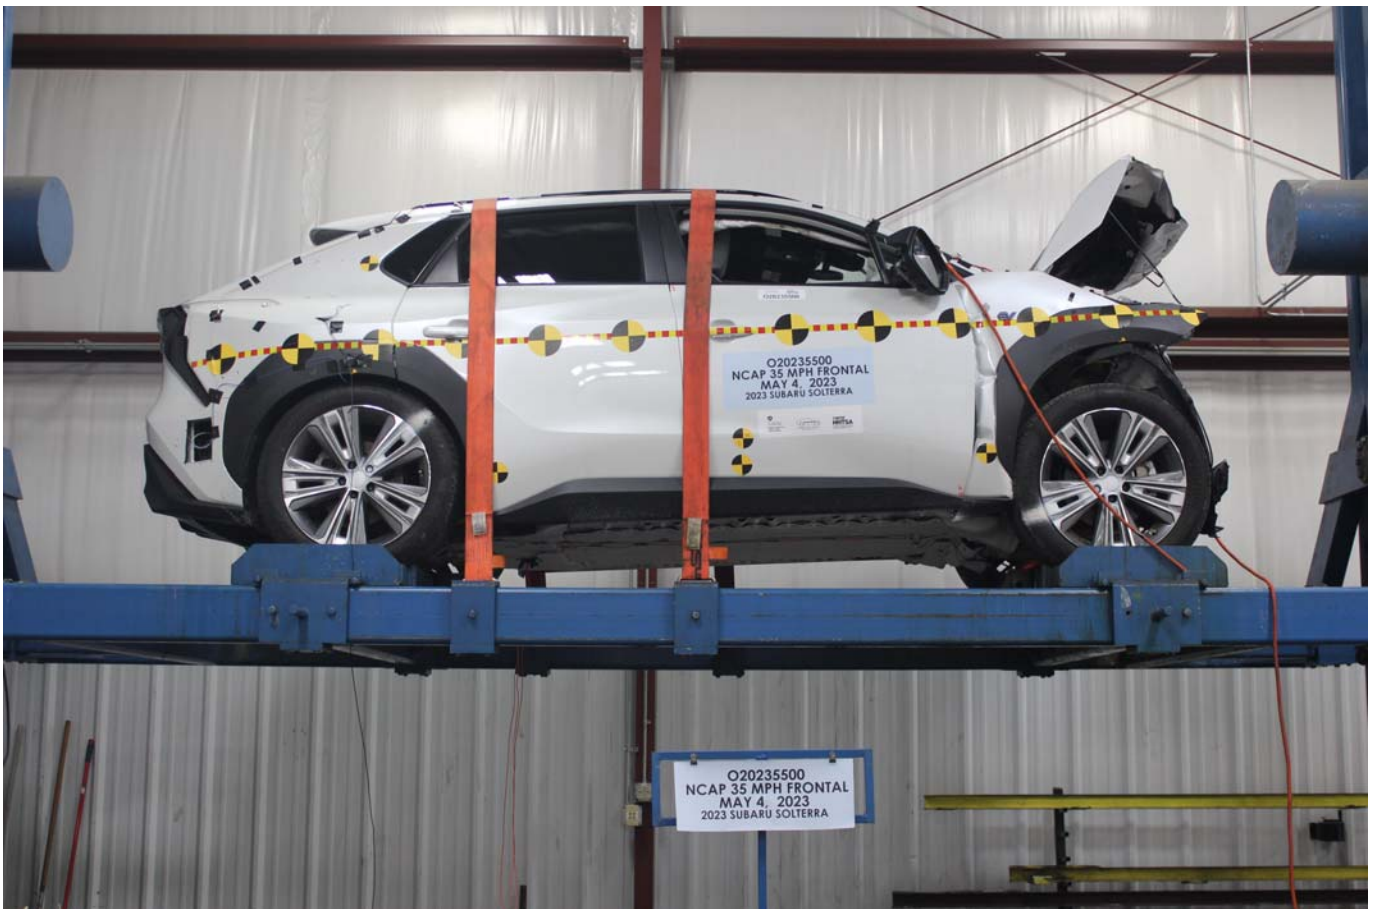
Photo No. 305-31 - FMVSS No. 305 Static Rollover at 360 Degrees
