**Final Report Number: NCAP-TRC-23-004**

**New Car Assessment Program (NCAP)  
Frontal Barrier Impact Test**

**BAYERISCHE MOTOREN WERKE AG  
2023 MINI Countryman 5HB  
NHTSA Number: M20234103**

**PREPARED BY:  
Transportation Research Center Inc.  
10820 State Route 347  
P. O. Box B-67  
East Liberty, OH 43319**

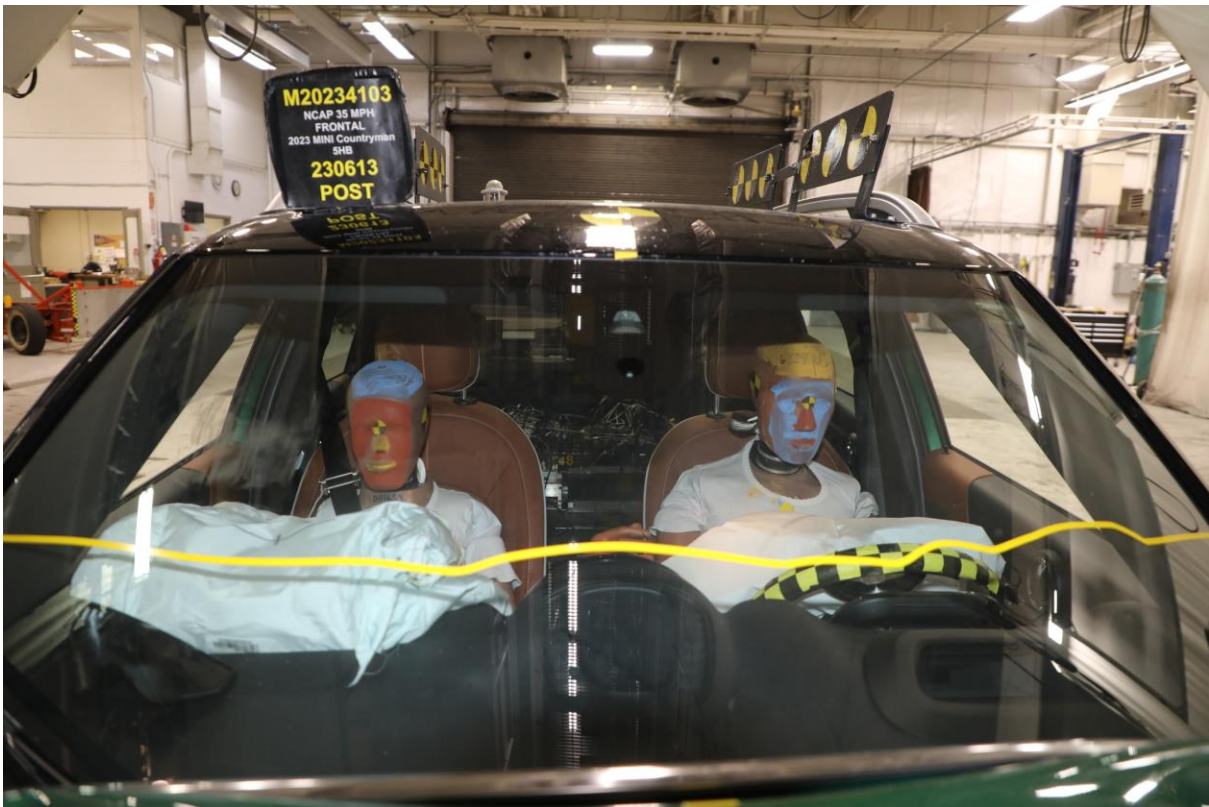
019 Post-Test Windshield View

Critical Areas of Performance	Observations
Windshield Damage	Cracked sides
Window Damage	None
Other Notable Effects	None

There was 100.0 percent windshield retention and no intrusion into the protected zone of the windshield during the event. There was no Stoddard solvent leakage (or electrolyte spillage) after the event or during any phase of the static rollover.
