**FINAL REPORT NUMBER: SPNCAP-TRC-23-004**

**NEW CAR ASSESSMENT PROGRAM (NCAP)  
SIDE IMPACT POLE TEST**

**BAYERISCHE MOTOREN WERKE AG  
2023 MINI Countryman 5HB  
NHTSA NUMBER: M20234104**

**PREPARED BY:  
Transportation Research Center Inc.  
10820 State Route 347  
P. O. Box B-67  
East Liberty, OH 43319**

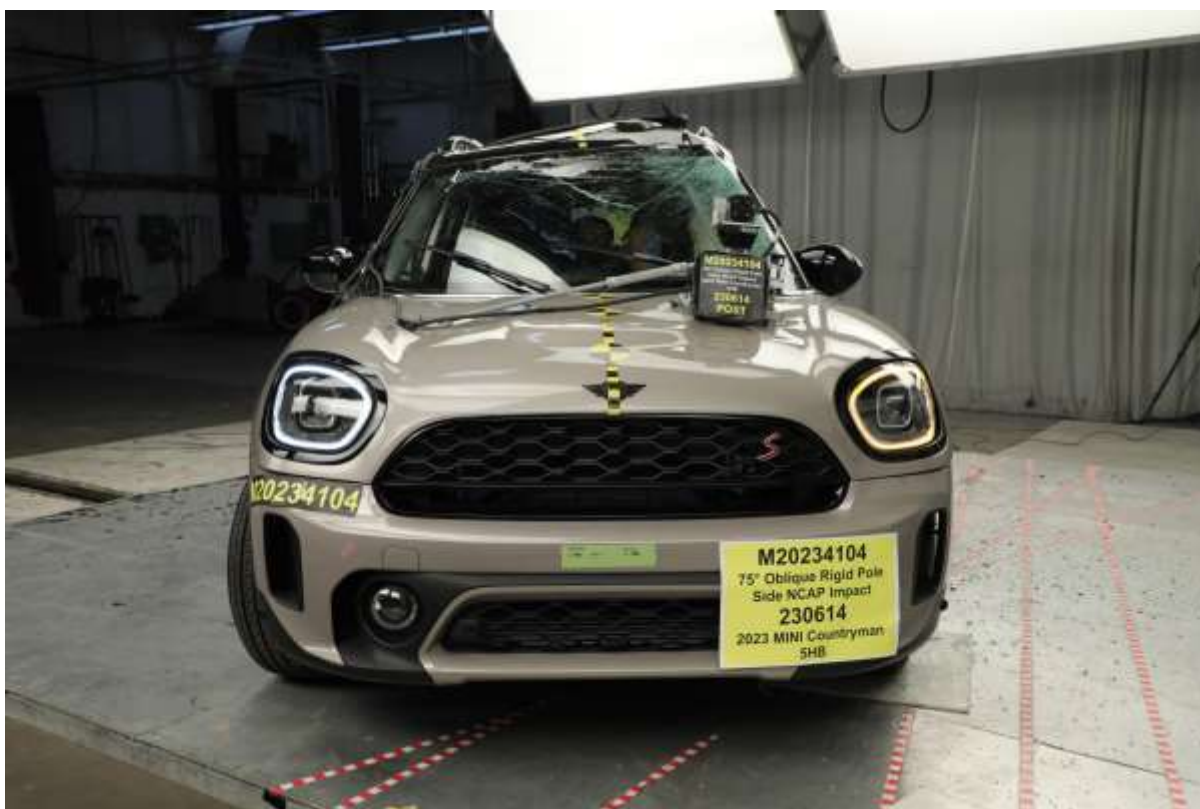
No. 004 Post-Test Frontal View of Test Vehicle

| Critical Areas of Performance | Observations and Conclusions |
|---|---|
| Windshield Damage | Cracked throughout |

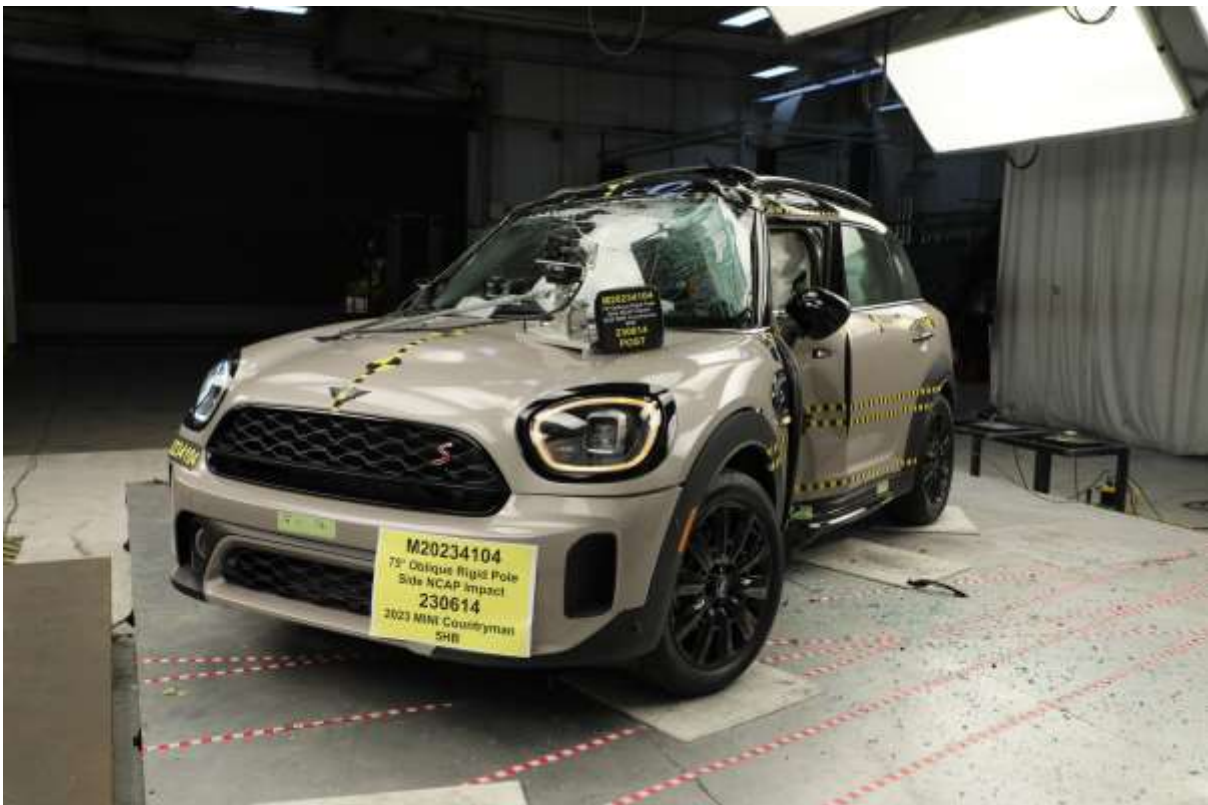
**No. 006 Post-Test Left Front  $\frac{3}{4}$  View of Test Vehicle**

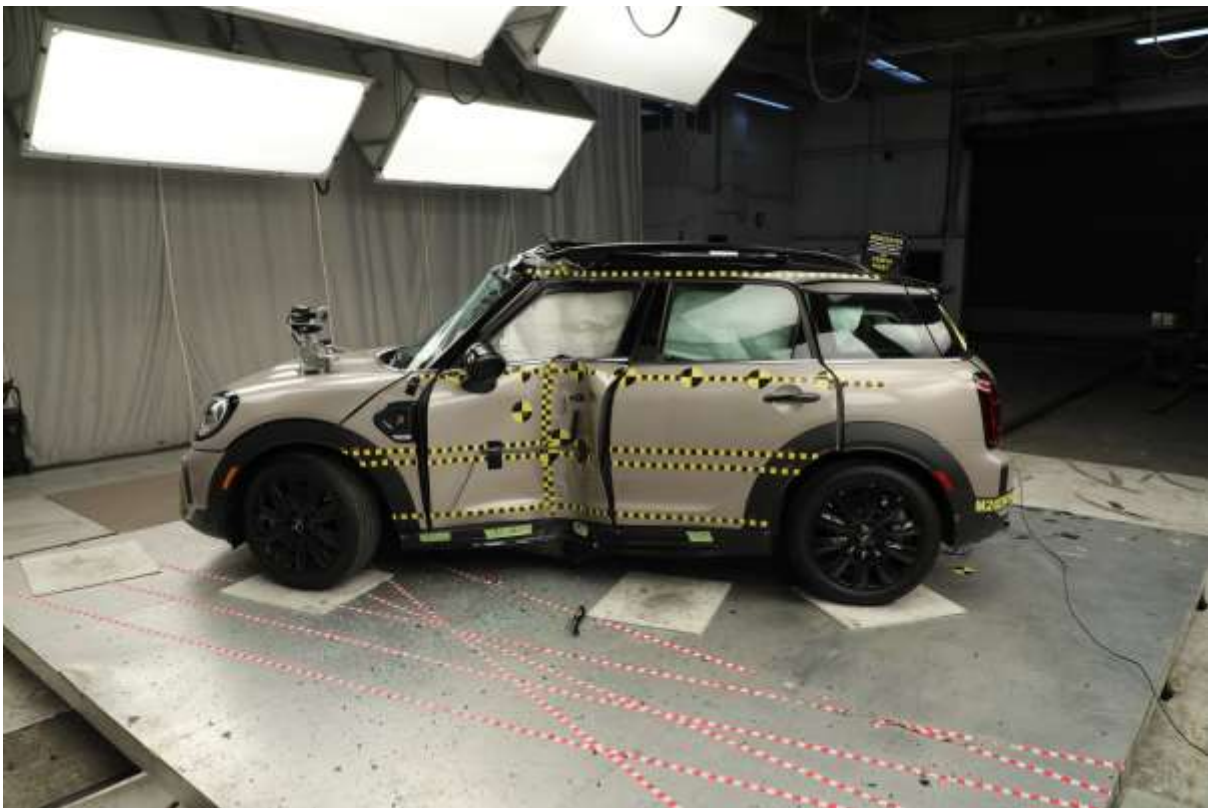
**No. 008 Post-Test Left Side View of Test Vehicle**

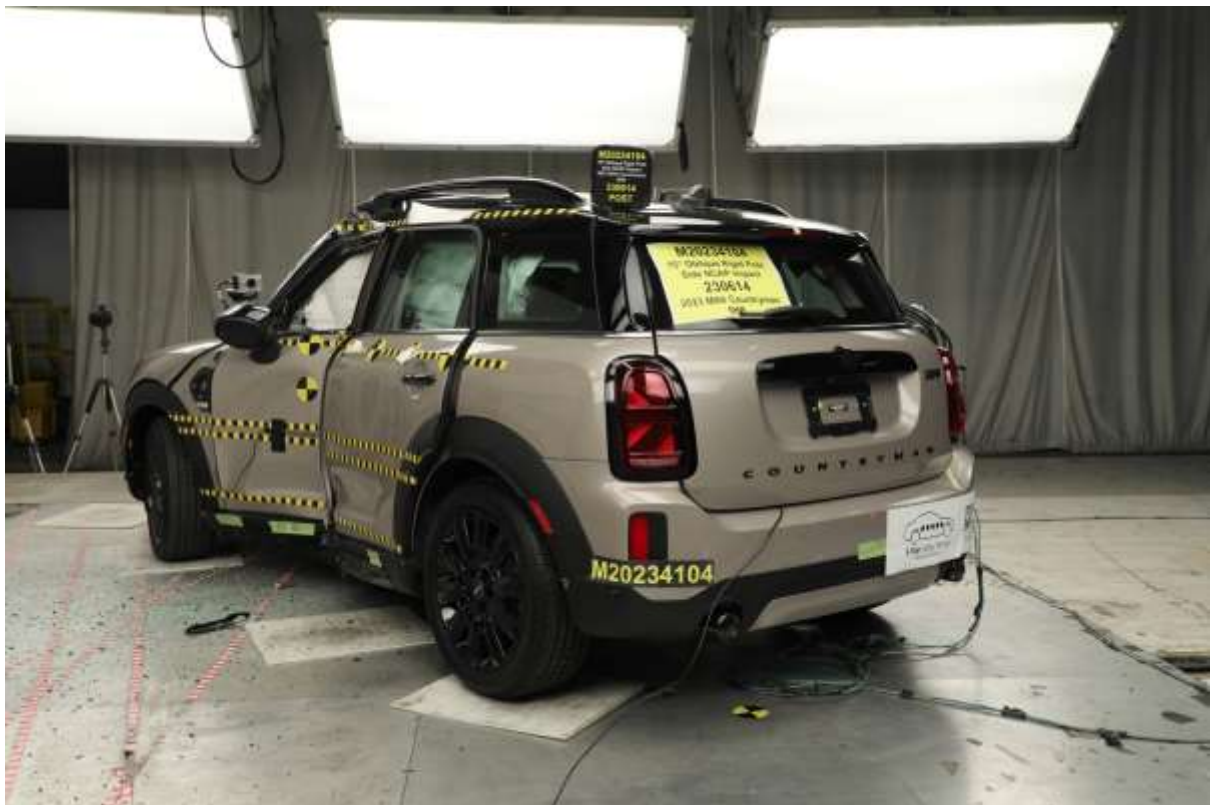
**No. 010 Post-Test Left Rear  $\frac{3}{4}$  View of Test Vehicle**

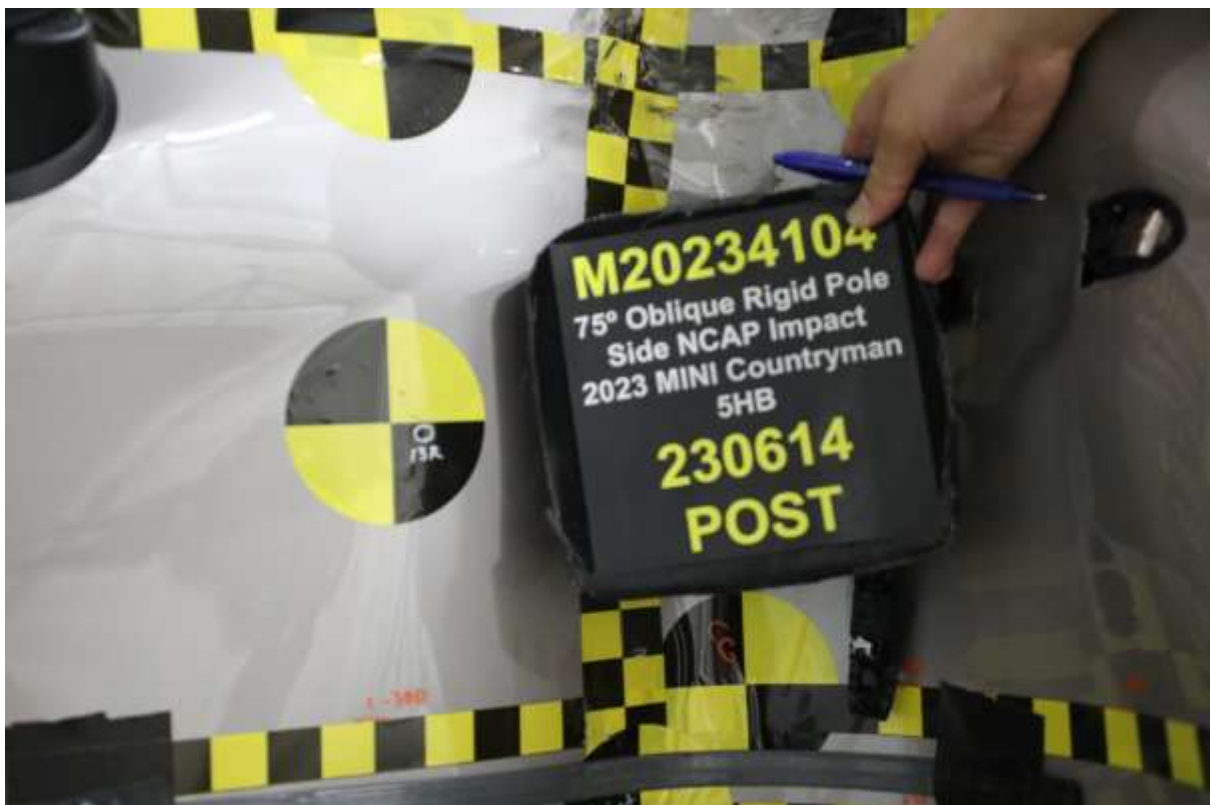
No. 020 Post-Test Close-Up View of Impact Point Target Showing Impact Location

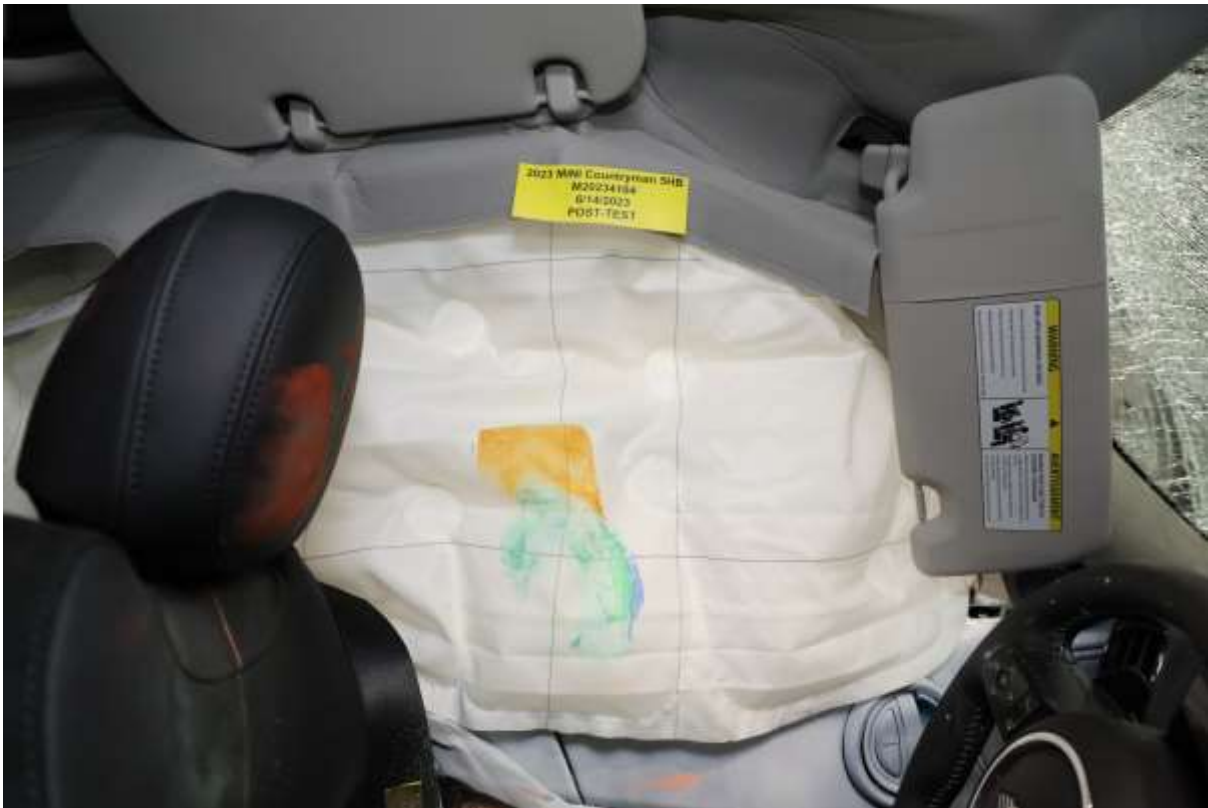
**No. 047 Post-Test Dummy Close-Up Head Contact with Side Airbag View**

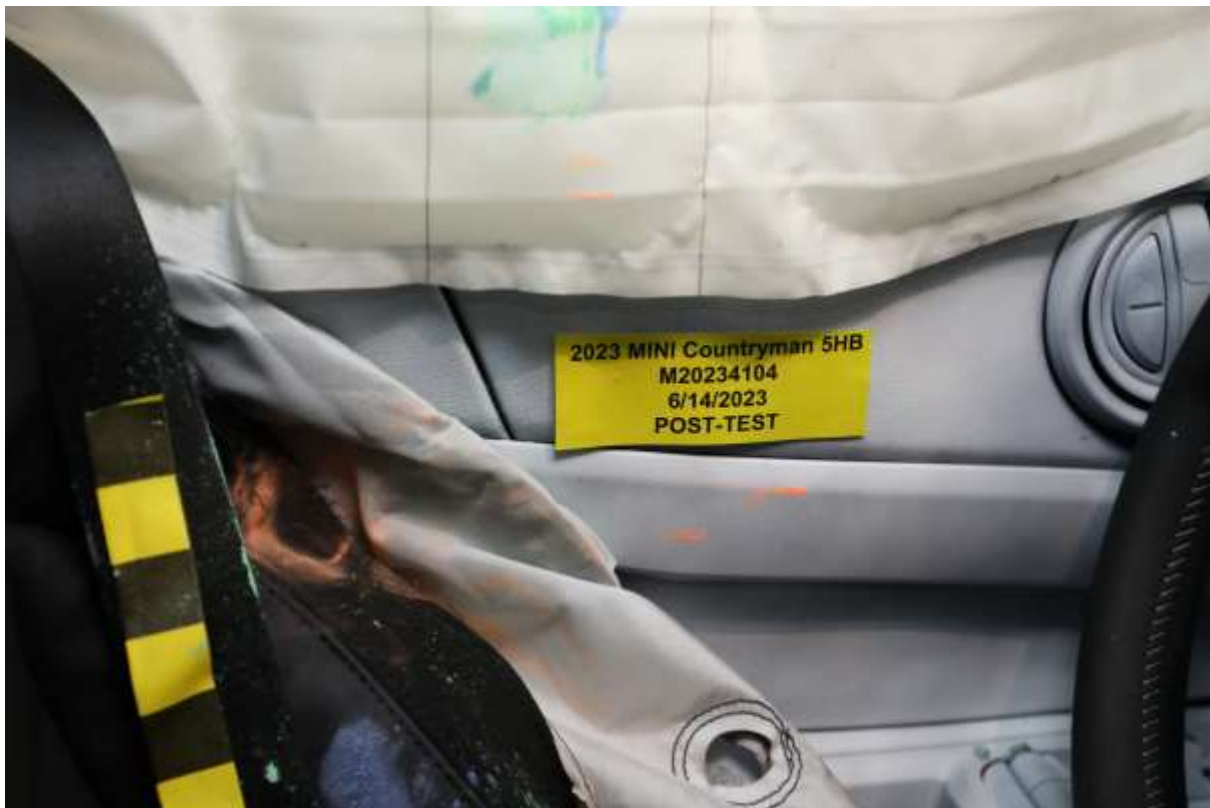
**No. 049 Post-Test Dummy Close-Up Torso Contact with Side Airbag View**

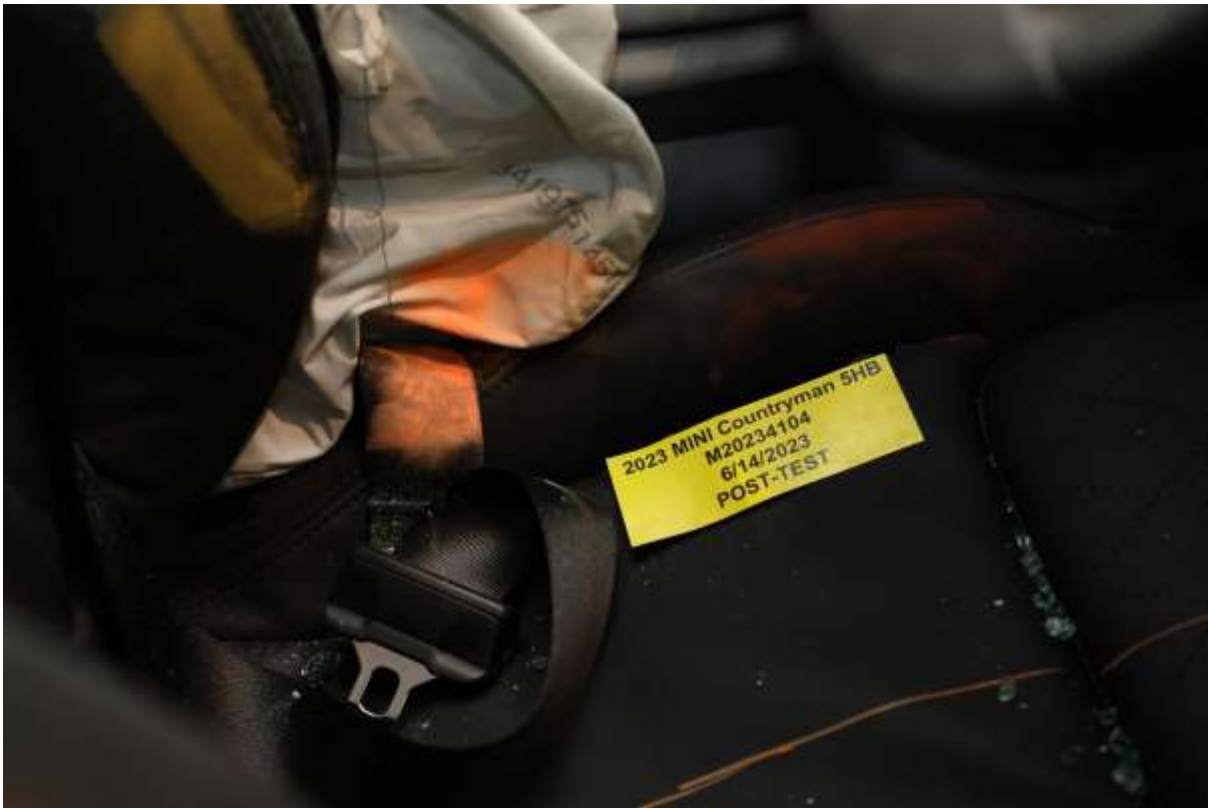
**No. 051 Post-Test Dummy Close-Up Pelvis Contact with Side Airbag View**

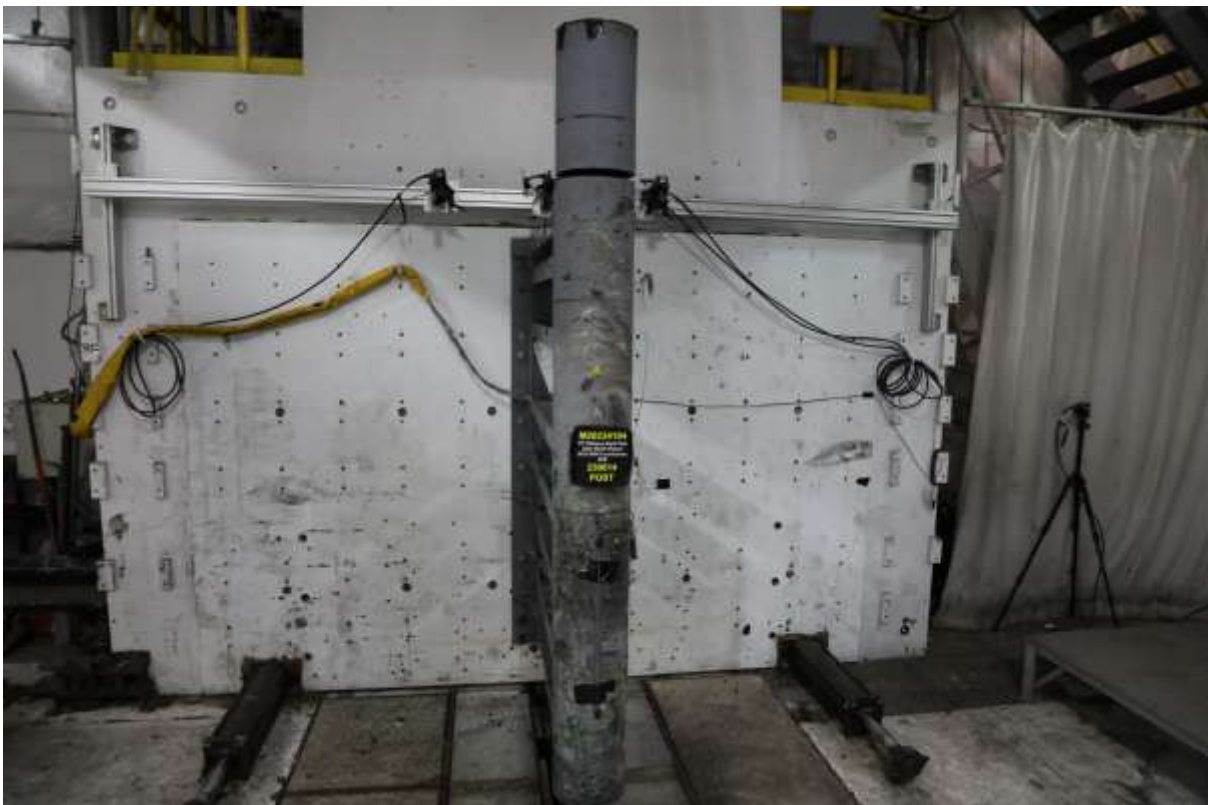
**No. 060 Post-Test Pole Barrier Front View**

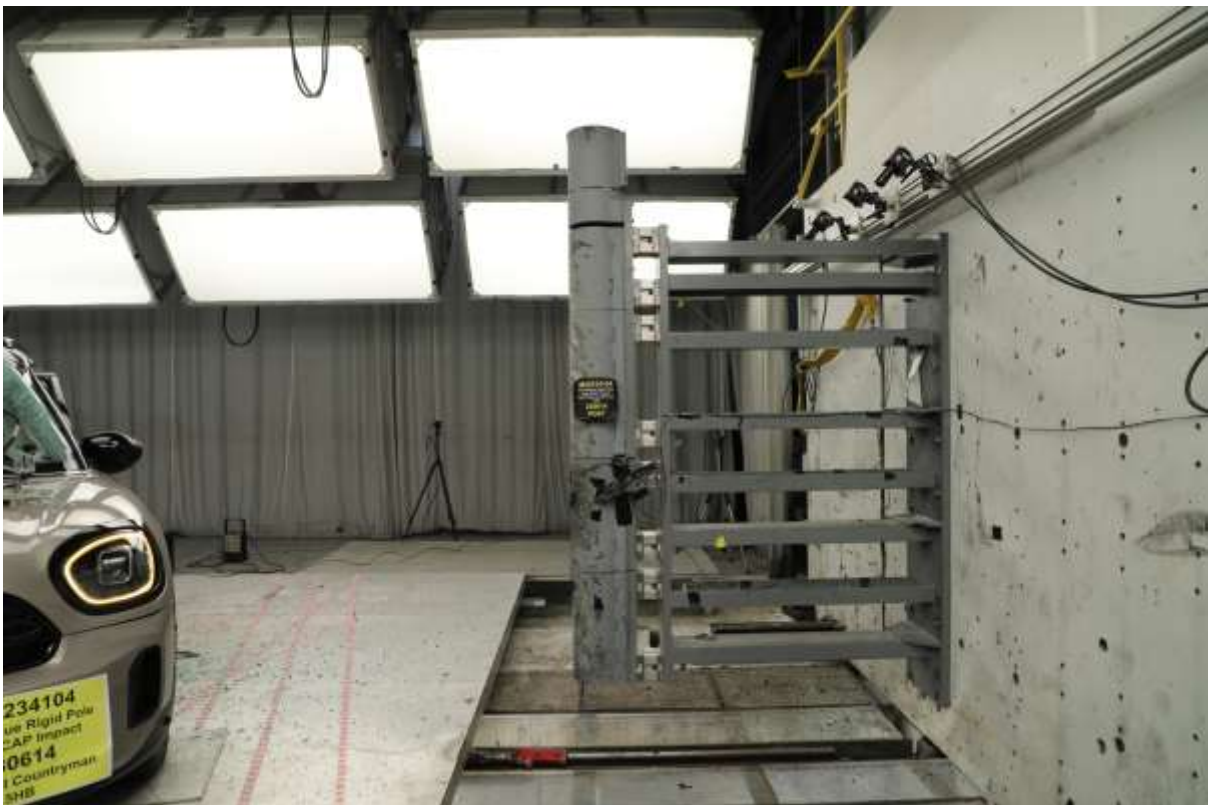
**No. 062 Post-Test Pole Barrier Side View**

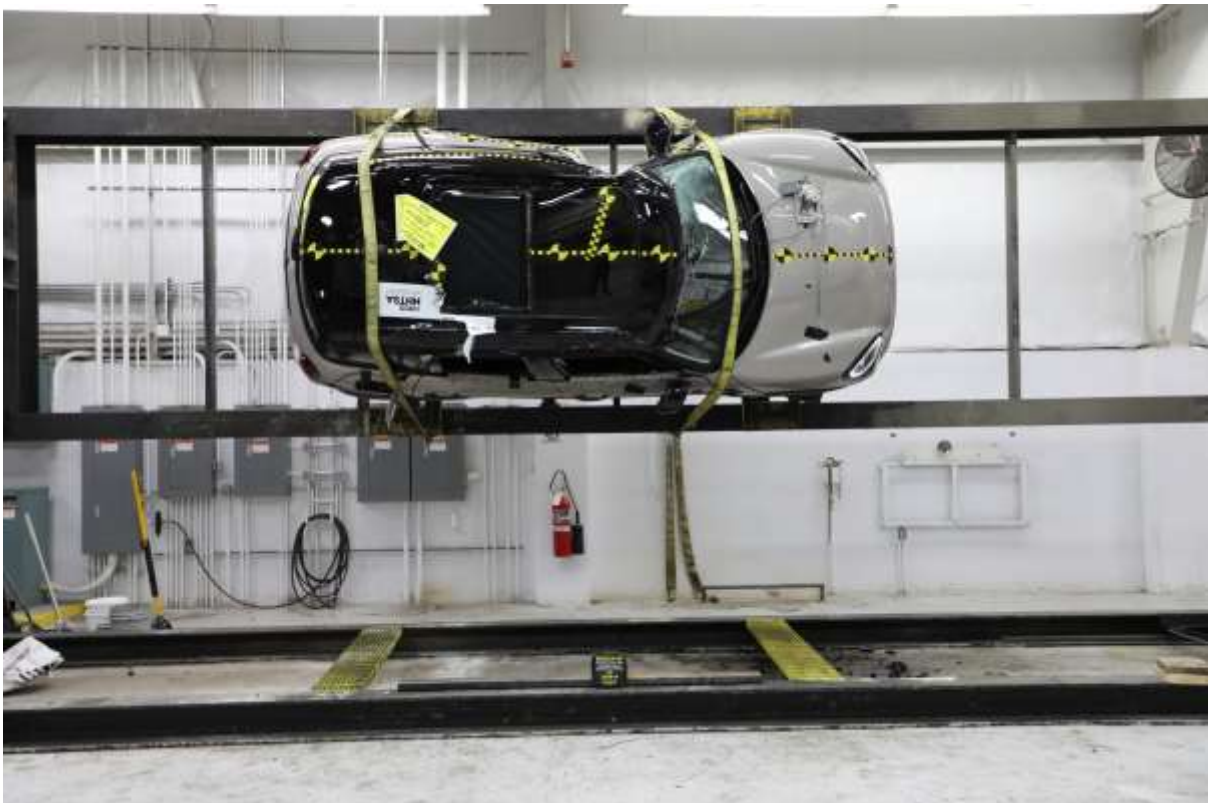
**No. 066 FMVSS No. 301 Static Rollover 90 Degrees**

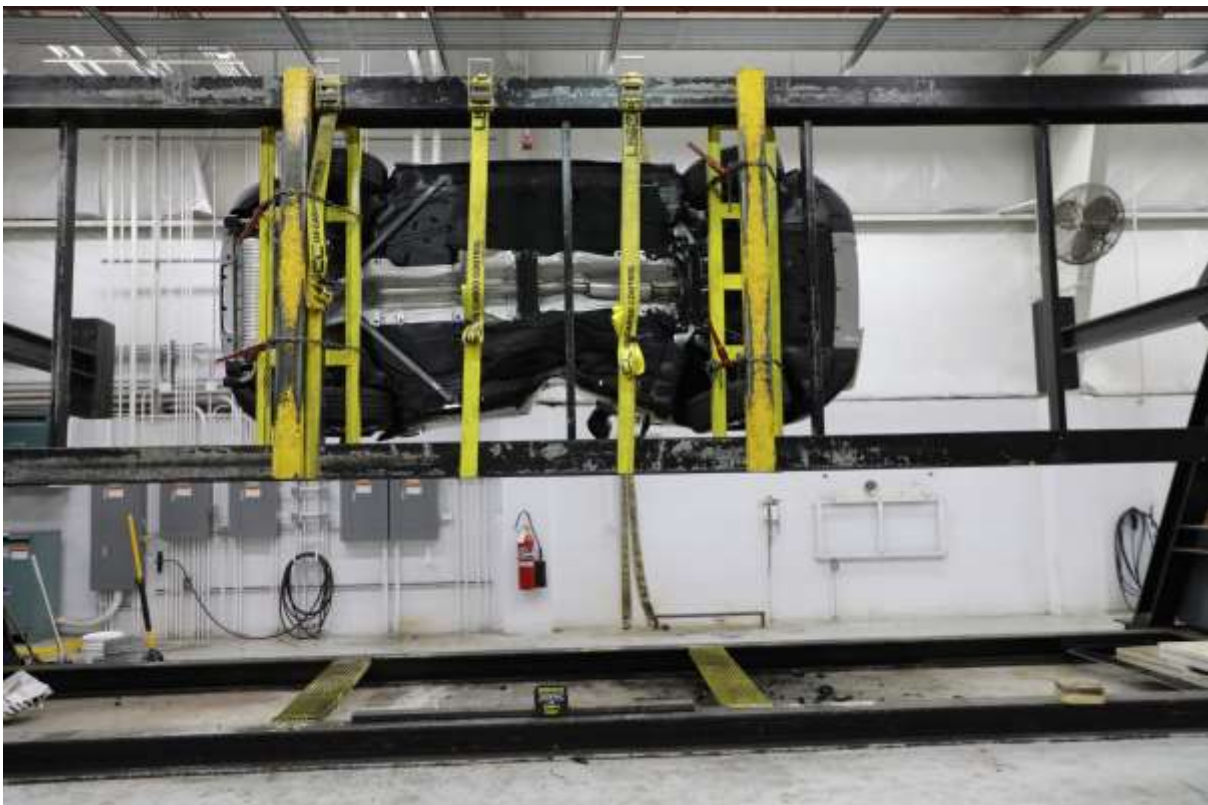
**No. 068 FMVSS No. 301 Static Rollover 270 Degrees**

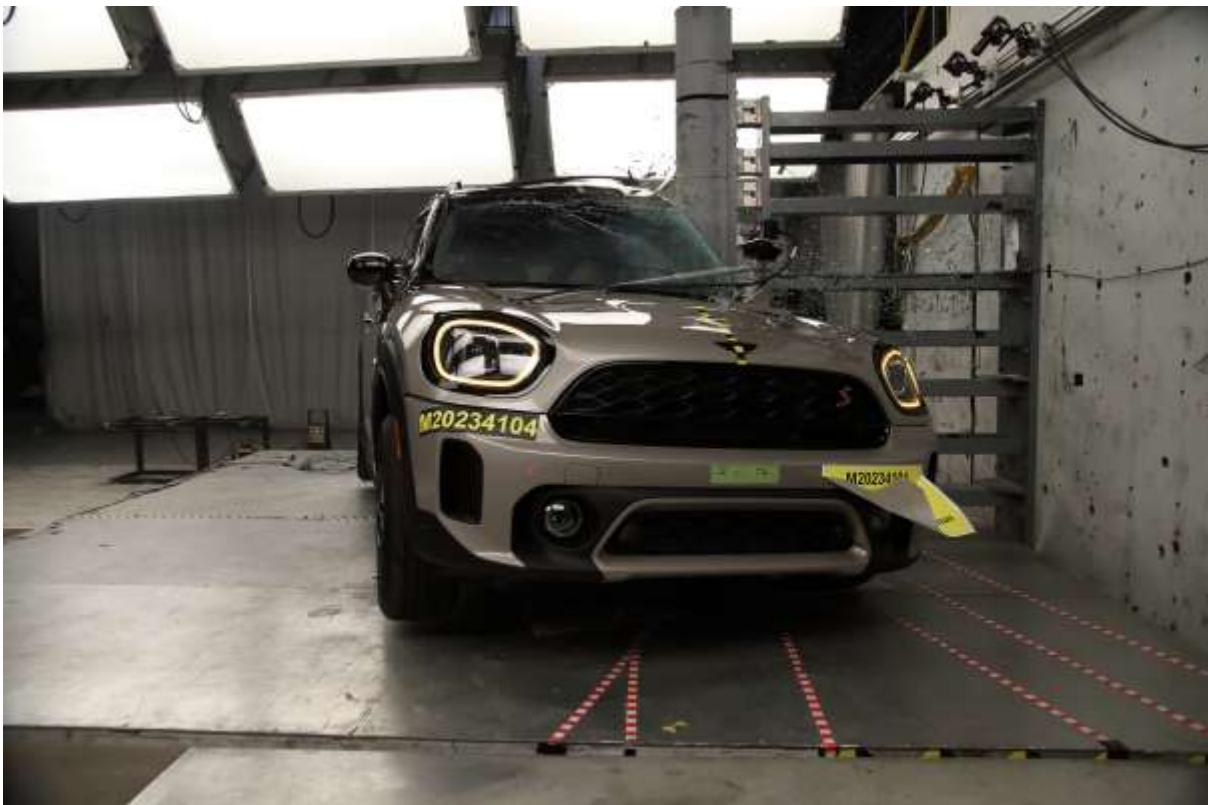
**No. 070 Impact Event**

A rigid pole side impact test was conducted on a model year 2023 MINI Countryman 5HB. The subject vehicle was towed into the rigid pole at an angle of 75° and a velocity of 32.29 km/h. The side impact test was conducted by Transportation Research Center Inc. in East Liberty, OH, on June 14, 2023. Pre-test and post-test photographs of the test vehicle and the side impact dummy (SID-IIs) are included in Appendix A of this report.
