**REPORT NUMBER: SideNCAPPole-MGA-23-019**

**NEW CAR ASSESSMENT PROGRAM (NCAP)  
Side Impact Pole Test**

**TOYOTA MOTOR CORPORATION  
2023 Subaru Solterra 5-Door SUV  
NHTSA No.: O20235501**

**FINAL REPORT**

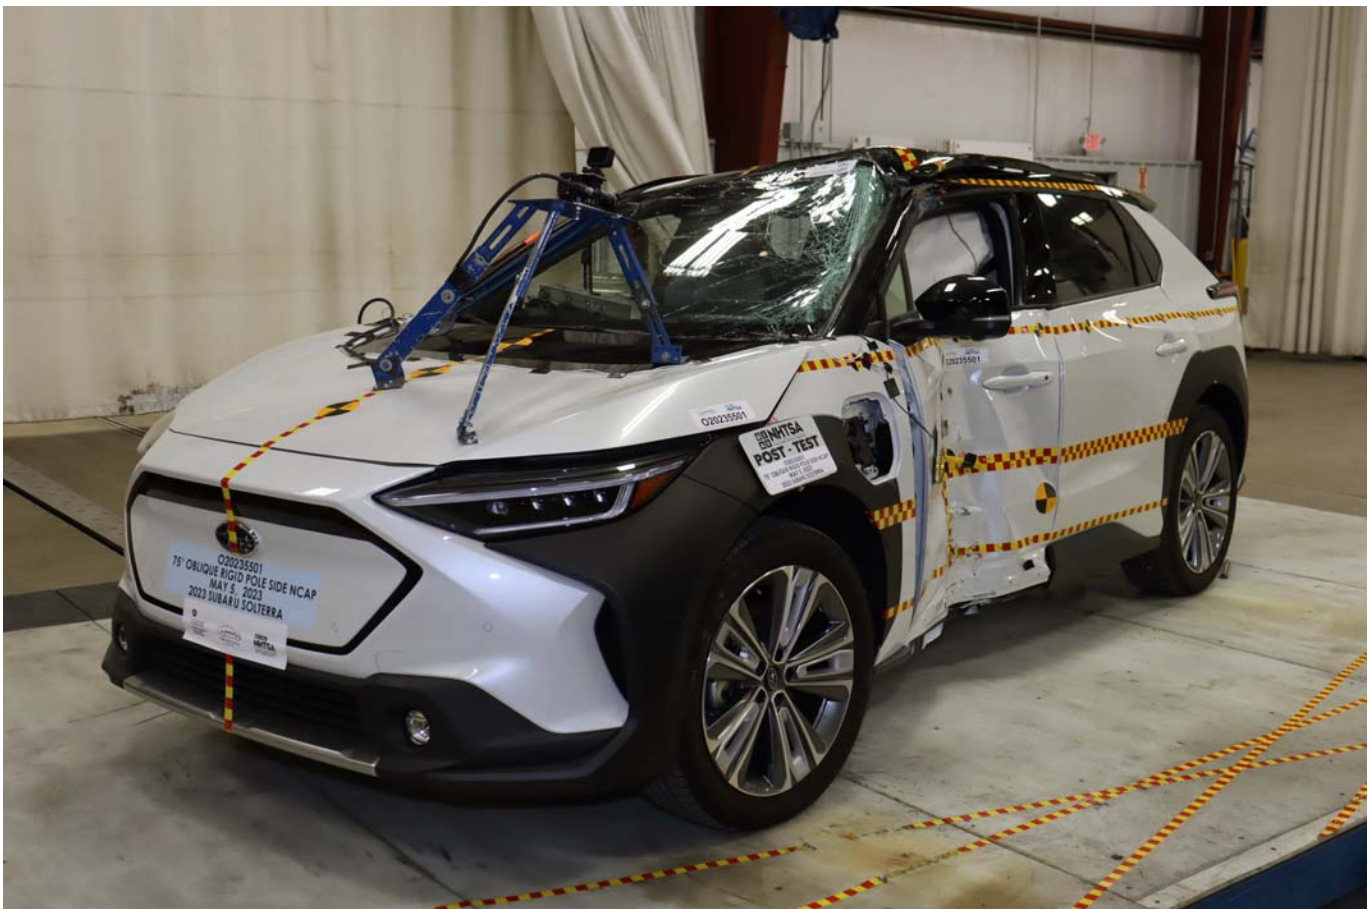
Photo No. 006 - Post-Test Left Front Three-Quarter View of Test Vehicle

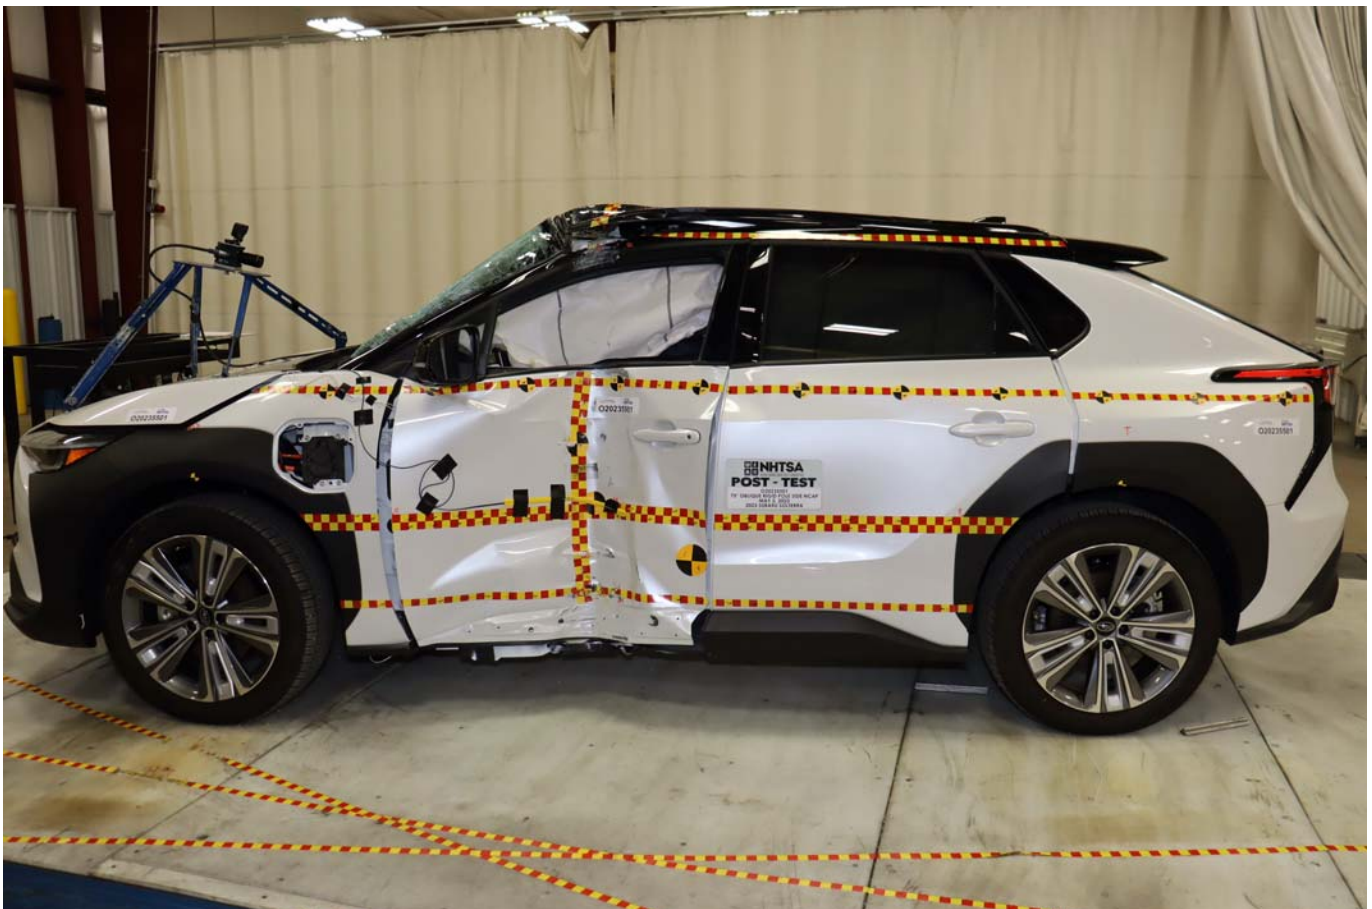
Photo No. 008 - Post-Test Left Side View of Test Vehicle

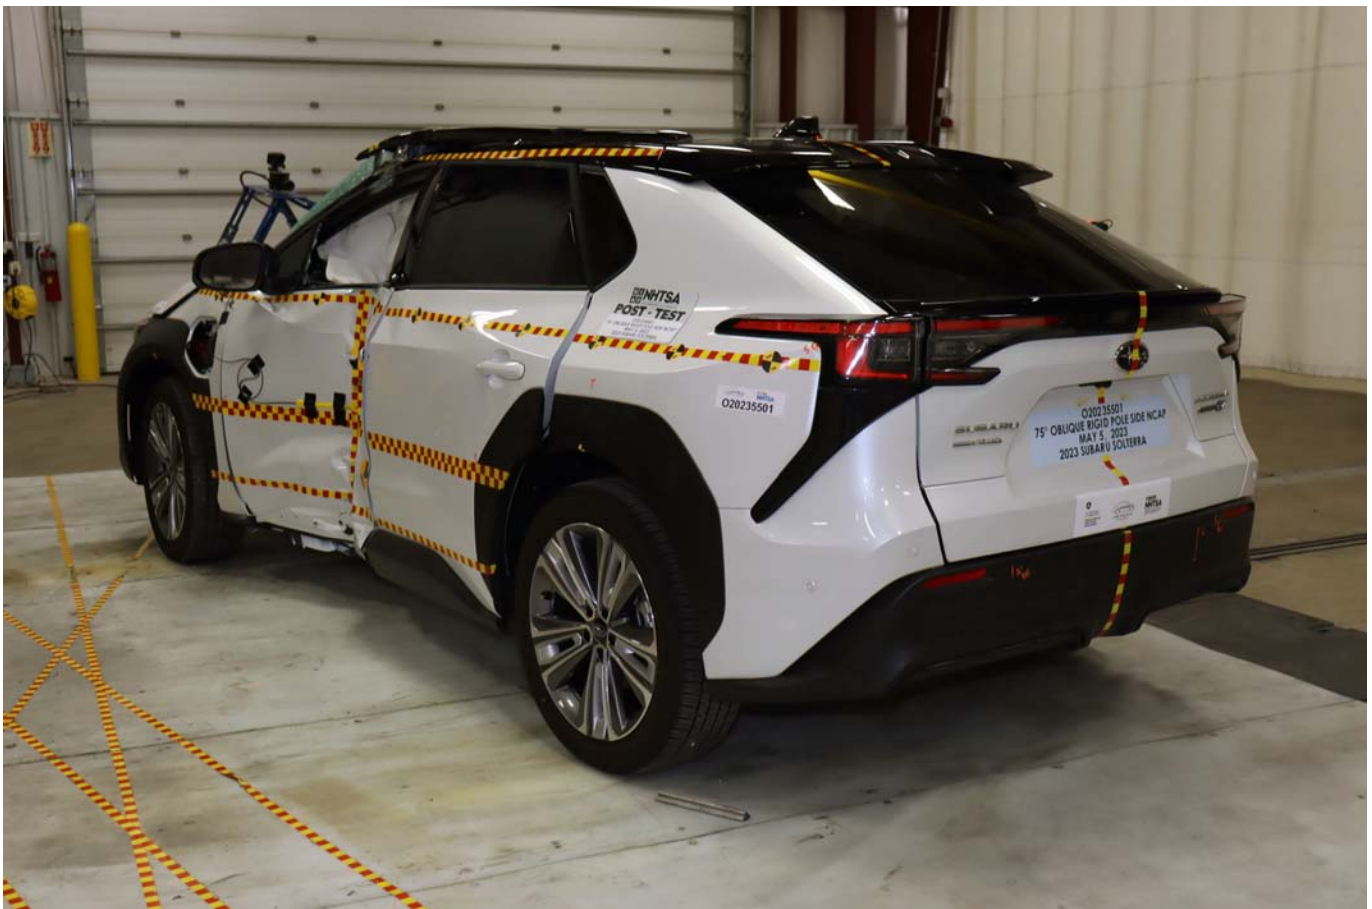
Photo No. 010 - Post-Test Left Rear Three-Quarter View of Test Vehicle

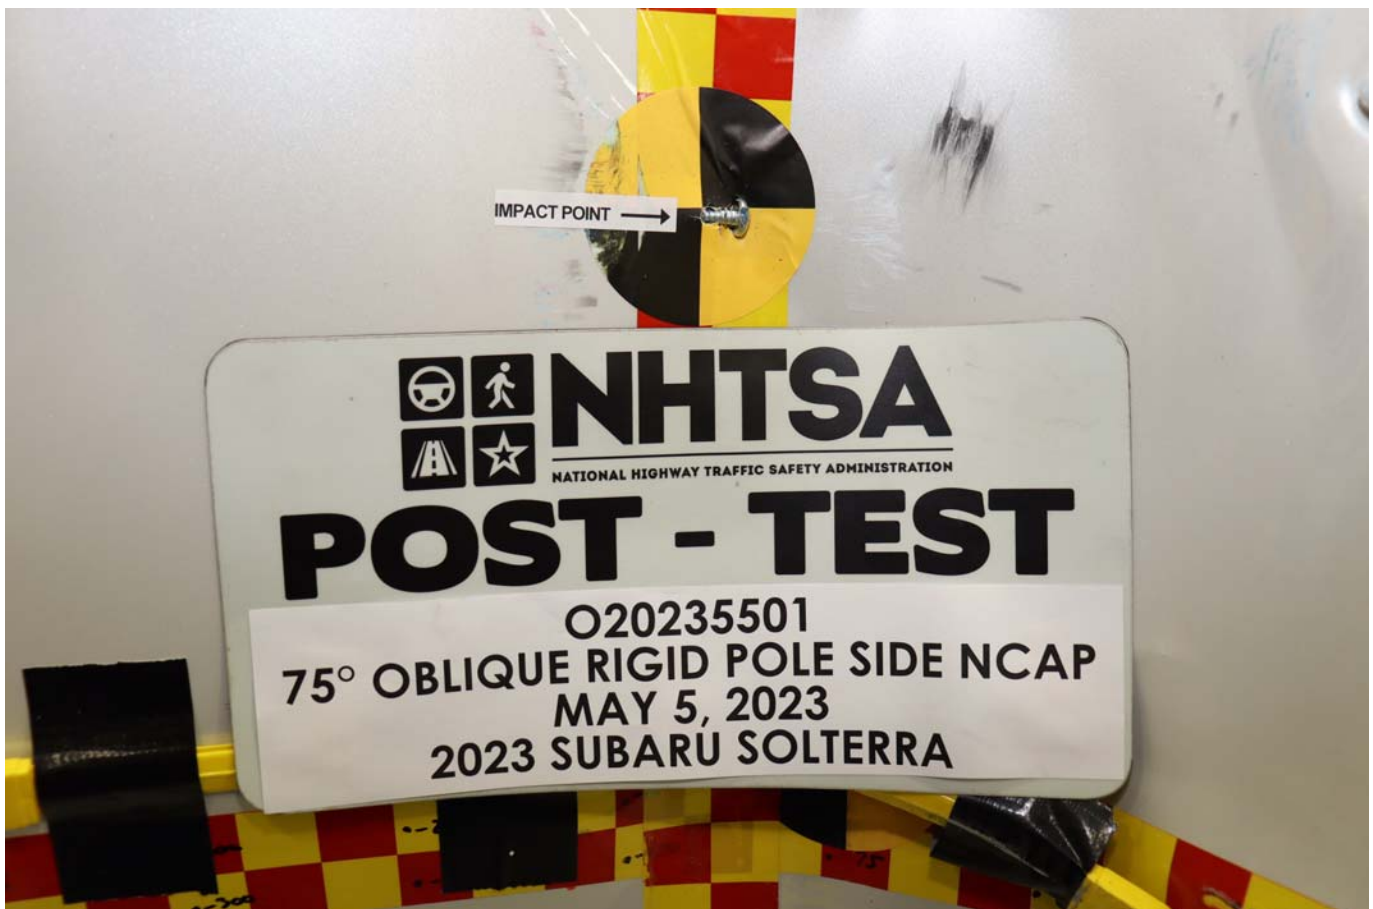
Photo No. 020 - Post-Test Close-Up View of Impact Point Target Showing Impact Location

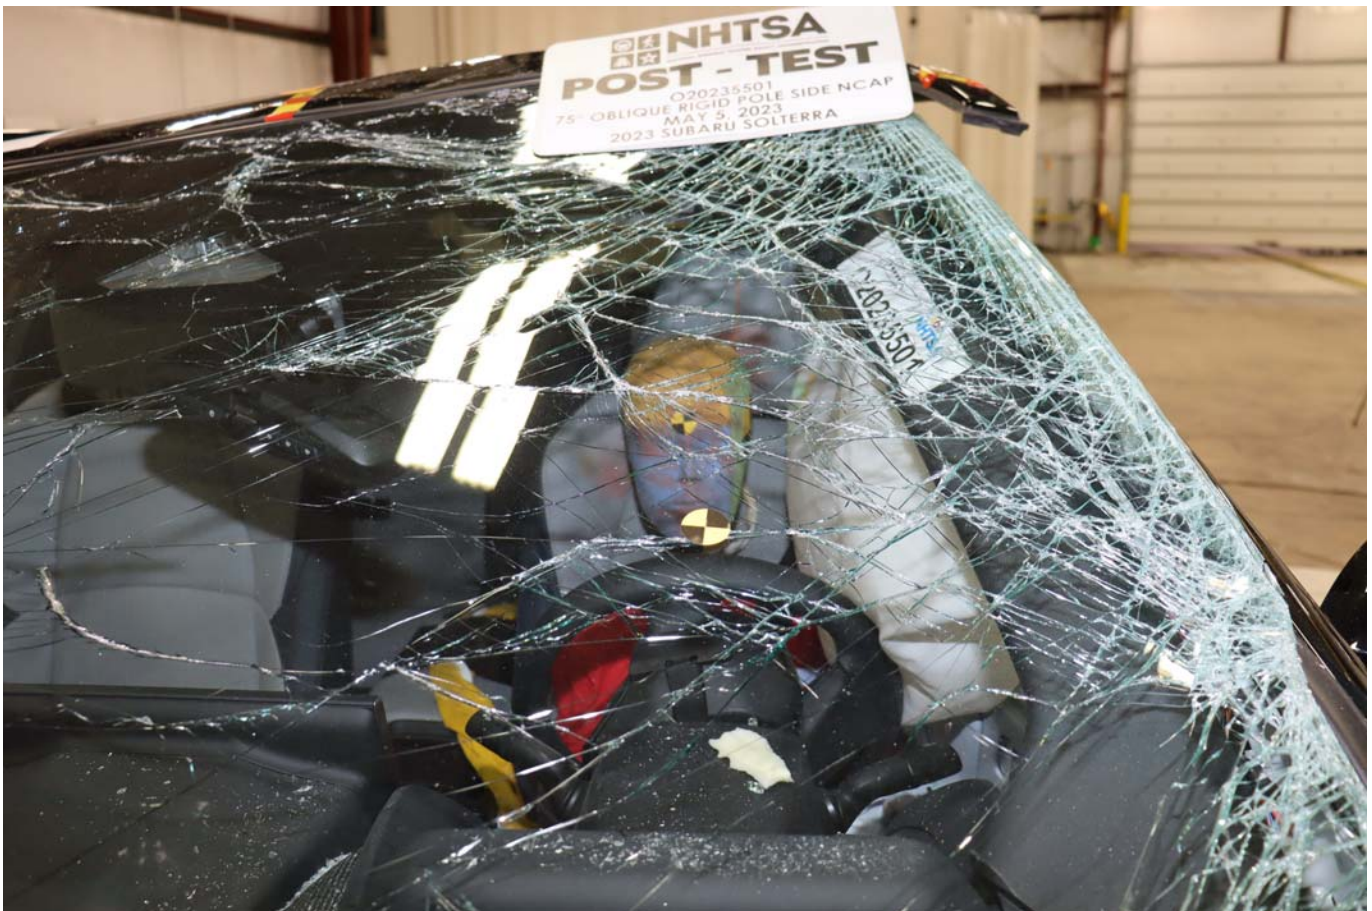
Photo No. 022 - Post-Test Front Close-Up View of Dummy

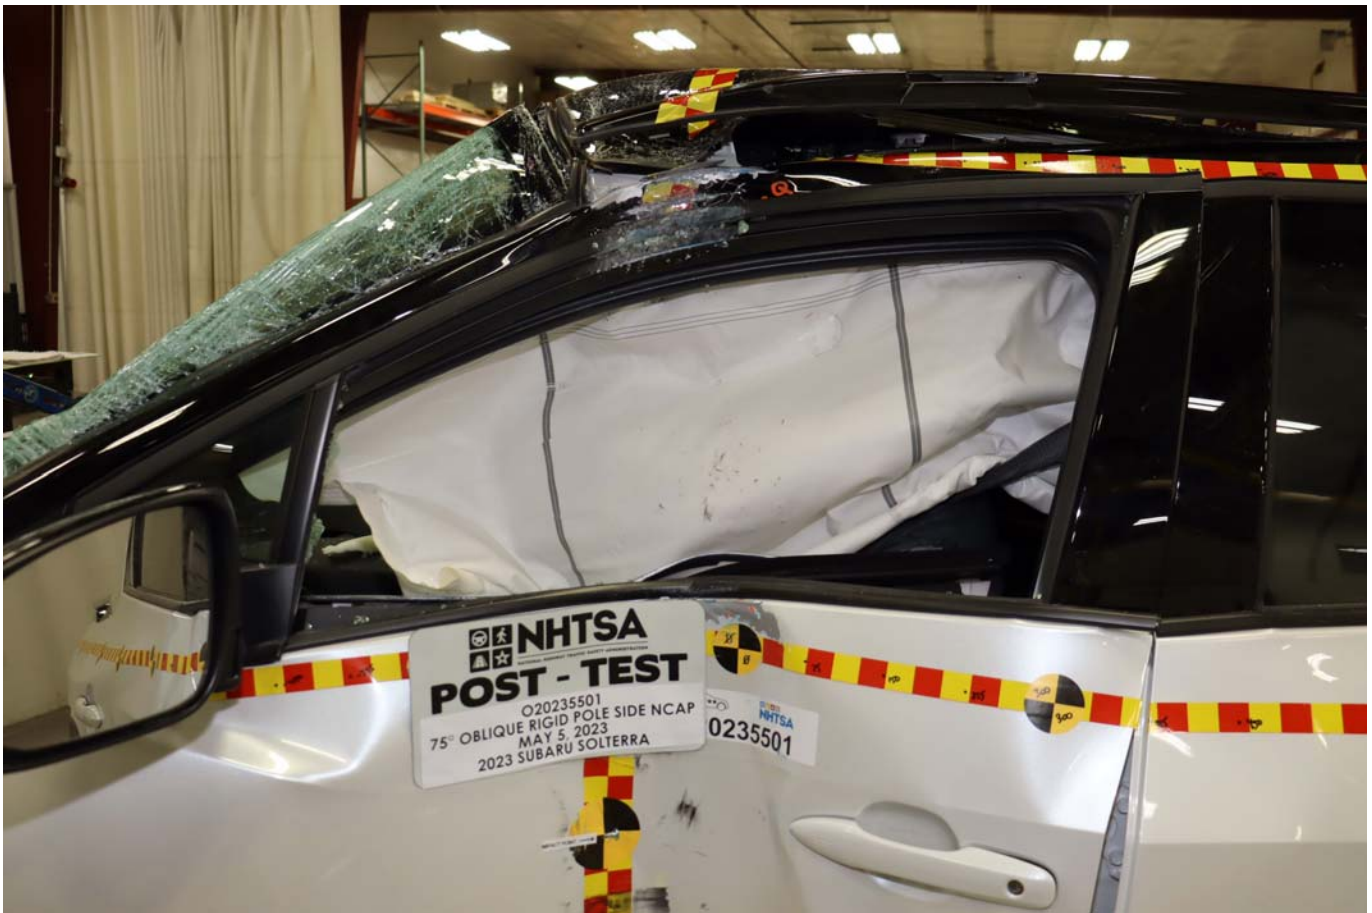
Photo No. 025 - Post-Test Left Side View of Dummy Shoulder and Door Top View

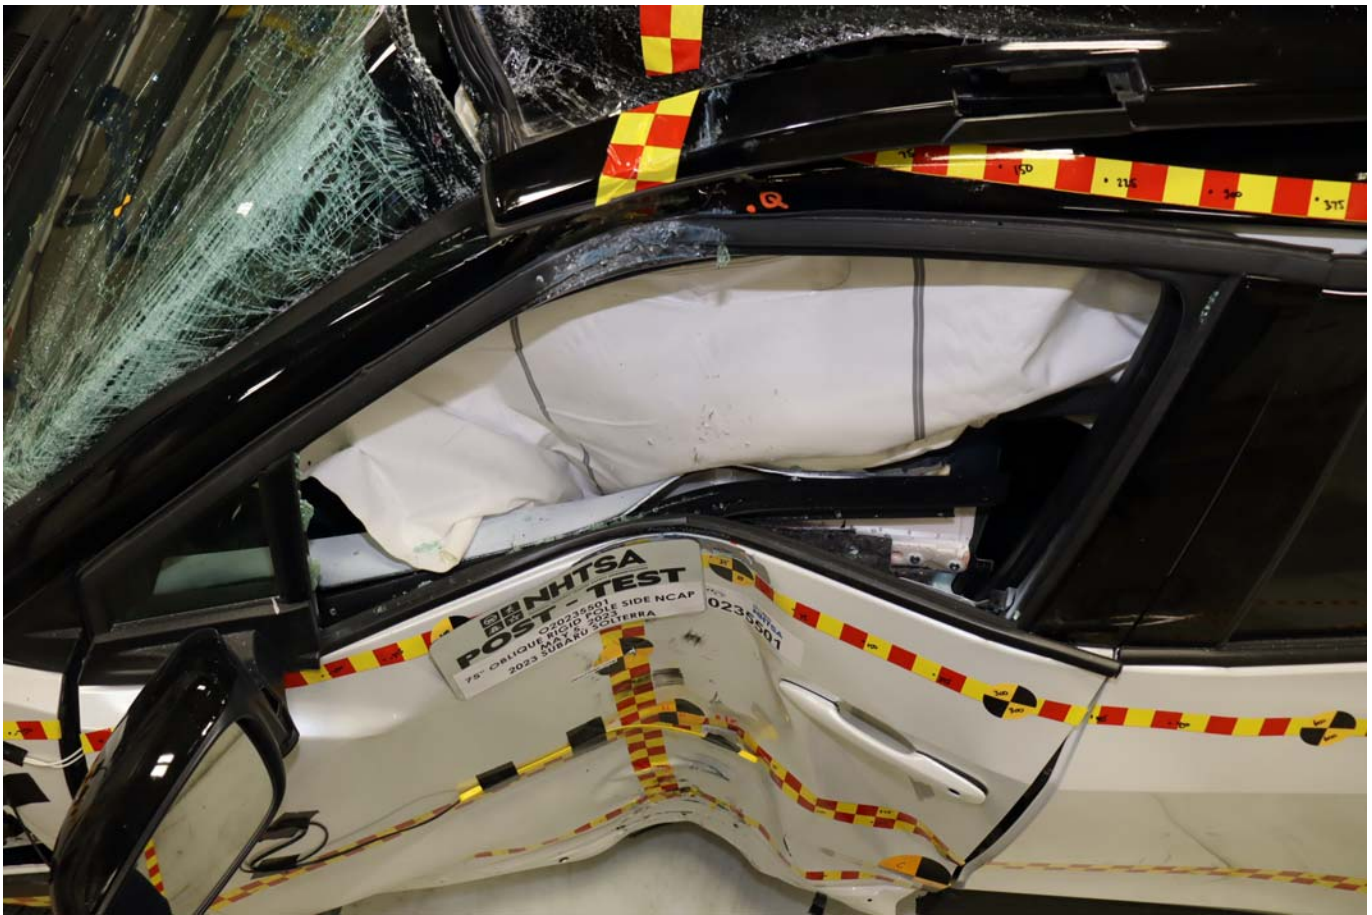
Photo No. 041 - Post-Test Dummy and Door Clearance View

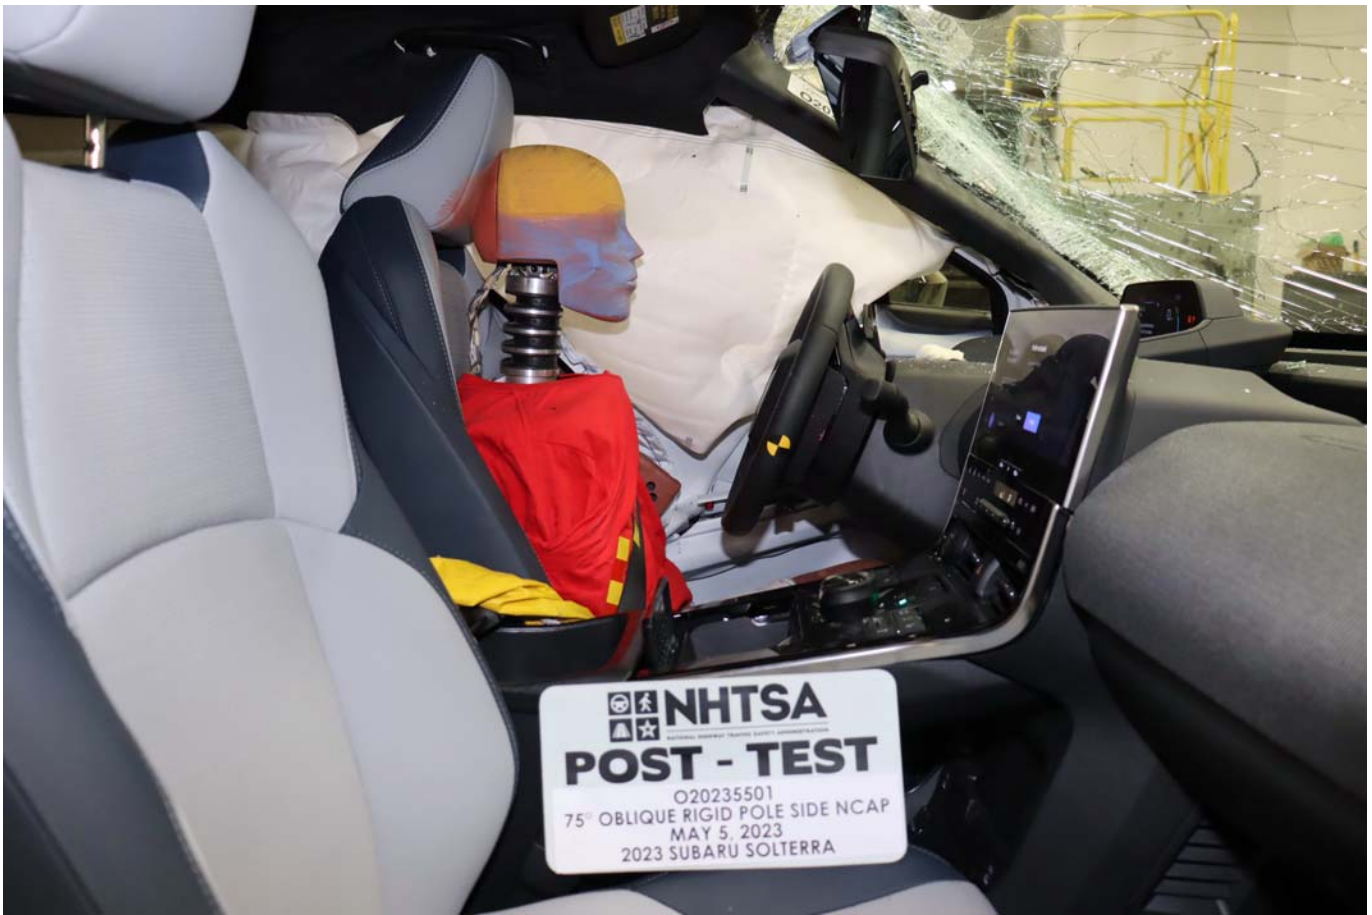
Photo No. 043 - Post-Test Right Side View of Dummy and Front Seat of Occupant Compartment

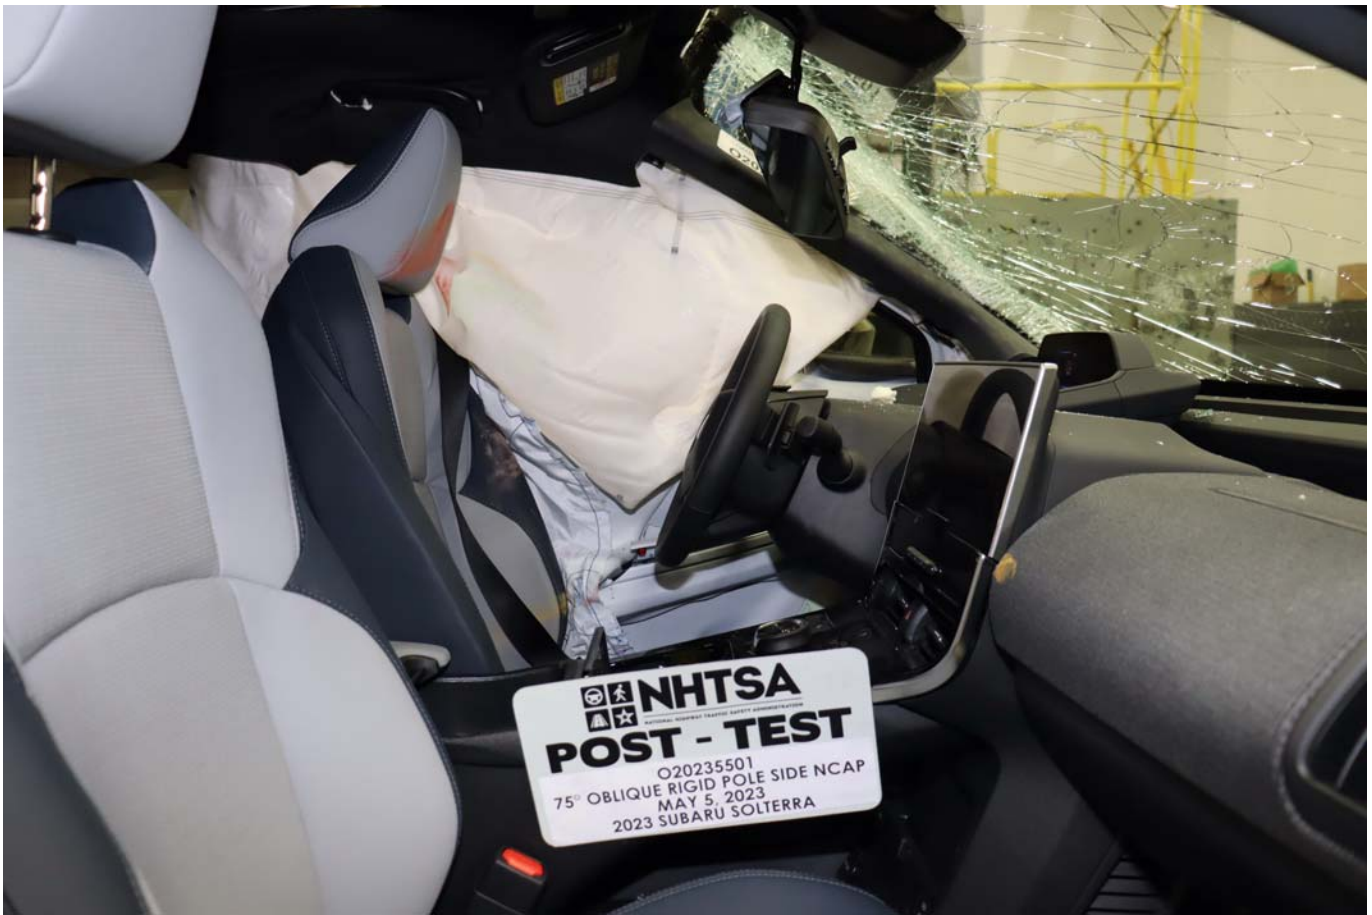
Photo No. 045 - Post-Test Inner Door Panel View Showing Dummy Contact Location

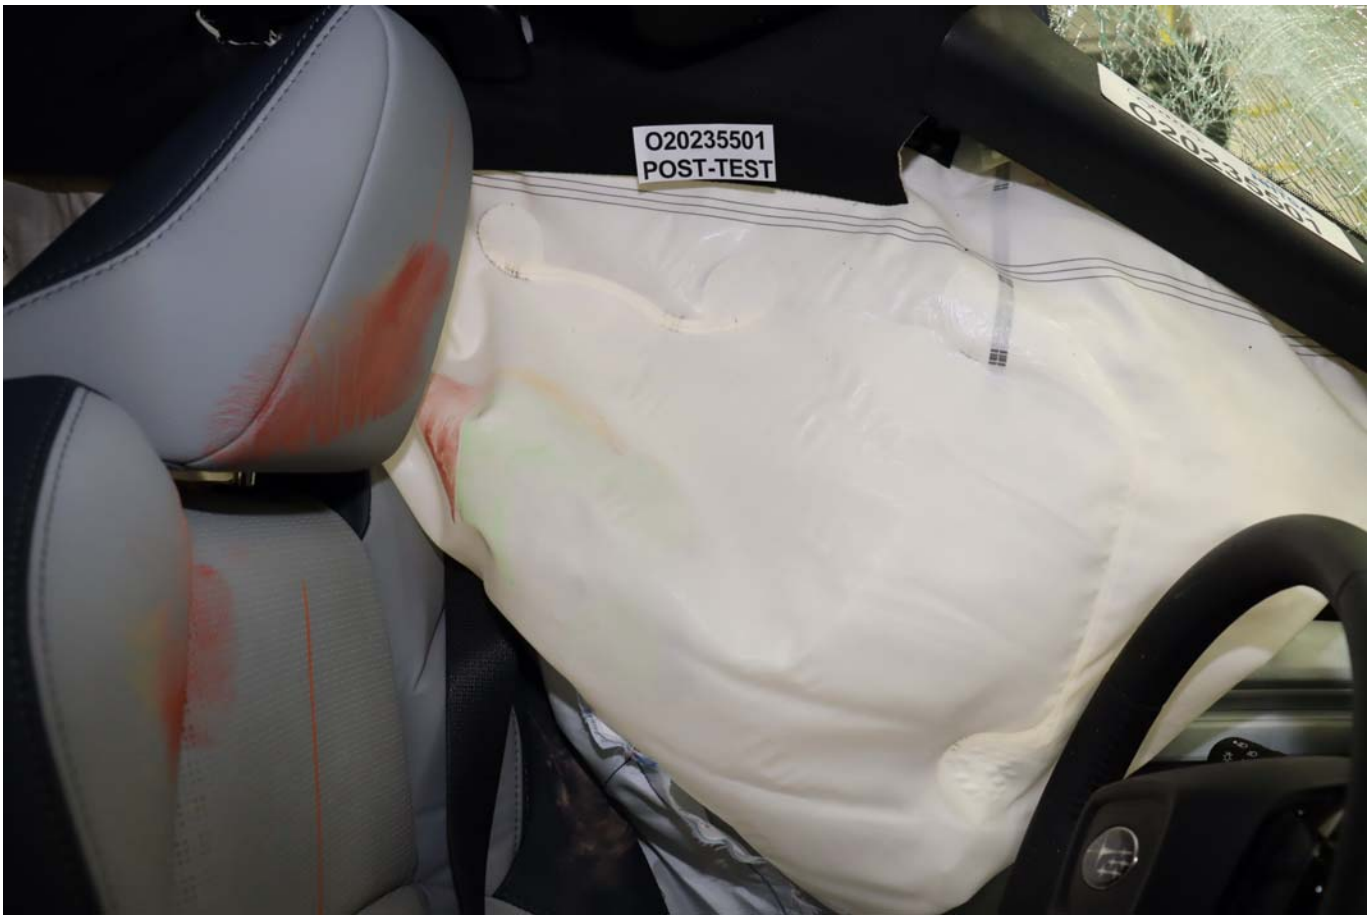
Photo No. 047 - Post-Test Dummy Close-Up Head Contact with Side Air Bag View

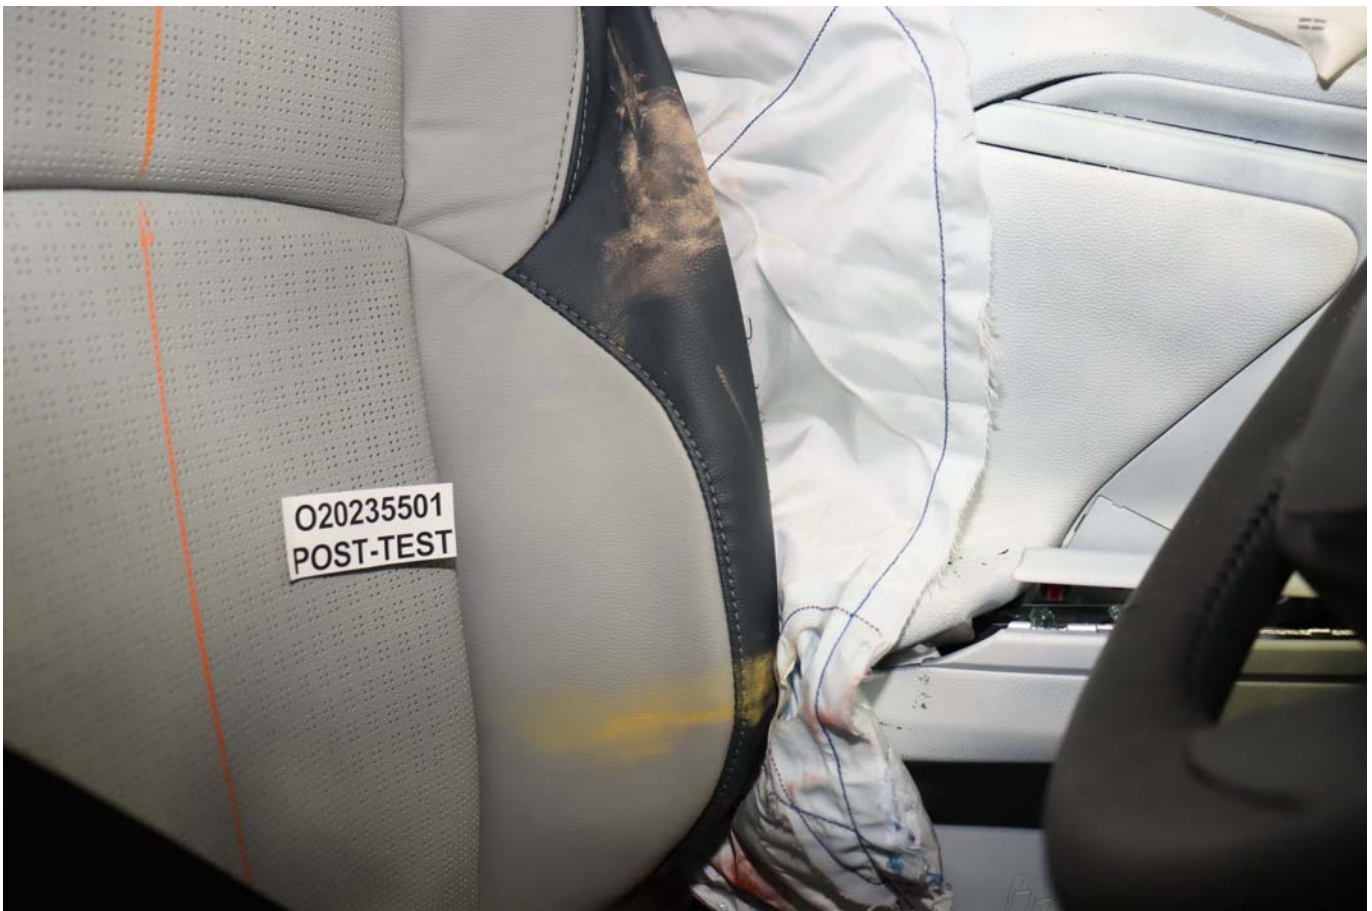
Photo No. 048 - Post-Test Dummy Close-Up Torso Contact with Vehicle Interior View

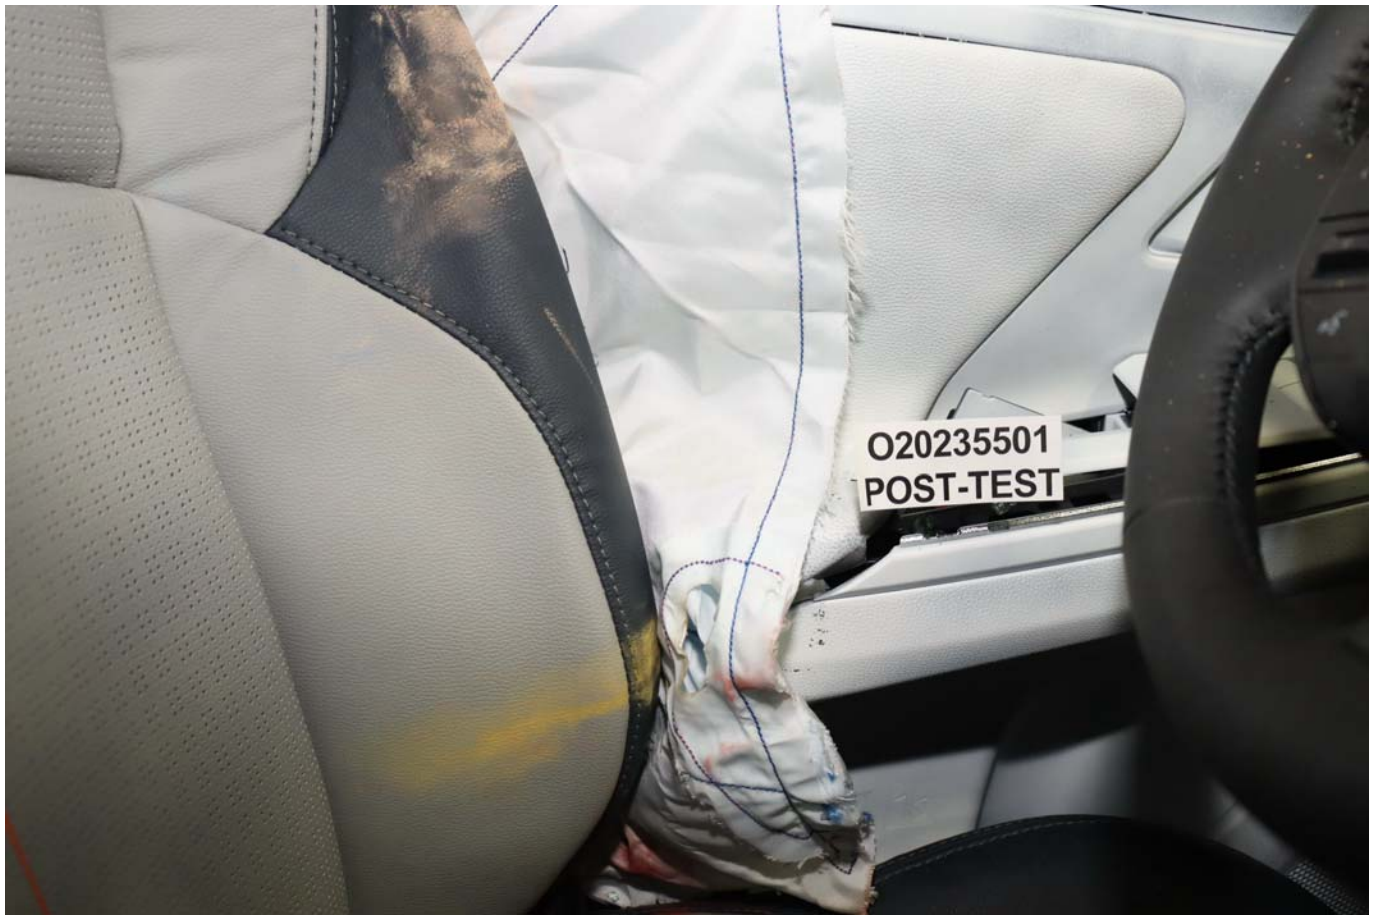
Photo No. 049 - Post-Test Dummy Close-Up Torso Contact with Side Air Bag View

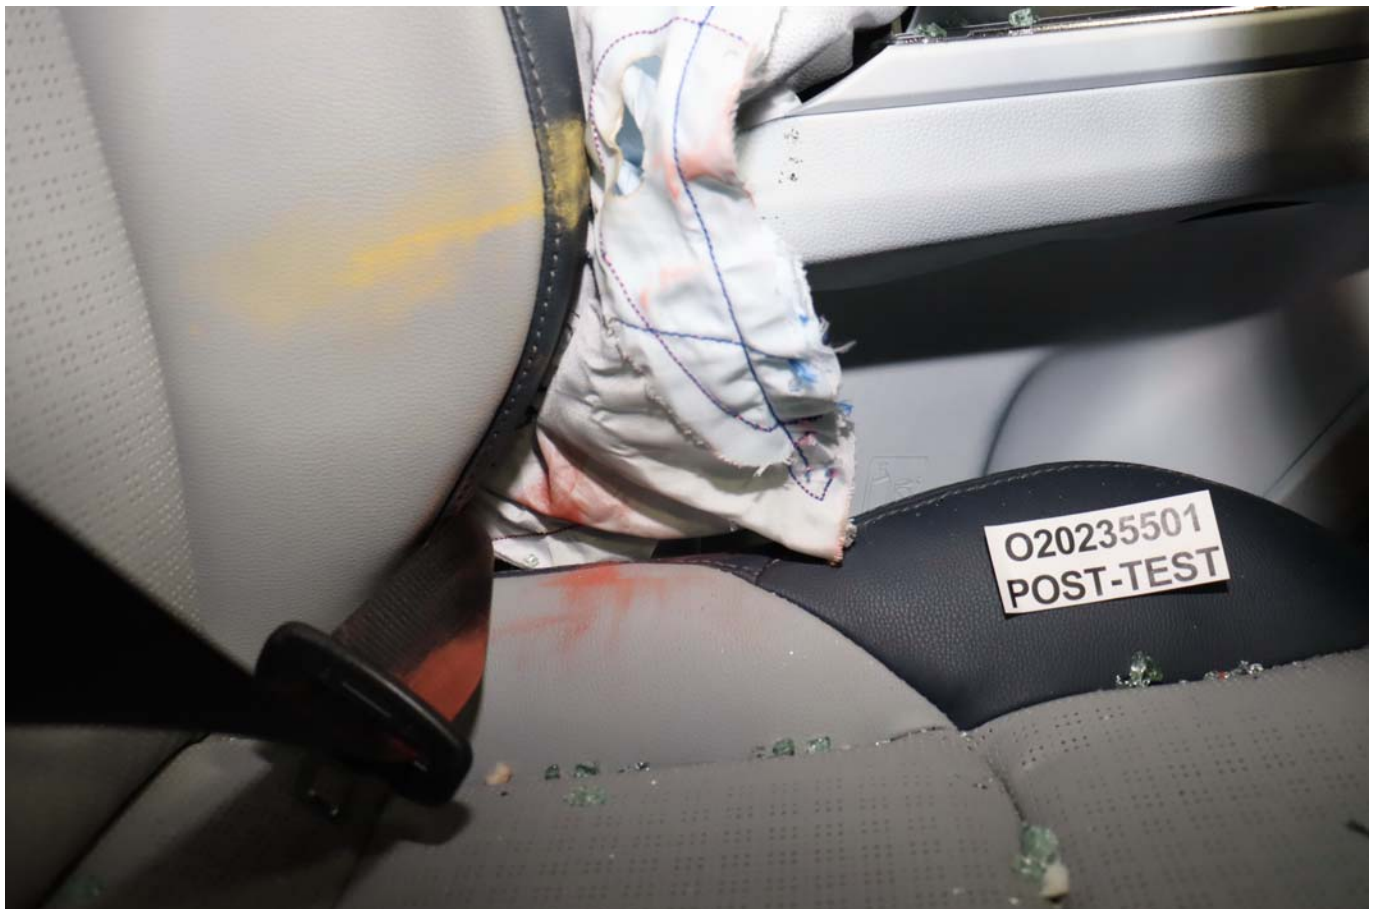
Photo No. 050 - Post-Test Dummy Close-Up Pelvis Contact with Vehicle Interior View

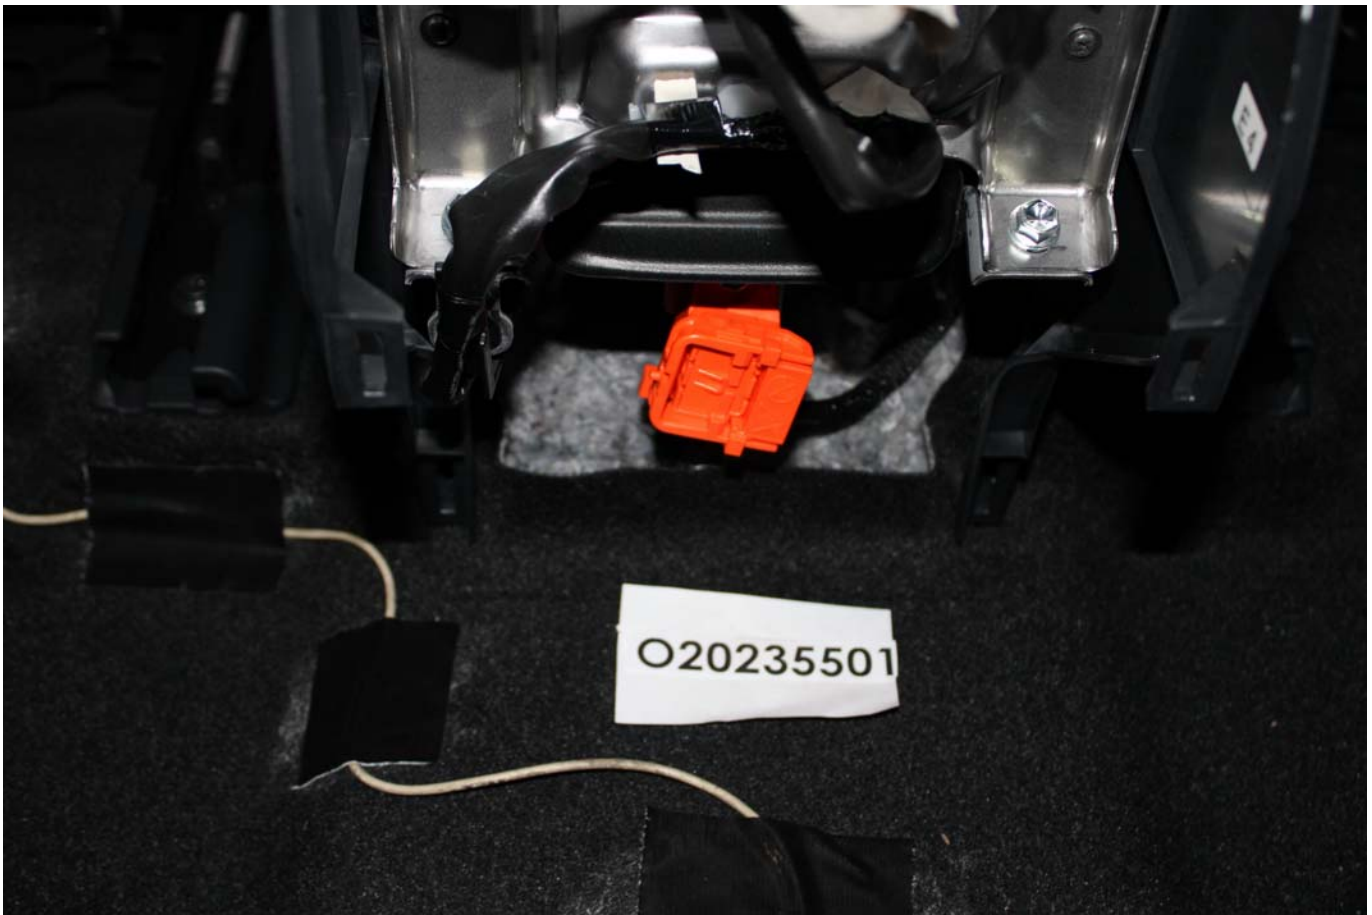
Photo No. 305-06 - Manual High Voltage Service Disconnect in Place

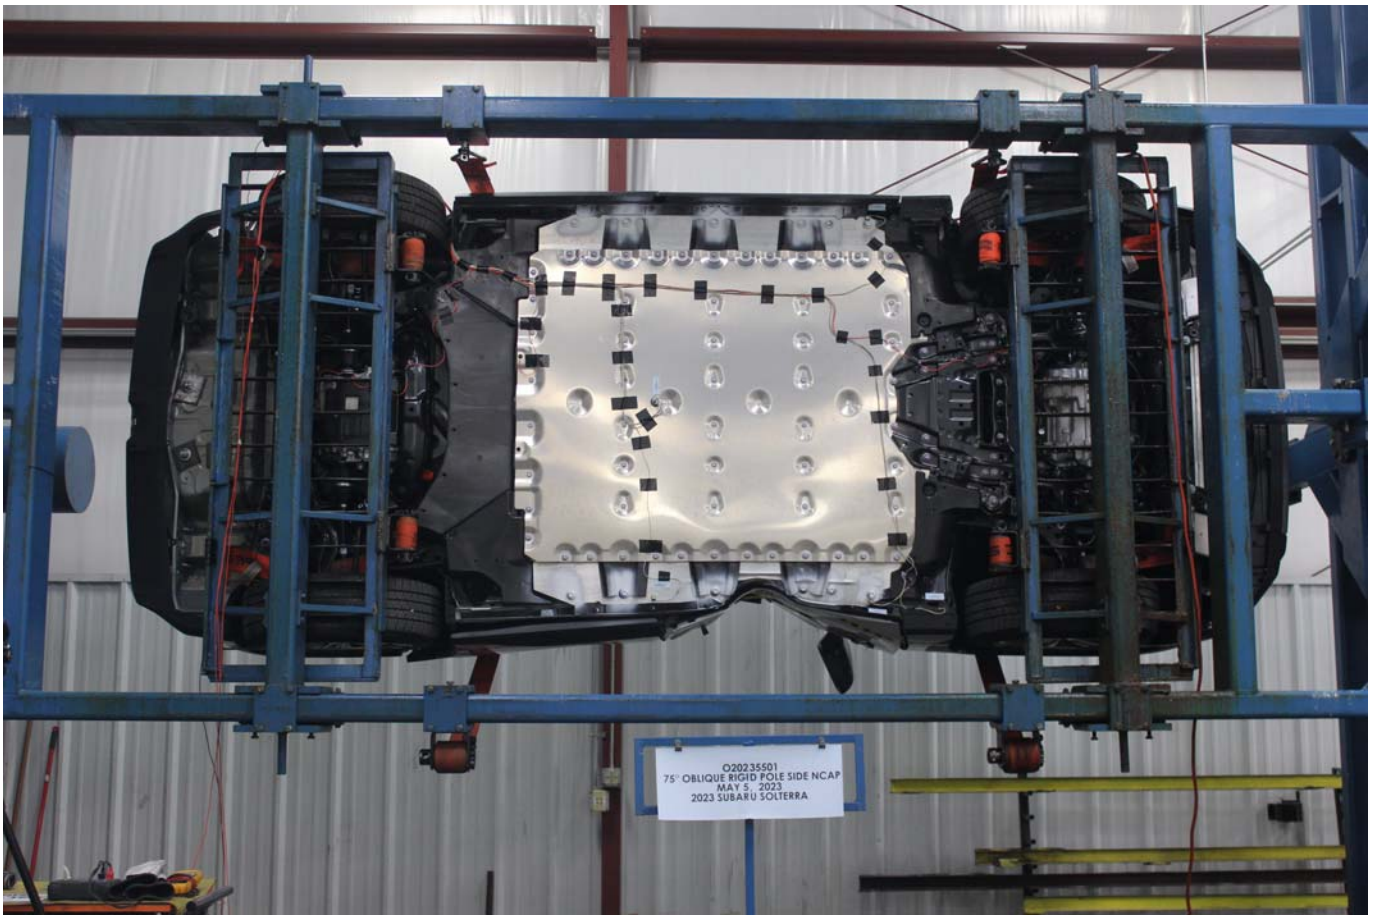
Photo No. 305-28 - FMVSS No. 305 Static Rollover at 90 Degrees

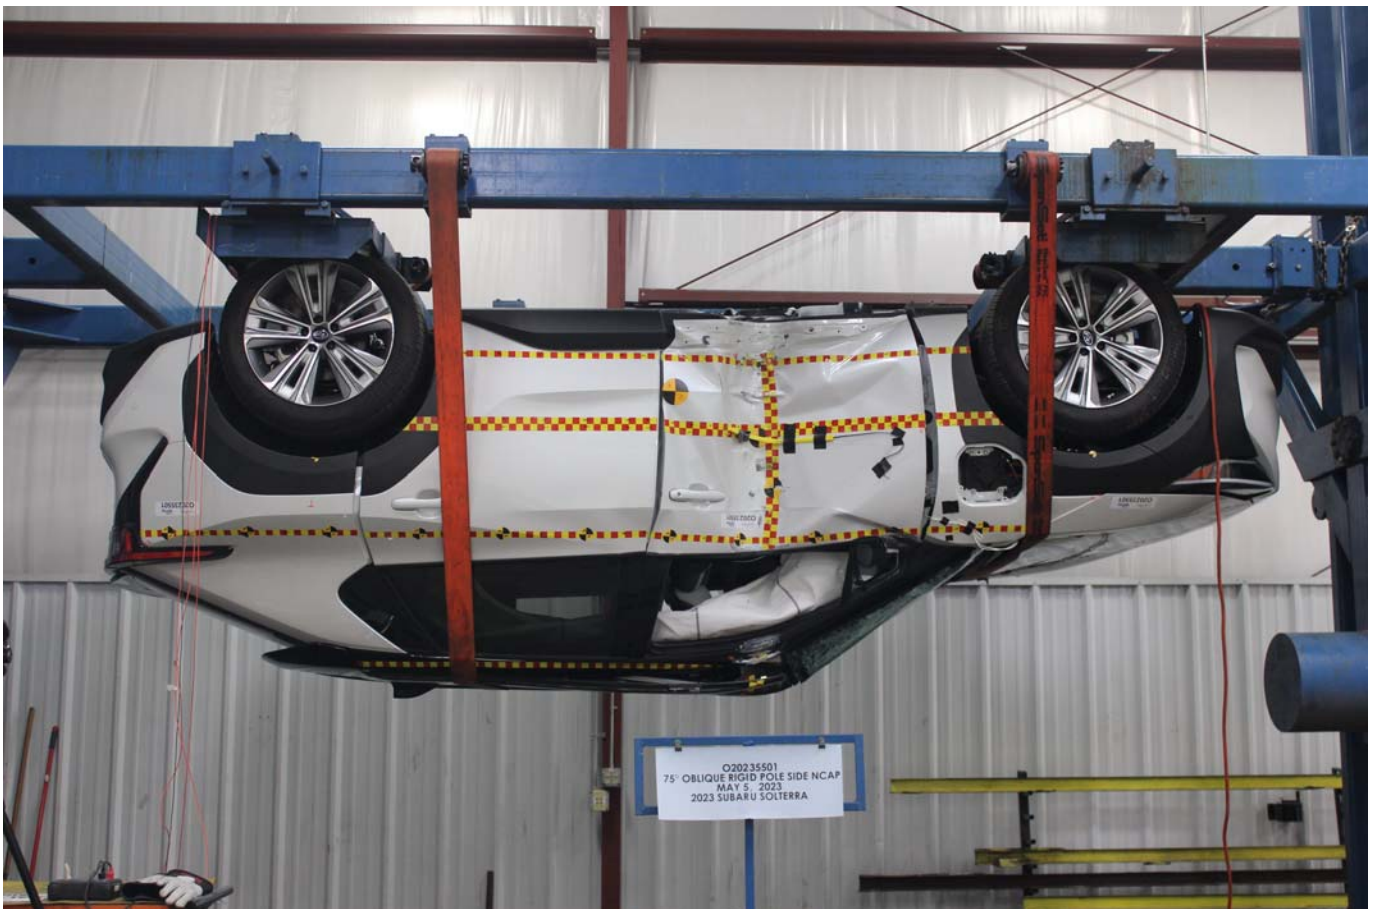
Photo No. 305-29 - FMVSS No. 305 Static Rollover at 180 Degrees

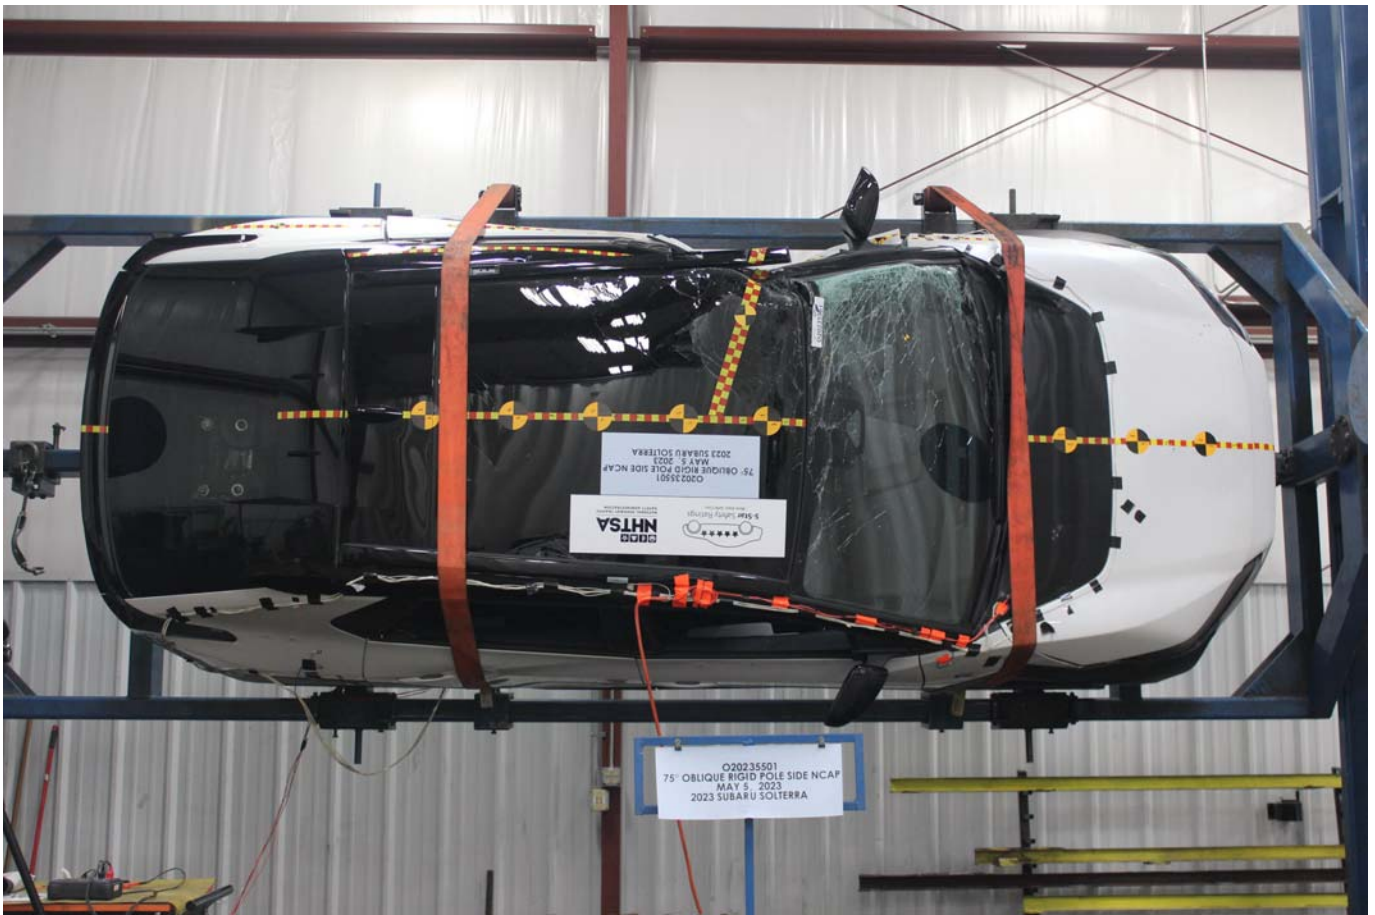
Photo No. 305-30 - FMVSS No. 305 Static Rollover at 270 Degrees

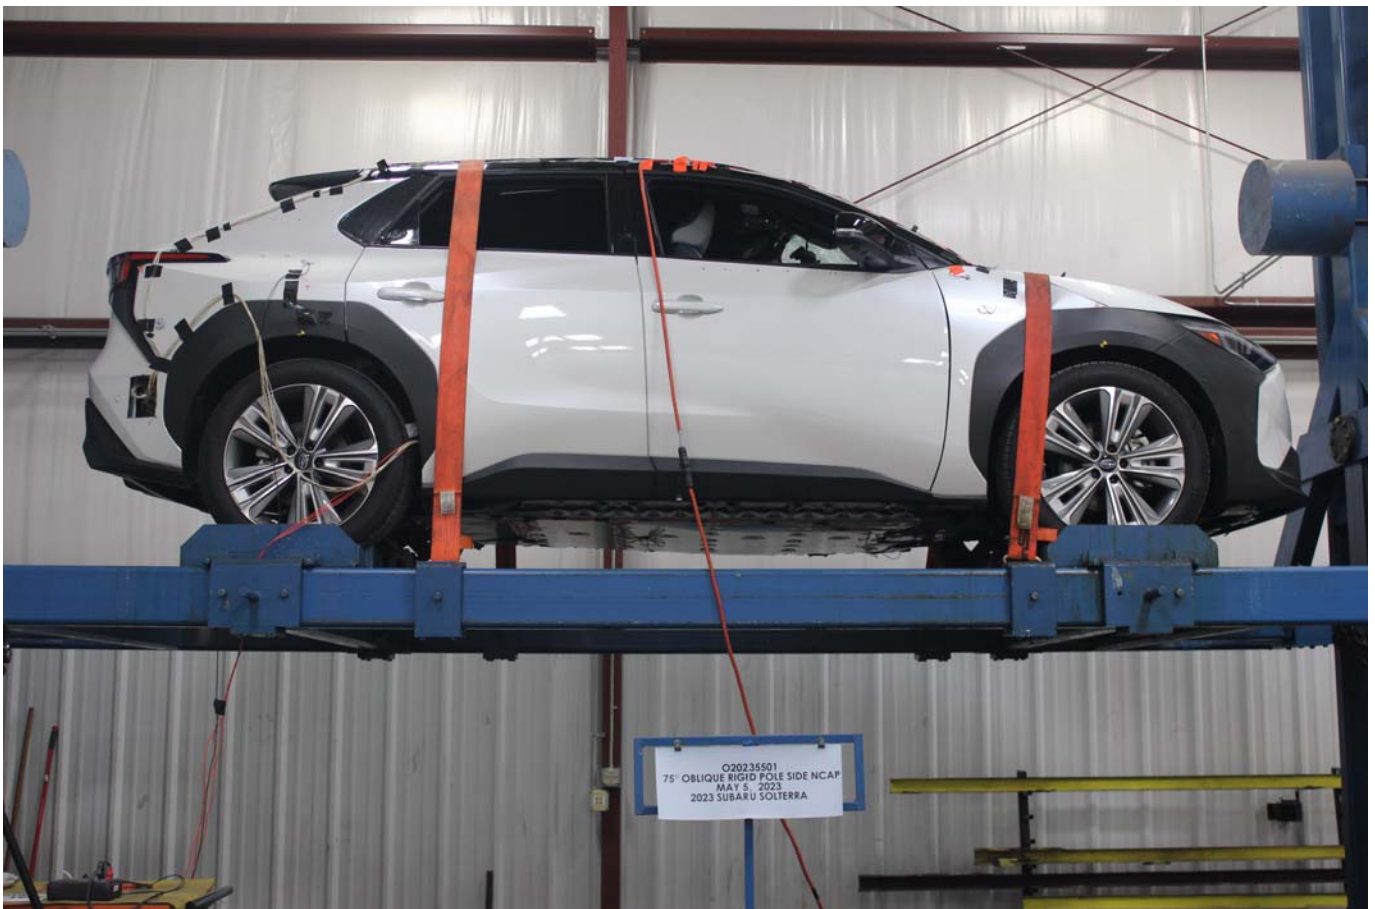
Photo No. 305-31 - FMVSS No. 305 Static Rollover at 360 Degrees
