**REPORT NUMBER: NCAP-MGA-23-021**

**NEW CAR ASSESSMENT PROGRAM (NCAP)  
Frontal Barrier Impact Test**

**TOYOTA MOTOR MANUFACTURING CANADA INC.  
2023 Lexus RX 350 AWD 5-Door SUV  
NHTSA No.: O20235100**

**MGA RESEARCH CORPORATION  
5000 Warren Road  
Burlington, WI 53105**

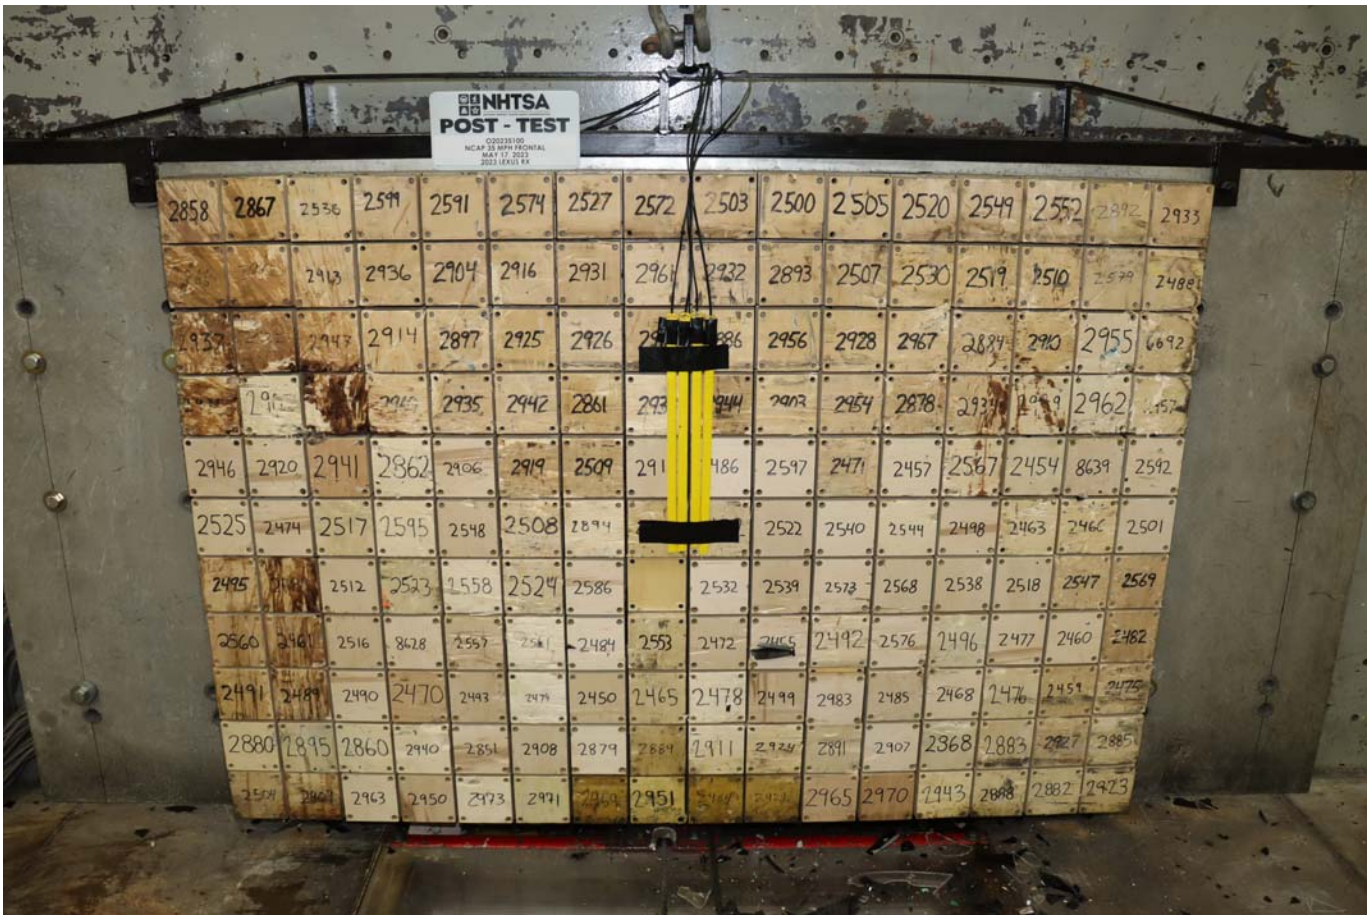
Photo No. 003 - Post-Test Load Cell Wall

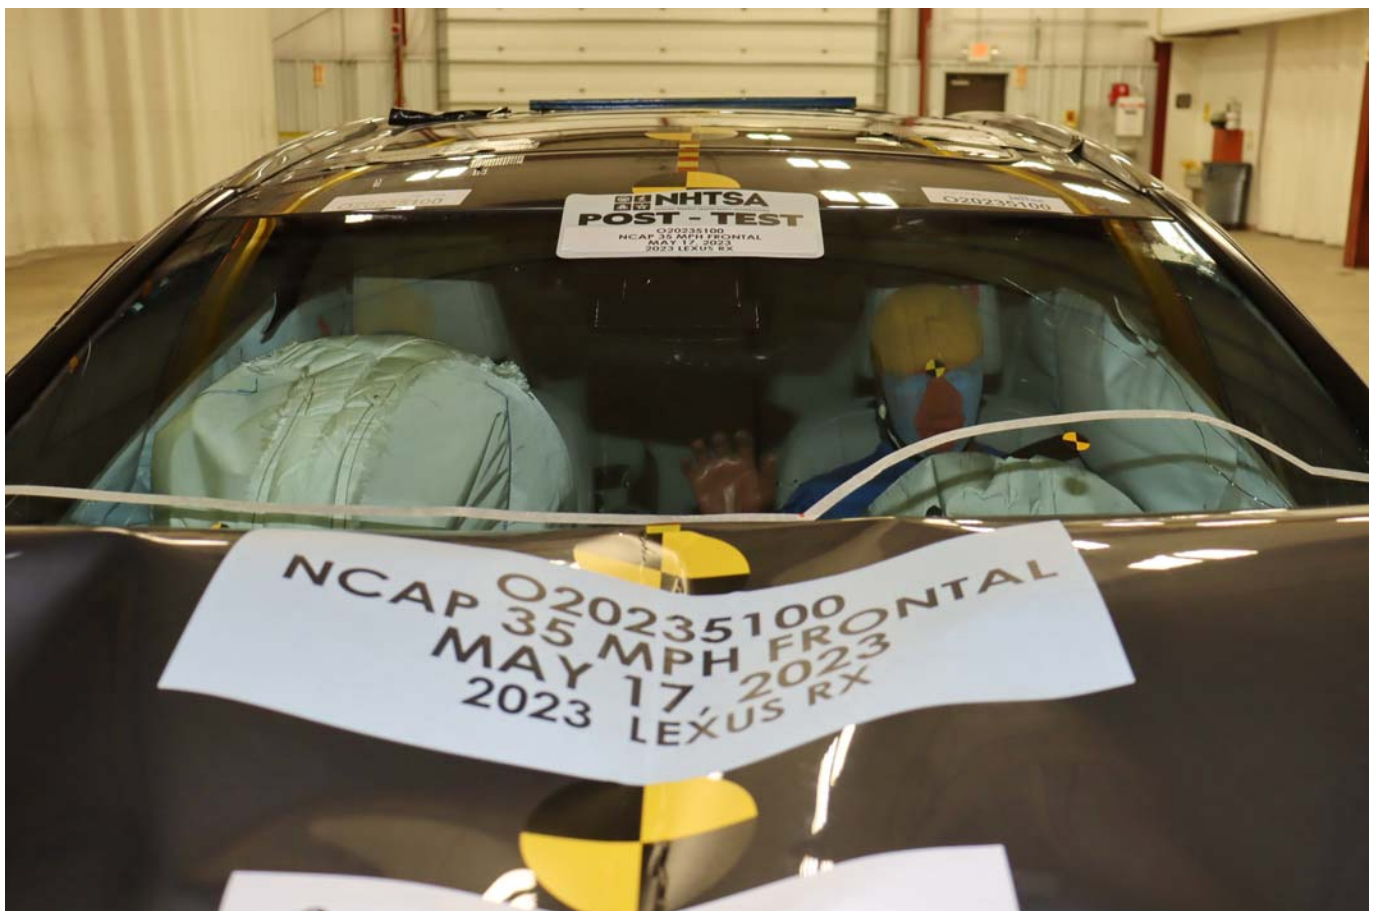
Photo No. 019 - Post-Test Windshield View

There was 100 percent windshield retention and no intrusion into the protected zone of the windshield during the event. There was no Stoddard Solvent leakage after the event or during any phase of the static rollover.

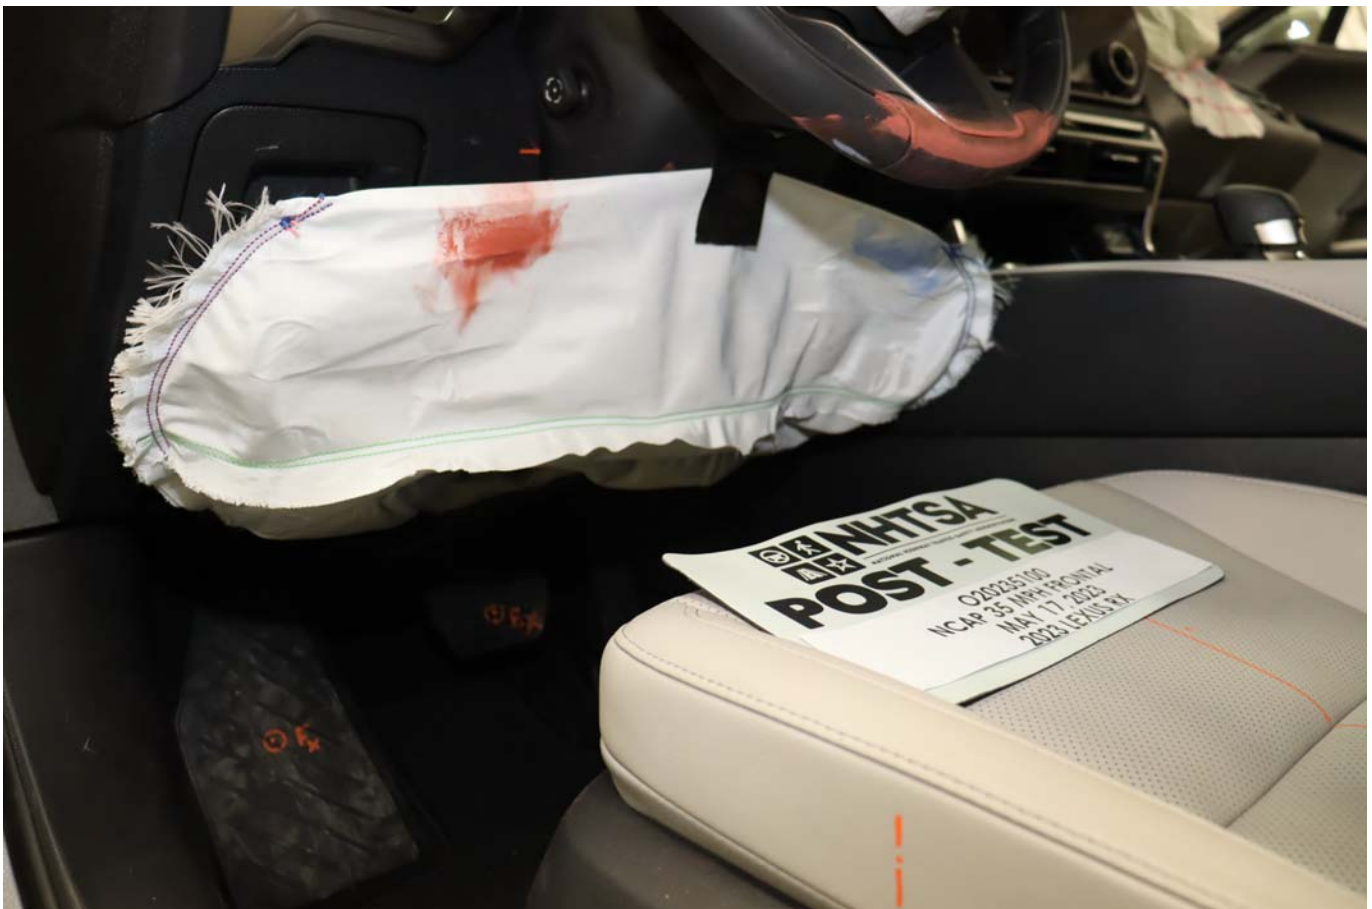
Photo No. 045 - Post-Test Driver's Side Knee Bolster

The driver's visible contact points were as follows: The driver's head contacted the airbag. The driver's head also contacted the headrest. The driver's knees contacted the knee airbag.

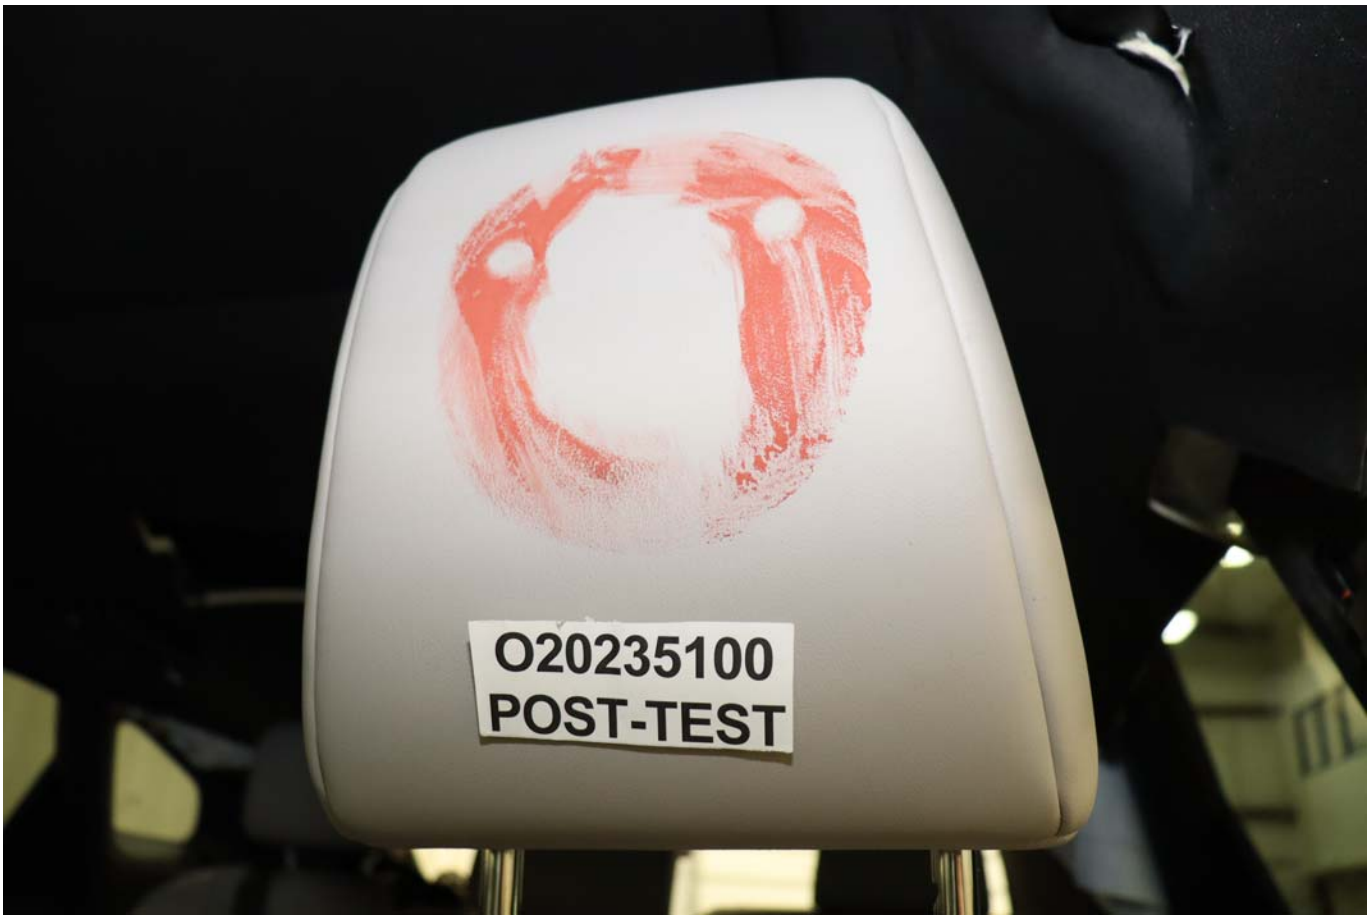
Photo No. 050 - Post-Test Driver Dummy Contact with Headrest

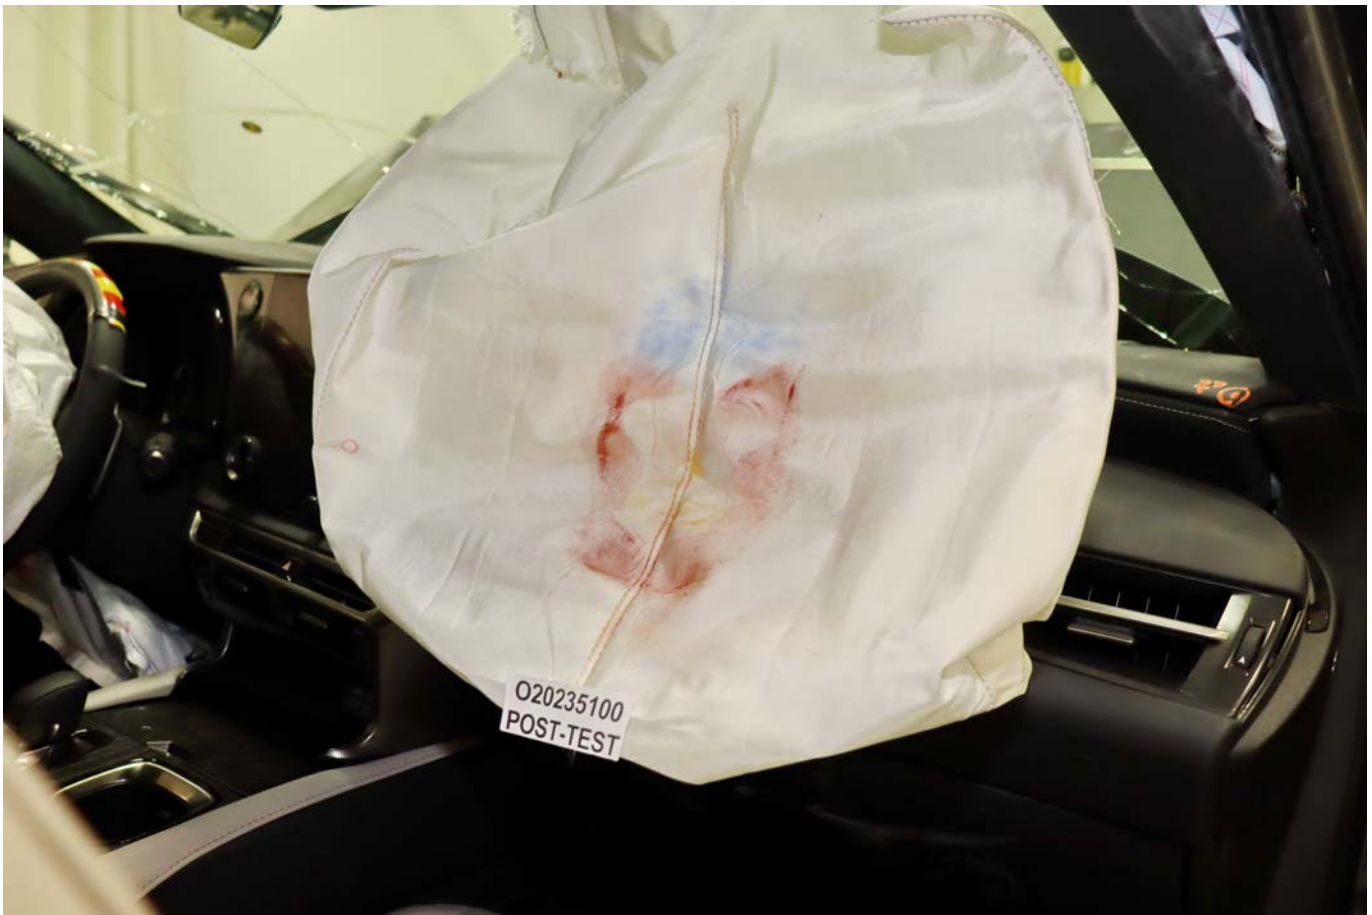
Photo No. 072 - Post-Test Passenger Dummy Contact with Airbag

The passenger's visible contact points were as follows: The passenger's head contacted the airbag. The passenger's head also contacted the headrest. The passenger's knees contacted the glove box.

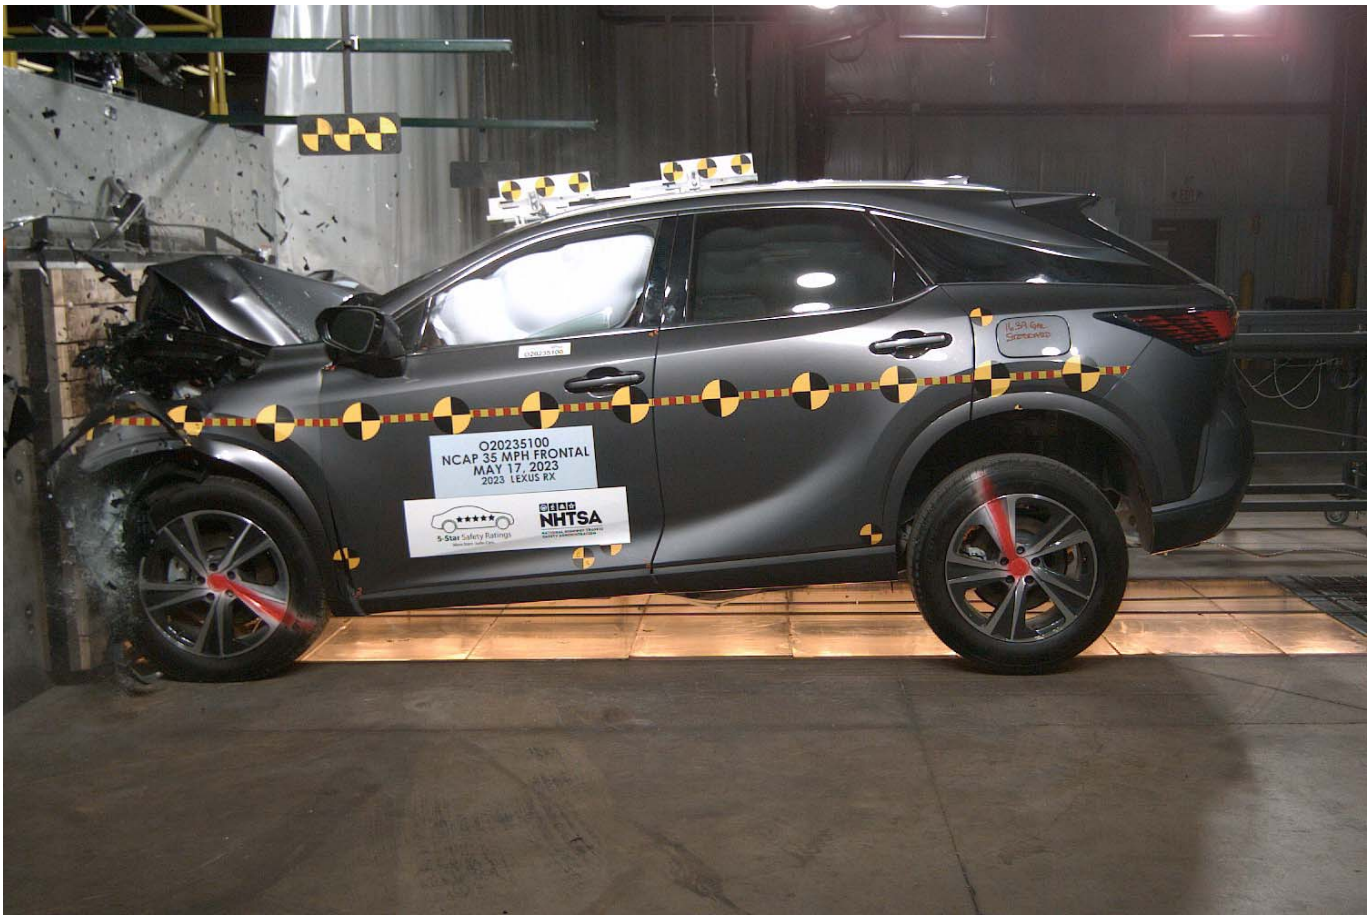
Photo No. 082 - 2023 Lexus RX 350 AWD 5-Door SUV Frontal Impact Event

A load cell barrier consisting of 176 load cells was impacted by a 2023 Lexus RX 350 AWD 5-Door SUV at a velocity of 56.26 km/h. The test was performed at MGA Research Corporation on May 17, 2023. Pre-test and post-test photographs of the vehicle and dummies can be found in Appendix A.
