**REPORT NUMBER: NCAP-CAL-23-008**

**NEW CAR ASSESSMENT PROGRAM (NCAP)  
SIDE IMPACT POLE TEST**

**General Motors LLC  
2023 Chevrolet Colorado  
4 Door Truck**

**FINAL REPORT**

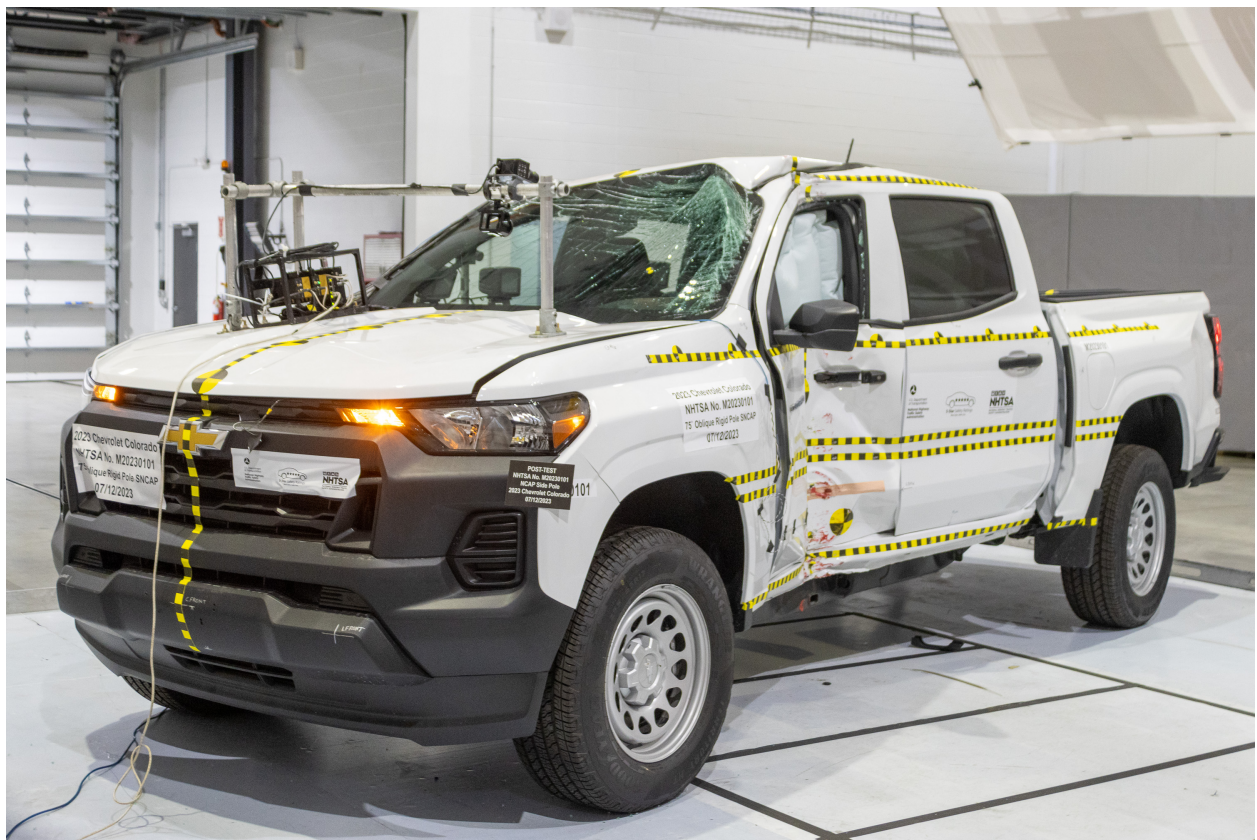
**Figure A-6: Post-Test Left Front  $\frac{3}{4}$  View of Test Vehicle**

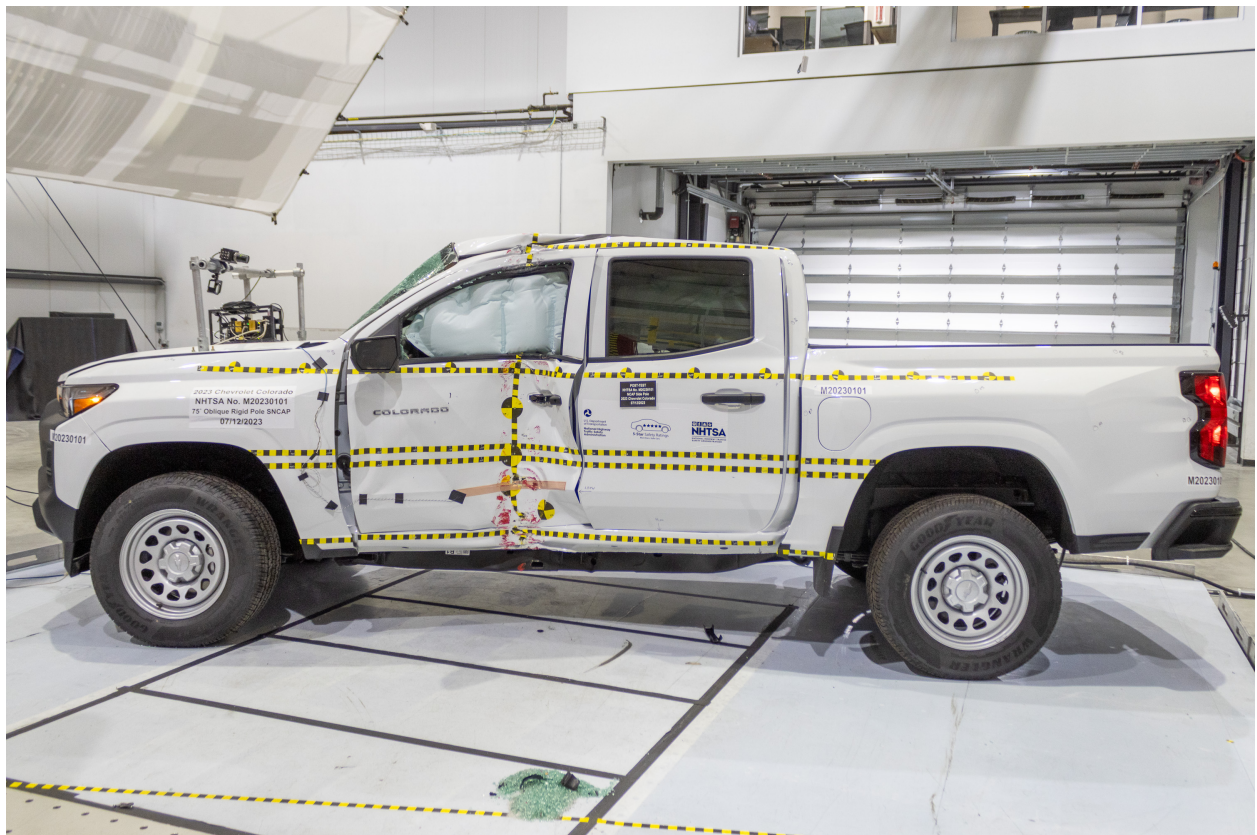
**Figure A-8: Post-Test Left Side View of Test Vehicle**

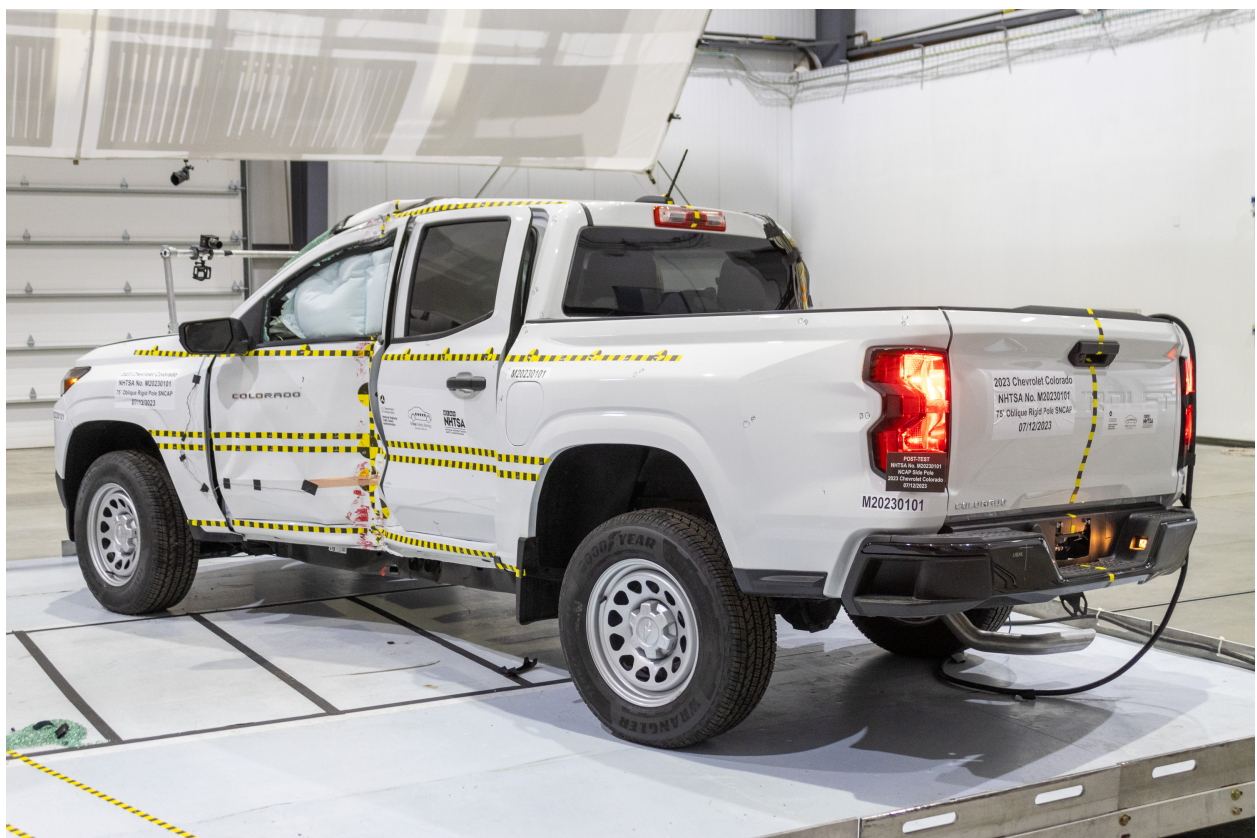
**Figure A-10: Post-Test Left Rear  $\frac{3}{4}$  View of Test Vehicle**

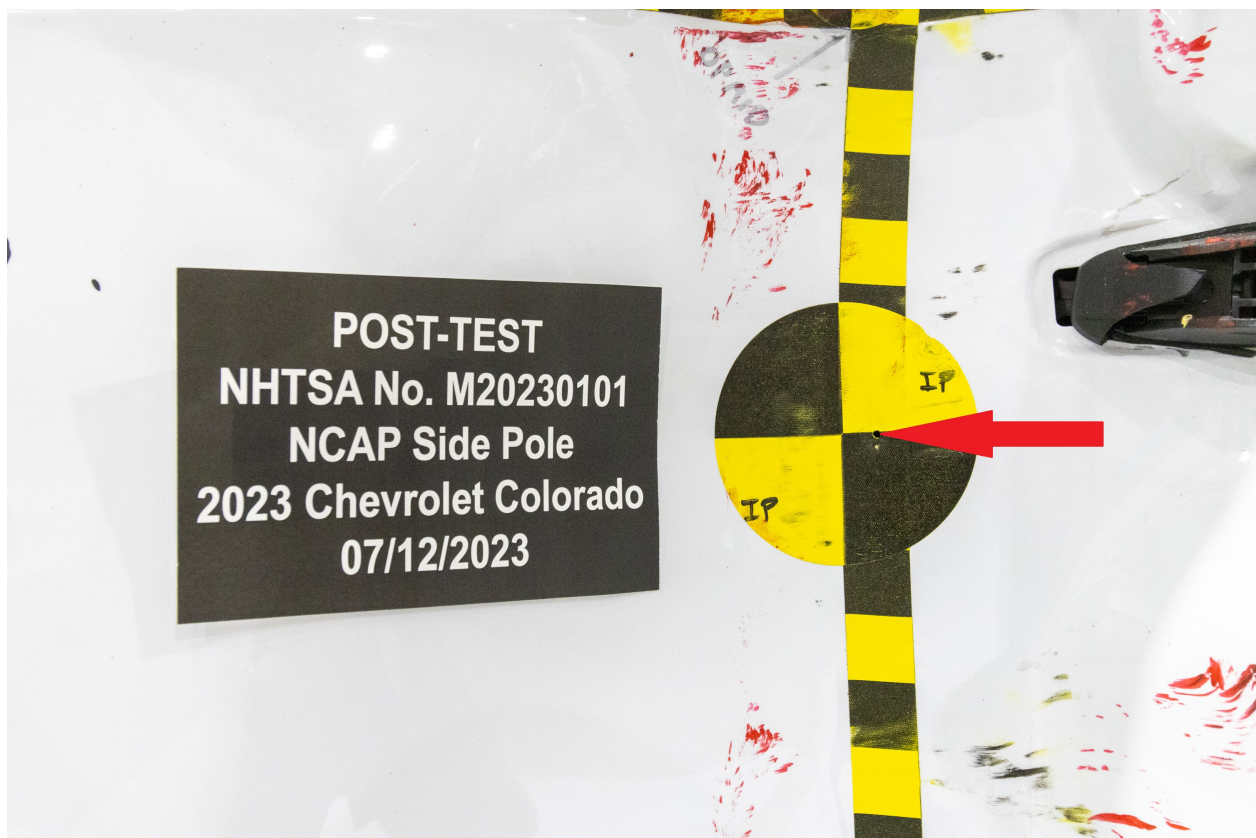
Figure A-20: Post-Test Close-Up View of Impact Point Target Showing Impact Location

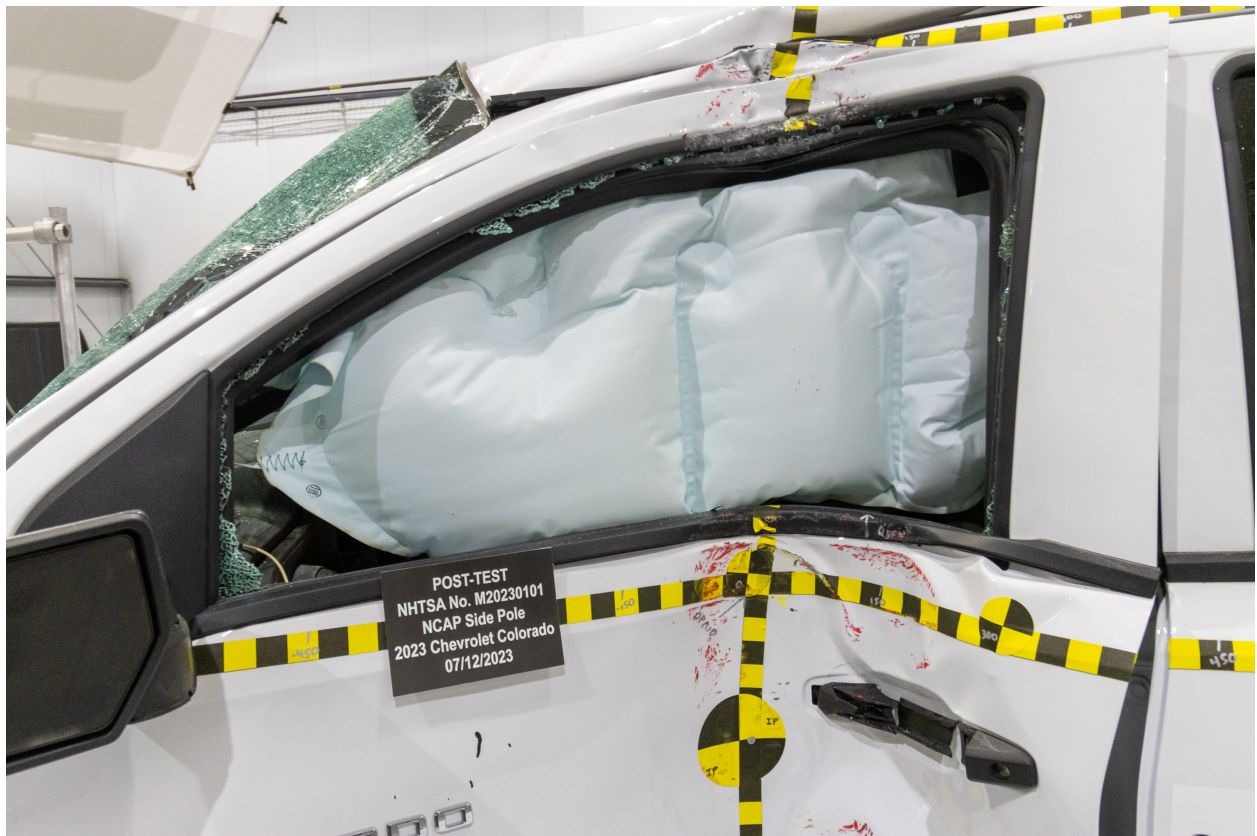
**Figure A-25: Post-Test Left Side View of Dummy Shoulder and Door Top View**

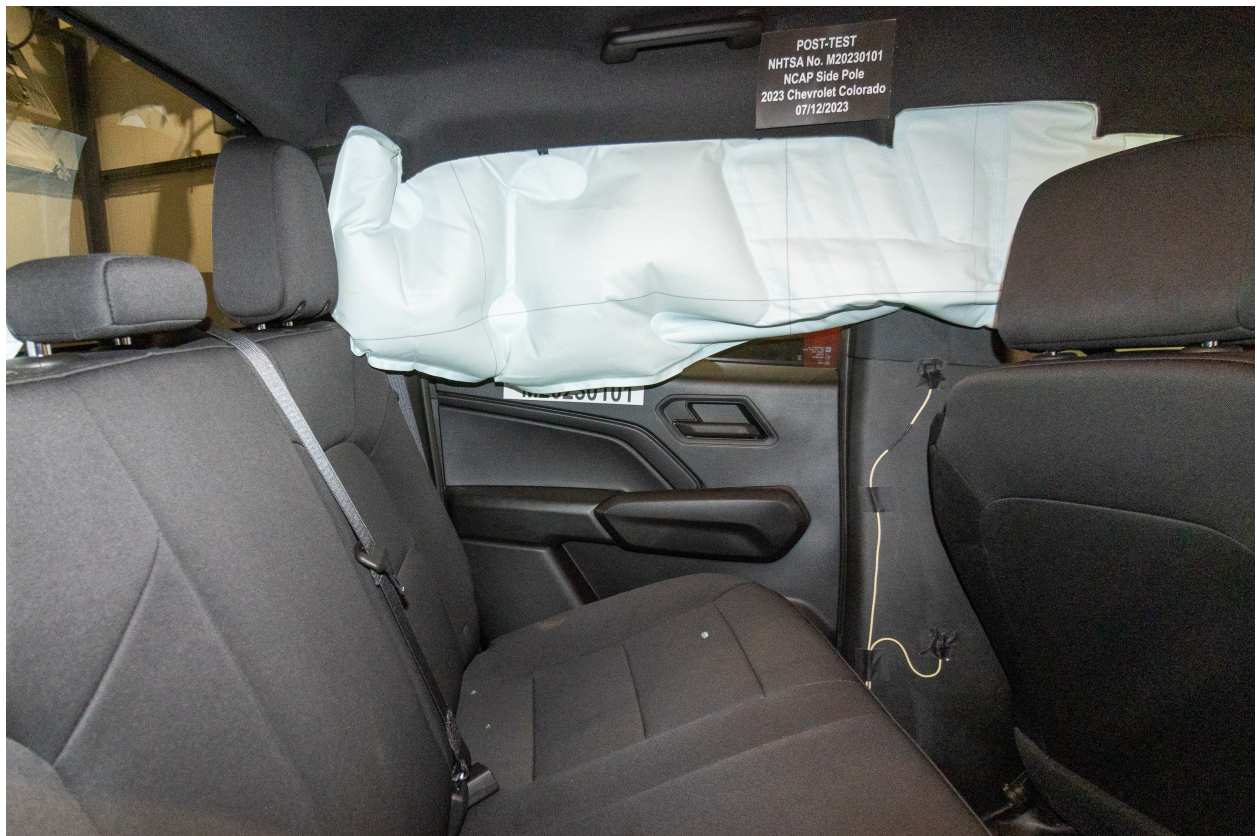
**Figure A-54: Post-Test Inner Rear Passenger Torso Air Bag Deployment View**

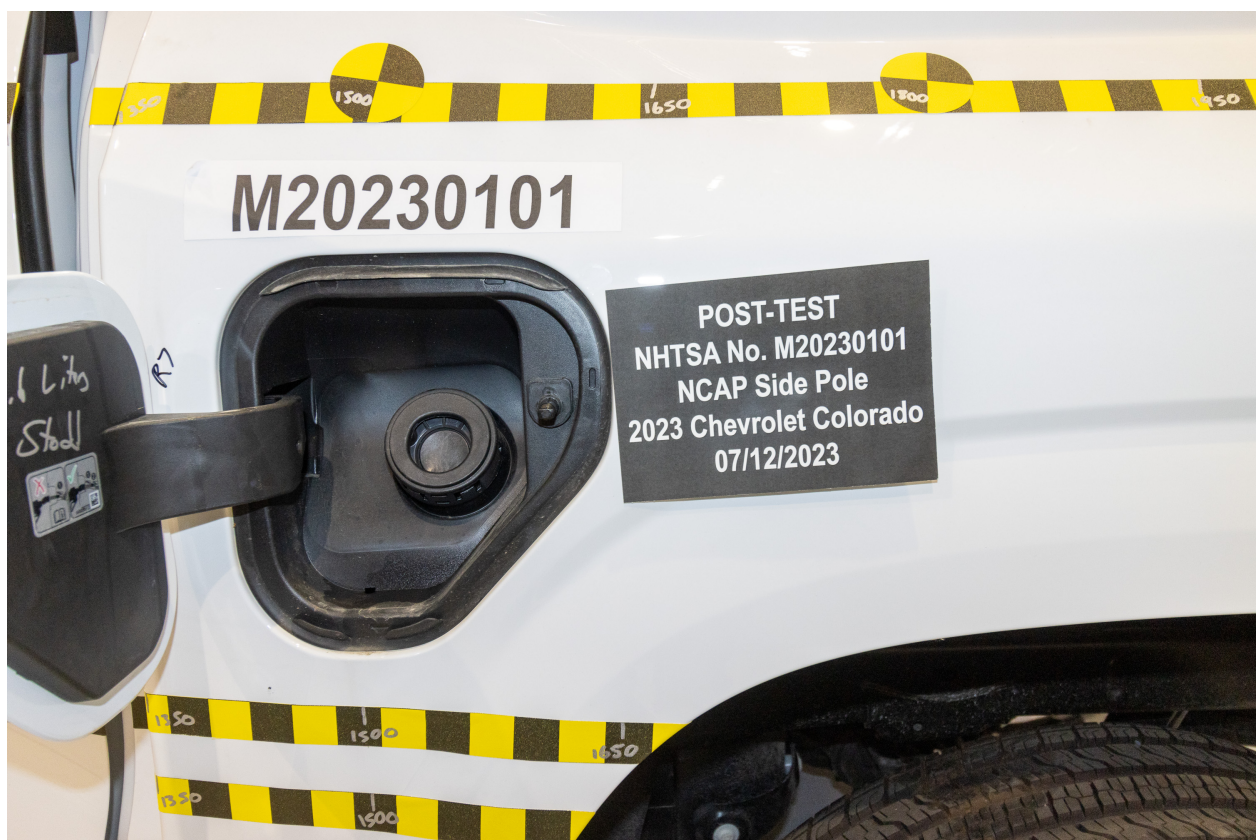
Figure A-56: Post-Test View of Fuel Filler Cap or Fuel Filler Neck

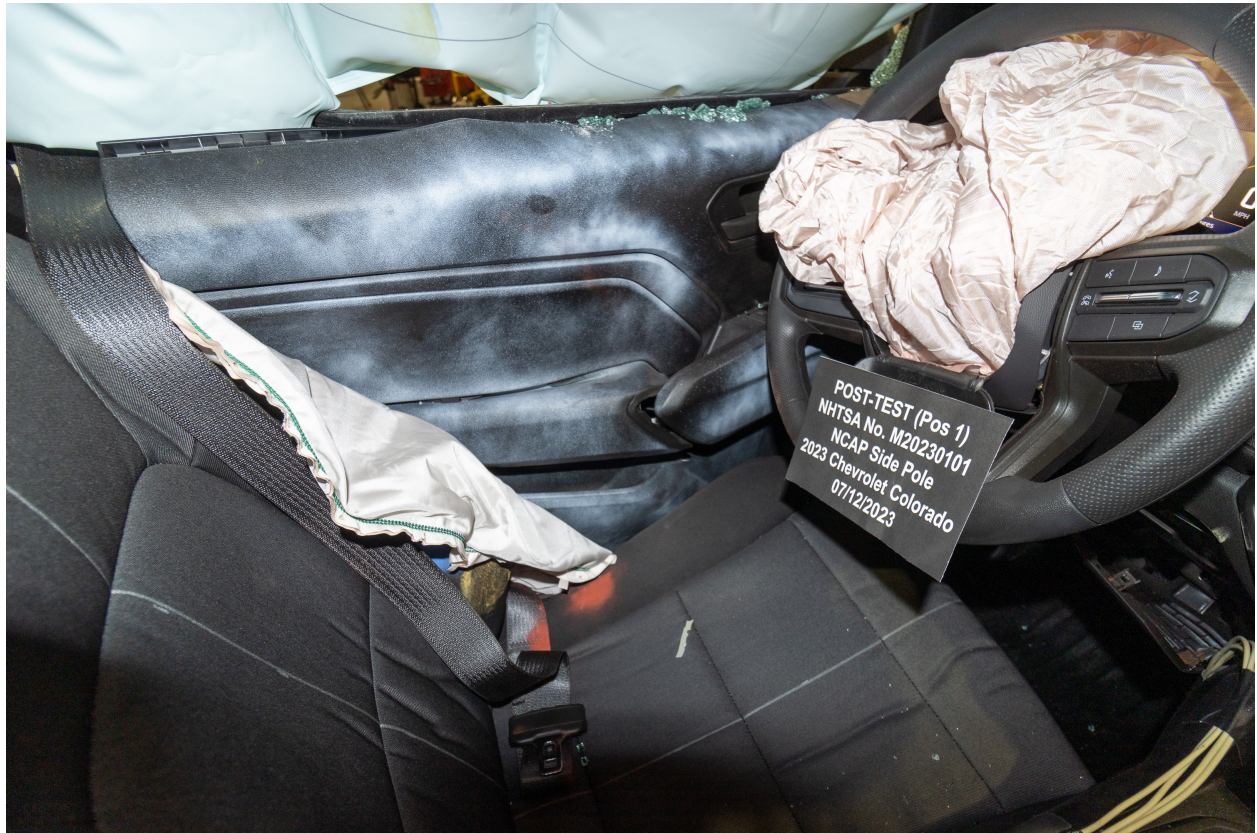
**Figure A-73: Post-Test View of Shattered Vehicle Inner Door Panel**

| Critical Areas of Performance | Observations and Conclusions |
|---|---|
| Side Window Damage | Driver window shattered |
