REPORT NUMBER: NCAP-CAL-23-007

**NEW CAR ASSESSMENT PROGRAM (NCAP)
FRONTAL BARRIER IMPACT TEST**

**Hyundai Motor Company
2023 Genesis GV70
5 Door SUV**

NHTSA No: M20234203

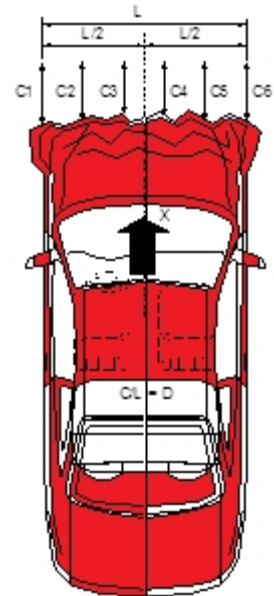
CRUSH PROFILE

Collision Deformation Classification: 12FDEW2
Midpoint of Damage: C4
Damage Region Length (mm): 1565
Impact Mode: Frontal

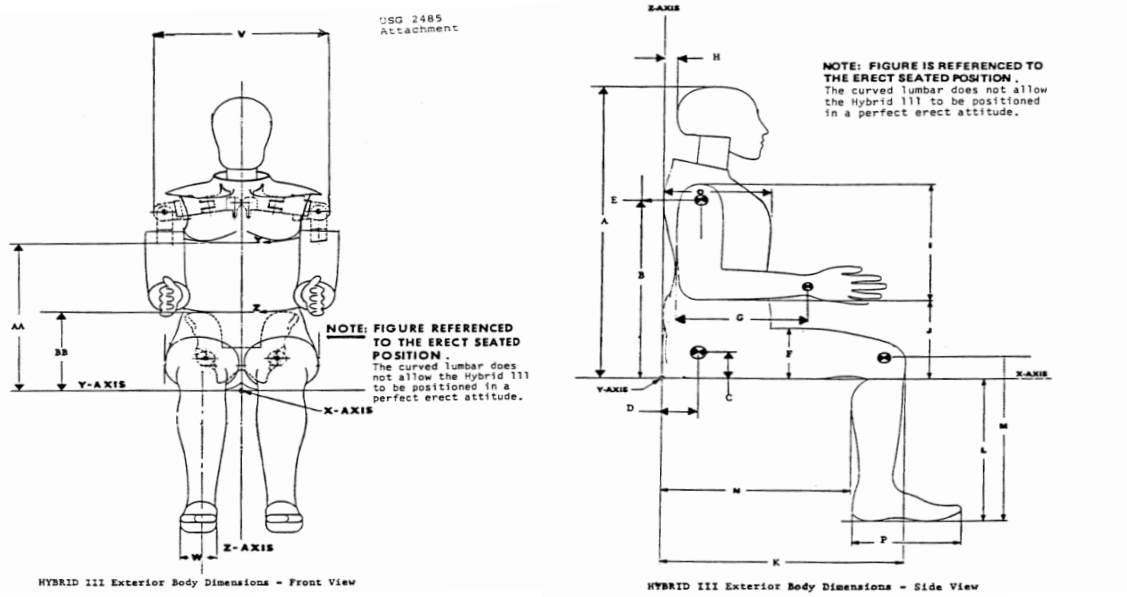
Dummy Serial Number: 142

Symbol	Description	Specification (in)		Result (in)	Pass/Fail
A	Sitting Height	34.6	35.0	34.7	Pass
B	Shoulder Pivot Height	19.9	20.5	20.2	Pass
C	H-Point Height	3.3	3.5	3.3	Pass
D	H-Point from Backline	5.3	5.5	5.4	Pass
E	Shoulder Pivot from Backline	3.3	3.7	3.4	Pass
F	Thigh Clearance	5.5	6.1	5.9	Pass
G	Back of Elbow to Wrist Pivot	11.4	12.0	11.7	Pass
H	Head Back to Backline	1.6	1.8	1.7	Pass
I	Shoulder to Elbow Length	13.0	13.6	13.4	Pass
J	Elbow Rest Height	7.5	8.3	7.9	Pass
K	Buttock to Knee Length	22.8	23.8	23.6	Pass
L	Popliteal Height	16.9	17.9	17.4	Pass
M	Knee Pivot Height	19.1	19.7	19.5	Pass
N	Buttock Popliteal Length	17.8	18.8	18.2	Pass
O	Chest Depth without Jacket	8.4	9.0	8.8	Pass
P	Foot Length (right)	9.9	10.5	10.3	Pass
V	Shoulder Breadth	16.3	17.2	16.8	Pass
W	Foot Breadth	3.6	4.2	3.9	Pass
Y	Chest Circumference with Jacket	38.2	39.4	38.9	Pass
Z	Waist Circumference	32.9	34.1	33.5	Pass
AA	Reference Location (Chest Circumference)	16.9	17.1	17.0	Pass

BB	Reference Location (Waist Circumference)	8.9	9.1	9.0	Pass

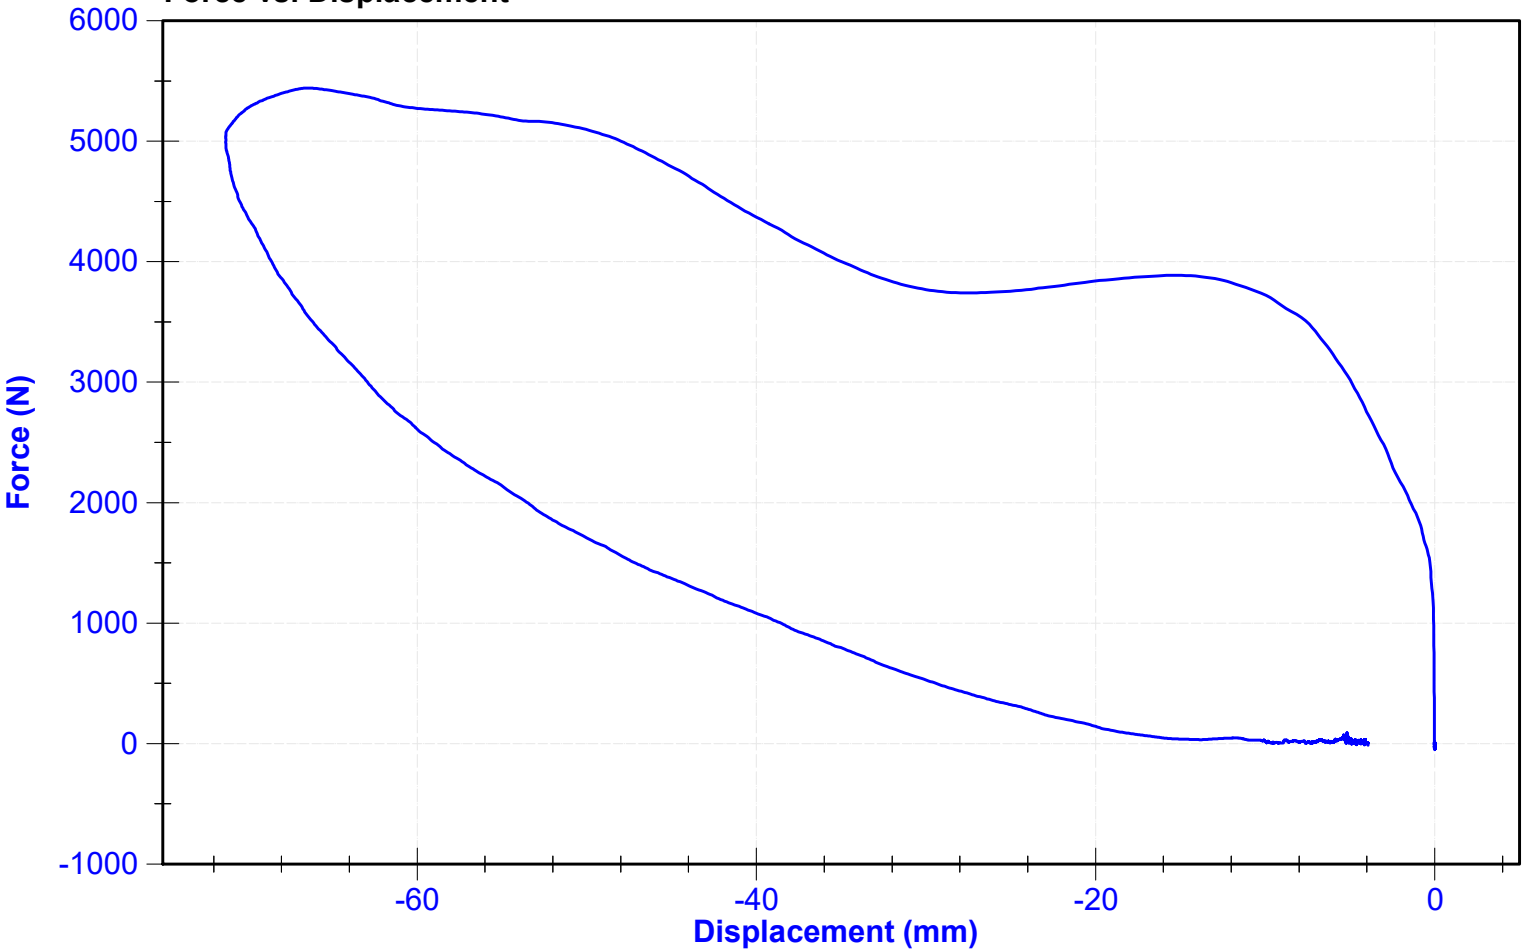
Force vs. Displacement

Test Parameter	Minimum Specification	Maximum Specification	Unit	Result	Pass/Fail
Temperature	20.6	22.2	°C	21.8	Pass
Humidity	10	70	%	57	Pass
Velocity	6.59	6.83	m/s	6.719	Pass
Chest Displacement	-72.6	-63.5	mm	-71.29	Pass
Resistive Force	5160	5894	N	5441.1	Pass
Hysteresis	69	85	%	71.6	Pass

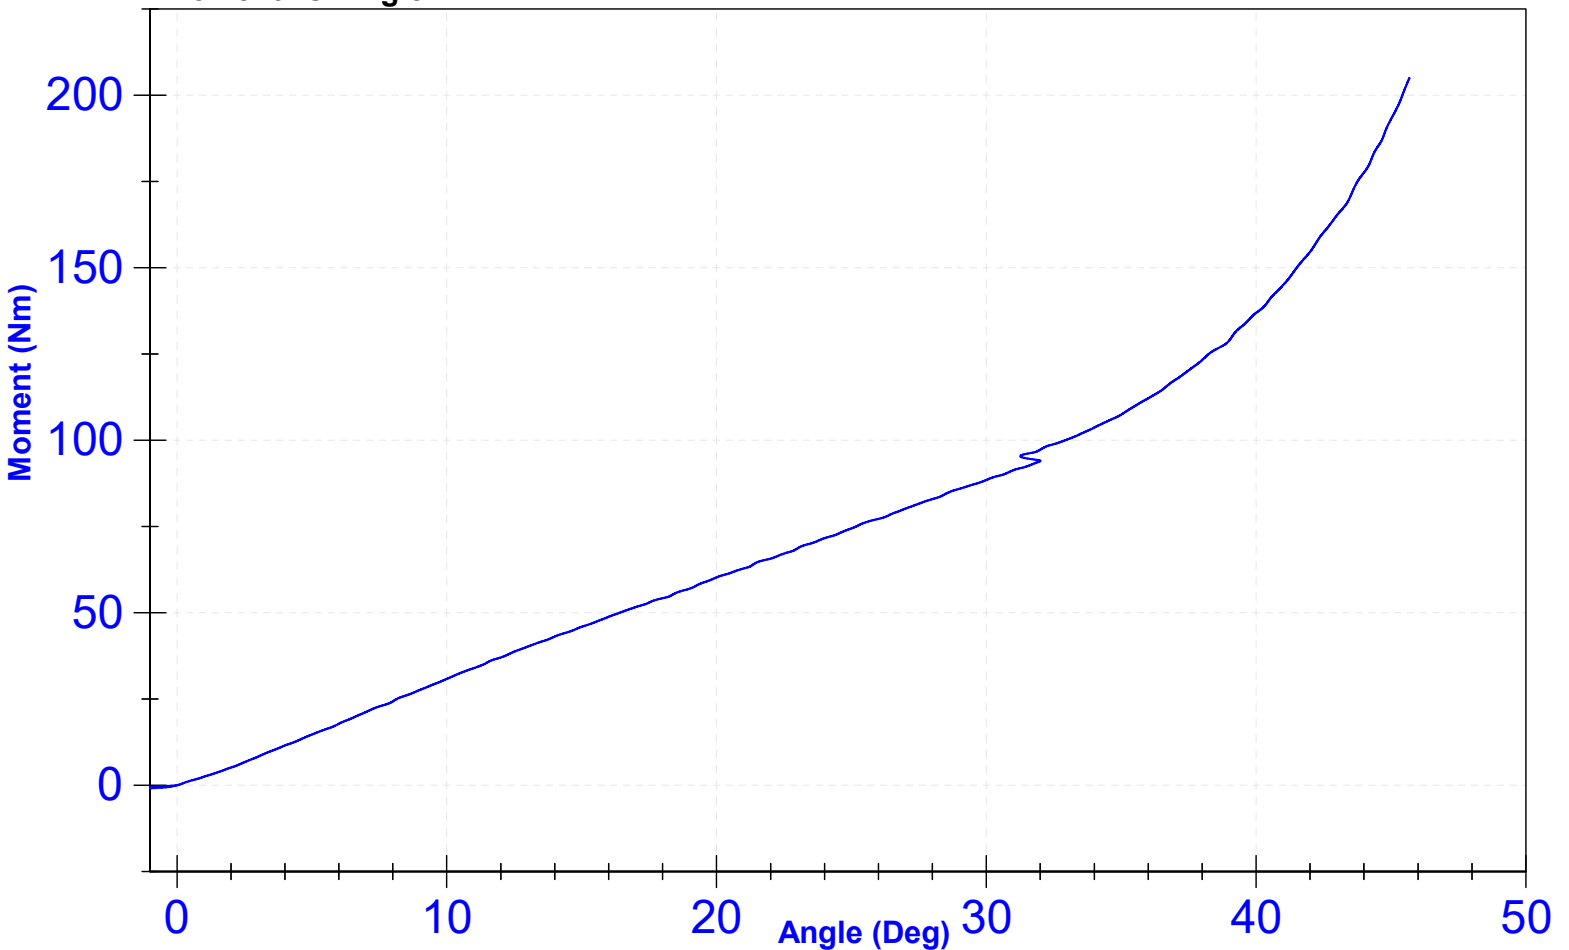
Moment vs. Angle

Test Parameter	Minimum Specification	Maximum Specification	Unit	Result	Pass/Fail
Temperature	18.9	25.6	°C	21.5	Pass
Humidity	10	70	%	51.2	Pass
Average Velocity	5	10	deg/s	7.3	Pass
Angle at 203Nm	40	50	deg	45.6	Pass
Moment at 30 degrees	0	94.9	Nm	88.5	Pass

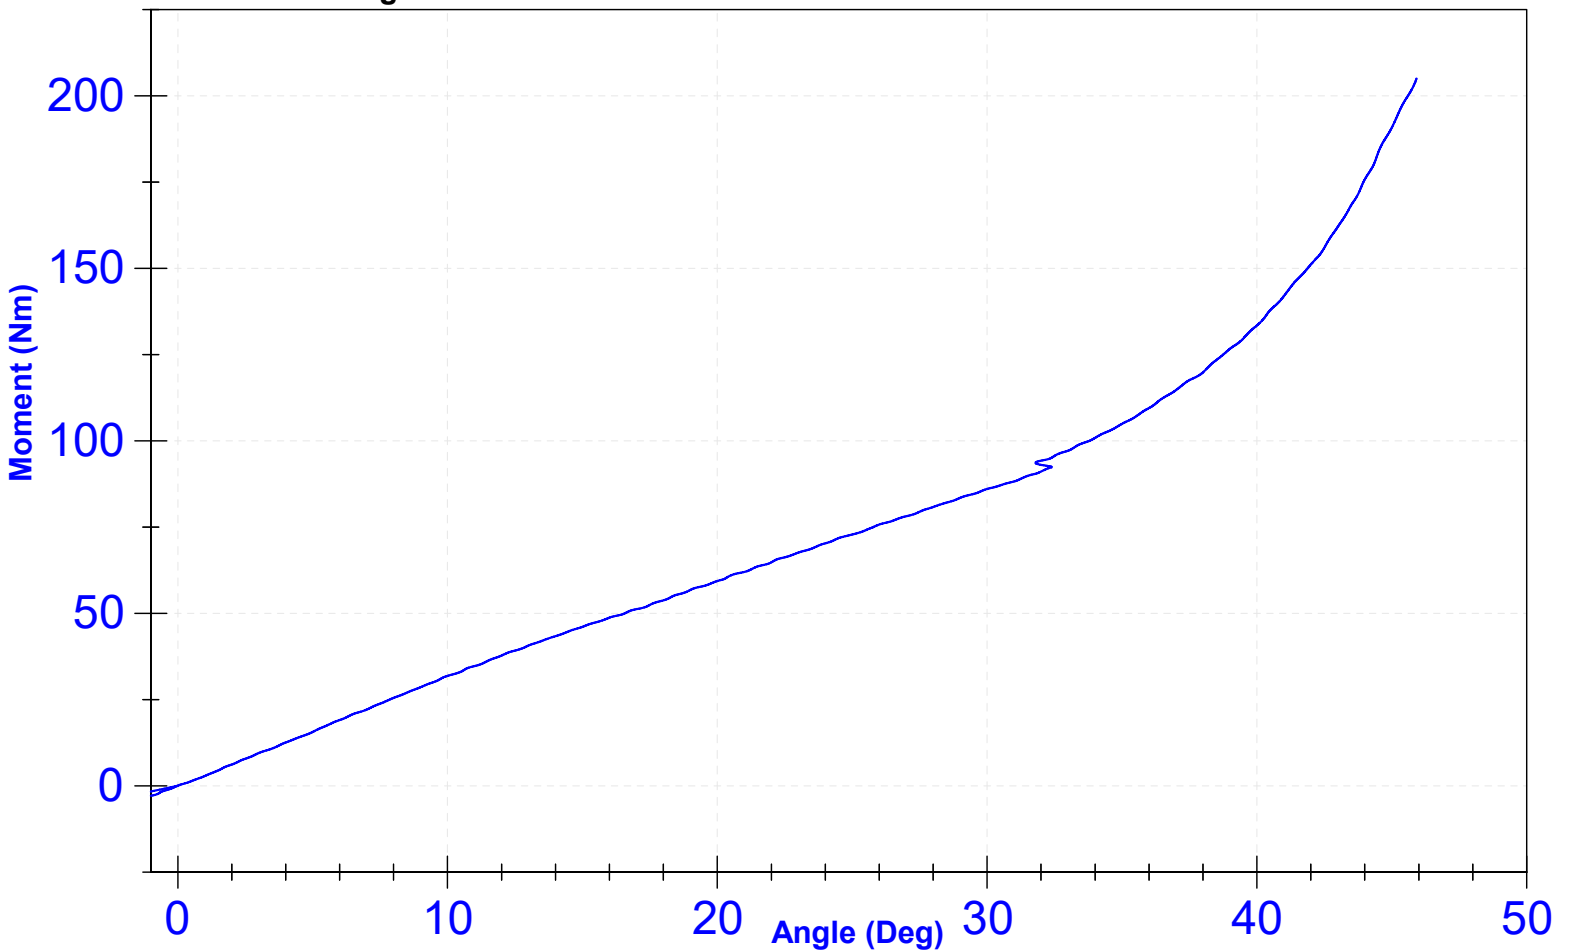
Moment vs. Angle

Test Parameter	Results		Unit	Result	Pass/Fail
	Minimum Specification	Maximum Specification			
Temperature	18.9	25.6	°C	21.5	Pass
Humidity	10	70	%	51.2	Pass
Average Velocity	5	10	deg/s	7.3	Pass
Angle at 203Nm	40	50	deg	45.8	Pass
Moment at 30 degrees	0	94.9	Nm	86.0	Pass

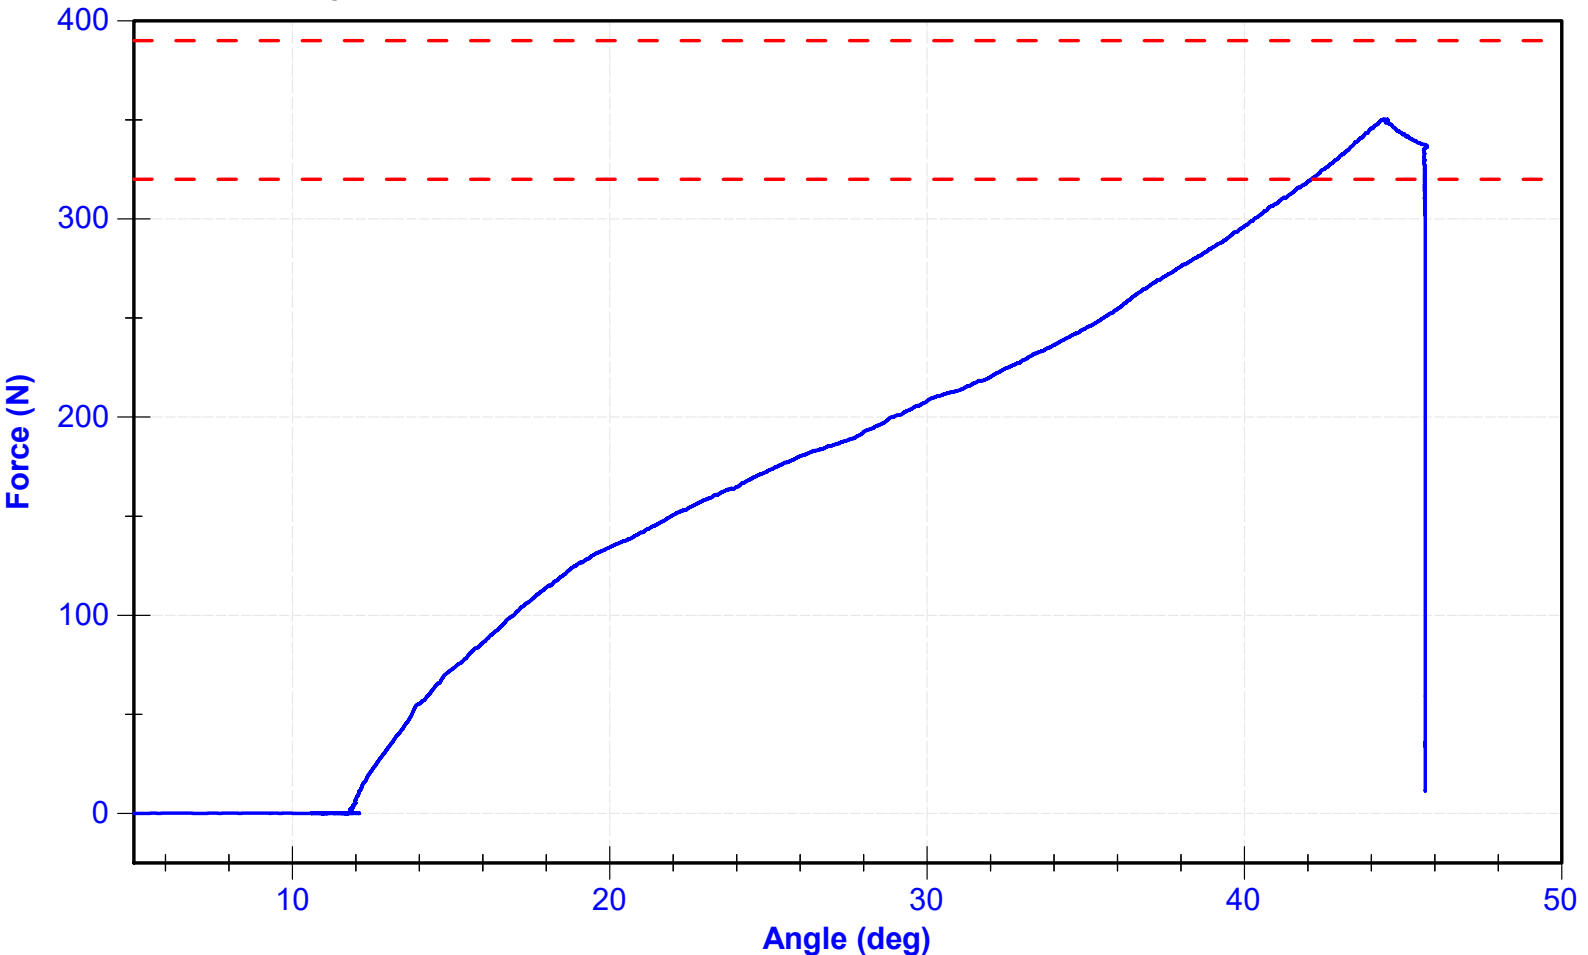
Force vs. Displacement

Test Parameter	Minimum Specification	Maximum Specification	Unit	Result	Pass/Fail
Temperature	18.6	25.6	°C	21.4	Pass
Humidity	10	70	%	64.1	Pass
Initial Angle	0	20	deg	11.4	Pass
Force at 45 Degrees	320	390	N	350.5	Pass
Return Angle Relative to Initial	0	8	deg	4.4	Pass

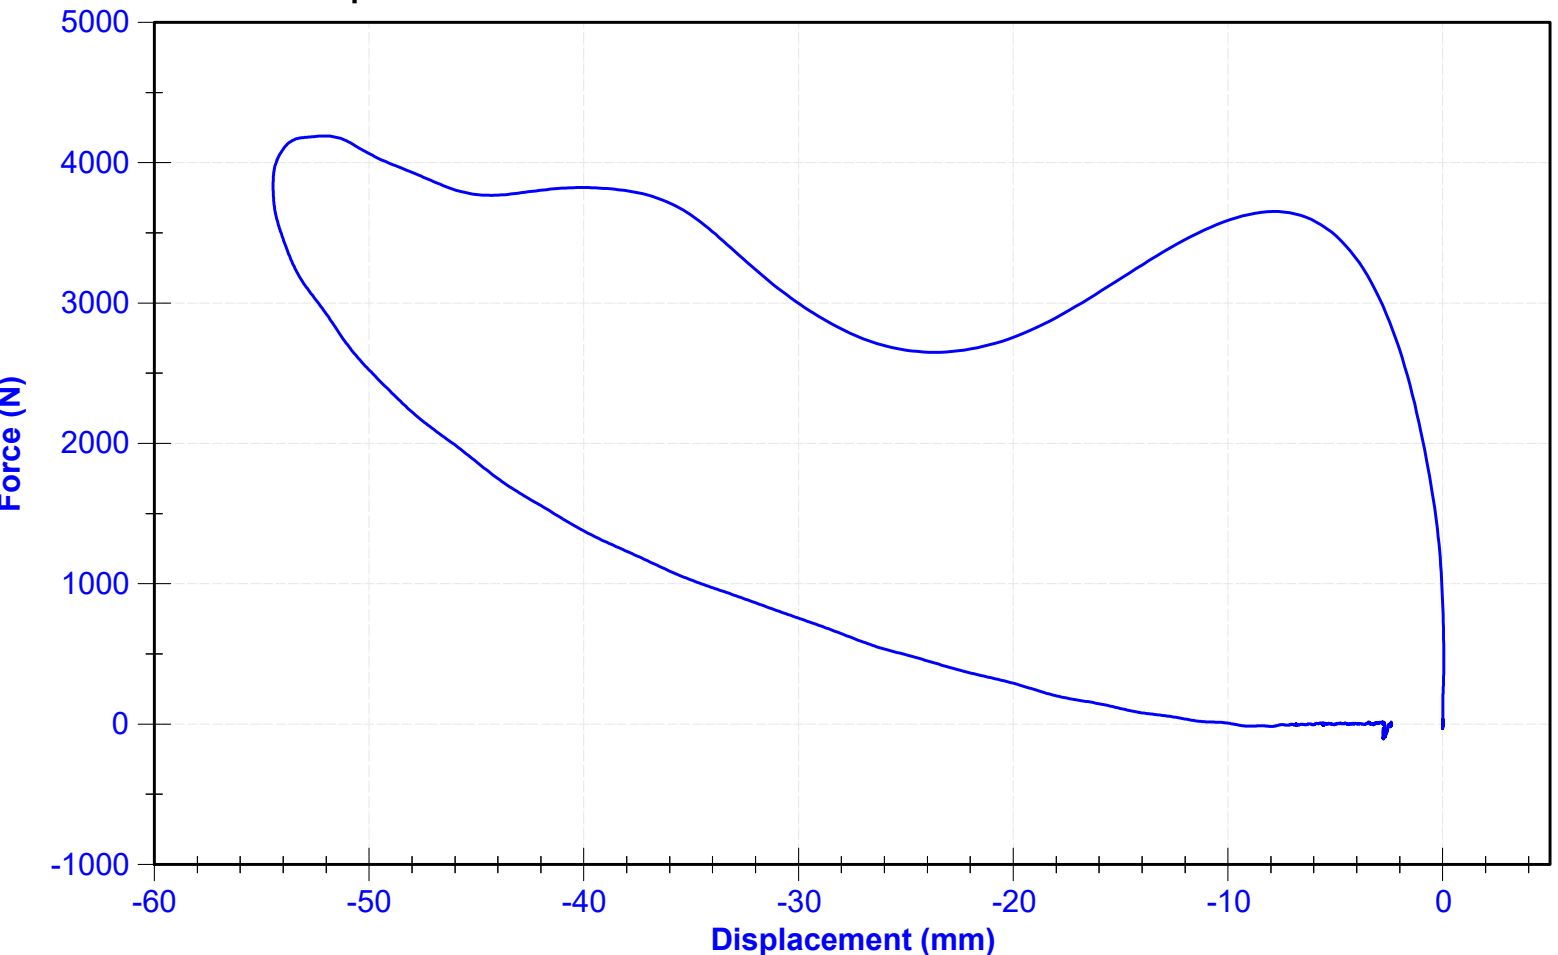
Force vs. Displacement

Test Parameter	Minimum Specification	Maximum Specification	Unit	Result	Pass/Fail
Temperature	20.6	22.2	°C	21.6	Pass
Humidity	10	70	%	63.4	Pass
Velocity	6.59	6.83	m/s	6.658	Pass
Chest Deflection	-58	-50	mm	-54.5	Pass
Maximum Resistive Force (50 to 58mm)	3900	4400	N	4191.9	Pass
Maximum Resistive Force (18 to 50mm)	0	4600	N	4060.1	Pass
Hysteresis	69	85	%	73.2	Pass

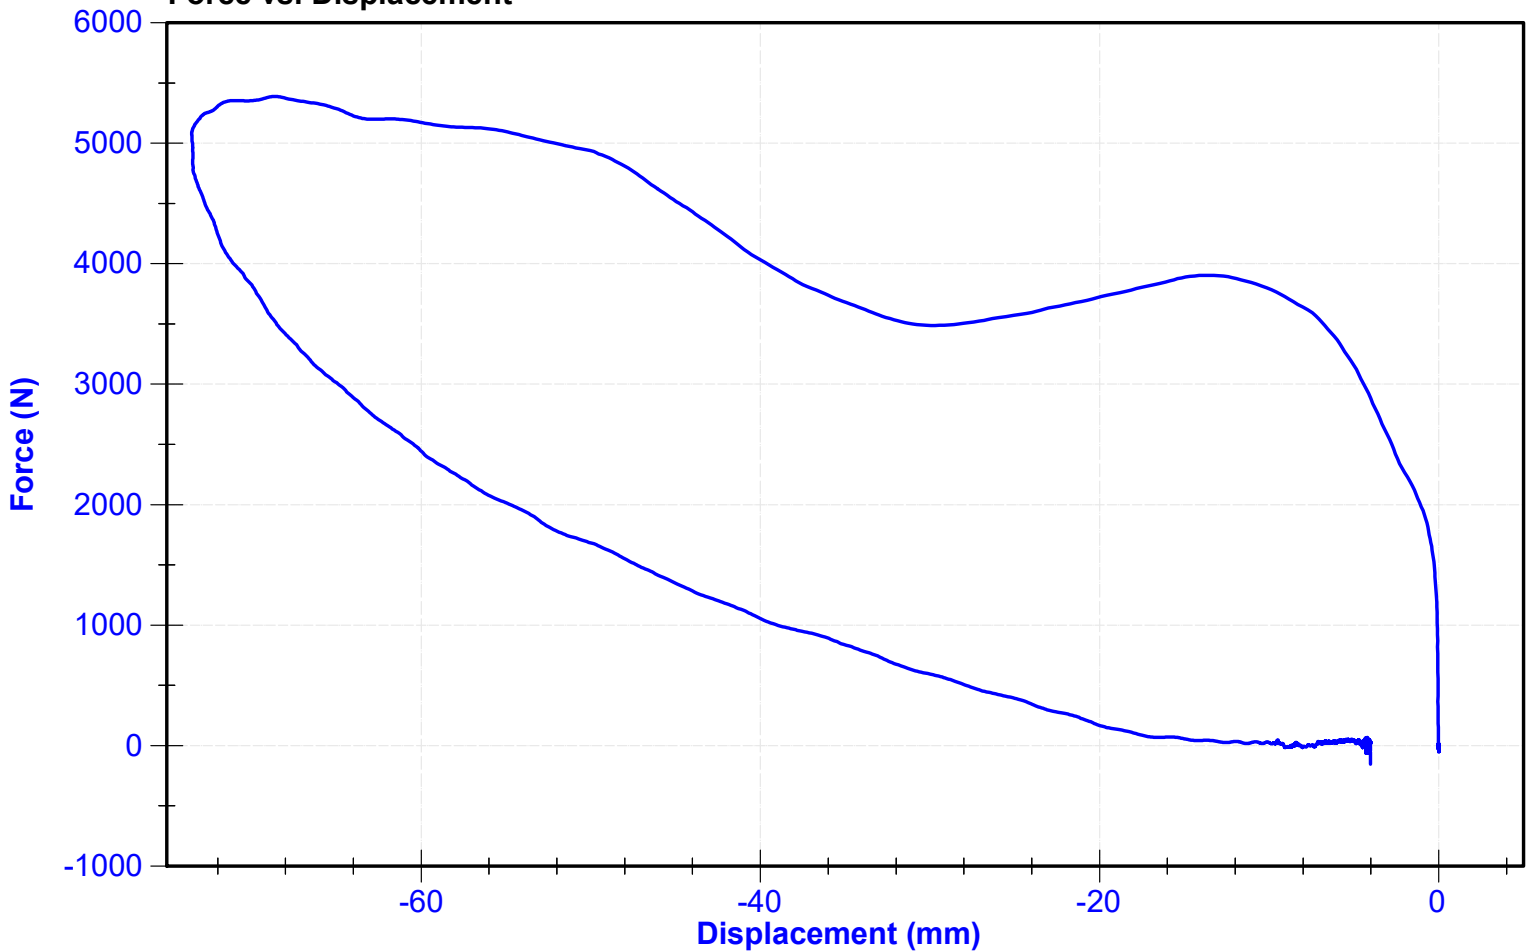
Force vs. Displacement

Test Parameter	Minimum Specification	Maximum Specification	Unit	Result	Pass/Fail
Temperature	20.6	22.2	°C	22.0	Pass
Humidity	10	70	%	60.5	Pass
Velocity	6.59	6.83	m/s	6.723	Pass
Chest Displacement	-72.6	-63.5	mm	-72.07	Pass
Resistive Force	5160	5894	N	5388.2	Pass
Hysteresis	69	85	%	70.1	Pass

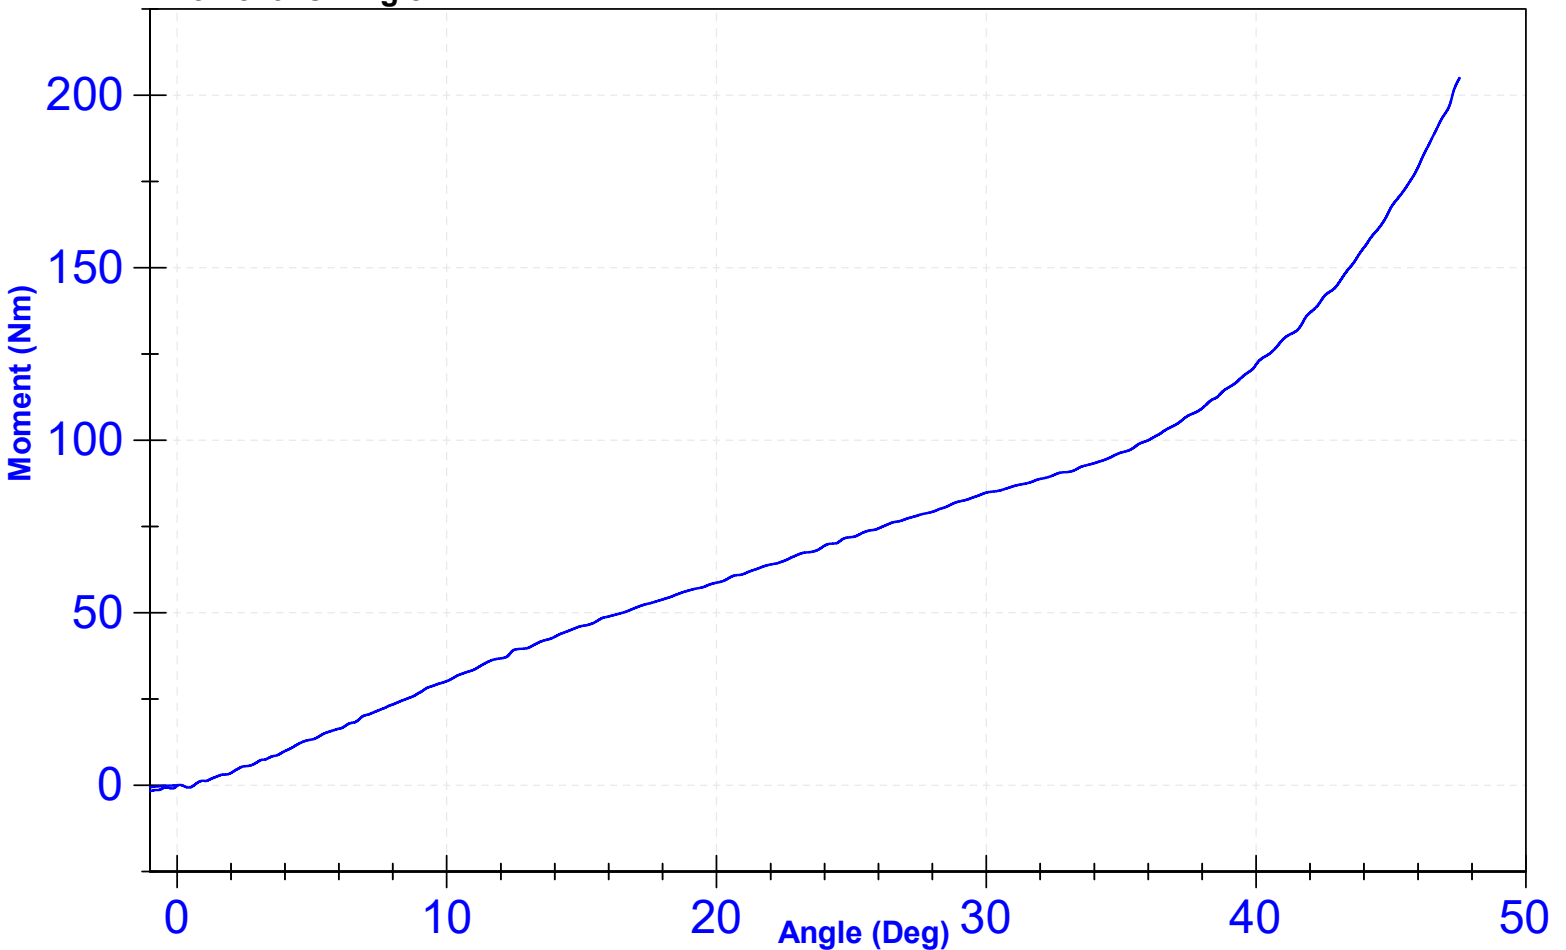
Moment vs. Angle

Test Parameter	Minimum Specification	Maximum Specification	Unit	Result	Pass/Fail
Temperature	18.9	25.6	°C	21.8	Pass
Humidity	10	70	%	62.3	Pass
Average Velocity	5	10	deg/s	7.5	Pass
Angle at 203Nm	40	50	deg	47.4	Pass
Moment at 30 degrees	0	94.9	Nm	84.8	Pass

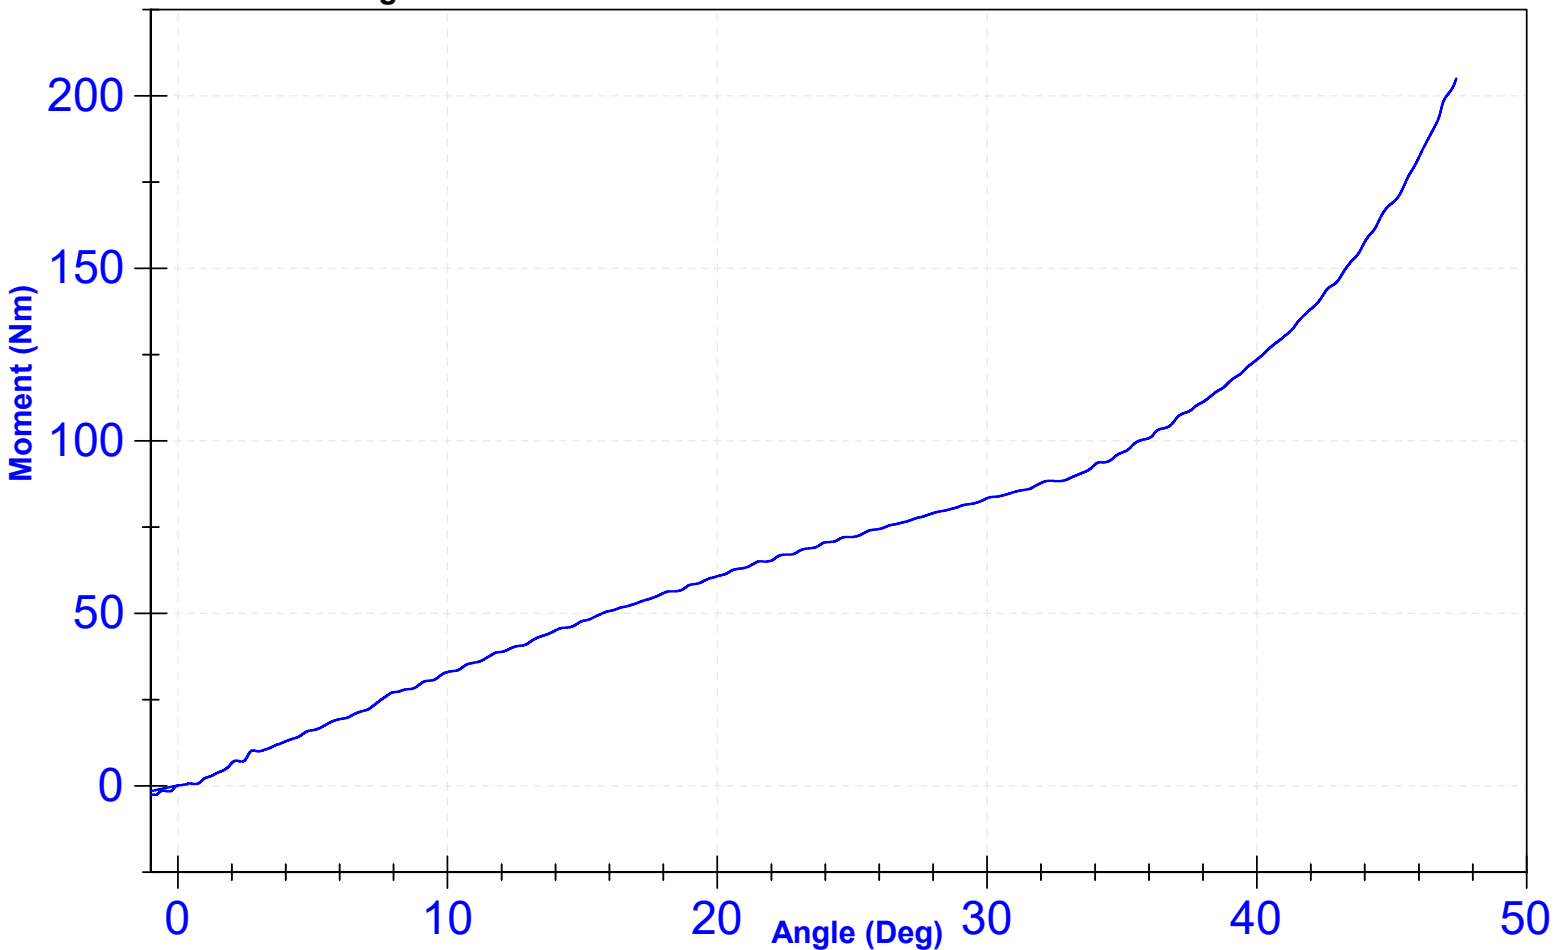
Moment vs. Angle

Test Parameter	Minimum Specification	Maximum Specification	Unit	Result	Pass/Fail
Temperature	18.9	25.6	°C	21.8	Pass
Humidity	10	70	%	62.3	Pass
Average Velocity	5	10	deg/s	7.6	Pass
Angle at 203Nm	40	50	deg	47.3	Pass
Moment at 30 degrees	0	94.9	Nm	83.3	Pass
