**NEW CAR ASSESSMENT PROGRAM (NCAP)
SIDE IMPACT POLE TEST**

**Hyundai Motor Company
2023 Genesis GV70
5 Door SUV**

NHTSA No: M20234204

**PREPARED BY:
CALSPAN CORPORATION
P.O. BOX 400
BUFFALO, NEW YORK 14225**

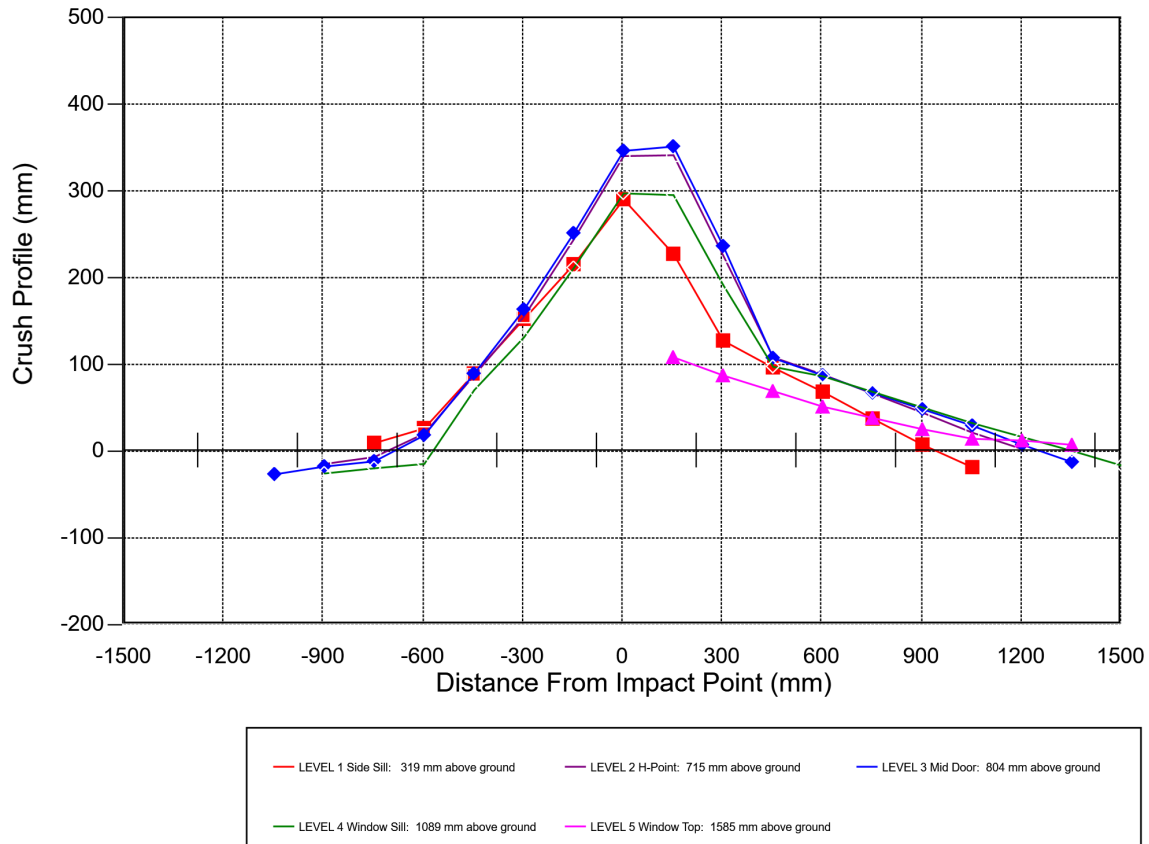
Vehicle Exterior Crush Measurements - Visual Representation

DPD	Distance From Impact Point (mm)	Level	Post-Test (mm)	Pre-Test (mm)	Crush (mm)
1	-1050	3	17	43	-26
2	-570	3	94	61	33
3	-90	3	349	59	290
4	390	3	220	61	159
5	870	3	120	67	53
6	1350	3	31	43	-12

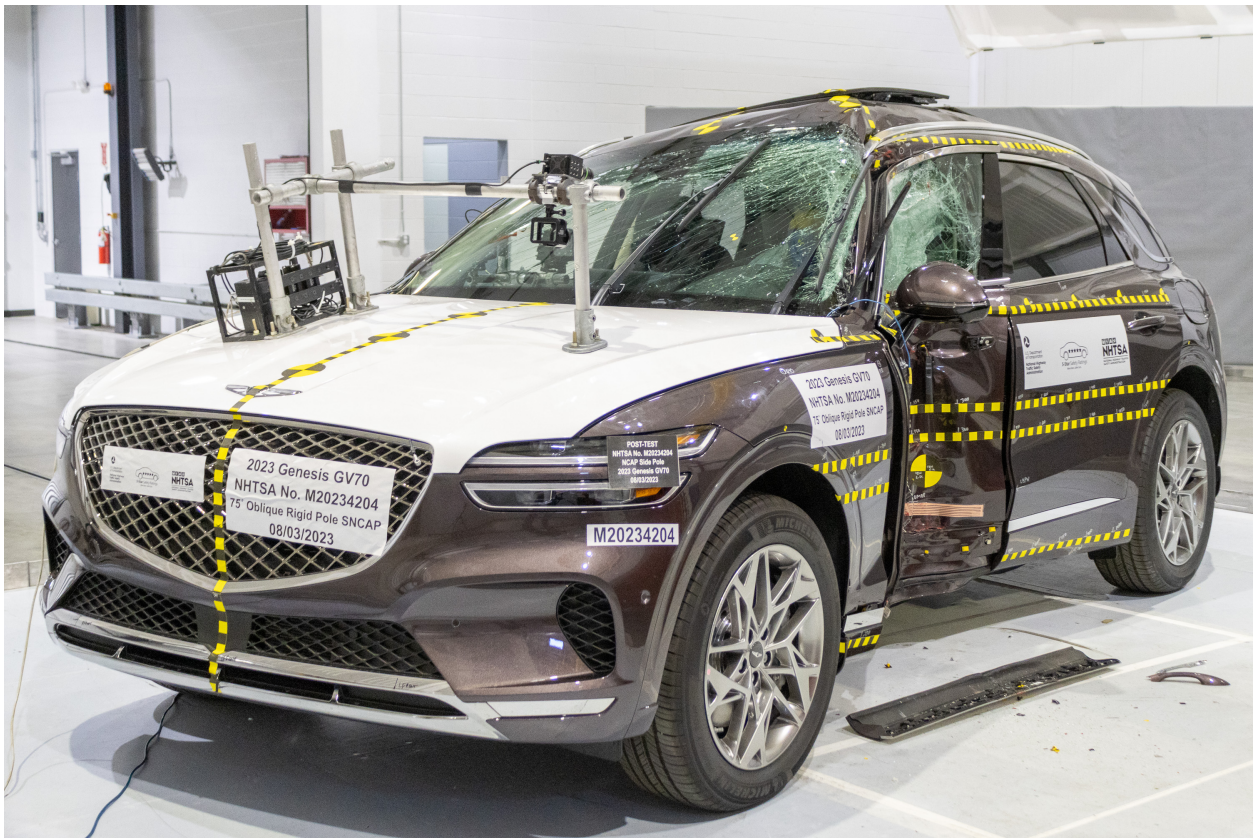
Figure A-6: Post-Test Left Front $\frac{3}{4}$ View of Test Vehicle

Critical Areas of Performance	Observations and Conclusions
Pillar Performance	A-Pillar, B-Pillar, & C-Pillar buckled
Sill Separation	175 mm of separation at rear door & 290 mm at impact location
Windshield Damage	Separation along A-Pillar, roof near A-pillar, & cracked throughout
Side Window Damage	Driver window shattered
Other Notable Effects	Sunroof separated from roof on impact side

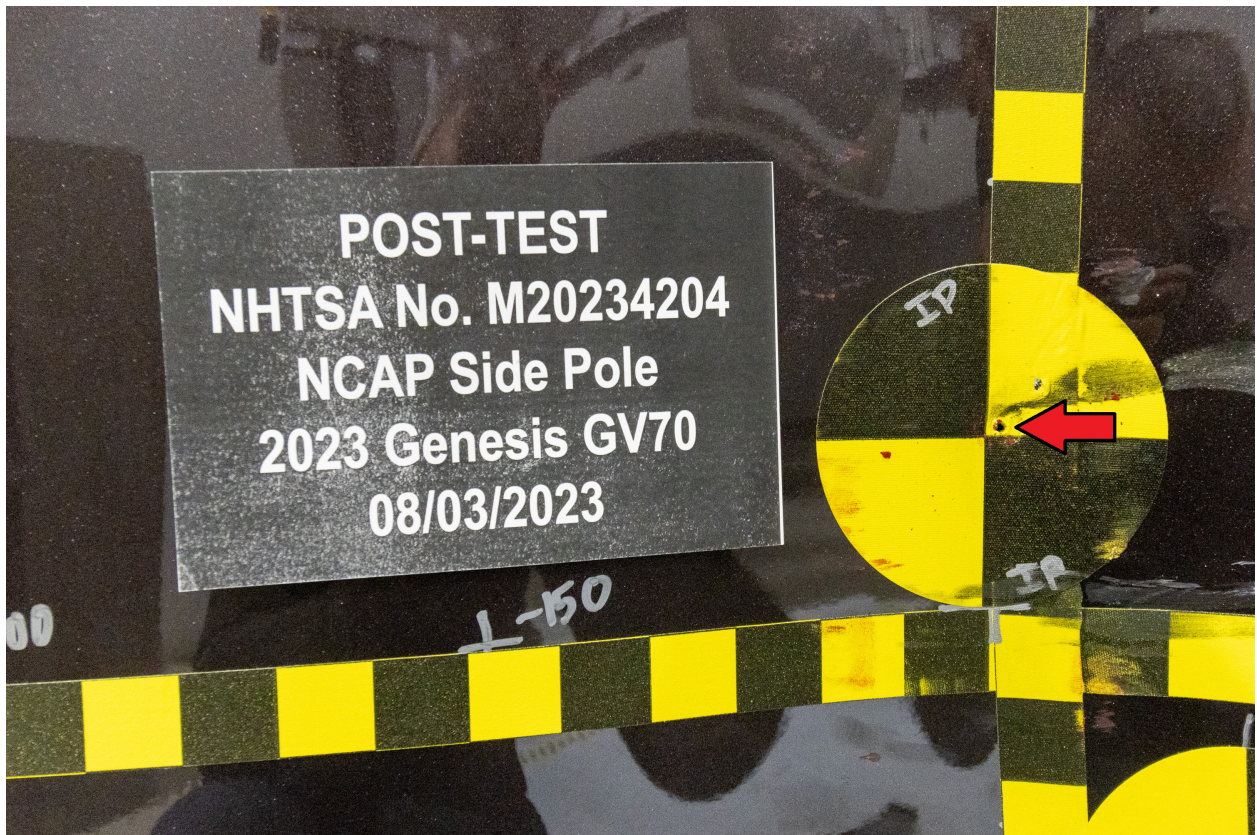
Figure A-20: Post-Test Close-Up View of Impact Point Target Showing Impact Location

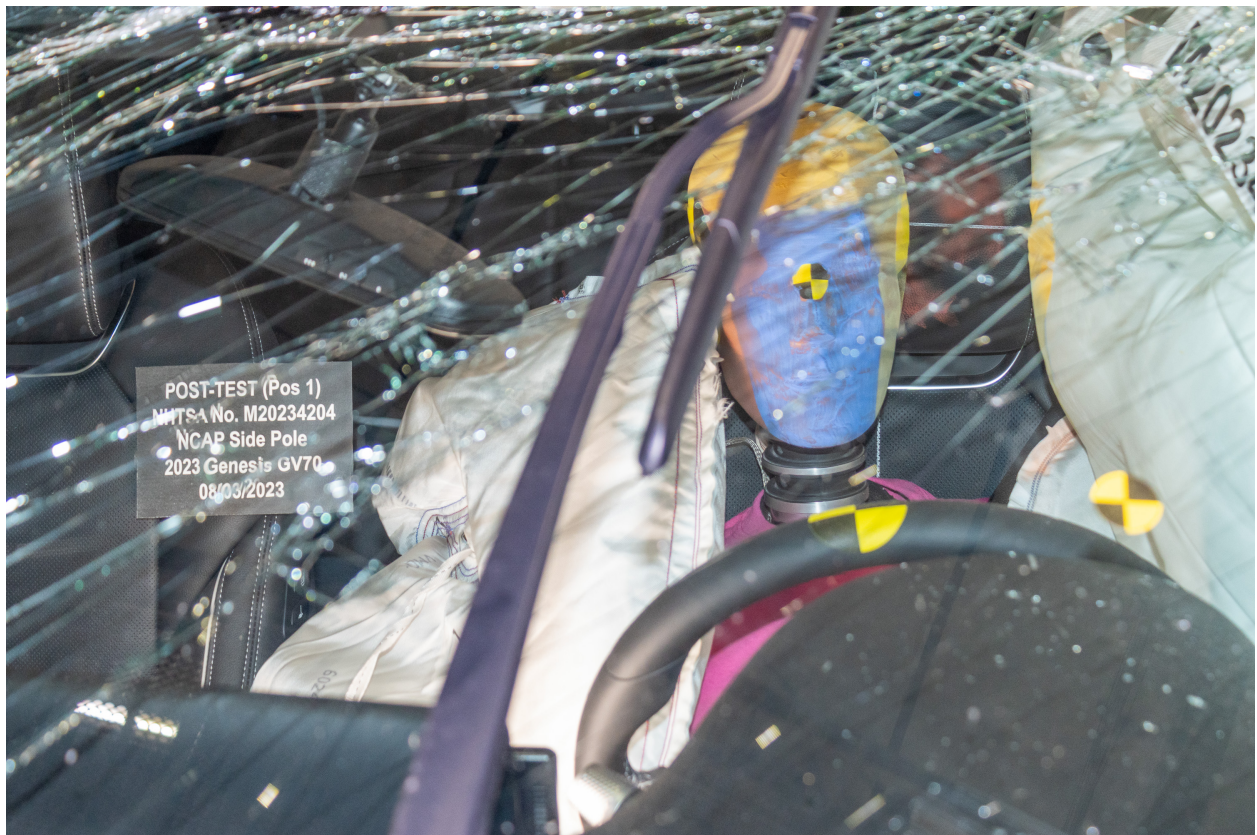
Figure A-22: Post-Test Front Close-Up View of Dummy

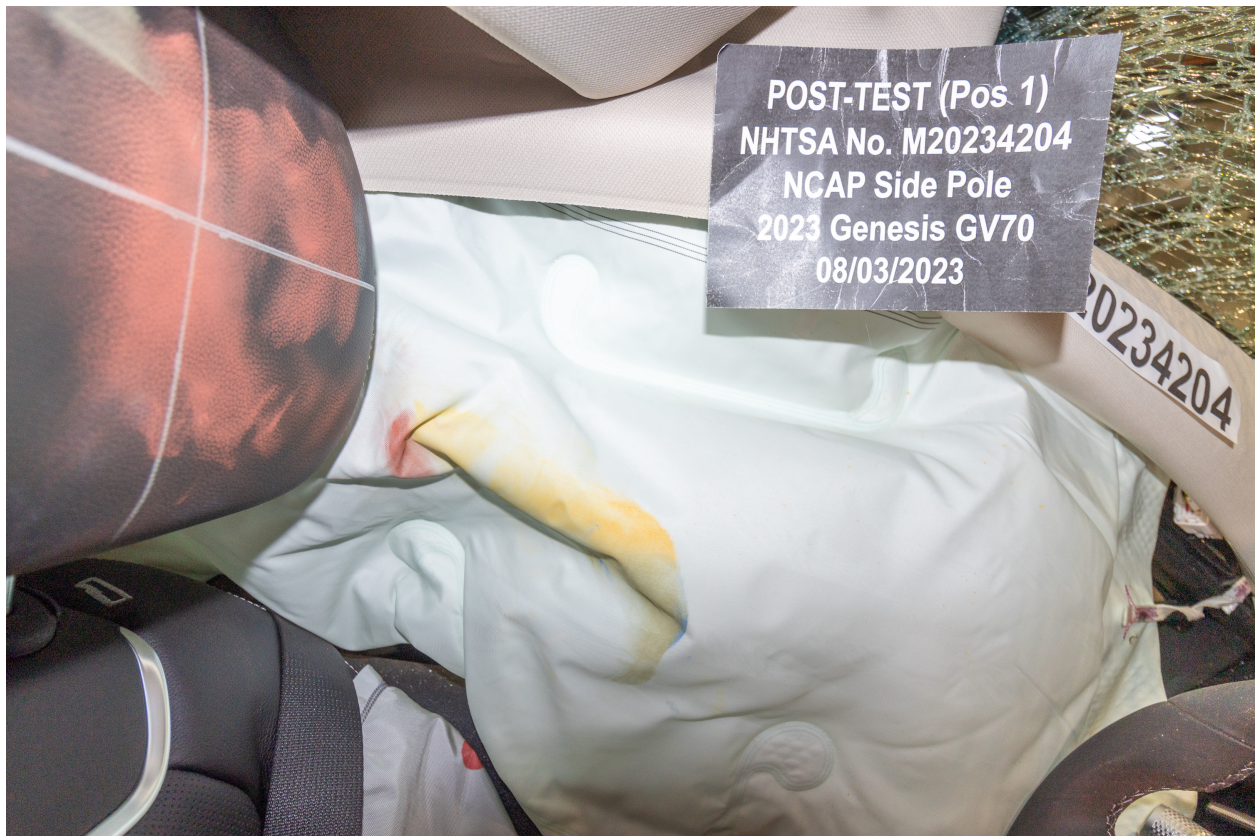
Figure A-47: Post-Test Dummy Close-Up Head Contact with Side Airbag View

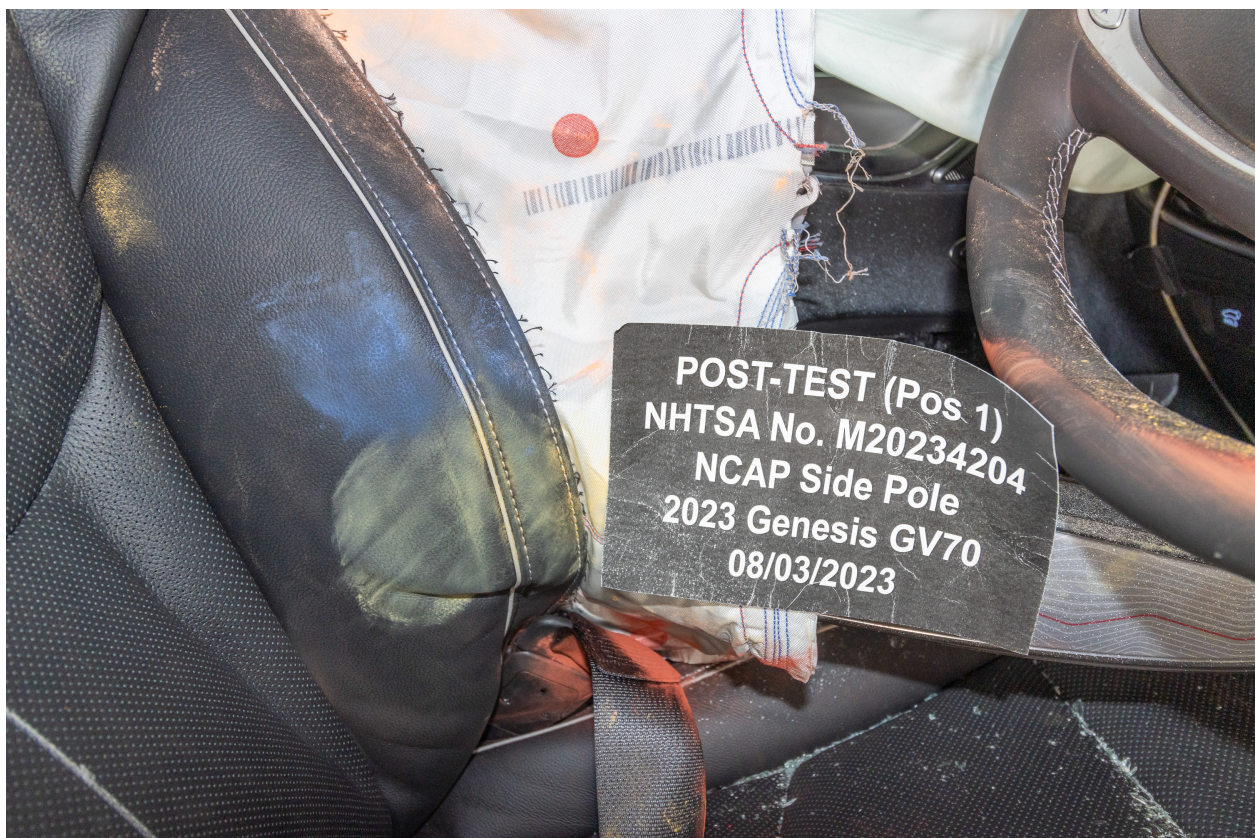
Figure A-48: Post-Test Dummy Close-Up Torso Contact with Vehicle Interior View

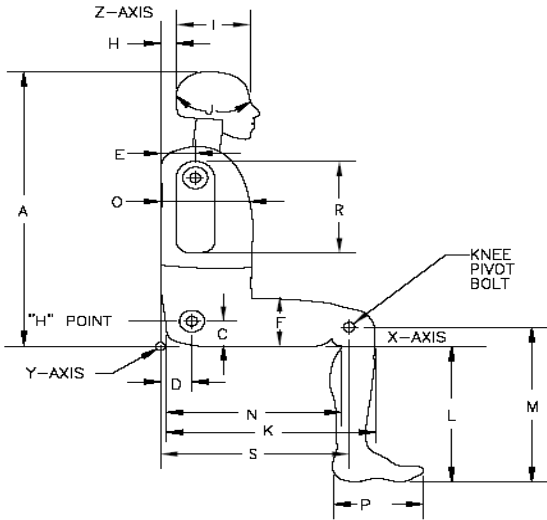
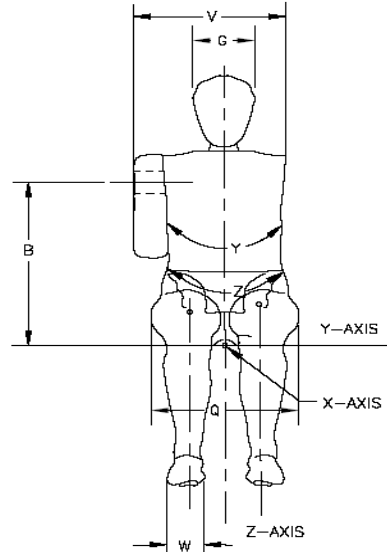
Symbol	Description	Specification (mm)		Result (mm)	Pass/Fail
A	Sitting Height	772	788	782	Pass
B	Shoulder Pivot Height	437	453	443	Pass
C	H-point Height	79	89	85	Pass
D	H-point from seatback	141	151	144	Pass
E	Shoulder Pivot from Backline	97	107	101	Pass
F	Thigh Clearance	119	135	123	Pass
G	Head Breadth	140	148	142	Pass
H	Head Back from Backline	40	46	43	Pass
I	Head Depth	178	188	181	Pass
J	Head Circumference	541	551	545	Pass
K	Buttock to Knee Length	514	540	529	Pass
L	Popliteal Height	343	369	356	Pass
M	Knee Pivot to floor height	392	409	401	Pass
N	Buttock Popliteal Length	416	442	430	Pass
O	Chest Depth w/o jacket	195	211	198	Pass
P	Foot Length	216	232	221	Pass
Q	Hip Breadth (w/pelvic plugs)	313	323	317	Pass
R	Arm Length	249	259	252	Pass
S	Knee Joint to seatback	477	493	482	Pass
V	Shoulder Width	341	357	350	Pass
W	Foot Width	78	94	85	Pass
Y	Chest Circumference w/jacket	851	881	876	Pass
Z	Waist Circumference	761	791	779	Pass

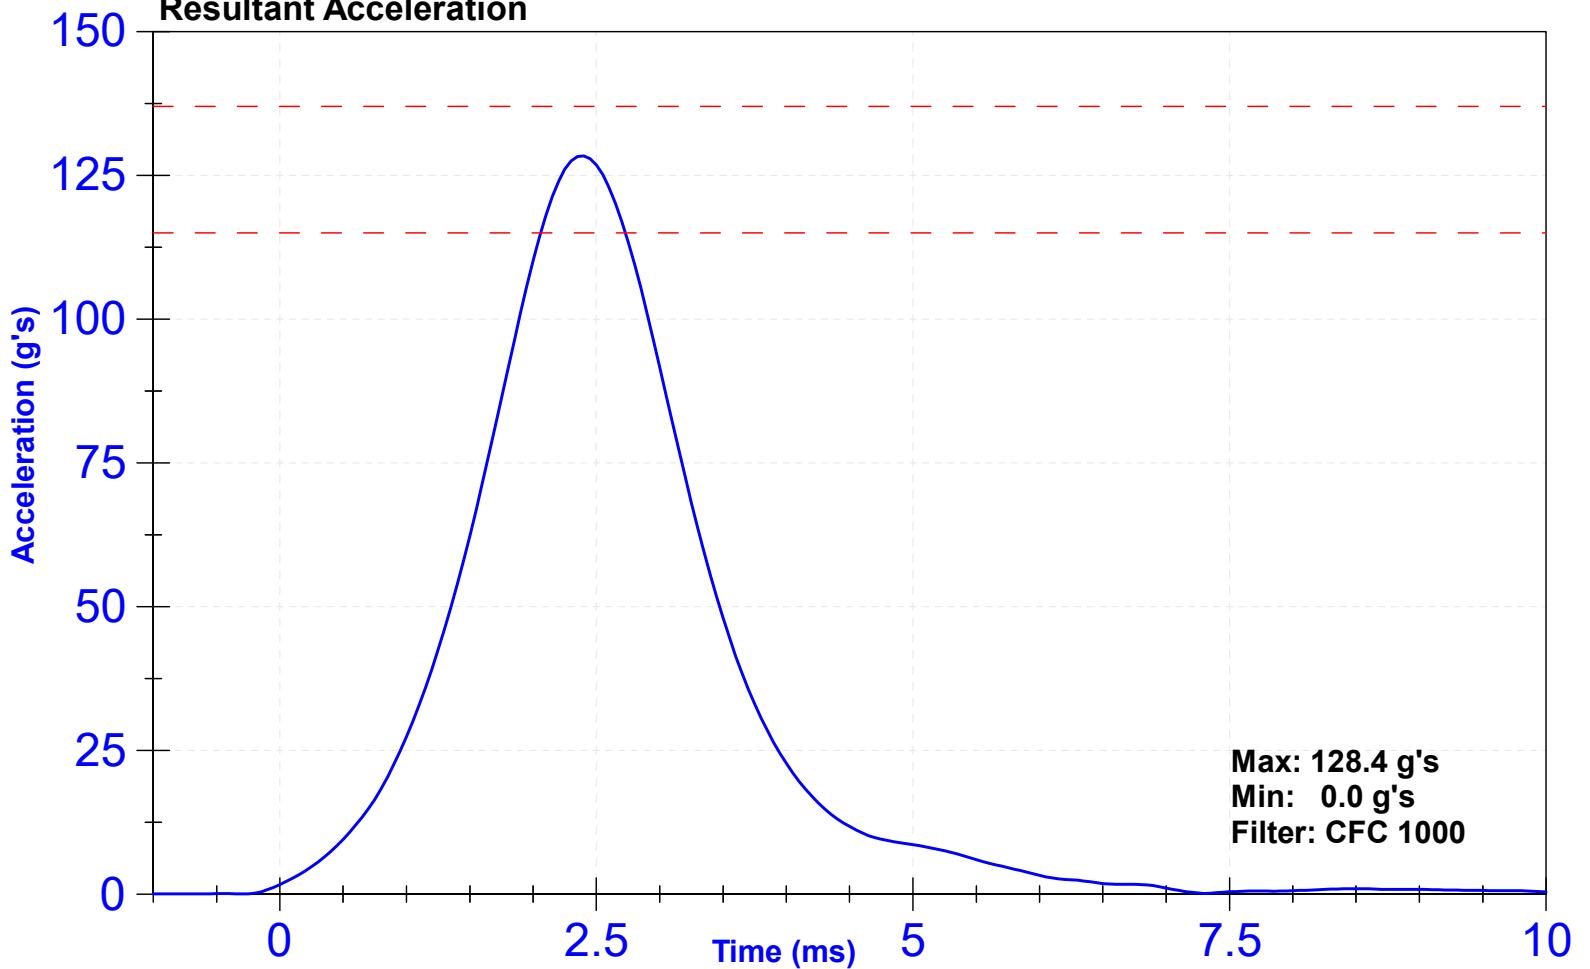
Test Parameter	Minimum Specification	Maximum Specification	Unit	Result	Pass/Fail
Temperature	20.6	22.2	°C	22	Pass
Humidity	10	70	%	60	Pass
Resultant Acceleration	115	137	g's	128.4	Pass
Oscillation	0	15	%	1.3	Pass
Fore-Aft Acceleration	-15	15	g's	0.0	Pass

Resultant Acceleration

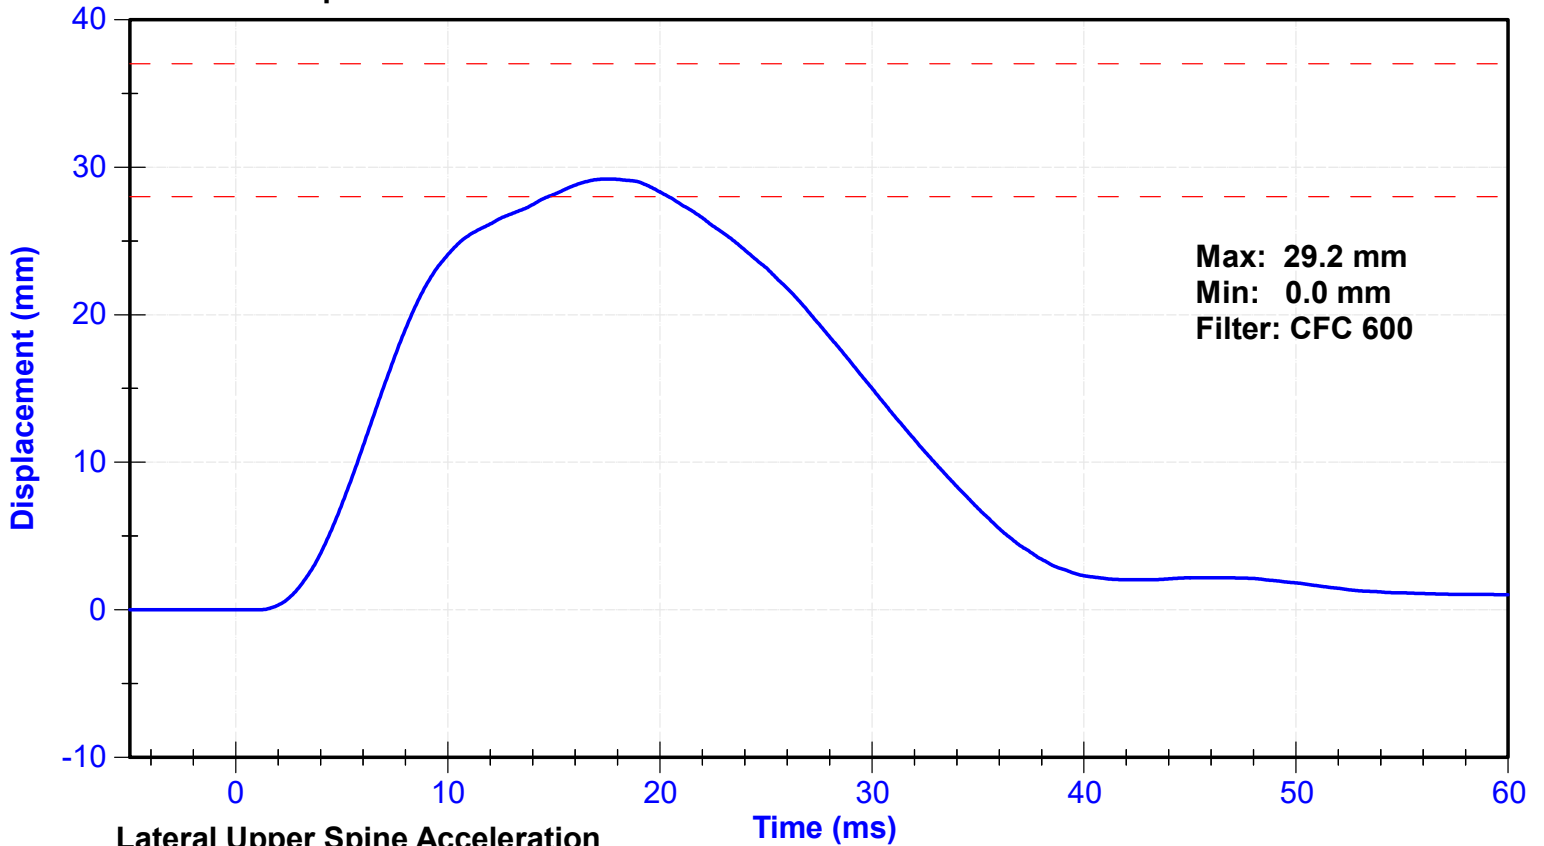
Test Parameter	Minimum Specification	Maximum Specification	Unit	Result	Pass/Fail
Temperature	20.6	22.2	°C	22.1	Pass
Humidity	10	70	%	58	Pass
Velocity	4.2	4.4	m/s	4.30	Pass
Probe Acceleration	13	18	g's	15.9	Pass
Shoulder Deflection	28	37	mm	29.2	Pass
Lateral Upper Spine Acceleration	17	22	g's	19.0	Pass

Shoulder Displacement

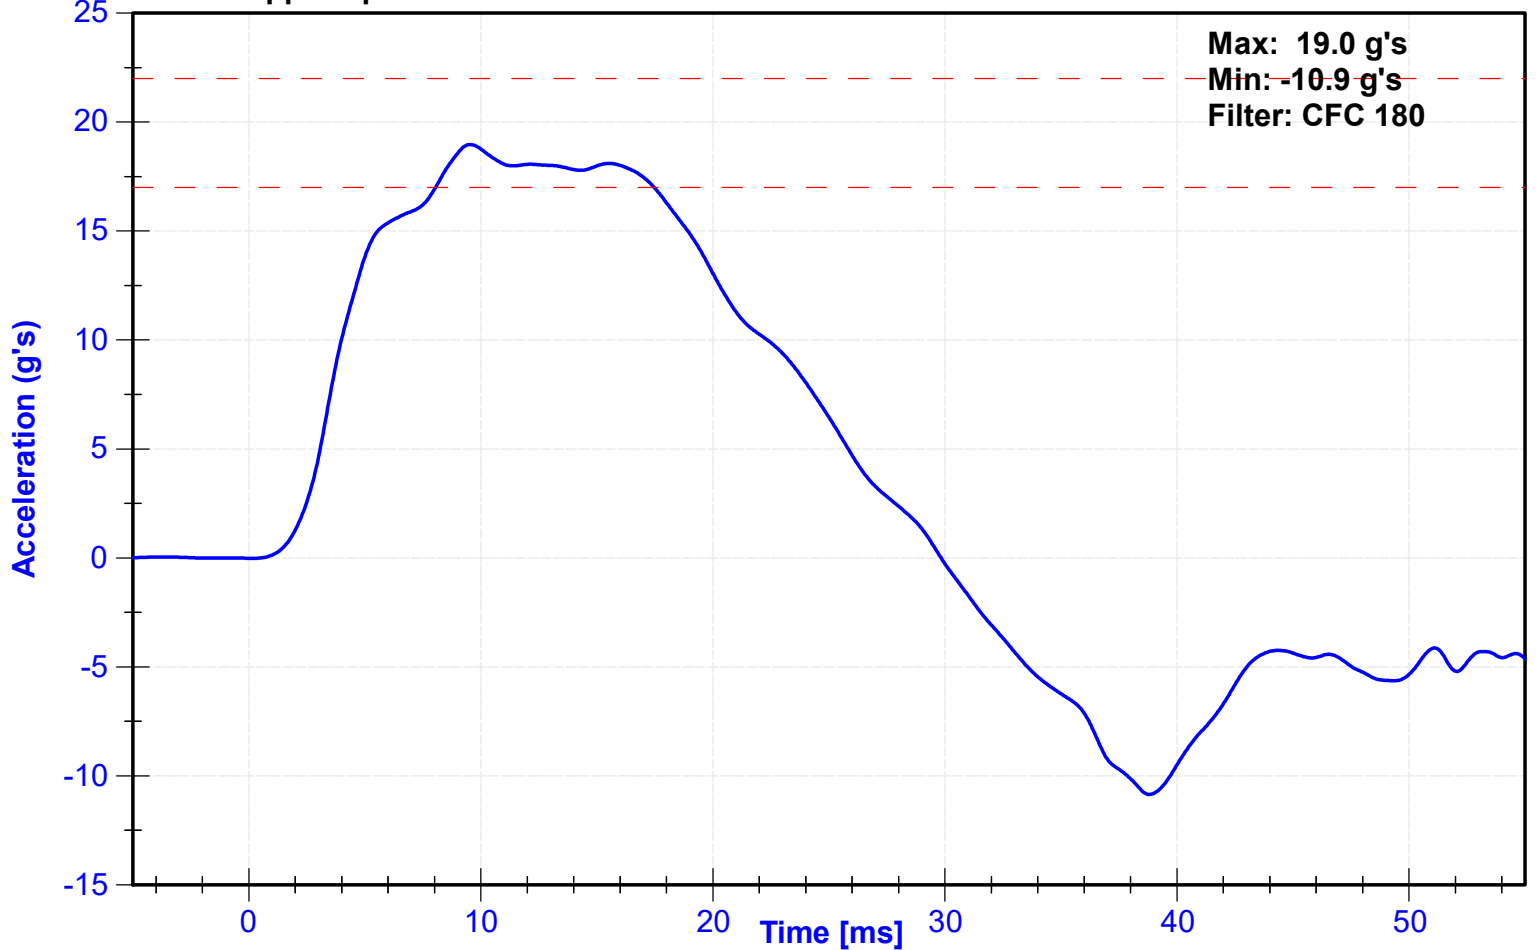
Lateral Upper Spine Acceleration

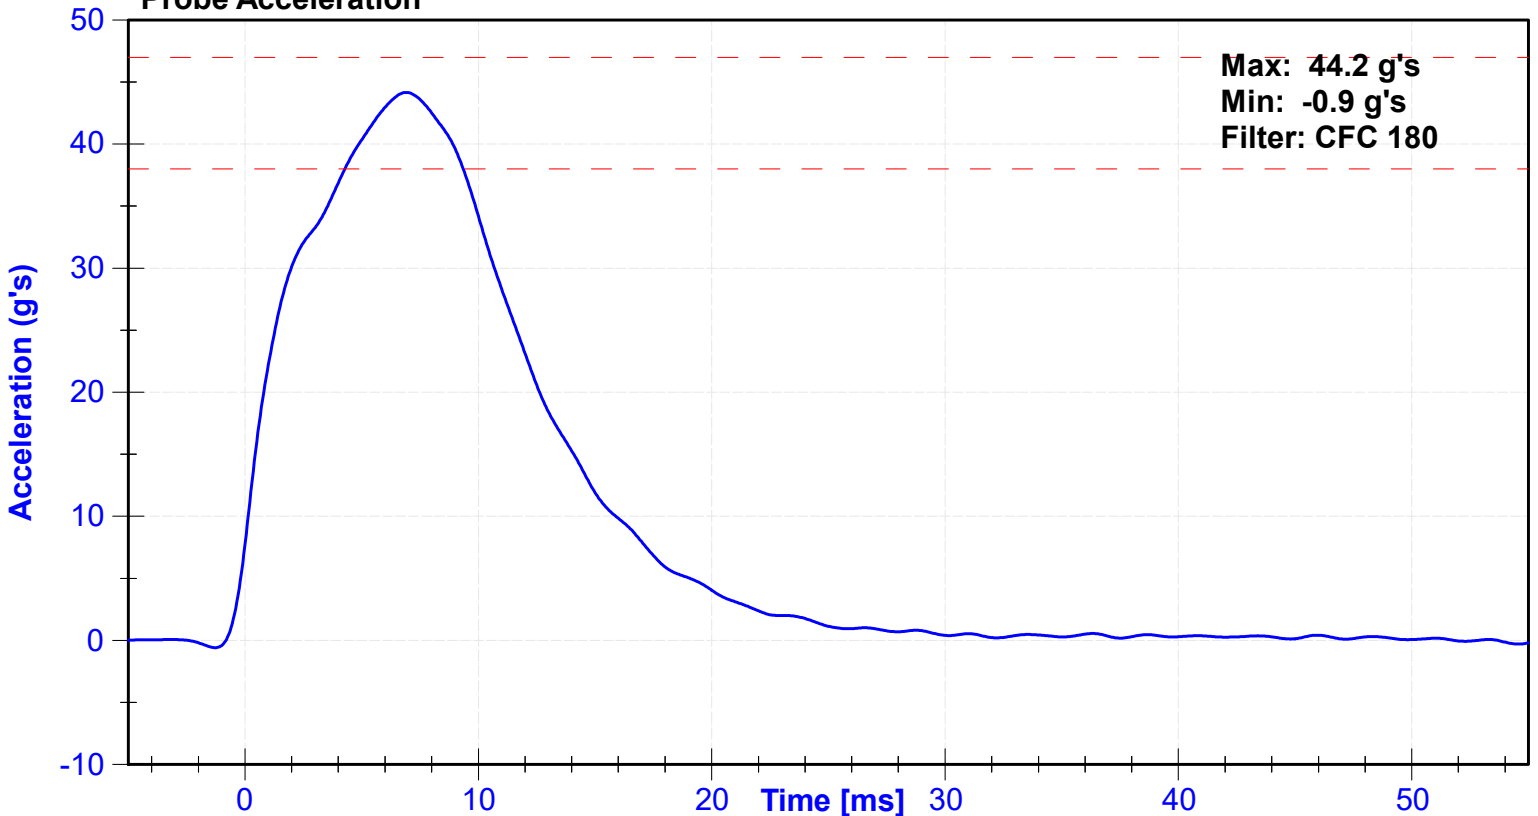
Test Parameter	Minimum Specification	Maximum Specification	Unit	Result	Pass/Fail
Temperature	20.6	22.2	°C	22.1	Pass
Humidity	10	70	%	58	Pass
Velocity	6.6	6.8	m/s	6.70	Pass
Probe Acceleration	38	47	g's	44.2	Pass
Lateral Pelvis Acceleration after 6ms	34	42	g's	39.1	Pass
Acetabulum Force	3600	4300	N	3975.8	Pass

Probe Acceleration

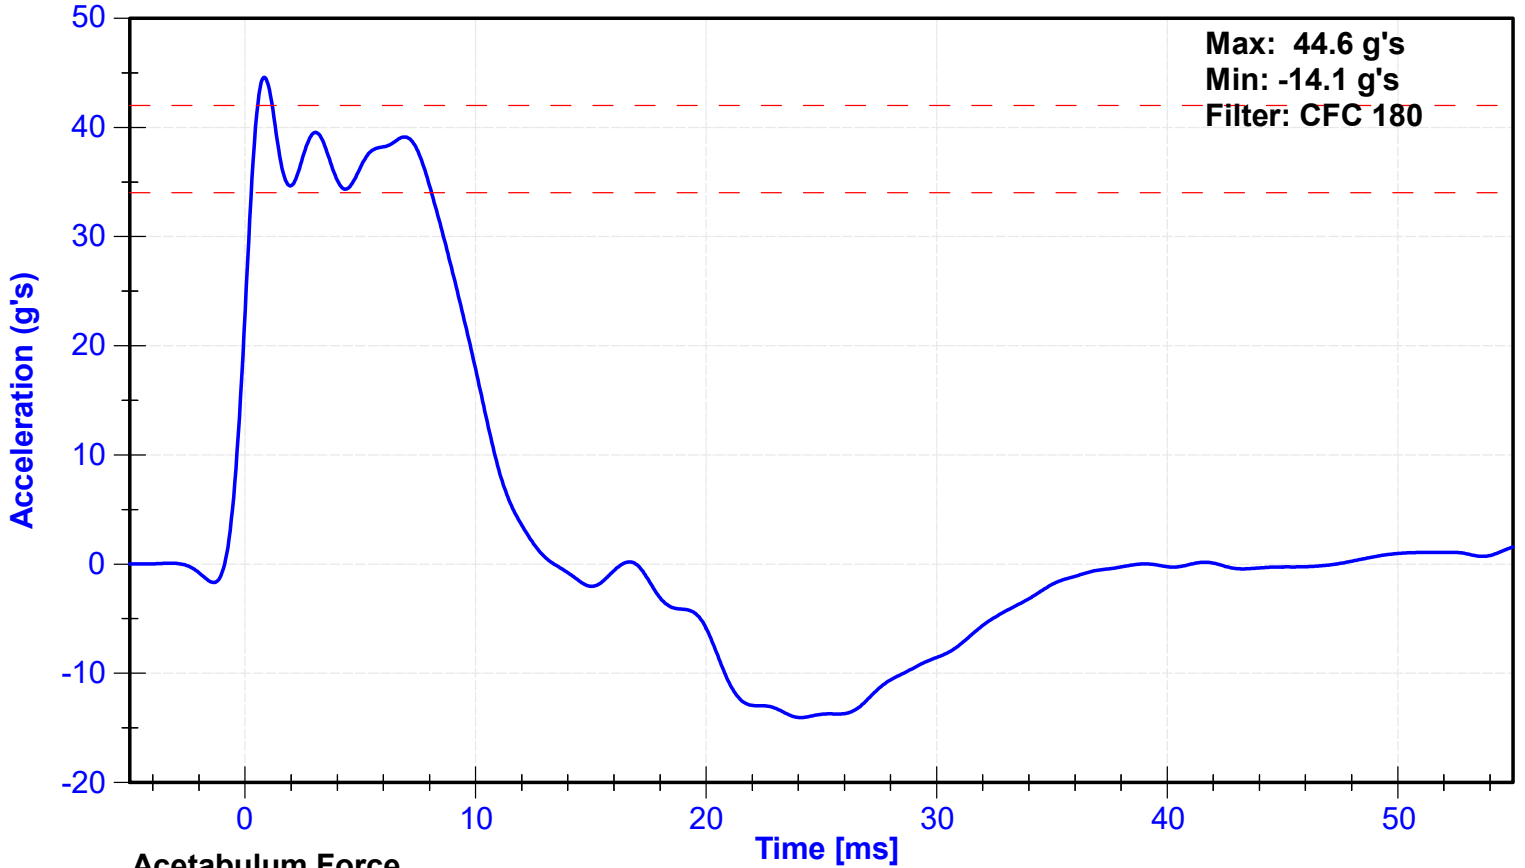
Lateral Pelvis Acceleration

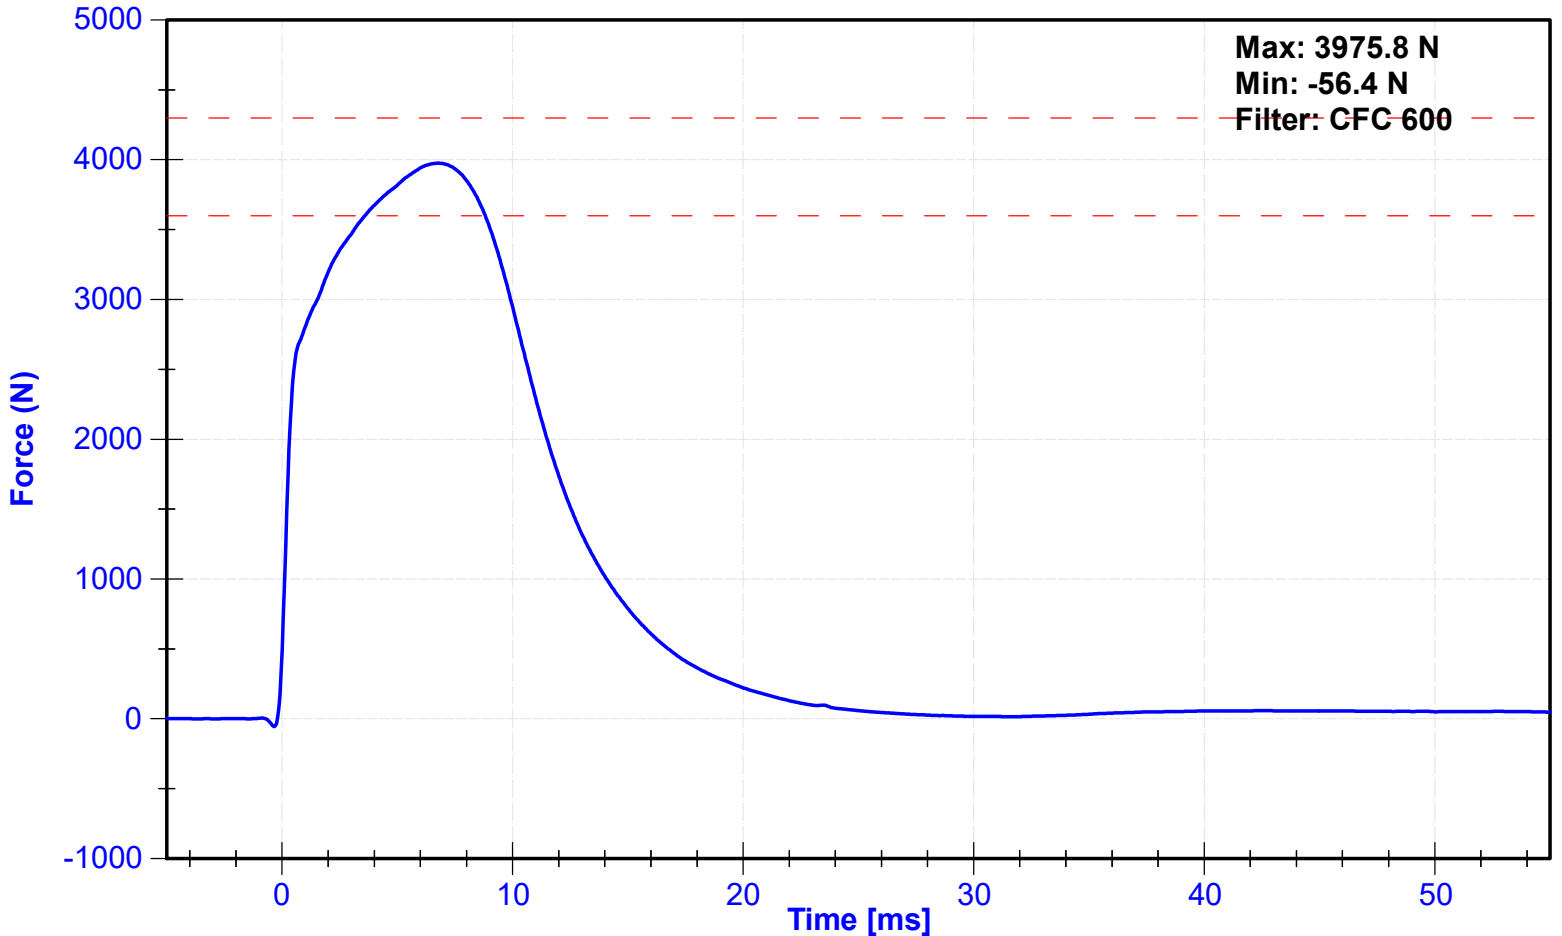
Acetabulum Force

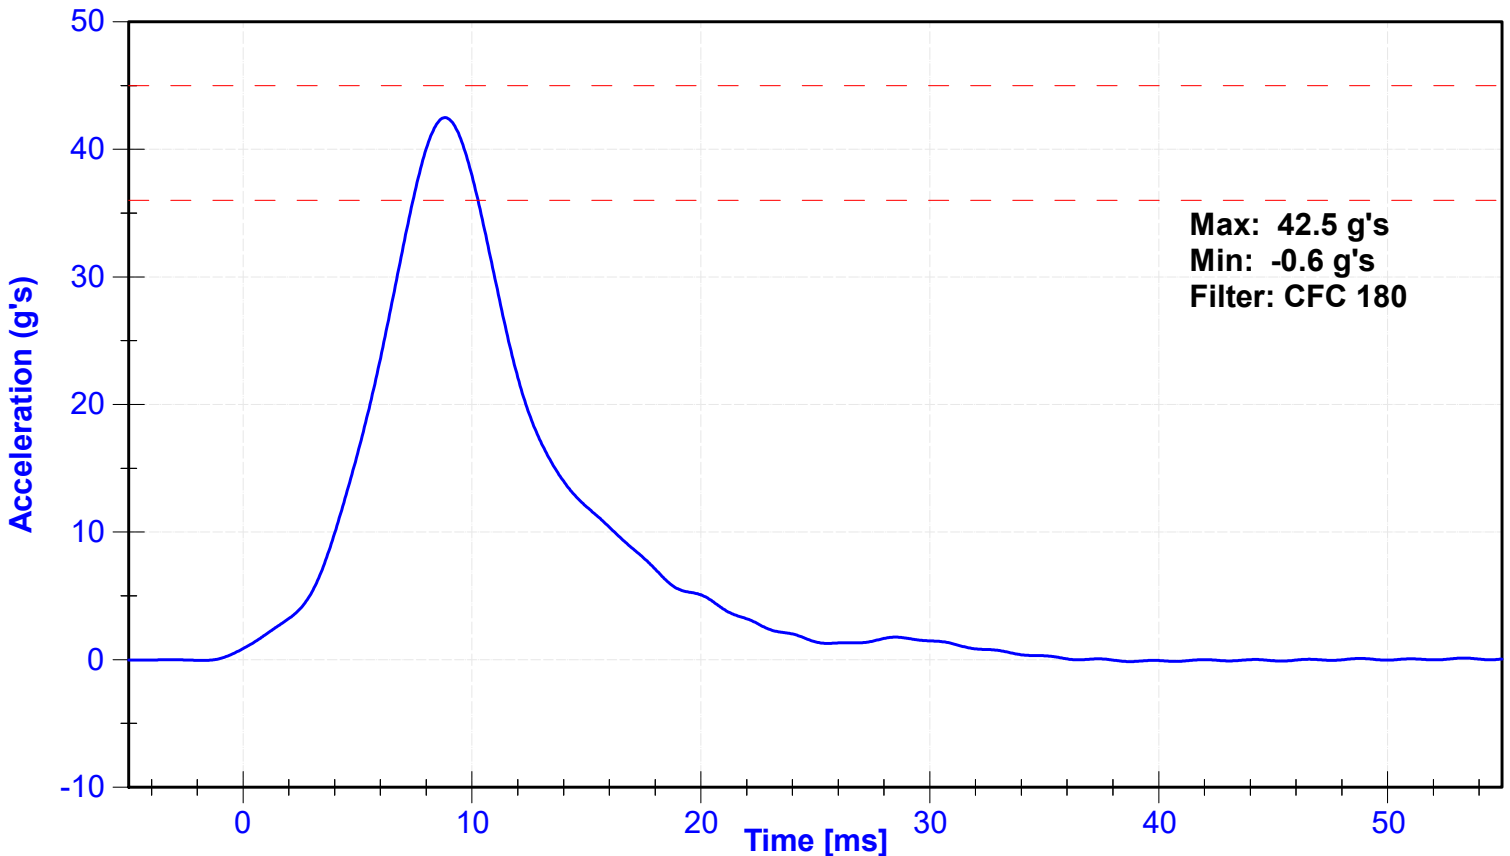
Test Parameter	Minimum Specification	Maximum Specification	Unit	Result	Pass/Fail
Temperature	20.6	22.2	°C	22.1	Pass
Humidity	10	70	%	58	Pass
Velocity	4.2	4.4	m/s	4.29	Pass
Probe Acceleration	36	45	g's	42.5	Pass
Lateral Pelvis Acceleration	28	39	g's	33.2	Pass
Iliac Force	4100	5100	N	4688.4	Pass

Probe Acceleration

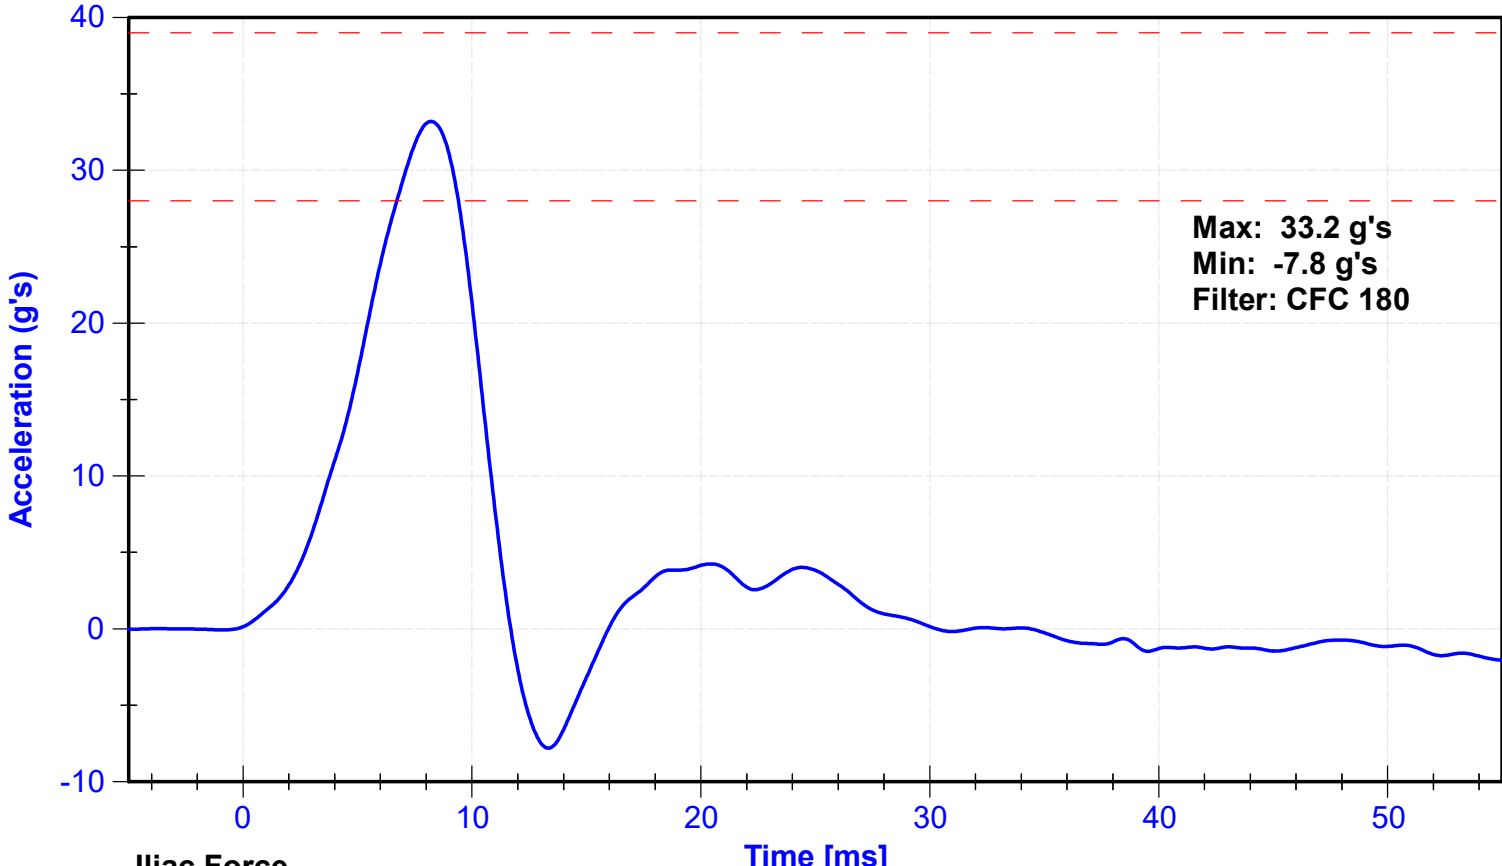
Lateral Pelvis Acceleration

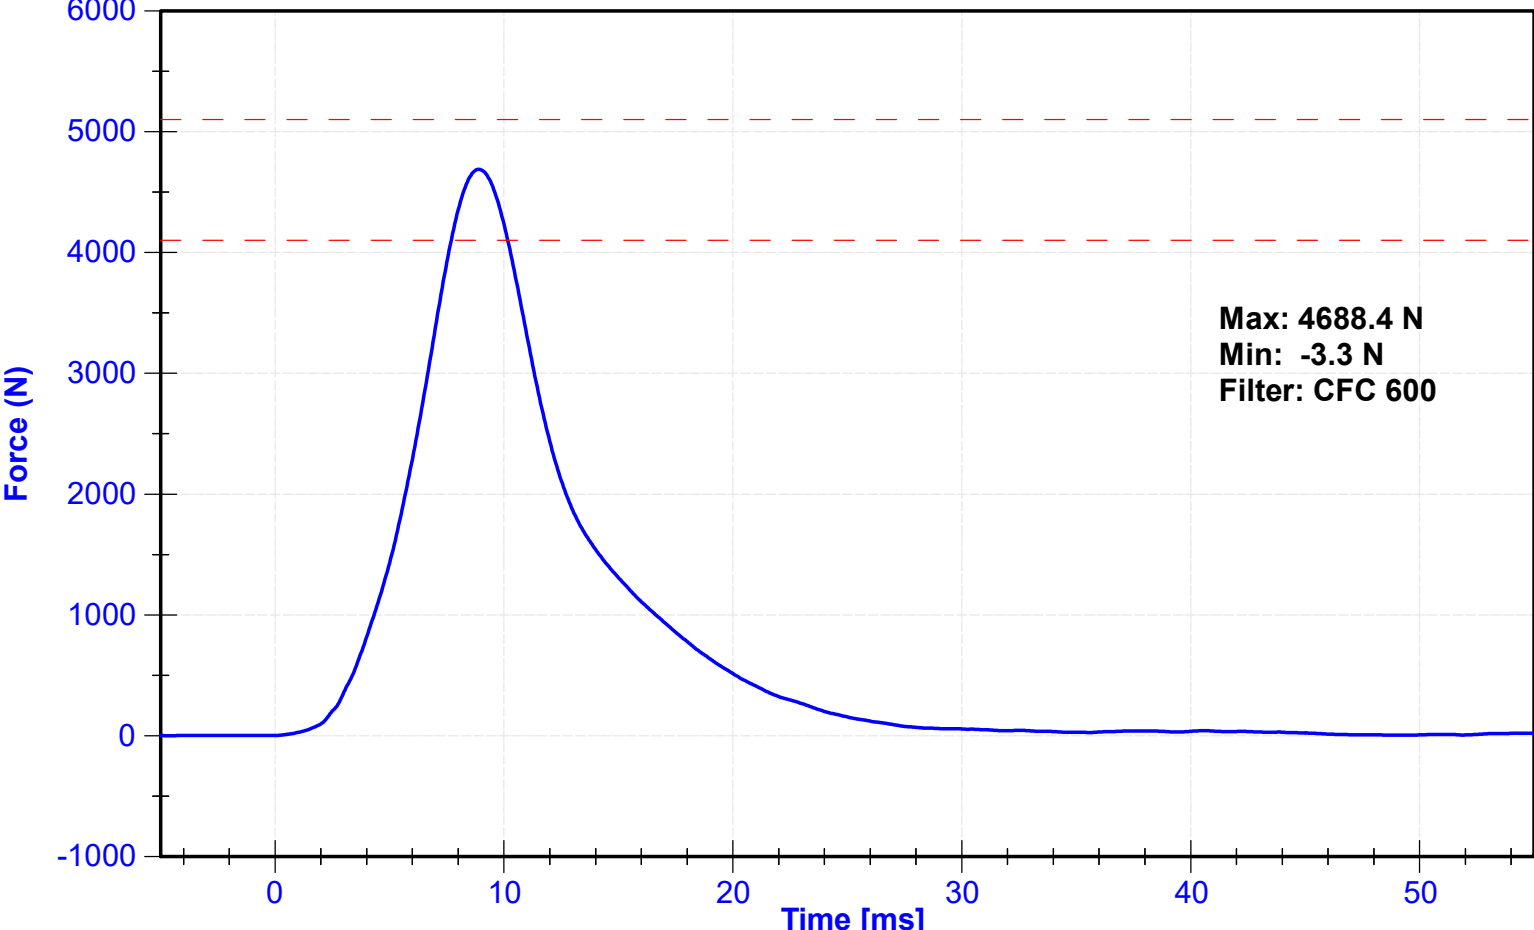
Iliac Force

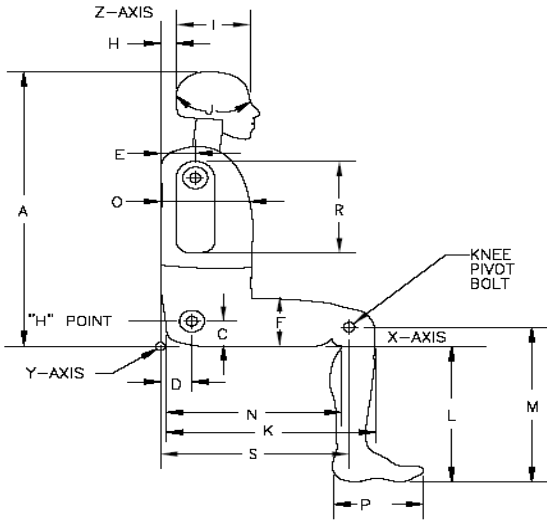
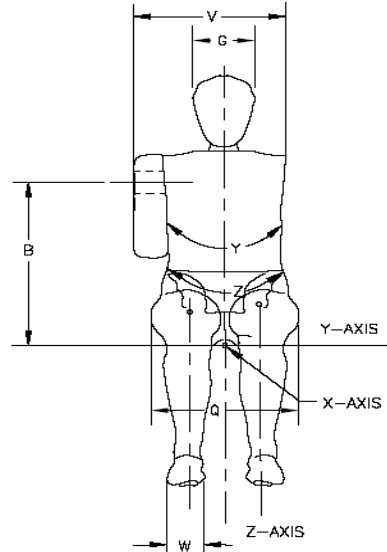
Symbol	Description	Specification (mm)		Result (mm)	Pass/Fail
A	Sitting Height	772	788	782	Pass
B	Shoulder Pivot Height	437	453	444	Pass
C	H-point Height	79	89	85	Pass
D	H-point from seatback	141	151	144	Pass
E	Shoulder Pivot from Backline	97	107	101	Pass
F	Thigh Clearance	119	135	124	Pass
G	Head Breadth	140	148	142	Pass
H	Head Back from Backline	40	46	43	Pass
I	Head Depth	178	188	180	Pass
J	Head Circumference	541	551	545	Pass
K	Buttock to Knee Length	514	540	529	Pass
L	Popliteal Height	343	369	357	Pass
M	Knee Pivot to floor height	392	409	401	Pass
N	Buttock Popliteal Length	416	442	430	Pass
O	Chest Depth w/o jacket	195	211	198	Pass
P	Foot Length	216	232	220	Pass
Q	Hip Breadth (w/pelvic plugs)	313	323	317	Pass
R	Arm Length	249	259	252	Pass
S	Knee Joint to seatback	477	493	482	Pass
V	Shoulder Width	341	357	351	Pass
W	Foot Width	78	94	85	Pass
Y	Chest Circumference w/jacket	851	881	876	Pass
Z	Waist Circumference	761	791	778	Pass

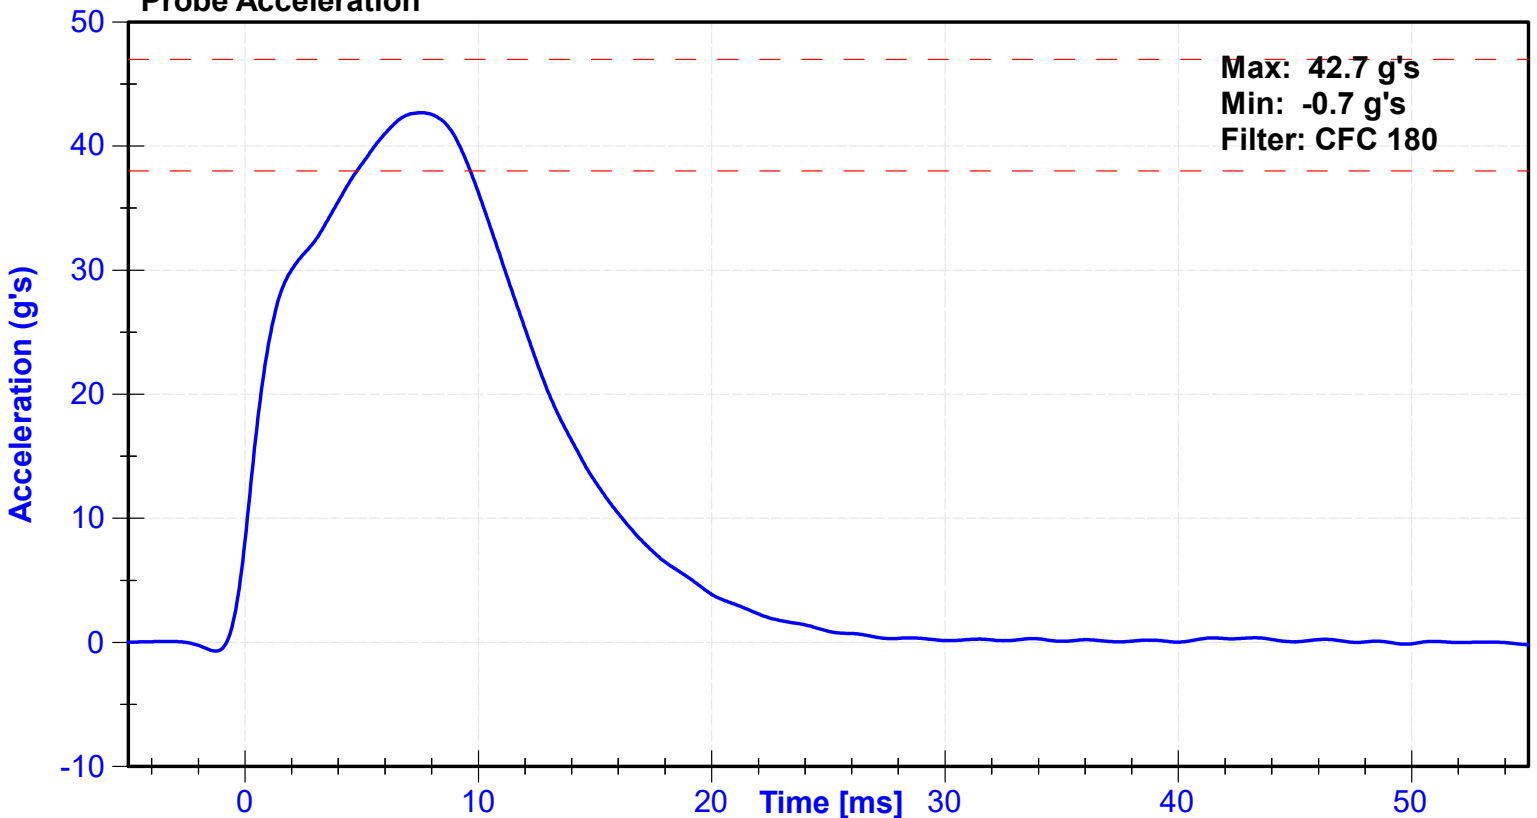
Test Parameter	Minimum Specification	Maximum Specification	Unit	Result	Pass/Fail
Temperature	20.6	22.2	°C	21.8	Pass
Humidity	10	70	%	62	Pass
Velocity	6.6	6.8	m/s	6.70	Pass
Probe Acceleration	38	47	g's	42.7	Pass
Lateral Pelvis Acceleration after 6ms	34	42	g's	36.6	Pass
Acetabulum Force	3600	4300	N	3905.7	Pass

Probe Acceleration
