**NEW CAR ASSESSMENT PROGRAM (NCAP)
SIDE IMPACT POLE TEST**

**Hyundai Motor Company
2023 Genesis GV70
5 Door SUV**

NHTSA No: M20234204

**PREPARED BY:
CALSPAN CORPORATION
P.O. BOX 400
BUFFALO, NEW YORK 14225**

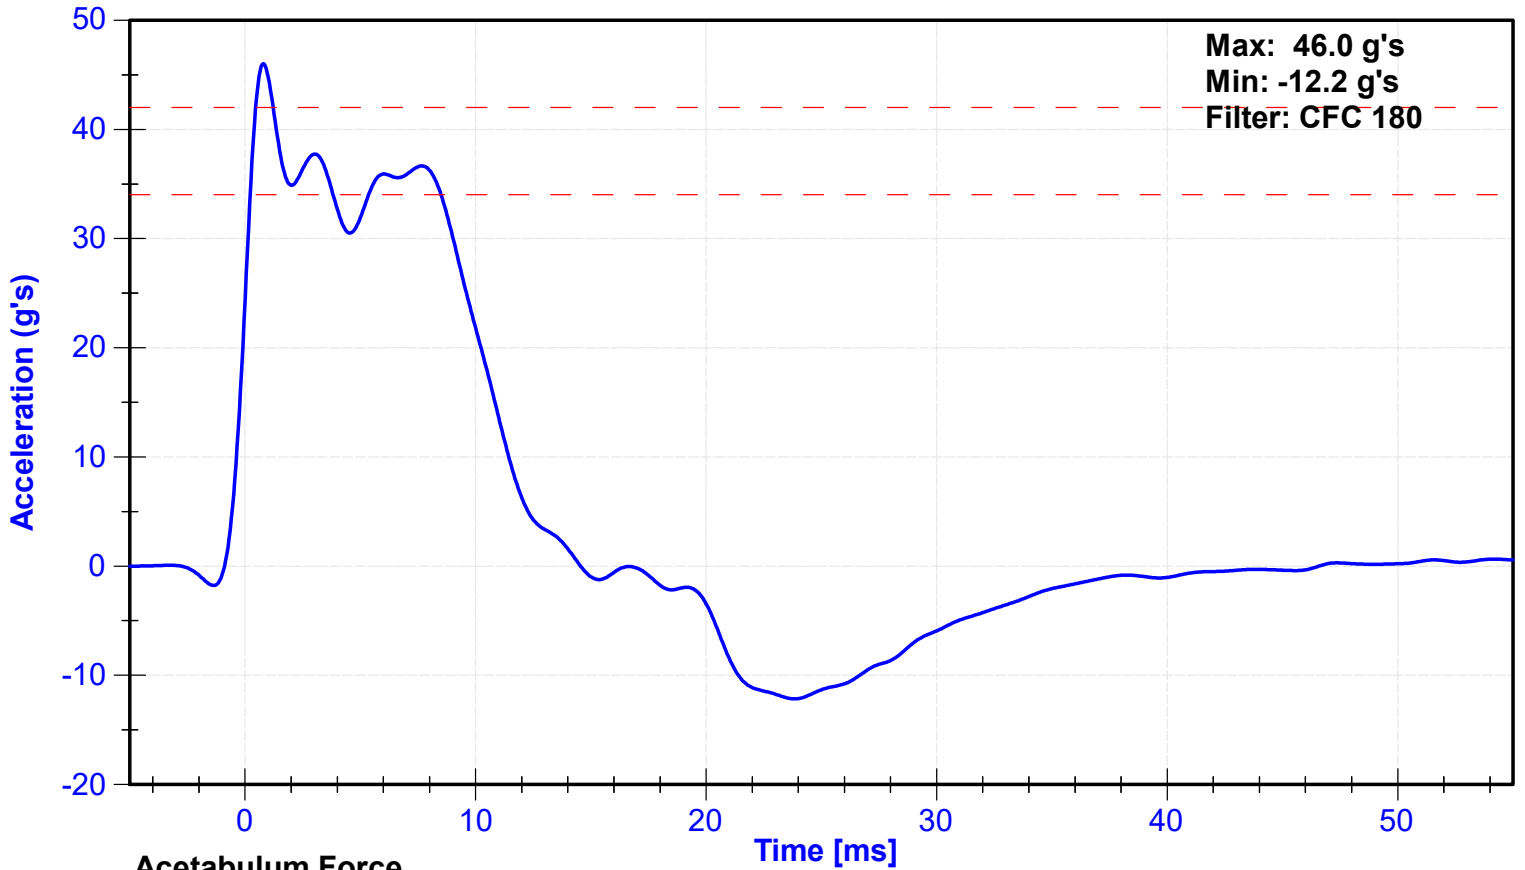
Lateral Pelvis Acceleration

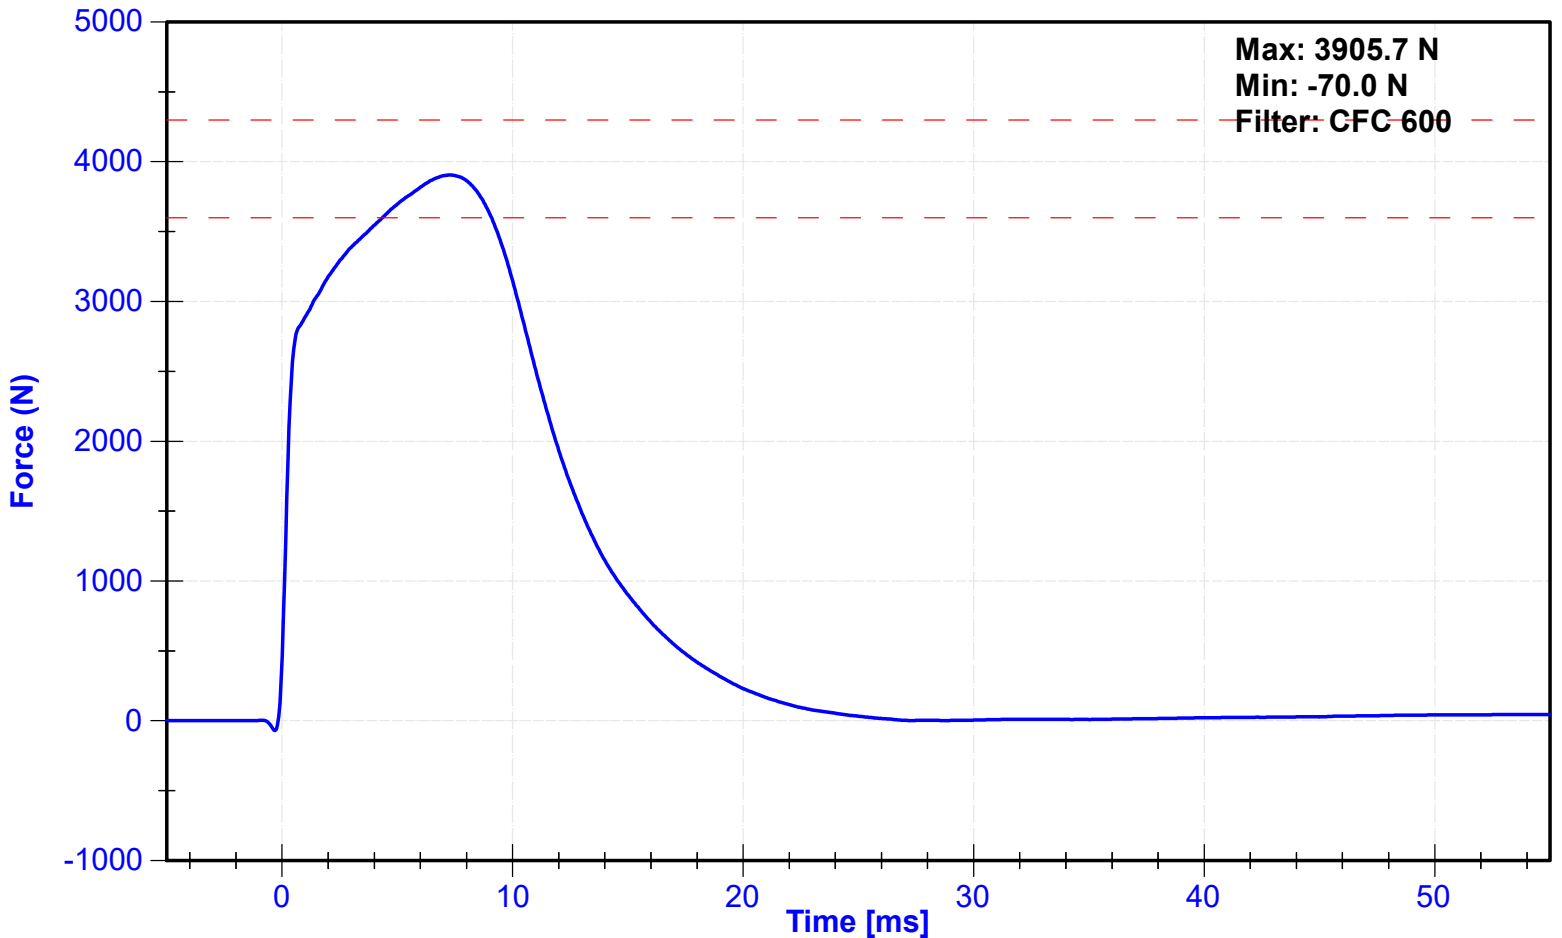
Acetabulum Force

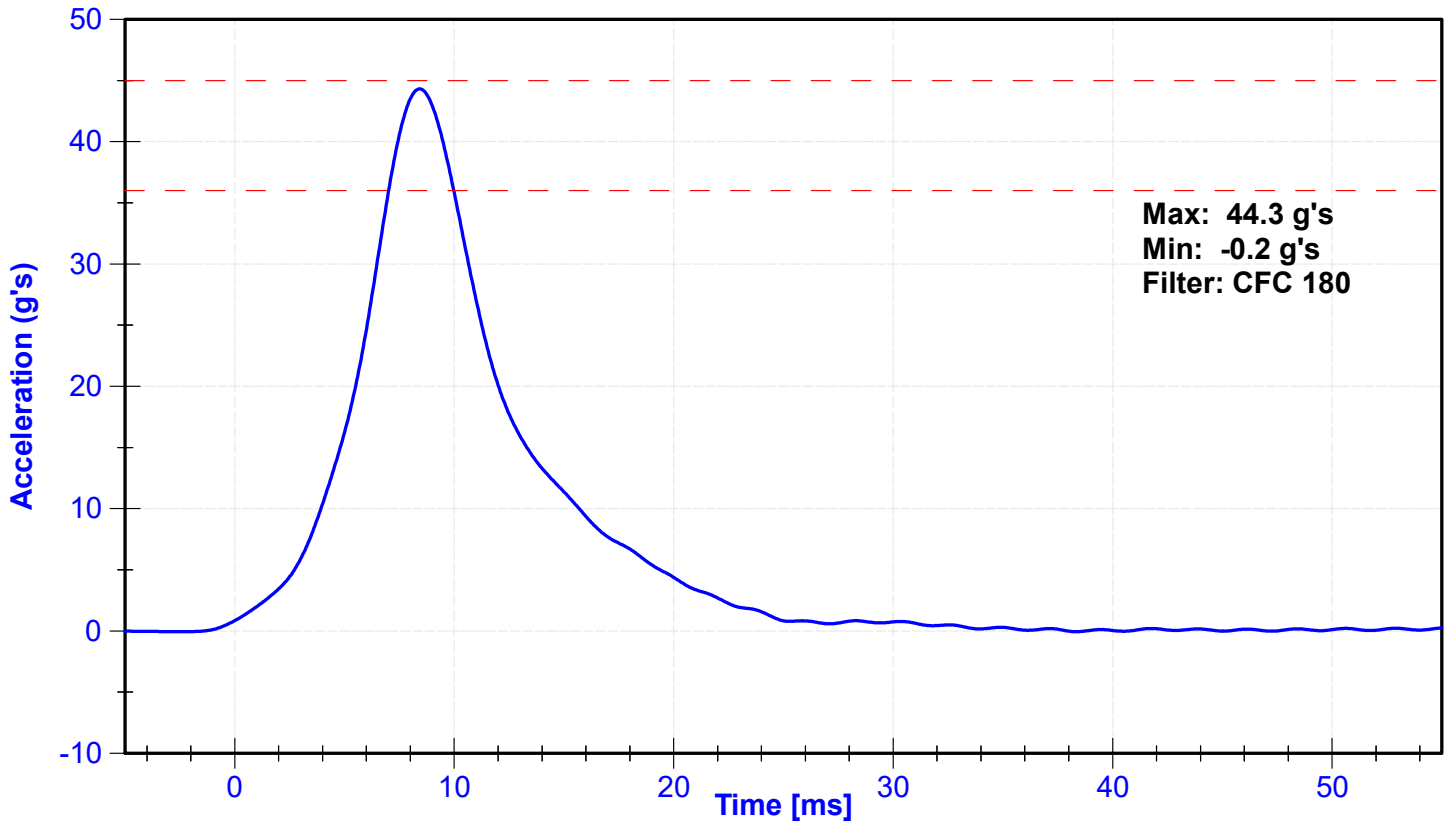
Test Parameter	Minimum Specification	Maximum Specification	Unit	Result	Pass/Fail
Temperature	20.6	22.2	°C	21.8	Pass
Humidity	10	70	%	60	Pass
Velocity	4.2	4.4	m/s	4.24	Pass
Probe Acceleration	36	45	g's	44.3	Pass
Lateral Pelvis Acceleration	28	39	g's	37.7	Pass
Iliac Force	4100	5100	N	4905.9	Pass

Probe Acceleration

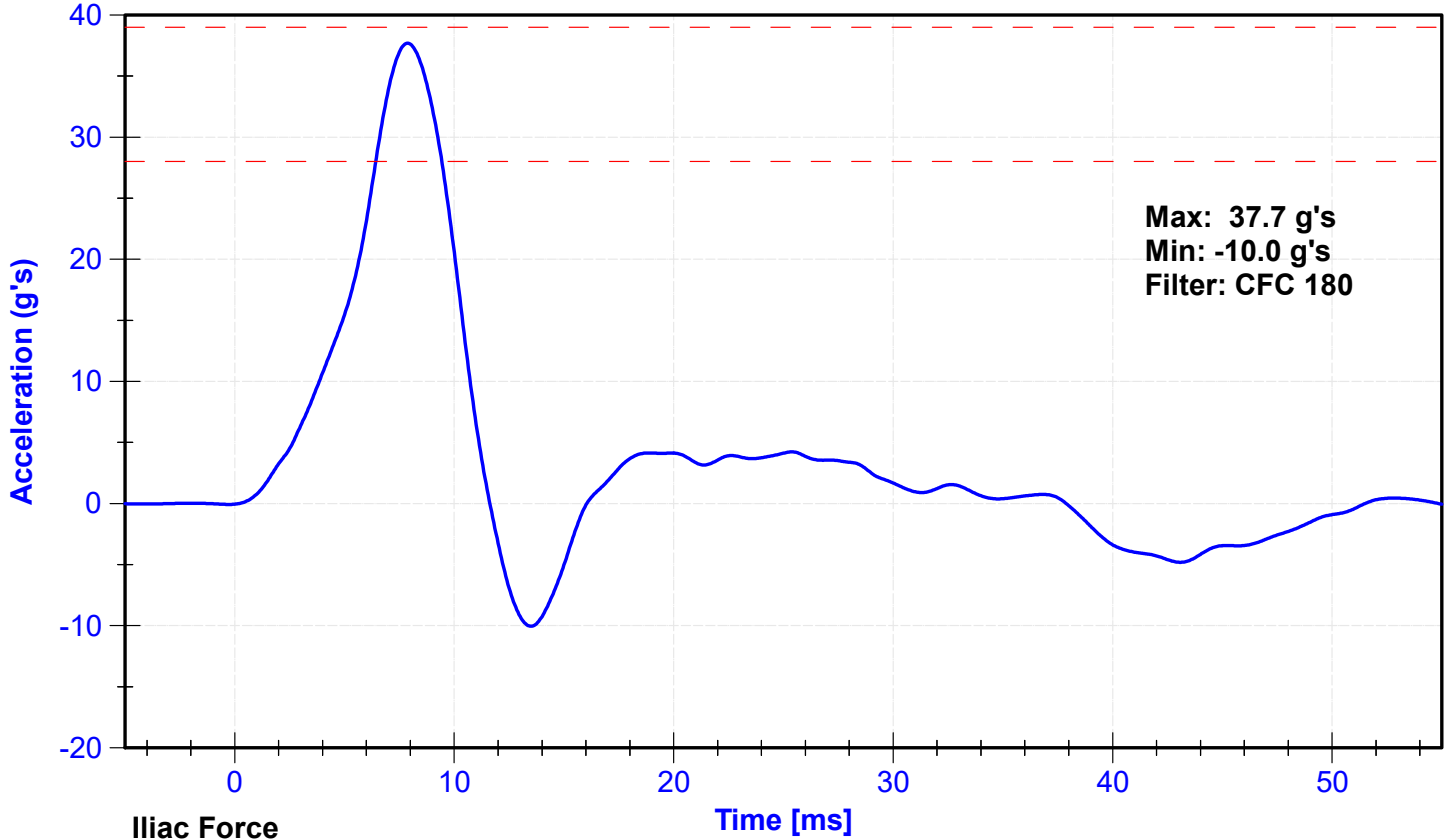
Lateral Pelvis Acceleration

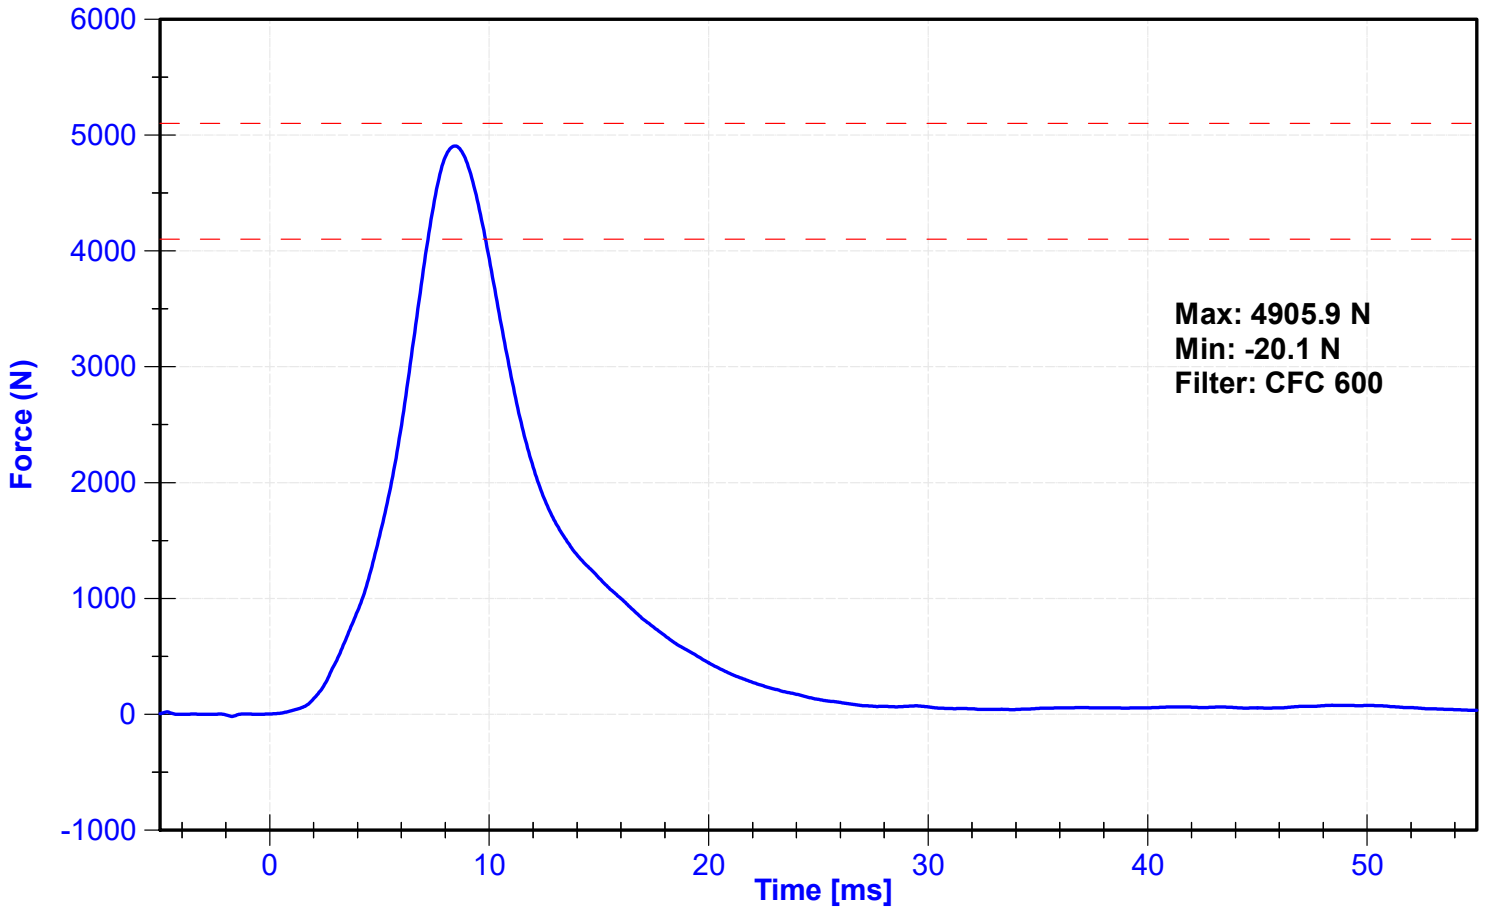
Iliac Force
