REPORT NUMBER: SINCAP-CAL-23-006

**NEW CAR ASSESSMENT PROGRAM (NCAP)
MOVING DEFORMABLE BARRIER SIDE IMPACT TEST**

**Mazda Motor Manufacturing De Mexico S.A. De C.V.
2023 Mazda CX-30
5 Door SUV**

NHTSA No: O20235401

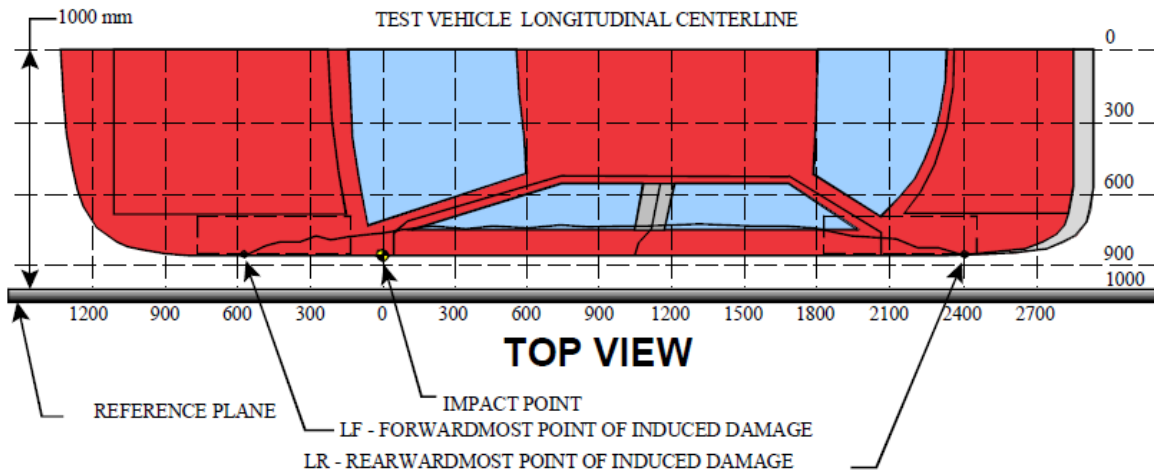
**DATA SHEET NO. 13
VEHICLE AND MDB DAMAGE PROFILE DISTANCES**

For guidance regarding damage profile distance measurements, please refer to the latest version of the *NHTSA Test Reference Guide, Volume 1: Vehicle Tests*.

MEASUREMENT CONVENTIONS:
 Forward of the impact point (towards front of vehicle) is considered negative (-).
 Rearward of the impact point (toward rearend of vehicle) is considered positive (+).

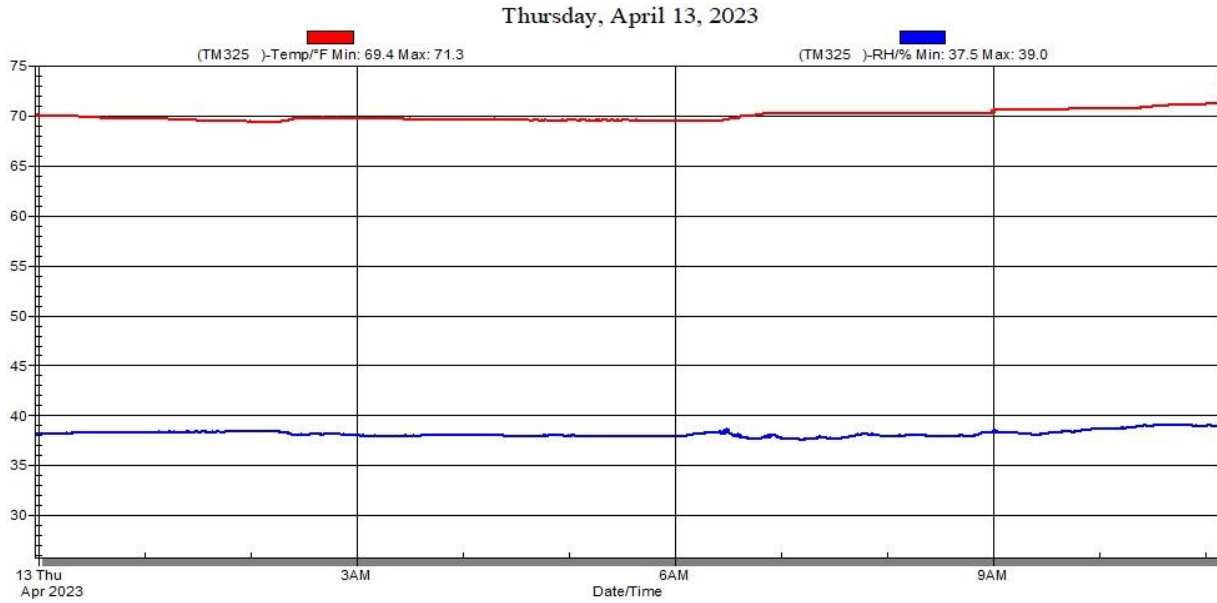
Temperature and Humidity Stabilization Chart/Data for Dummies and Test Vehicle
