REPORT NUMBER: SideNCAPMDB-KAR-24-004

**NEW CAR ASSESSMENT PROGRAM (NCAP)
MOVING DEFORMABLE BARRIER SIDE IMPACT TEST**

**SUBARU CORPORATION
2024 SUBARU CROSSTREK 5-DOOR SW**

NHTSA No: O20245502

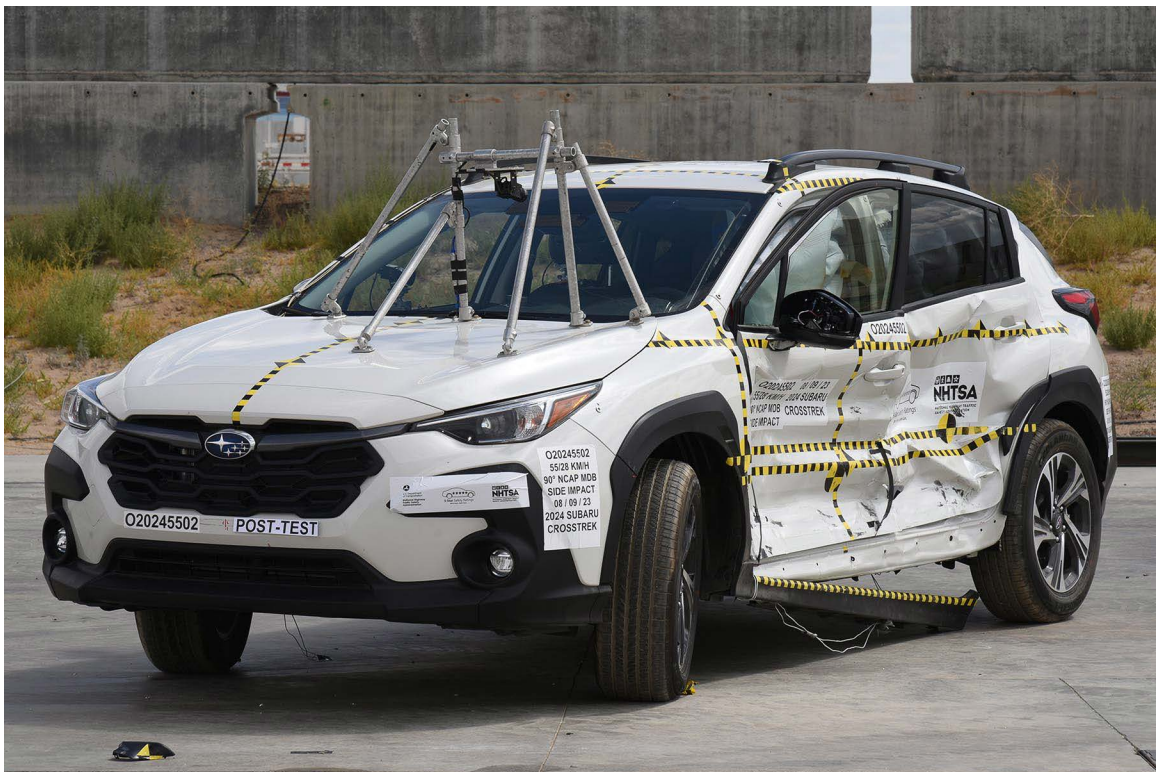
FIGURE 6. Post-Test Left Front 3/4 View of Test Vehicle

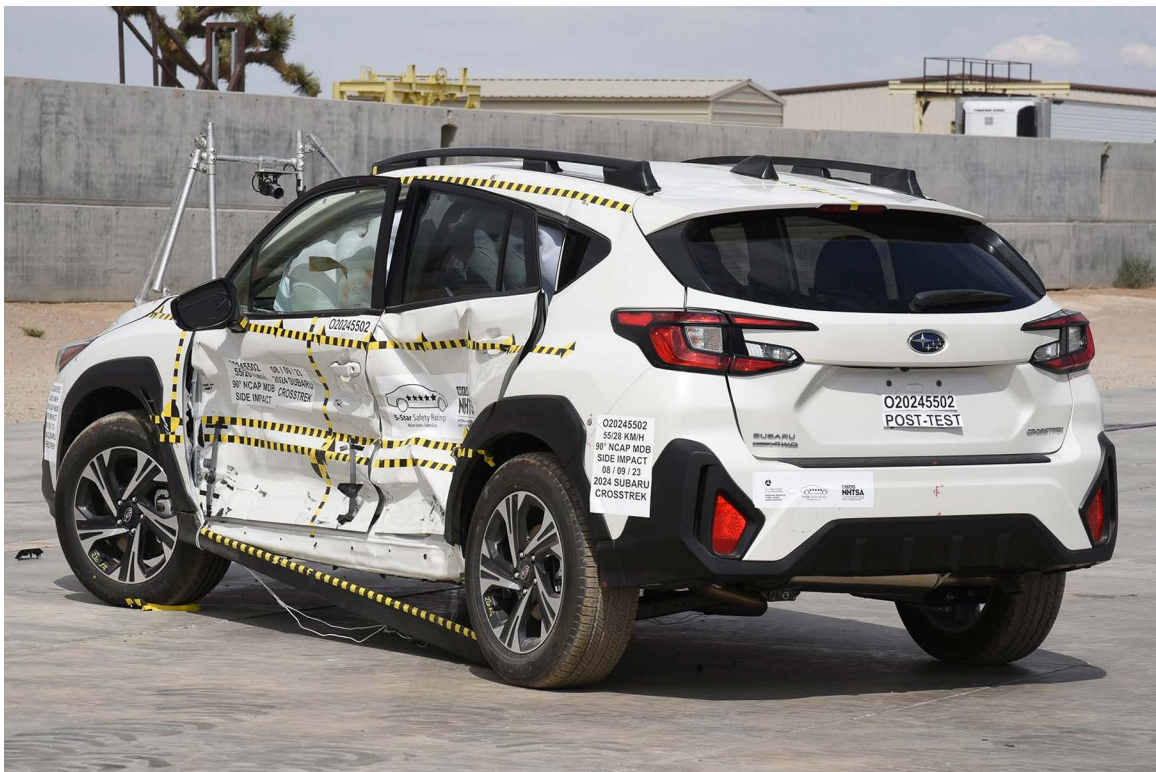
FIGURE 10. Post-Test Left Rear 3/4 View of Test Vehicle

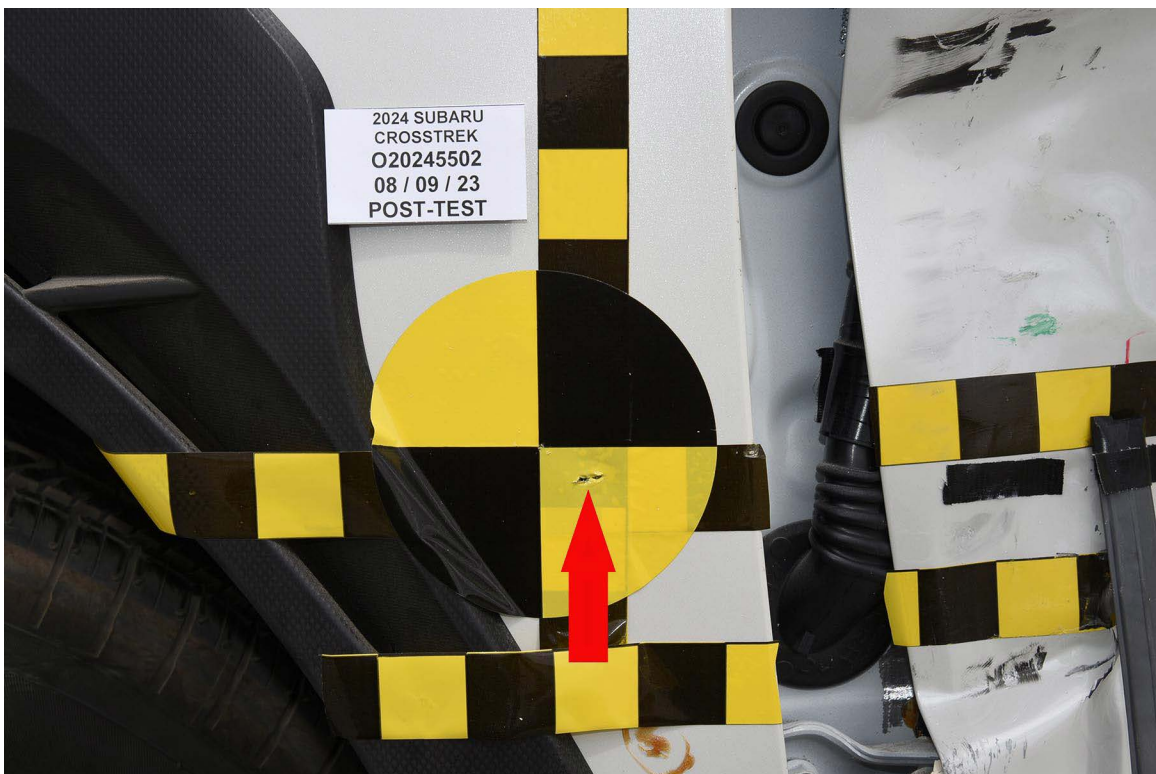
FIGURE 20. Post-Test Close-Up View of Impact Point Target

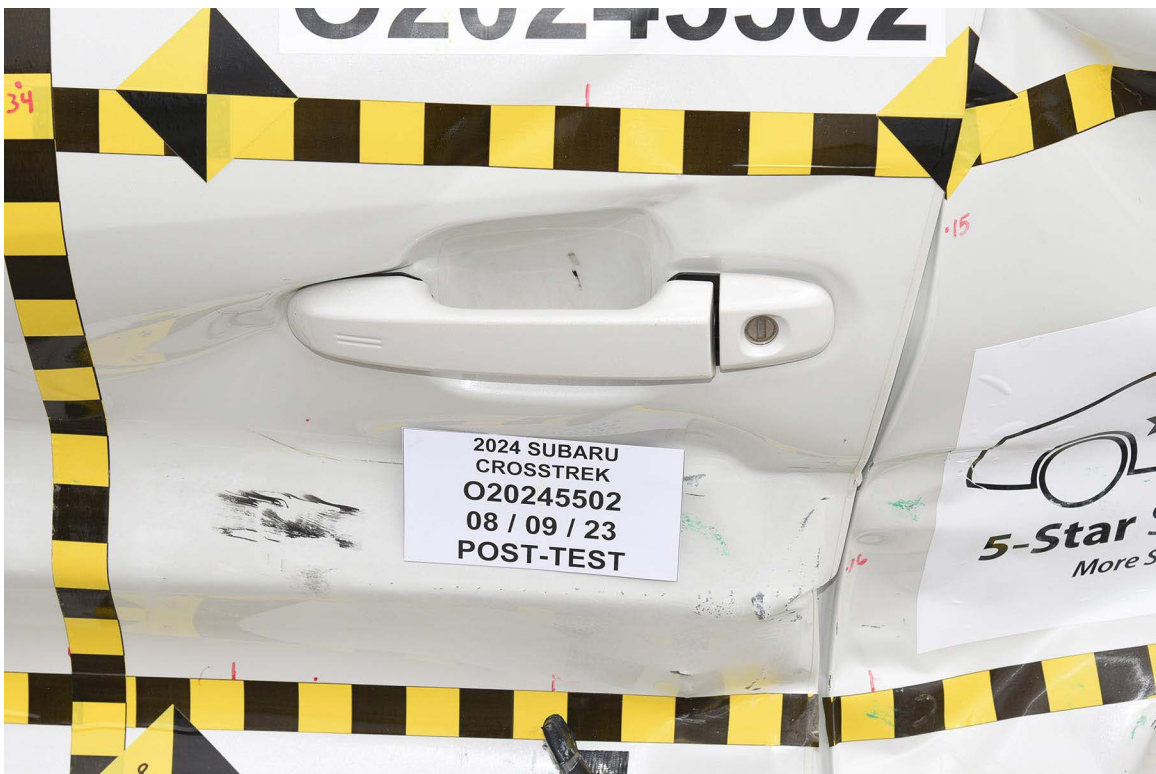
FIGURE 22. Post-Test Left Front Door Latch Close-Up

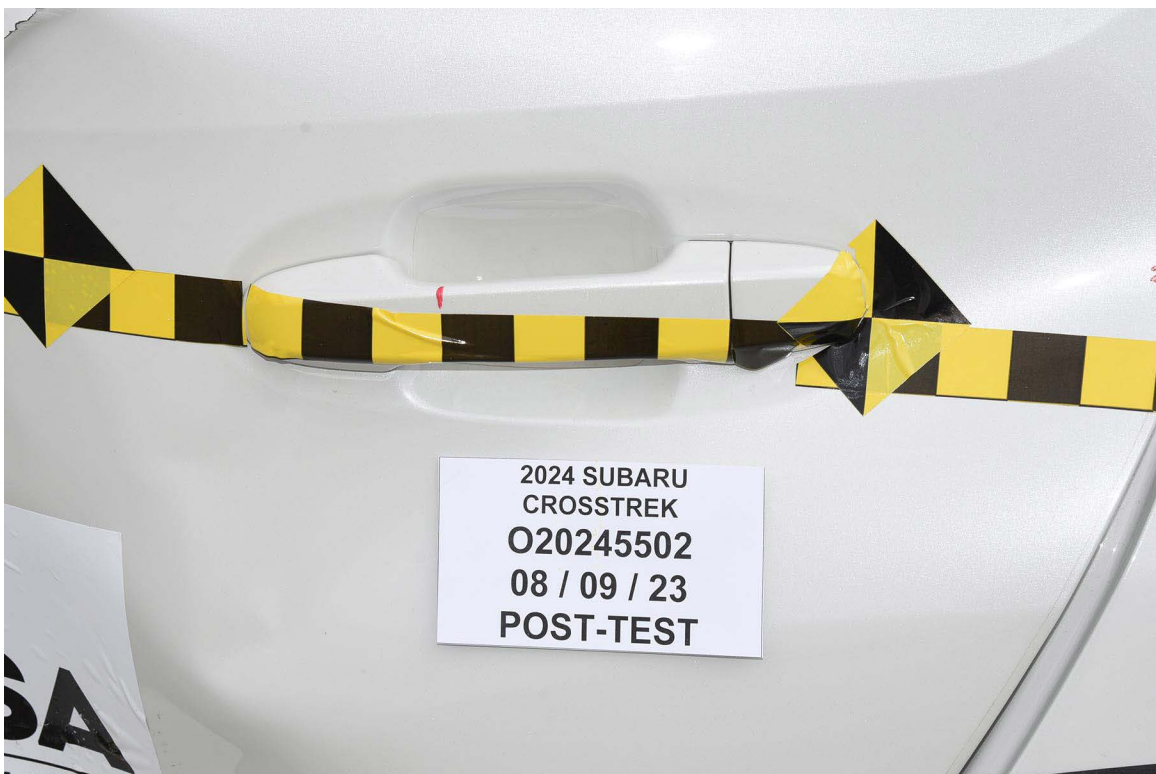
FIGURE 24. Post-Test Left Rear Door Latch Close-Up

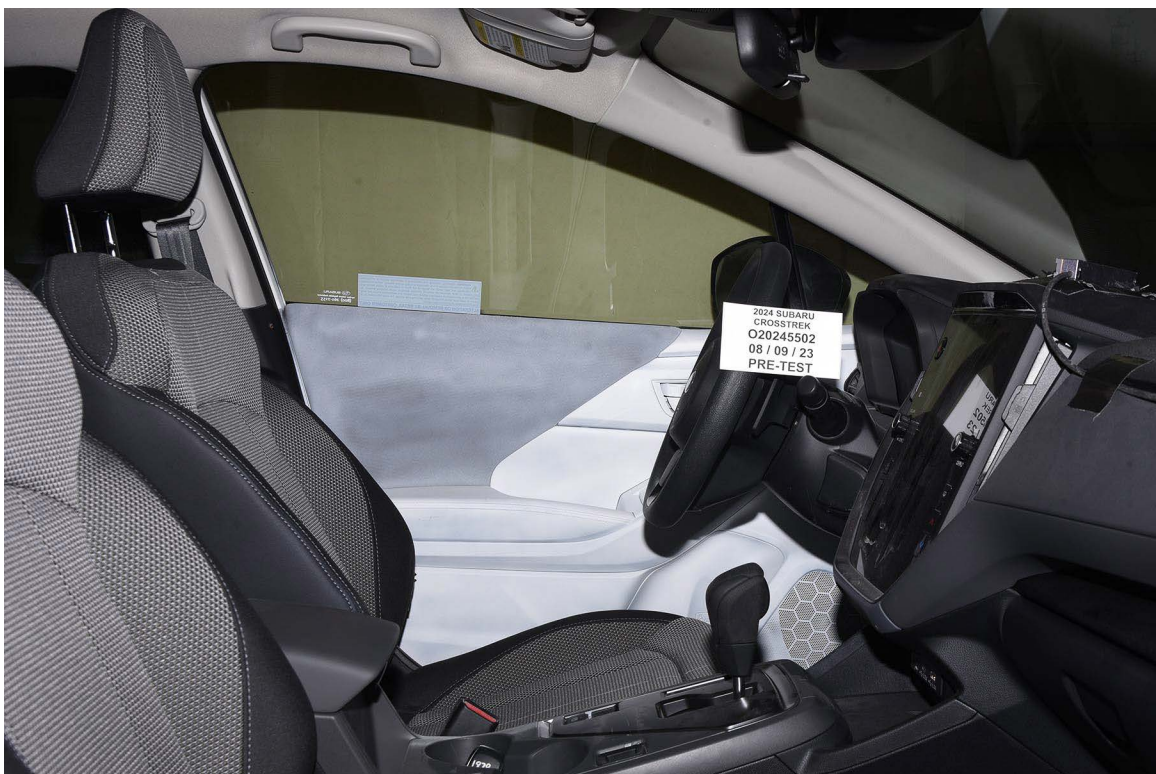
FIGURE 46. Pre-Test Driver Inner Door Panel View

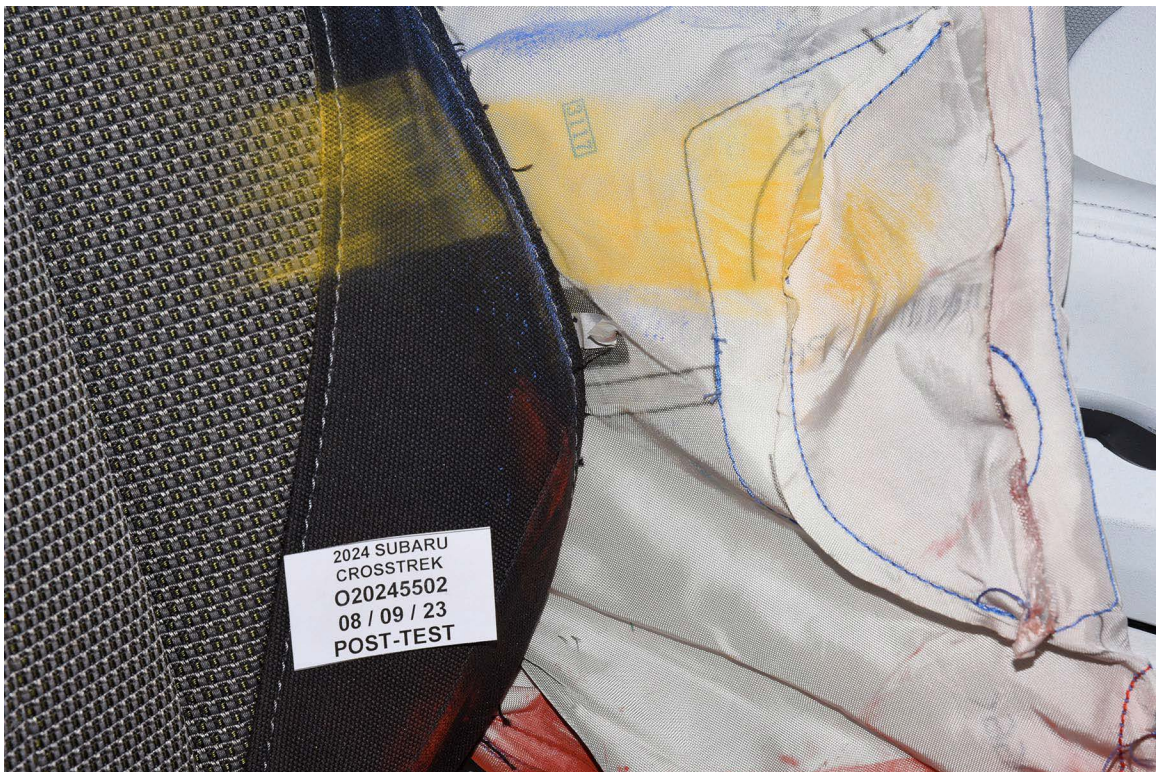
FIGURE 51. Post-Test Driver Dummy Close-Up Torso Contact With Side Airbag View

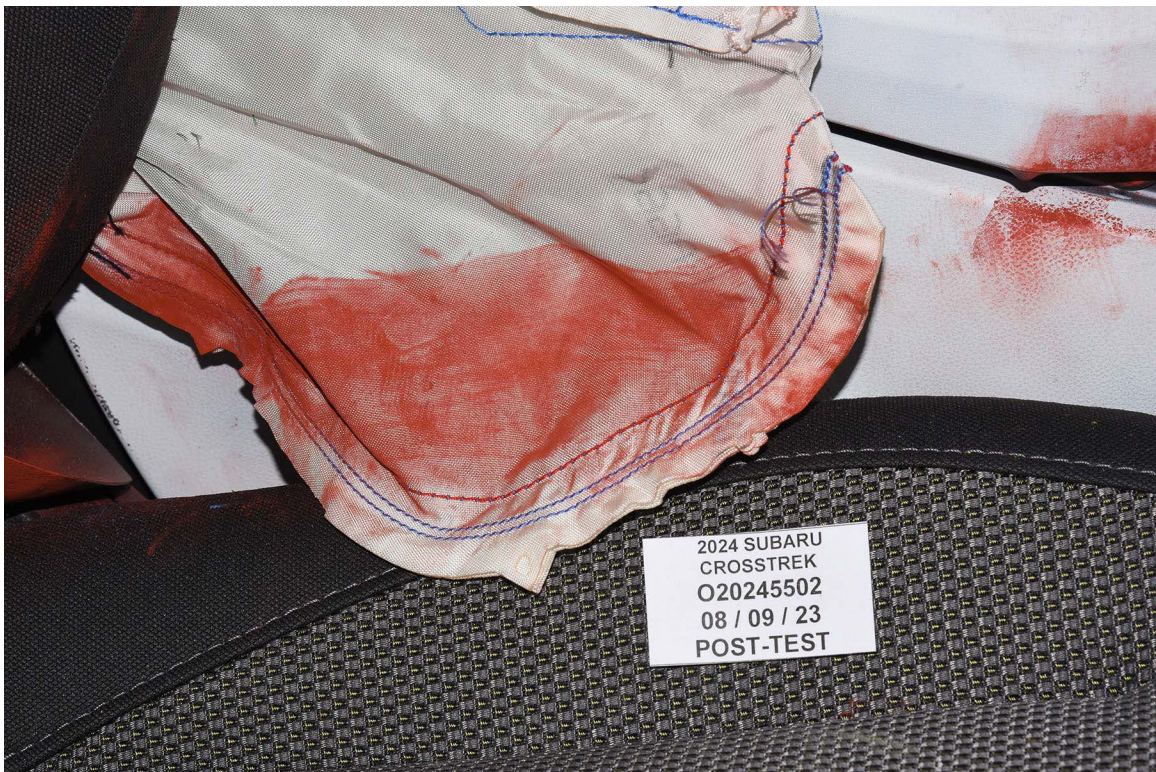
FIGURE 53. Post-Test Driver Dummy Close-Up Pelvis Contact With Side Airbag View

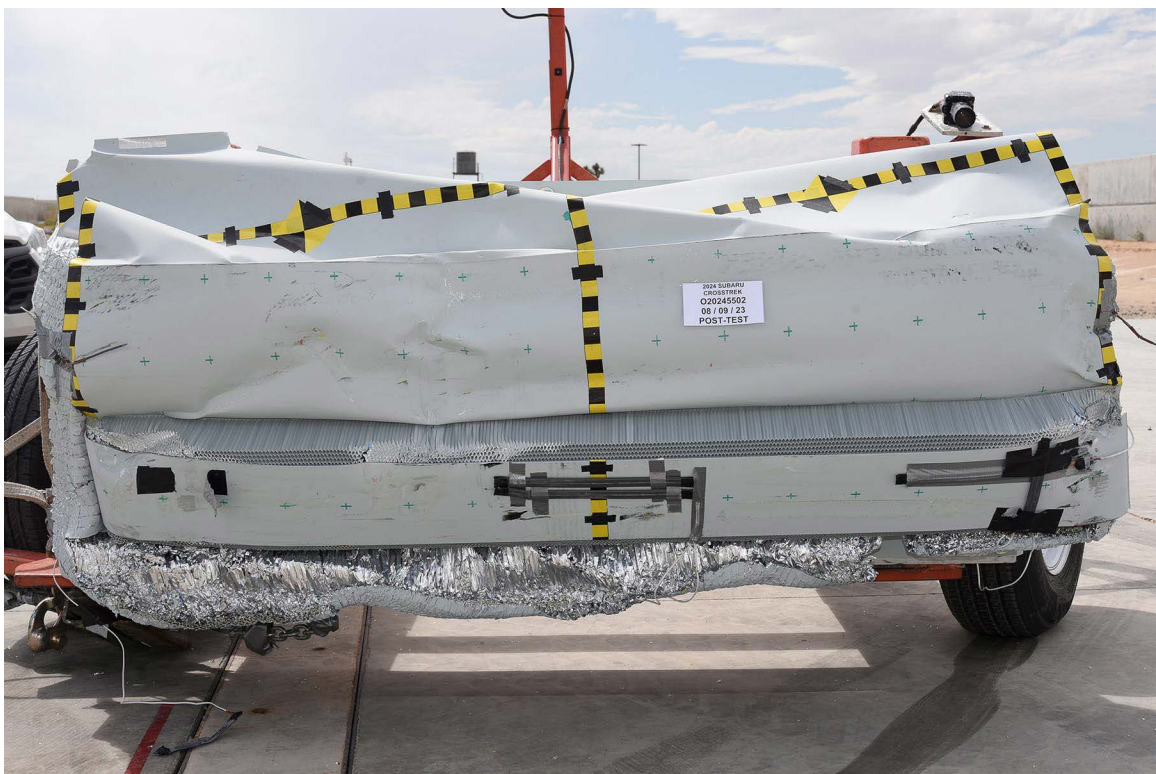
FIGURE 85. Post-Test Front View of MDB Impactor Face

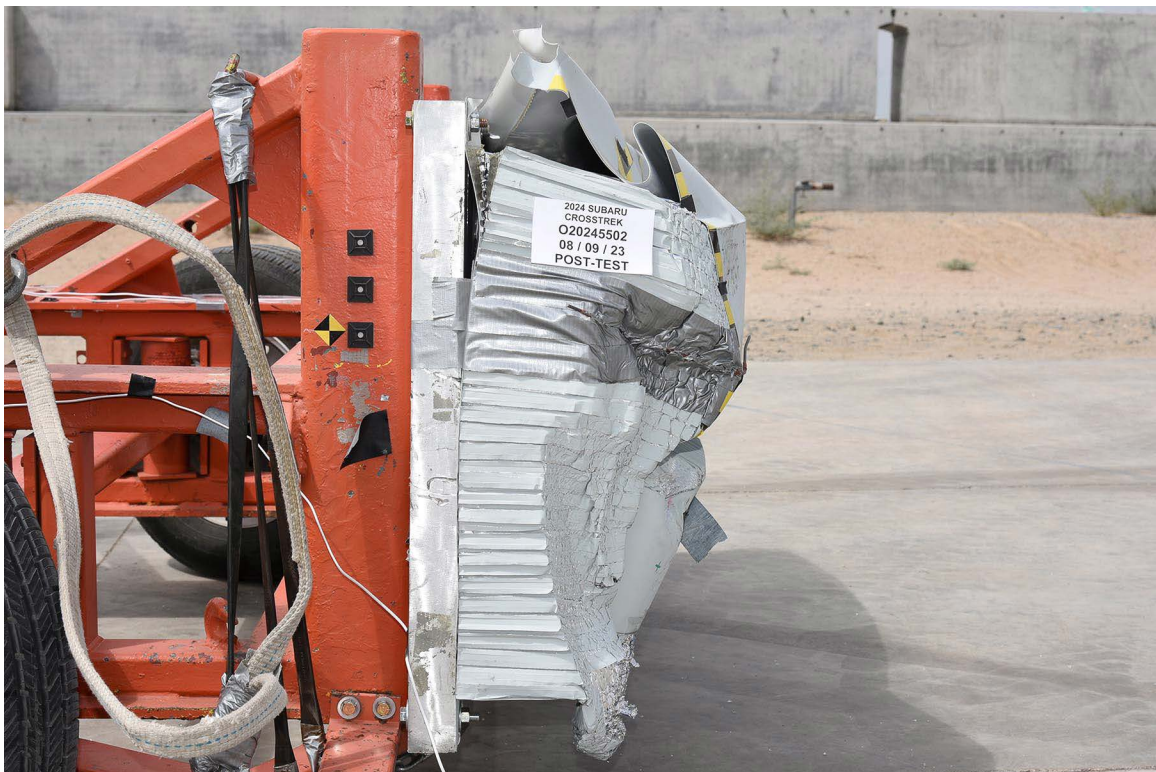
FIGURE 91. Post-Test Right View of MDB Impactor Face
