**REPORT NUMBER: SideNCAPPole-MGA-23-026**

**NEW CAR ASSESSMENT PROGRAM (NCAP)  
Side Impact Pole Test**

**HONDA OF CANADA MFG., A DIVISION OF HONDA CANADA INC.  
2023 Honda CR-V EX 5-Door SUV  
NHTSA No.: O20235307**

**FINAL REPORT**

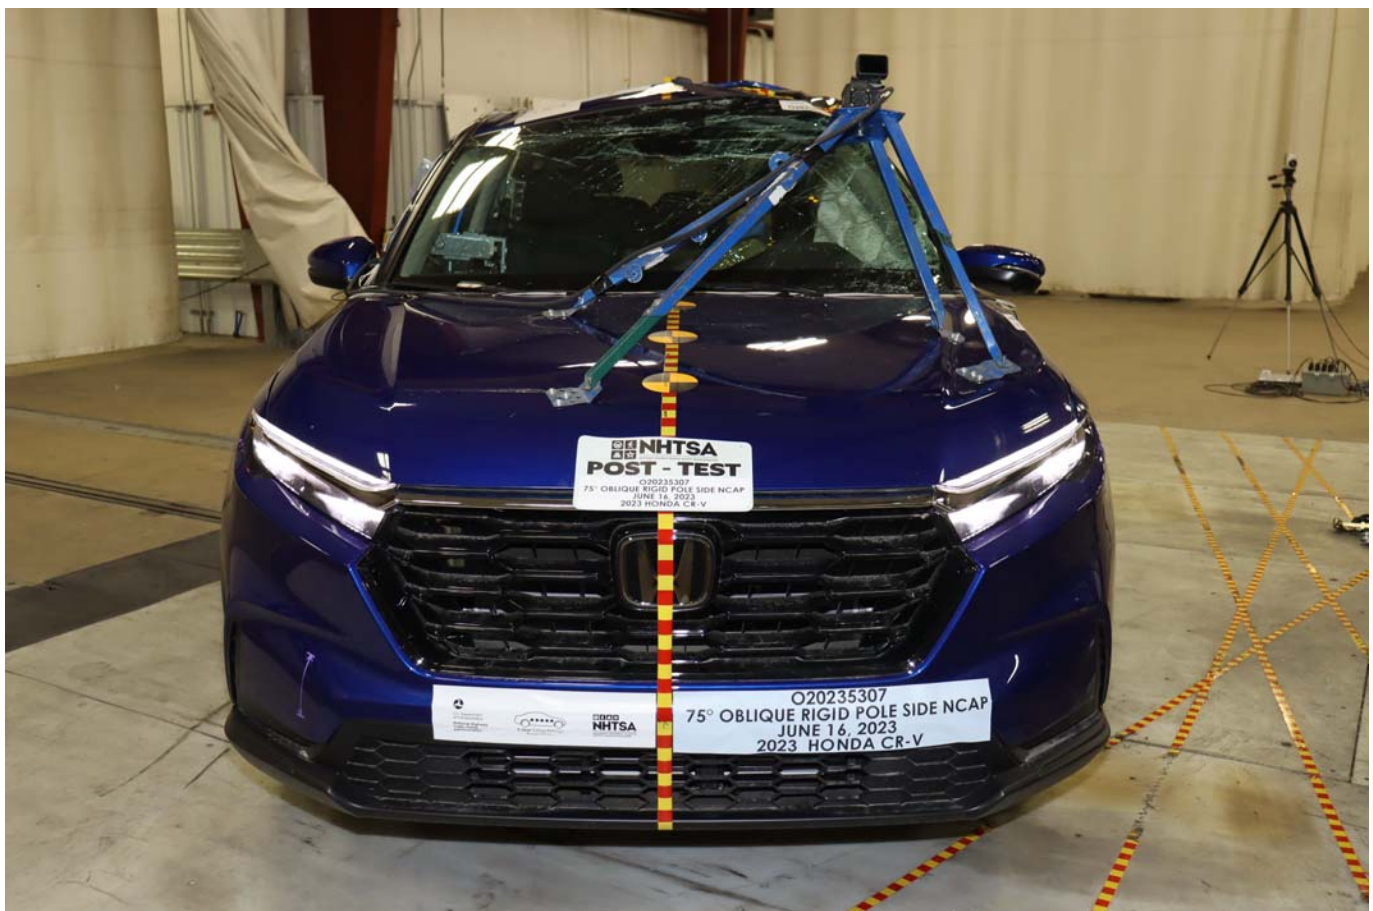
Photo No. 004 - Post-Test Frontal View of Test Vehicle

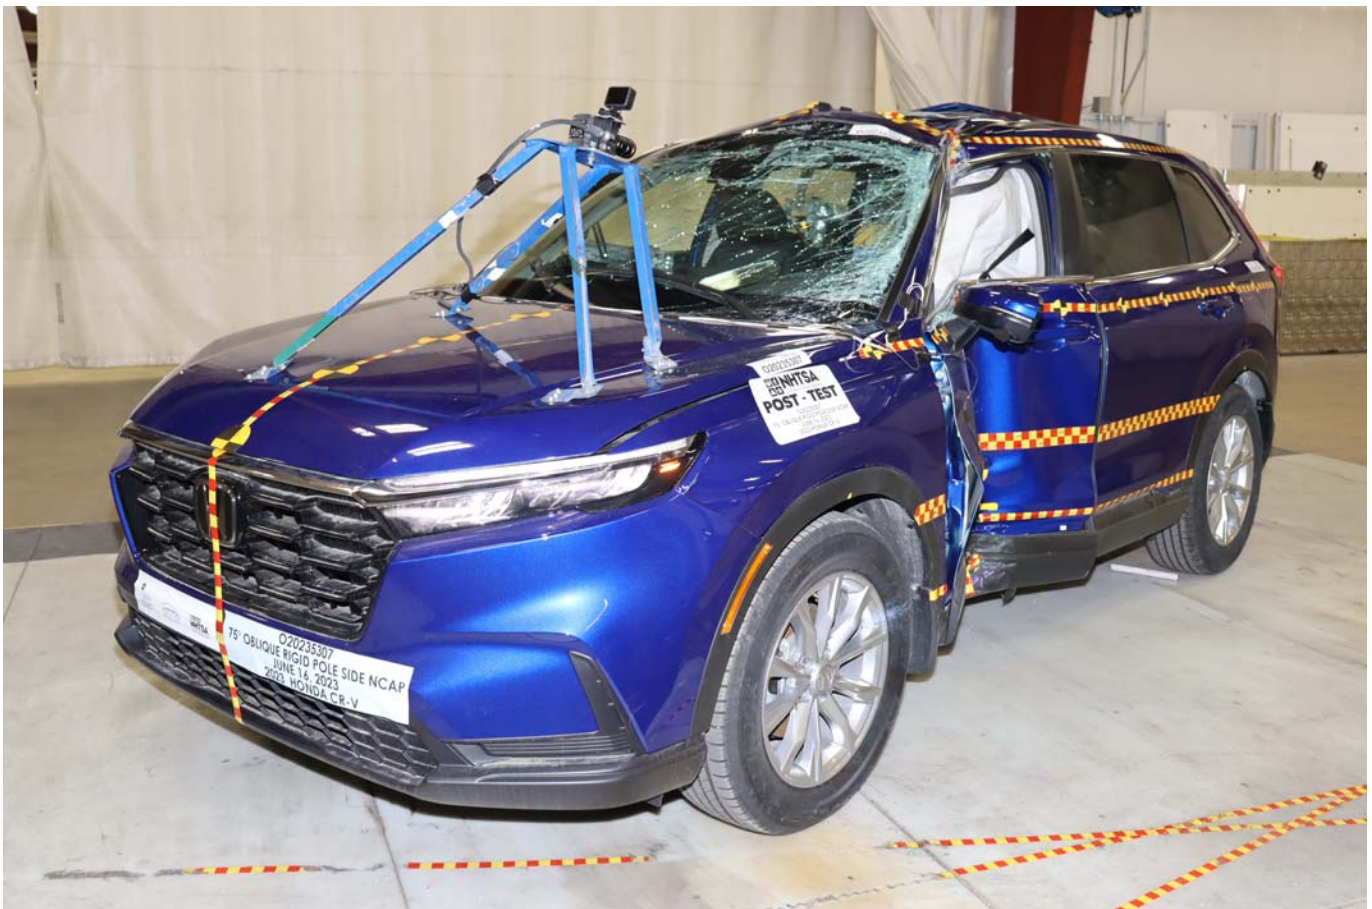
Photo No. 006 - Post-Test Left Front Three-Quarter View of Test Vehicle

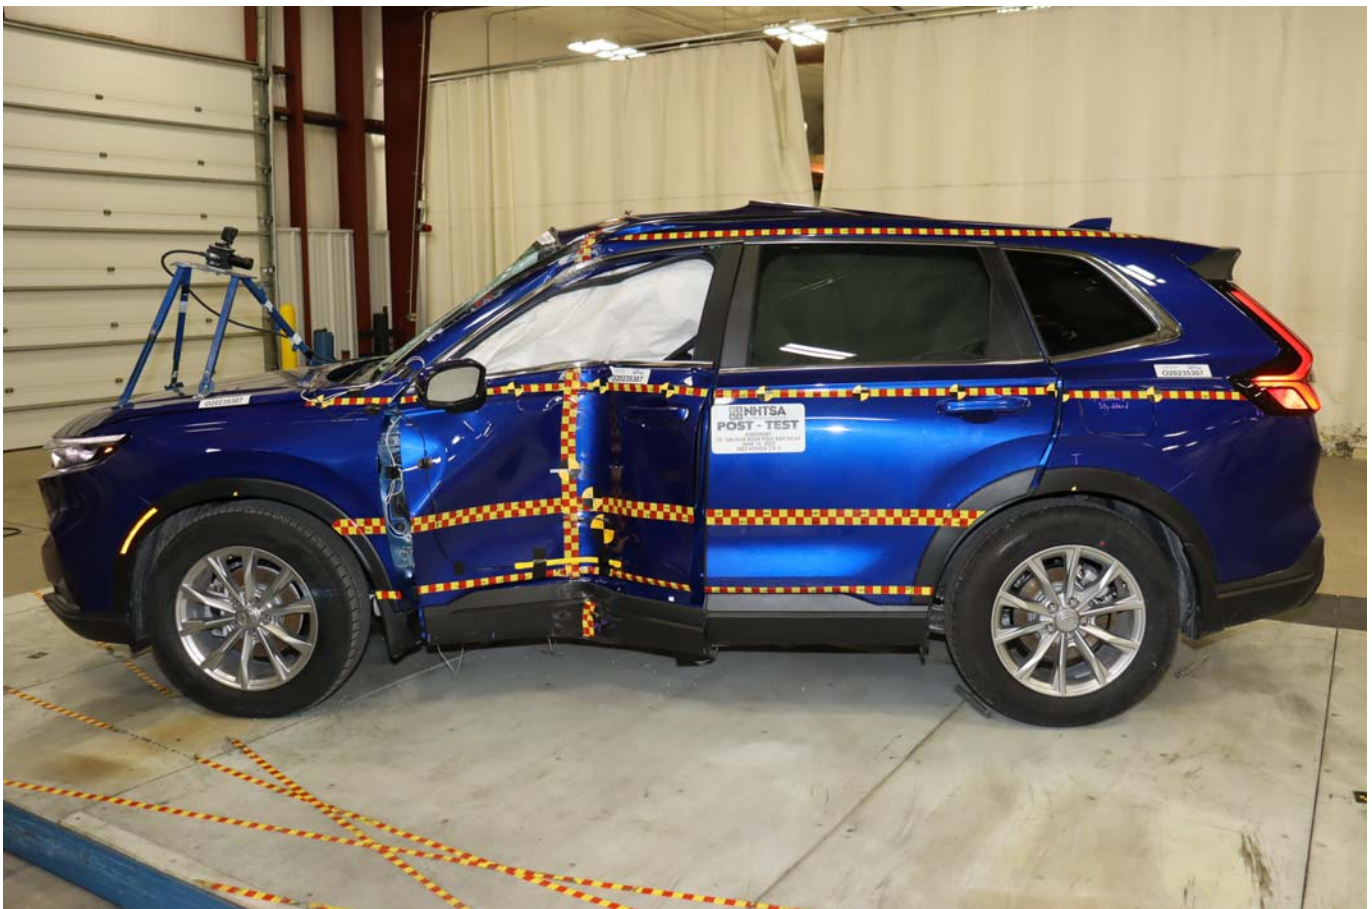
Photo No. 008 - Post-Test Left Side View of Test Vehicle

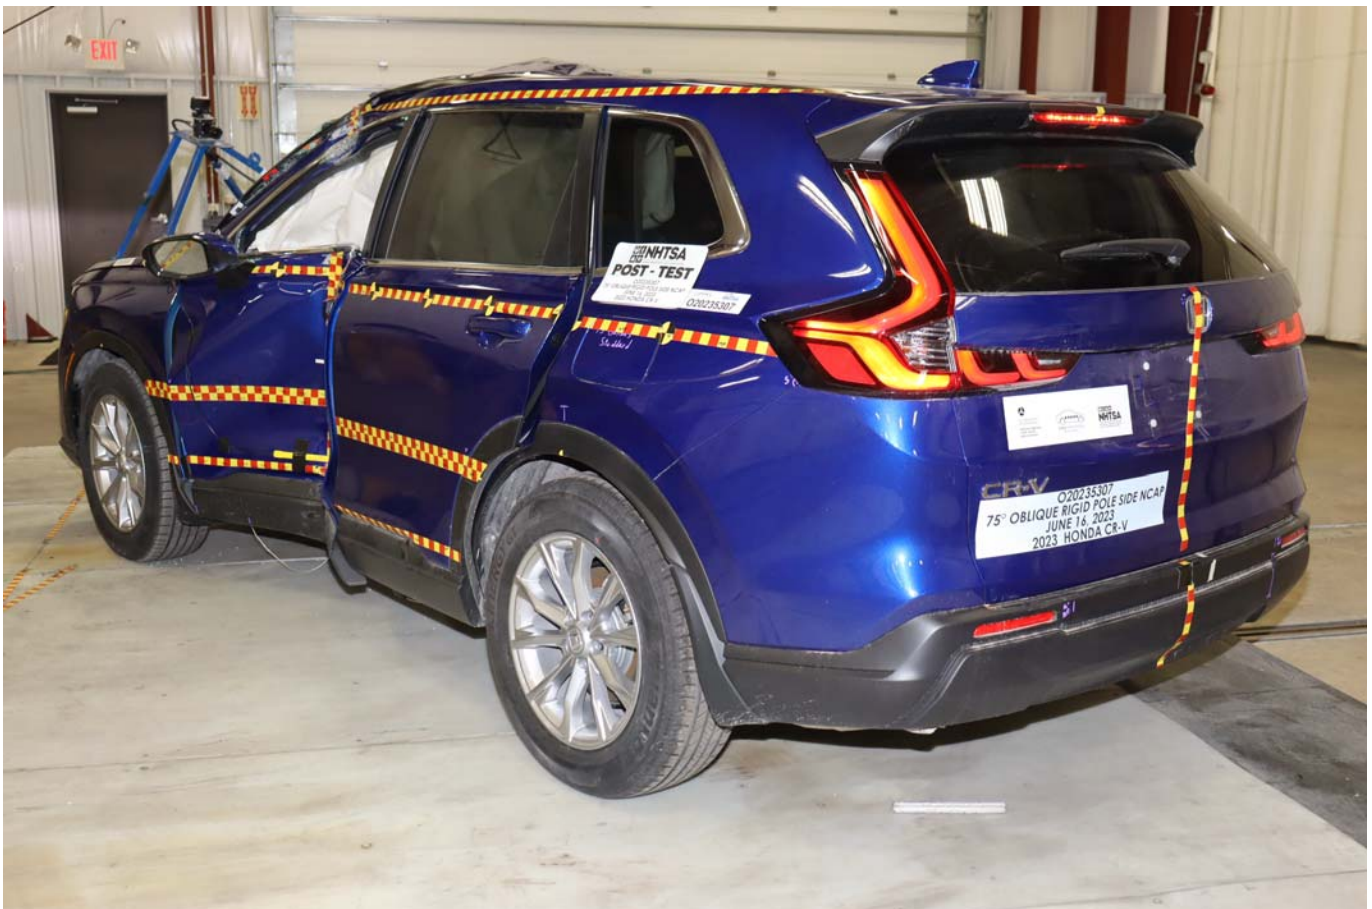
Photo No. 010 - Post-Test Left Rear Three-Quarter View of Test Vehicle

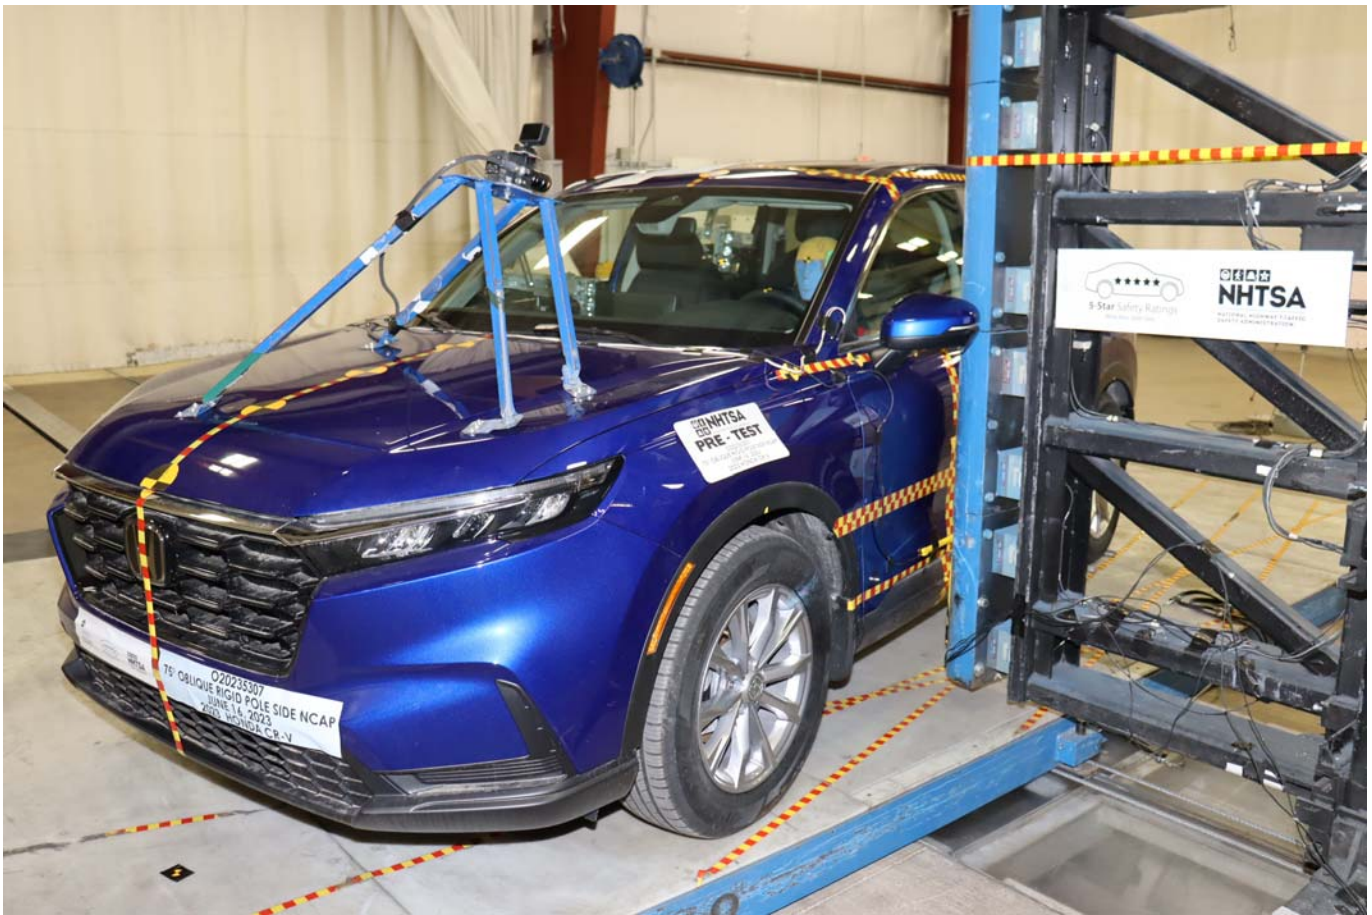
Photo No. 017 - Pre-Test Left Side View of Pole Positioned Against Side of Vehicle

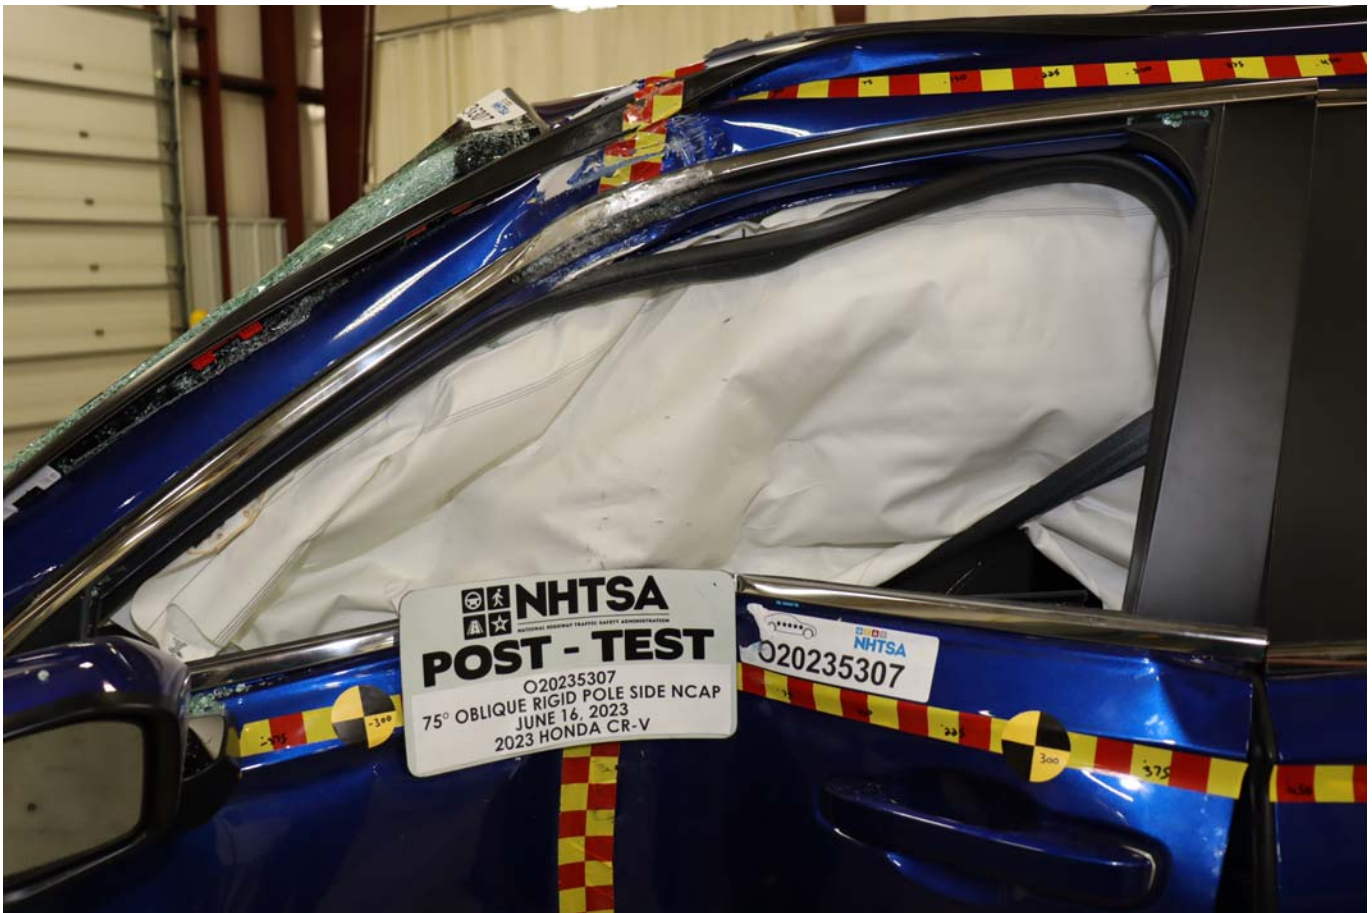
Photo No. 025 - Post-Test Left Side View of Dummy Shoulder and Door Top View

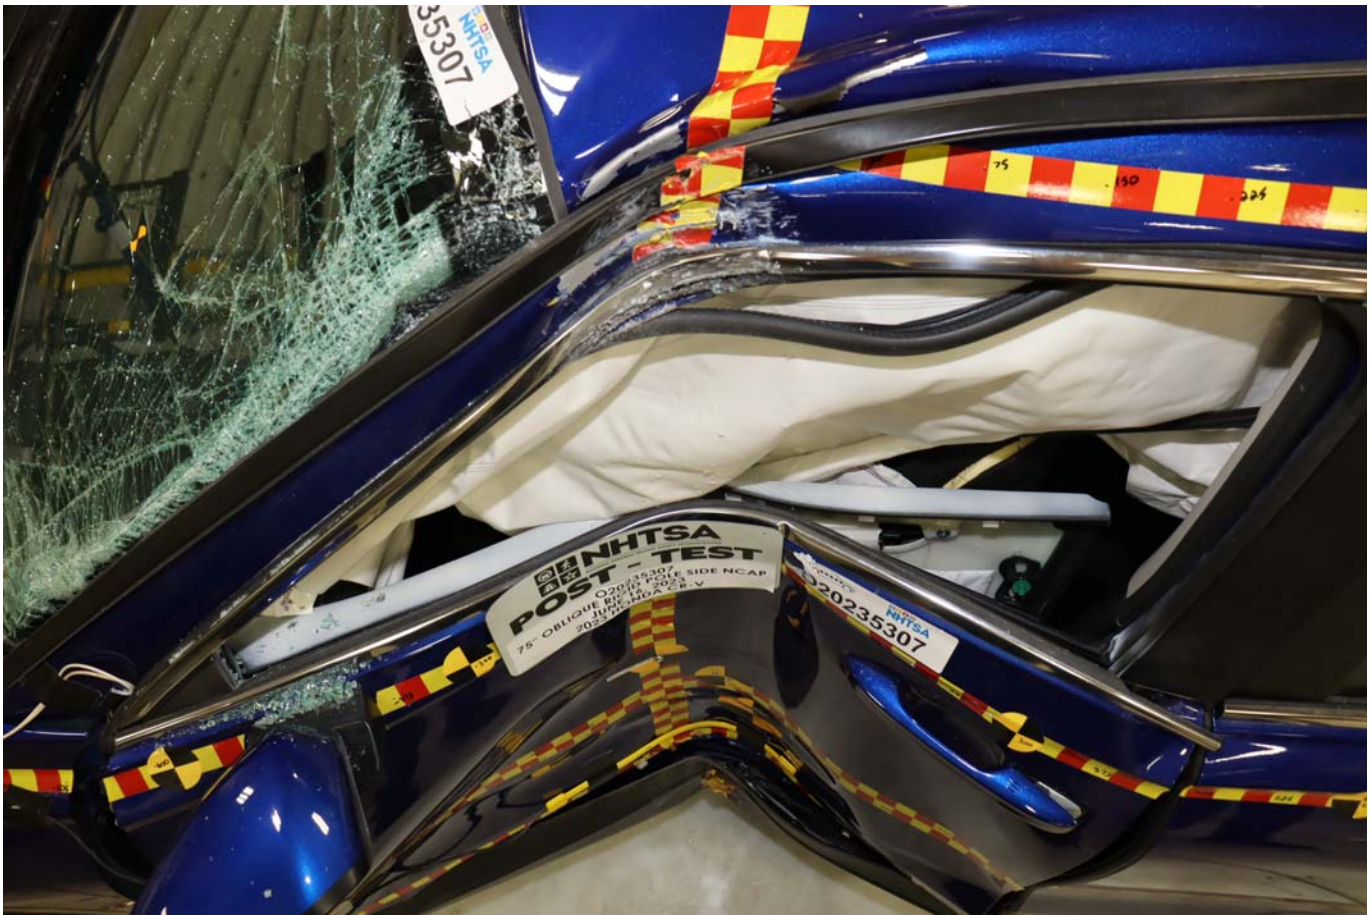
Photo No. 041 - Post-Test Dummy and Door Clearance View

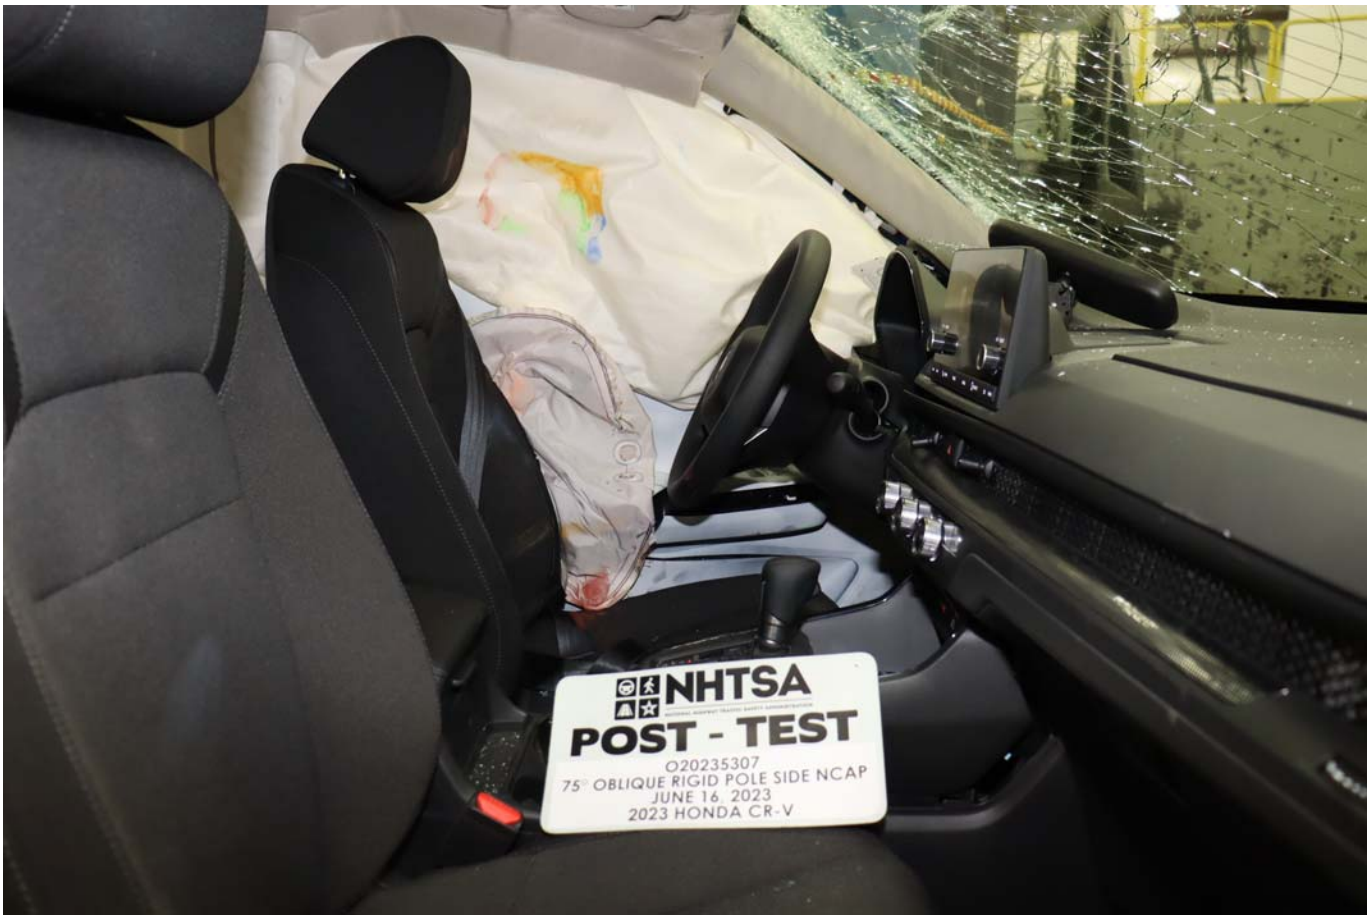
Photo No. 045 - Post-Test Inner Door Panel View Showing Dummy Contact Location

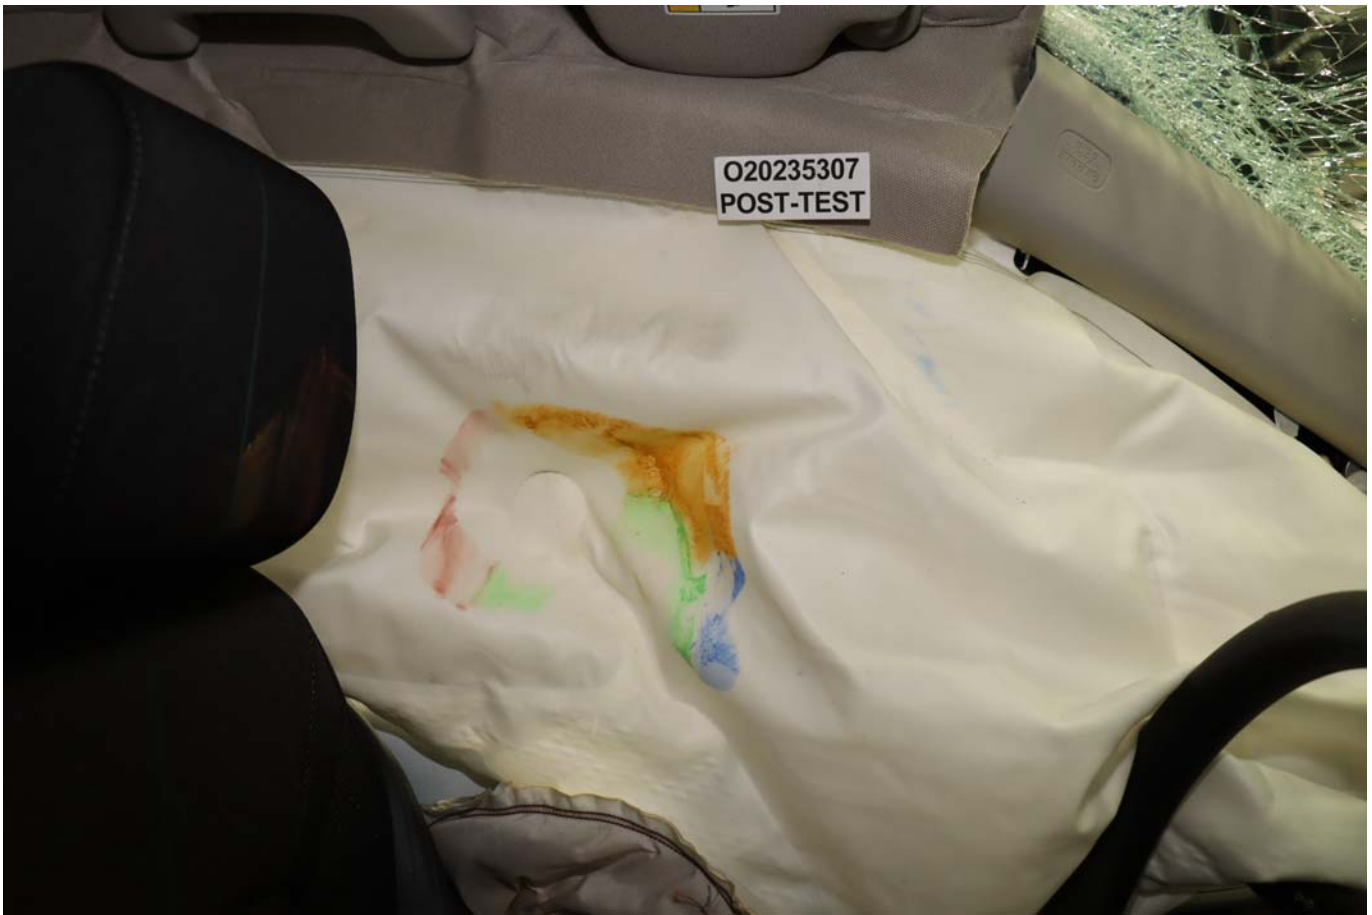
Photo No. 047 - Post-Test Dummy Close-Up Head Contact with Side Air Bag View

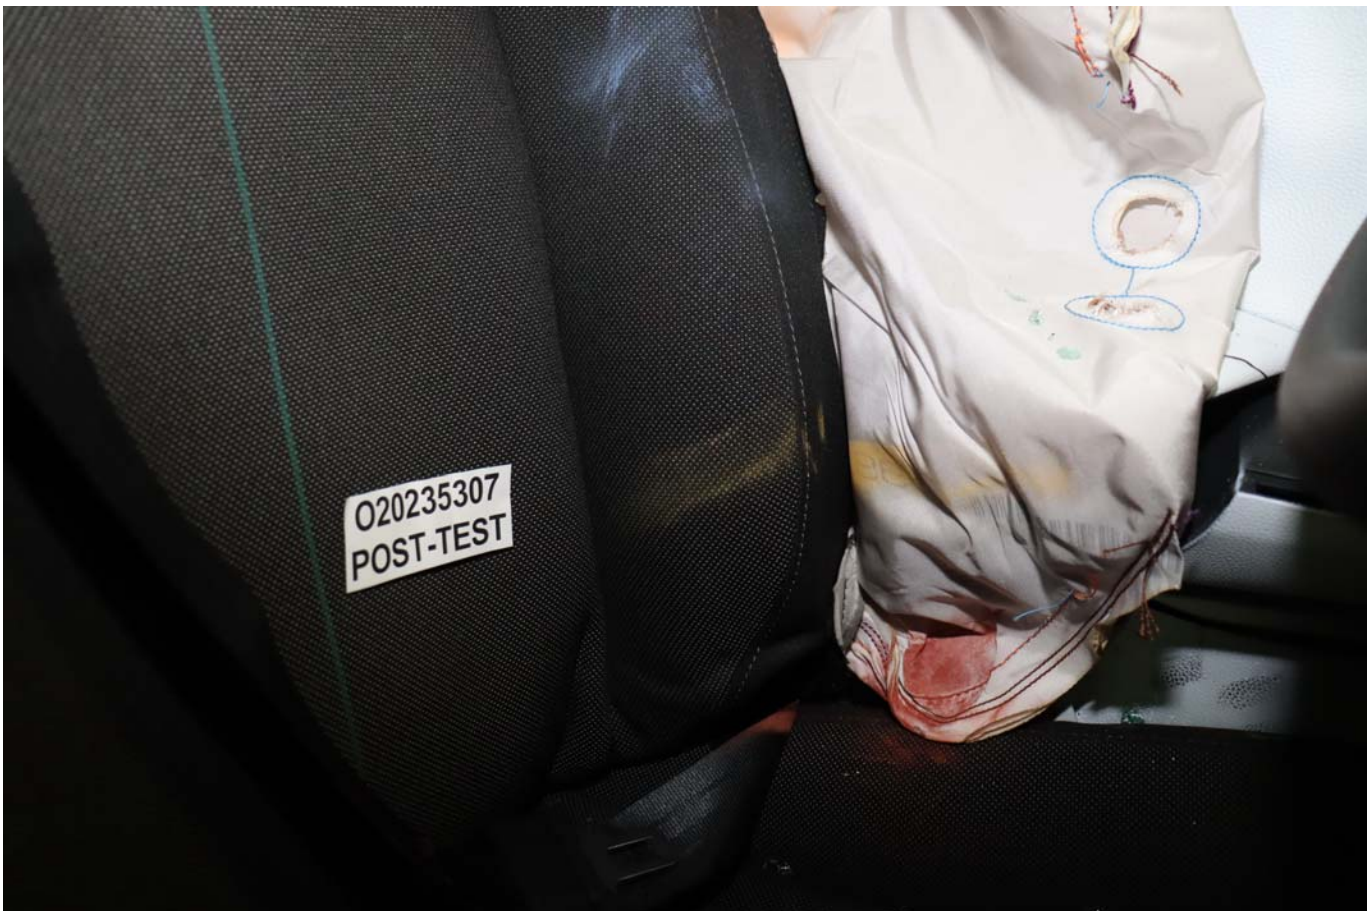
Photo No. 048 - Post-Test Dummy Close-Up Torso Contact with Vehicle Interior View

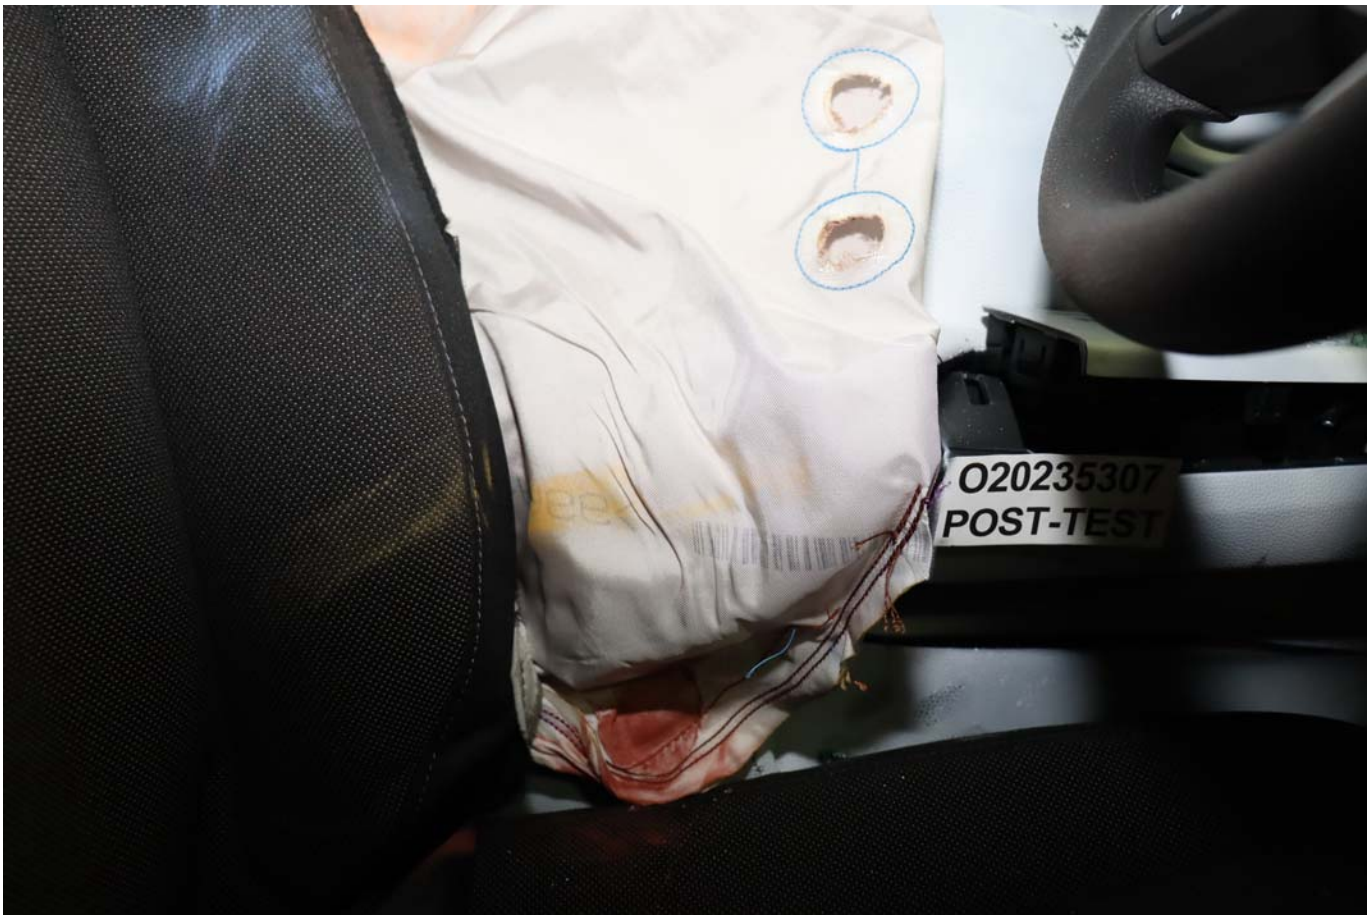
Photo No. 051 - Post-Test Dummy Close-Up Pelvis Contact with Side Air Bag View

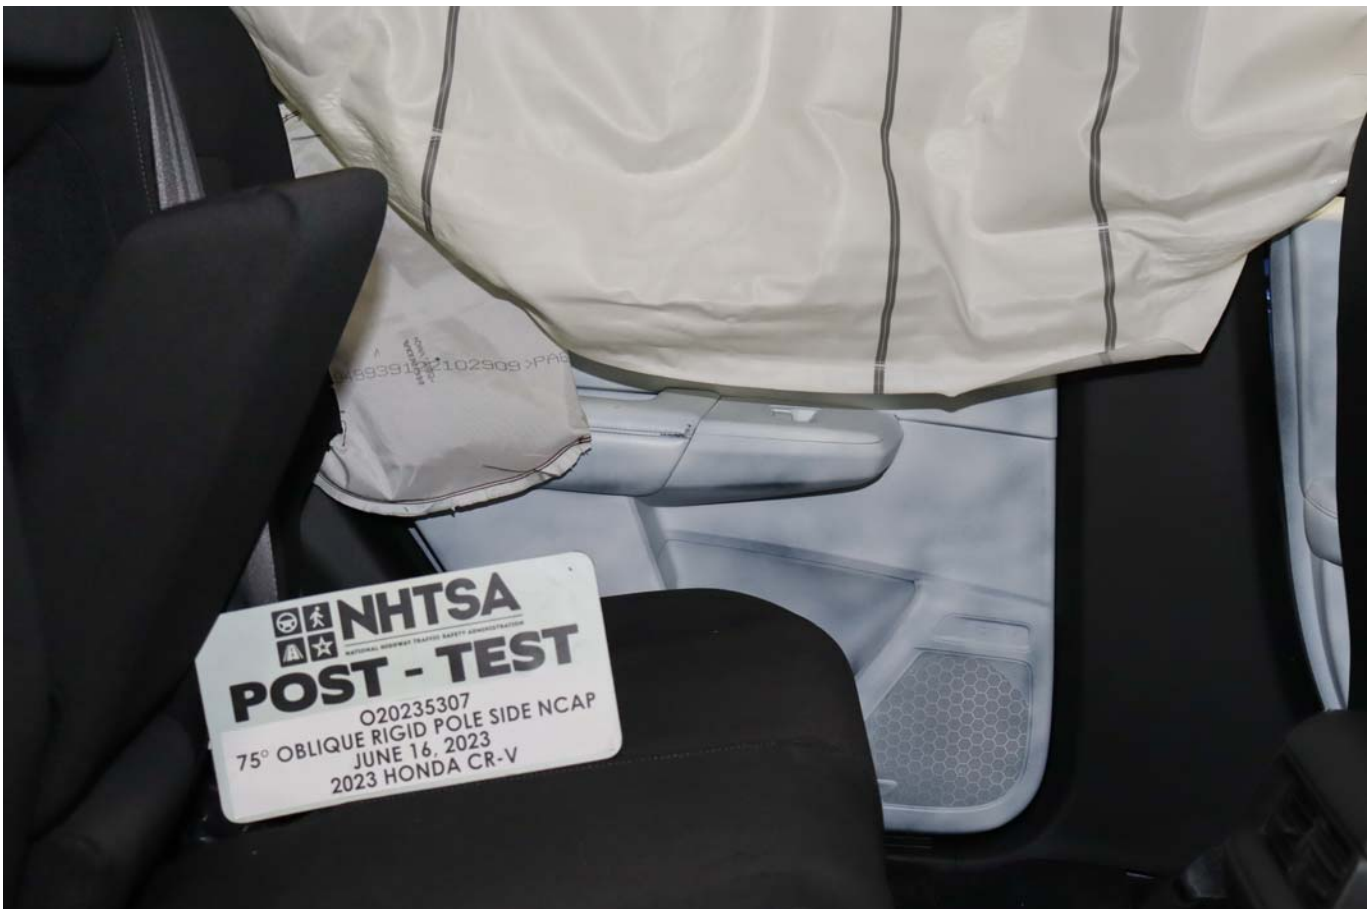
Photo No. 054 - Post-Test Inner Rear Passenger Torso Air Bag Deployment View

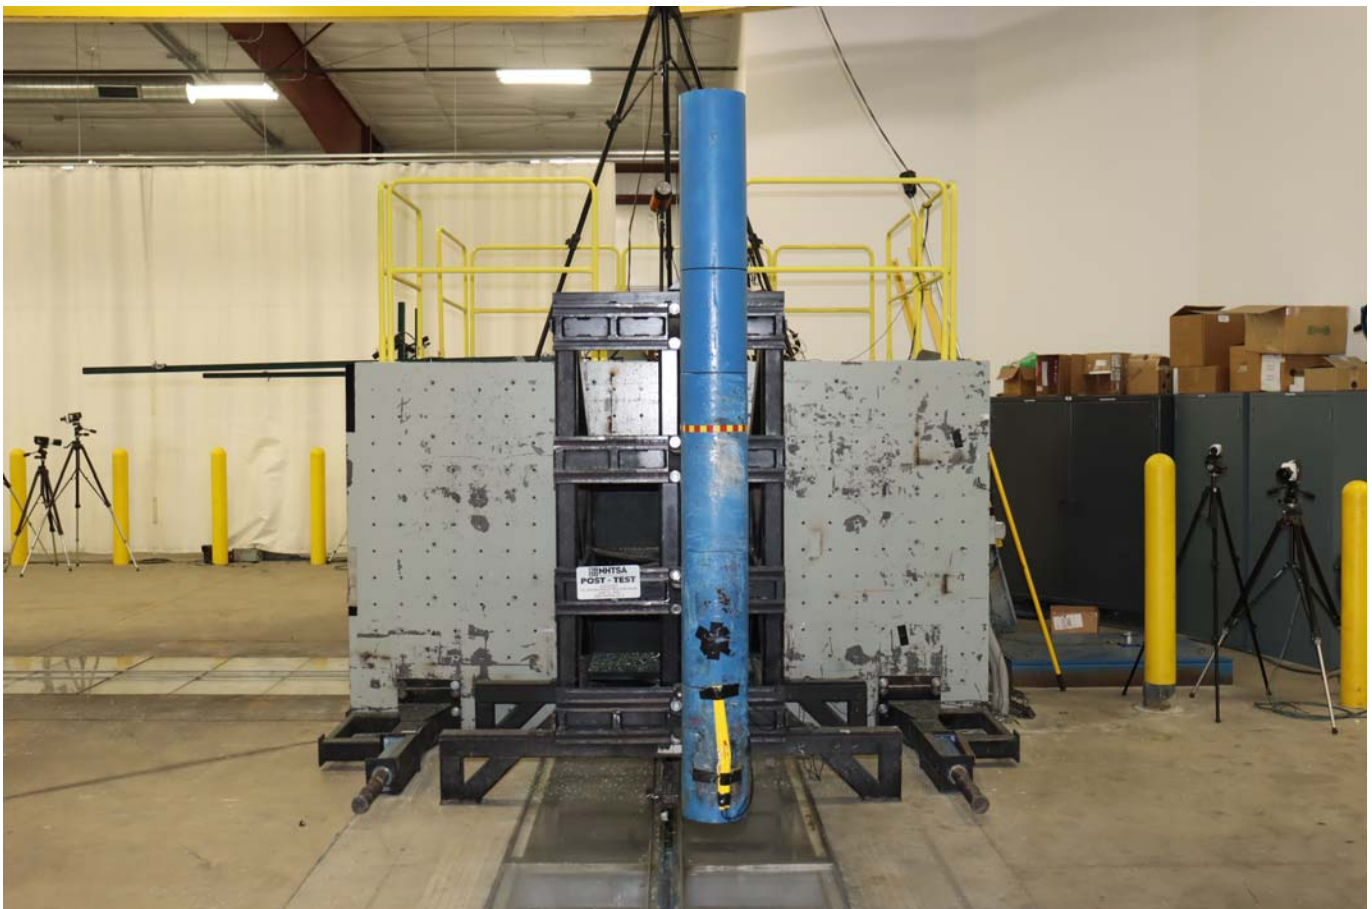
Photo No. 060 - Post-Test Pole Barrier Front View

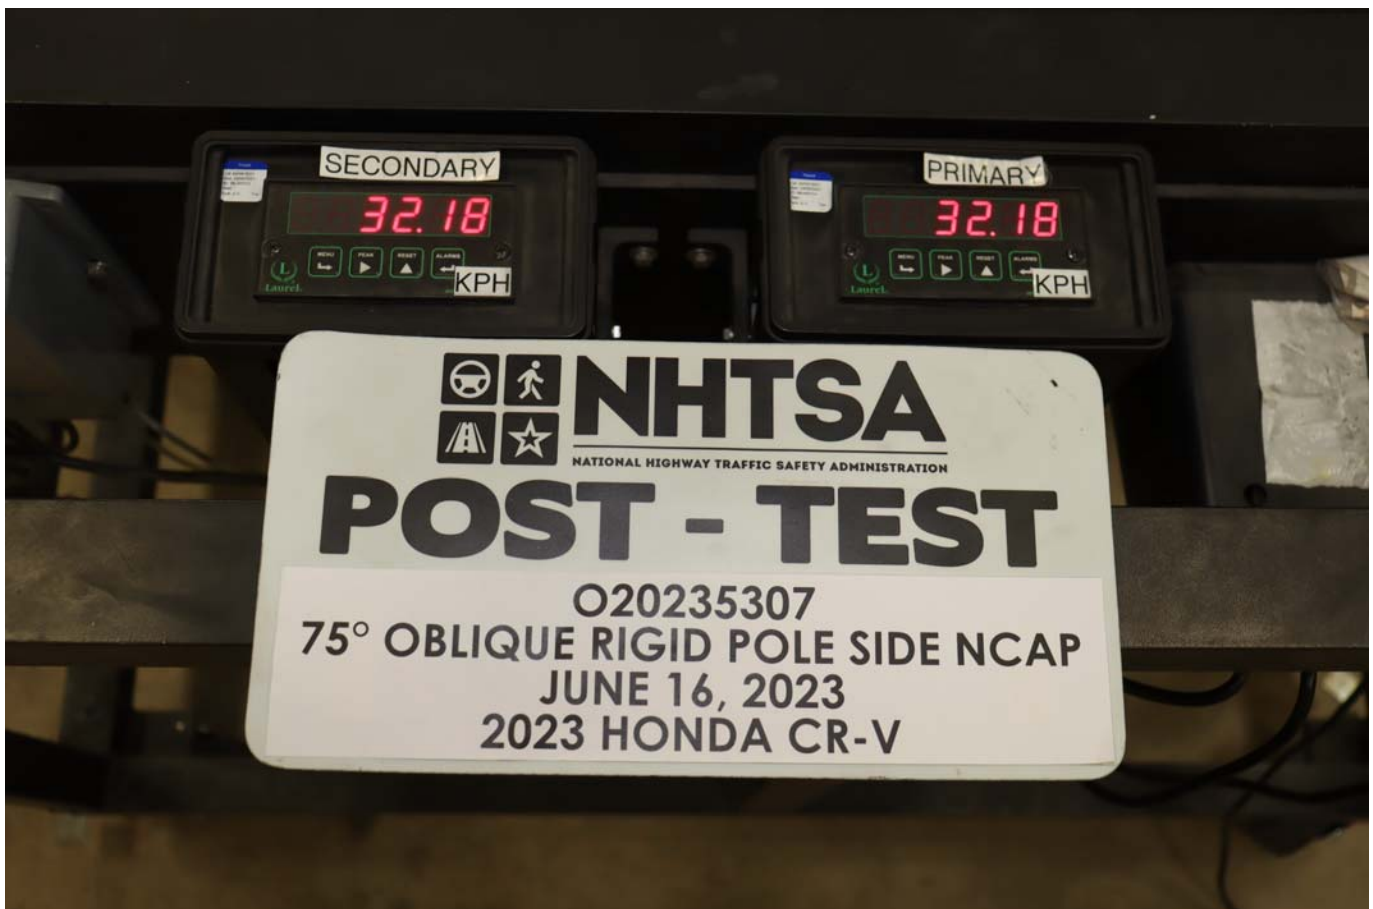
Photo No. 064 - Post-Test Primary and Redundant Speed Trap Read-Out
