**REPORT NUMBER: SideNCAPPole-MGA-23-026**

**NEW CAR ASSESSMENT PROGRAM (NCAP)  
Side Impact Pole Test**

**HONDA OF CANADA MFG., A DIVISION OF HONDA CANADA INC.  
2023 Honda CR-V EX 5-Door SUV  
NHTSA No.: O20235307**

**FINAL REPORT**

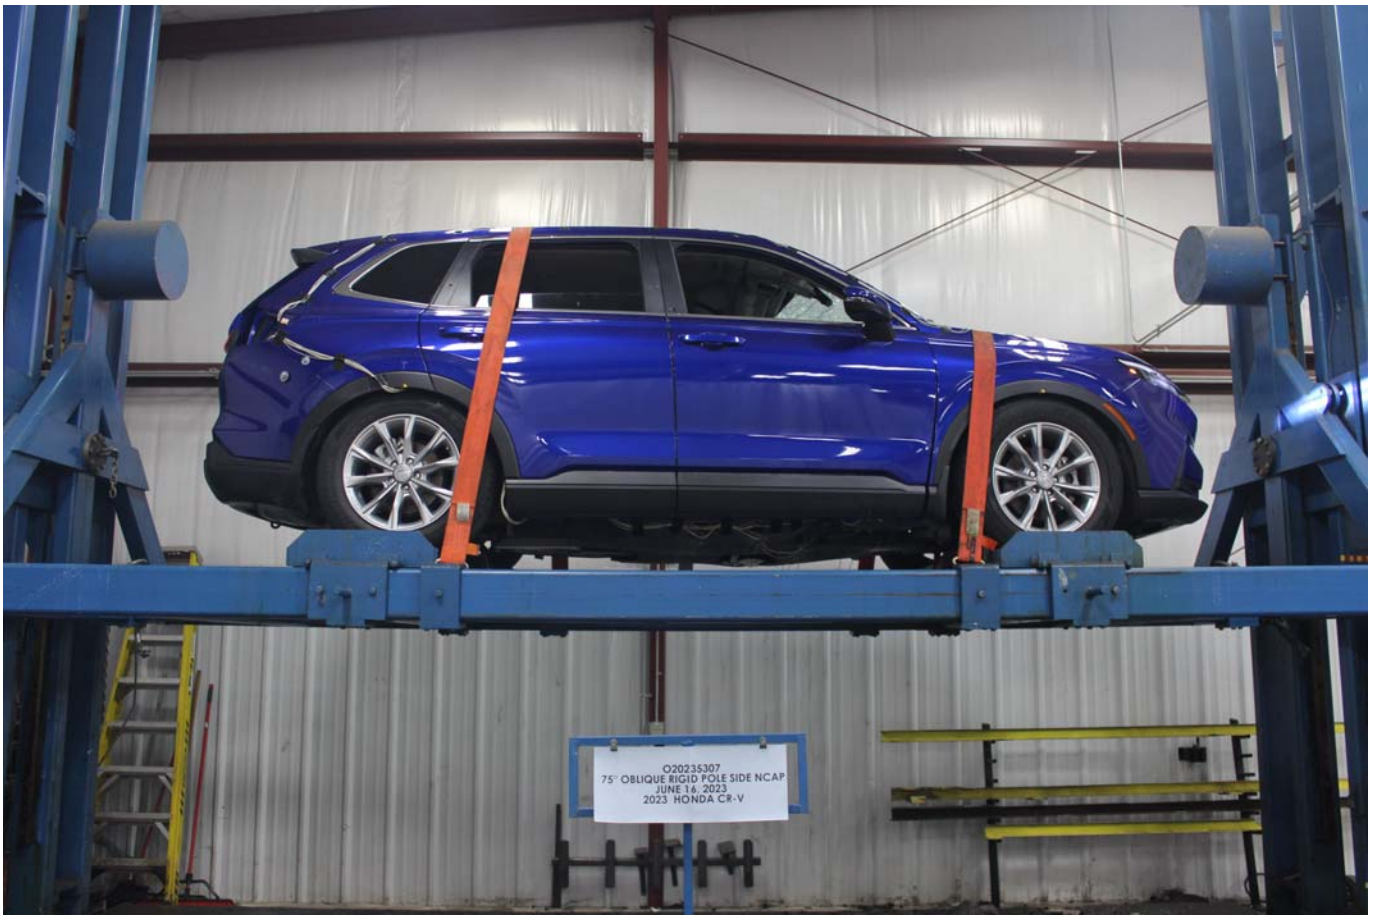
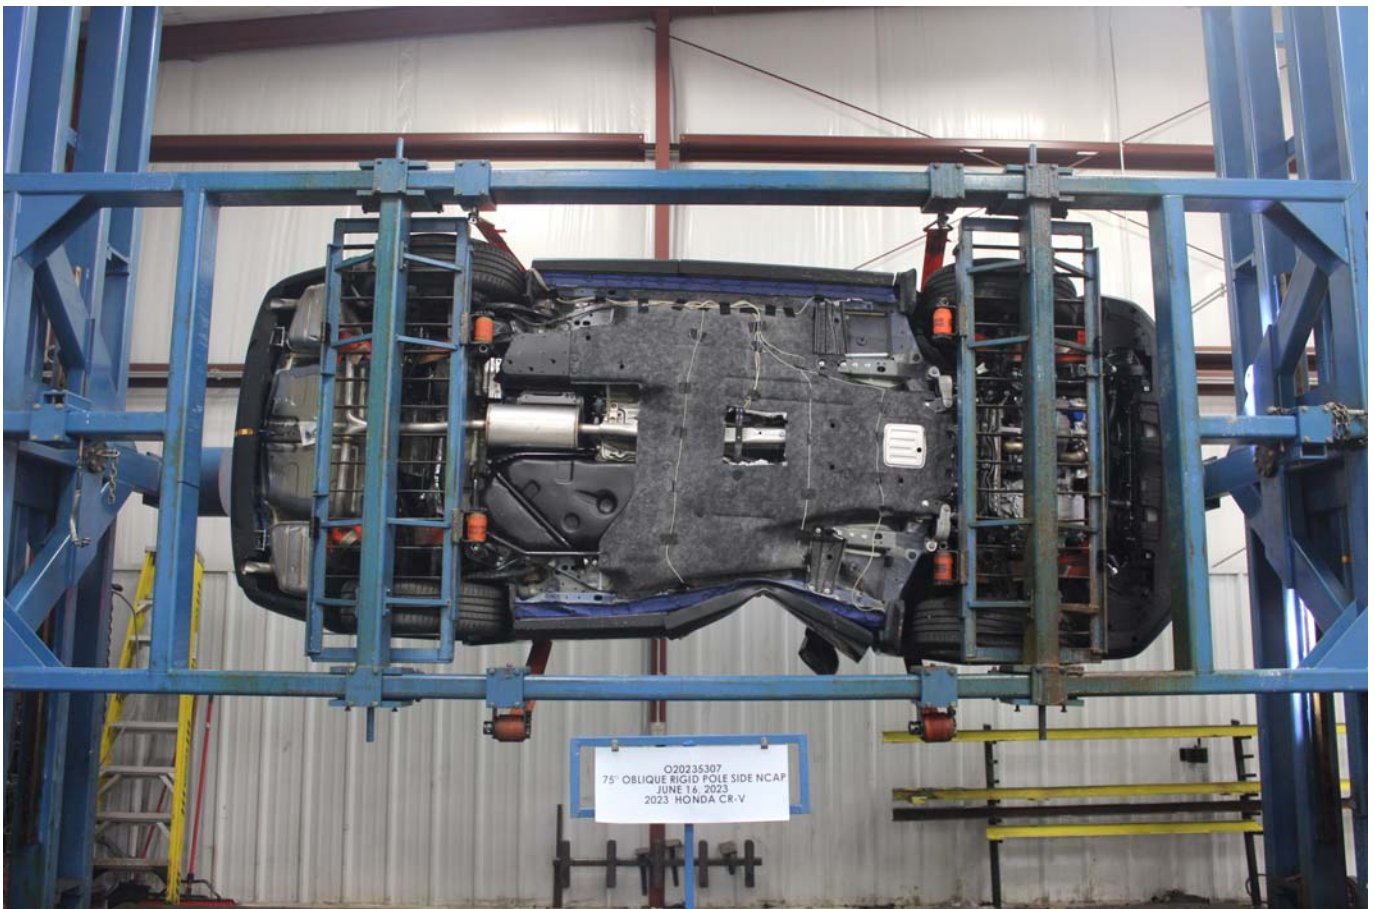
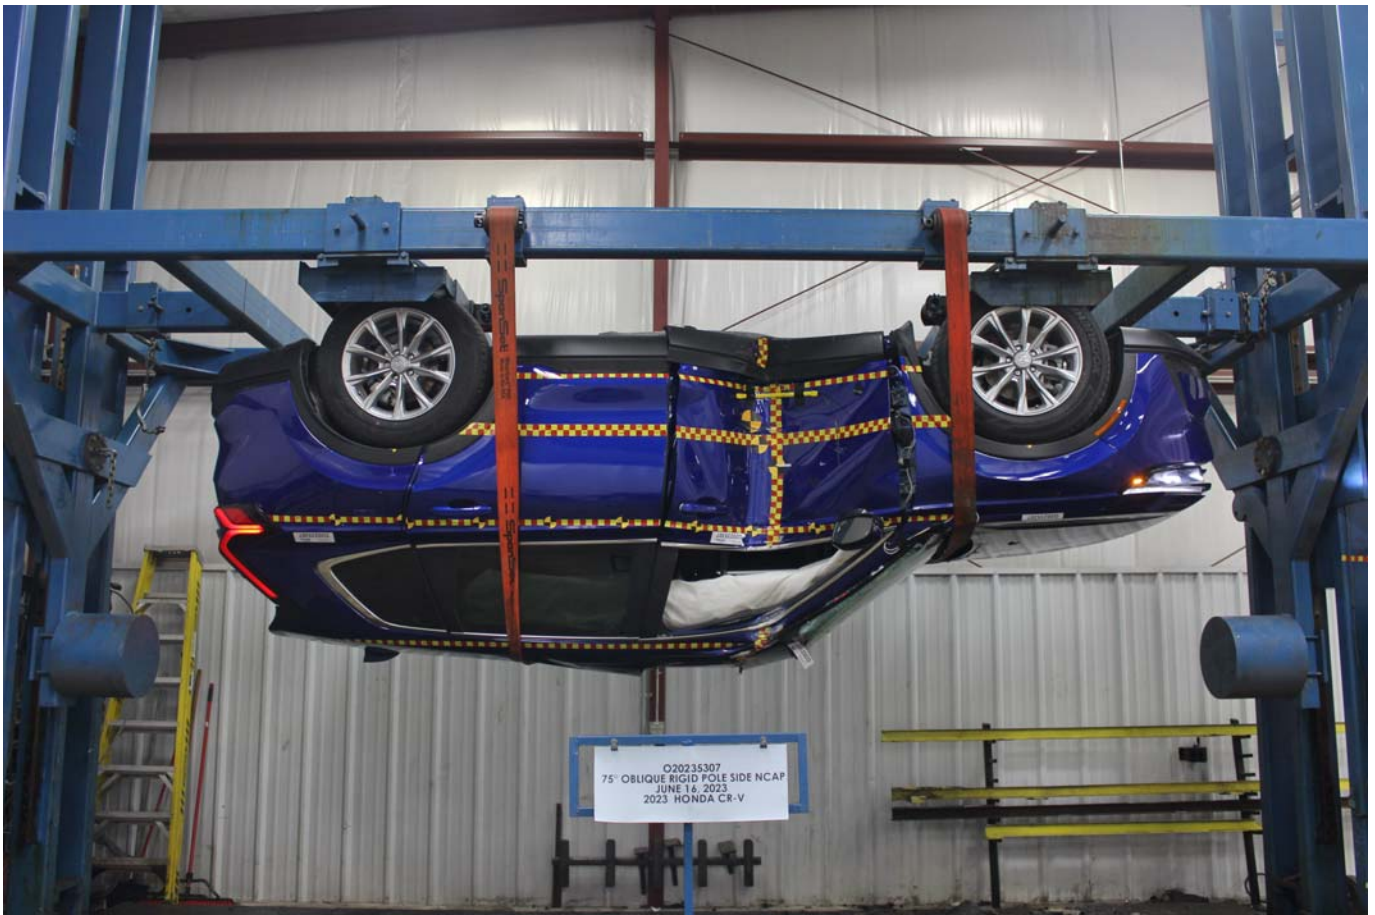
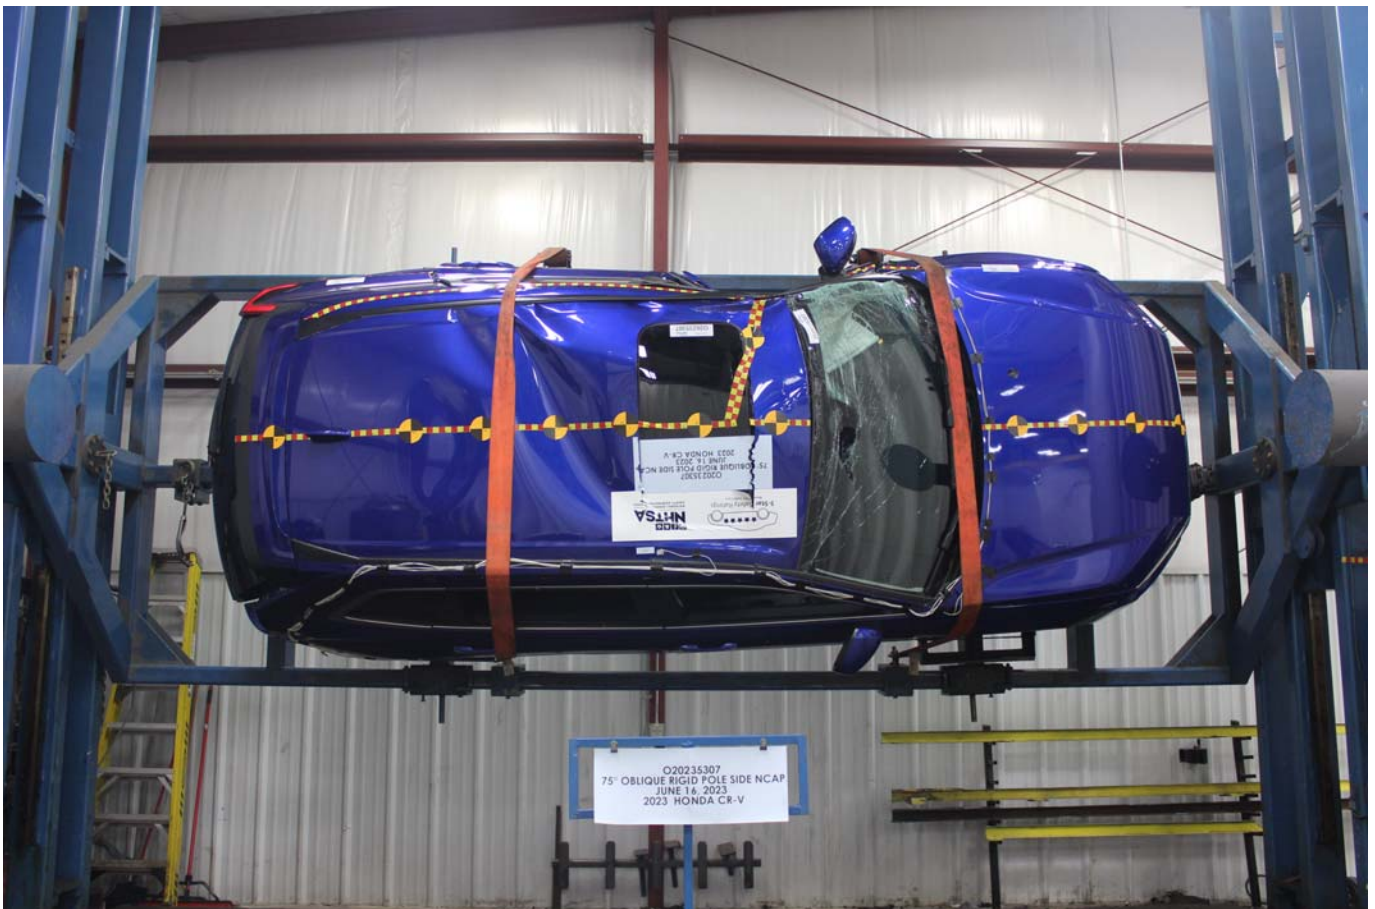
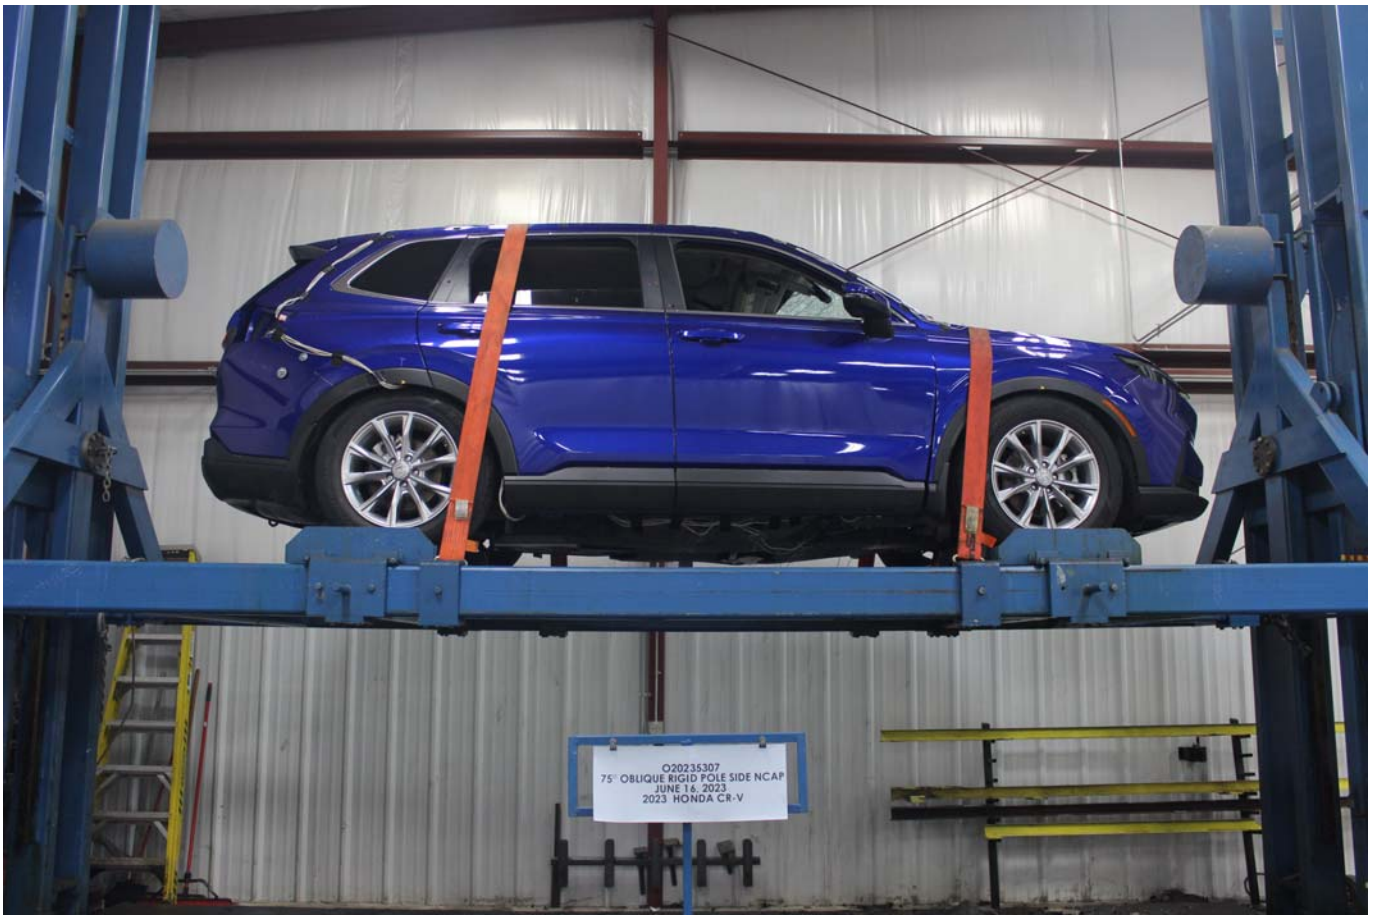
Photo No. 065 - FMVSS Photo No. 301 Static Rollover 0 Degrees

Photo No. 066 - FMVSS Photo No. 301 Static Rollover 90 Degrees

Photo No. 067 - FMVSS Photo No. 301 Static Rollover 180 Degrees

Photo No. 068 - FMVSS Photo No. 301 Static Rollover 270 Degrees

Photo No. 069 - FMVSS Photo No. 301 Static Rollover 360 Degrees

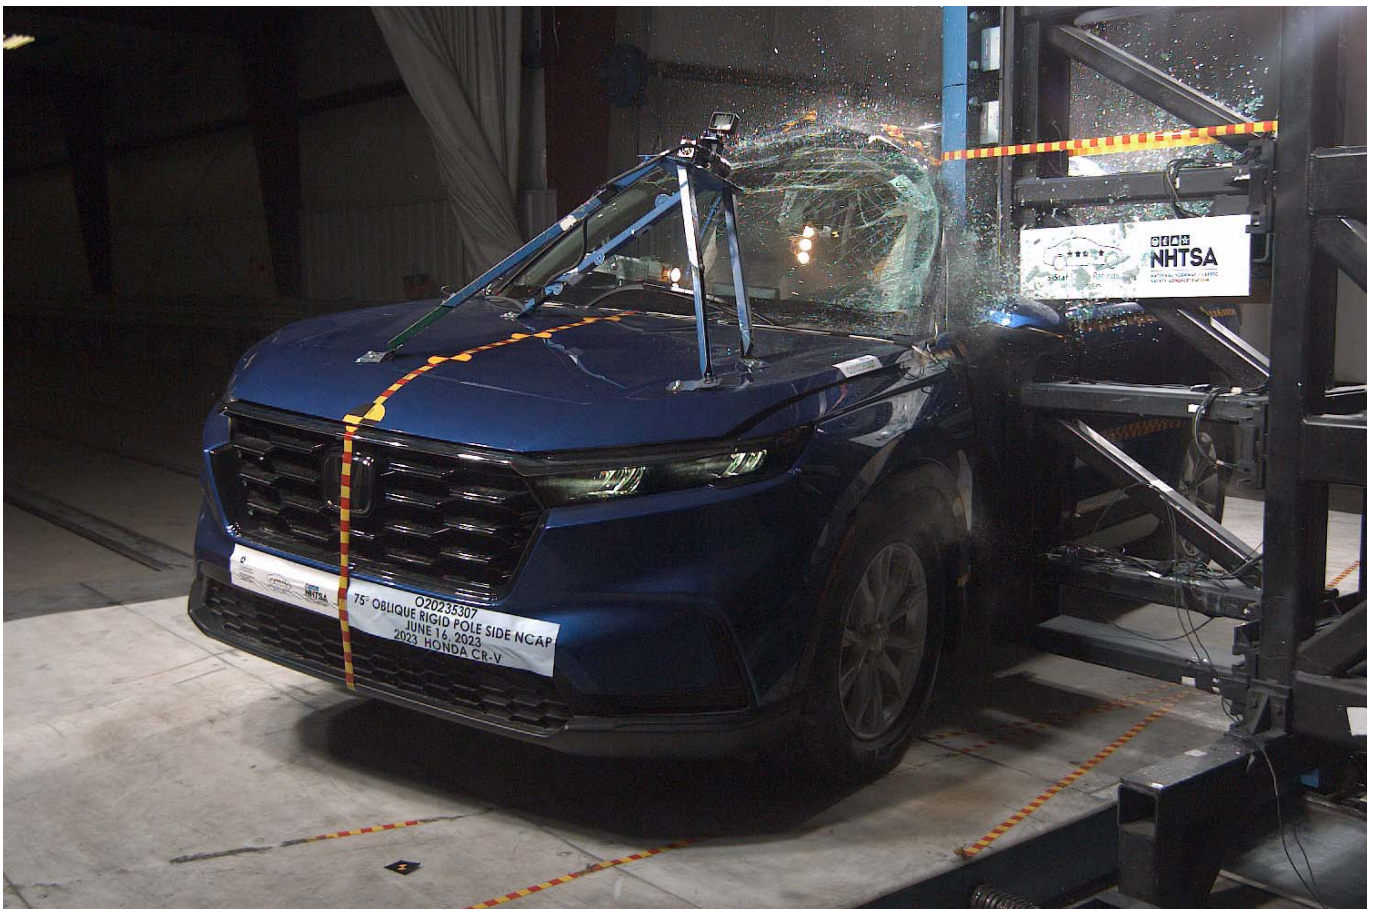
Photo No. 070 - Impact Event

A rigid pole side impact test was conducted on a 2023 Honda CR-V EX 5-Door SUV. The subject vehicle was towed into the rigid pole at an angle of 75° and a velocity of 32.18 km/h. The test was conducted by MGA Research Corporation in Burlington, Wisconsin on June 16, 2023. Pre-test and post-test photographs of the test vehicle and side impact dummy (SID-IIs) are included in Appendix A of this report.
