**REPORT NUMBER: NCAP-MGA-23-027**

**NEW CAR ASSESSMENT PROGRAM (NCAP)  
Frontal Barrier Impact Test**

**HONDA DEVELOPMENT & MANUFACTURING OF AMERICA, LLC  
2023 Honda Pilot AWD LX 5-Door SUV  
NHTSA No.: O20235312**

**FINAL REPORT**

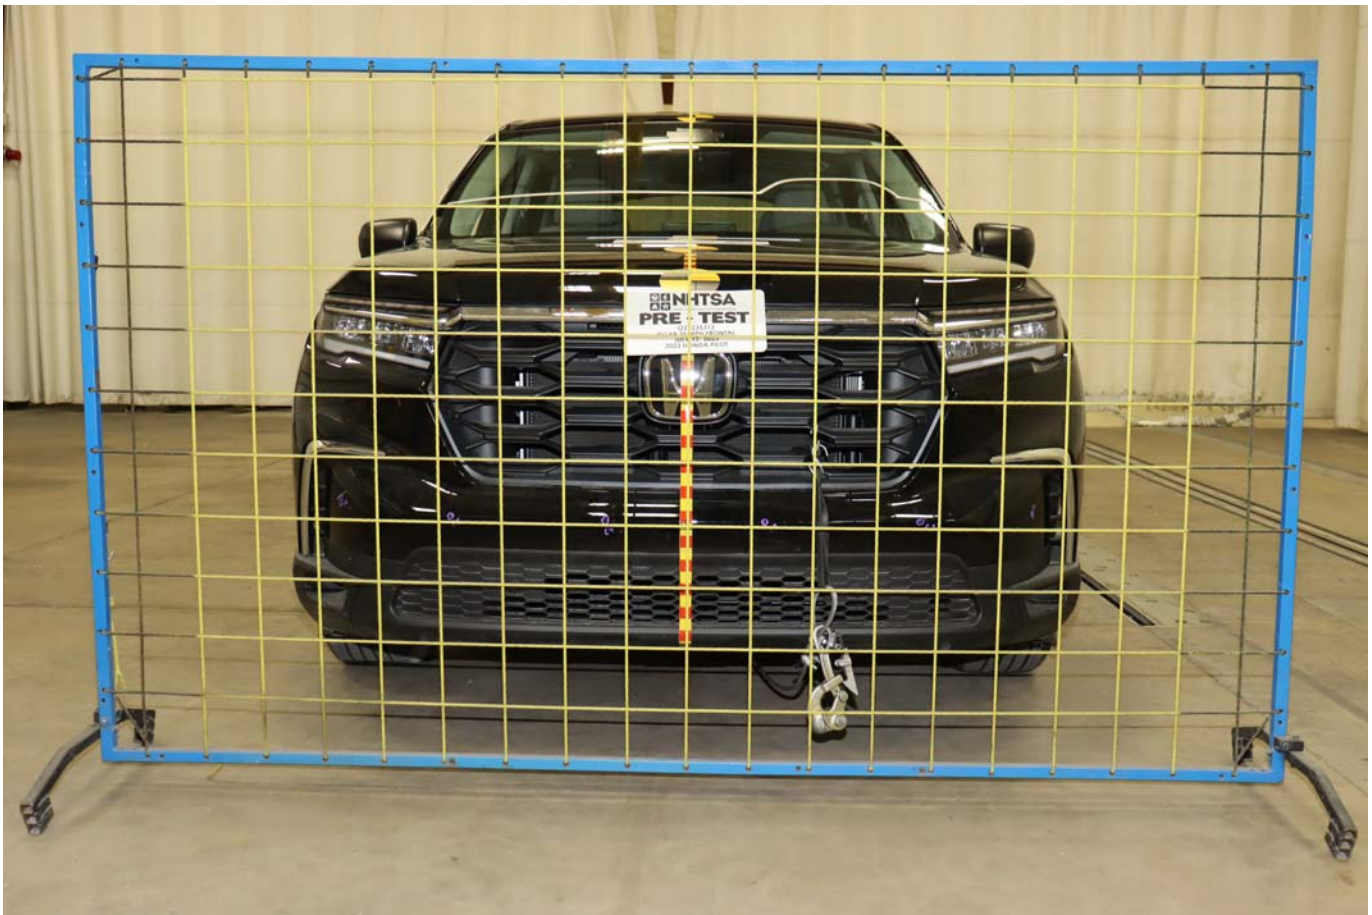
Photo No. 001 - Load Cell Location

A load cell barrier consisting of 176 load cells was impacted by a 2023 Honda Pilot AWD LX 5-Door SUV at a velocity of 56.34 km/h. The test was performed at MGA Research Corporation on July 12, 2023. Pre-test and post-test photographs of the vehicle and dummies can be found in Appendix A.

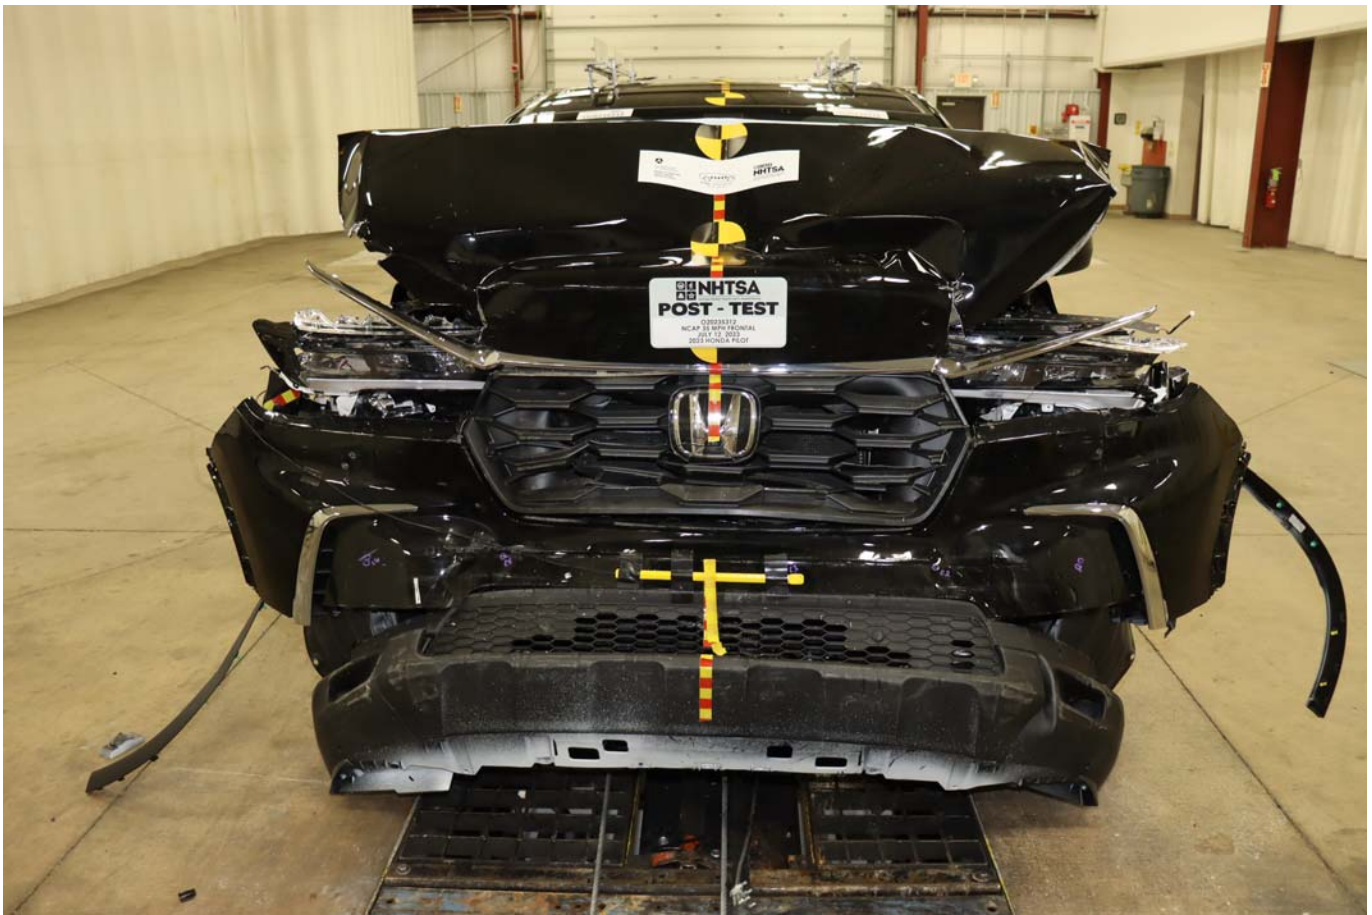
Photo No. 009 - Post-Test Front View of Test Vehicle

The maximum static crush of the vehicle was 508 mm located to the right of the vehicle centerline and both the driver and passenger side doors remained closed during the impact event and were operable after the impact.

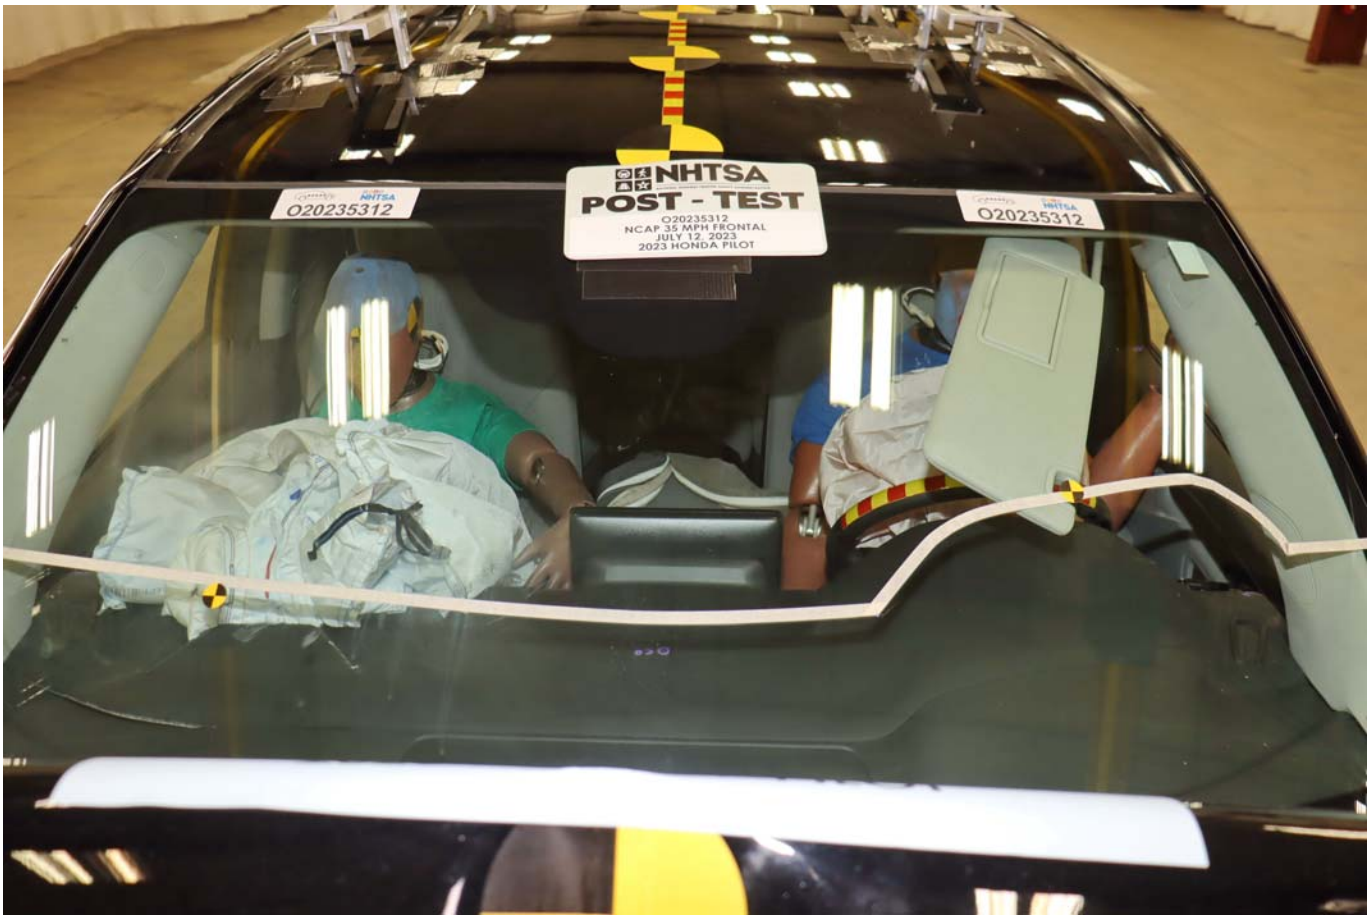
Photo No. 019 - Post-Test Windshield View

There was 100 percent windshield retention and no intrusion into the protected zone of the windshield during the event. There was no Stoddard Solvent leakage after the event or during any phase of the static rollover.

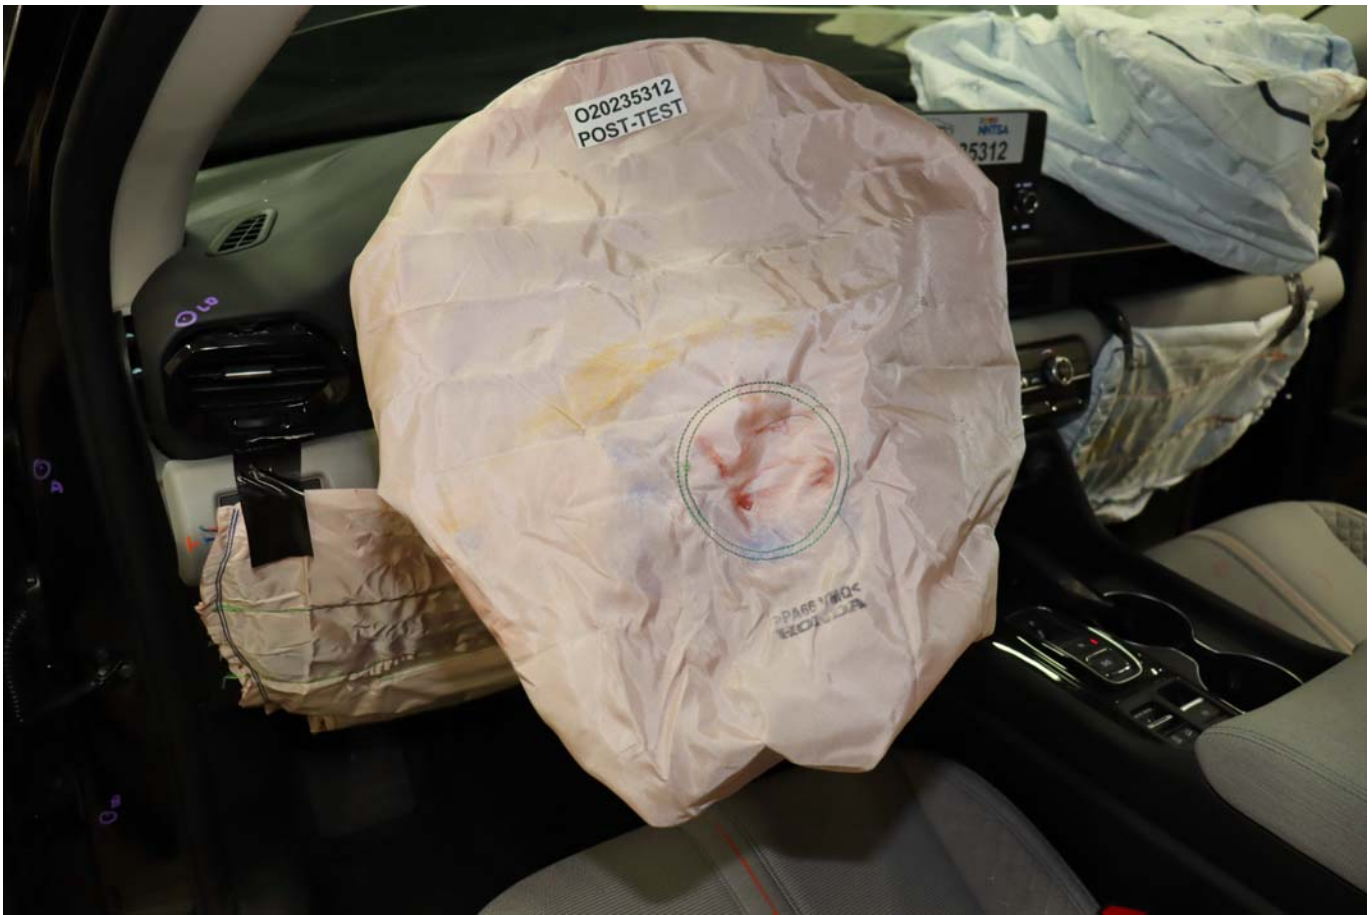
Photo No. 049 - Post-Test Driver Dummy Contact with Airbag

The driver's visible contact points were as follows: The driver's head contacted the airbag. The driver's head also contacted the headrest. The driver's knees contacted the knee airbag.

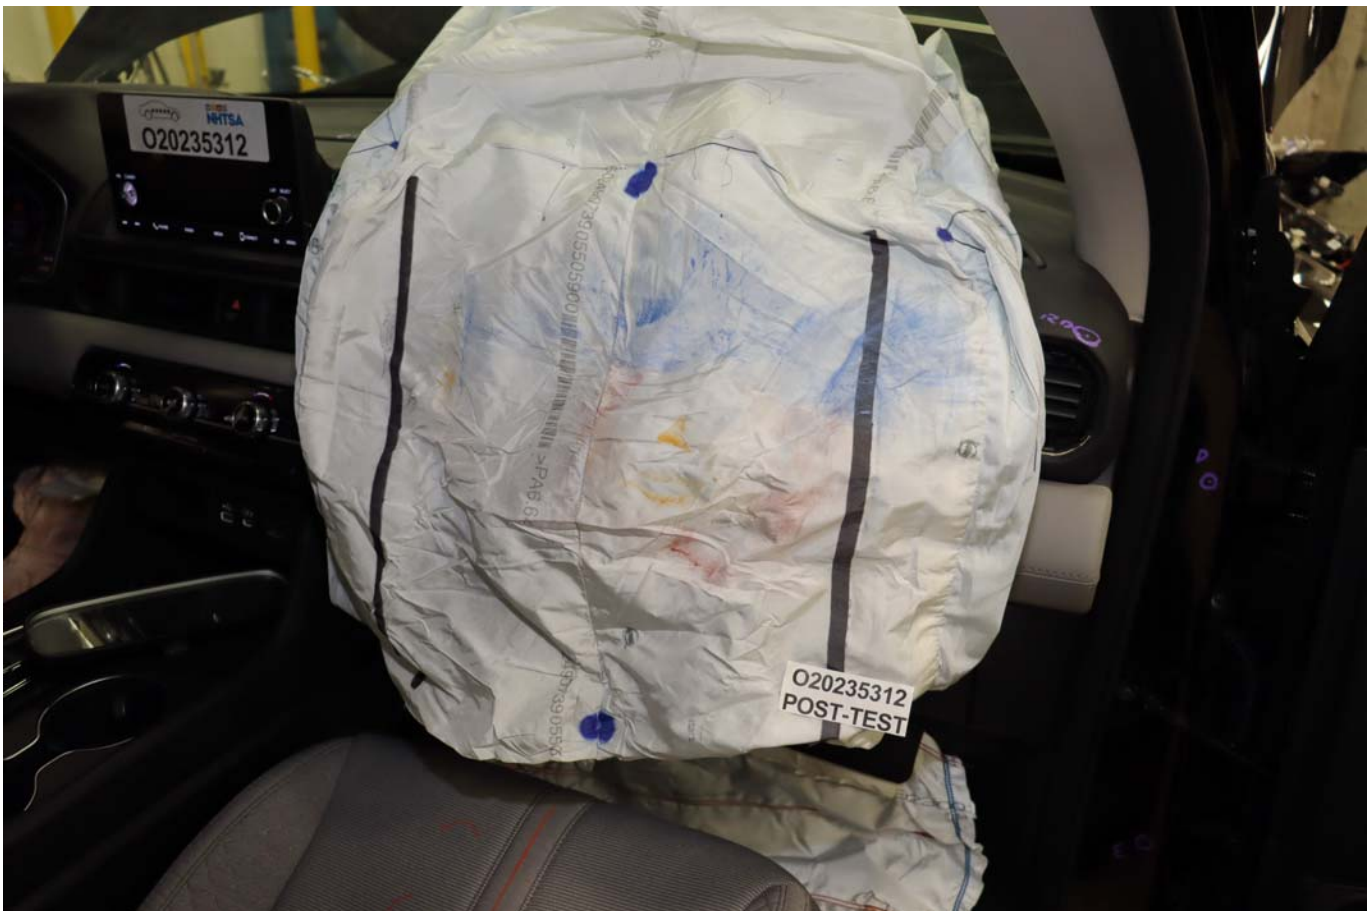
Photo No. 072 - Post-Test Passenger Dummy Contact with Airbag

The passenger's visible contact points were as follows: The passenger's head contacted the airbag. The passenger's head also contacted the headrest. The passenger's knees contacted the knee airbag.
