REPORT NUMBER: 214P-CAL-23-006

**NEW CAR ASSESSMENT PROGRAM (NCAP)
SIDE IMPACT POLE TEST**

**Mazda Motor Manufacturing de Mexico S.A. DE C.V.
2023 Mazda Mazda3
4 Door Sedan**

NHTSA No: O20235402

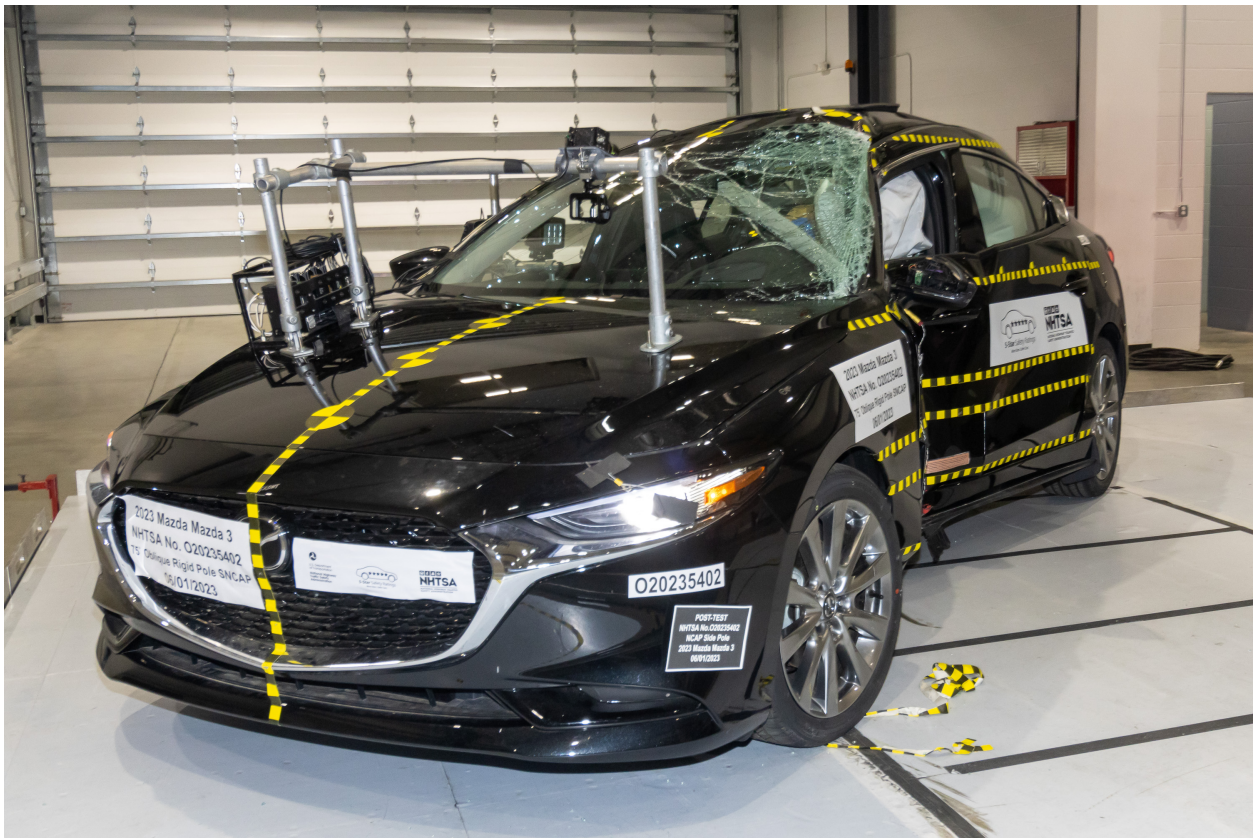
Figure A-6: Post-Test Left Front 3/4 View of Test Vehicle

Critical Areas of Performance	Observations and Conclusions
Pillar Performance	A-Pillar and C-Pillar buckled
Sill Separation	345 mm at rear pinch weld and 185 mm on pinch weld at impact location
Windshield Damage	Cracked throughout and separated along A-Pillar
Side Window Damage	Driver window shattered on impact
Other Notable Effects	Sunroof separated from its track on the left side
