**REPORT NUMBER: SideNCAPMDB-KAR-24-002
NEW CAR ASSESSMENT PROGRAM (NCAP)
MOVING DEFORMABLE BARRIER SIDE IMPACT TEST**

**SUBARU CORPORATION
2024 SUBARU IMPREZA 5-DOOR STATION WAGON**

NHTSA No: O20245503

**PREPARED BY:
APPLUS+ IDIADA KARCO ENGINEERING, LLC.
9270 HOLLY ROAD
ADELANTO, CA 92301**

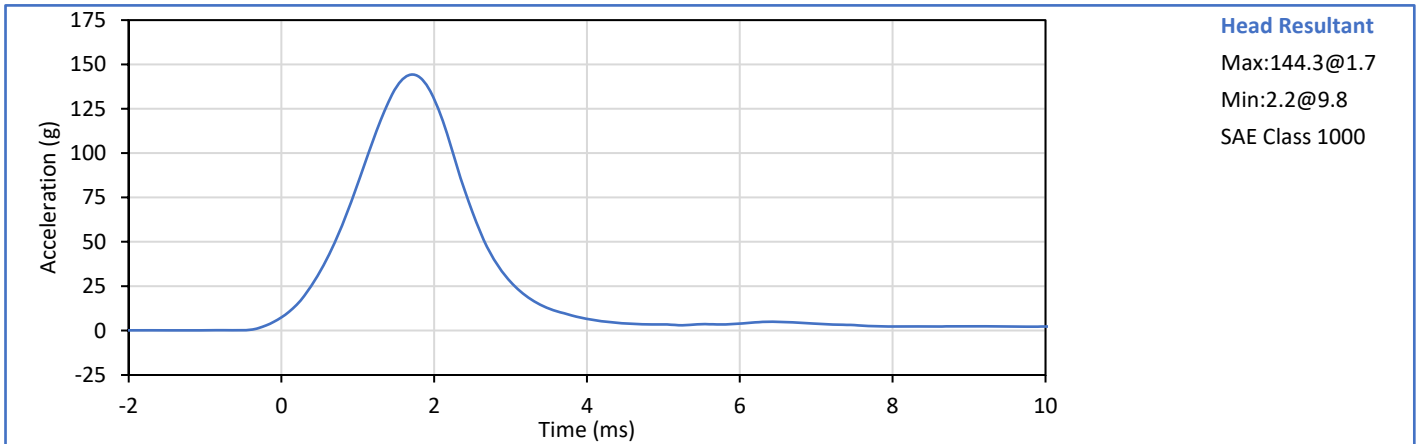
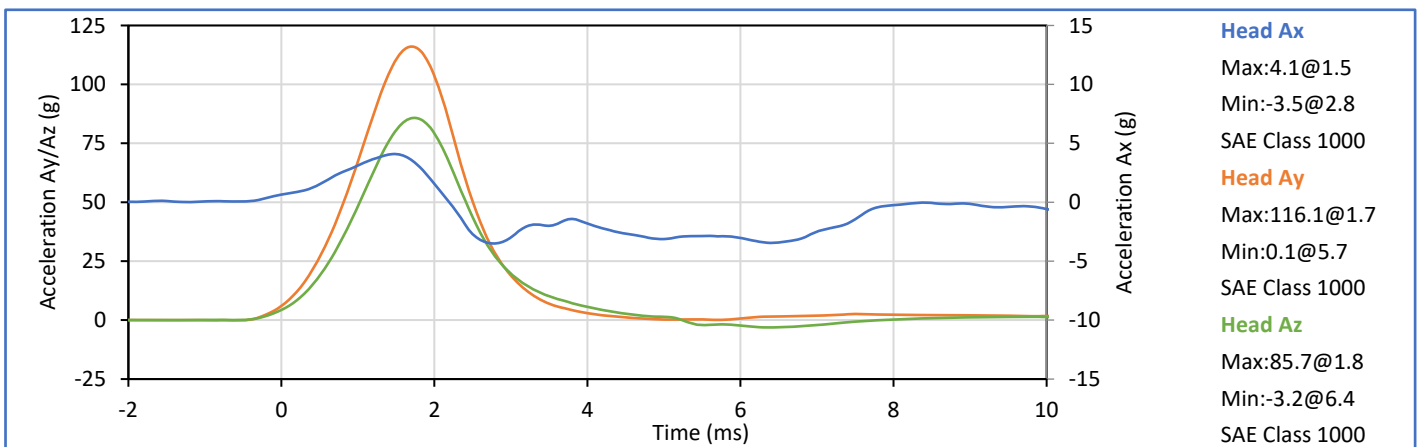
Tested Parameter	Units	Spec. Low	Spec. High	Result	Pass/Fail
Laboratory Temperature	°C	18.9	25.6	21.4	Pass
Laboratory Relative Humidity	%	10	70	32	Pass
Peak Resultant Acceleration	g	125.0	155.0	144.3	Pass
Peak Head Ax	g	-15.0	15.0	4.1	Pass
Oscillations After Main Pulse	%	0.0	15.0	3.4	Pass
Is Acceleration Unimodal?	Yes/No	Yes		Yes	Pass
				Overall Test Results	Pass

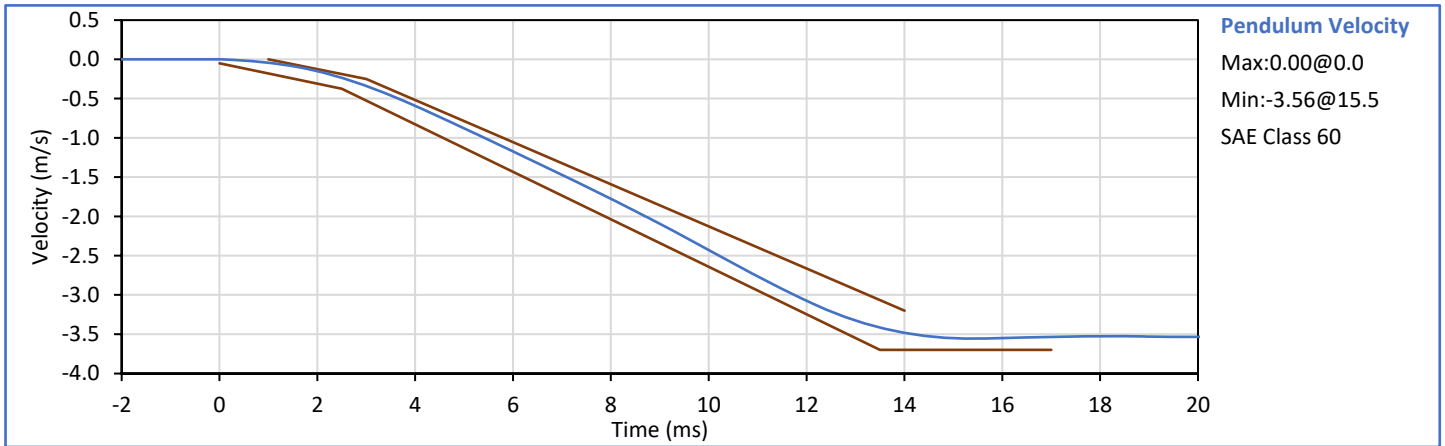
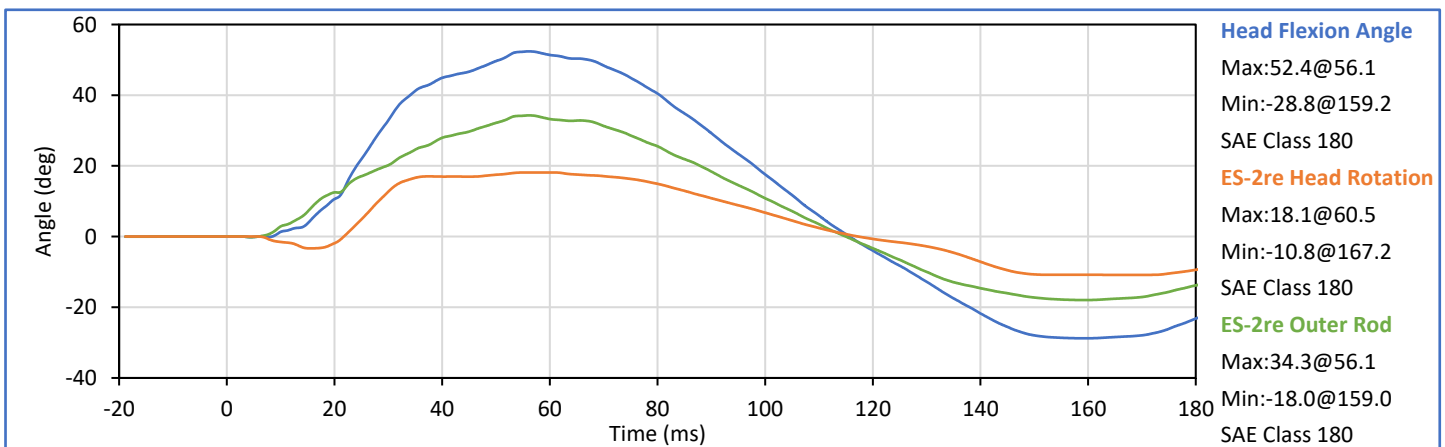
Tested Parameter	Units	Spec. Low	Spec. High	Result	Pass/Fail
Laboratory Temperature	°C	20.6	22.2	21.4	Pass
Laboratory Relative Humidity	%	10	70	31	Pass
Pendulum Velocity	m/s	3.30	3.50	3.44	Pass
Peak Headform Flexion	deg	49.0	59.0	52.4	Pass
Time of Peak Headform Flexion	ms	54.0	66.0	56.1	Pass
Flexion Decay (Peak to zero)	ms	53.0	88.0	59.7	Pass
Overall Test Results					Pass

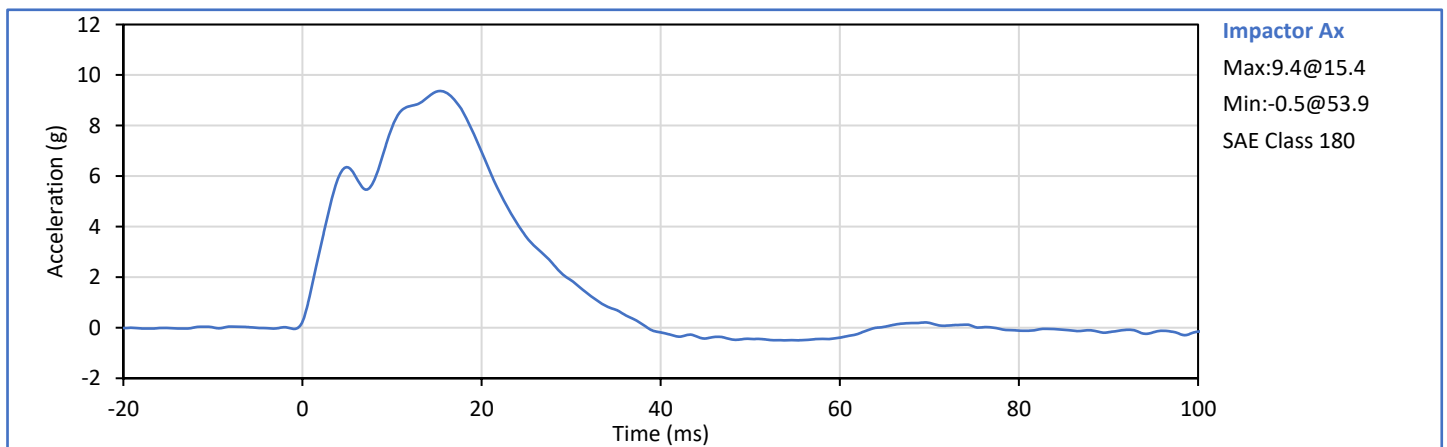
Tested Parameter	Units	Spec. Low	Spec. High	Result	Pass/Fail
Laboratory Temperature	°C	20.6	22.2	21.5	Pass
Laboratory Relative Humidity	%	10	70	38	Pass
Impactor Velocity	m/s	4.20	4.40	4.33	Pass
Peak Impactor Ax	g	7.5	10.5	9.4	Pass
Overall Test Results					Pass

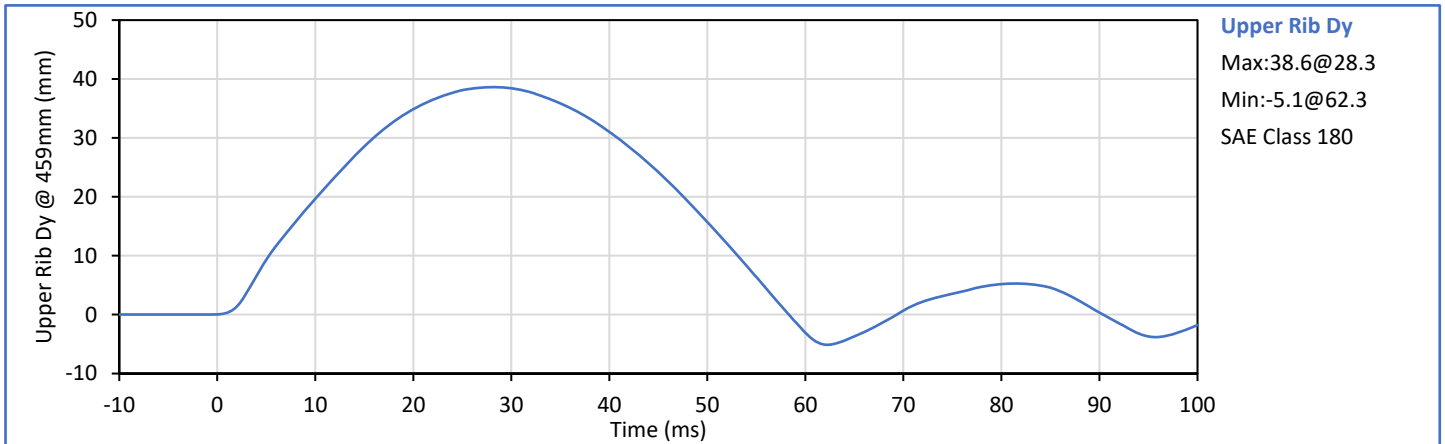
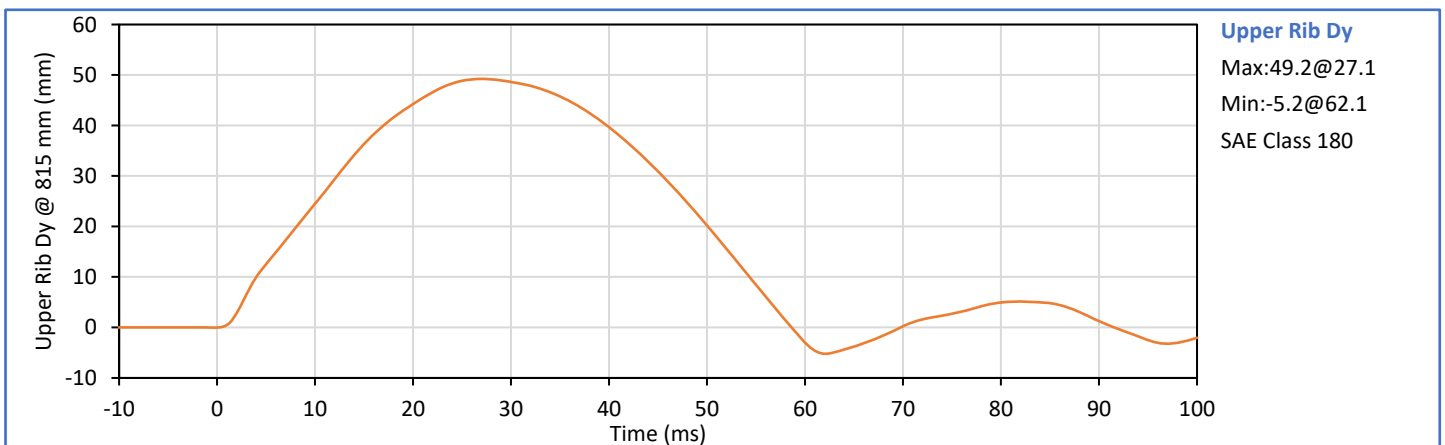
Tested Parameter	Units	Spec. Low	Spec. High	Result	Pass/Fail
Laboratory Temperature	°C	20.6	22.2	21.6	Pass
Laboratory Relative Humidity	%	10	70	35	Pass
Upper Rib Dy @ 459mm	mm	36.0	40.0	38.6	Pass
Upper Rib Dy @ 815mm	mm	46.0	51.0	49.2	Pass
Overall Test Results					Pass

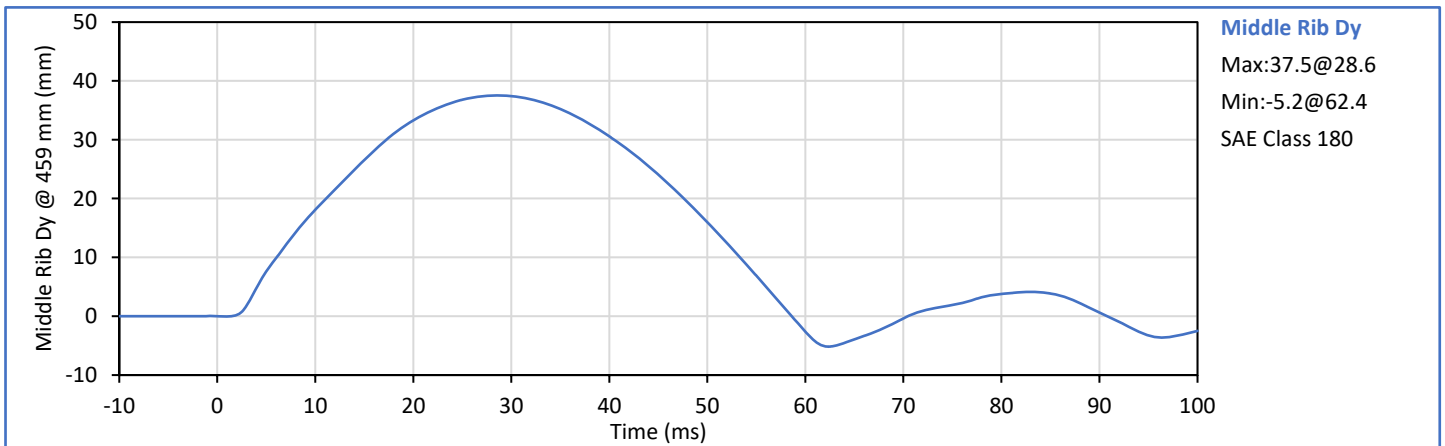
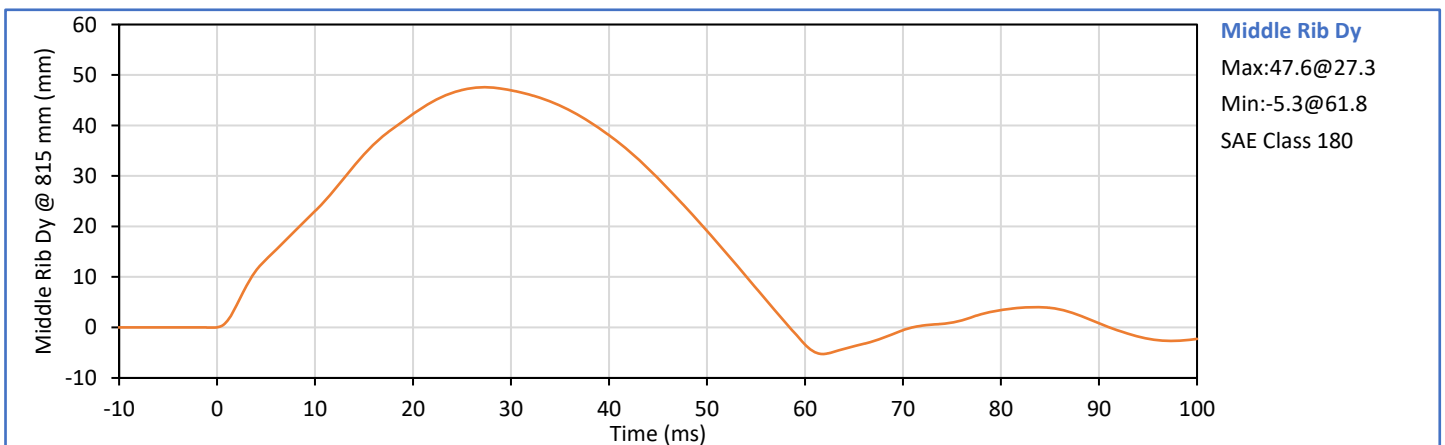
Tested Parameter	Units	Spec. Low	Spec. High	Result	Pass/Fail
Laboratory Temperature	°C	20.6	22.2	21.6	Pass
Laboratory Relative Humidity	%	10	70	35	Pass
Middle Rib Dy @ 459mm	mm	36.0	40.0	37.5	Pass
Middle Rib Dy @ 815mm	mm	46.0	51.0	47.6	Pass
Overall Test Results					Pass

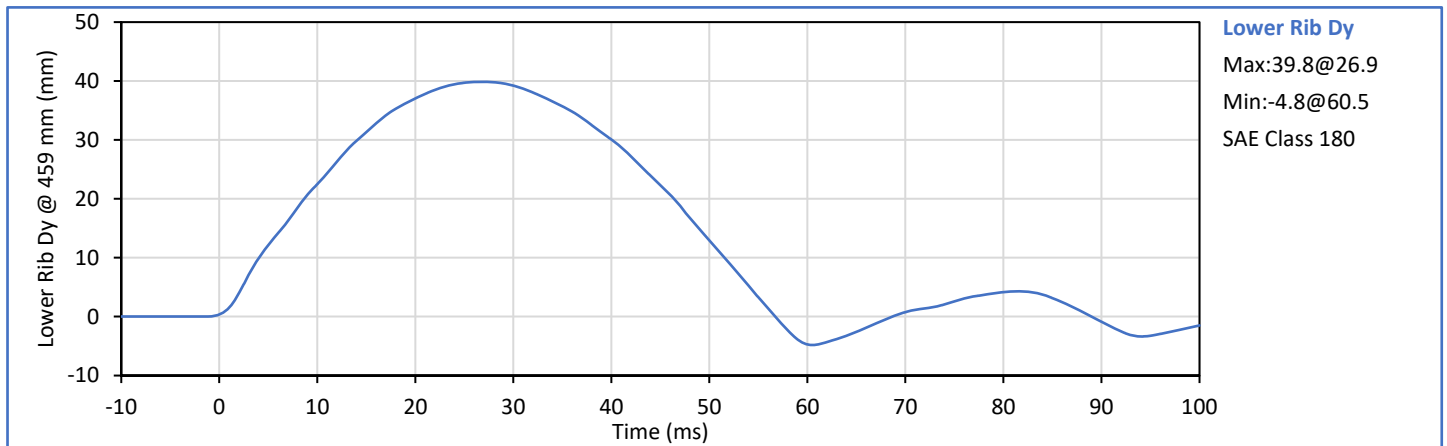
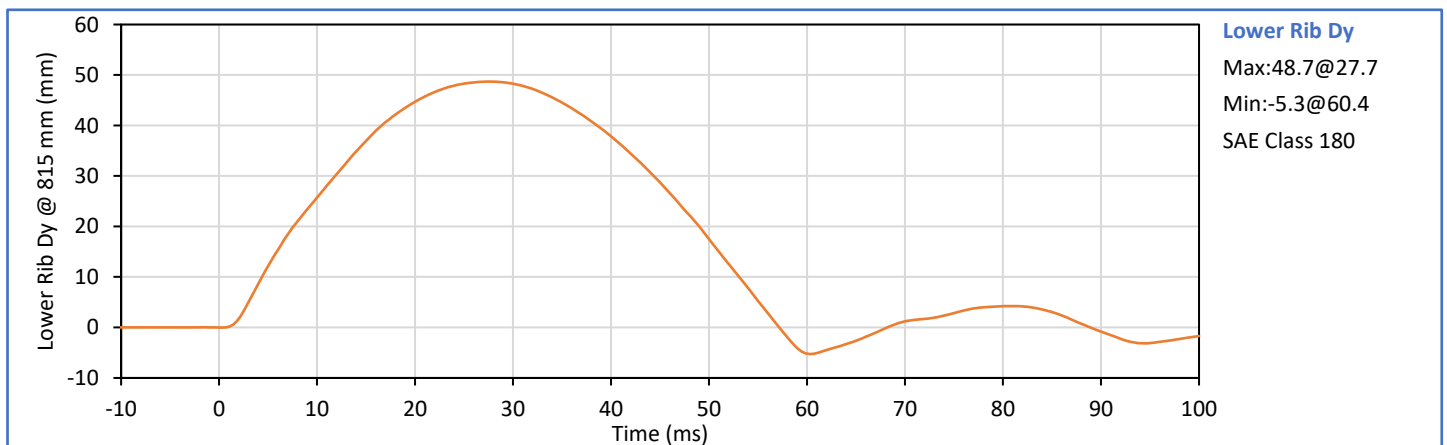
Tested Parameter	Units	Spec. Low	Spec. High	Result	Pass/Fail
Laboratory Temperature	°C	20.6	22.2	21.6	Pass
Laboratory Relative Humidity	%	10	70	35	Pass
Lower Rib Dy @ 459mm	mm	36.0	40.0	39.8	Pass
Lower Rib Dy @ 815mm	mm	46.0	51.0	48.7	Pass
Overall Test Results					Pass

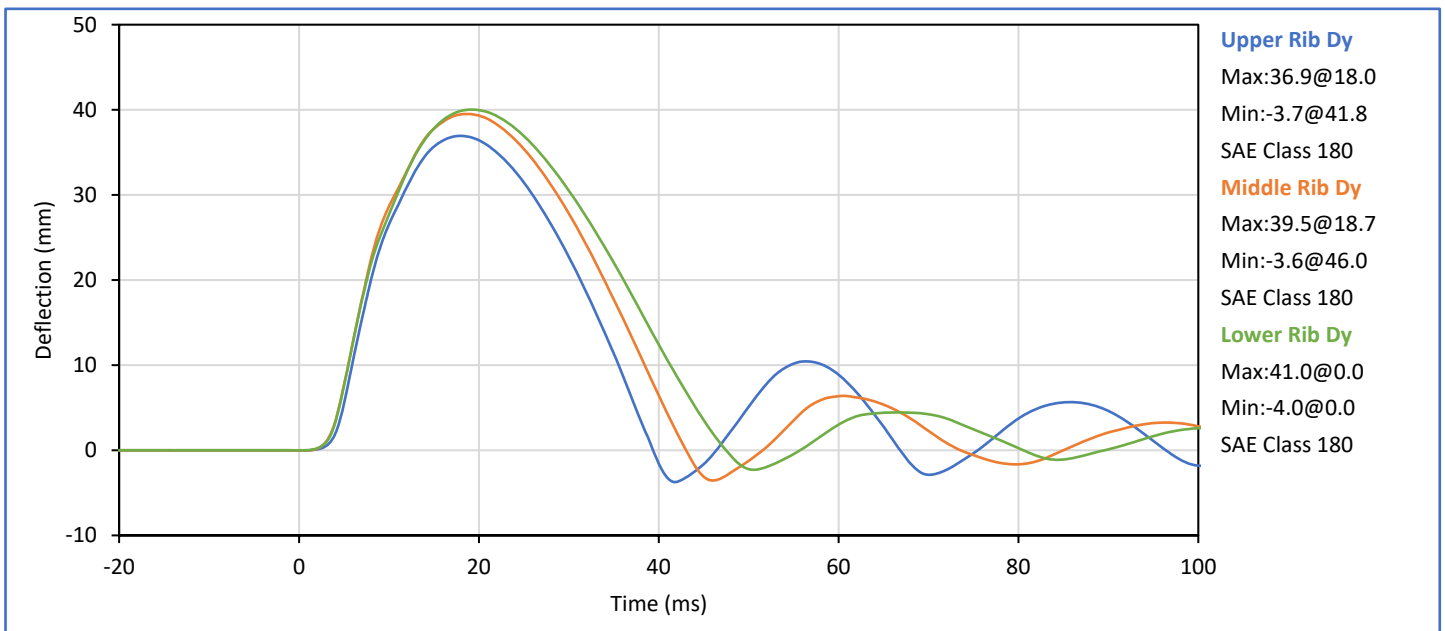
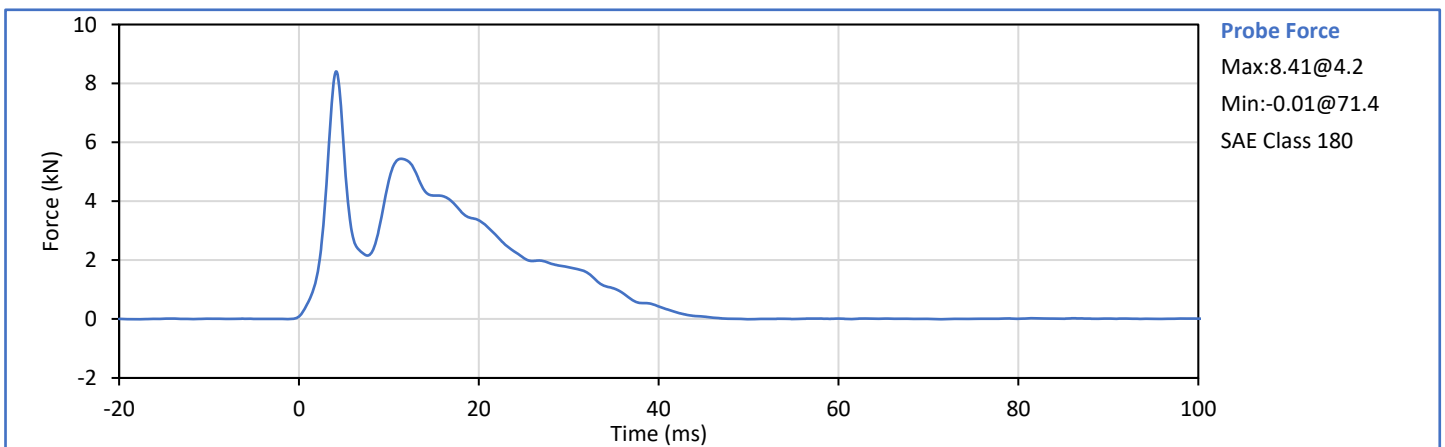
Tested Parameter	Units	Spec. Low	Spec. High	Result	Pass/Fail
Laboratory Temperature	°C	20.6	22.2	21.2	Pass
Laboratory Relative Humidity	%	10	70	36	Pass
Impactor Velocity	m/s	5.40	5.60	5.55	Pass
Peak Upper Rib Dy	mm	34.0	41.0	36.9	Pass
Peak Middle Rib Dy	mm	37.0	45.0	39.5	Pass
Peak Lower Rib Dy	mm	37.0	44.0	40.0	Pass
Peak Impactor Force After 6 ms	kN	5.10	6.20	5.44	Pass
Overall Test Results					Pass

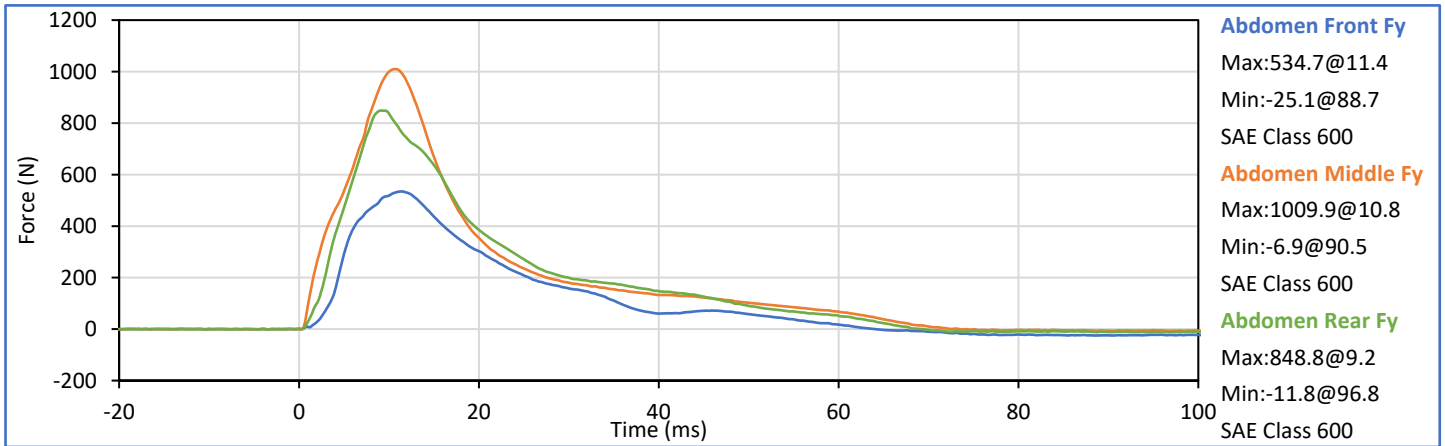
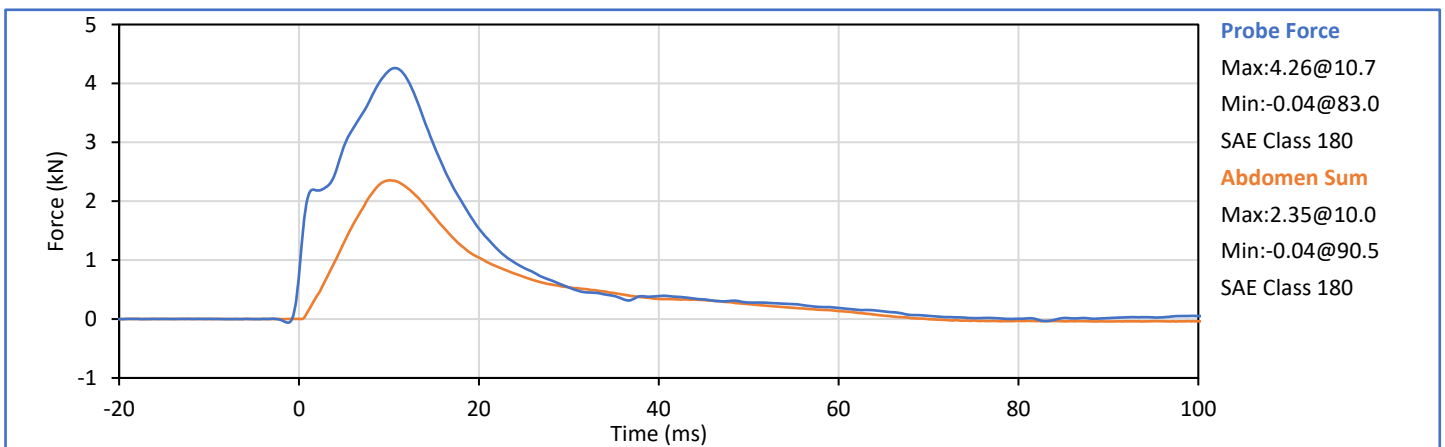
Tested Parameter	Units	Spec. Low	Spec. High	Result	Pass/Fail
Laboratory Temperature	°C	20.6	22.2	21.2	Pass
Laboratory Relative Humidity	%	10	70	37	Pass
Impactor Velocity	m/s	3.90	4.10	4.05	Pass
Peak Impactor Force	kN	4.00	4.80	4.26	Pass
Time of Peak Impactor Force	ms	10.6	13.0	10.7	Pass
Sum of Abdomen Forces	kN	2.20	2.70	2.35	Pass
Time of Peak Sum Abdomen Force	ms	10.0	12.3	10.0	Pass
Overall Test Results					Pass

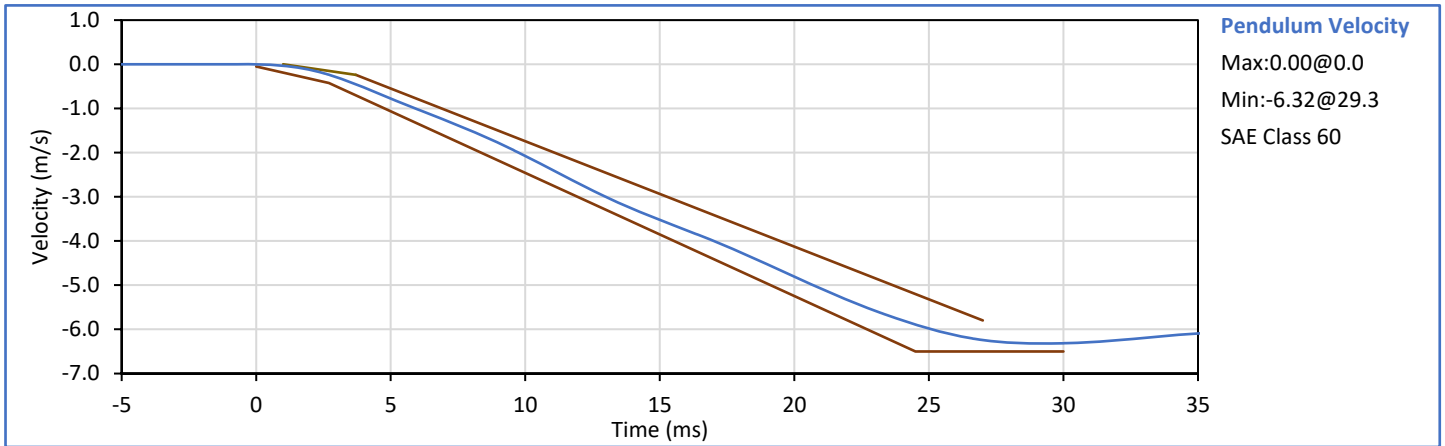
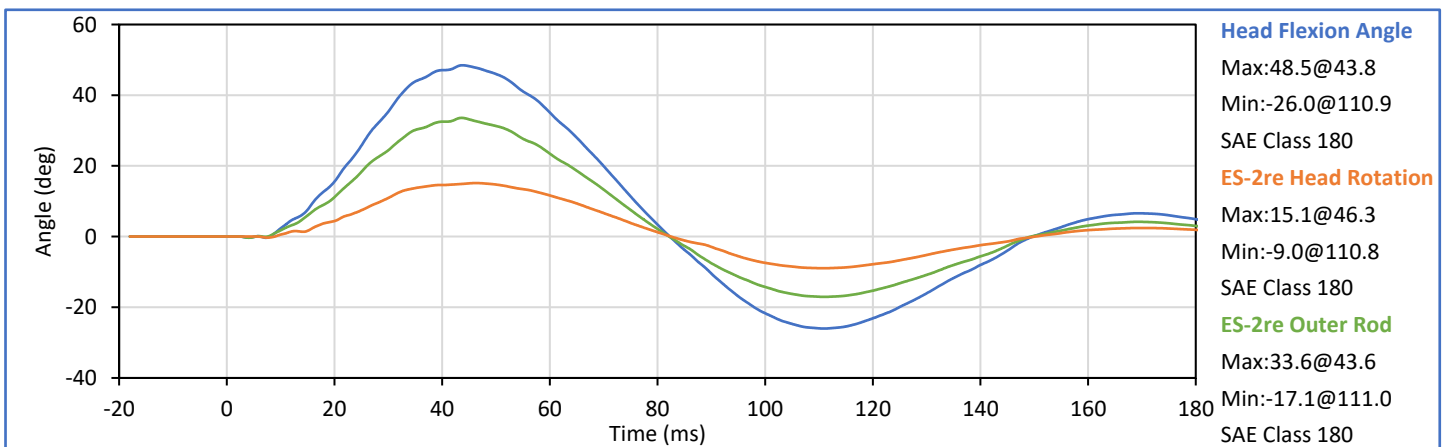
Tested Parameter	Units	Spec. Low	Spec. High	Result	Pass/Fail
Laboratory Temperature	°C	20.6	22.2	21.2	Pass
Laboratory Relative Humidity	%	10	70	30	Pass
Pendulum Velocity	m/s	5.95	6.15	6.11	Pass
Peak Headform Flexion	deg	45.0	55.0	48.5	Pass
Time of Peak Headform Flexion	ms	39.0	53.0	43.8	Pass
Flexion Decay (Peak to zero)	ms	37.0	57.0	38.6	Pass
Overall Test Results					Pass

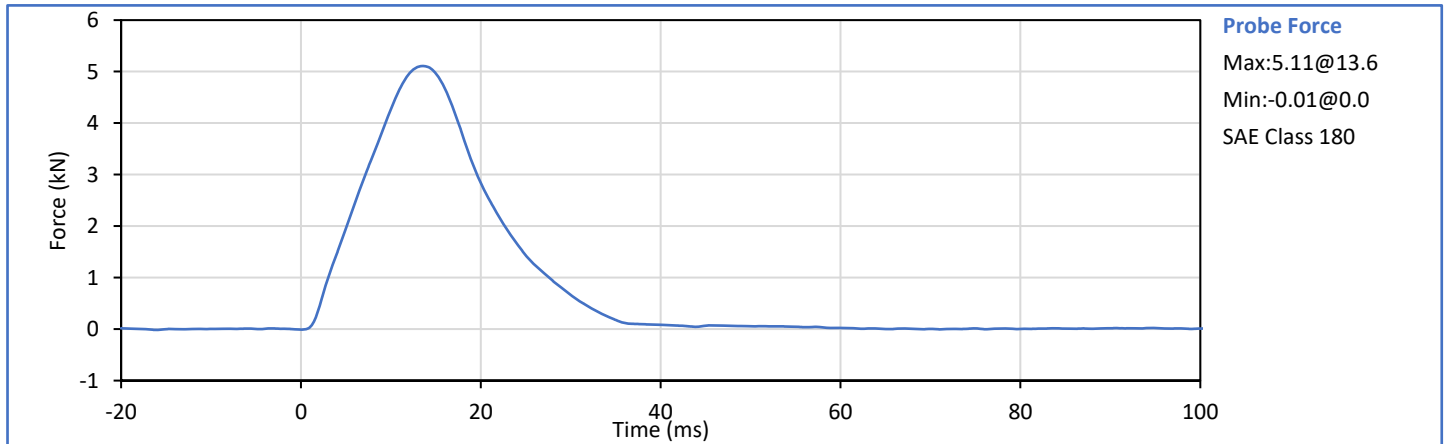
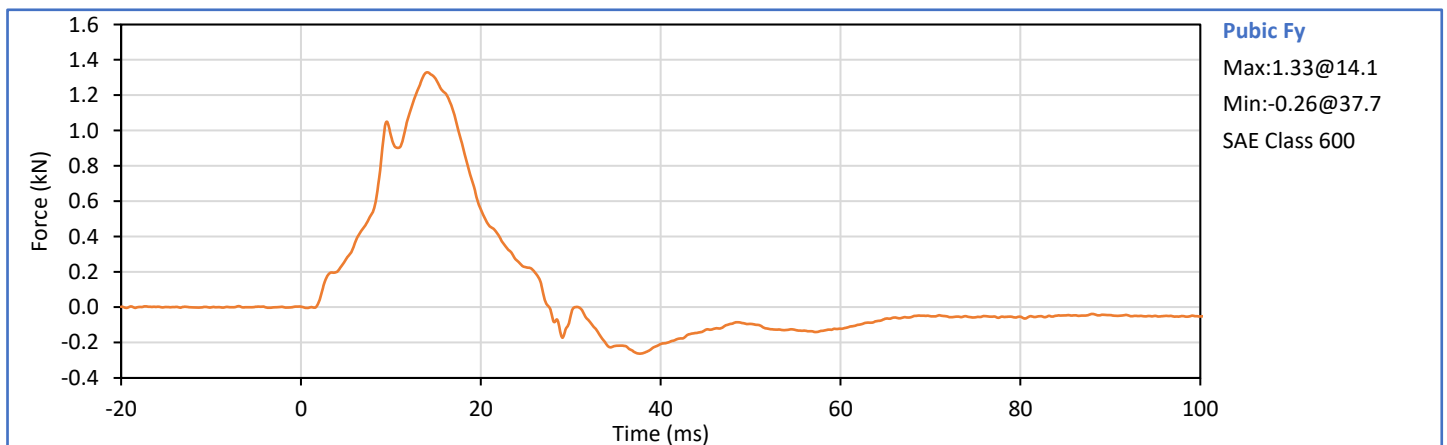
Tested Parameter	Units	Spec. Low	Spec. High	Result	Pass/Fail
Laboratory Temperature	°C	20.6	22.2	21.3	Pass
Laboratory Relative Humidity	%	10	70	37	Pass
Impactor Velocity	m/s	4.20	4.40	4.32	Pass
Peak Impactor Force	kN	4.70	5.40	5.11	Pass
Time of Peak Impactor Force	ms	11.8	16.1	13.6	Pass
Pubic Symphysis Fy	kN	1.23	1.59	1.33	Pass
Time of Peak Pubic Symphysis Fy	ms	12.2	17.0	14.1	Pass
Overall Test Results					Pass
